Division of Oil, Gas and Mining

Inspection Report

Permit Number:	C0070033
Inspection Type:	COMPLETE
Inspection Date:	Thursday, September 13, 2012
Start Date/Time:	9/13/2012 10:00:00 AM
End Date/Time:	9/13/2012 1:00:00 PM
Last Inspection:	Tuesday, August 14, 2012

Site: **WILDCAT LOADOUT**

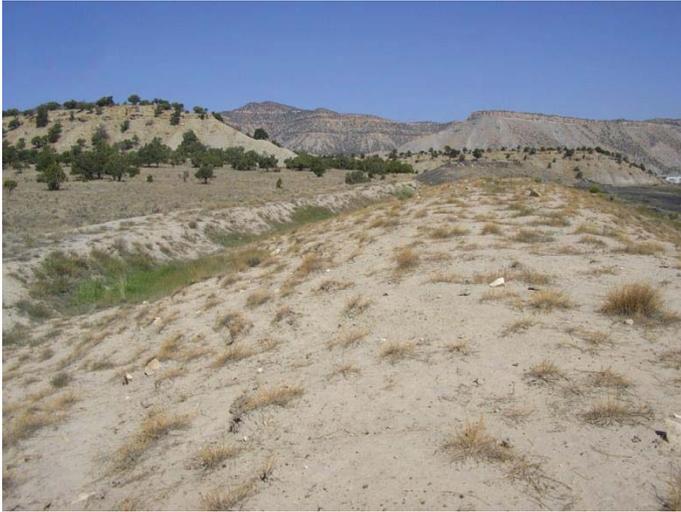
Topsoil Pile B

Refer to Plate 1 for topsoil stockpile locations. Topsoil stockpile B vegetation was extremely dry. Even Halogeton and forage Kochia (a seeded species) were dessicated. Grasses were growing only in the shade of the thistle and in the shade of the gouged depressions. (The history of topsoil pile B is found in the MRP Section R645-301-212, pp 2-3 and 2-4.) Topsoil stockpile E had better vegetation than stockpile B; I saw sagebrush, winterfat, opuntia, wheat grasses and Indian ricegrass on stockpile E. But even on stockpile E, the Indian ricegrass clumps were dried out. Topsoil pile F appeared windblown, with only a few grasses and rabbitbrush growing on its surface. These stockpiles have been in existence for over 20 years, but the growth is very poor, reflecting not only the most recent dry summer, but also the difficulty of establishing vegetation on an elevated mound of soil. (Topsoil pile A was not observed on this visit.) By comparison, the surrounding, undisturbed area is vegetated with rabbitbrush, sagebrush, rice grass, and globemallow; and where water is plentiful (I.e. the sediment pond) vegetation is squirreltail, rabbitbrush, and poplar trees. Appendix D provides the soil survey of the mine site and analysis of the topsoil in the stockpiles. The mine site was constructed on Hernandez soil. There are no limiting factors to this soil (other than water availability).

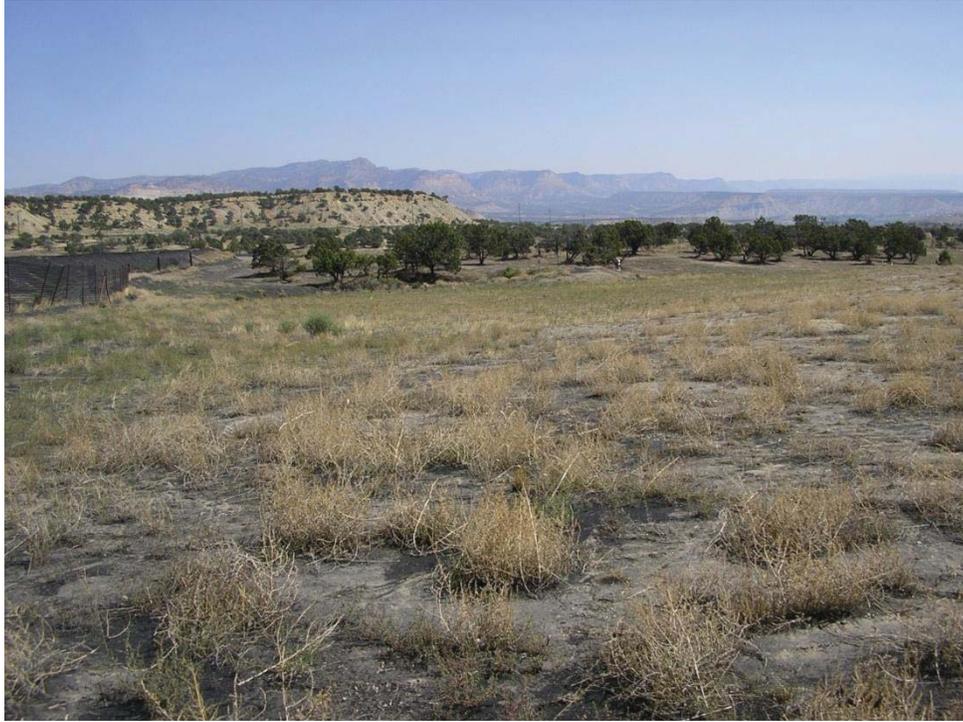
Area reseeded in 2010

The undisturbed area which was cleared of coal fines and reseeded in 2010 was observed. There are many globemallow plants growing. These were seen pre-existing in photos from 9/2010. Also noted were Indian ricegrass, wheat grasses and Triticale stalks. Excelsior logs placed in the reseeded area in 2010 have trapped greater than six inches of coal fines.

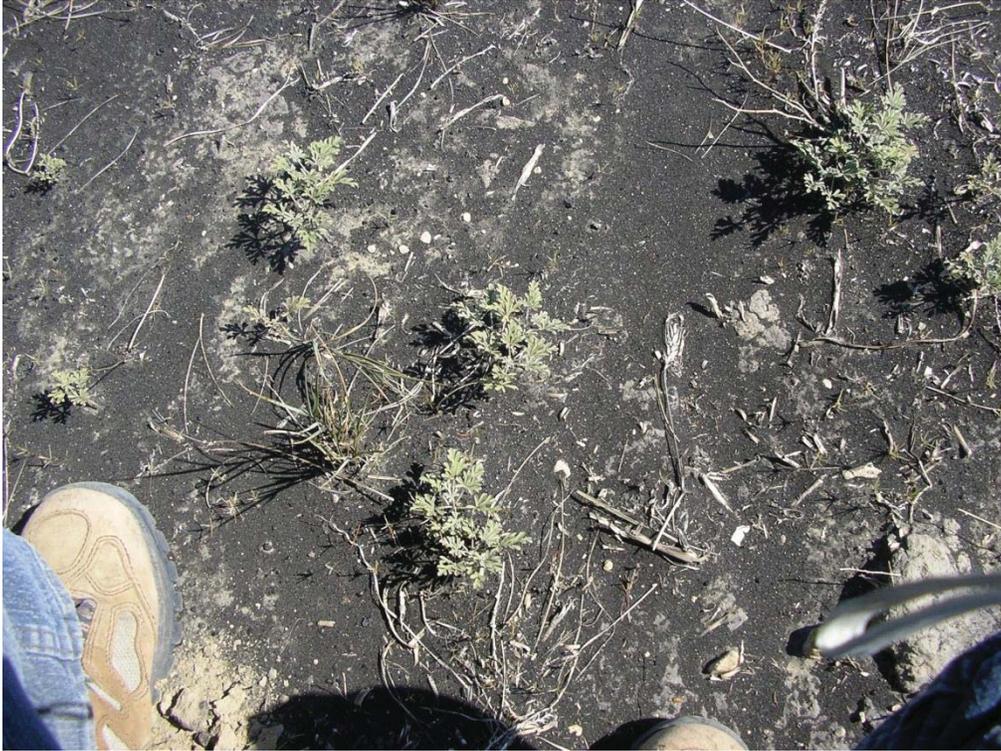
Desert globemallow (*Sphaeralcea ambigua*) was seeded in 2010
