**WILDCAT COAL FINES ISSUE
DIVISION ORDER-04 (WIND BLOWN FINES)
FIRST QUARTER 2015**

March 2015

WILD WEST EQUIPMENT & HAULING, LLC

**J. T. Paluso, P.E.
EIS ENVIRONMENTAL & ENGINEERING CONSULTING
31 NORTH MAIN, HELPER, UTAH**

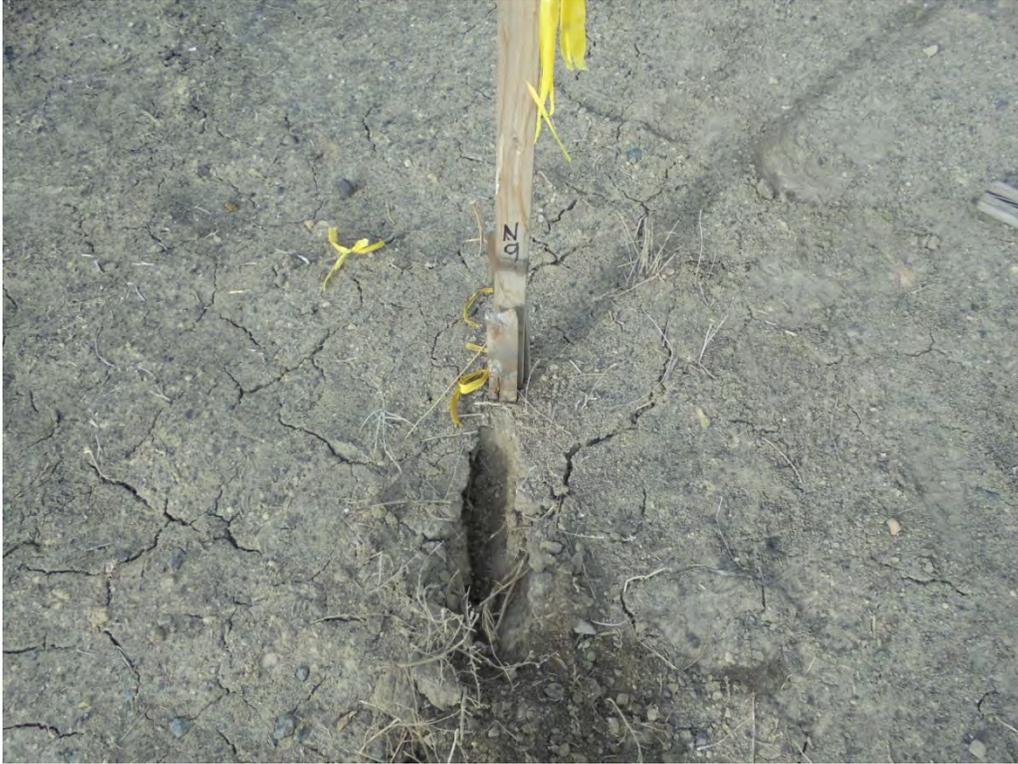
Site N9 had 3 inches of soil over coal fines during this measurement period. This site during the 4th Quarter 2014 measurement had 4.5 inches of coal fines. It appears that high flows of water moves soil and coal fines in and out of this area.

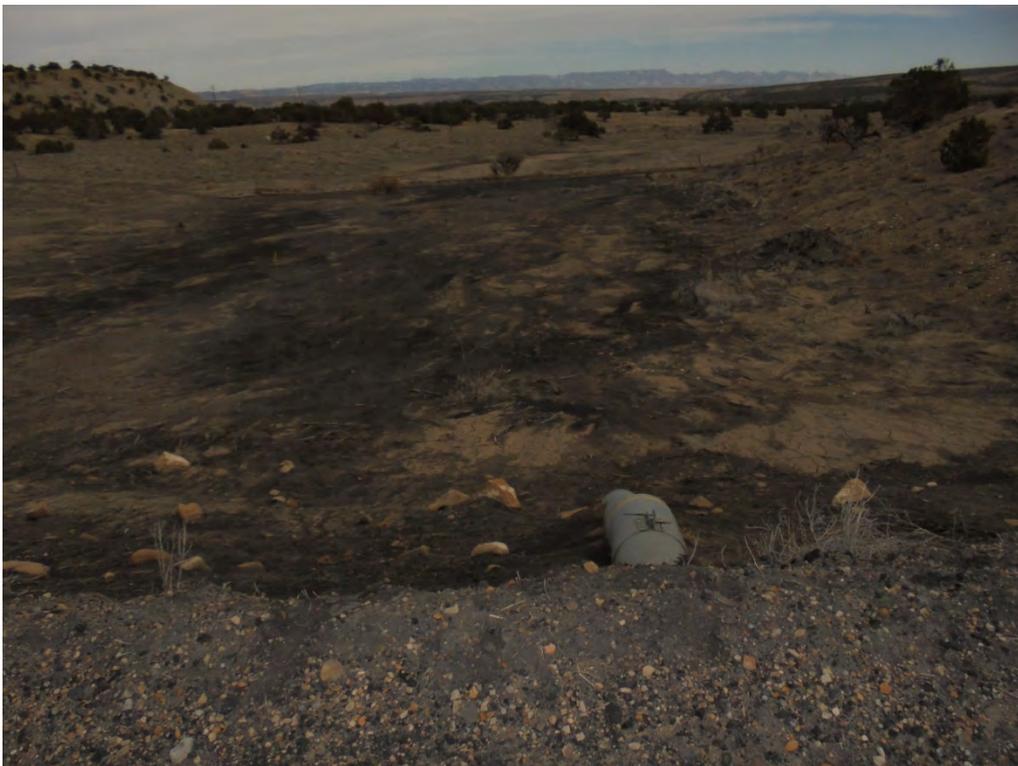
ABOVE N6 LOOKING SOUTHEAST

Vegetation reclamation work conducted in the spring of 2014 still has not produced much new vegetation. This reclamation work was to re-establish vegetation after coal fines greater than 4 inches were removed. These reclaimed areas have developed a hard crust. The hard crust is making it difficult for new vegetation to start growing. Please refer to the photographs located and the end of the photograph section.
