Inspection Report

Permit Number:	C0070033
Inspection Type:	COMPLETE
Inspection Date:	Thursday, February 22, 2018
Start Date/Time:	2/22/2018 10:00:00 AM
End Date/Time:	2/22/2018 2:00:00 PM
Last Inspection:	Wednesday, January 17, 2018

Site: **WILDCAT LOADOUT**

The Loadout is idle and needs major electrical repair due to vandalism.

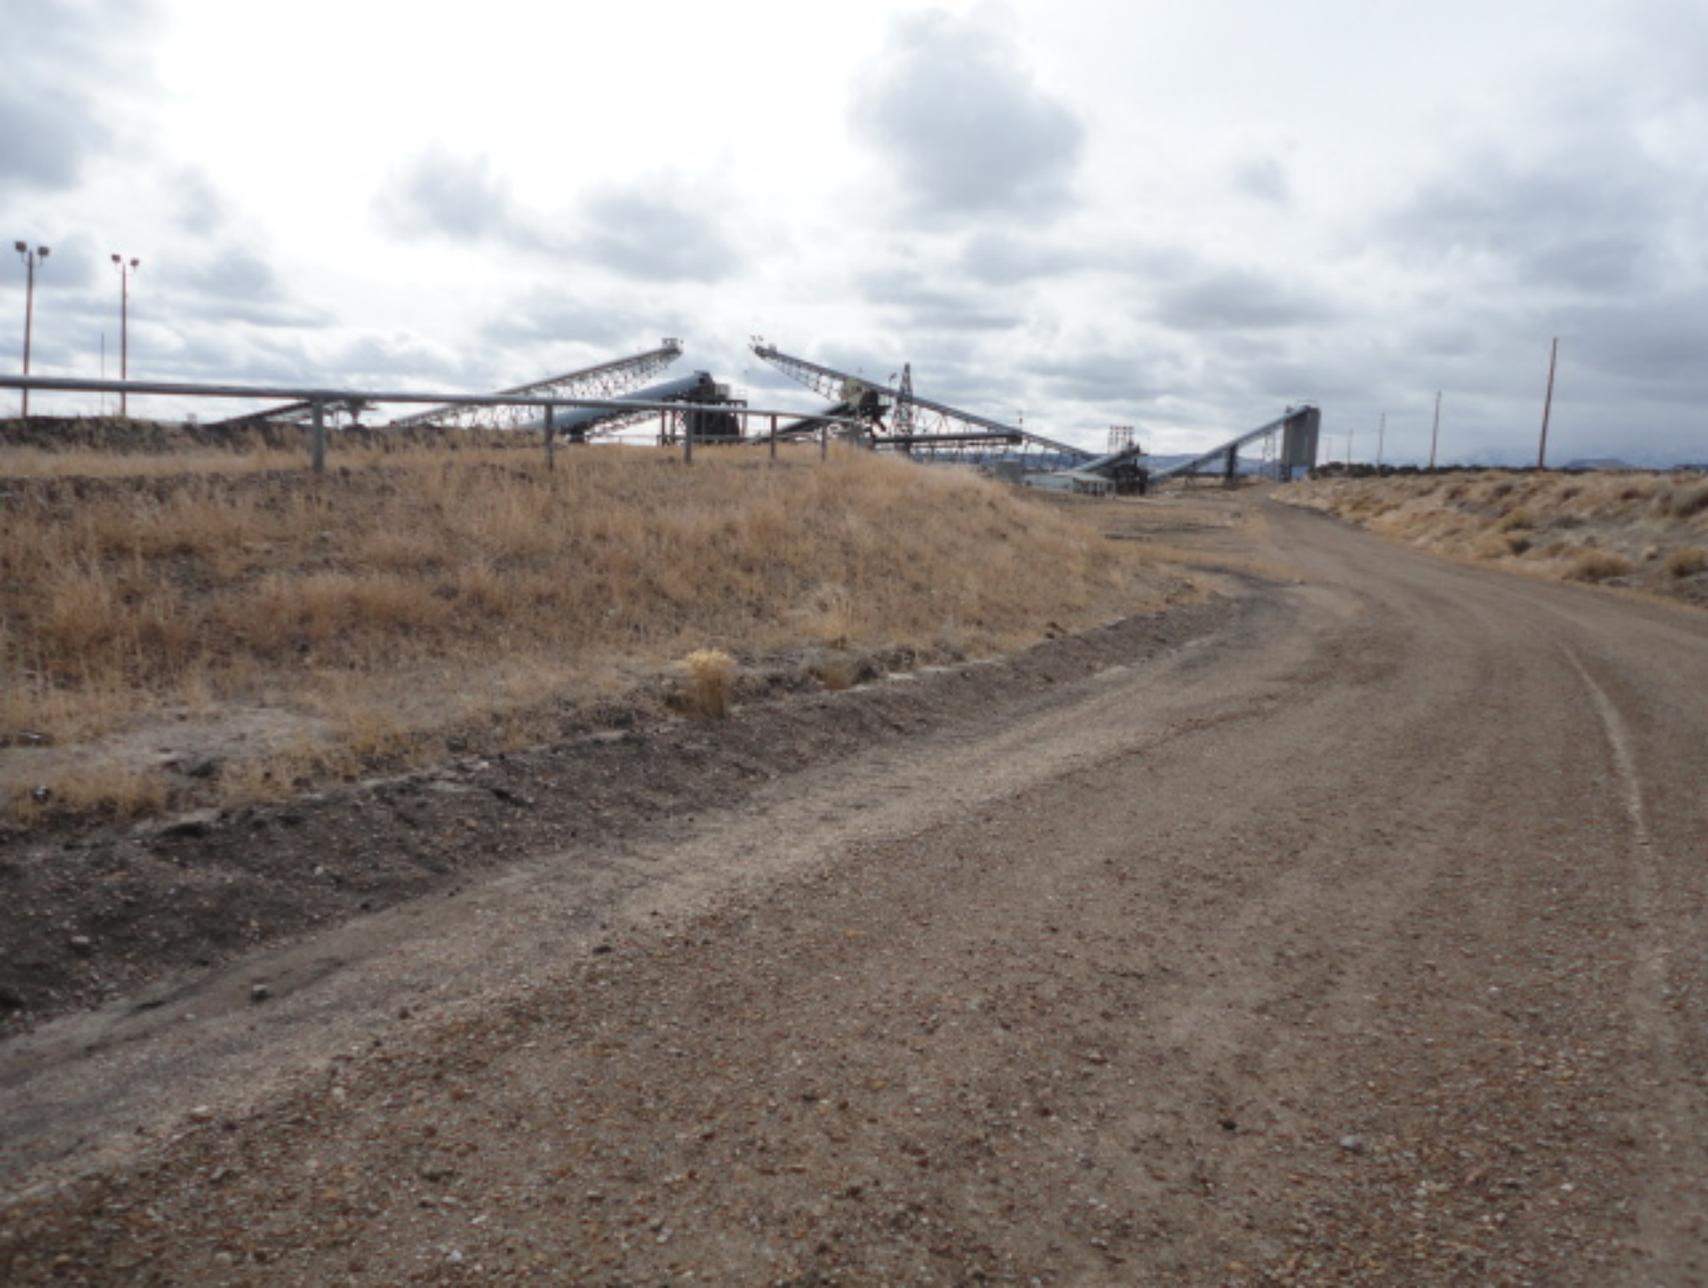
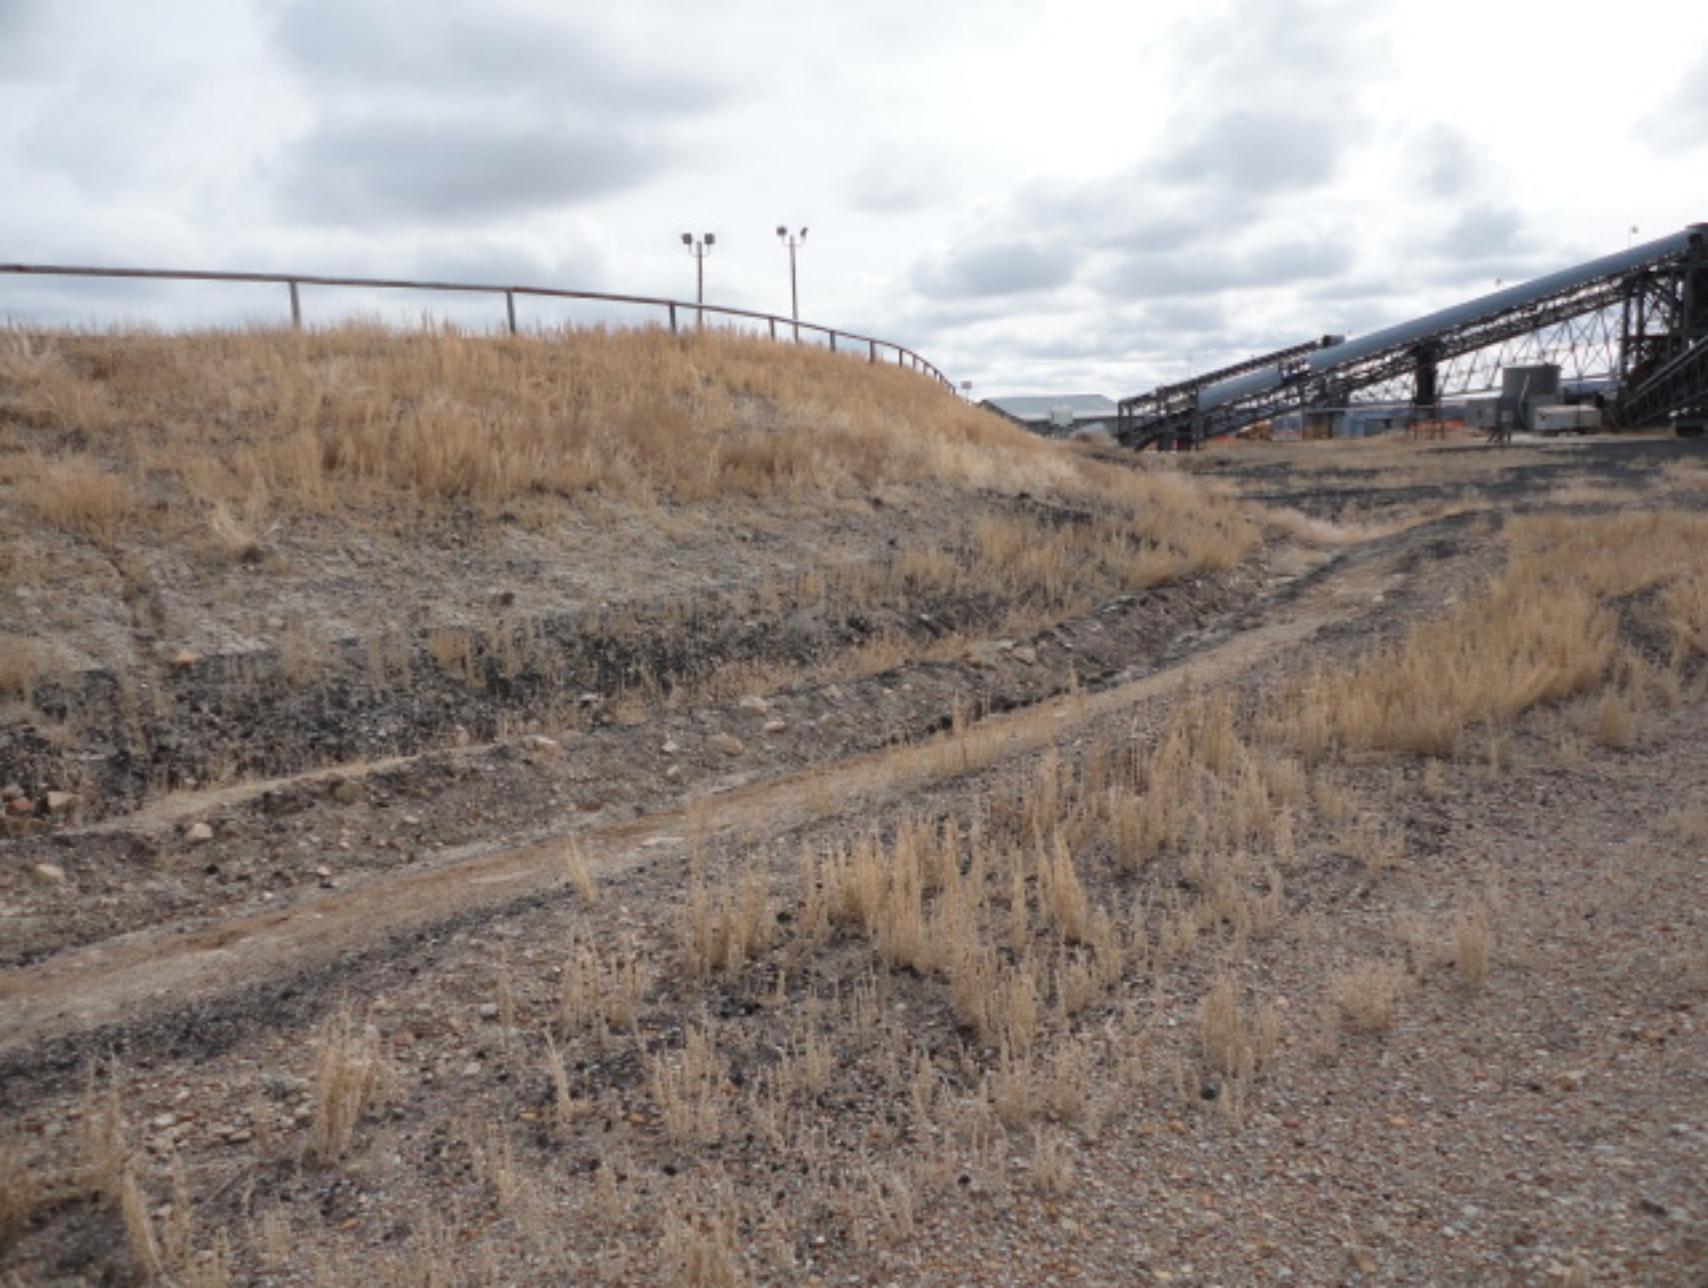
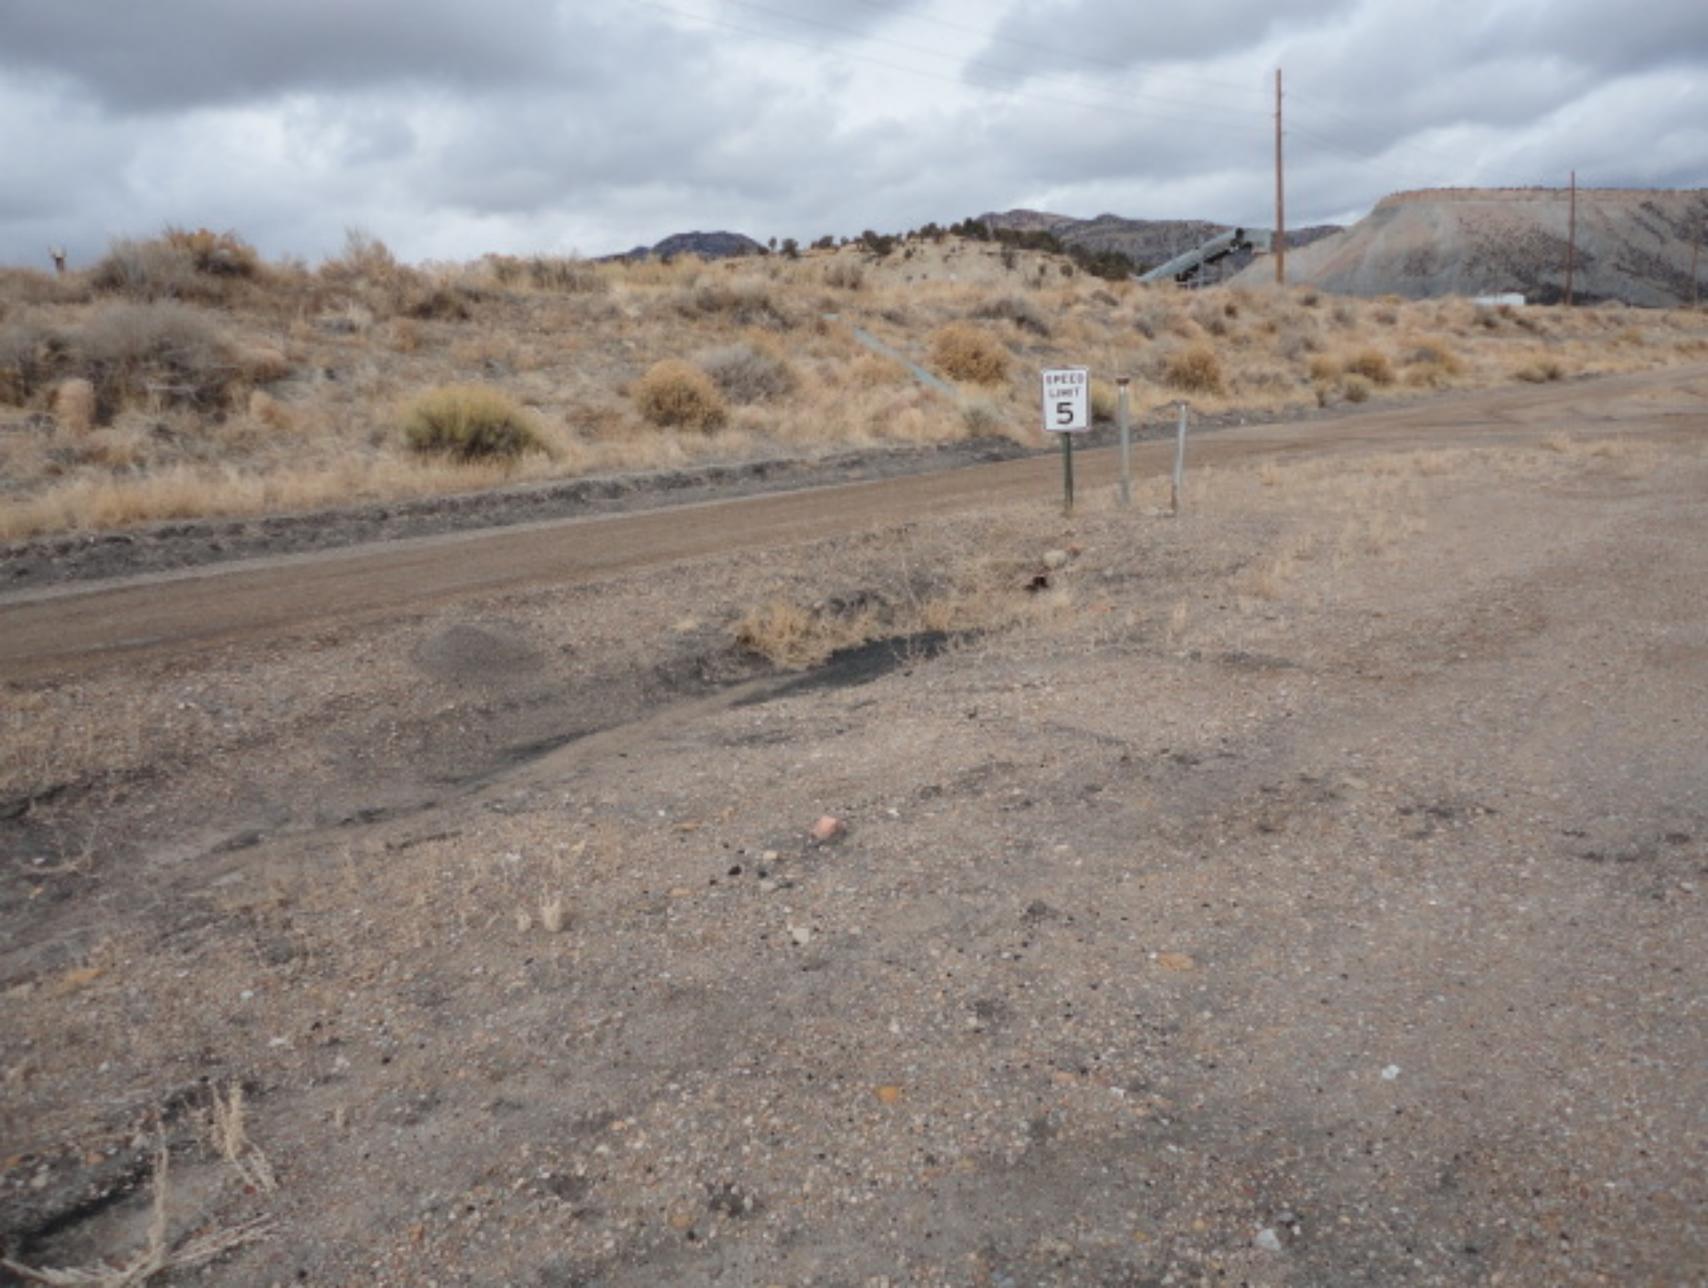
I inspected the refuse pile and it appears to be stable. I did not notice any hazardous conditions to the embankments. The refuse pile is active. The permittee conducted a fourth quarter refuse pile inspection on November 27, 2017. This document is P.E. certified. No hazardous conditions were reported. See Photos

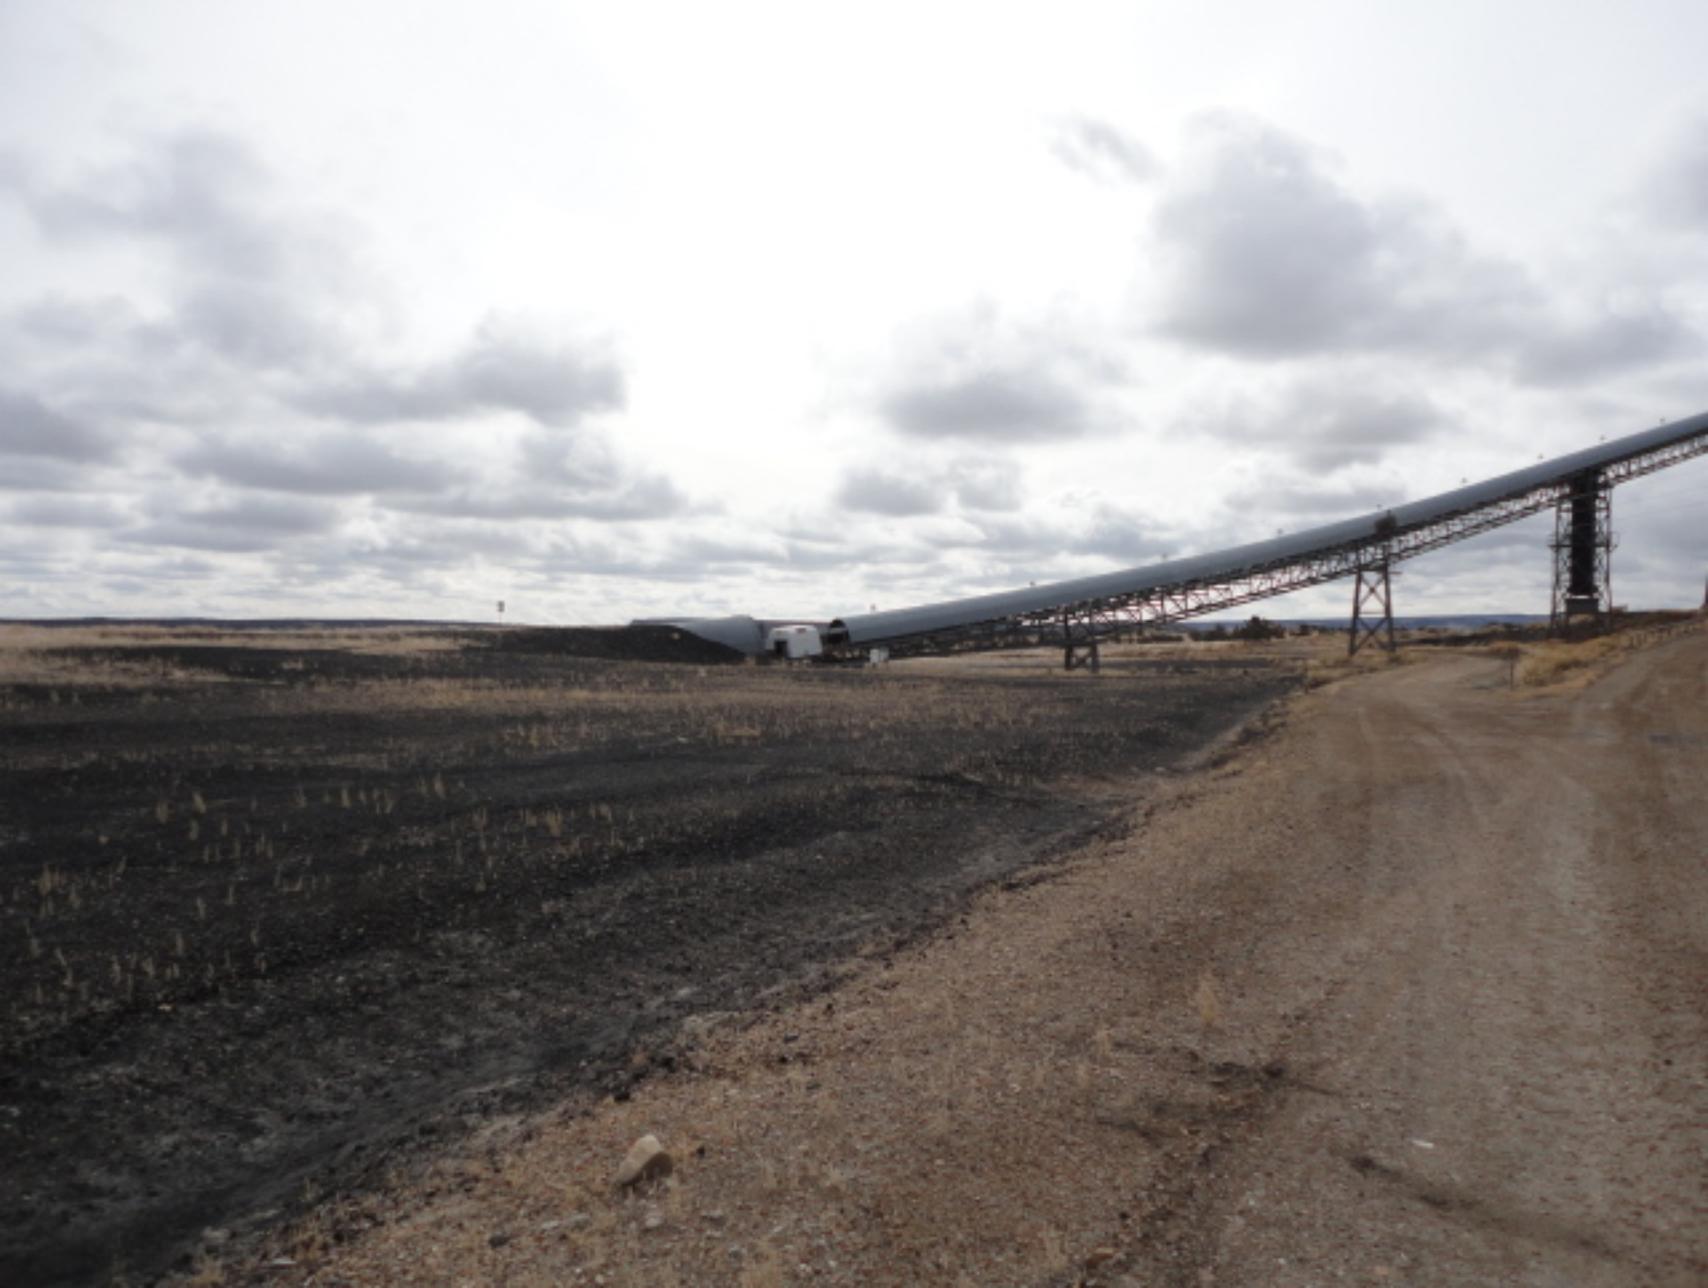
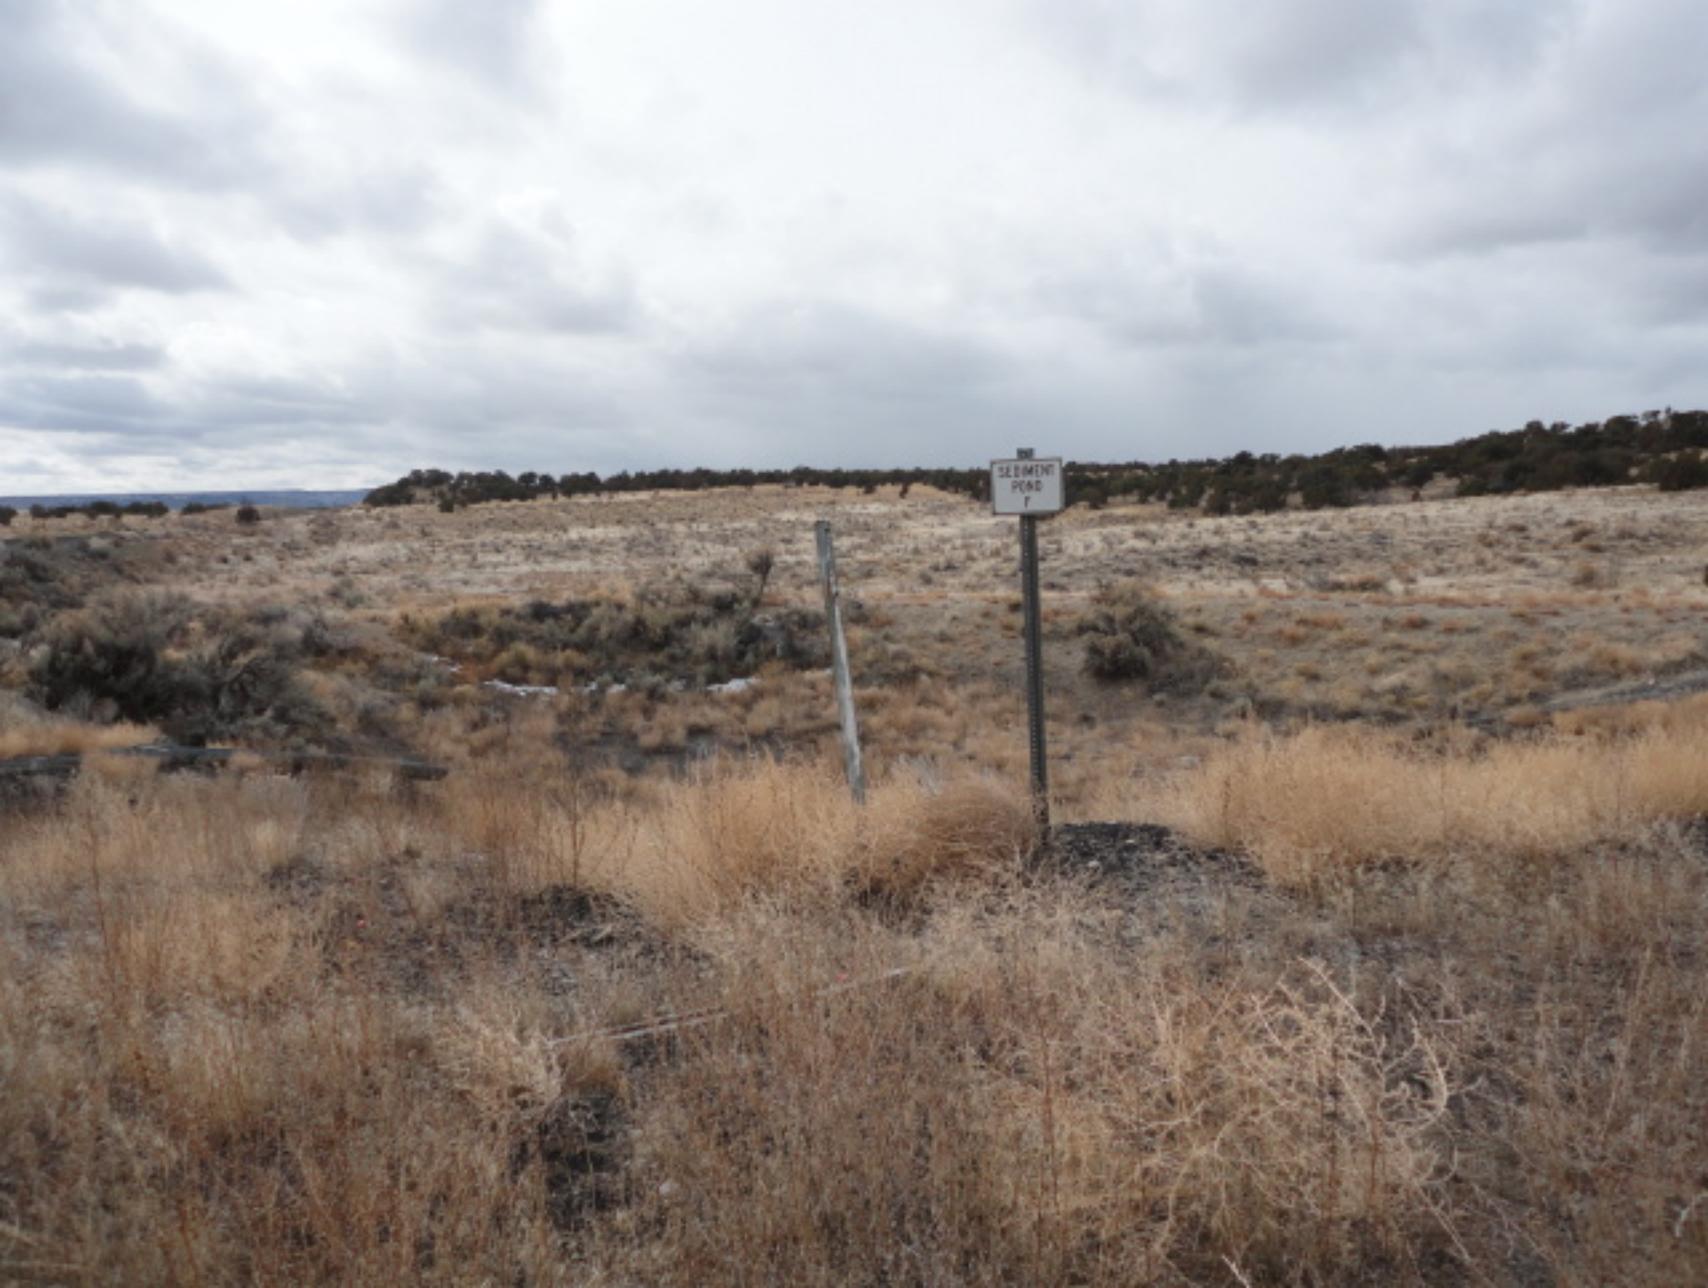
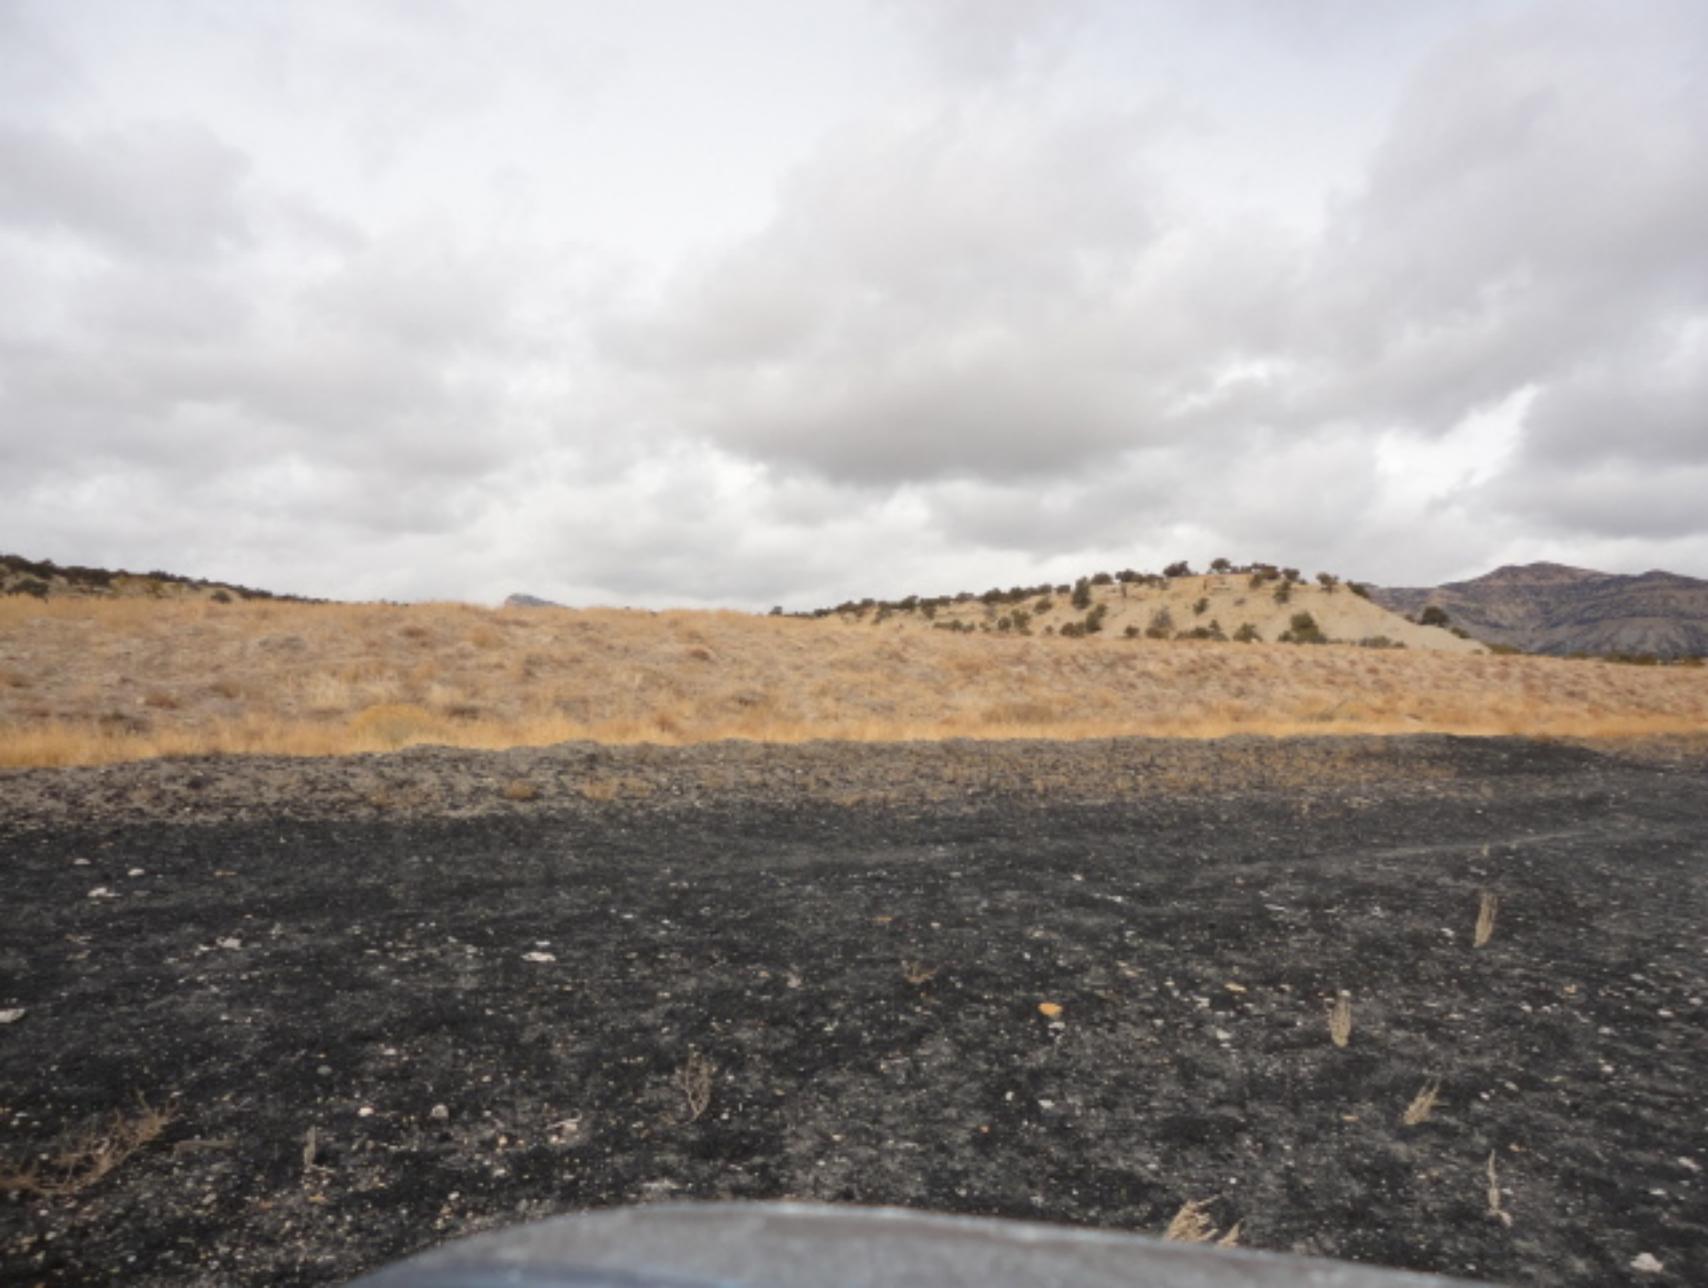
I inspected the road diversions and culverts throughout the property. They were functioning as designed. Some of the diversions have some sediment build-up within. Diversions will need cleaning out in the near future. See Photos
