Inspection Report

Permit Number:	C0070033
Inspection Type:	COMPLETE
Inspection Date:	Thursday, February 22, 2018
Start Date/Time:	2/22/2018 10:00:00 AM
End Date/Time:	2/22/2018 2:00:00 PM
Last Inspection:	Wednesday, January 17, 2018

Site: **WILDCAT LOADOUT**

The Loadout is idle and needs major electrical repair due to vandalism.

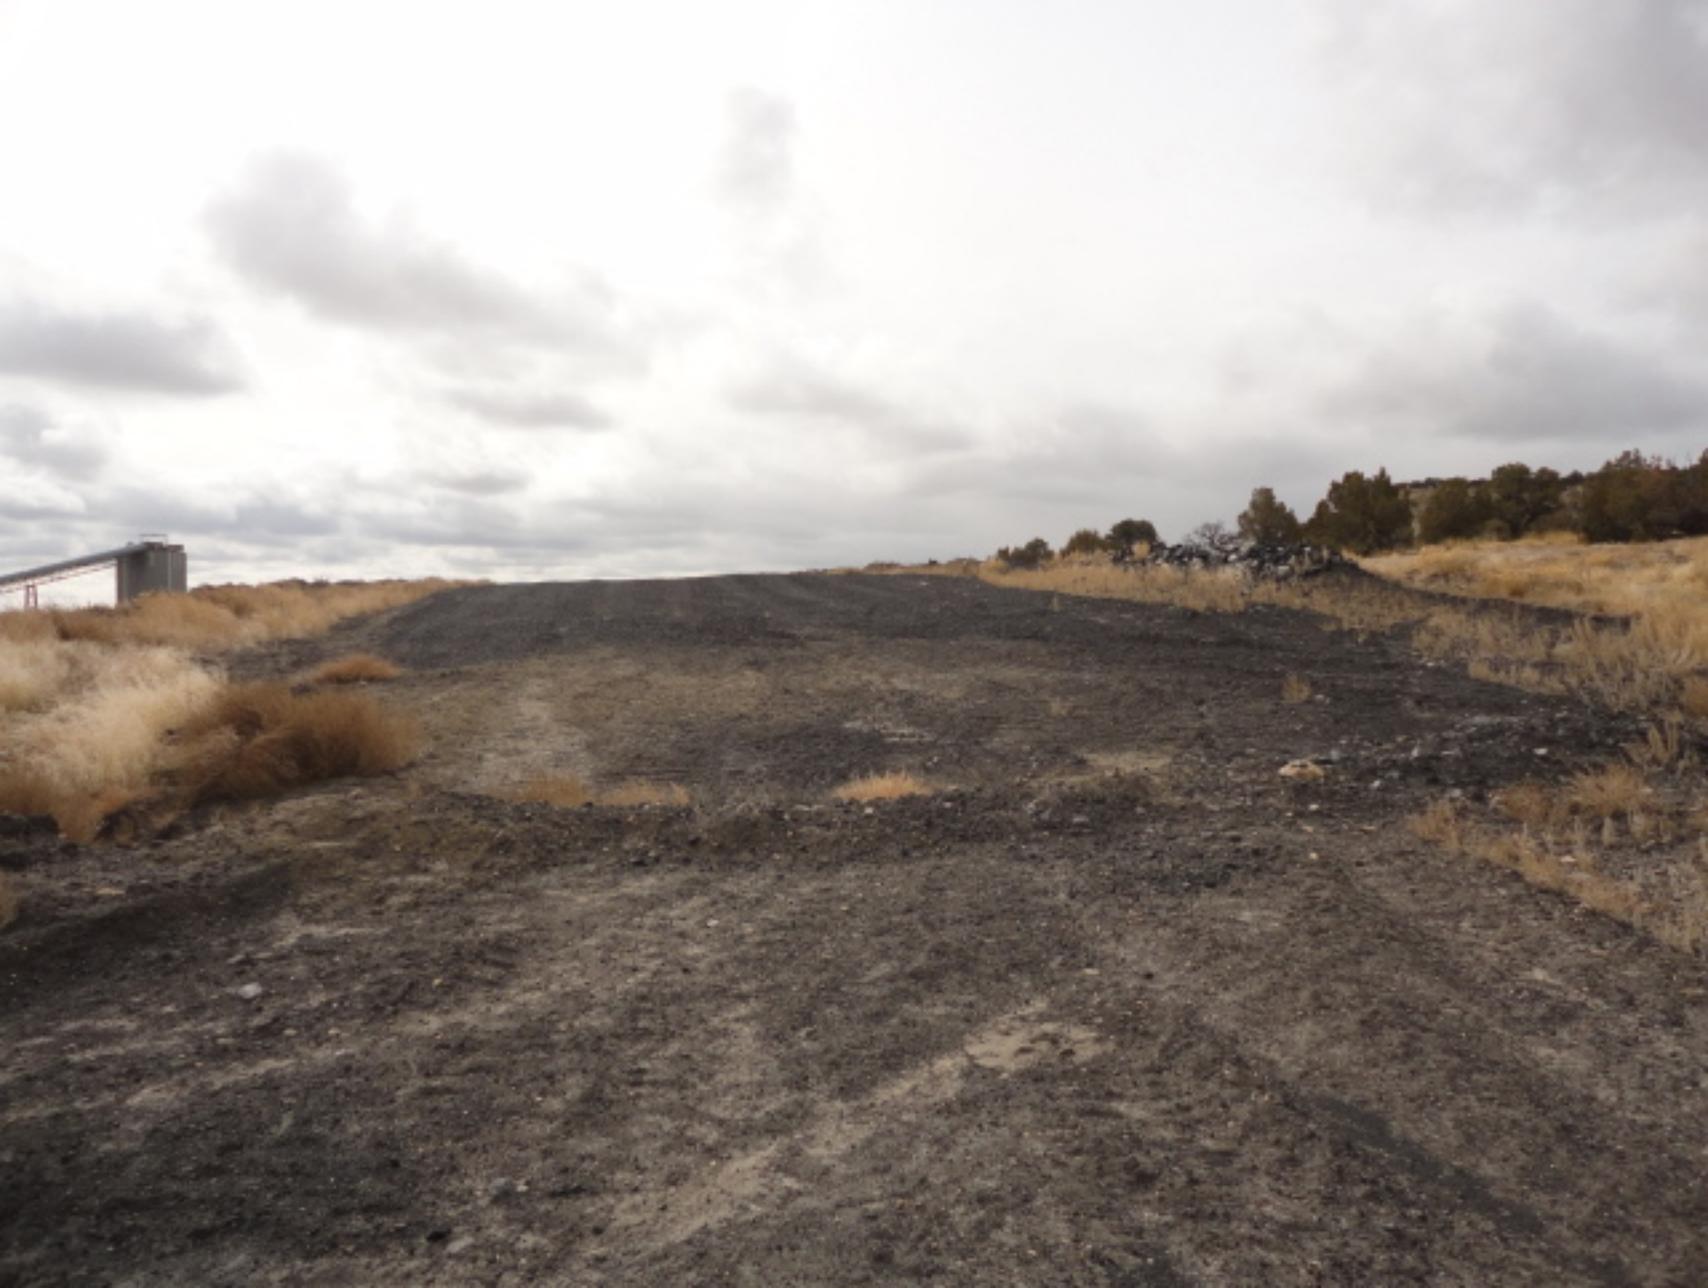
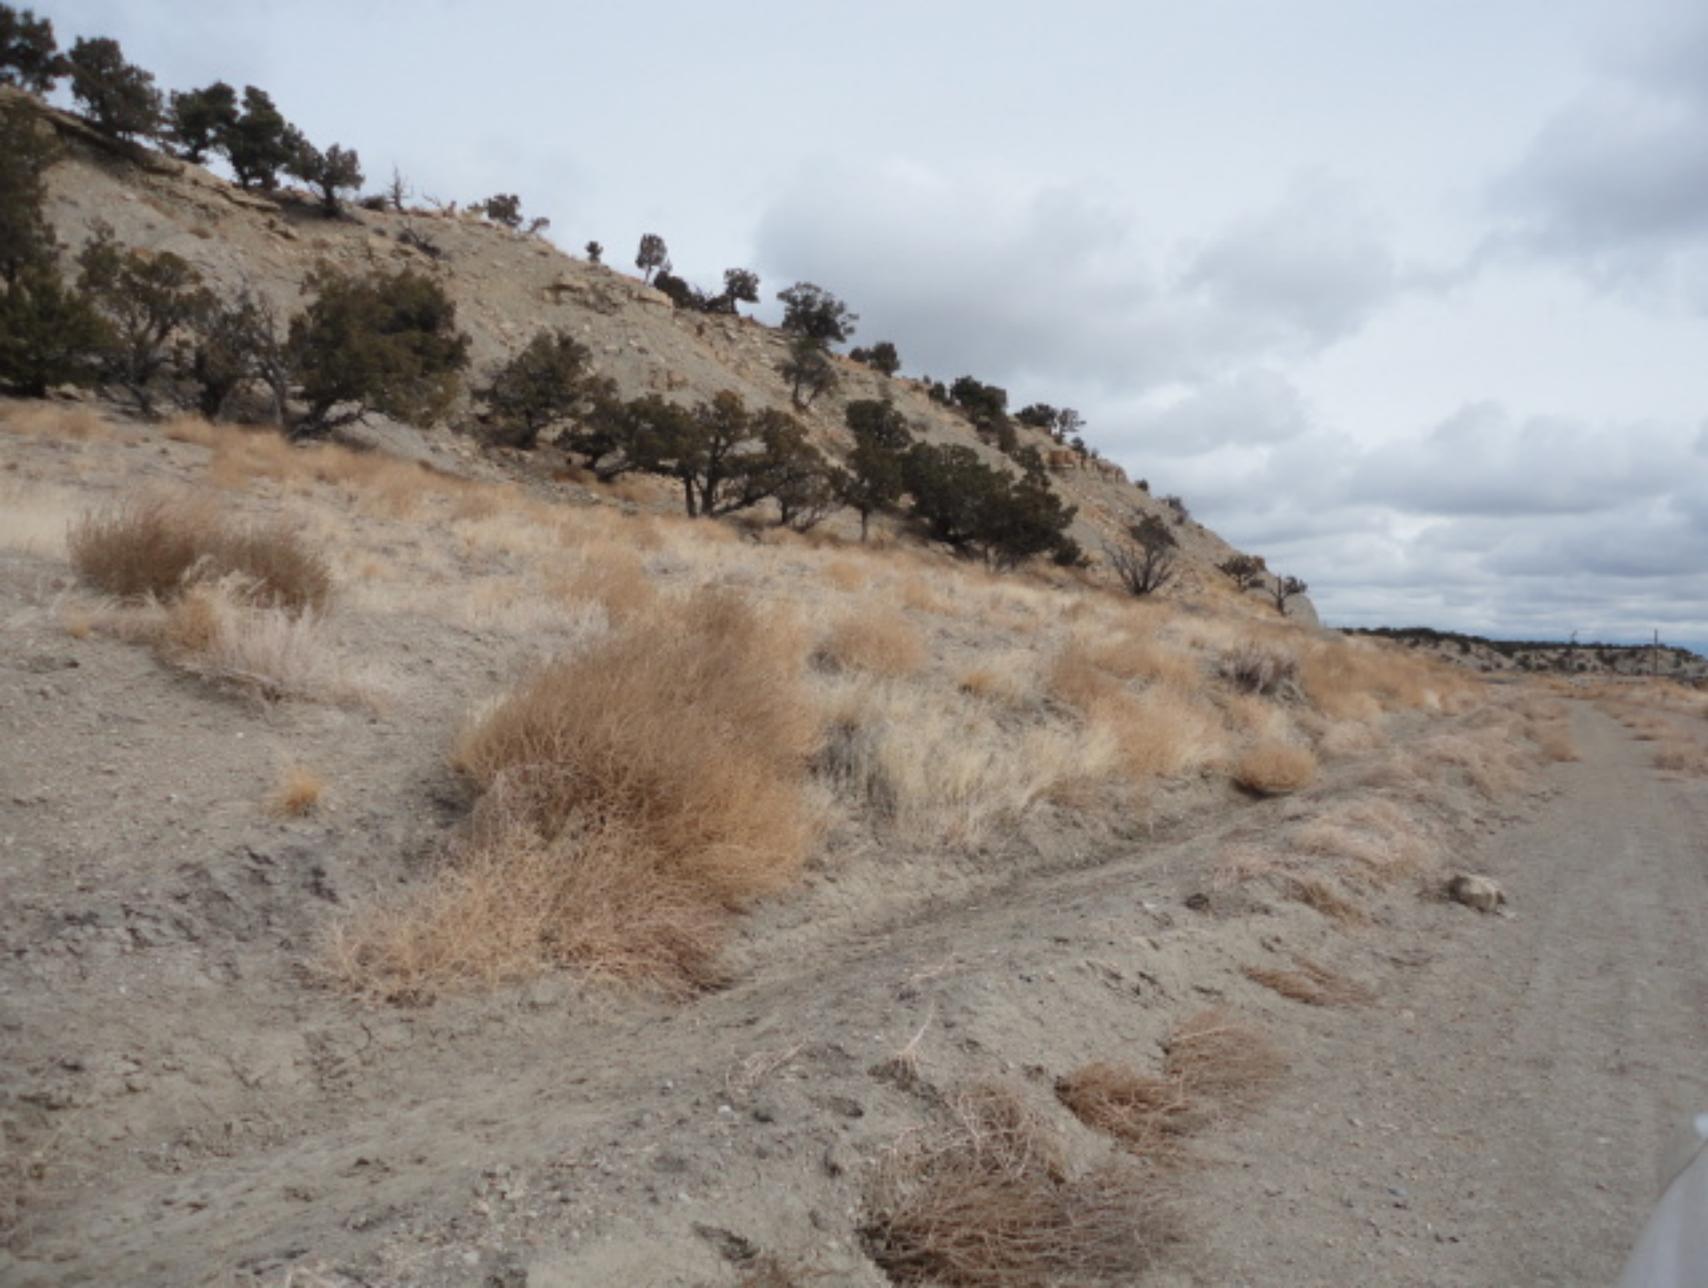
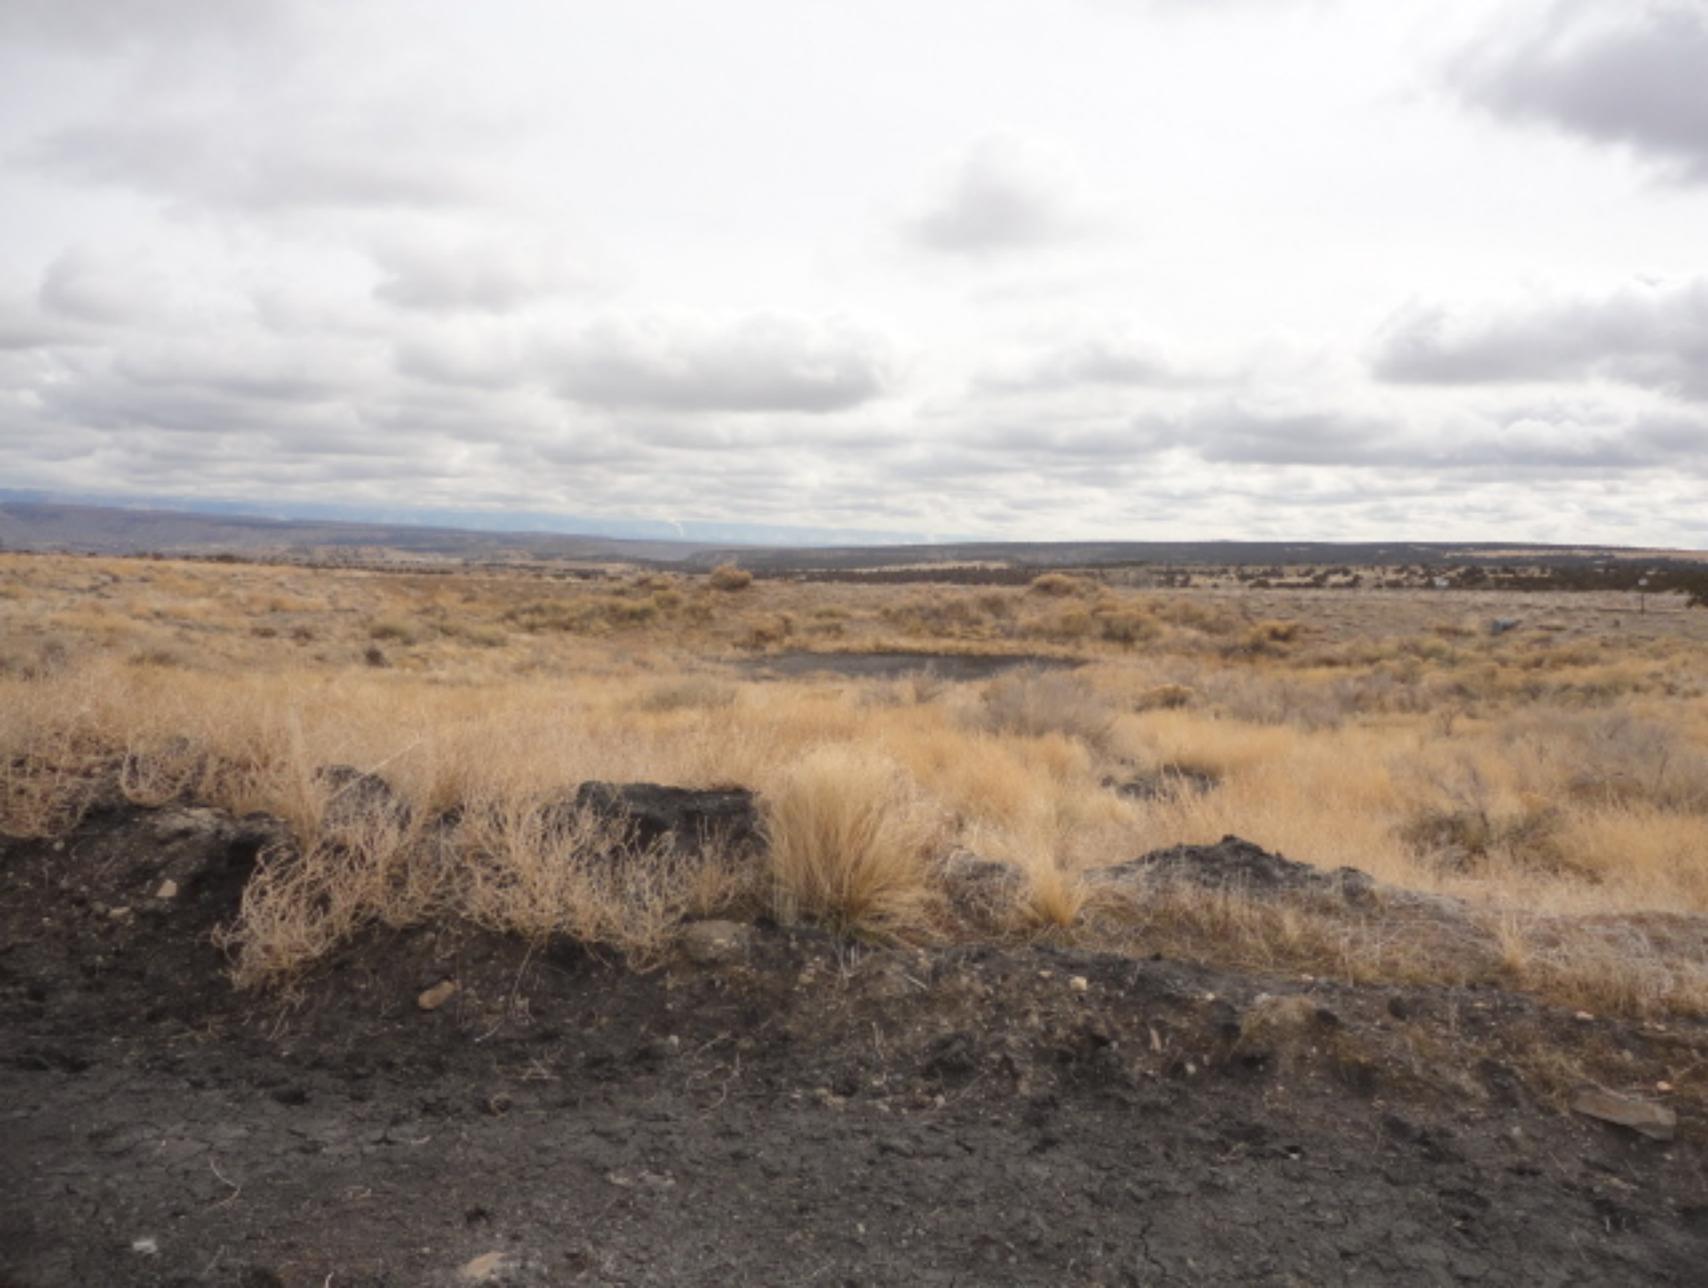
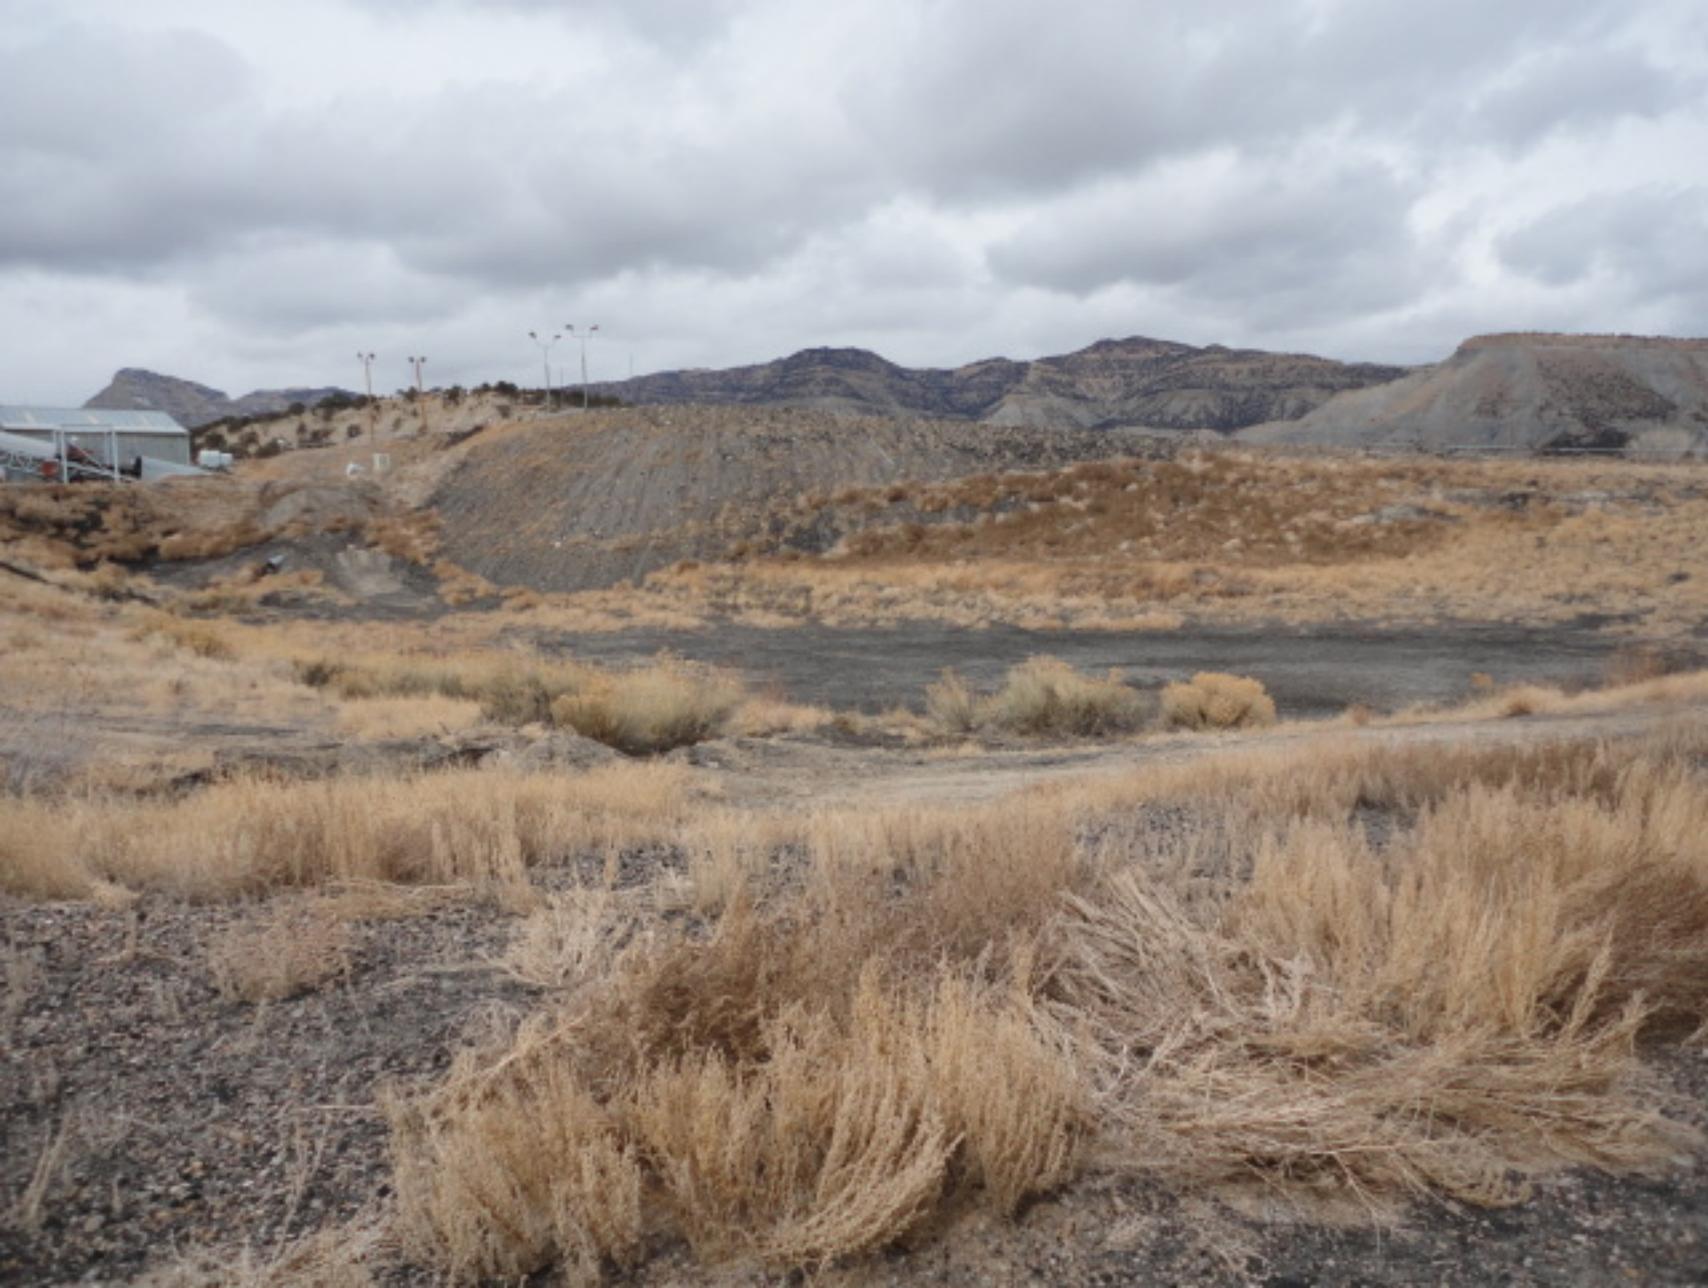
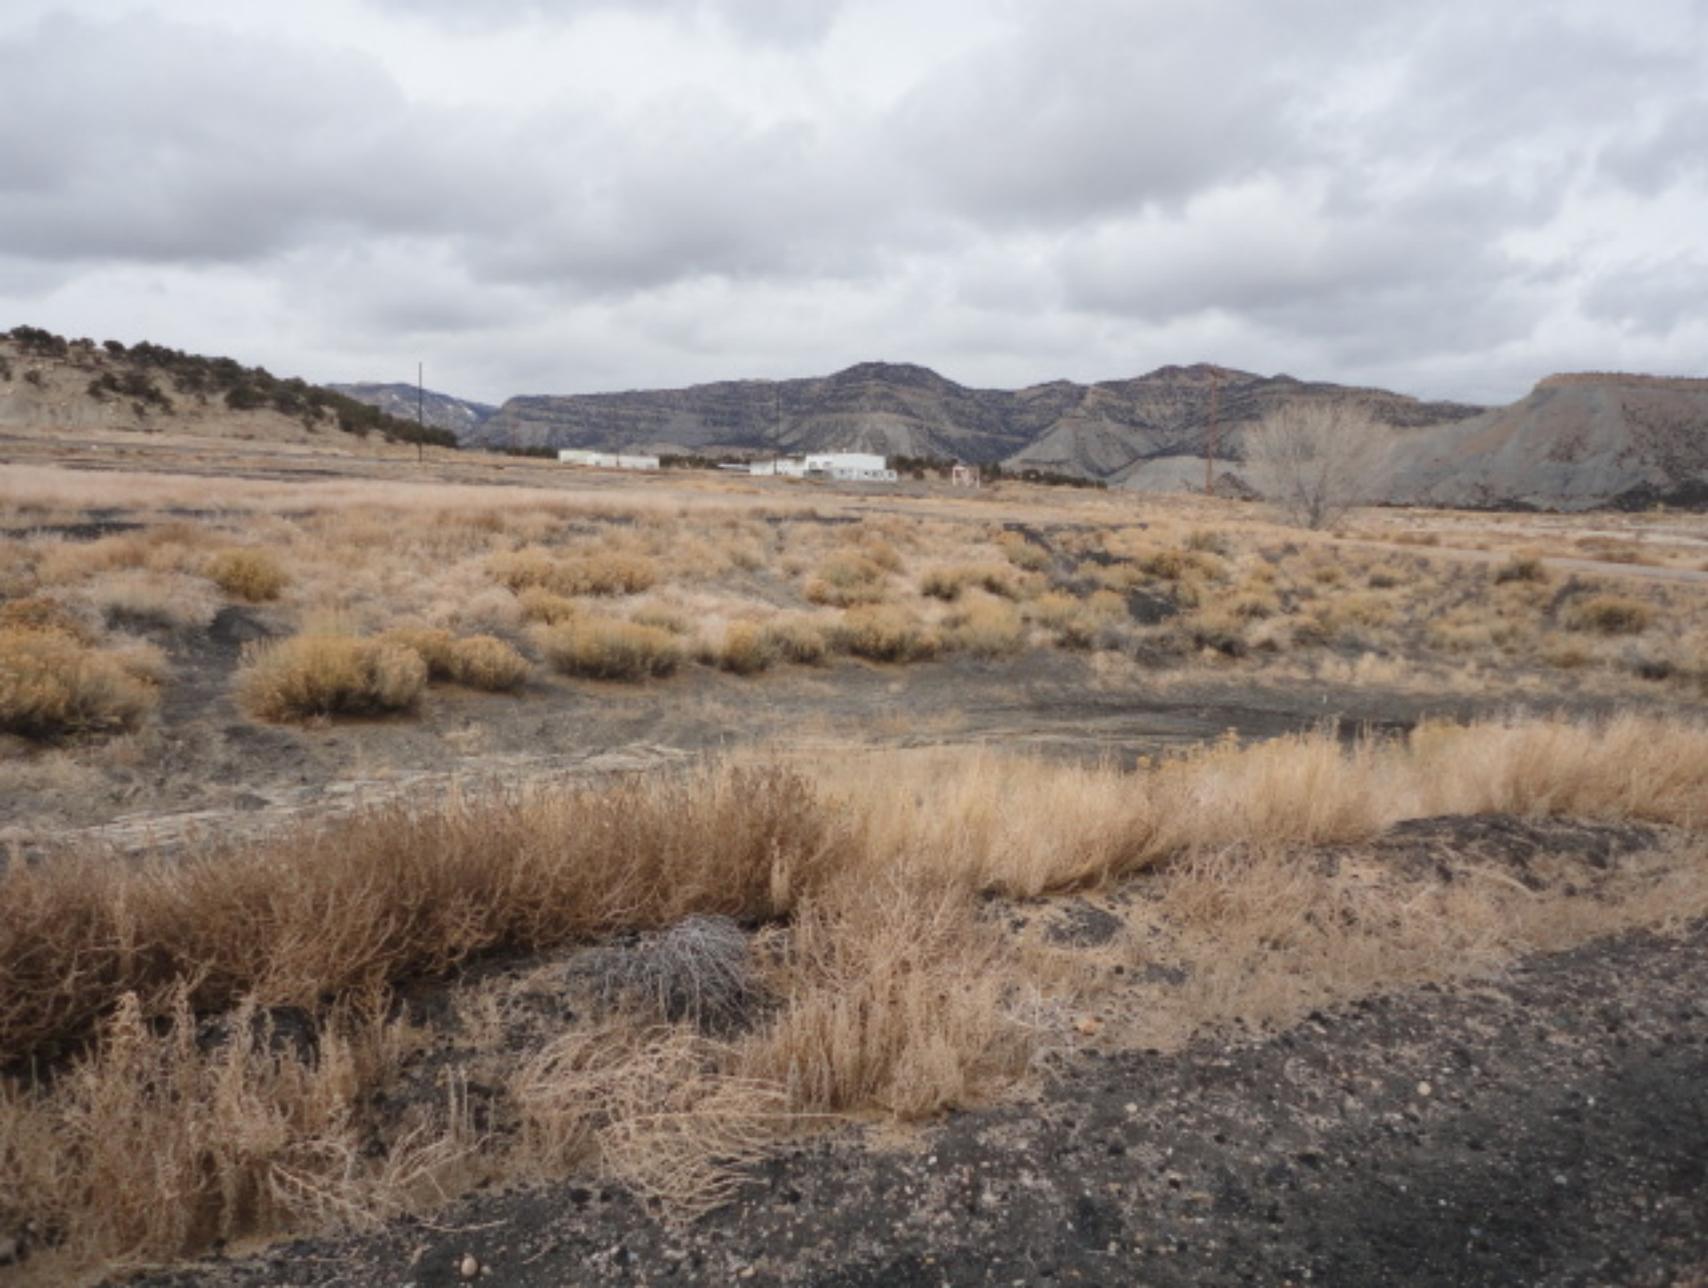
I inspected the refuse pile and it appears to be stable. I did not notice any hazardous conditions to the embankments. The refuse pile is active. The permittee conducted a fourth quarter refuse pile inspection on November 27, 2017. This document is P.E. certified. No hazardous conditions were reported. See Photos
