**SUNNYSIDE COGENERATION ASSOCIATES
ACT/007/035
ANNUAL REPORT
1994**

COAL MINING AND RECLAMATIONS OPERATIONS FOR 1994

SUNNYSIDE COGENERATION ASSOCIATES 1994 ANNUAL REPORT

EXHIBIT 2
PHOTOGRAPHS OF THE REVEGETATION AREAS

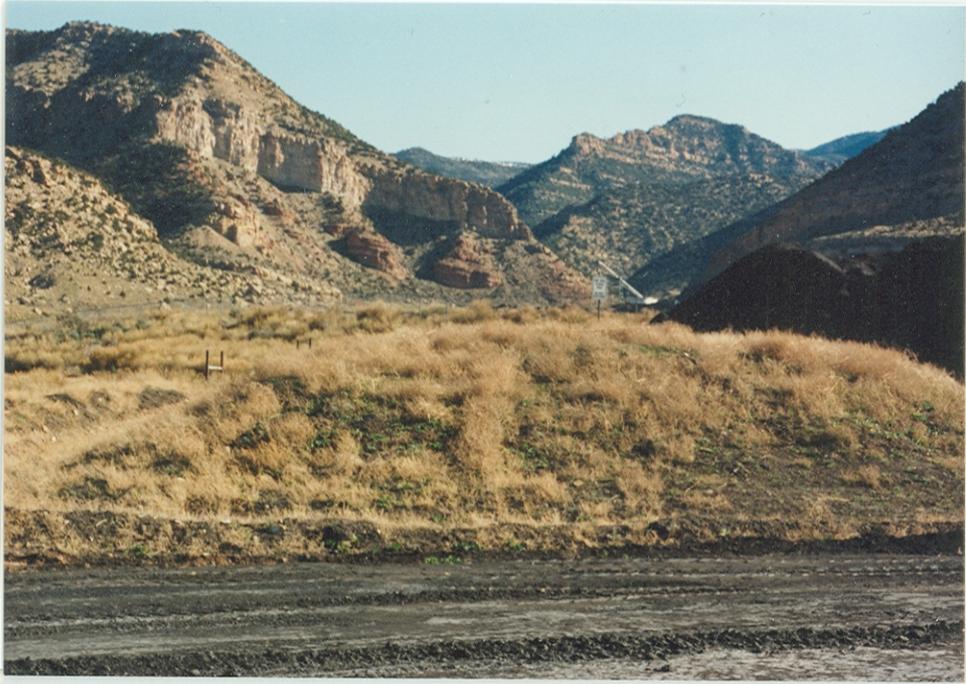
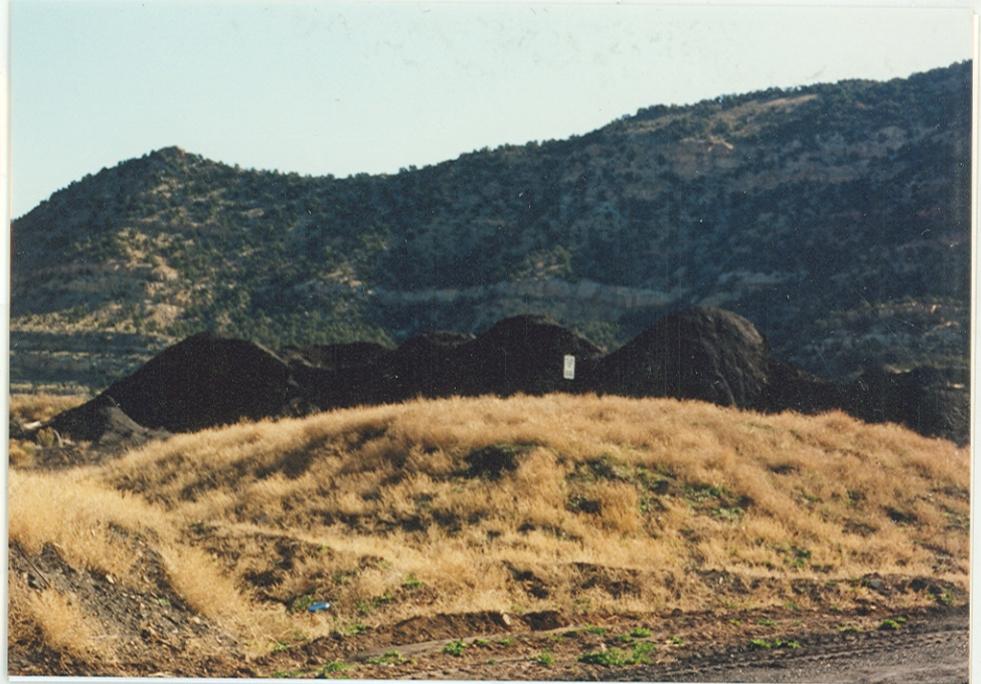
The Access Road Topsoil Stockpile was created and seeded prior to 1994. Additional seeding was done in March 1994 to improve the vegetation cover. Photographs shown in Exhibit 2 seem to show that the vegetation is improving.

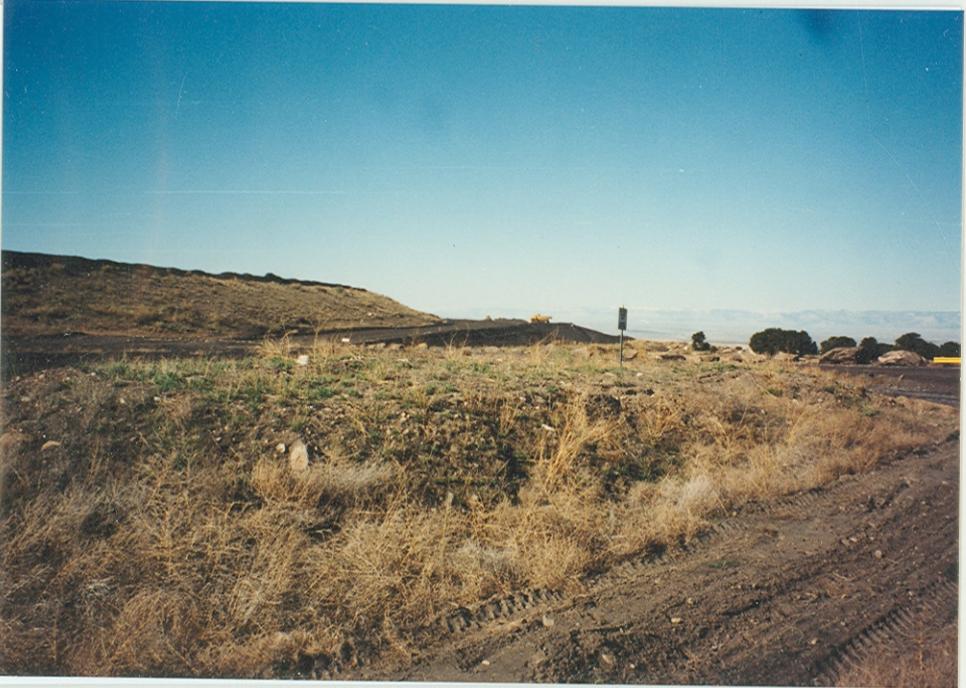
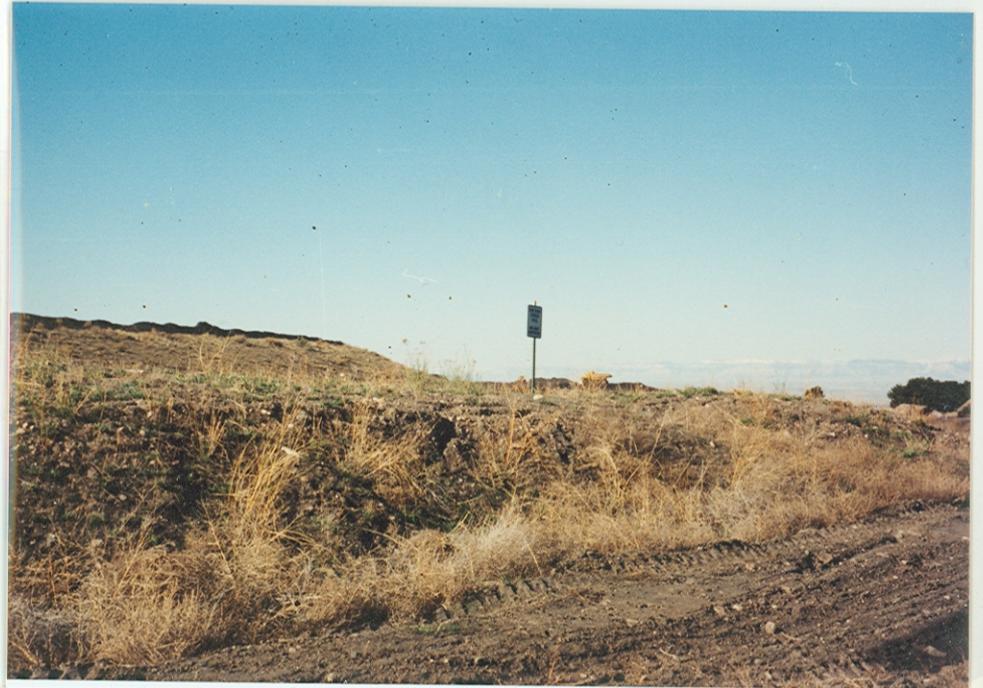
Storage Area #1 Topsoil Stockpile

Storage Area #1 was created during 1994. The topsoil was stockpiled towards the east end of the storage area. This stockpile received interim seeding in March 1994 and seems to have a significant amount of vegetation.

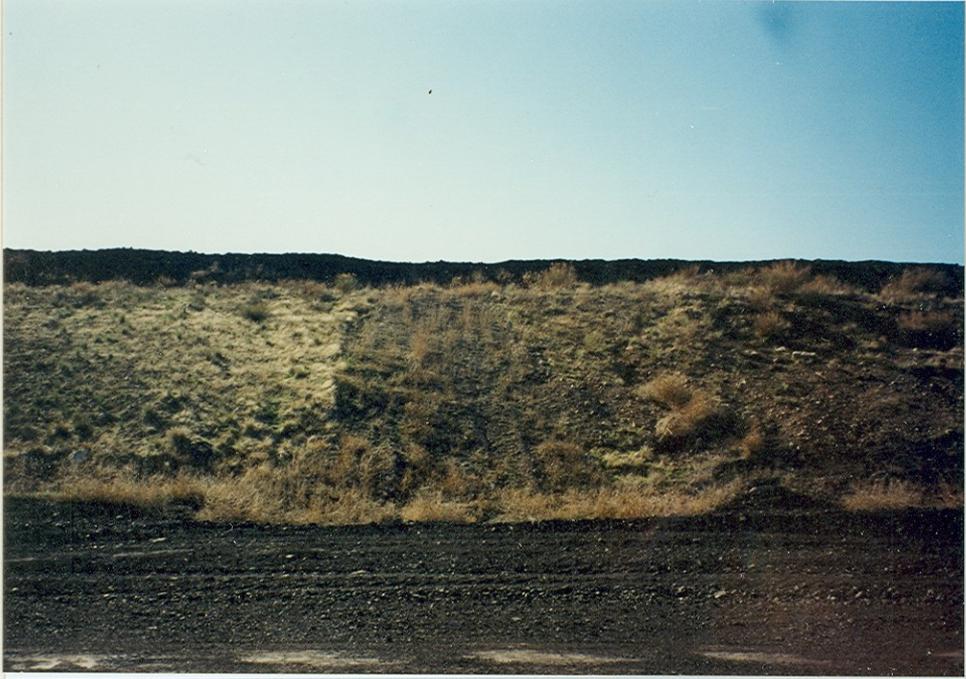
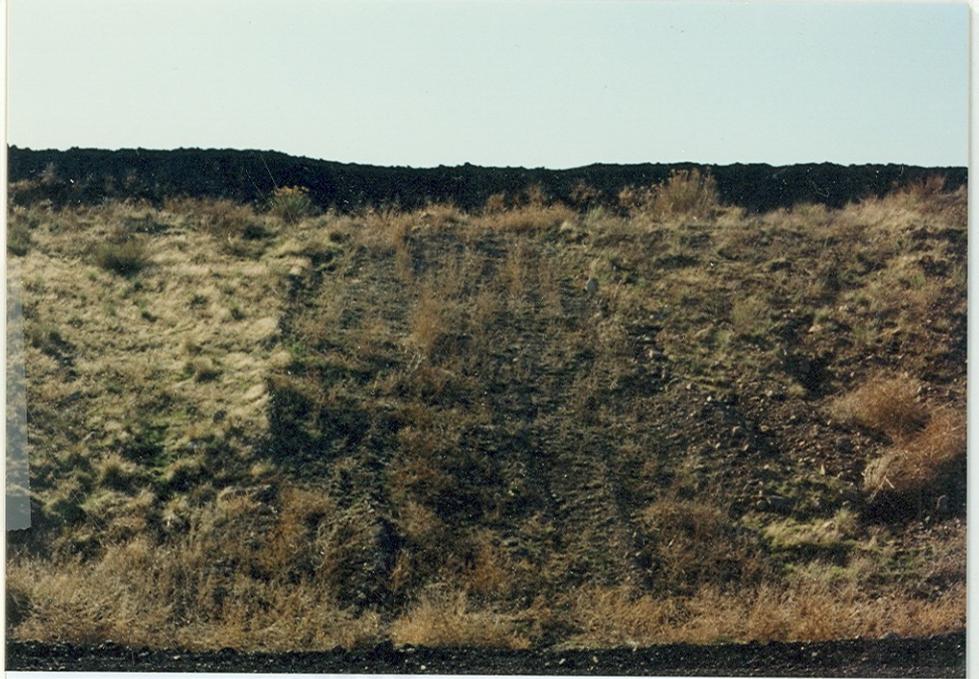
East Slurry Cell Bank

Two erosion areas on the east bank of the East Slurry Cell were repaired and reseeded during 1994. Photographs shown in Exhibit 2 seem to show that some vegetation is beginning to grow.

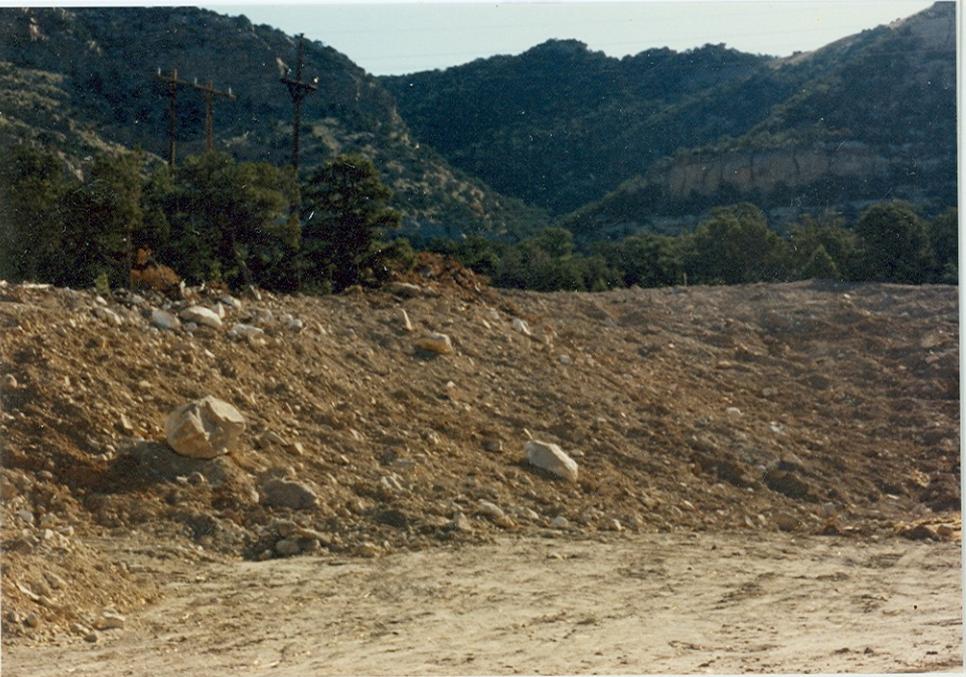
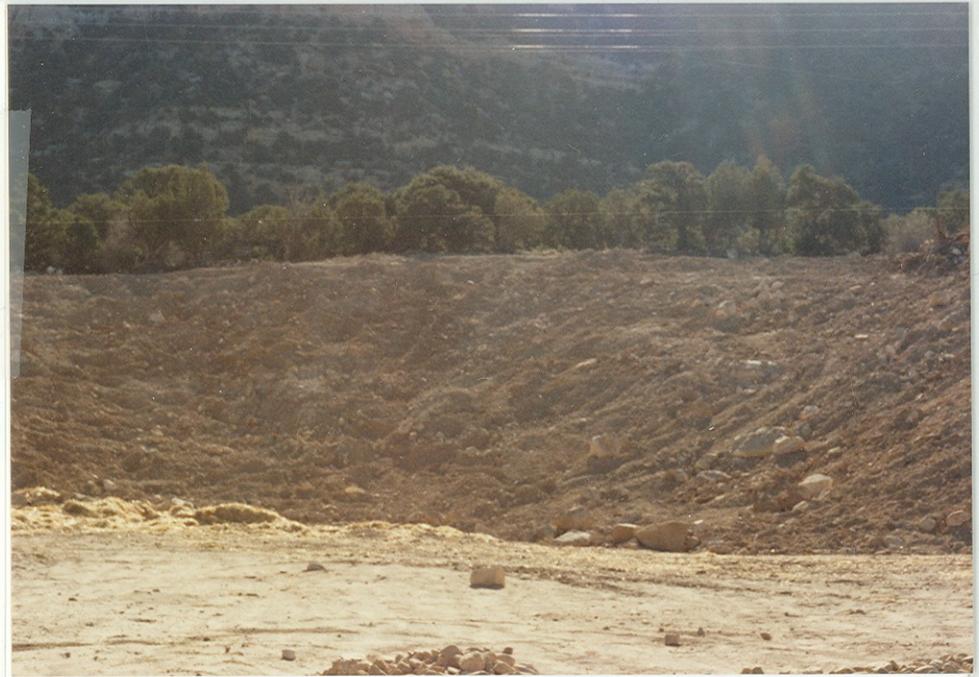
Borrow Area

Following completion of the reclamation work on the OCRR, the slopes of the borrow area were roughened and reseeded. Interim seeding was completed in December 1994. Photographs shown in Exhibit 2 do not yet show significant quantities of vegetation, but additional growth is expected to occur throughout the upcoming year.

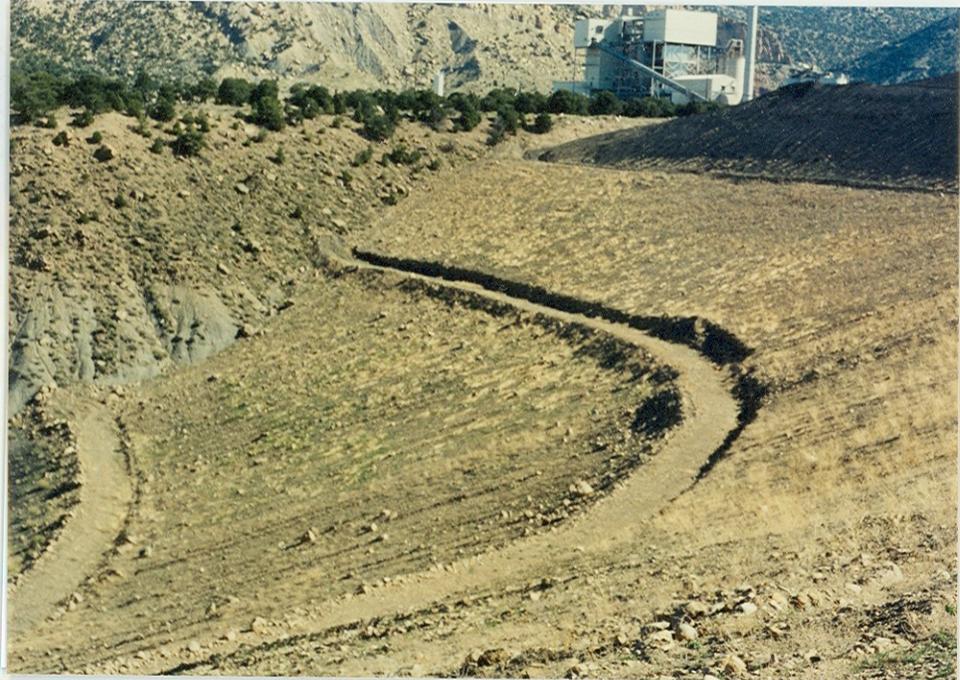
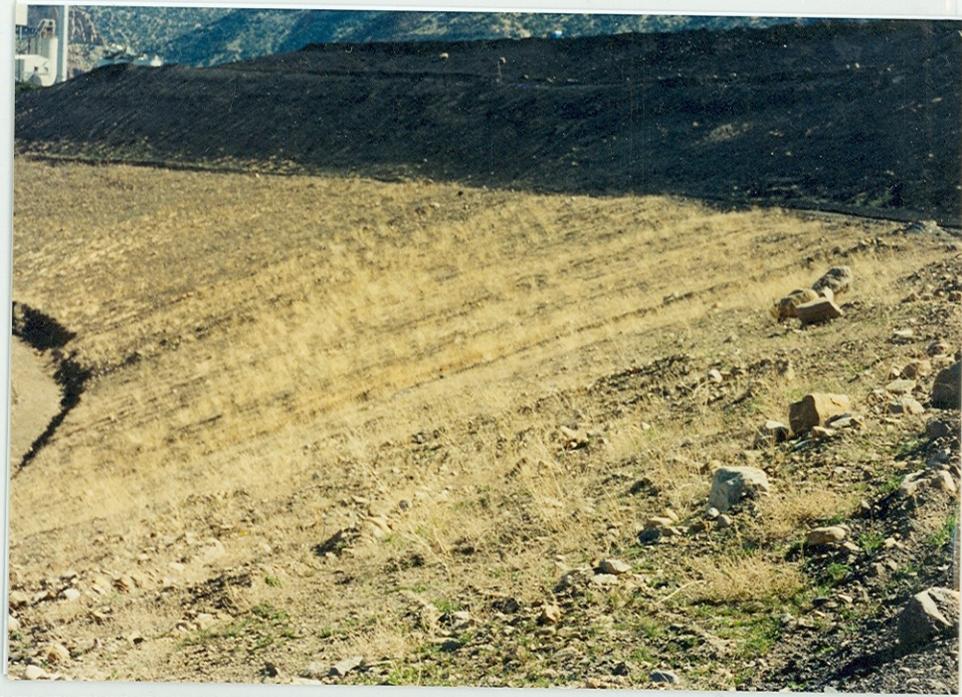
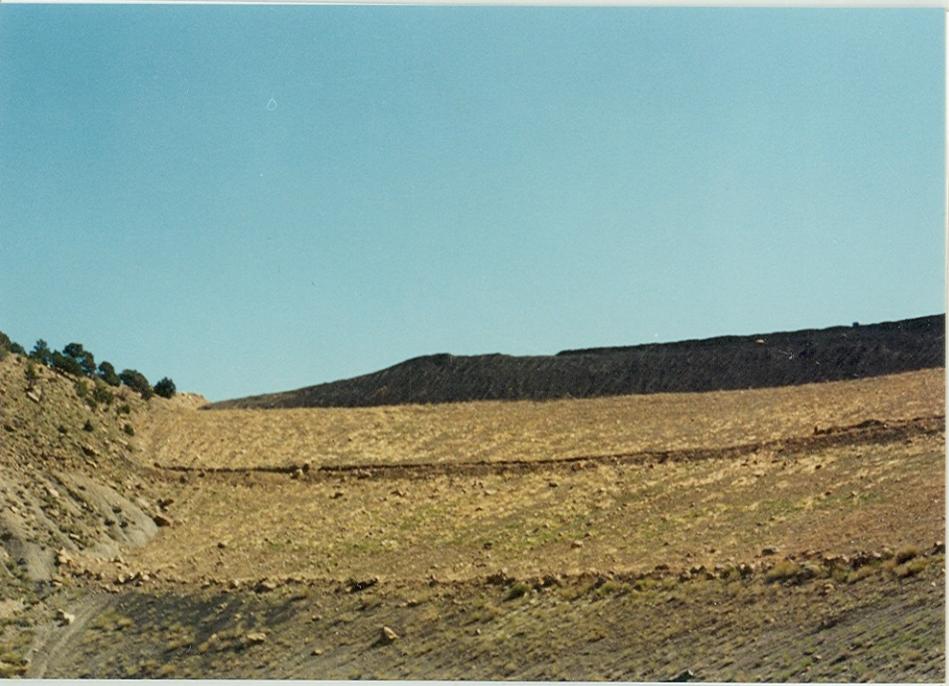
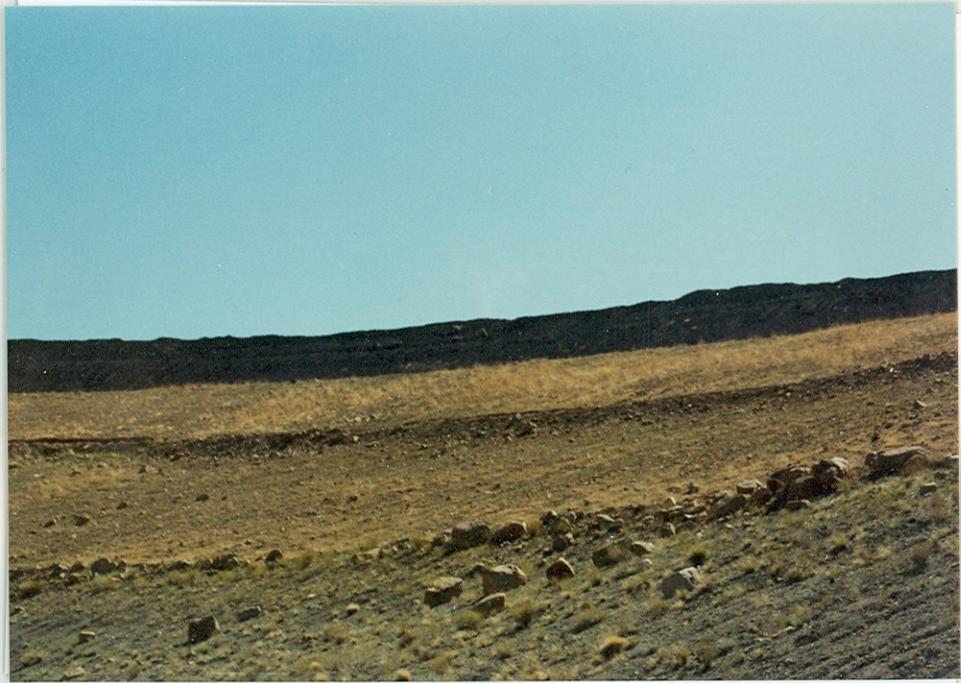
Third and Fourth Lifts

The third and fourth lifts of the Coarse Refuse Pile were covered with two feet of borrow material in 1993. Interim seeding was completed in March 1994. Photographs of the lifts are shown in

Exhibit 2. A significant amount of vegetation existed in 1994 and the area is already beginning to green up again for 1995.

During an intense fall storm, some ditches down the face of the Refuse Pile were washed out. SCA replaced these ditches with 36" culverts. Interim seeding was completed in December 1994.

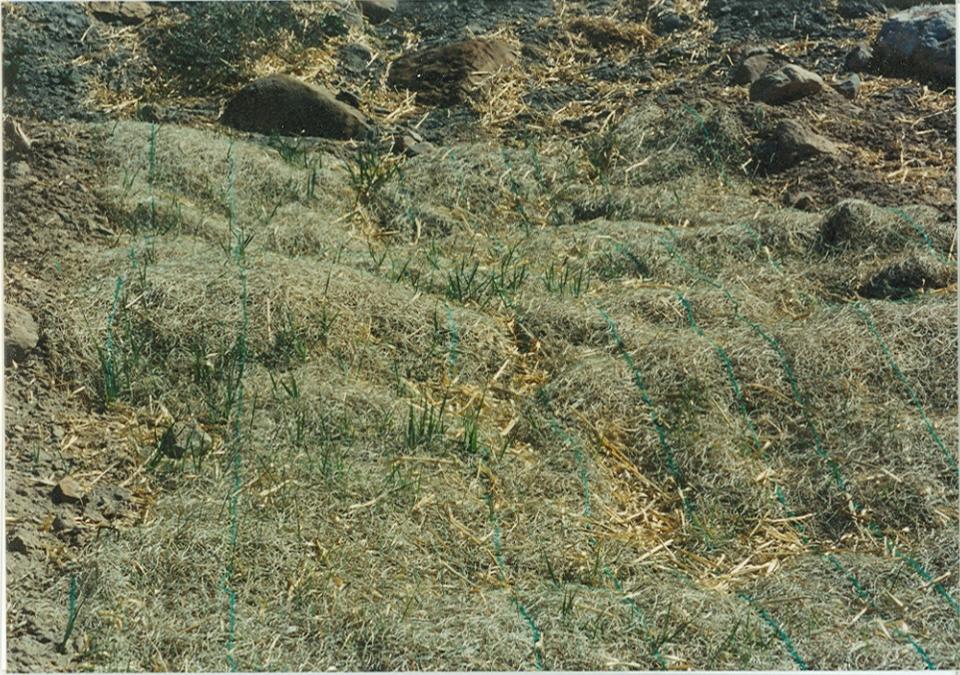
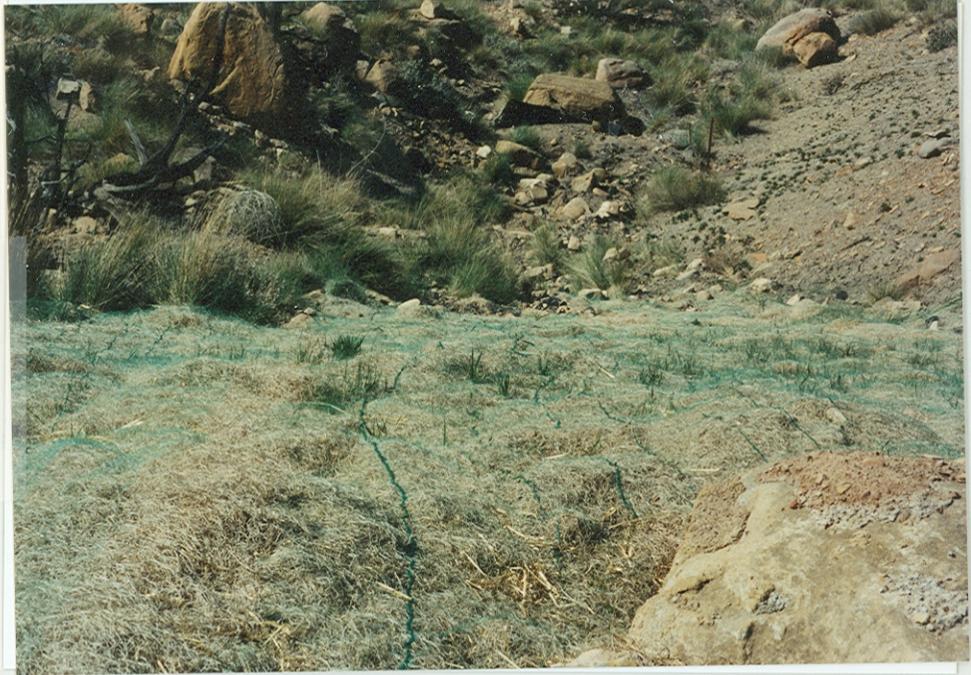
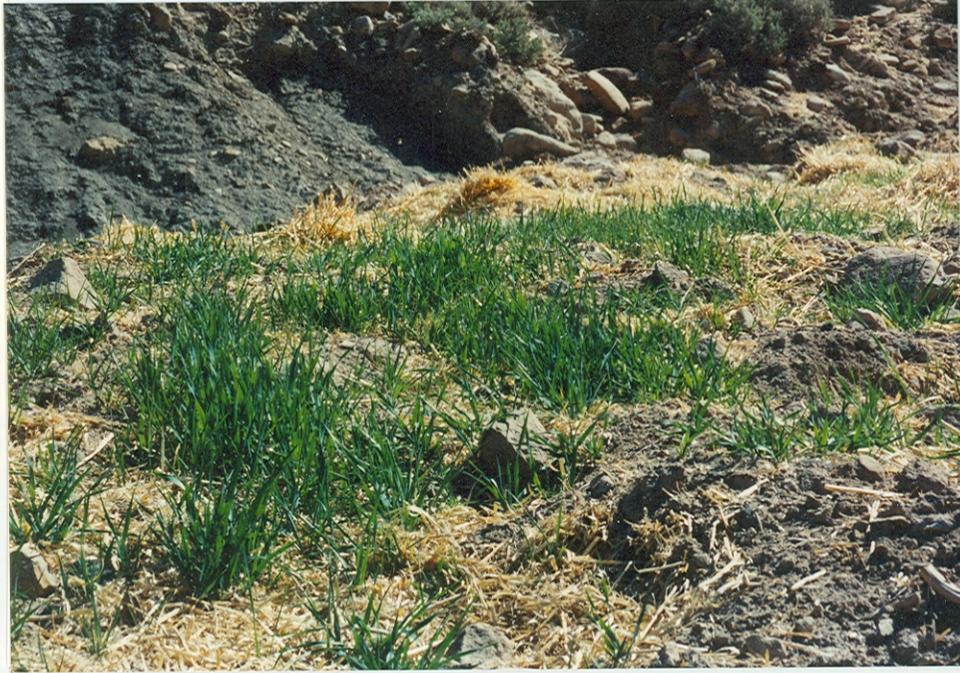
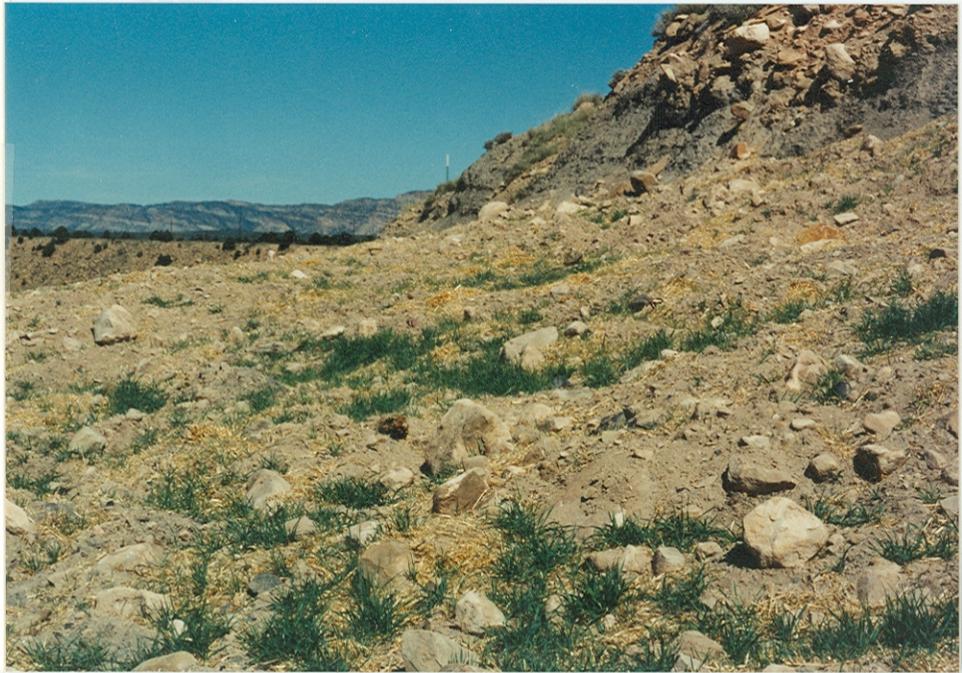
Final reclamation earthwork and reseeded was performed on the Old Coarse Refuse Road (OCRR) during 1994. Reseeding was done within the Fall seeding window. Photographs in Exhibit 2 seem to show many areas where vegetation is beginning to grow. SCA is in the process of requesting partial bond release for the work completed. SCA will be performing revegetation monitoring of the OCRR as required for final reclamation.
