Inspection Report

Permit Number:	C0070035
Inspection Type:	PARTIAL
Inspection Date:	Wednesday, July 25, 2018
Start Date/Time:	7/25/2018 1:00:00 PM
End Date/Time:	7/25/2018 4:00:00 PM
Last Inspection:	Thursday, June 21, 2018

Permitee: **SUNNYSIDE COGENERATION ASSOCIATES**

Site: **SUNNYSIDE REFUSE & SLURRY**

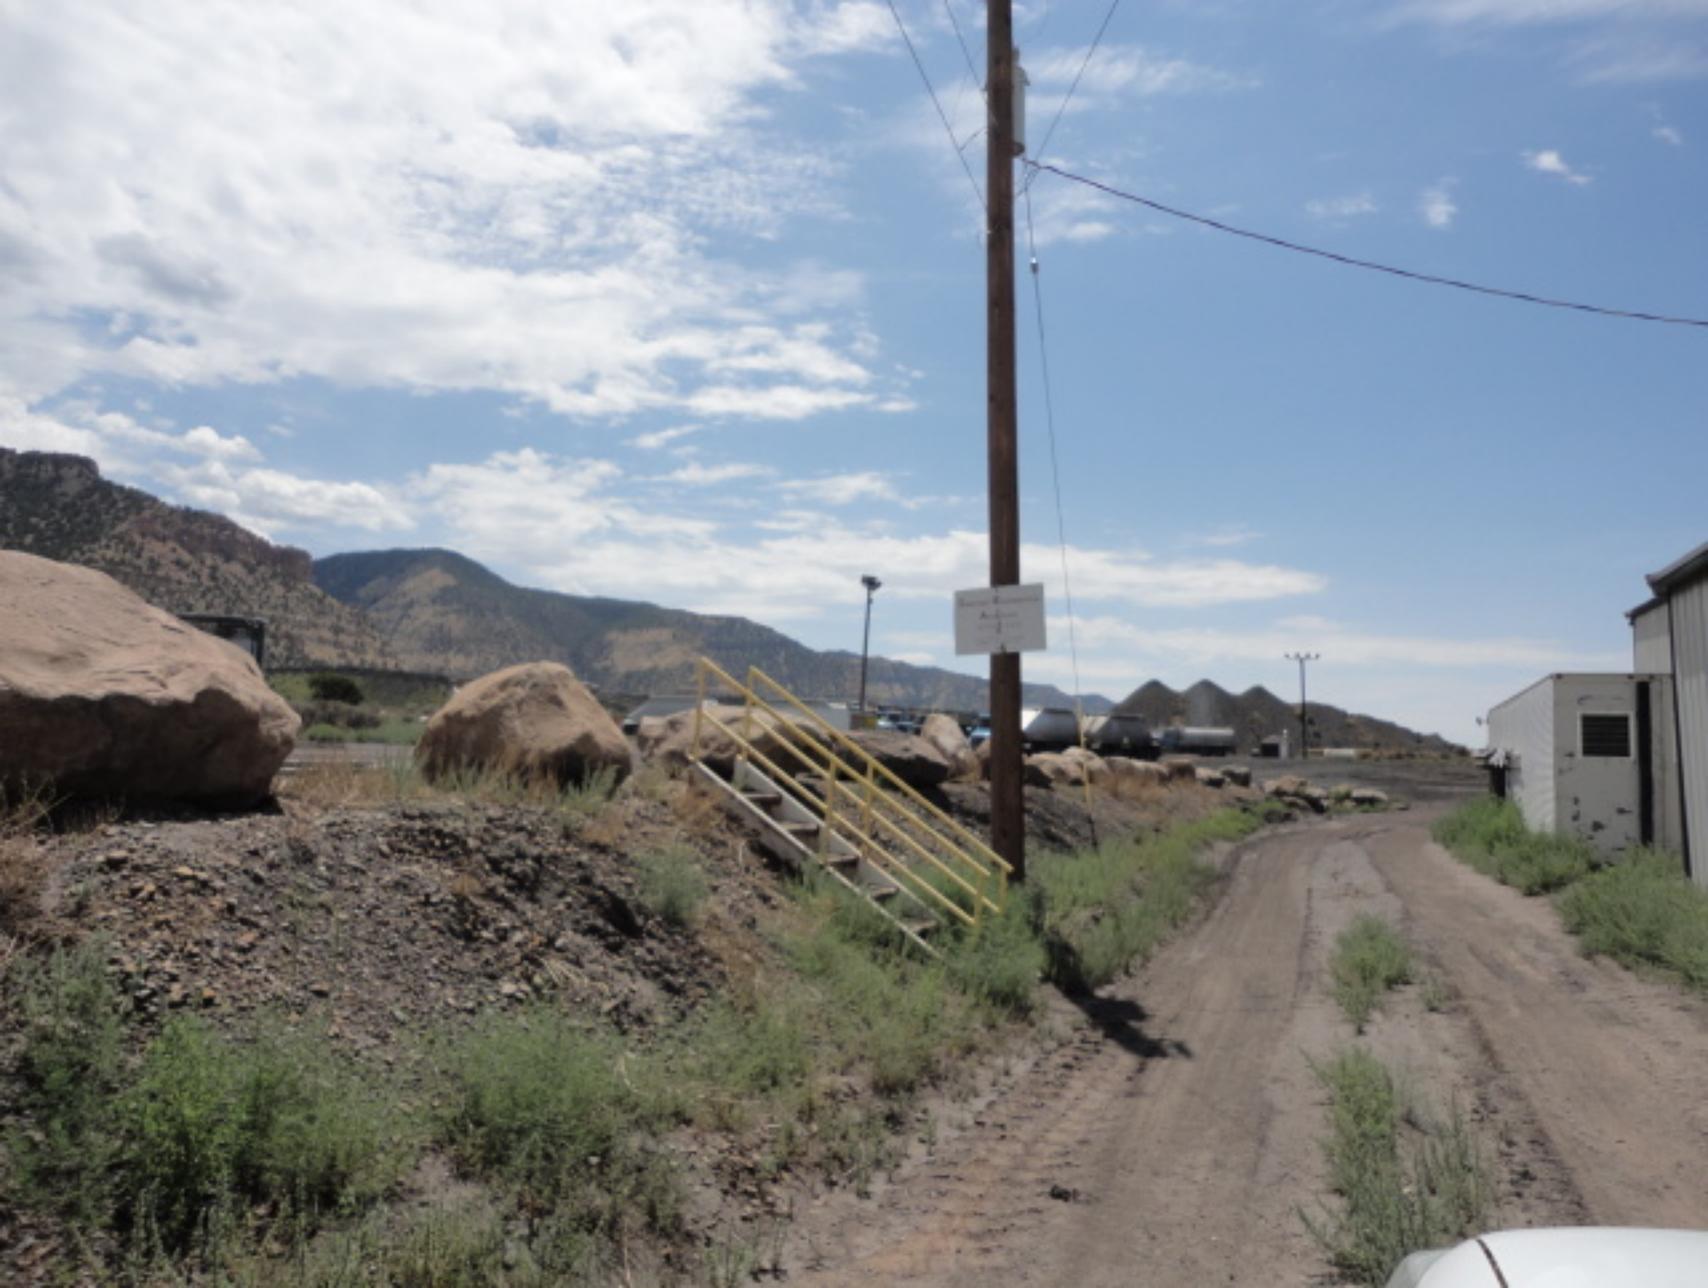
The identification sign was inspected and it meets the requirements of the R645 Coal Rules. See Photo

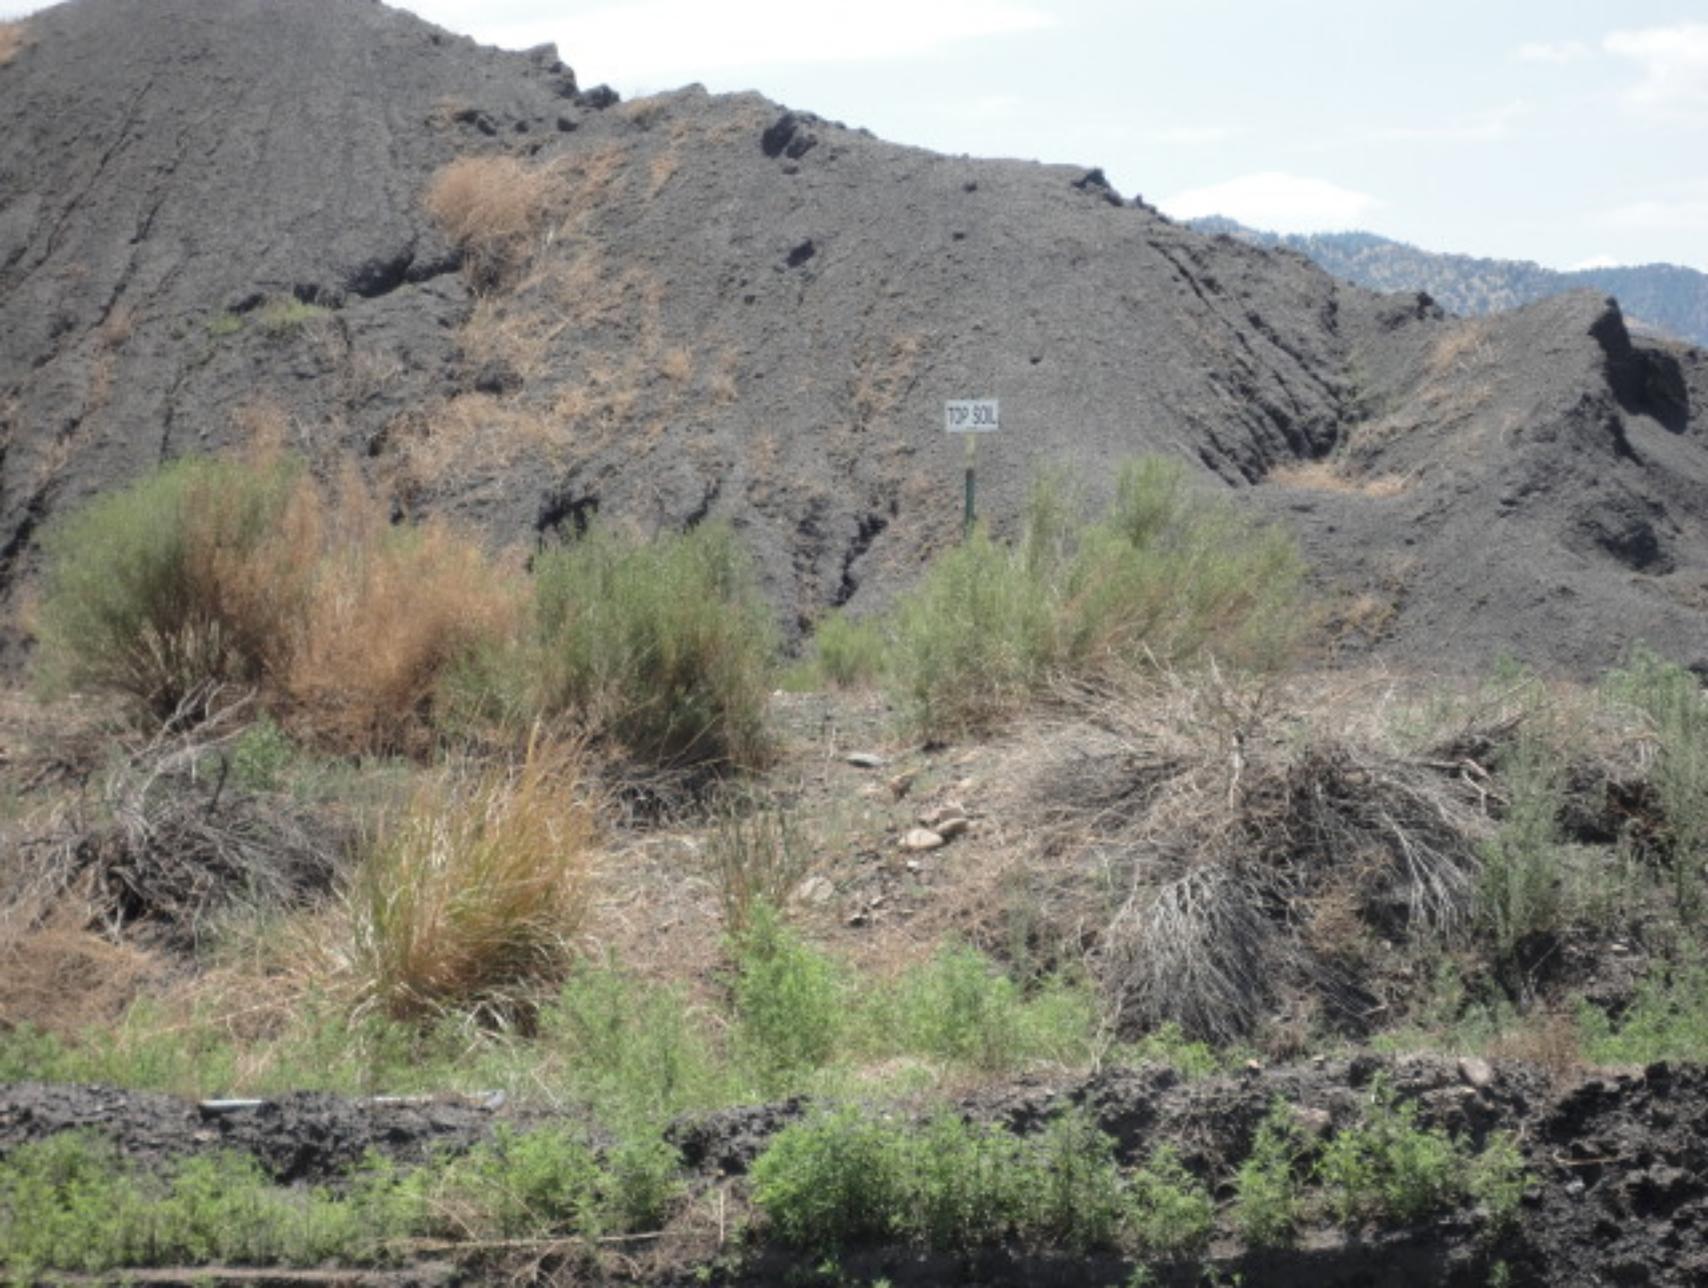
TOP SOIL

I inspected the topsoil piles and I did not see any signs of wind or water erosion. The topsoil piles appear to be stable and protected by a berm. See Photo

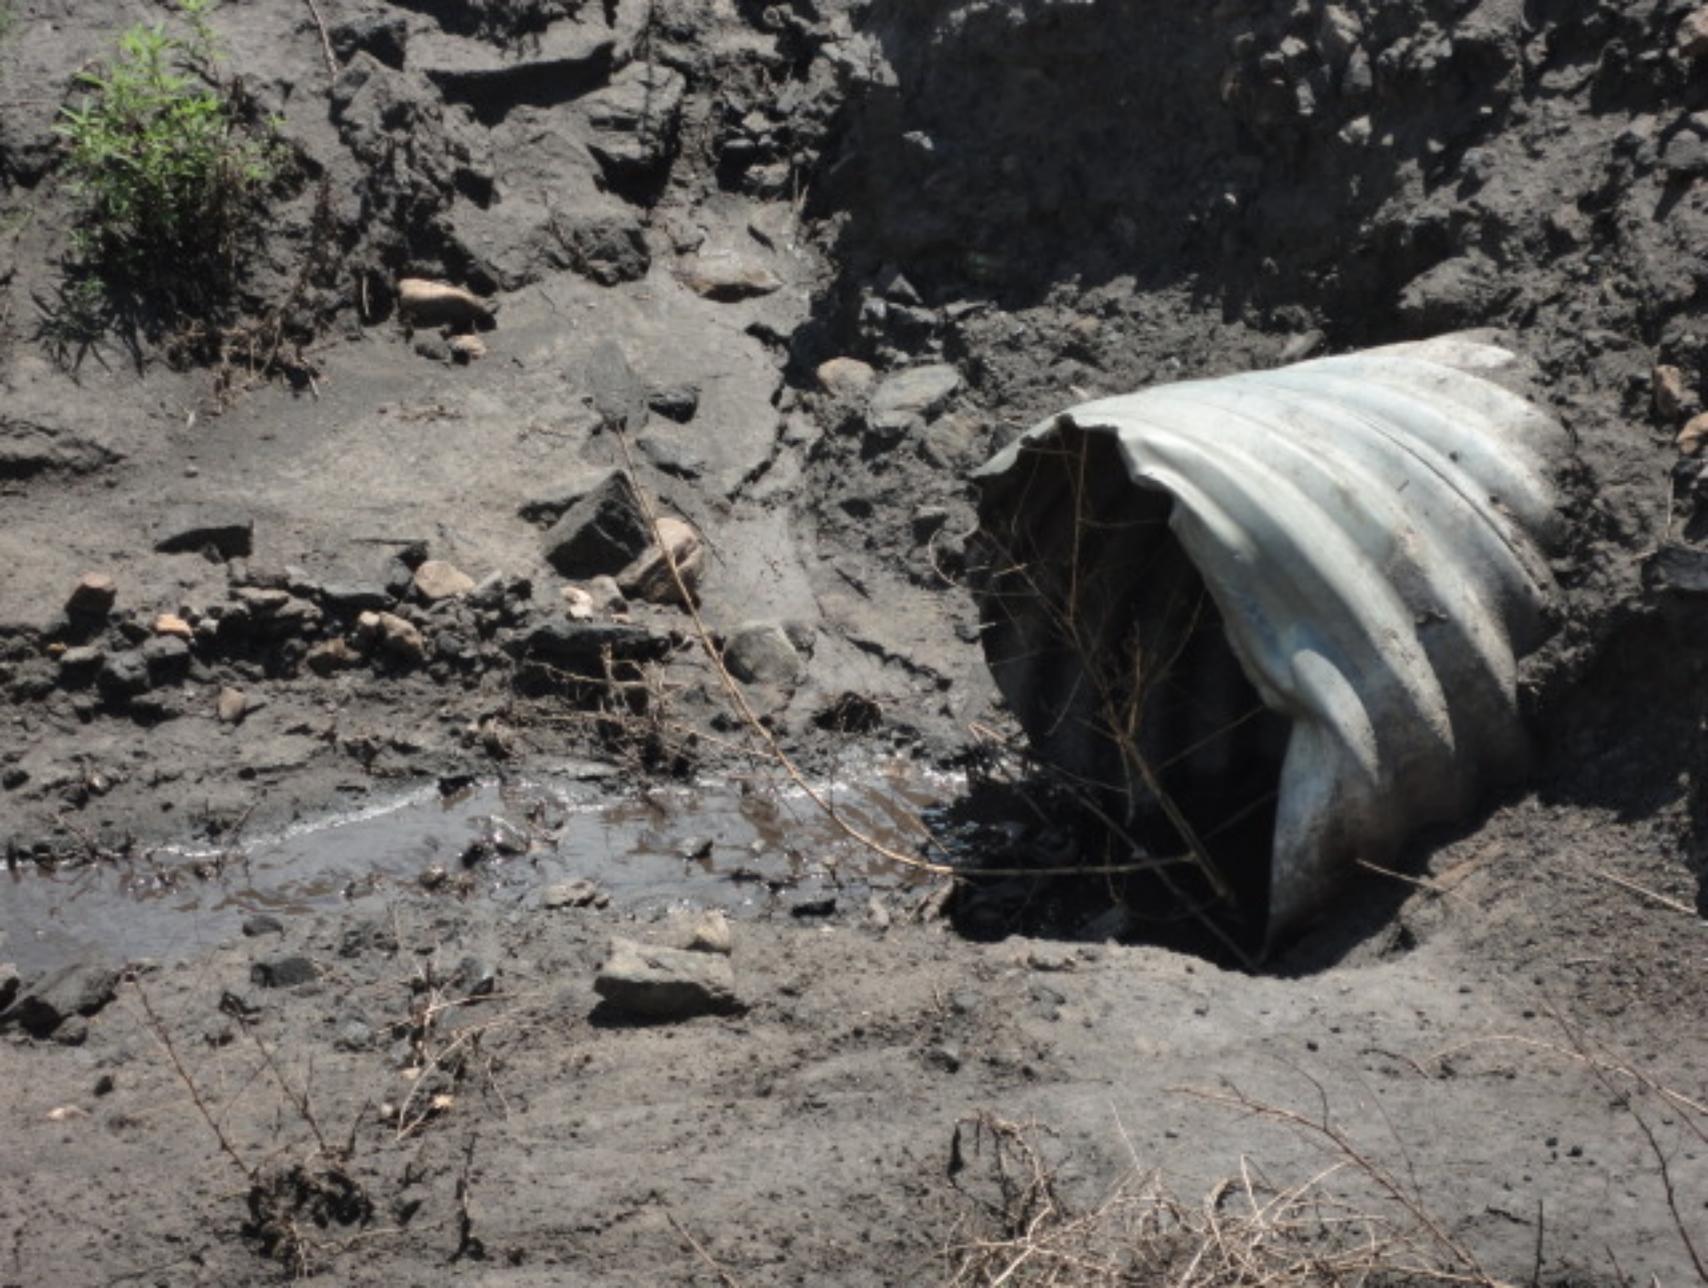
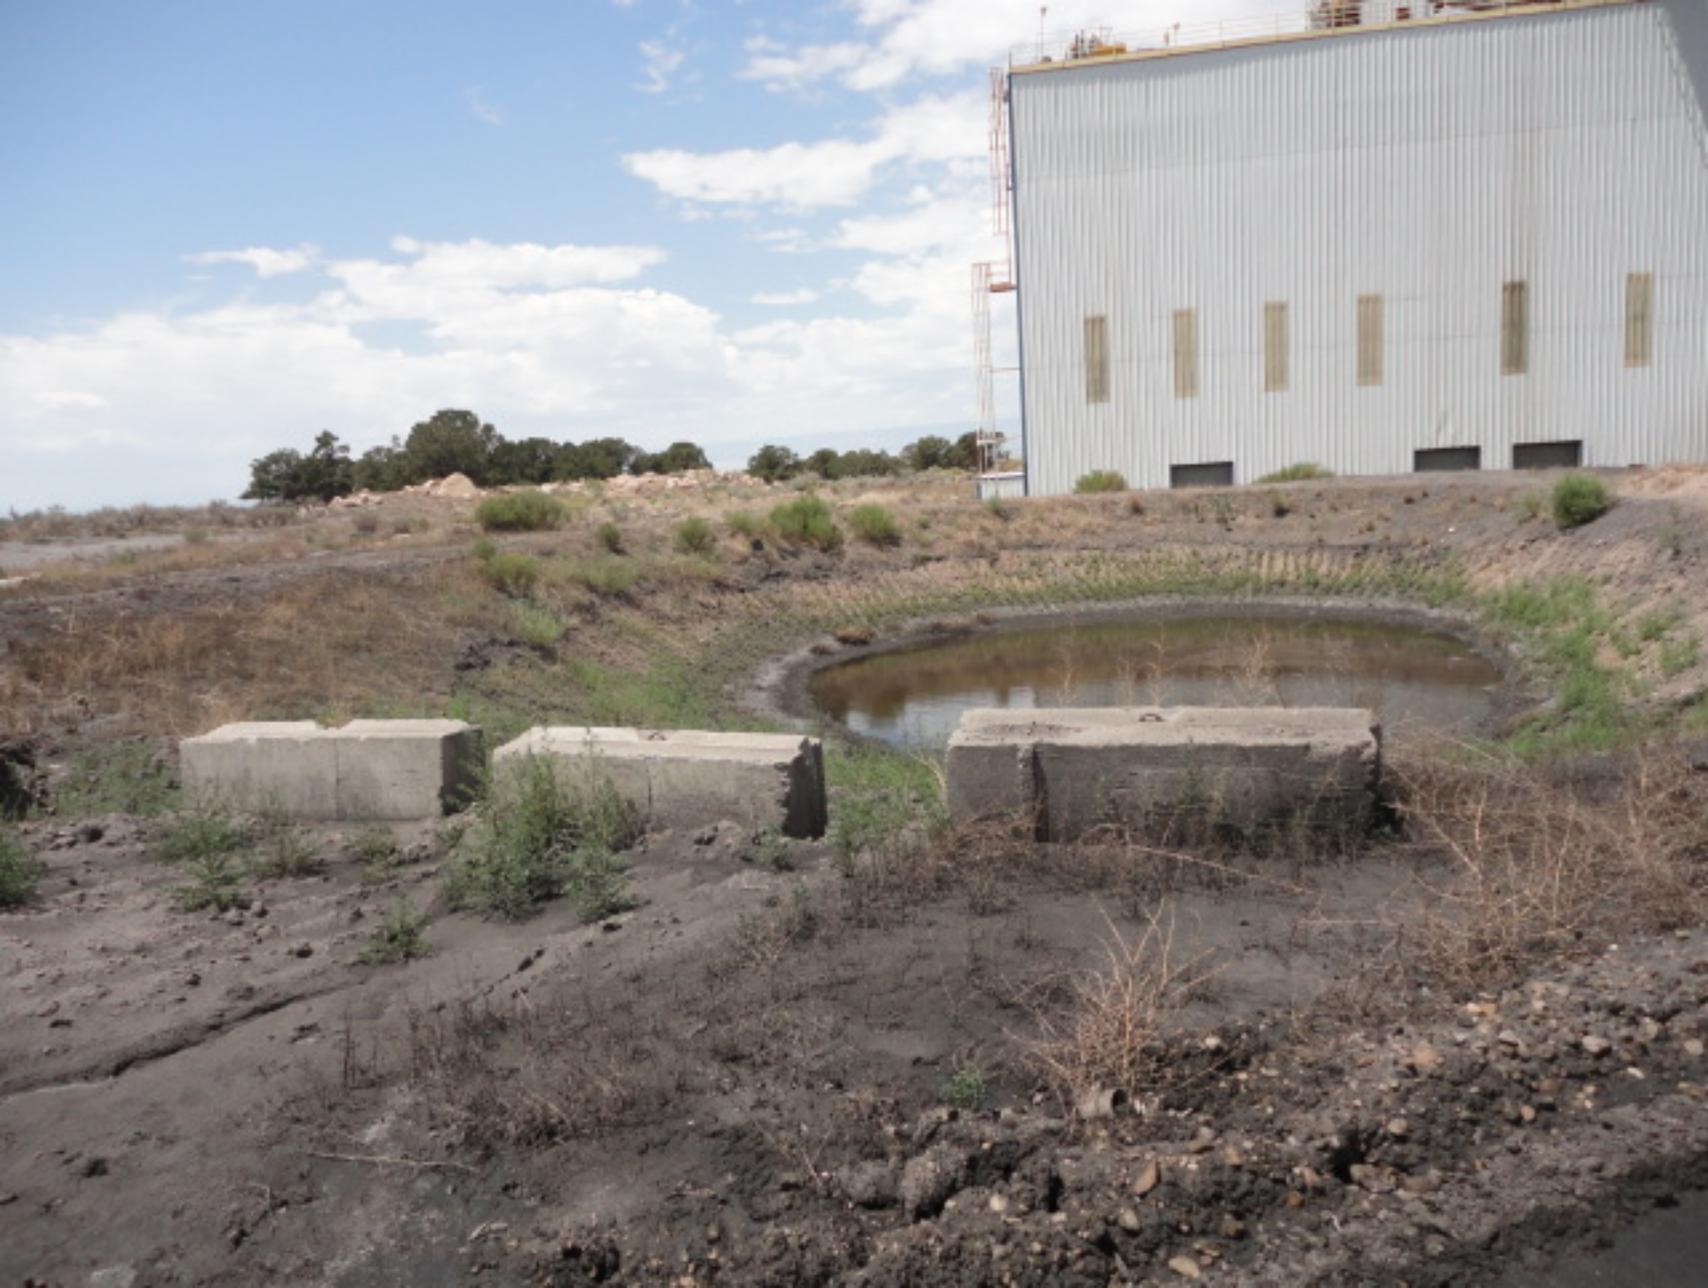
I inspected diversions and culverts throughout the property. They were open and would function as designed in a storm event. See Photos.
