# Inspection Report

Permit Number:	C0070035
Inspection Type:	PARTIAL
Inspection Date:	Monday, July 1, 2019
Start Date/Time:	7/1/2019 12:00:00 PM
End Date/Time:	7/1/2019 4:00:00 PM
Last Inspection:	Wednesday, June 5, 2019

Permitee: **SUNNYSIDE COGENERATION ASSOCIATES**  
 Operator: **SUNNYSIDE COGENERATION ASSOCIATES**  
 Site: **SUNNYSIDE REFUSE & SLURRY**  
 Address: **PO BOX 159, SUNNYSIDE UT 84539**  
 County: **CARBON**  
 Permit Type: **PERMANENT COAL PROGRAM**  
 Permit Status: **ACTIVE**

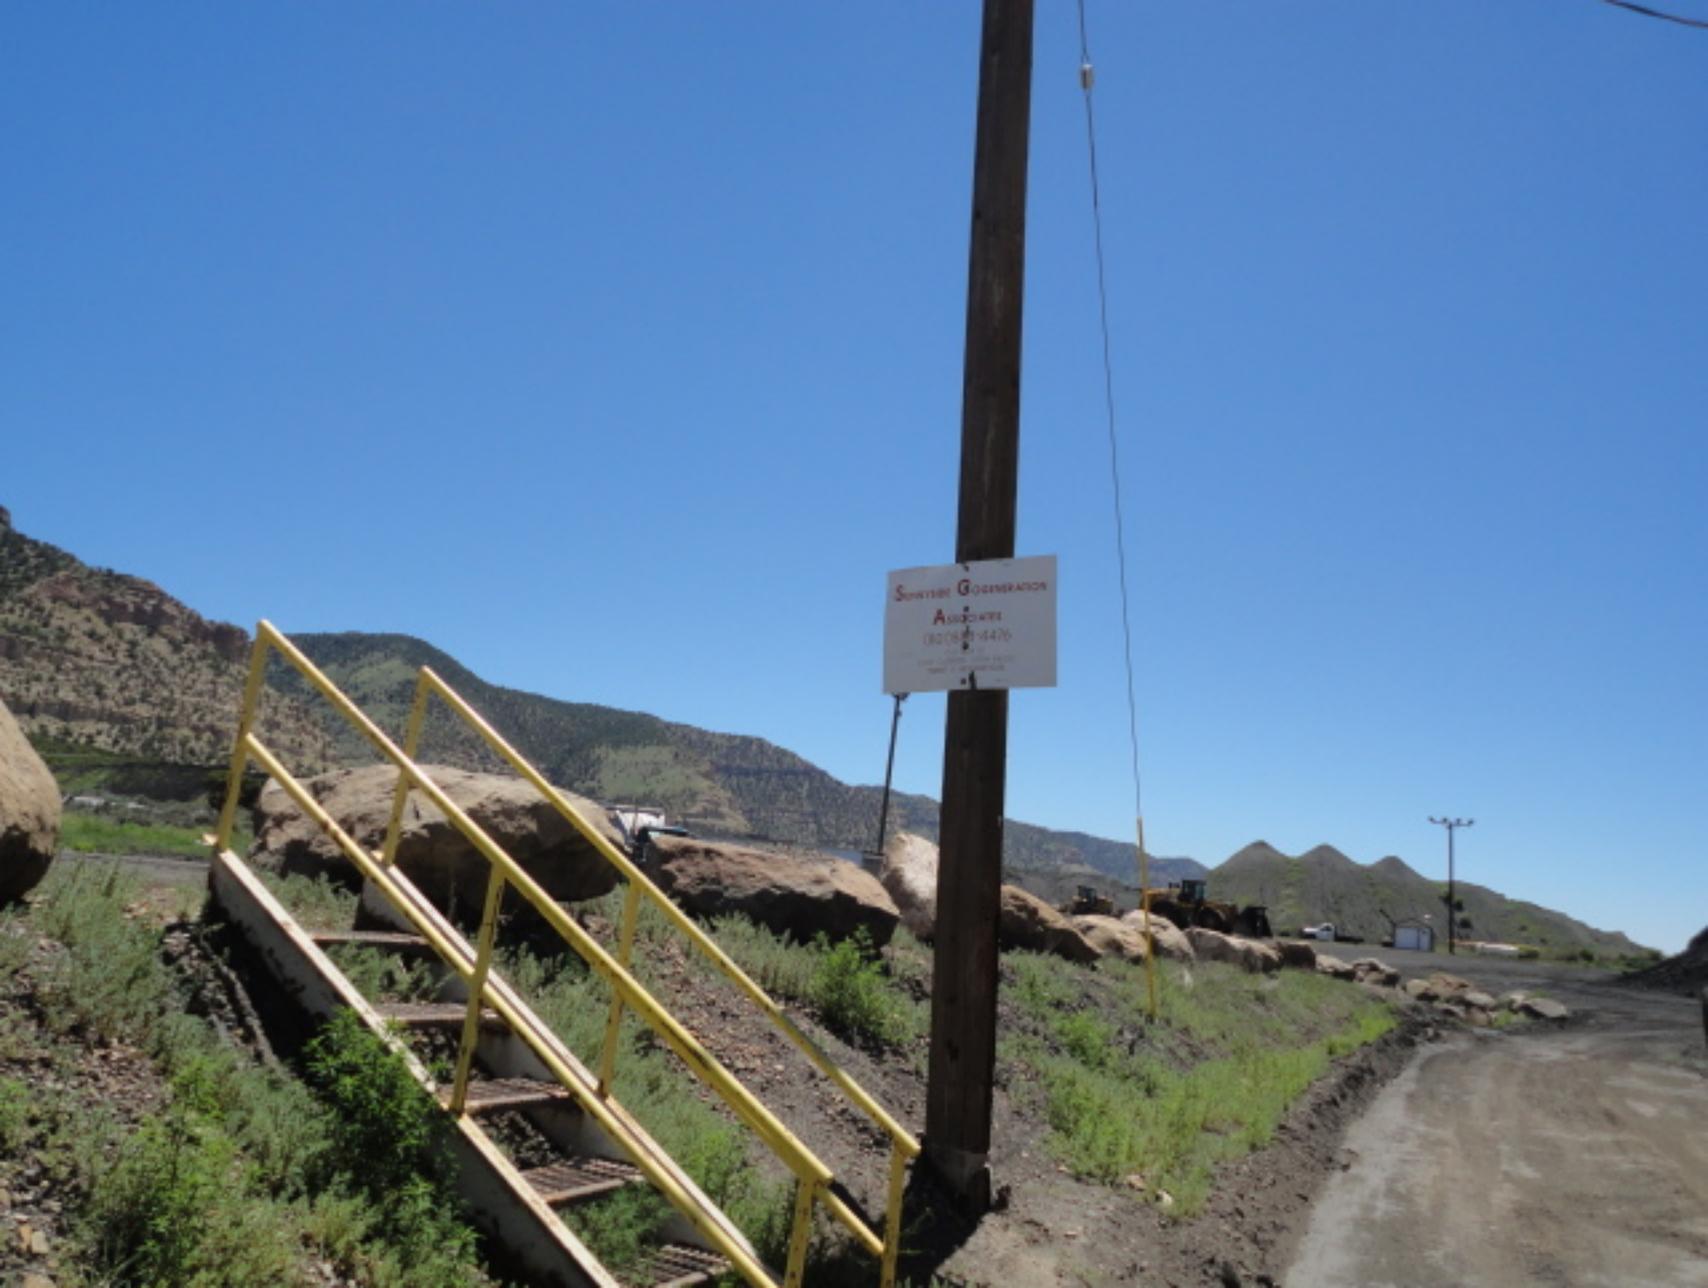
The identification sign was inspected and it meets the requirements of the R645 Coal Rules. See Photo

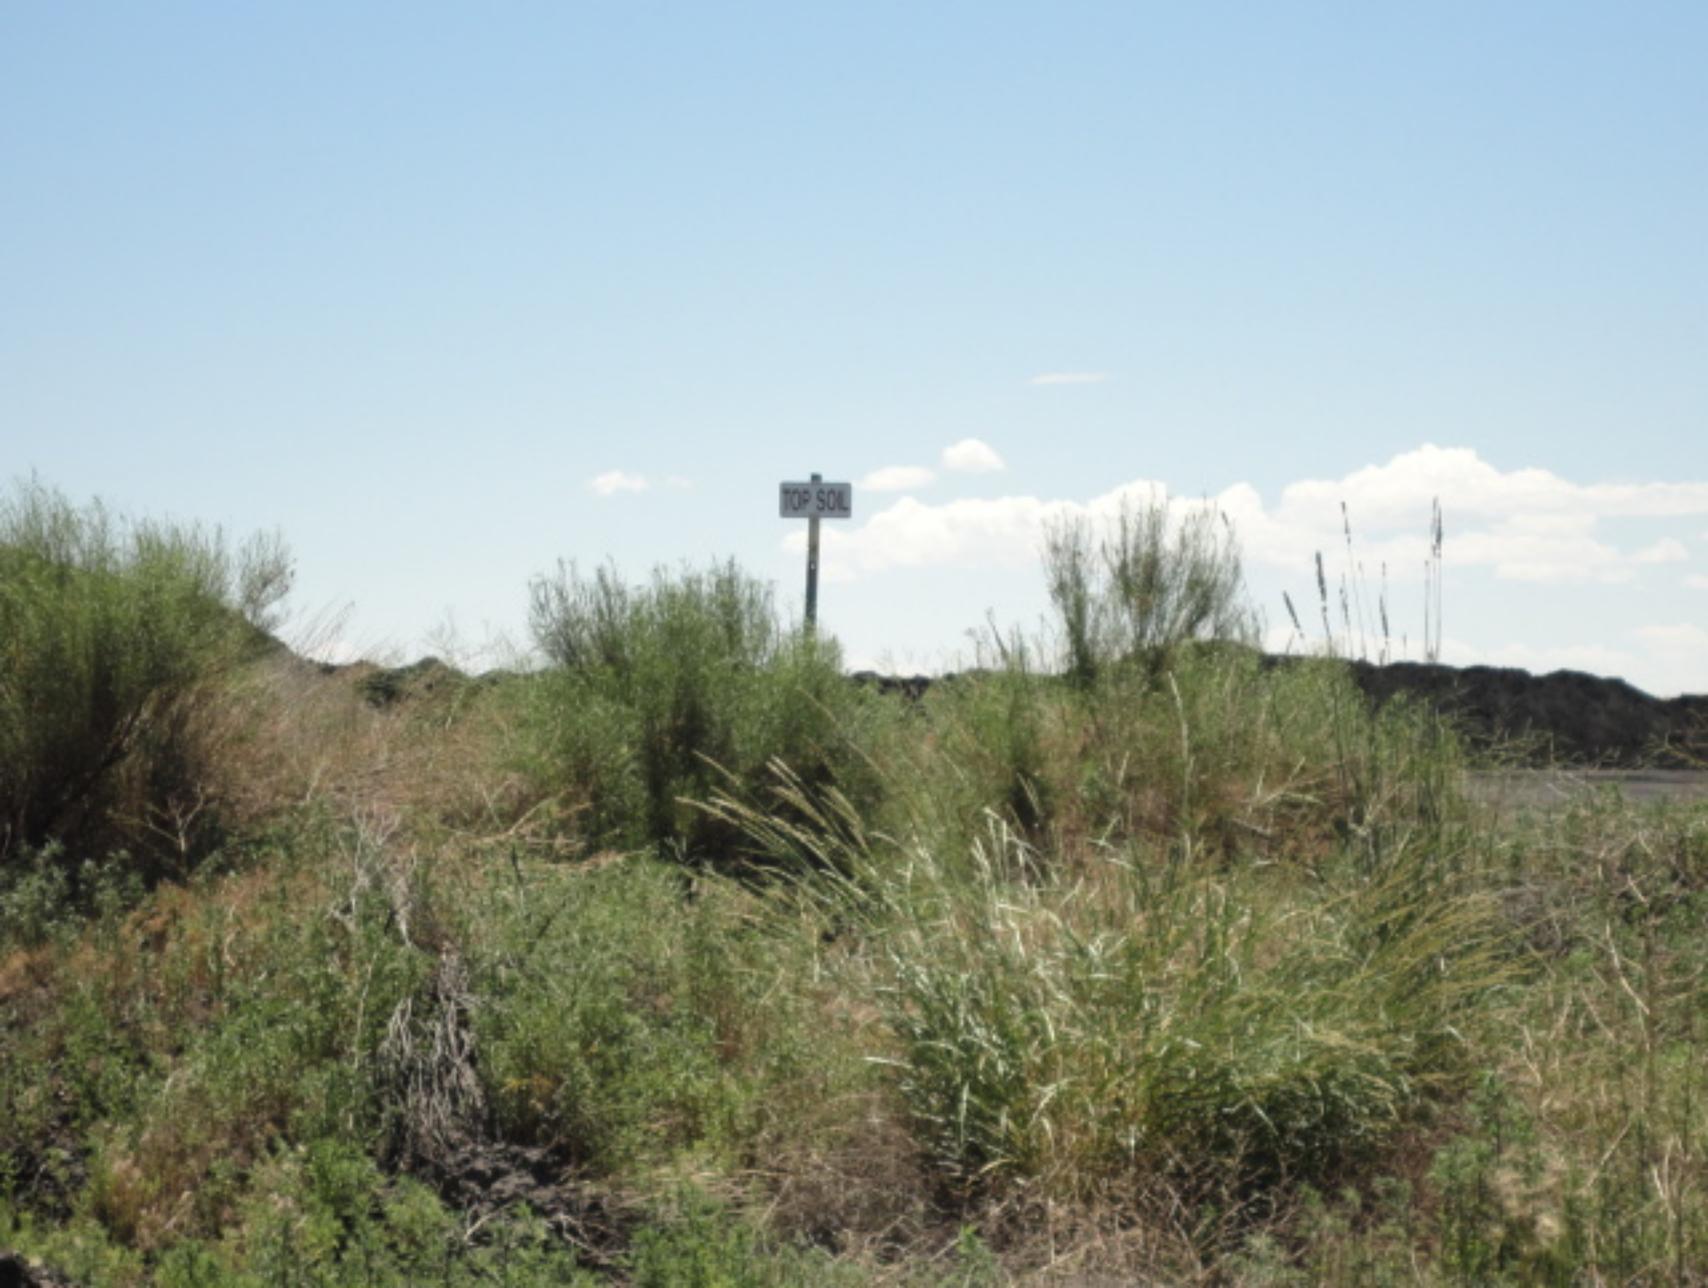
TOP SOIL

I inspected the topsoil piles and I did not see any signs of wind or water erosion. The topsoil piles appear to be stable and protected by a berm.

A photograph of a field with various green and brown plants. In the center background, a wooden sign on a post reads "TOP SOIL". The sky is blue with some white clouds. The foreground is filled with dense, tall grasses and shrubs, some of which are green and others are brown and dry. The sign is positioned in the middle ground, slightly to the left of the center. The overall scene appears to be a natural or agricultural setting, possibly a field being prepared for planting or a site of environmental study.

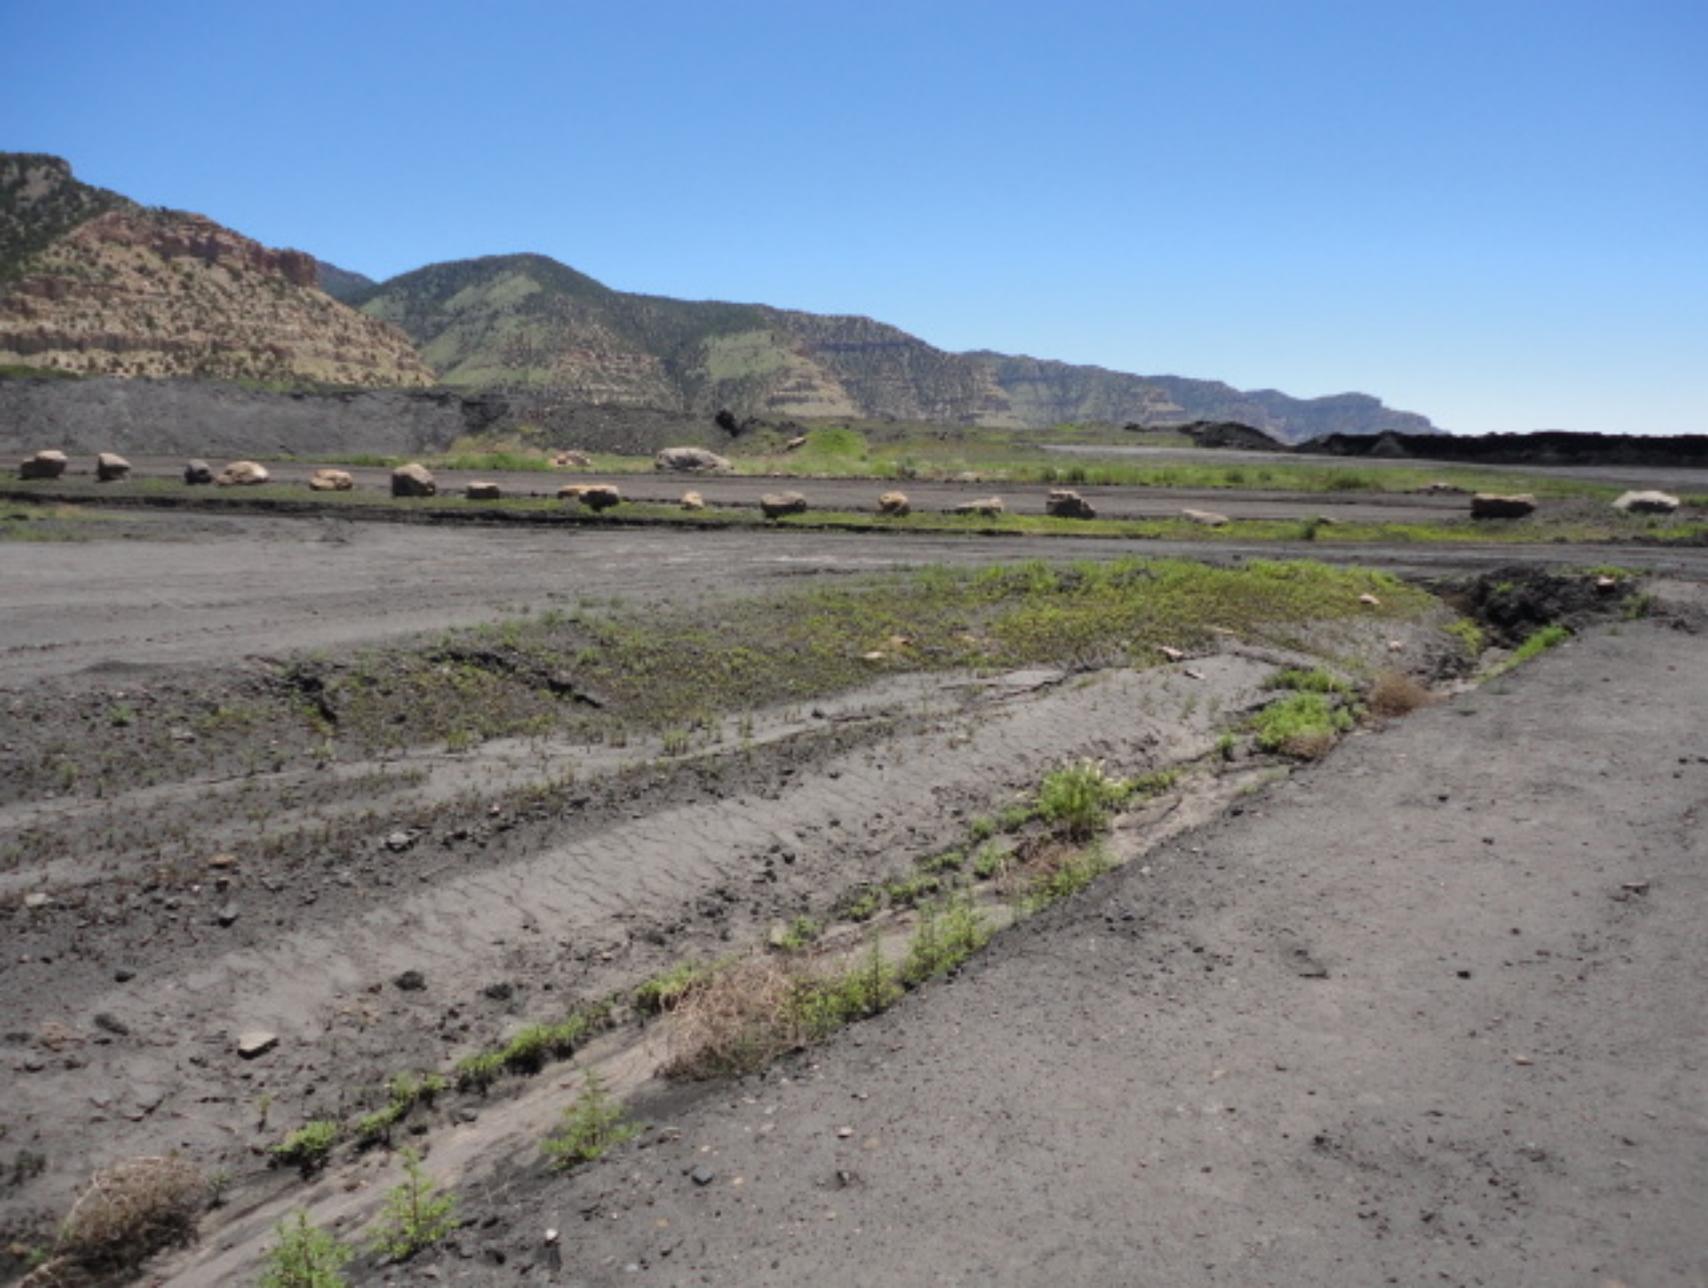
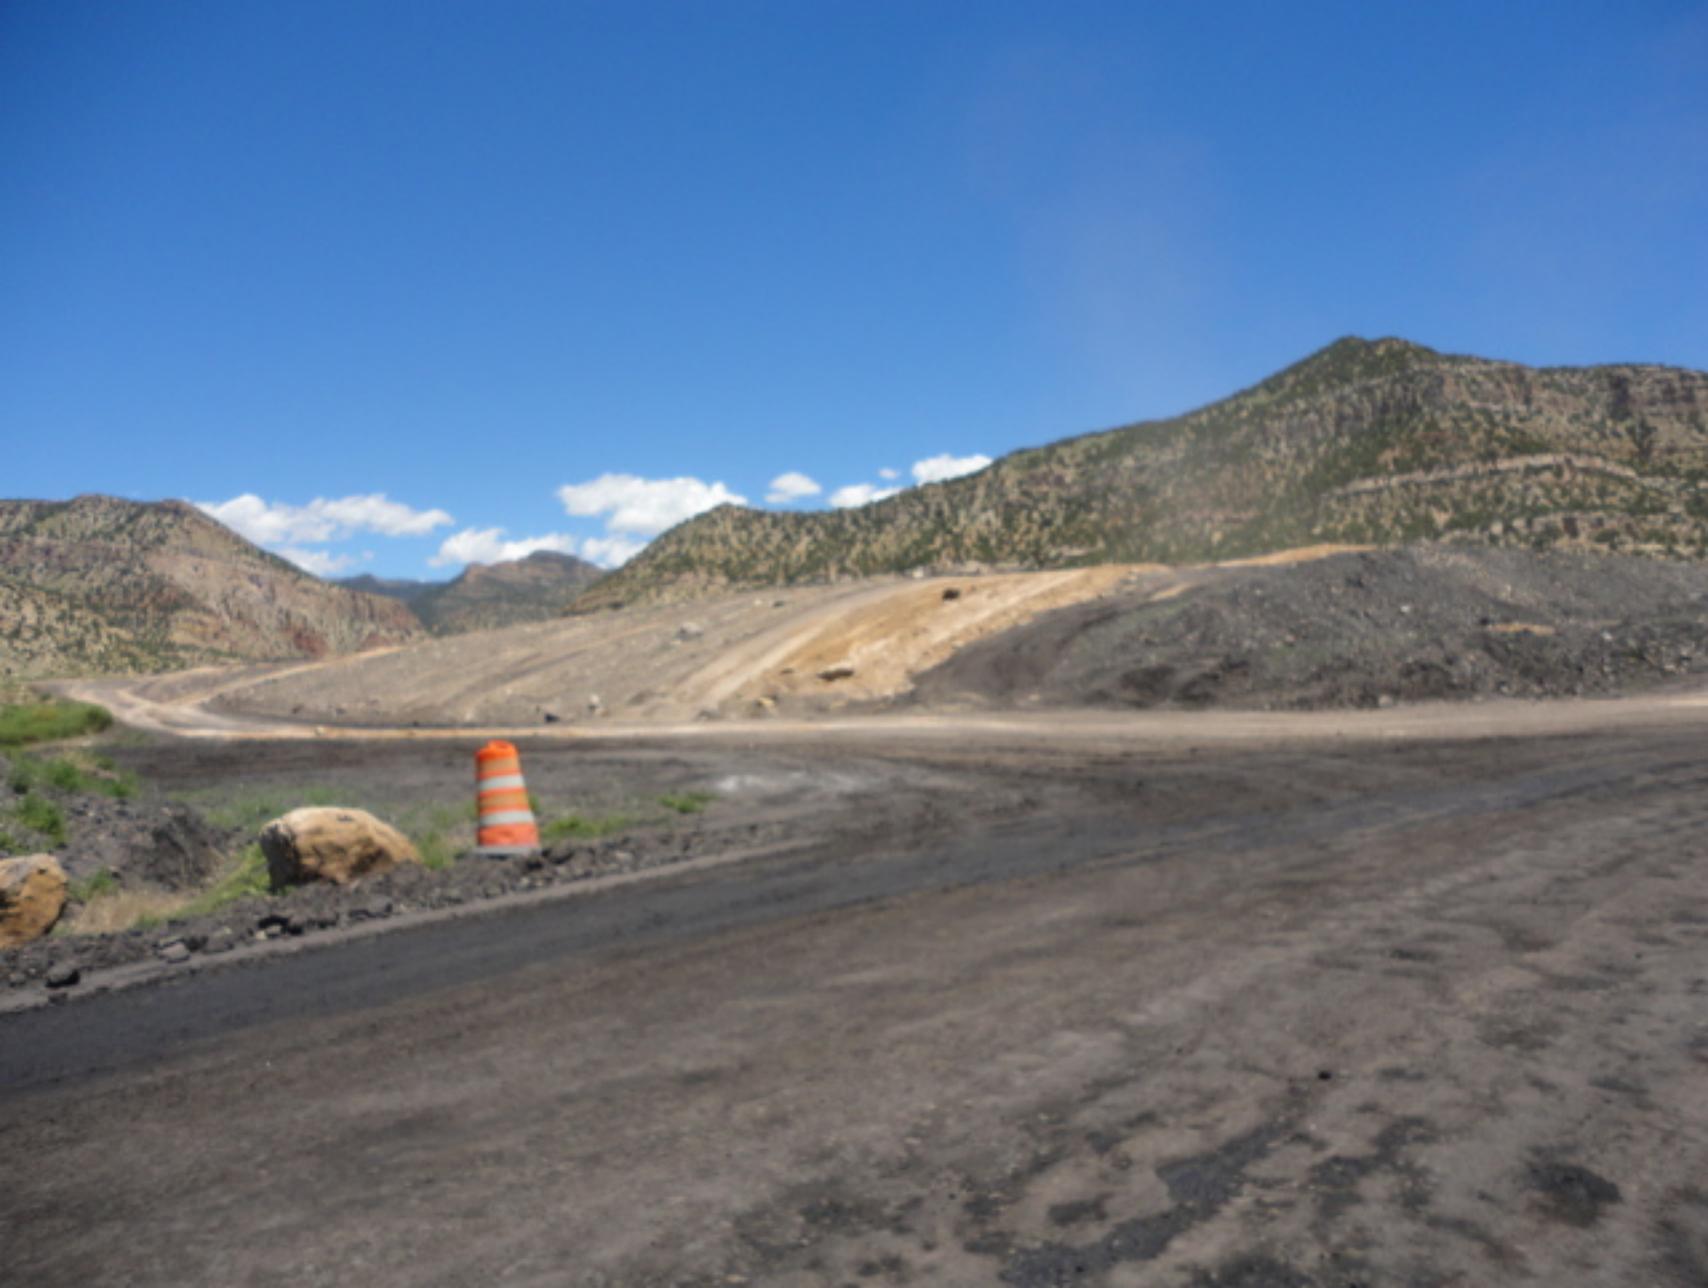
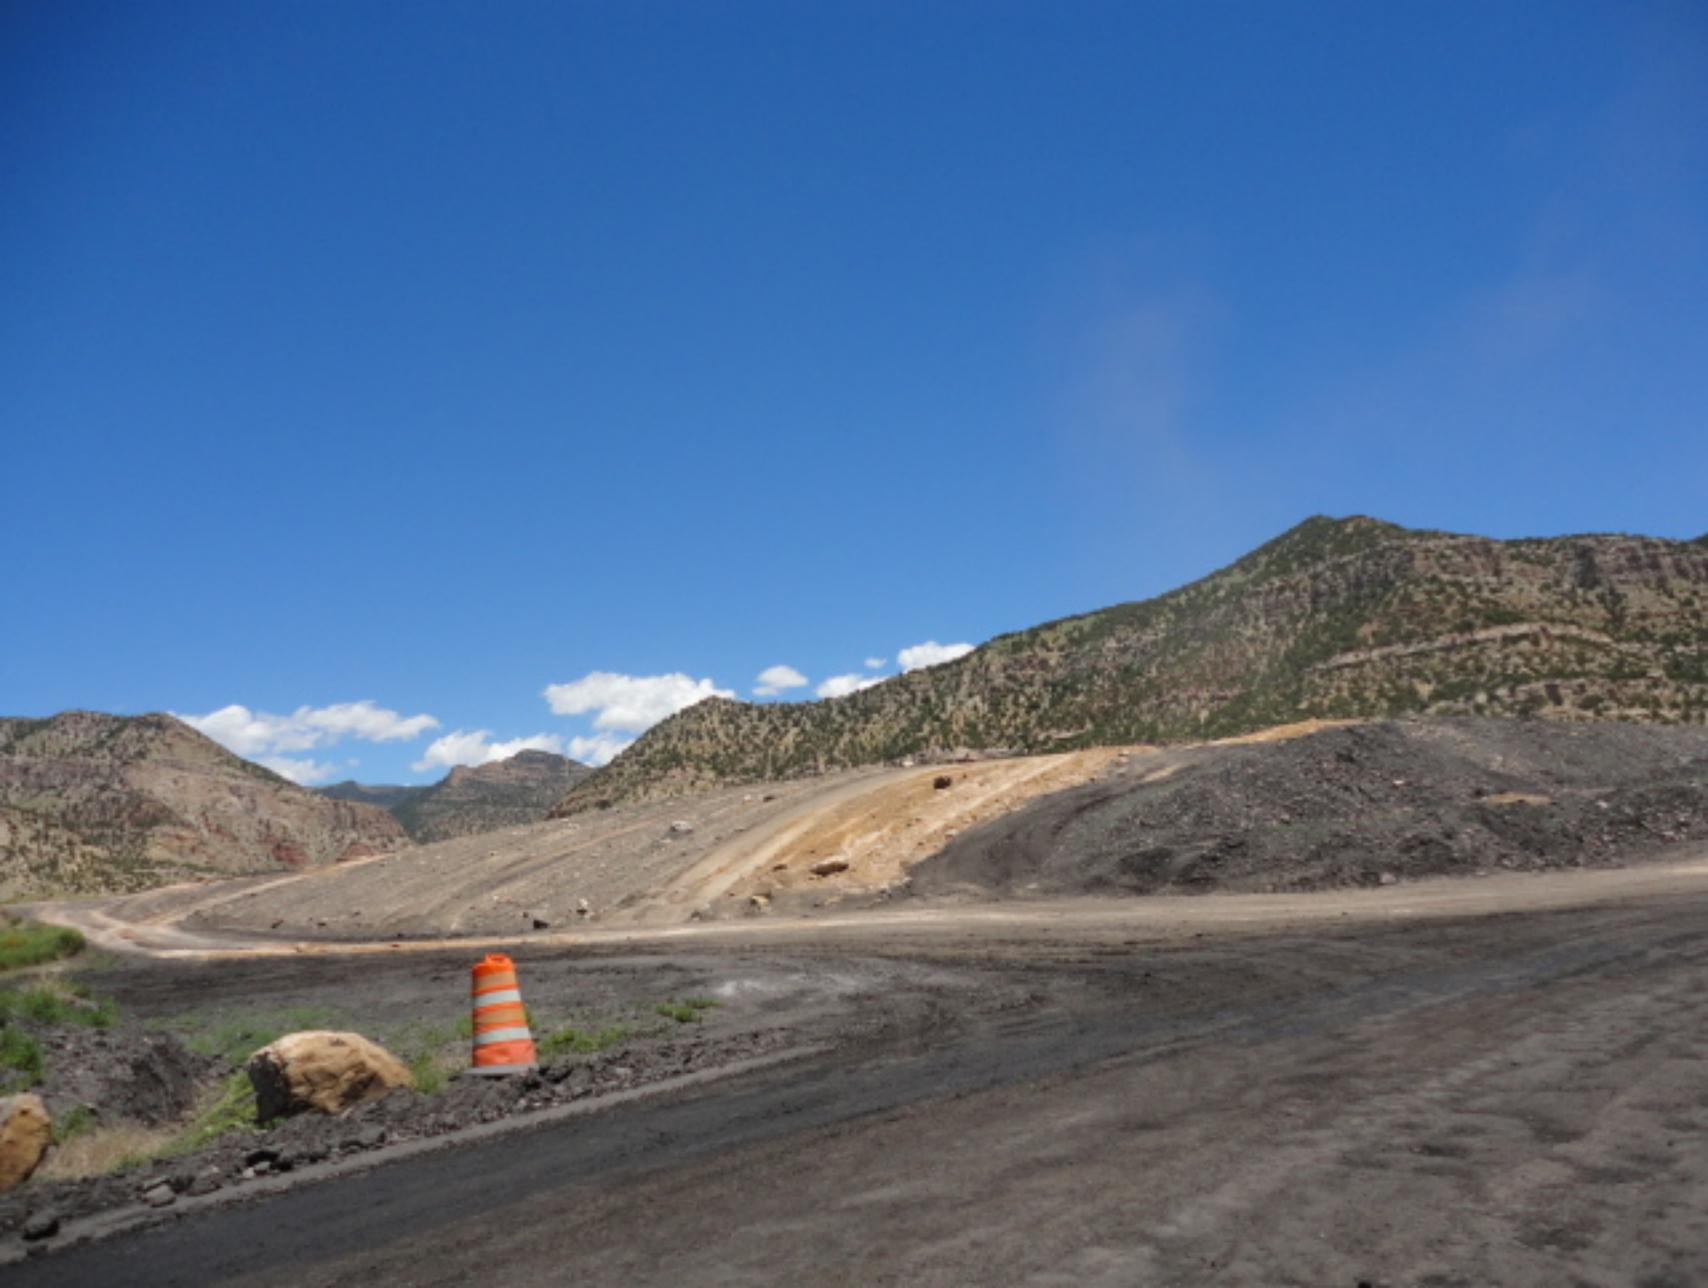
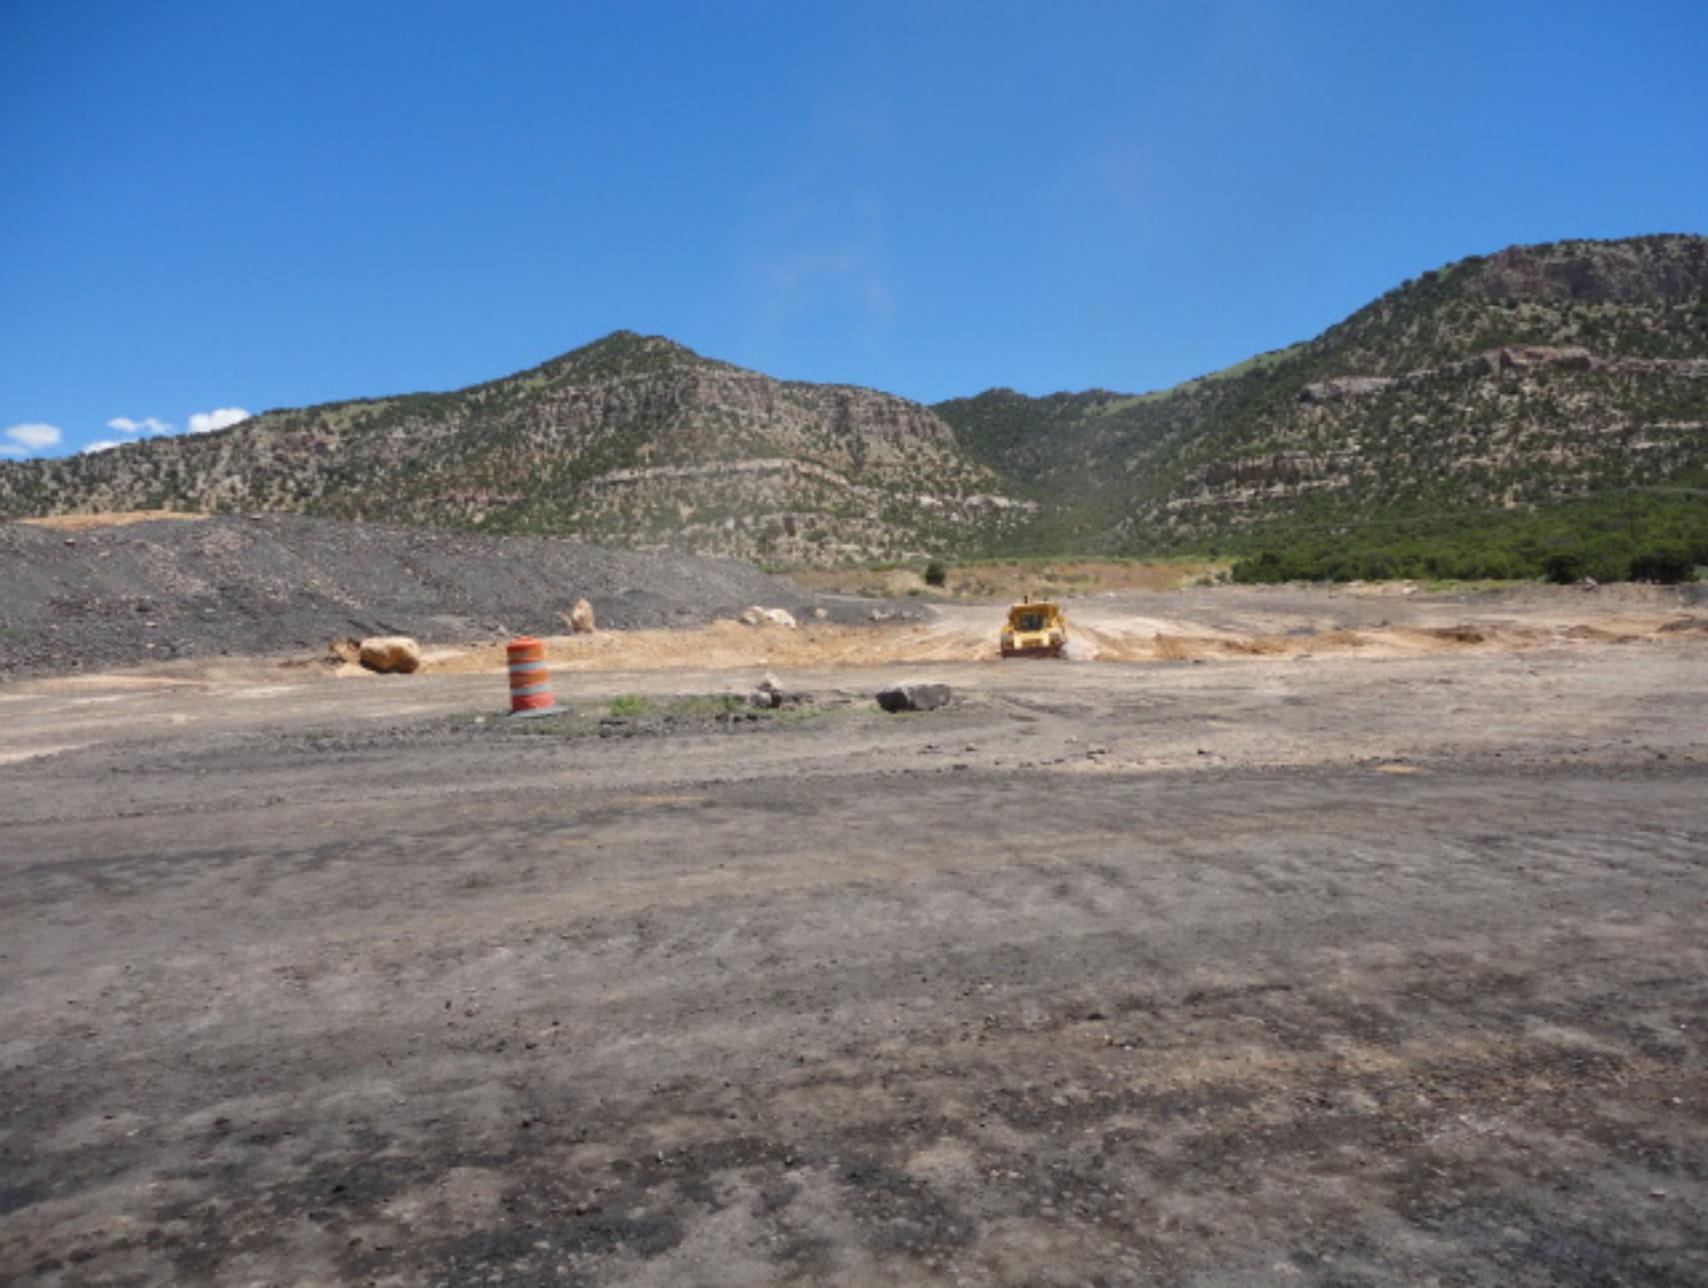
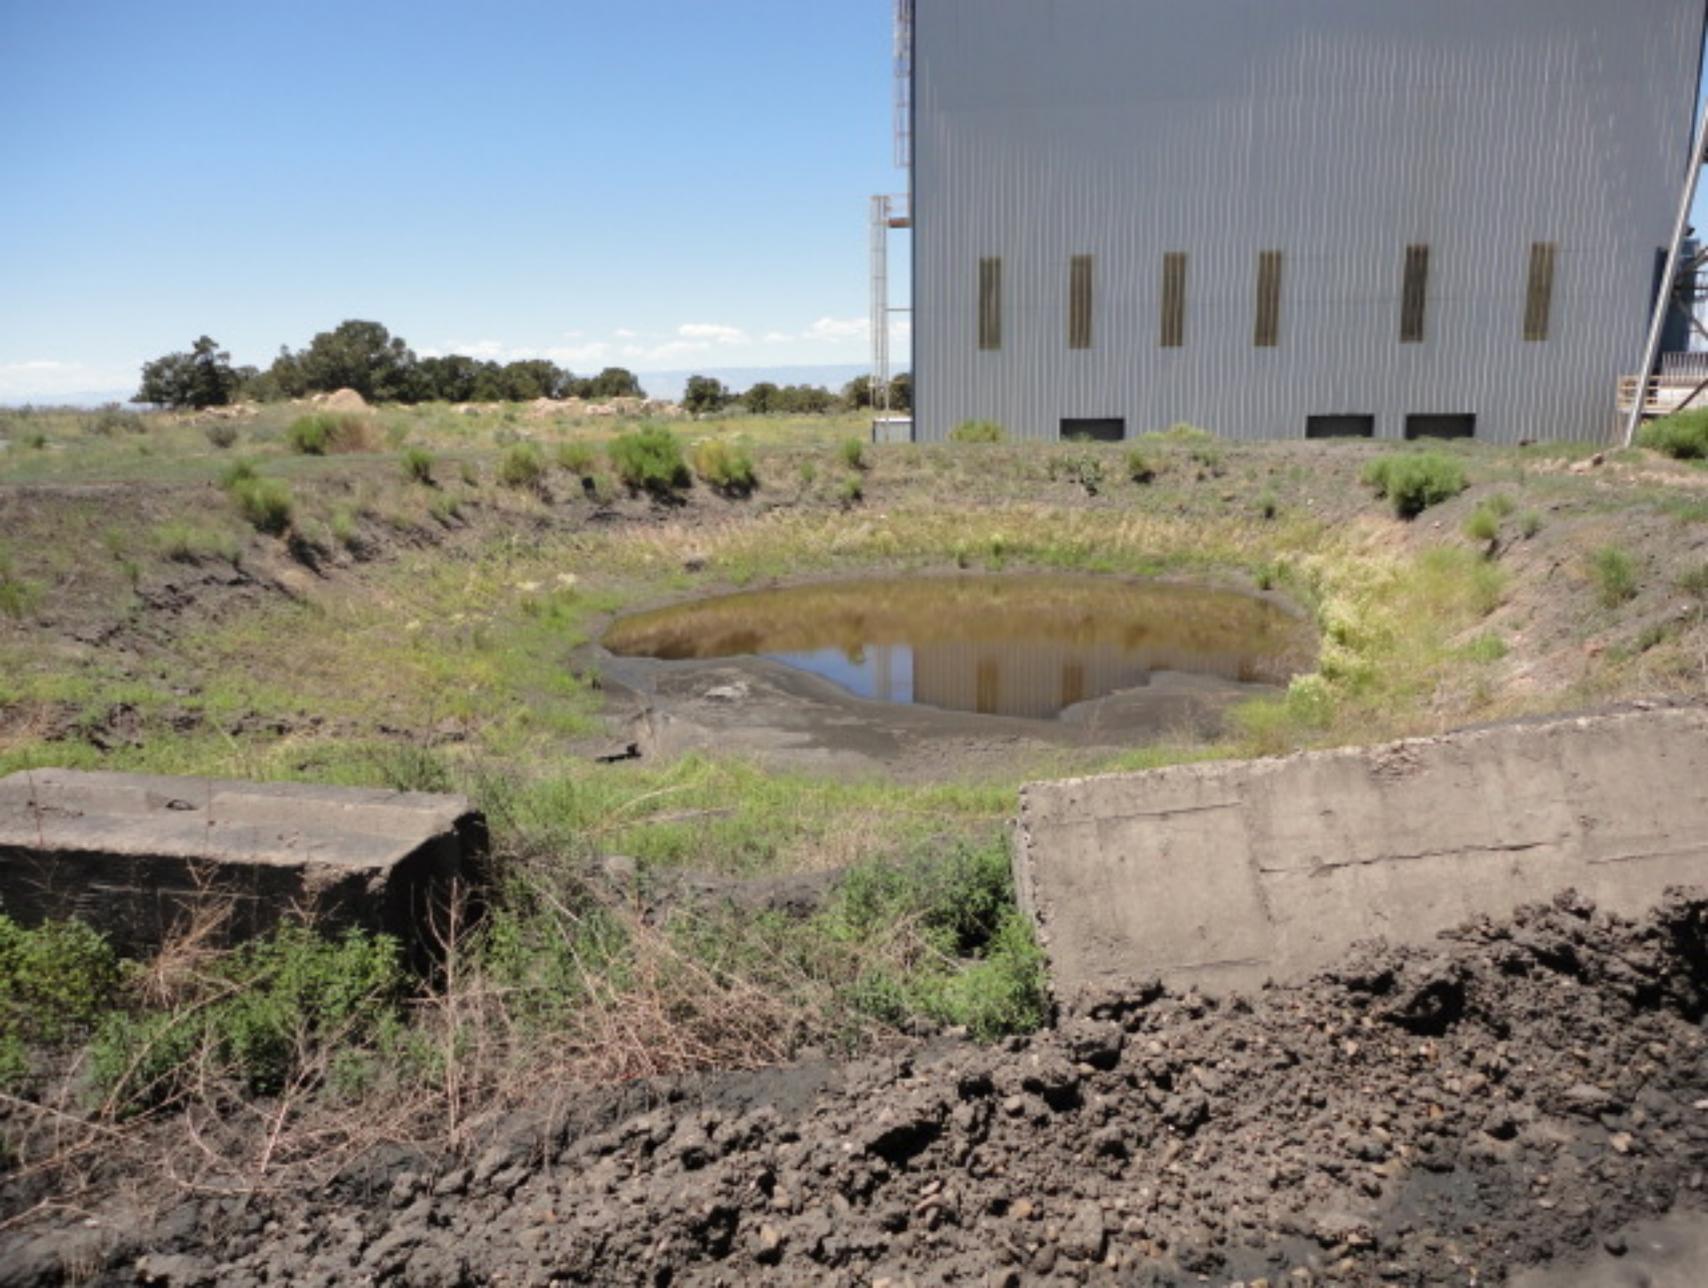
I inspected diversions and culverts throughout the property. They were open and would function as design in a storm event. See Photos.

I inspected the road diversions and culverts throughout the property. They were functioning as design. See Photos
