**CYPRUS**  
Plateau Mining

**WILLOW CREEK MINE  
1997 SUBSIDENCE  
MONITORING REPORT**

**ANNUAL REPORT**

**SUBSIDENCE MONITORING REPORT  
1997  
WILLOW CREEK MINE  
ACT/007/006**

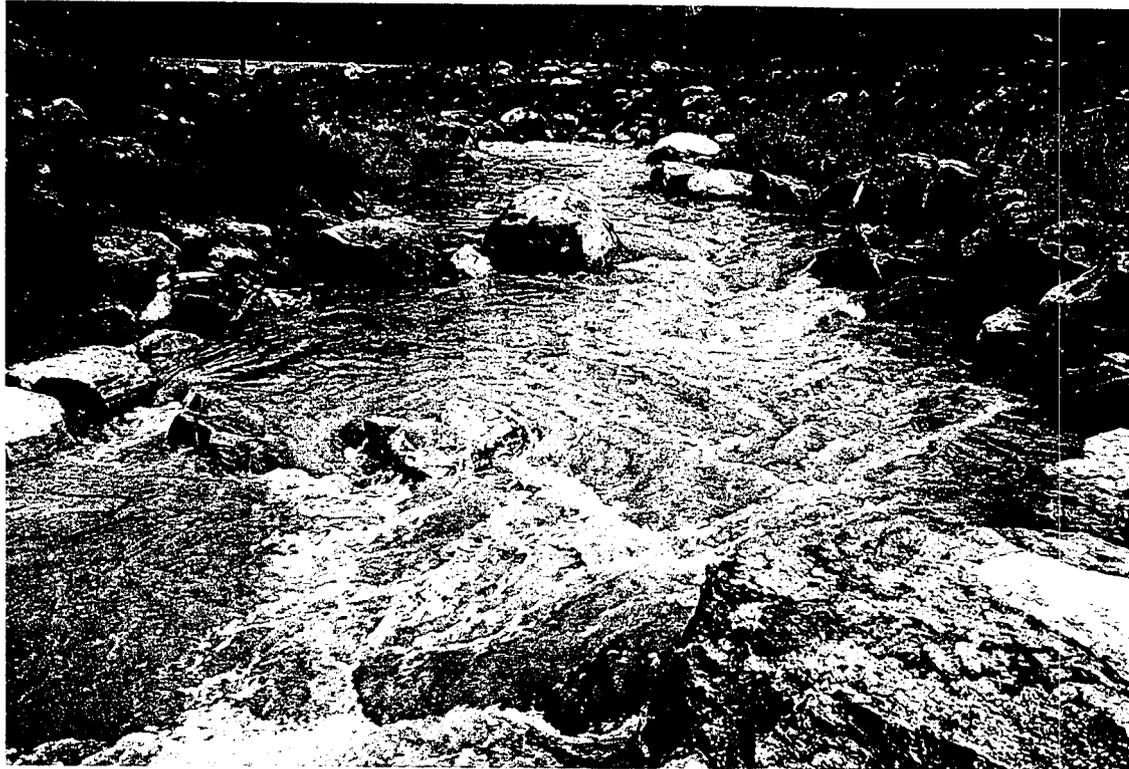
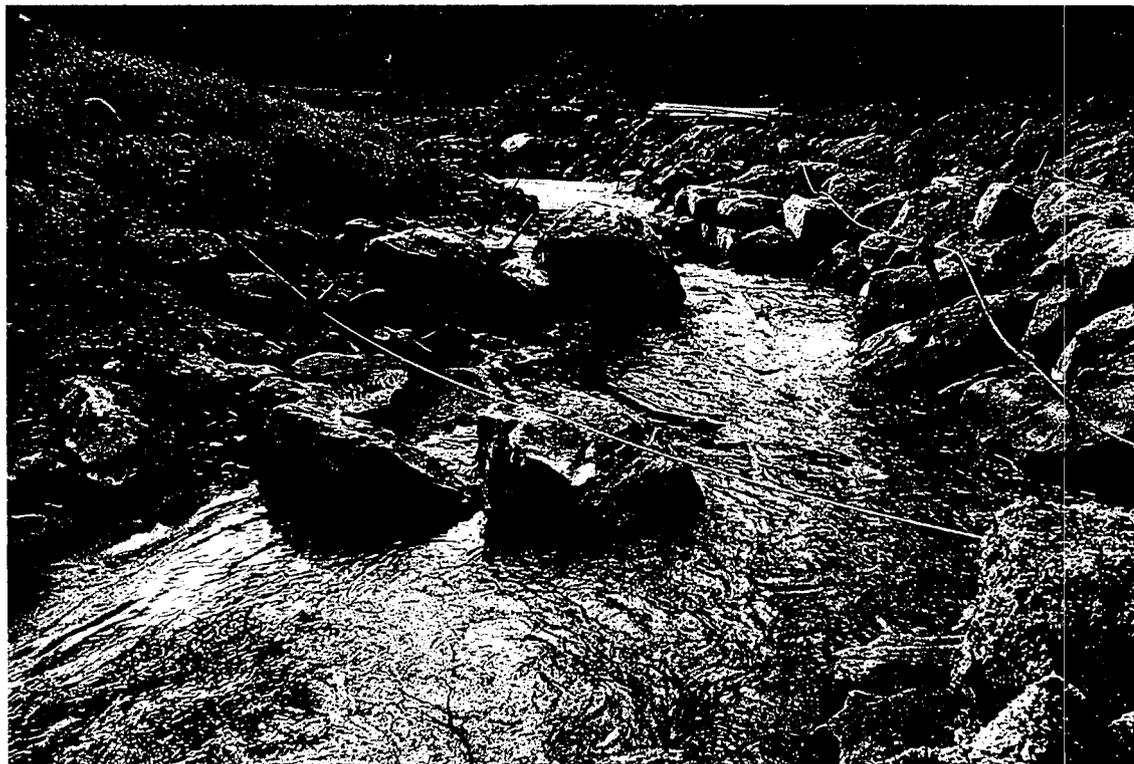
Based on a site inspection of Willow Creek conducted on May 24, 1998 by SWCA, the relocated channel was stable and functional. On this date, flow was overtopping the box weirs that Cyprus installed above and below the relocated channel. Discharge was higher than when SWCA inspected the creek relocation in 1997 (photos A through F, Figs. 3-5). The stream channel was successfully conveying flow and no streambank or channel structural failure was noticeable. The step-pool complexes in the relocated channel were in place, although flows were so high they were overtopping the entirety of most of the rock dam features. However, I observed areas of slack water due to the structural diversity designed into the channels (Figs. 3-5).

Figure 3. Photo A (top, may 24, 1998) and B (bottom, June 10, 1997). Photos taken of lower stretch of Willow Creek stream relocation. Note identical boulders in each photo and the higher flows of these two dates occurring in 1998.

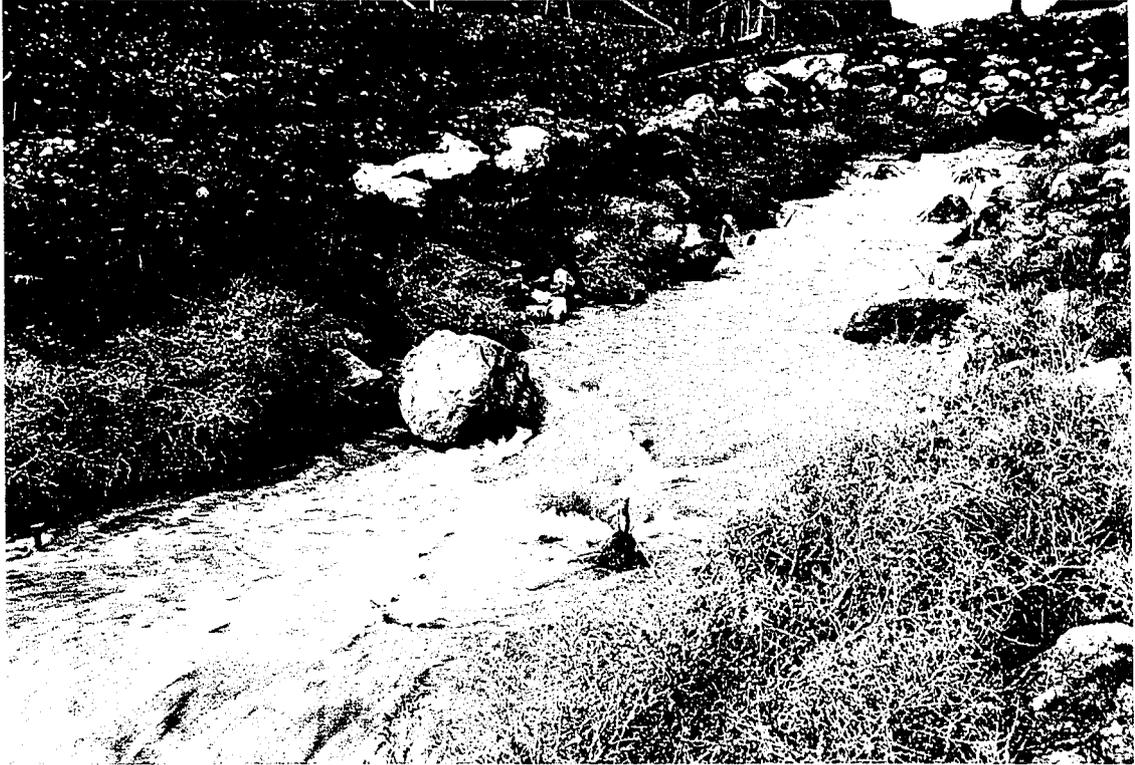
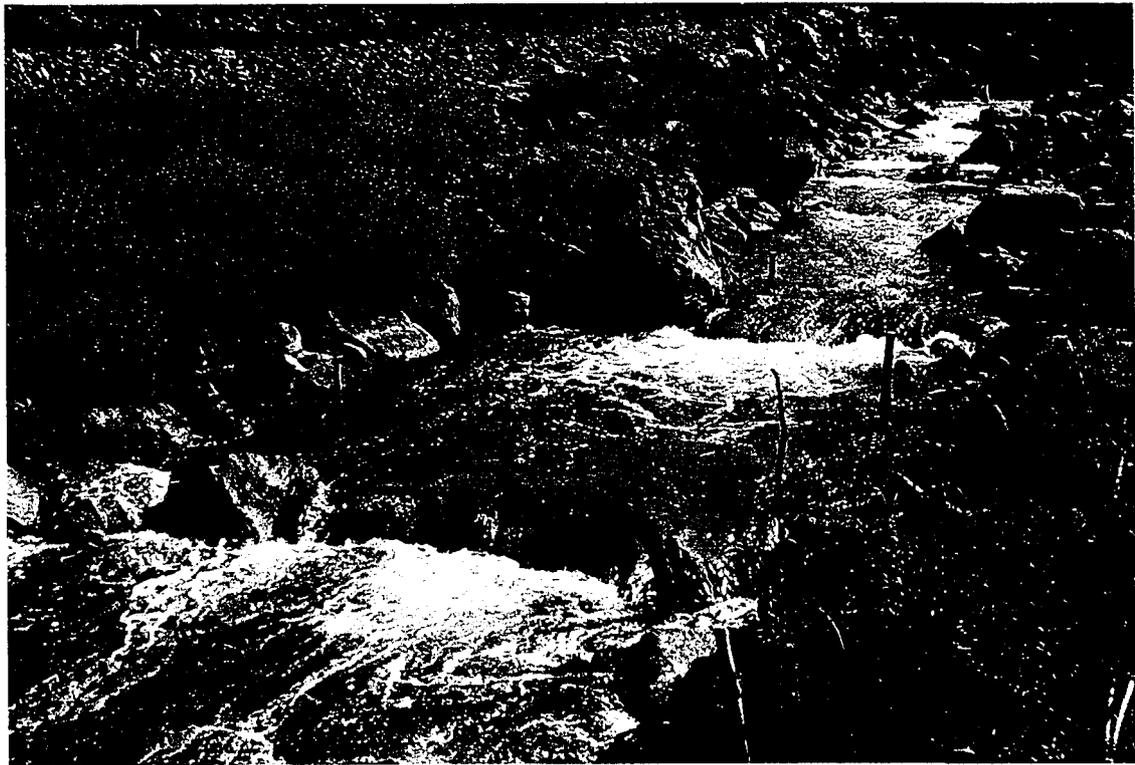
Figure 5. Photo E (top, may 24, 1998) and F (bottom, June 10, 1997). Photos taken at upper end of lower stretch of Willow Creek stream relocation, just below large culvert. Note identical boulders in each photo and the higher flows of these two dates occurring in 1998.

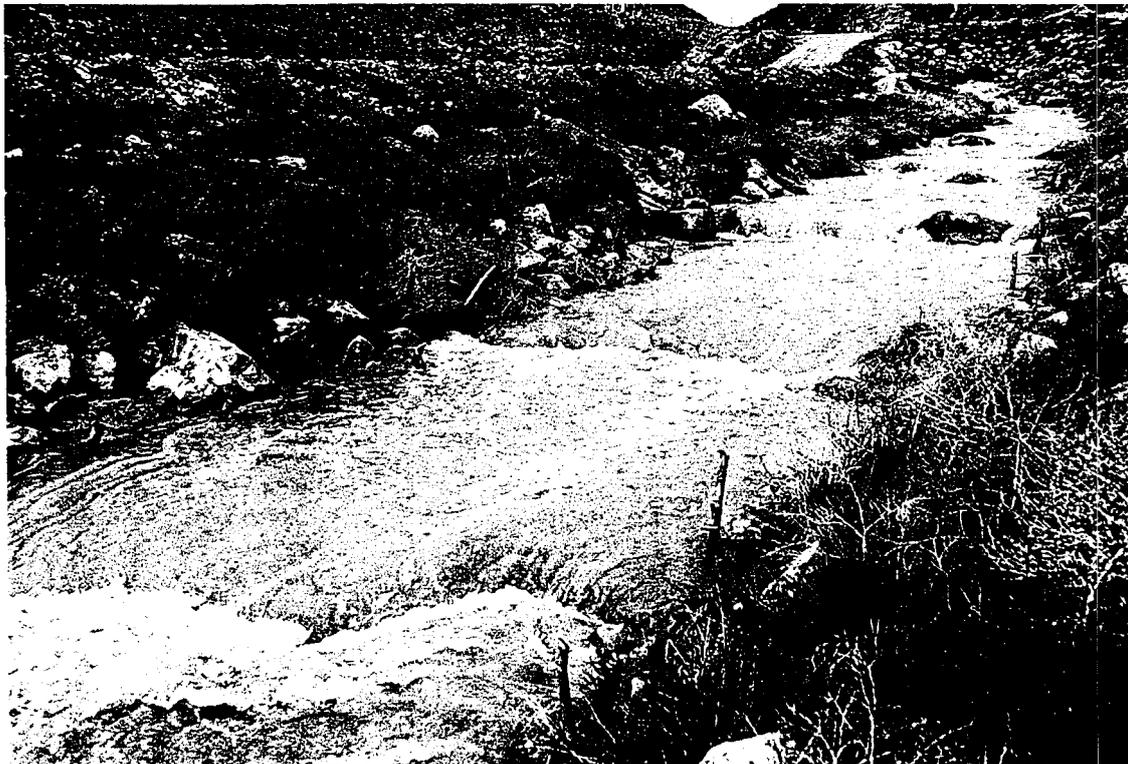
The rockdams and habitat features built in the relocated stretch of Willow Creek appear to have held up well under two years of above average discharge conditions (back-to-back years with 6/7-year recurrence intervals). Figure 6 compares 1998 conditions (photos G and H) with those photographed in 1996 and 1997 (Figures 3 and 4 in SWCA 1998) at Willow Creek. Figure 7 compares 1998 conditions (photos I and J) with those photographed in 1996 (Photos 1 and 2 in SWCA 1997, p.4) at Willow Creek. Comparison of these photos show that no boulders or rockdams show any significant sign of movement as a result of the high flows.

Figure 6. Willow Creek relocation, June 10, 1998. Photo G (top), upper end of upper stretch, and photo H (bottom), middle part of lower stretch. Photo G compares with Figure 3 in SWCA (1998) and photo H compares with Figure 4 in SWCA (1998).

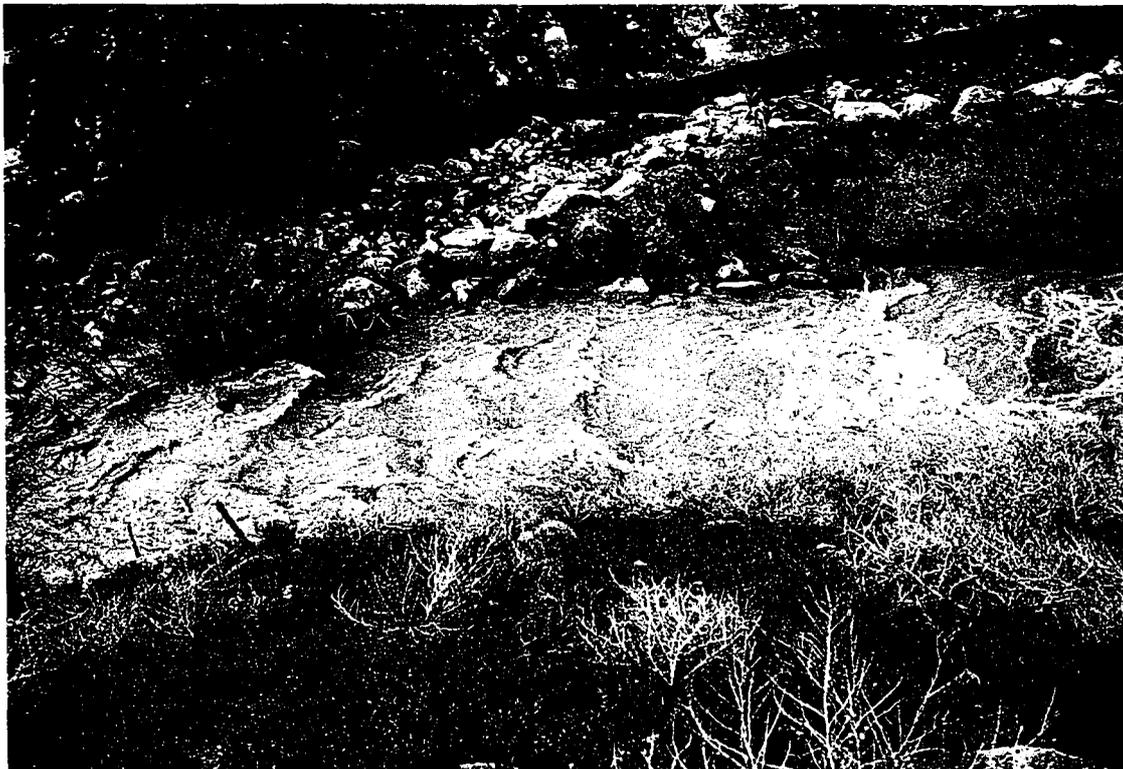
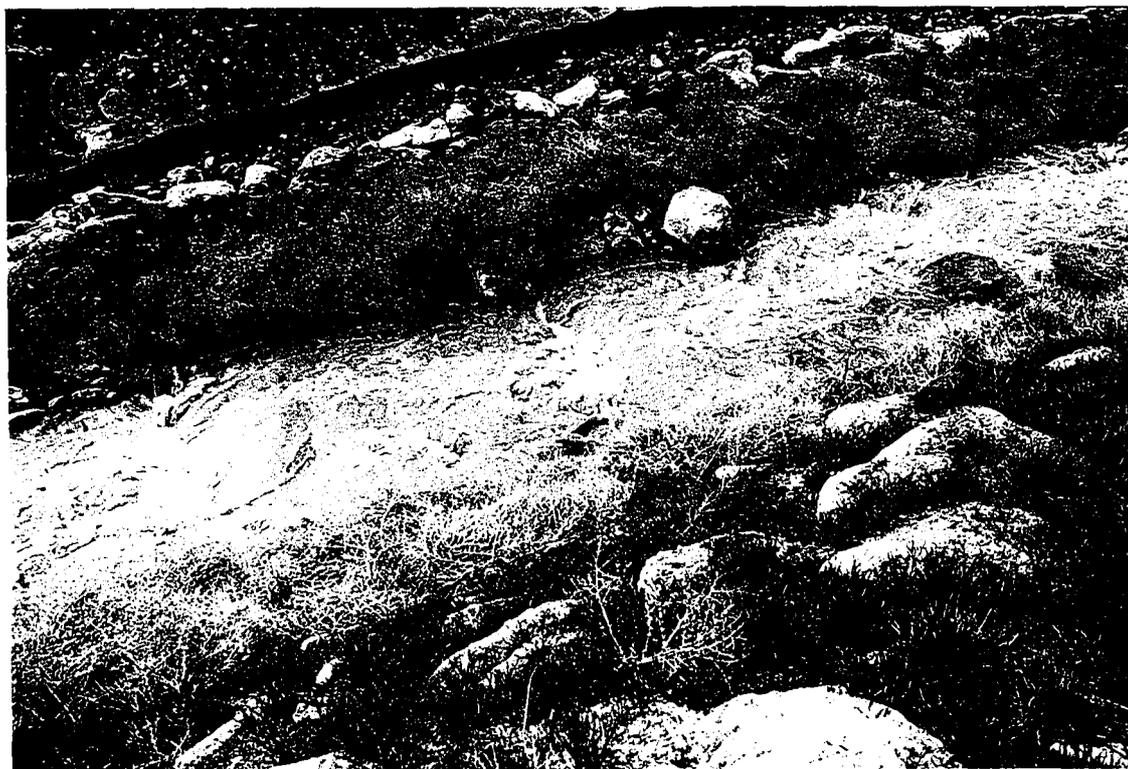
Figure 7. Willow Creek relocation, June 10, 1998. Photo I (top) and photo J (bottom) both of the lower portion of the upper stretch of Willow Creek stream relocation. Photos H and I compare with photos 1 and 2 (SWCA 1997, p. 4), respectively.
