Inspection Report

Permit Number:	C0070038
Inspection Type:	COMPLETE
Inspection Date:	Friday, November 14, 2014
Start Date/Time:	11/14/2014 10:00:00 AM
End Date/Time:	11/14/2014 1:00:00 PM
Last Inspection:	Thursday, October 23, 2014

Permitee: **PLATEAU MINING CORP**
 Operator: **PLATEAU MINING CORP**
 Site: **WILLOW CREEK MINE**
 Address: **PO BOX 30, HELPER UT 84526-0030**
 County: **CARBON**
 Permit Type: **PERMANENT COAL PROGRAM**
 Permit Status: **ACTIVE**

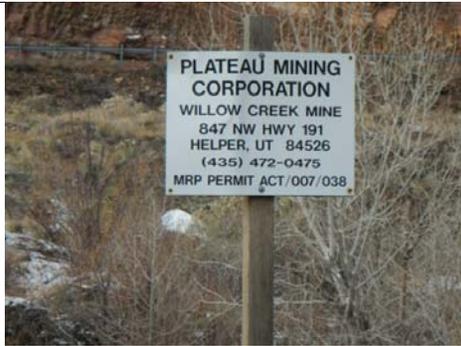
Photo 1 Permit Sign

The Mine and Permit identification signs were inspected at all three locations (School House Refuse pile, Rail Load-Out, Crandall Canyon, and west of the former Facilities) and found to be in working order. Photo 1 shows the information on the signs, which meet the minimum requirements of R645.521.200-.244 Coal Rules.

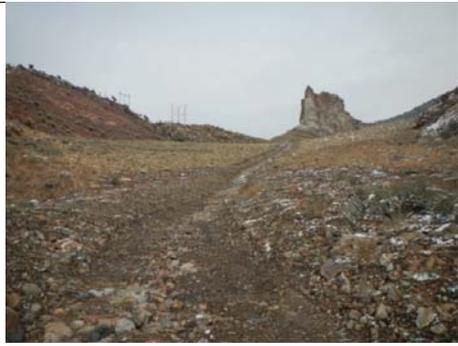
Photo 2 Vegetation on School House Refuse Pile

No topsoil piles remain as all available topsoil was applied during reclamation. There are no signs of instability or erosion above expected levels at any of the locations, as seen in Photo 2. The pocking of the soil near the old main facilities and up Crandall Canyon has assisted with reducing erosion of topsoil and promoting vegetation, as seen in Photo 3 of rail load out area.

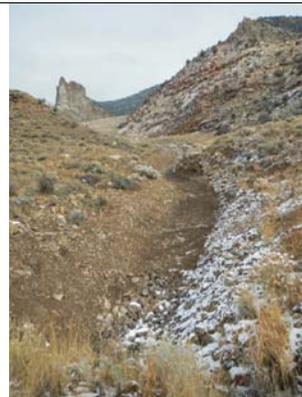
Photo 4 Repairs on lower School House refuse pile

A large rain event occurred in September of 2014 causing extensive runoff in many reclaimed areas. At the reclaimed School House refuse Pile, the runoff deposited sediment in the small basin just upstream of the culvert and filled culvert. The basin has been cleaned of sediment and the channel bed in the zone of deposition has been re-stabilized with rip-rap. The culvert will be cleaned in the next few weeks.

The site experienced several storm events in September-October 2014 that were above the required design capacity of the site's drainage systems. Maintenance and repairs were conducted along the ditches and culverts along Crandall Canyon and School House Refuse Pile. The lower section of the reclaimed School House Refuse pile had to be reconstructed to place rip-rap that had slide down to the culvert. Repairs to the area can be seen in photo 4. The culvert under frontage road of Hwy 6 was partially blocked at the time of inspection due to a shortage of equipment to finish the maintenance work in the area. The culvert, shown in photo 5, is scheduled to be cleaned out within a week.

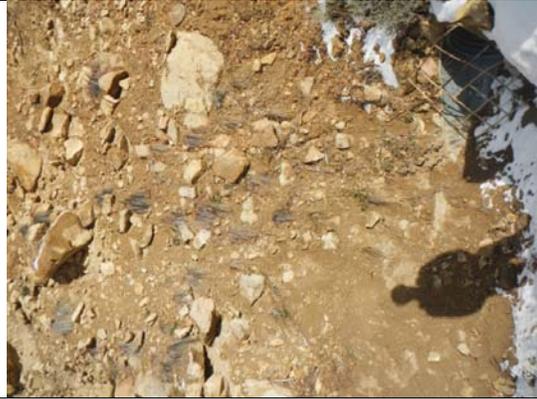
Photo 6 Culvert up Crandall Canyon

In Crandall Canyon, runoff deposited sediment in ditches running along the road and blocked a couple culverts. The ditches have been cleaned of sediment and only one culvert remains to be cleaned. This culvert will be cleaned in the next few weeks.

Ditches and culverts along Crandall Canyon were cleared by a maintenance crew to allow for proper drainage. See photo 6 and 7 of a culvert along Candall Canyon.
