**2006 ANNUAL REPORT  
TO THE  
UTAH DIVISION OF OIL, GAS AND MINING**

**DUGOUT CANYON MINE  
C/007/039**

RE: 2006 Annual Report for Dugout Canyon Mine, C/007/039

**RESULTS OF THE 2006  
GEOMORPHOLOGY EVALUATION  
OF THE PACE CREEK STREAM CHANNEL**

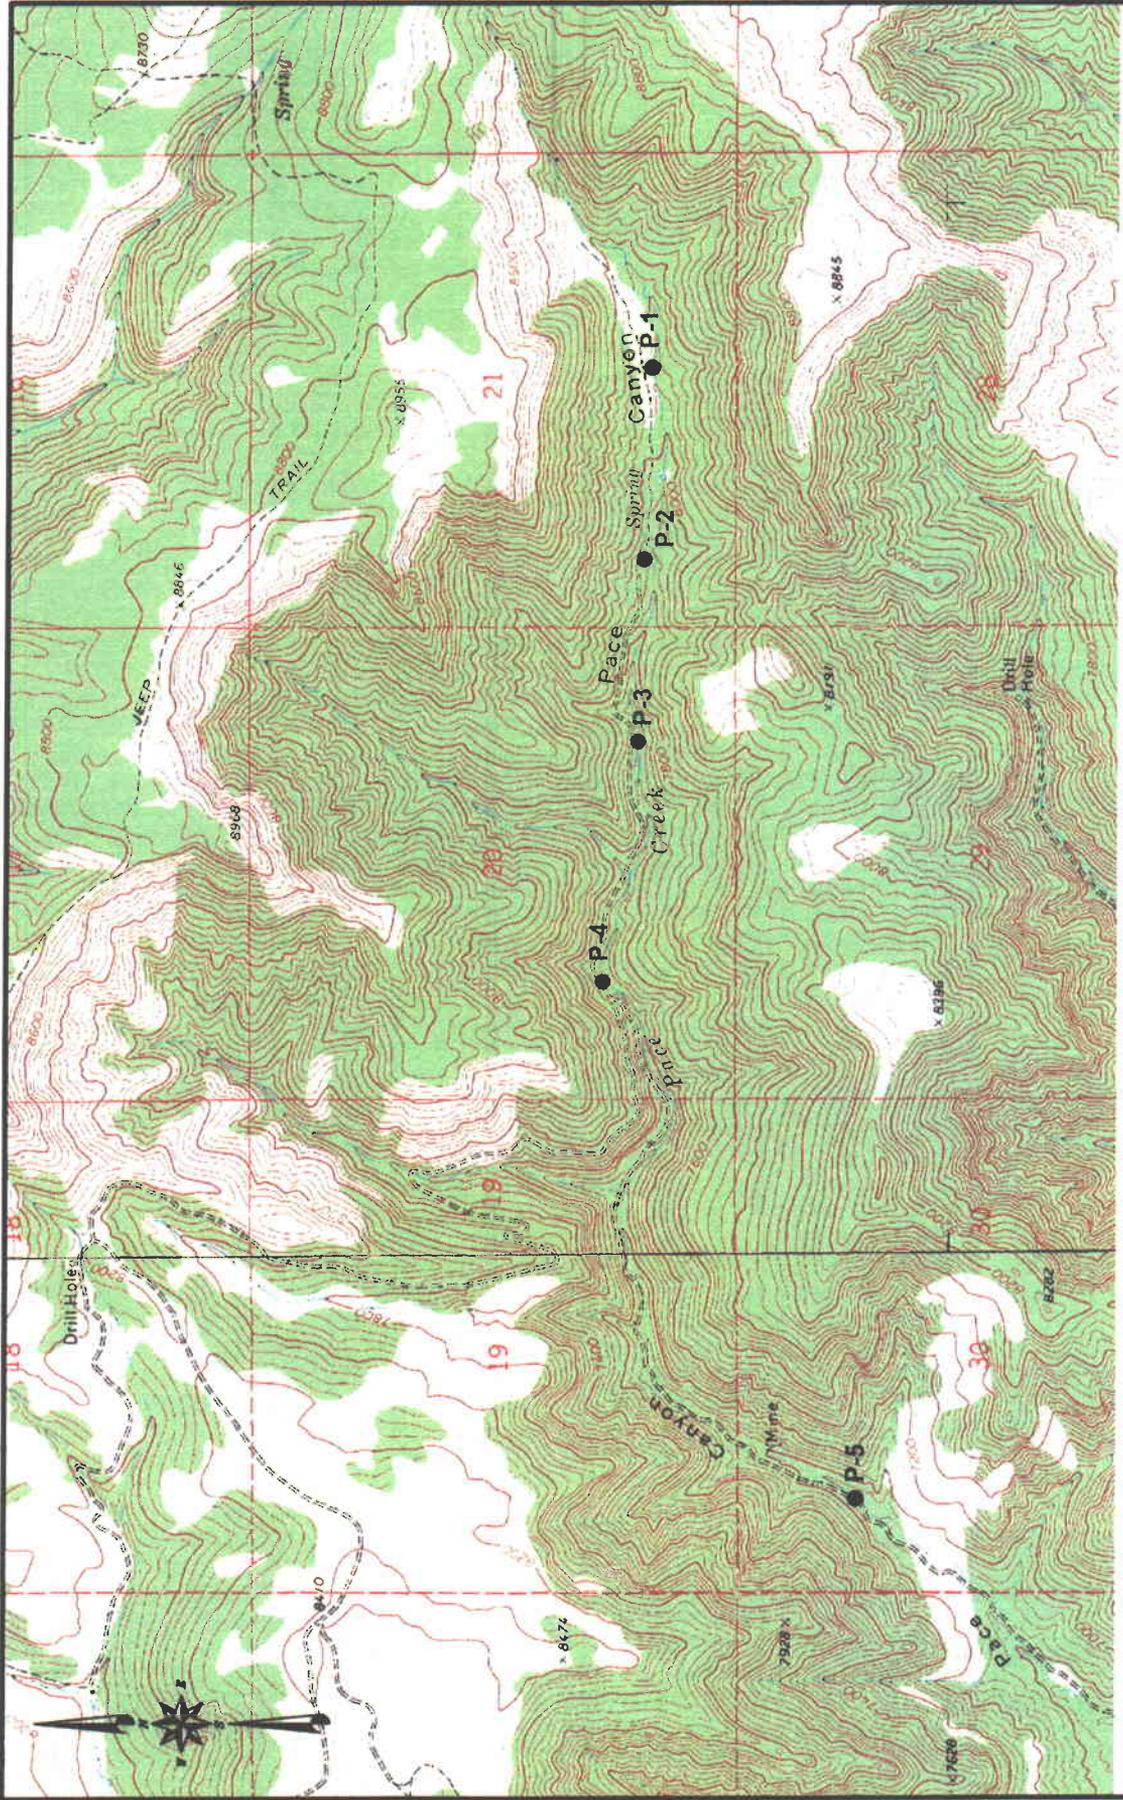
The locations of reference sites previously established on Pace Creek are shown on Figure 2-1. Monitoring of the reference sites was conducted on October 30, 2006 in general conformance with the recommendations of Harrelson et al. (1994) and included the following:

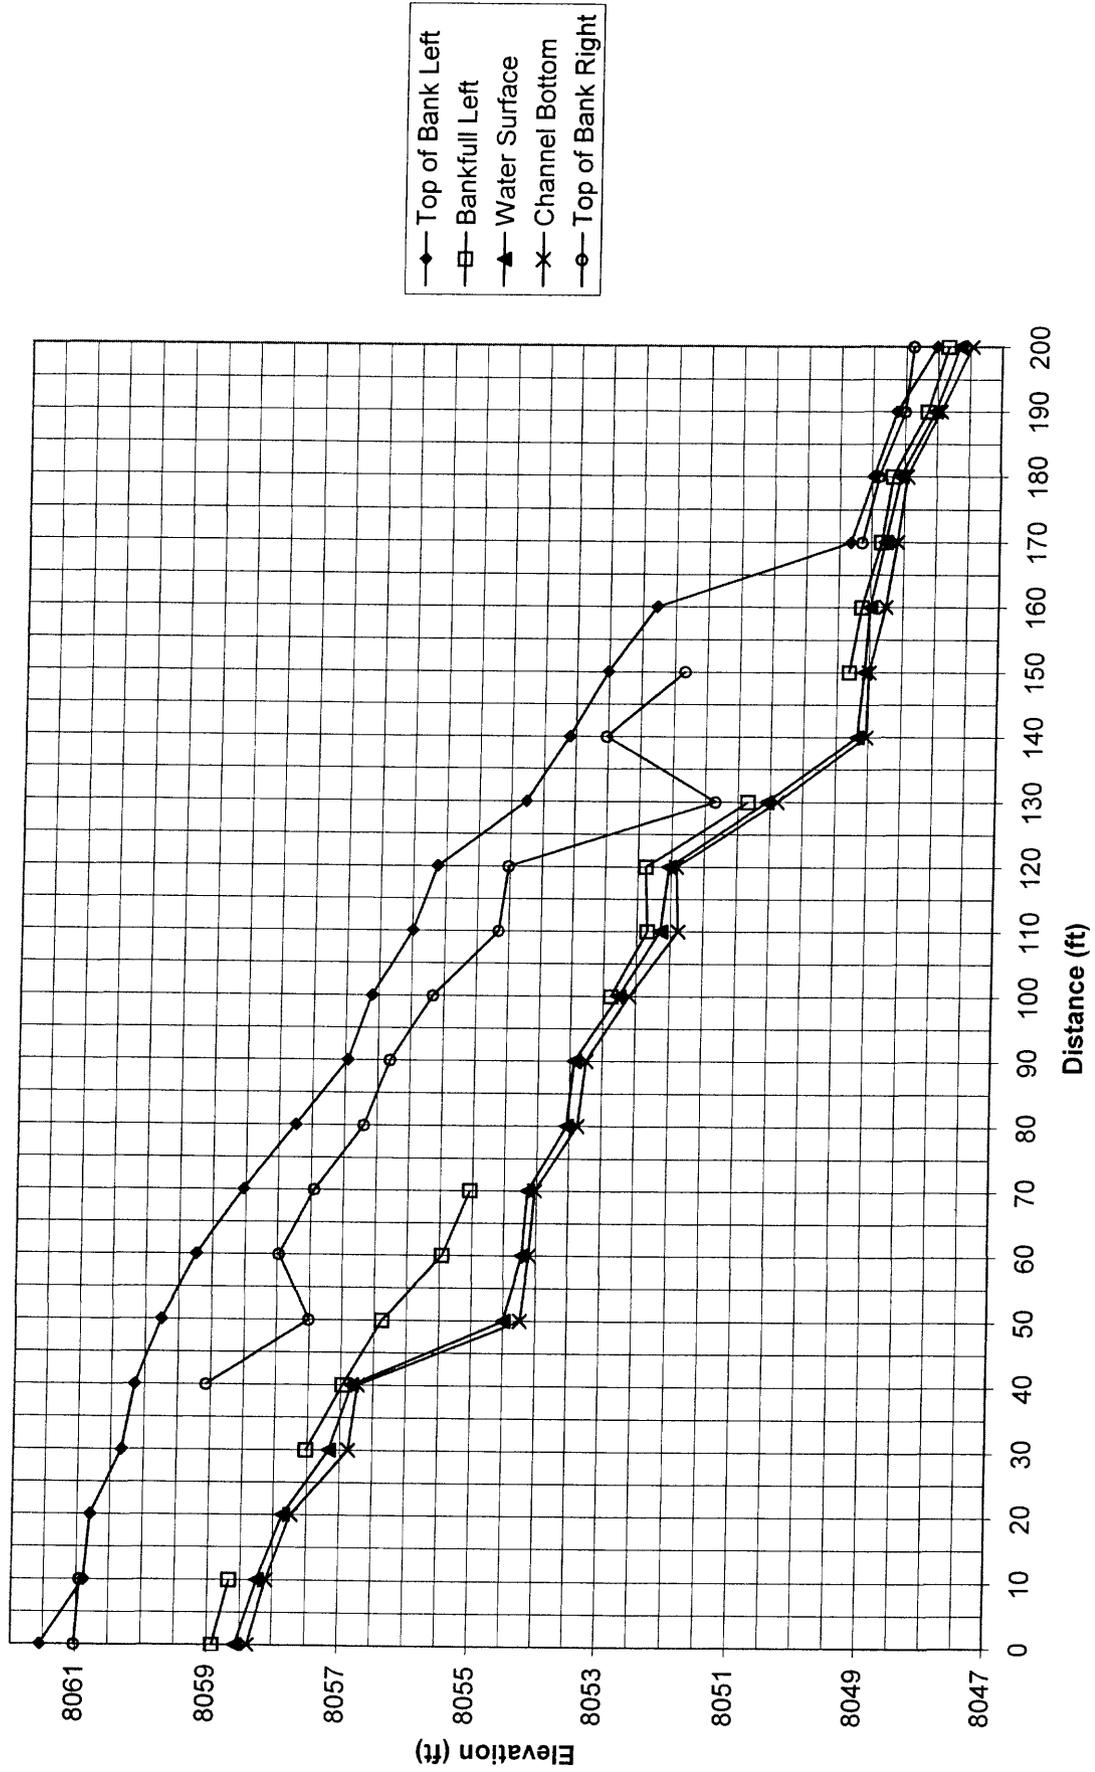
# 2006 Profile P-1

Max. Water Surface Slope (fraction): 0.233  
 Min. Water Surface Slope (fraction): 0.007  
 Avg. Water Surface Slope (fraction): 0.055

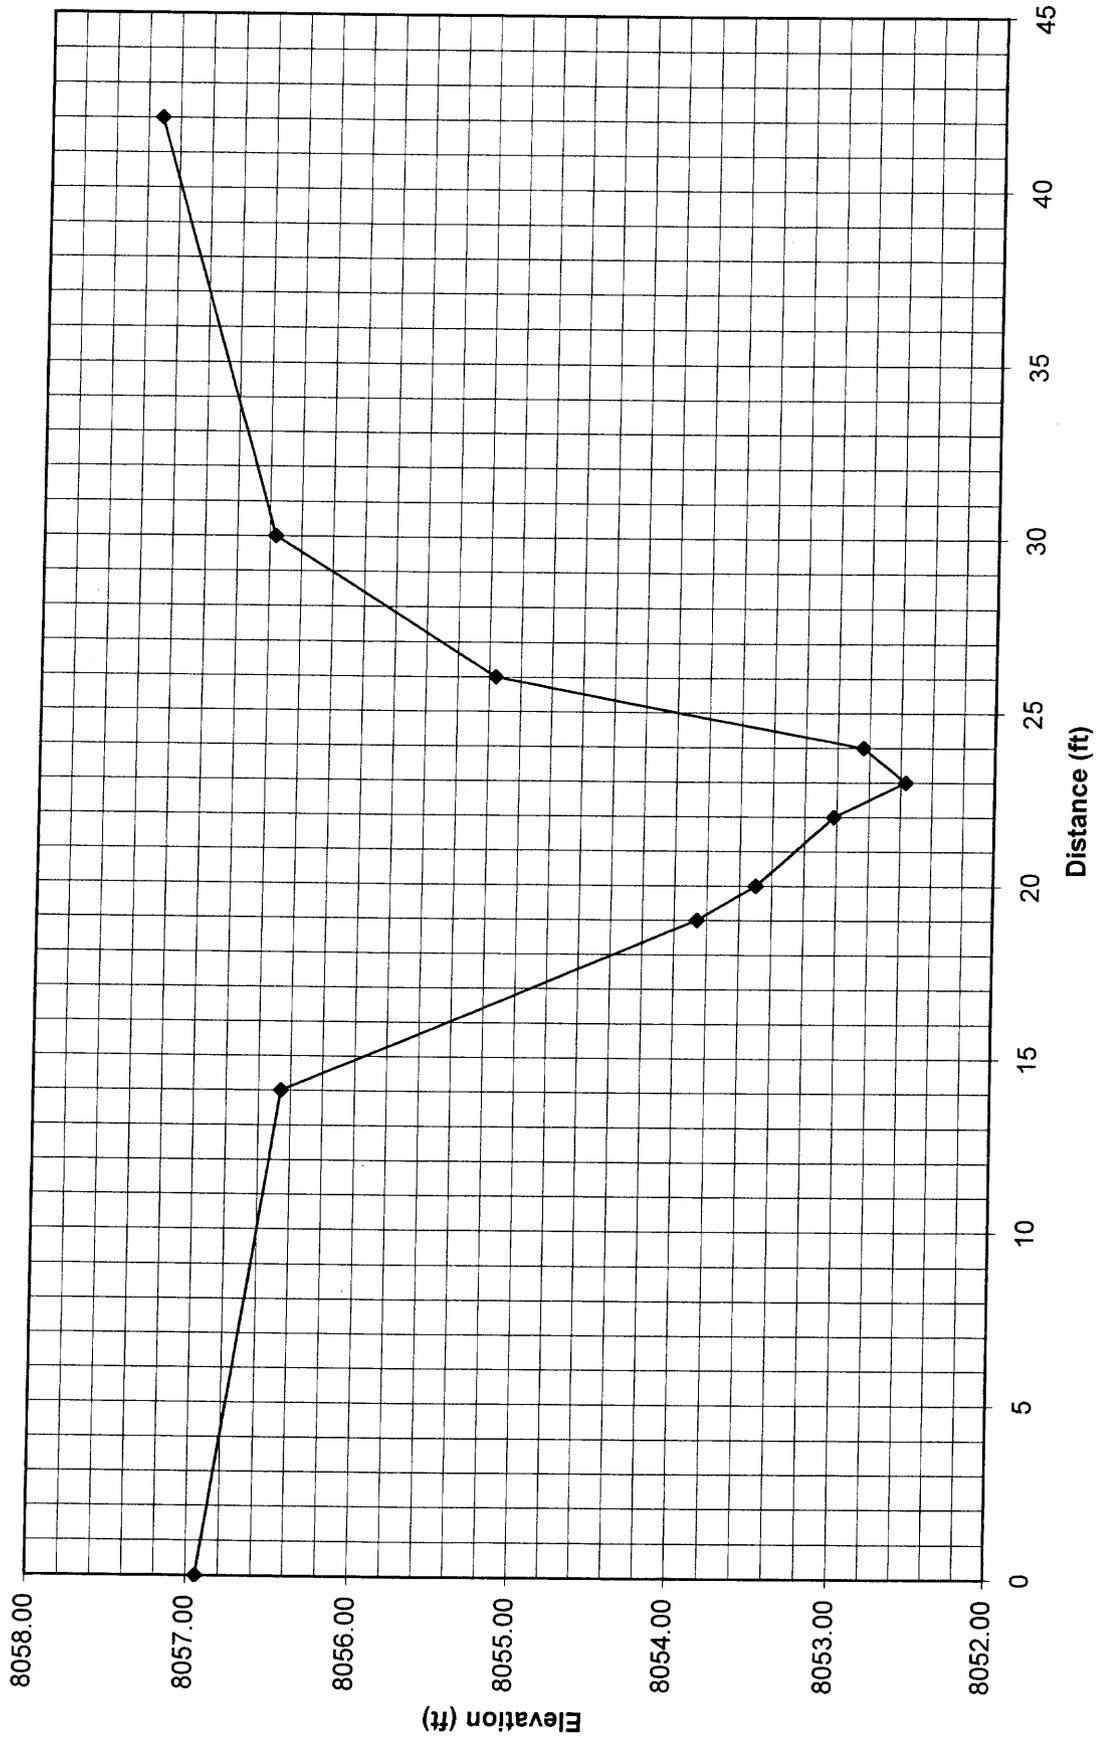
# 2006 Cross Section P-1

Survey date: 30-Oct-06  
Benchmark elevation: 8057.00  
Benchmark rod reading: 6.67

Station	Rod Reading	Elevation
42	6.36	8057.31
30	7.11	8056.56
26	8.51	8055.16
24	10.83	8052.84
23	11.10	8052.57
22	10.65	8053.02
20	10.17	8053.50
19	9.81	8053.86
14	7.21	8056.46
0	6.73	8056.94

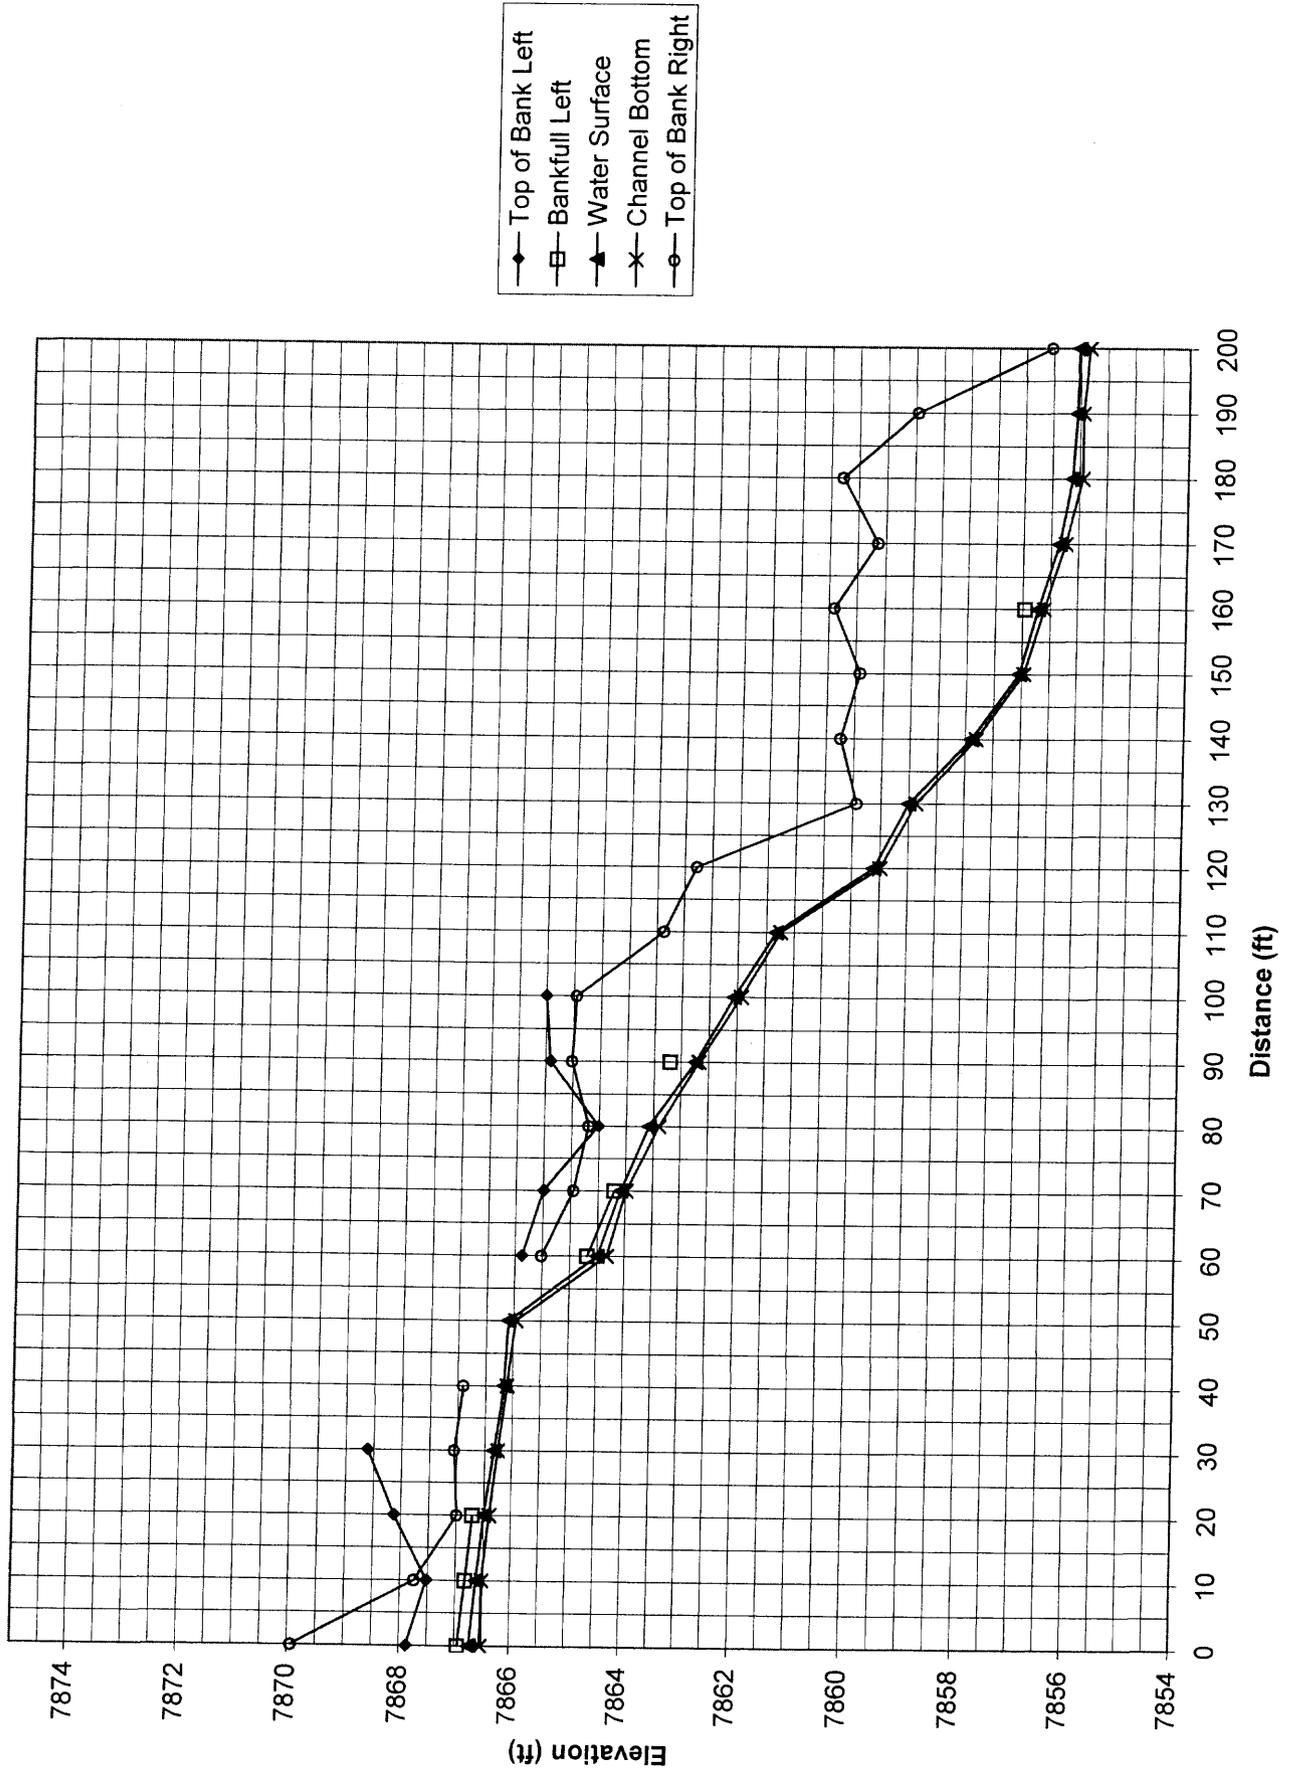
# 2006 Profile P-2

Survey date: 30-Oct-06  
 Benchmark elevation (ft): 7867  
 Rod reading at benchmark (ft): 3.92

Max. Water Surface Slope (fraction): 0.172  
 Min. Water Surface Slope (fraction): 0.003  
 Avg. Water Surface Slope (fraction): 0.054

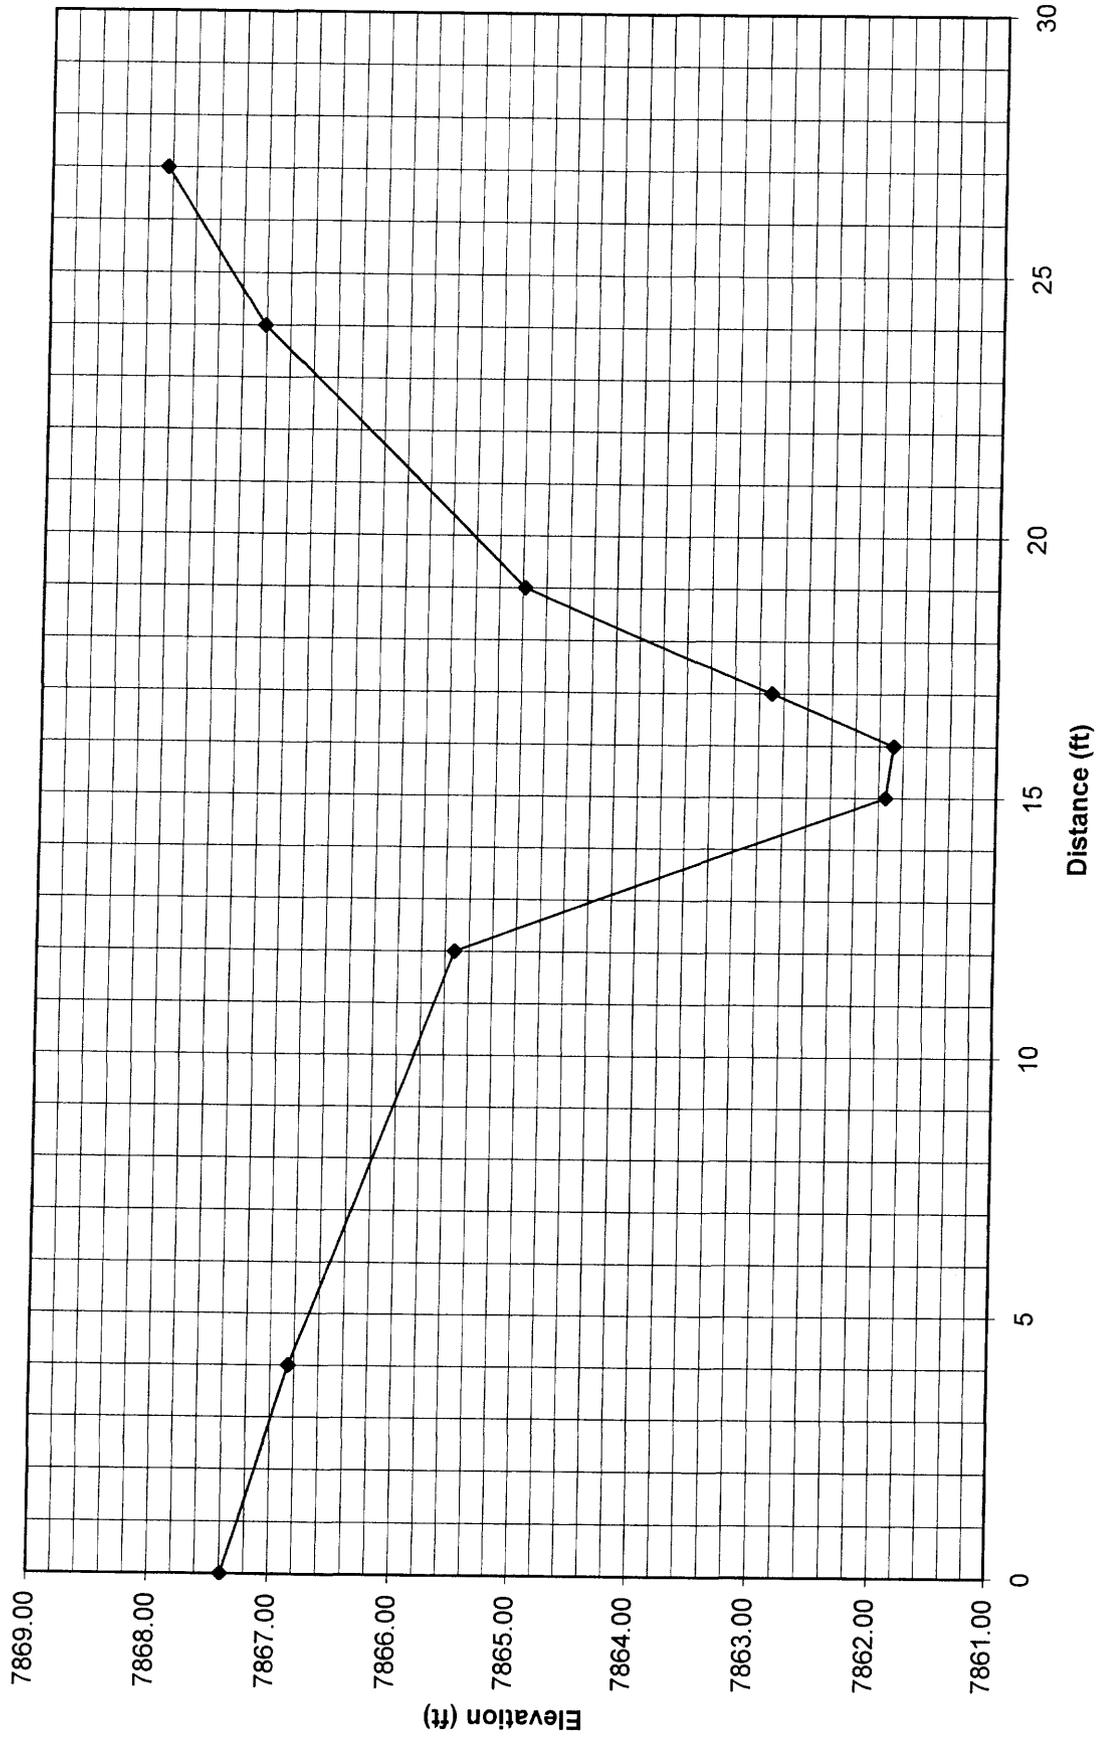
# 2006 Cross Section P-2

Survey date: 30-Oct-06  
Benchmark elevation: 7867.00  
Benchmark rod reading: 3.94

Station	Rod Reading	Elevation
27	2.90	7868.04
24	3.73	7867.21
19	5.96	7864.98
17	8.04	7862.90
16	9.06	7861.88
15	9.00	7861.94
12	5.42	7865.52
4	4.09	7866.85
0	3.55	7867.39

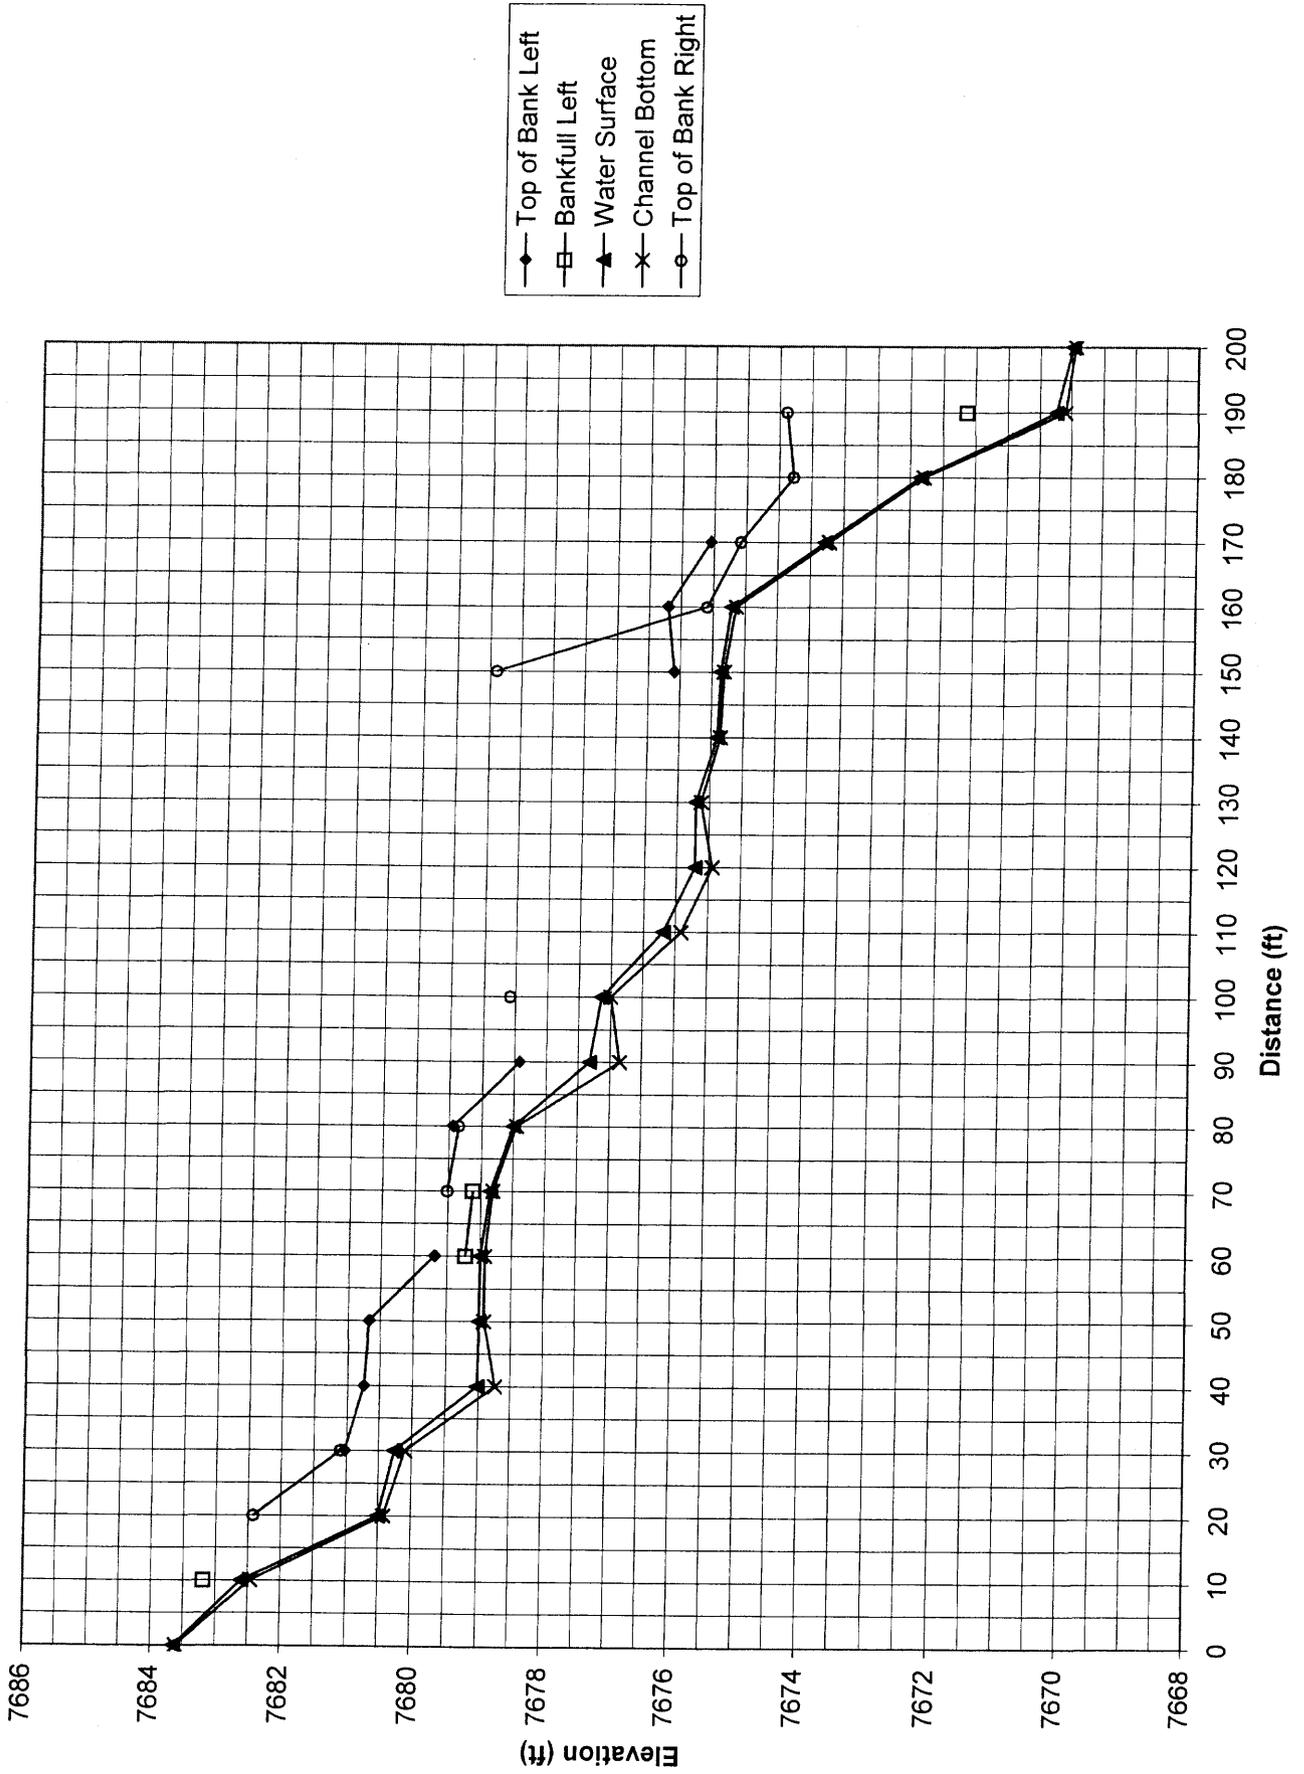
# 2006 Profile P-3

Survey date: 30-Oct-06  
 Benchmark elevation (ft): 7679  
 Rod reading at benchmark (ft): 4.64

Max. Water Surface Slope (fraction): 0.211  
 Min. Water Surface Slope (fraction): 0.000  
 Avg. Water Surface Slope (fraction): 0.068

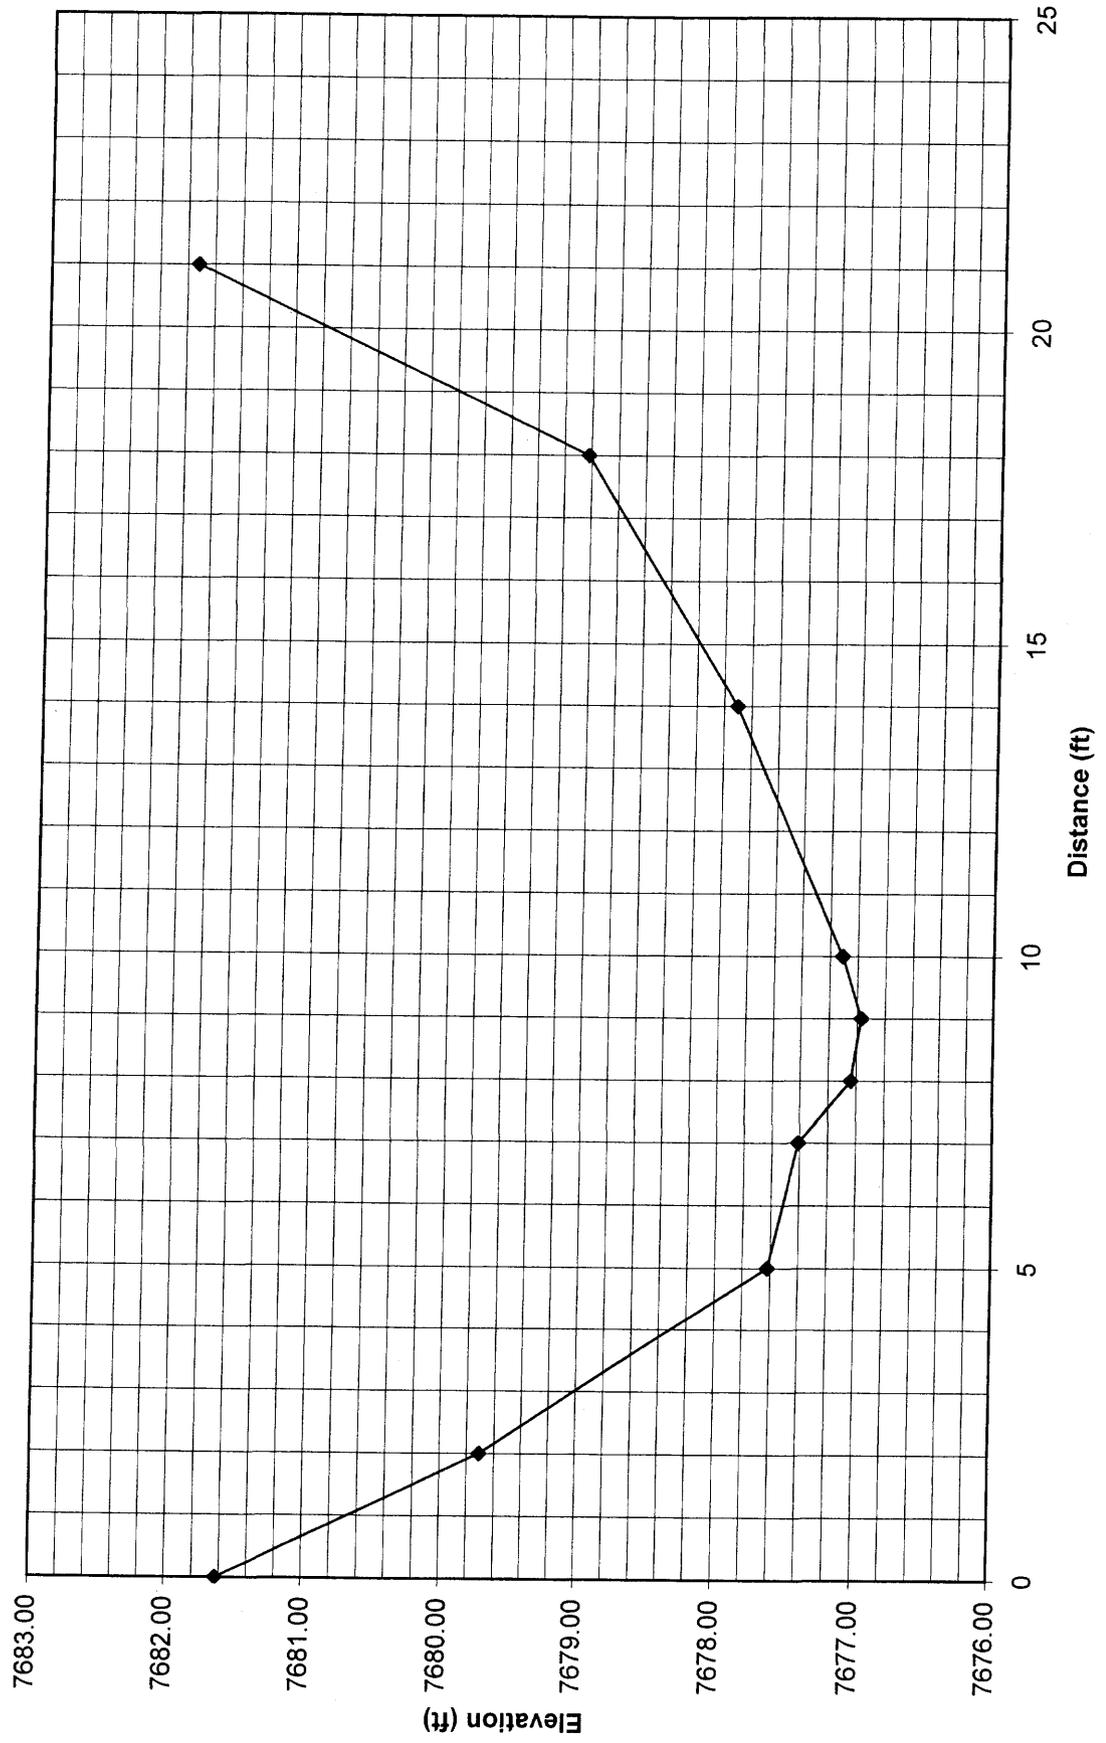
# 2006 Cross Section P-3

Survey date: 30-Oct-06  
Benchmark elevation: 7679.00  
Benchmark rod reading: 4.63

Station	Rod Reading	Elevation
21	1.71	7681.92
18	4.61	7679.02
14	5.73	7677.90
10	6.52	7677.11
9	6.66	7676.97
8	6.59	7677.04
7	6.22	7677.41
5	6.01	7677.62
2	3.92	7679.71
0	2.00	7681.63

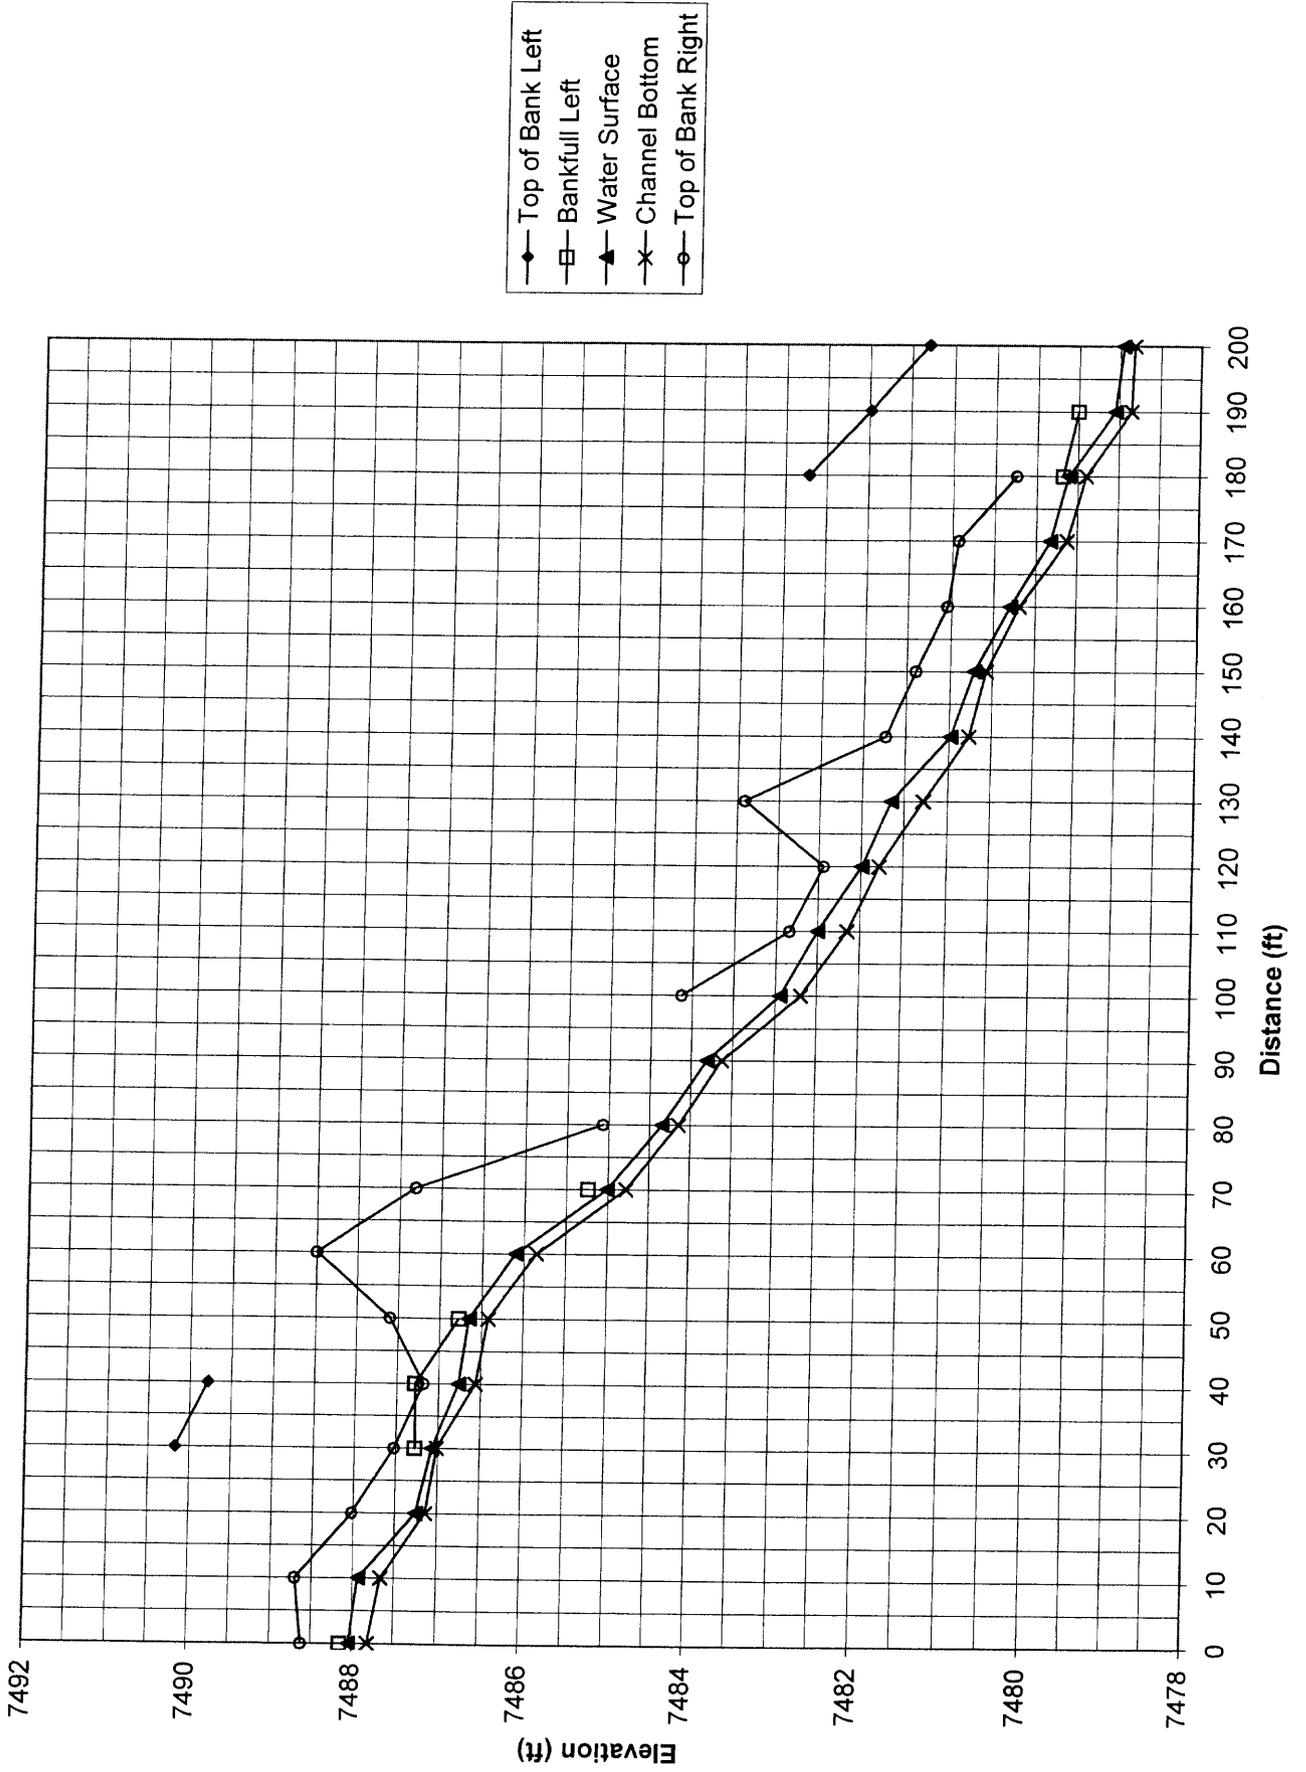
# 2006 Profile P-4

Survey date: 30-Oct-06  
 Benchmark elevation (ft): 7488  
 Rod reading at benchmark (ft): 2.74

Max. Water Surface Slope (fraction): 0.109  
 Min. Water Surface Slope (fraction): 0.010  
 Avg. Water Surface Slope (fraction): 0.045

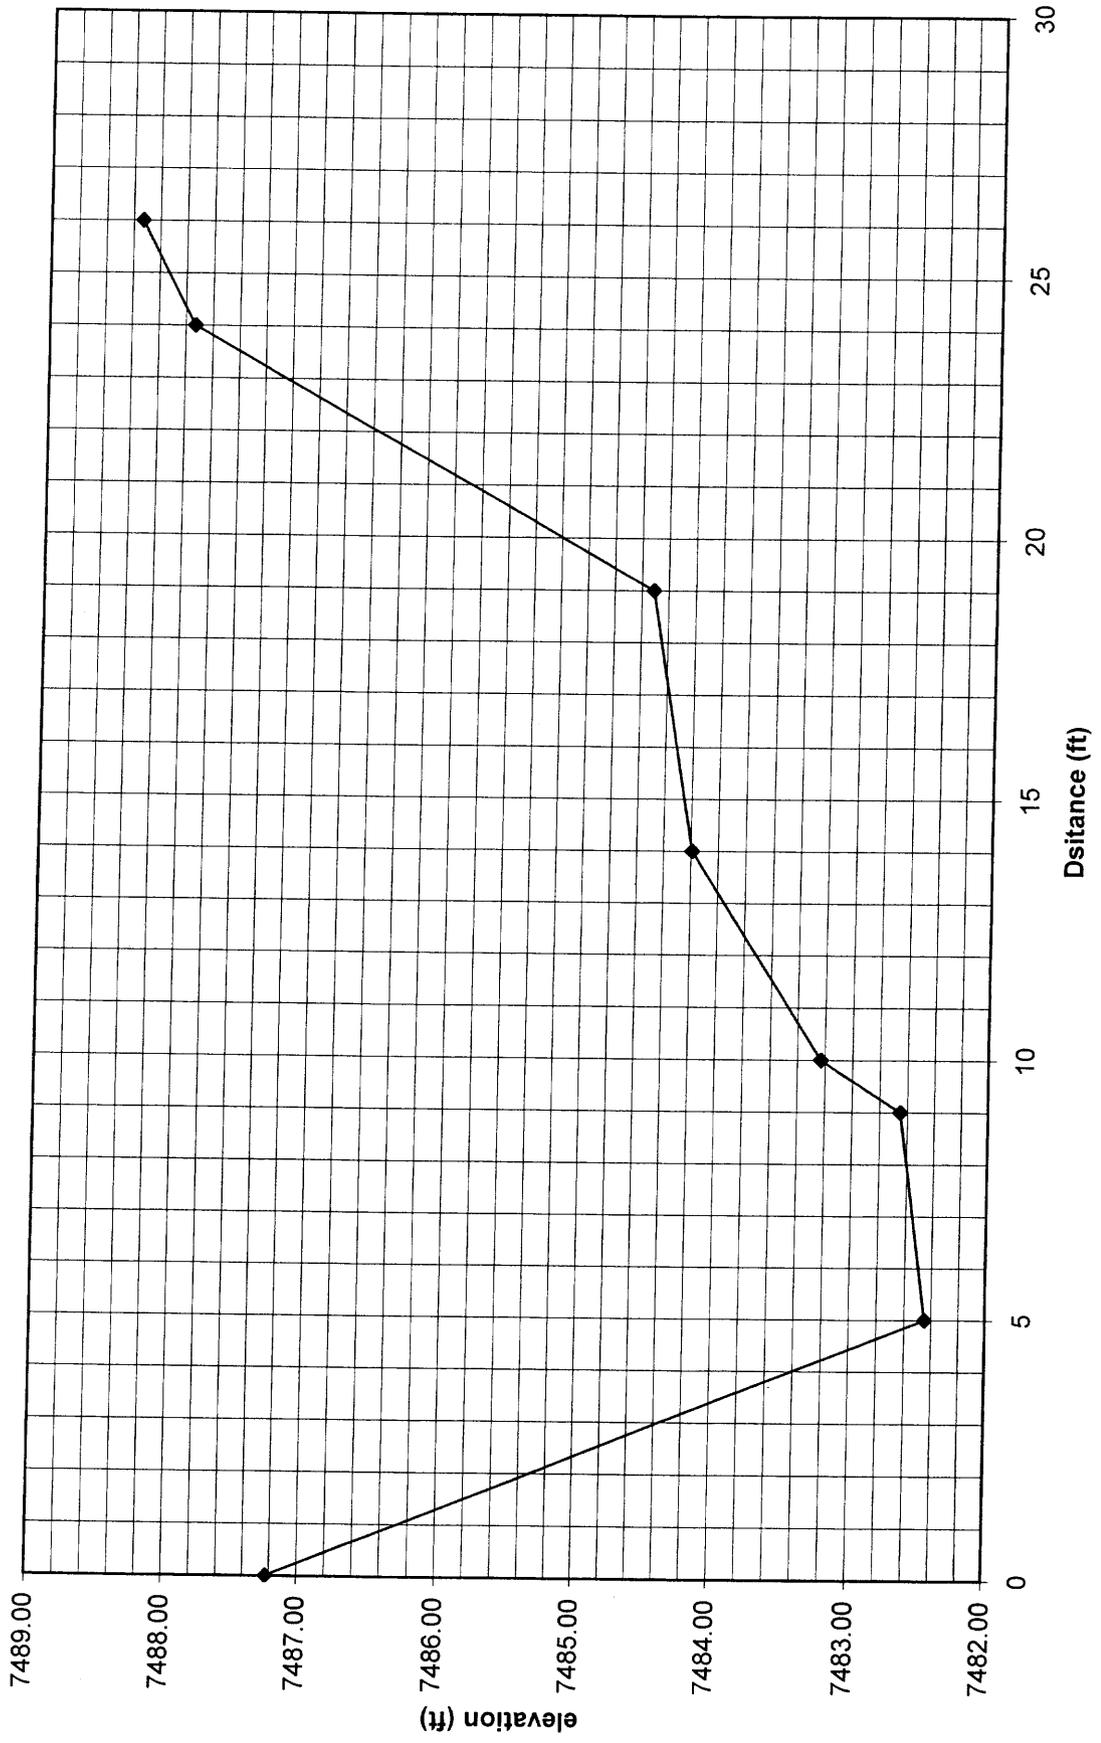
2006 Cross Section P-4

Survey date: 23-Sep-05  
Benchmark elevation: 7488.00  
Benchmark rod reading: 2.75

Station	Rod Reading	Elevation
26	2.42	7488.33
24	2.82	7487.93
19	6.24	7484.51
14	6.56	7484.19
10	7.52	7483.23
9	8.10	7482.65
5	8.30	7482.45
0	3.52	7487.23

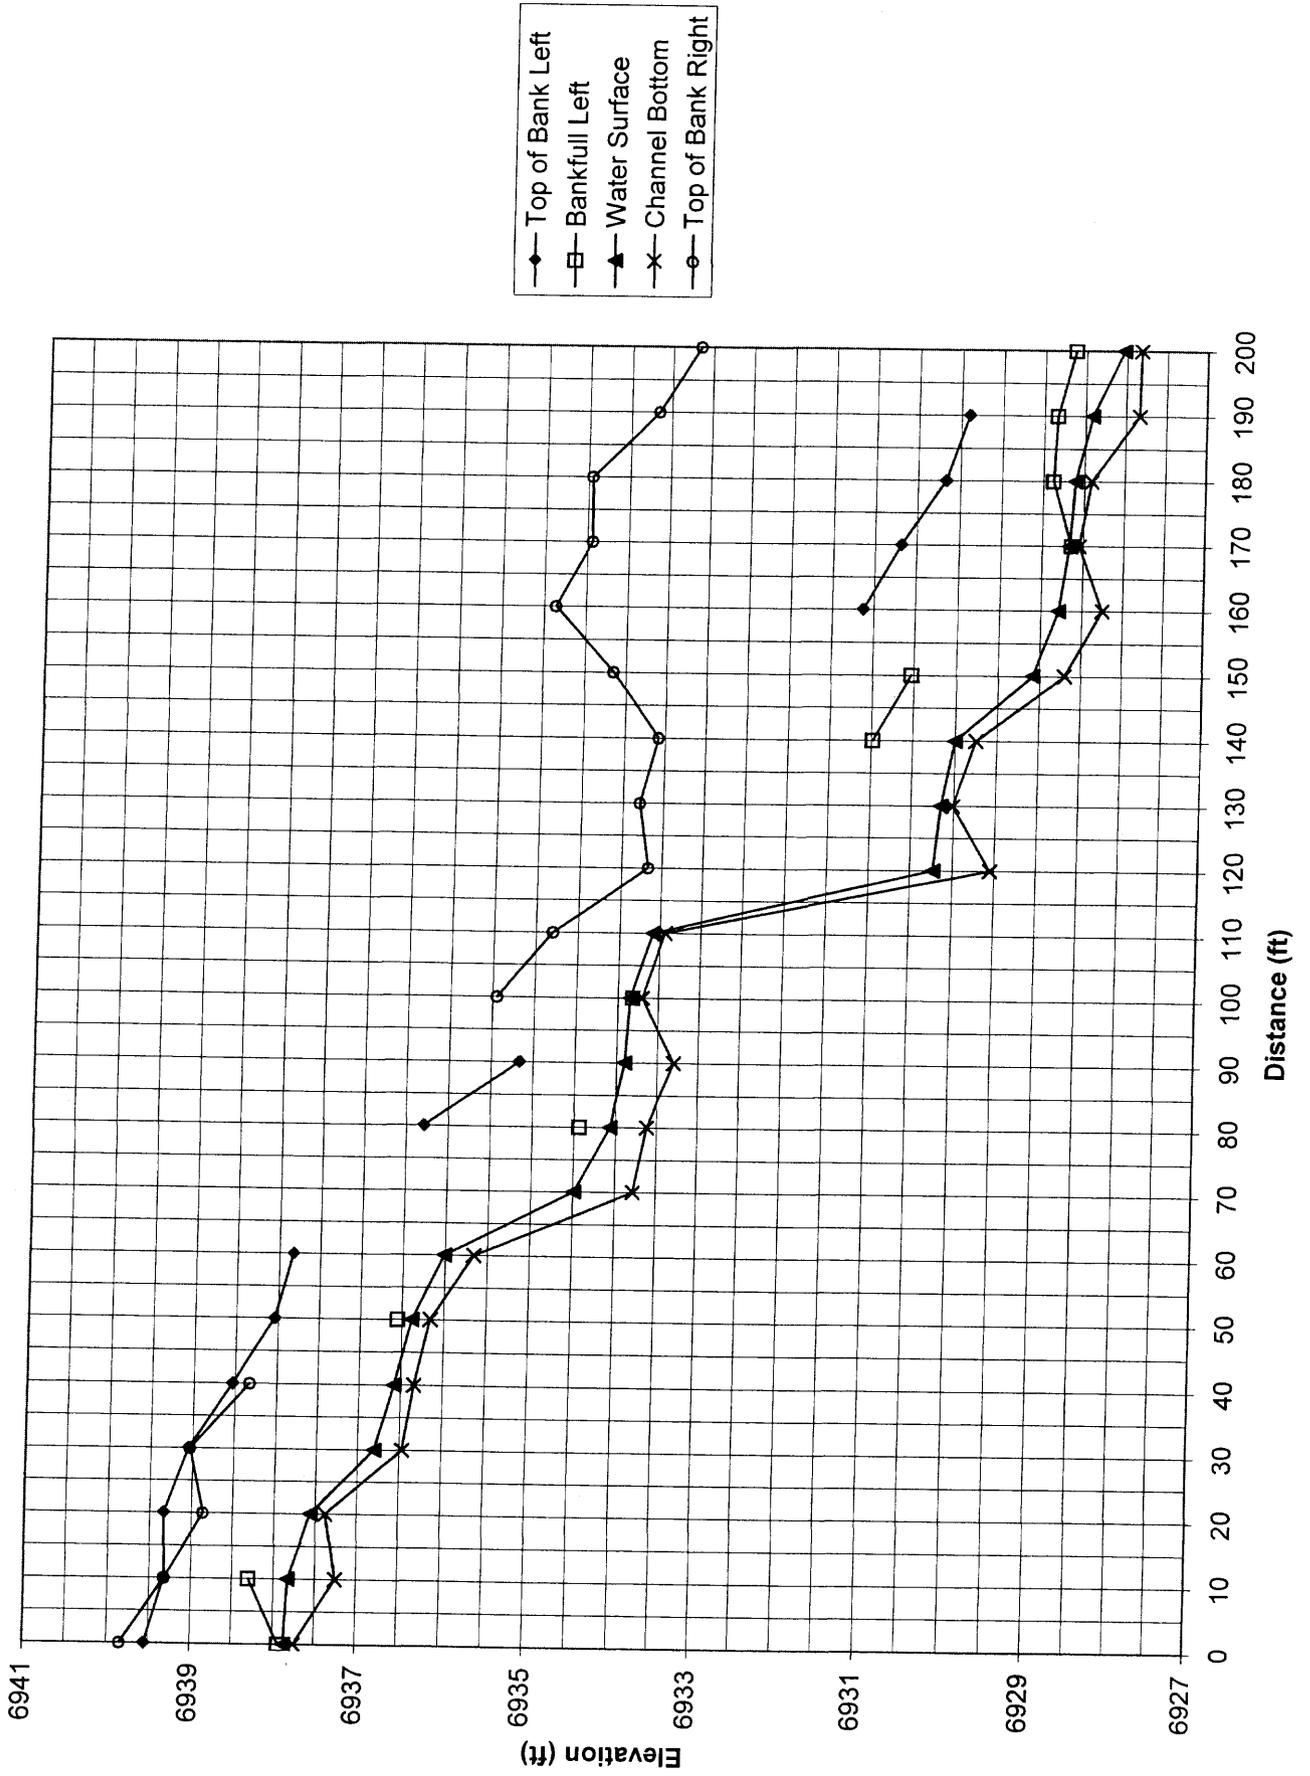
# 2006 Profile P-5

Survey date: 30-Oct-06  
 Benchmark elevation (ft): 6938  
 Rod reading at benchmark (ft): 3.25

Max. Water Surface Slope (fraction): 0.336  
 Min. Water Surface Slope (fraction): 0.004  
 Avg. Water Surface Slope (fraction): 0.049
