**2006 ANNUAL REPORT  
TO THE  
UTAH DIVISION OF OIL, GAS AND MINING**

**DUGOUT CANYON MINE  
C/007/039**

RE: 2006 Annual Report for Dugout Canyon Mine, C/007/039

**RESULTS OF THE 2006  
GEOMORPHOLOGY EVALUATION  
OF THE PACE CREEK STREAM CHANNEL**

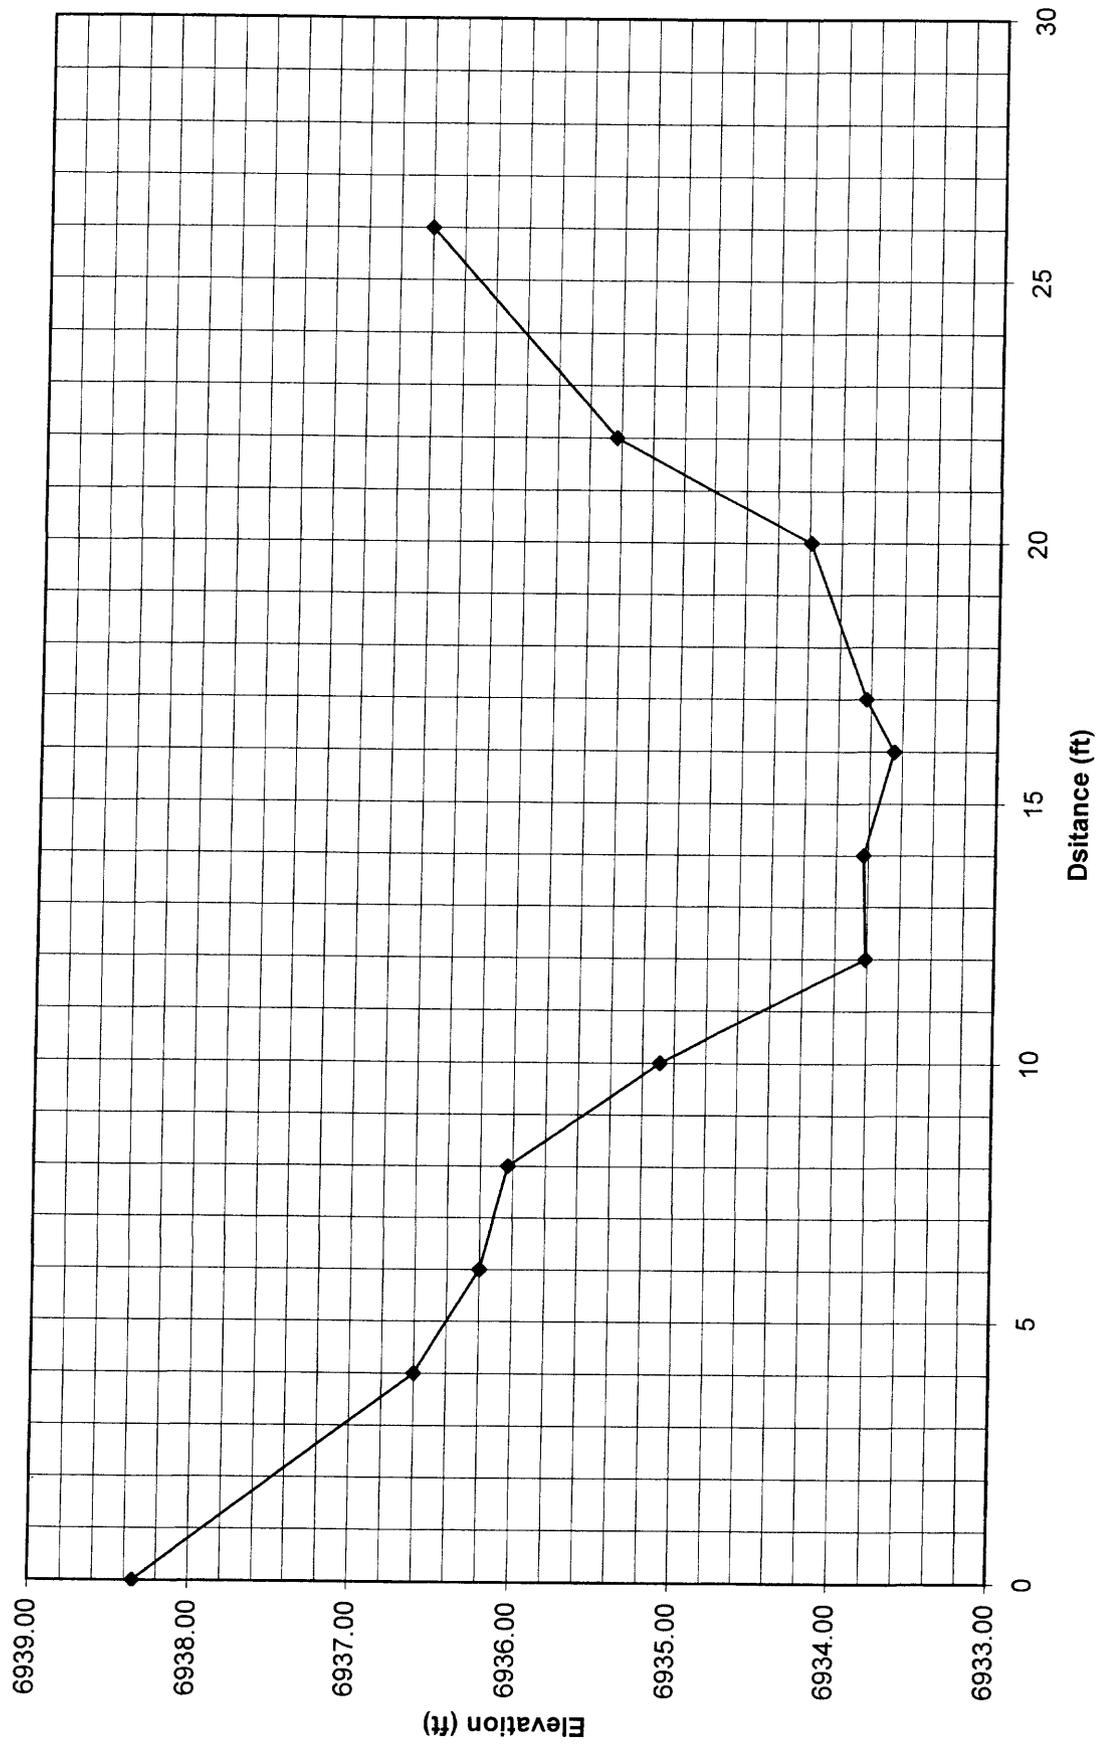
# 2006 Cross Section P-5

Survey date: 30-Oct-06  
Benchmark elevation: 6938.00  
Benchmark rod reading: 3.25

Station	Rod Reading	Elevation
26	4.65	6936.60
22	5.82	6935.43
20	7.06	6934.19
17	7.42	6933.83
16	7.60	6933.65
14	7.42	6933.83
12	7.44	6933.81
10	6.16	6935.09
8	5.22	6936.03
6	5.05	6936.20
4	4.65	6936.60
0	2.90	6938.35
