Subject: Reconnaissance Inspection (RI) Report
for Dugout Canyon Mine, UT0025593

Reconnaissance Inspection

Canyon Fuel Company, Inc., Dugout Canyon Mine

Dugout Mine Pictures of Discharge from Pace Canyon
Outfall 005

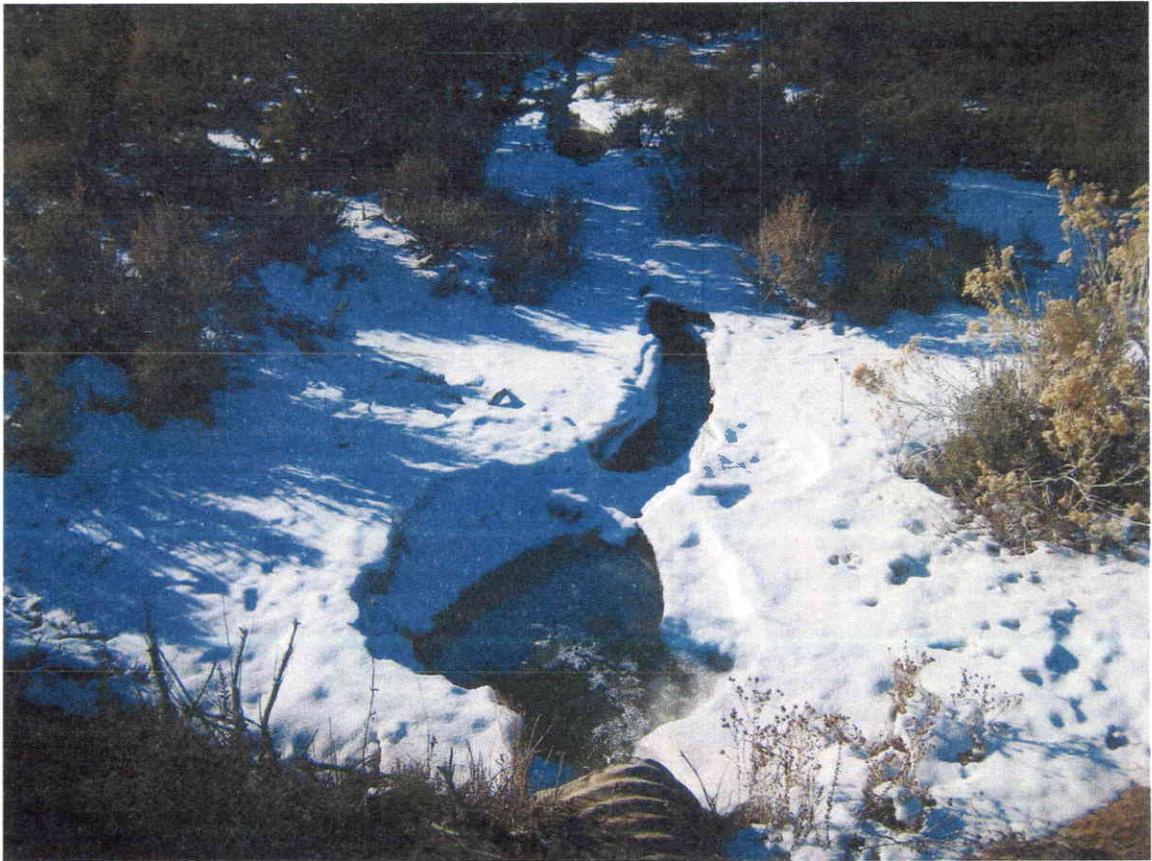
Photo#1

Photo Number	File Name	Description	Date/Time	Photographer
1		Diversion from Pace Credits ^{Clark Valley Reservoir}	11/30	M. Herkimer
2		Same as photo #1	"	"
3		Same as photo #1	"	"
4		Clark Valley Reservoir north end.	"	"
5		Same as #4.	"	"
6		Clark Valley Reservoir middle to south end.	"	"
7		Same as #6.	"	"
8		Outlet from south end of Clark Valley Res.	"	"
9		Close-up of #8.	"	"
10		→ South end of Clark Valley Res. Outlet going towards Pace Creek	"	"
11		In Clark Valley Reservoir ^{South end.} just before outlet	"	"
12		^{CVR = Clark Valley Reservoir.} Small pond just downstream from CVR	"	"
13		Same as #12 - closer look.	"	"
14		Pace Canyon Creek just ^(from DOS outlet) downstream	"	"
15		Same as 14	"	"
16		^{DOS} Outfall to Pace Canyon Creek	"	"
17		Outfall DOS to Pace Canyon Creek.	"	"
