Subject: Approval of Phase I & II Bond Release of Select Methane Degasification Well Sites, Task ID #4711, Canyon Fuel Company, LLC, Dugout Canyon Mine, C/007/0039

EXHIBIT “D”

- * Action
- * Background
- * Chronology
- * Summary of Findings
- * Recommendation for Phase I & II Bond Release

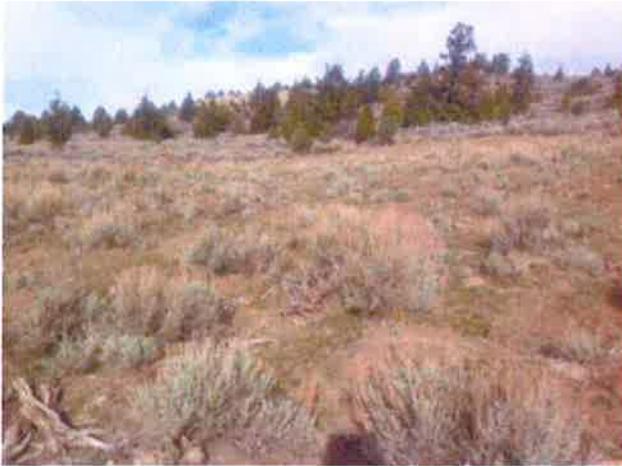
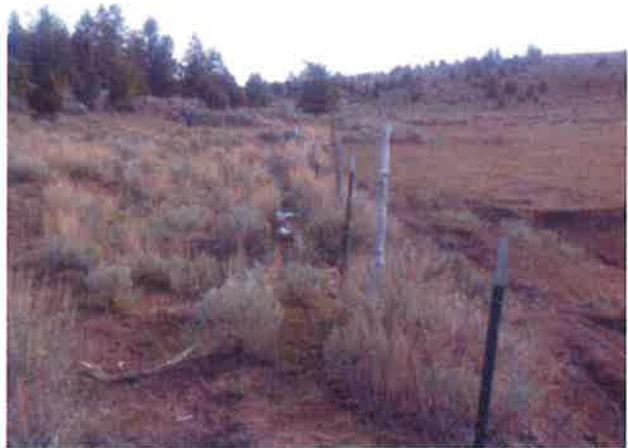
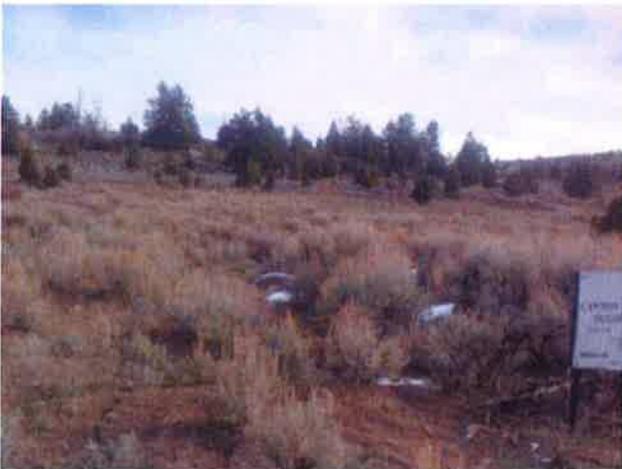
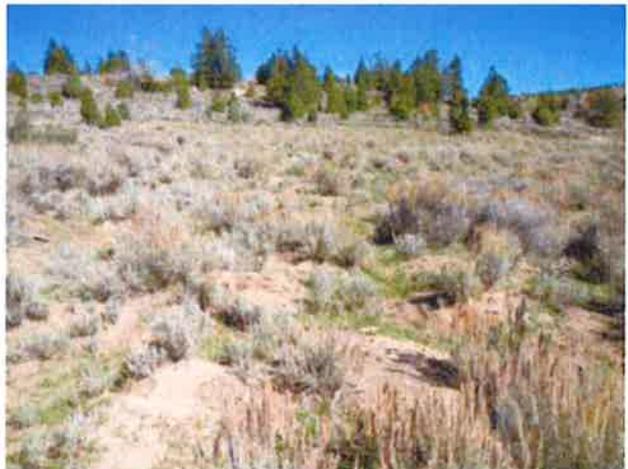
G2: Site has been re contoured, seeded and vegetation is established. It is enhanced for habitat for wildlife by the establishment of vegetation for wildlife food, cover, and breaks up large blocks of monoculture habitat. Phase 2 bond release recommend.

- G2: Phase 2 bond release recommended as the site appears stable with minimal signs of erosion through the reclaimed area and along the disturbed/undisturbed boundary.

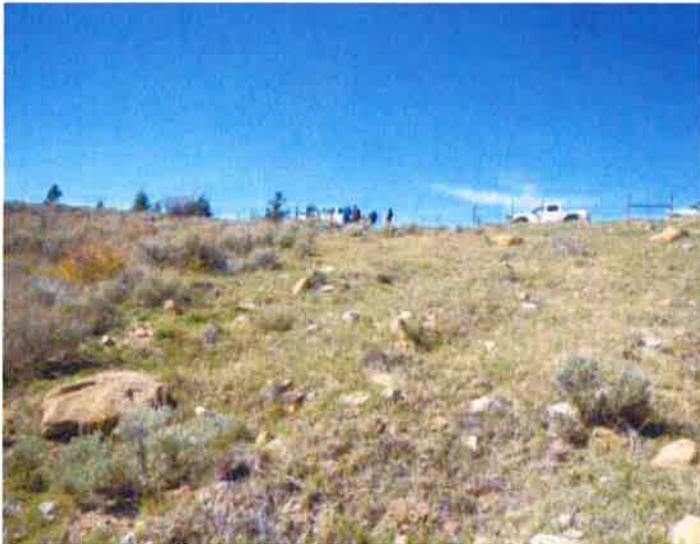
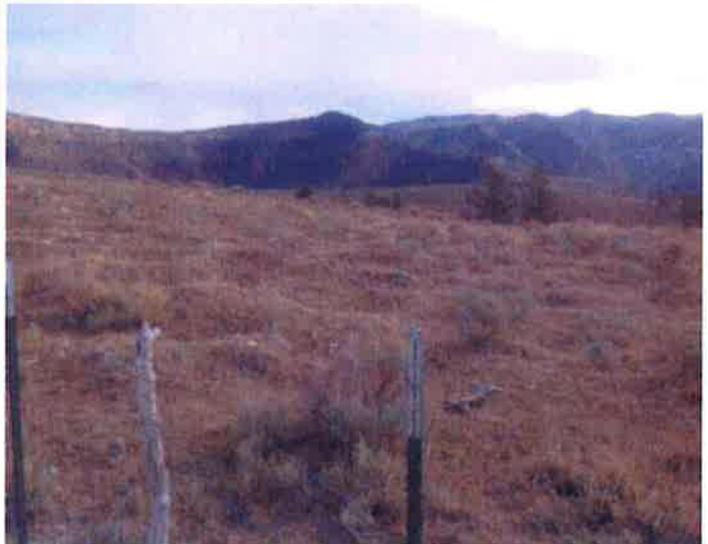
G3: The site is enhanced for habitat for wildlife by the establishment of vegetation for wildlife food, cover, and breaks up large blocks of monoculture habitat. Phase 2 bond release recommended. Permittee plans to request phase 3 release in 2015.

- G3: Phase 2 bond release recommended as the site appears stable with minimal signs of erosion through the reclaimed area and along the disturbed/undisturbed boundary.

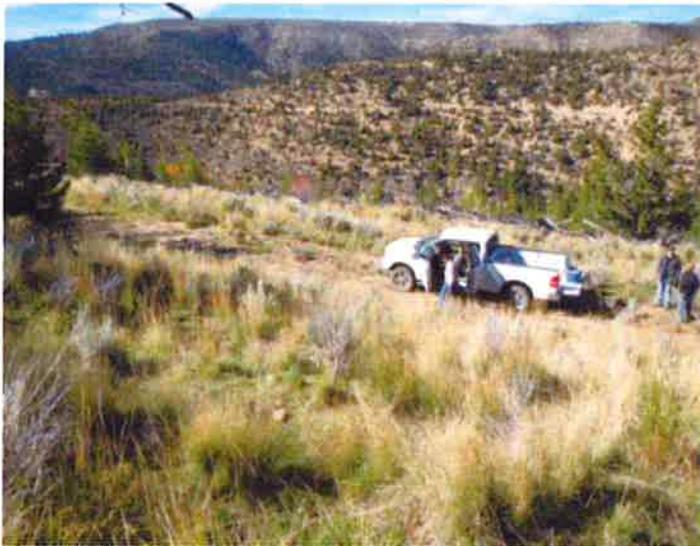
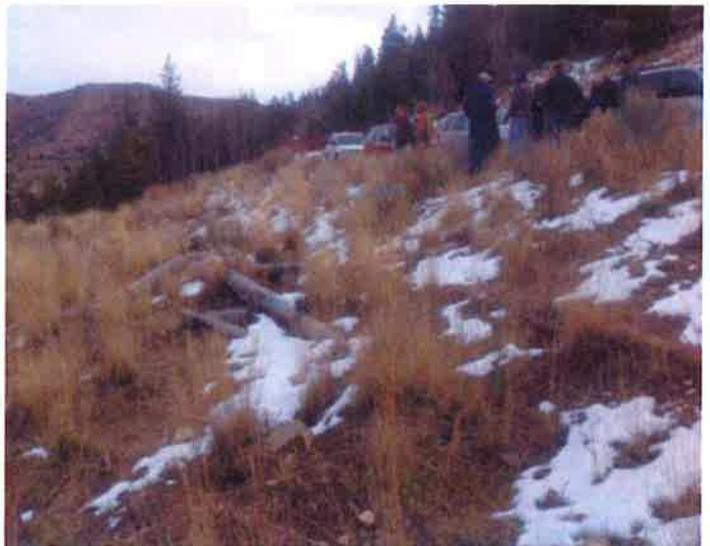
G4: Site has been re contoured, seeded and vegetation is established. Road and slash pile were pre existing from timber development. Phase 2 bond release recommend. Permittee plans to request phase 3 release next year.

- G4: Phase 2 bond release recommended as the site appears stable with minimal signs of erosion through the reclaimed area and along the disturbed/undisturbed boundary.

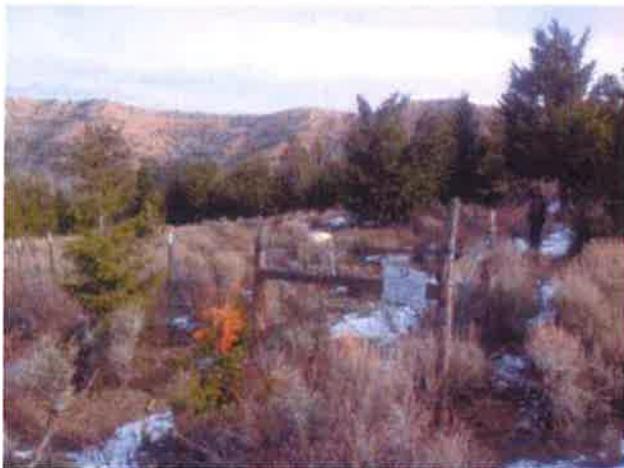
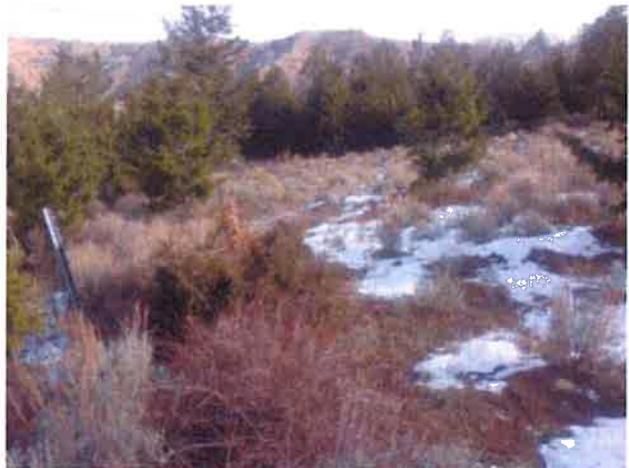
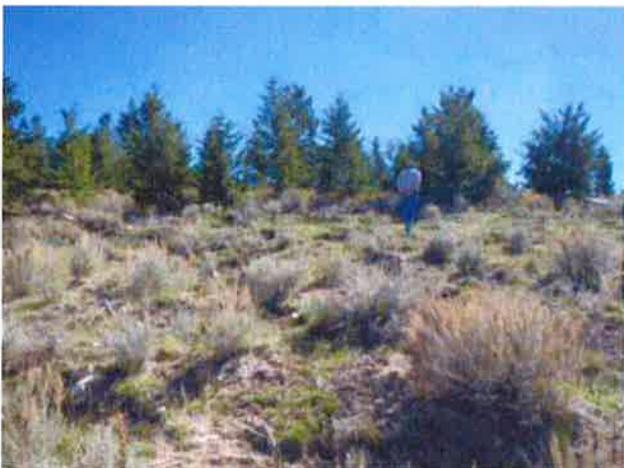
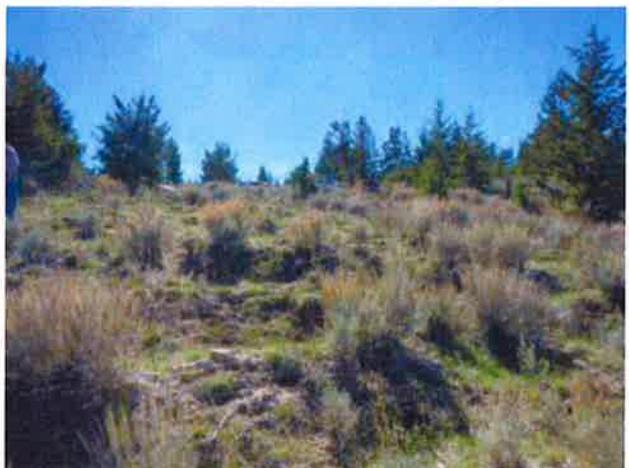
G5: Site has been re contoured, seeded and vegetation is established. It is enhanced for habitat for wildlife by the establishment of vegetation for wildlife food, cover, and breaks up large blocks of monoculture habitat. Phase 2 bond release recommend.

- G5: Phase 2 bond release recommended as the site appears stable with minimal signs of erosion through the reclaimed area and along the disturbed/undisturbed boundary.

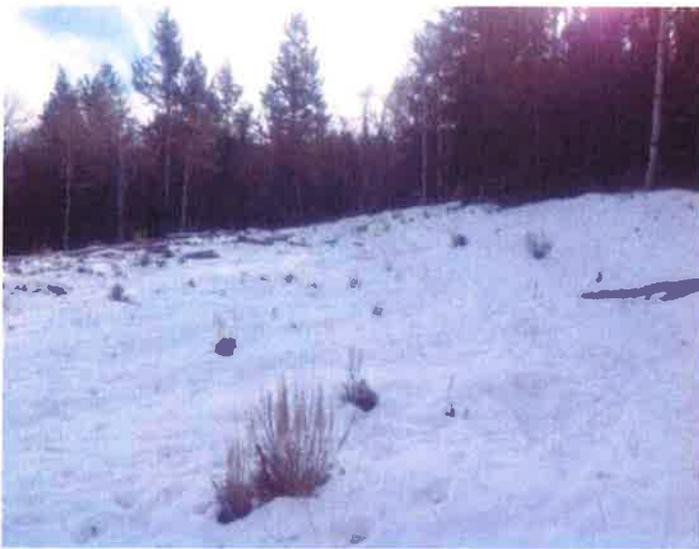
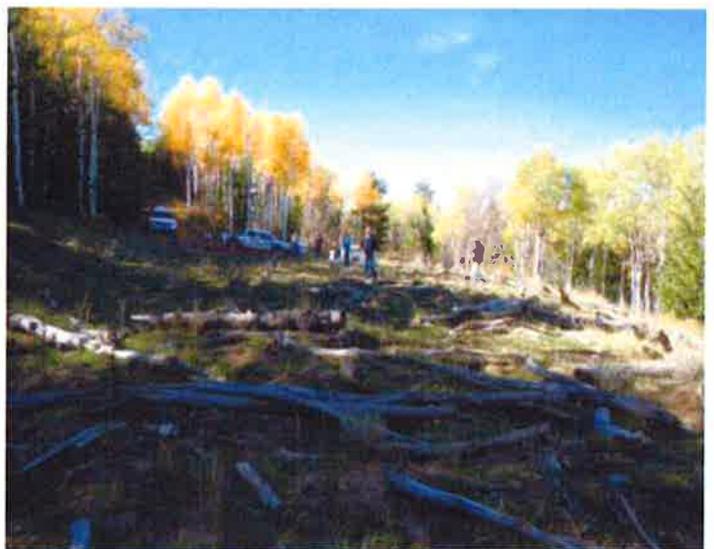
G6: Site has been re contoured, seeded and vegetation is established. Phase 2 bond release recommend.

- G6: Phase 2 bond release recommended as the site appears stable with minimal signs of erosion through the reclaimed area and along the disturbed/undisturbed boundary.

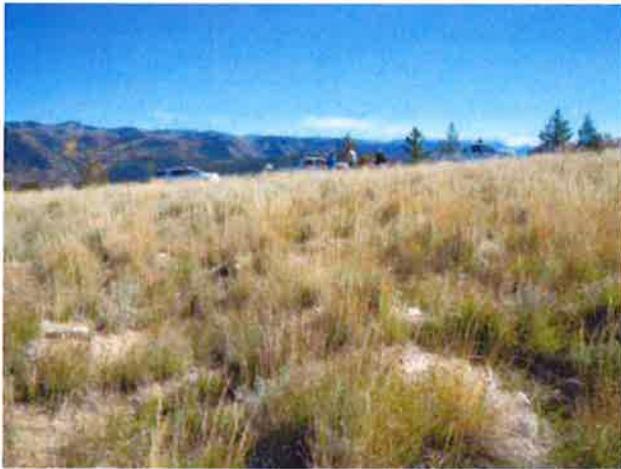
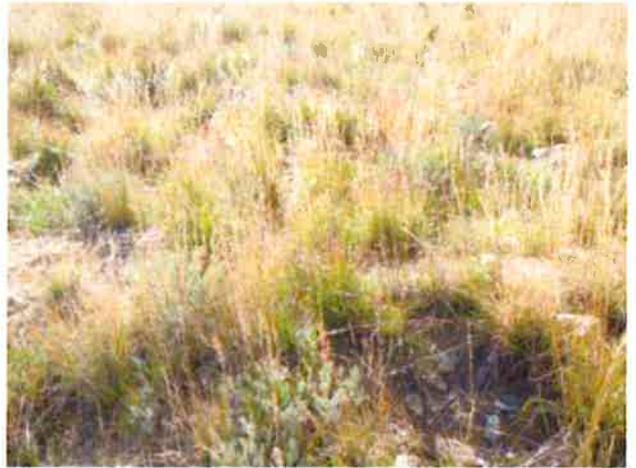
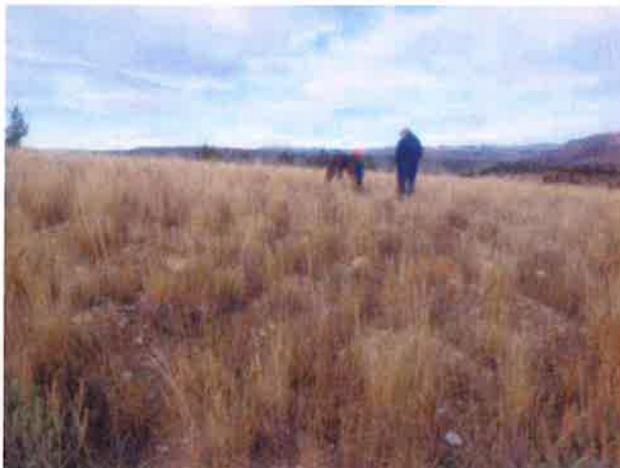
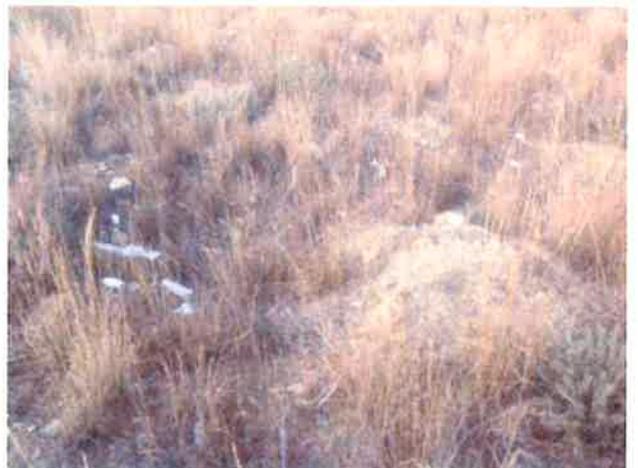
G7: Site has been re contoured, seeded and vegetation is established. It is enhanced for habitat for wildlife by the establishment of vegetation for wildlife food, cover, and breaks up large blocks of monoculture habitat. Phase 2 bond release recommend.

- G7: Phase 2 bond release recommended as the site appears stable with minimal signs of erosion through the reclaimed area and along the disturbed/undisturbed boundary.

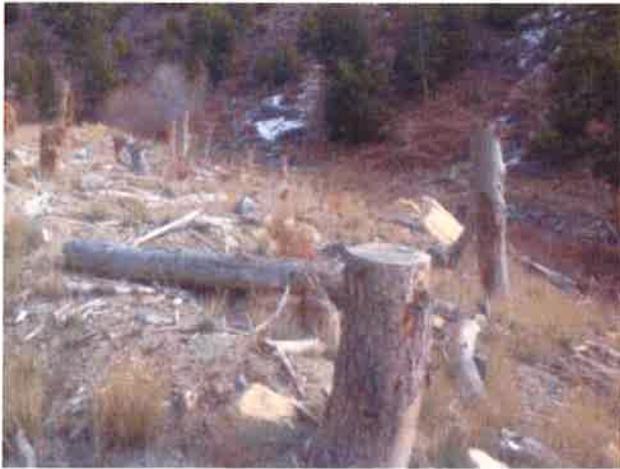
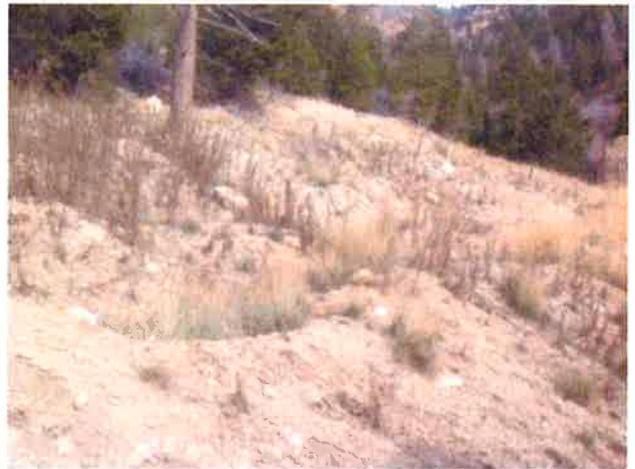
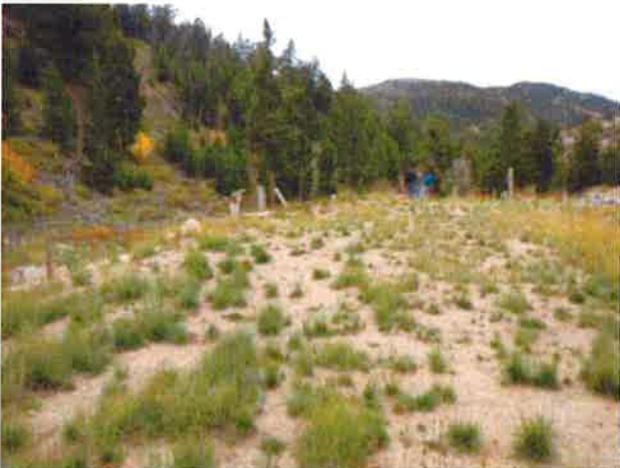
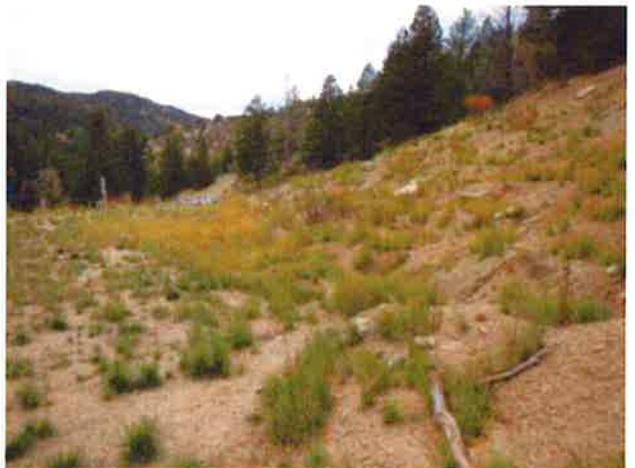
G9: Phase 1 bond release recommended

G9: Site has been re contoured, seeded and vegetation is establishing. Heavy weed invasion needs continued maintenance. Phase 1 bond release recommend with continued weed control.

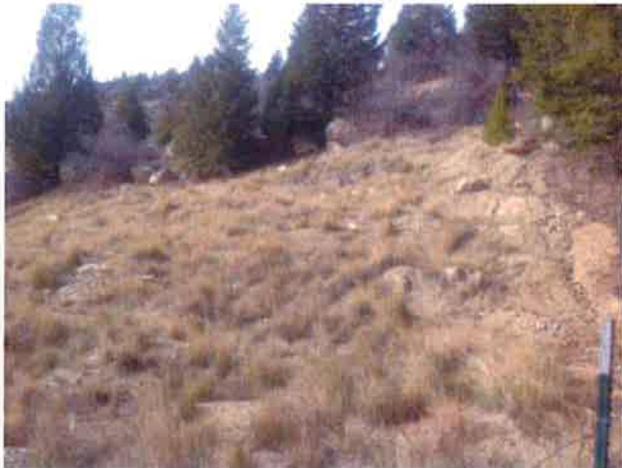
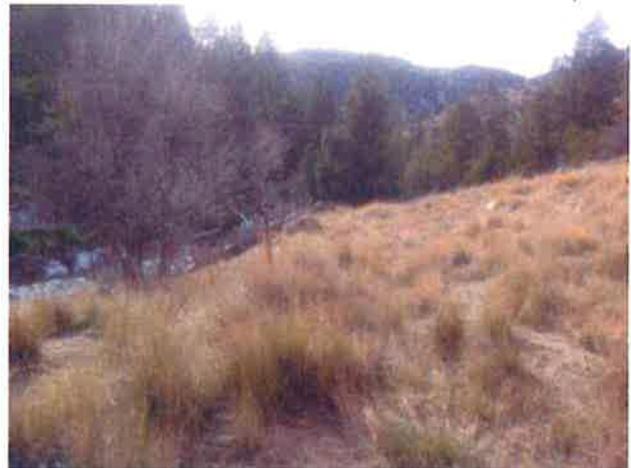
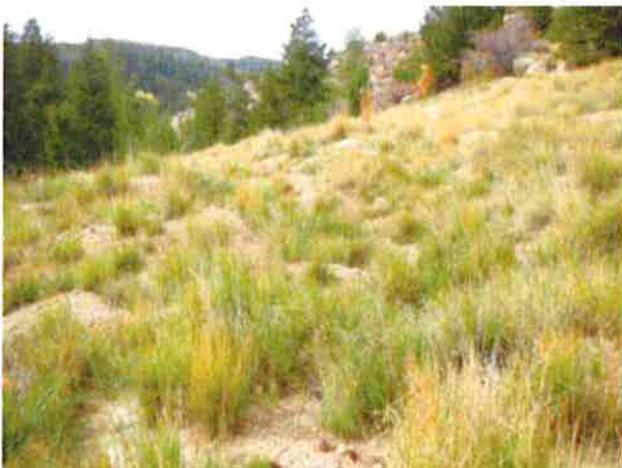
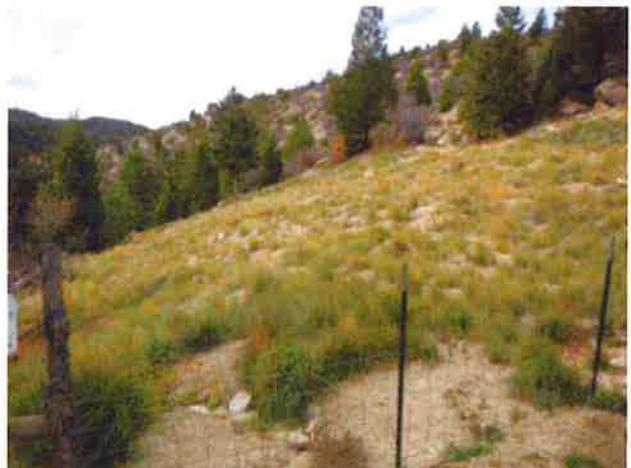
G10: Site has been re contoured, seeded and vegetation is established. It is enhanced for habitat for wildlife by the establishment of vegetation for wildlife food, cover, and breaks up large blocks of monoculture habitat. Phase 2 bond release recommend.

- G10: Phase 2 bond release recommended as the site appears stable with minimal signs of erosion through the reclaimed area and along the disturbed/undisturbed boundary.

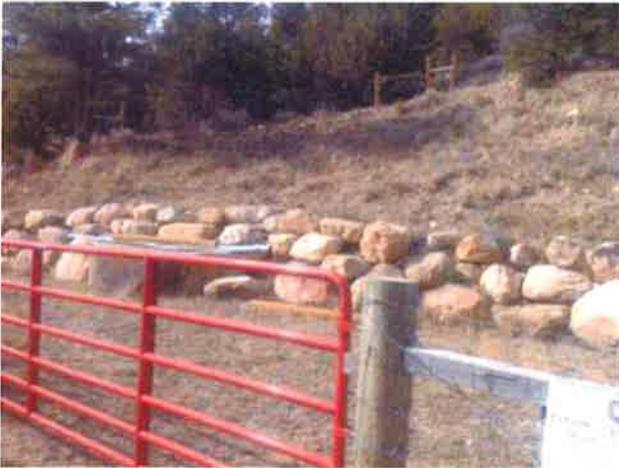
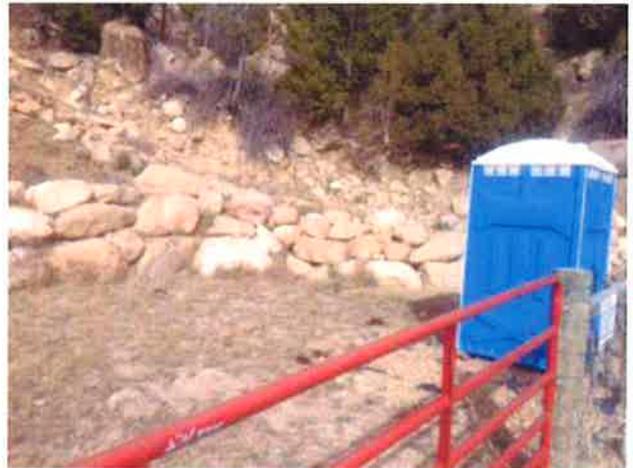
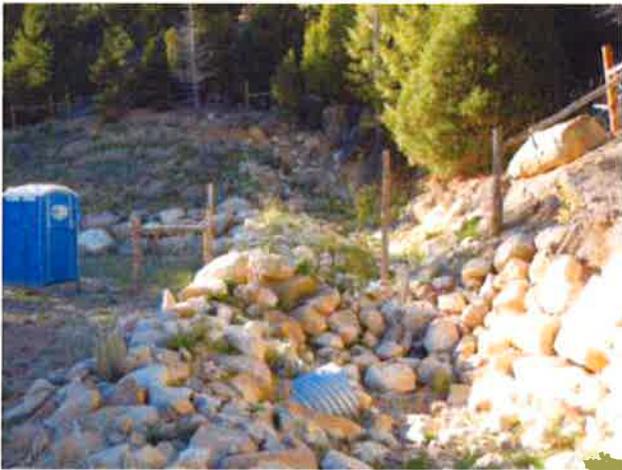
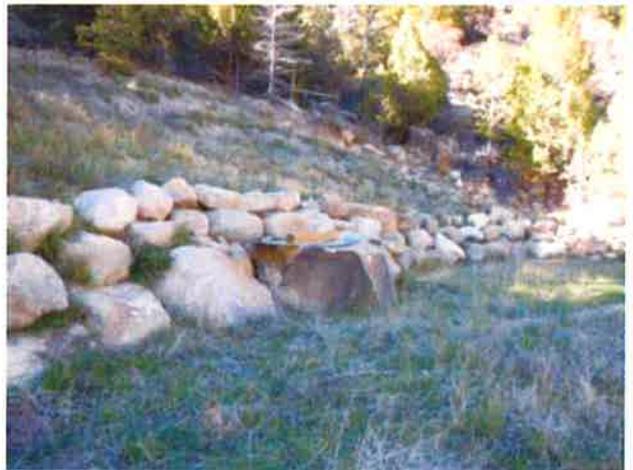
G12: Site has been re contoured, seeded and vegetation is established. Not back to original contour because landowner wanted to keep a pad and still meets the post mining land use for grazing operations. Phase 2 bond release recommend.

- G12: Phase 2 bond release recommended as the site appears stable with minimal signs of erosion through the reclaimed area and along the disturbed/undisturbed boundary.

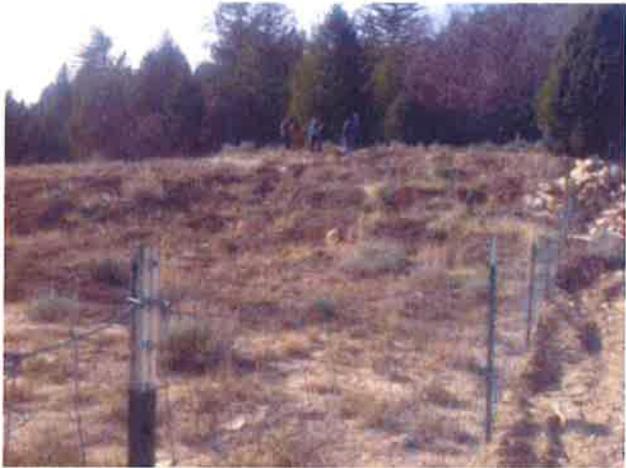
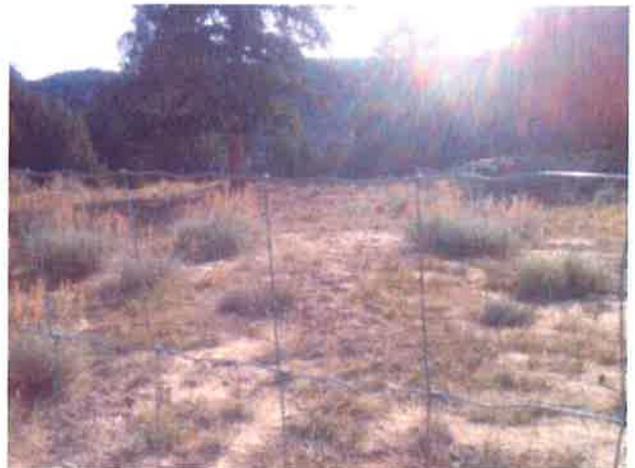
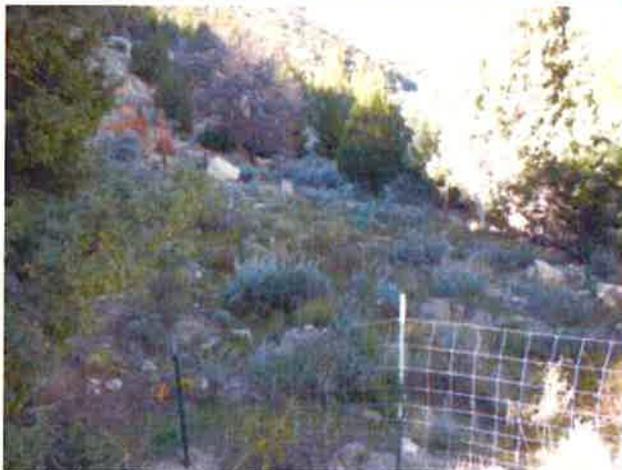
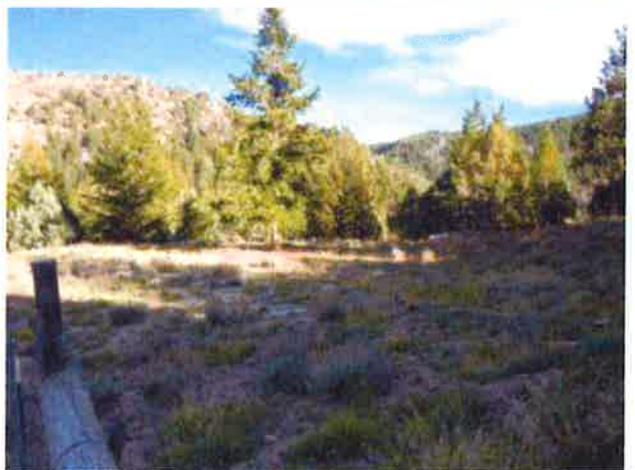
G13: Phase 2 bond release recommended

G13: Site has been re contoured, seeded and vegetation is established. Site has been recontoured to predisturbance. Erosion is evident on slope and should continued to be monitored. Phase 2 bond release recommend with continued maintenance on rilling slope.

- G13: Site has been recontoured to predisturbance. Erosion is evident on cut slope. This site should continue to be monitored and maintained. Phase 2 bond release recommended with continued maintenance on two large rills along the cut slope. An investigation at the drainage above this site might be helpful in decreasing the drainage to this area. The site appears stable with moderate signs of erosion through the reclaimed area and along the disturbed/undisturbed boundary.

G19 and G13 have cut slopes that were not reclaimed exactly to AOC due to site conditions and upon request of the landowner. Moderate signs of erosion can be seen as rills at both sites. Continued maintenance will be required until drainage through these sites is controlled.

G13: Erosion is evident on cut slope. This site should continue to be monitored and maintained. Phase 2 bond release recommend with continued maintenance on two large rills along the cut slope

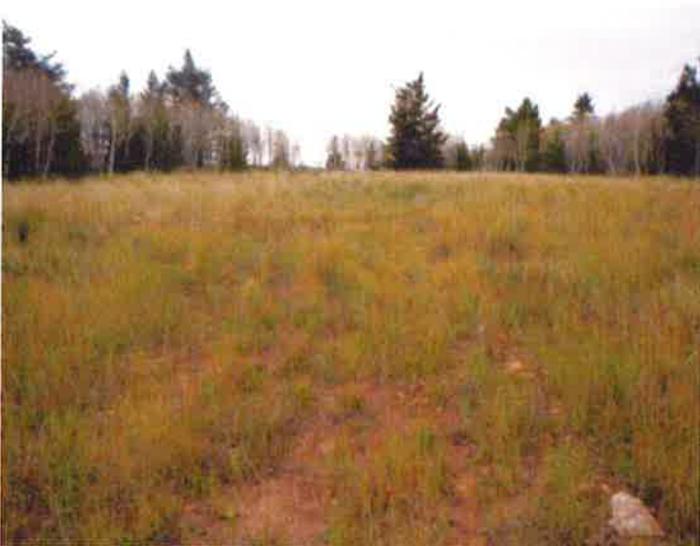
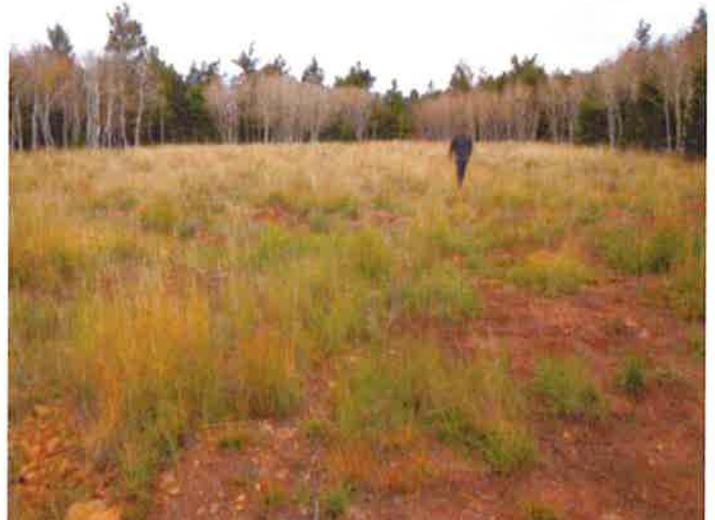
G14: Phase 2 bond release recommended

G14: Site has been re contoured, seeded and vegetation is establishing Phase 2 bond release recommend.

- G14: Site has been re contoured, seeded and vegetation is establishing Phase 2 bond release recommended. The site appears stable with minimal signs of erosion through the reclaimed area and along the disturbed/undisturbed boundary.

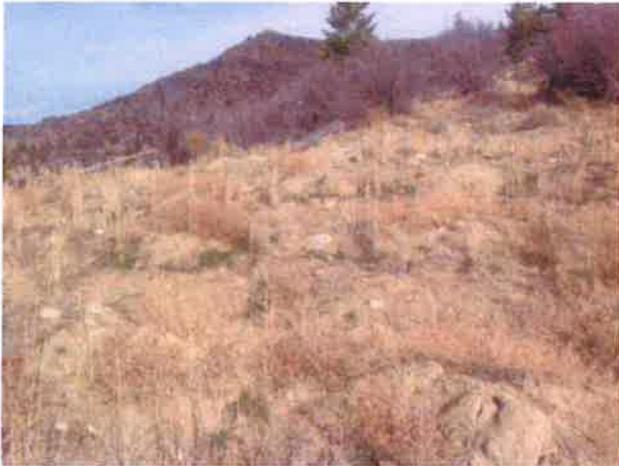
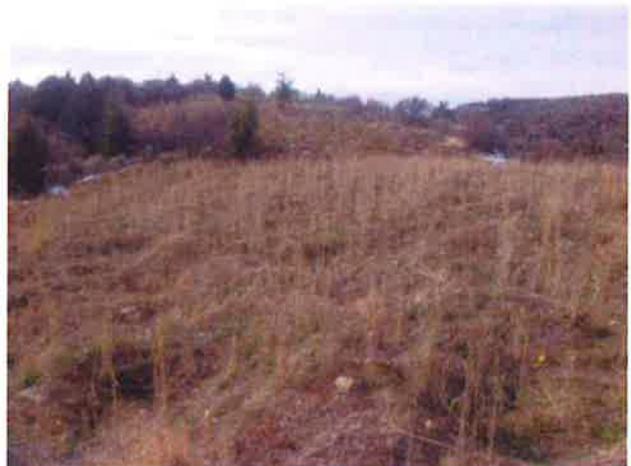
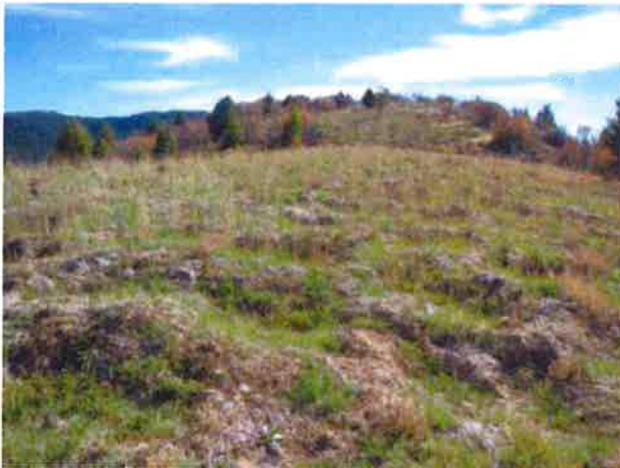
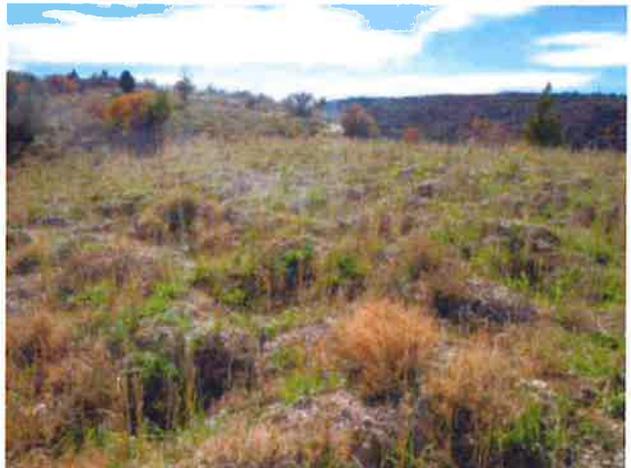
G16: Site has been re contoured and seeded but perennial vegetation from the seed mix is not established. Phase 1 bond release recommend.

- G16: Phase 1 bond release recommended as the site appears stable with minimal signs of erosion through the reclaimed area and along the disturbed/undisturbed boundary.

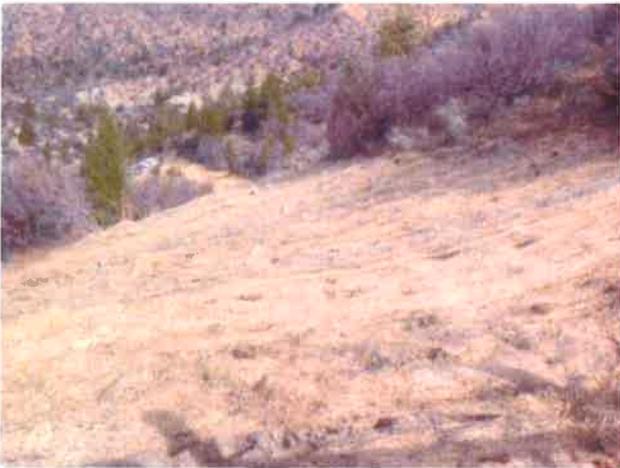
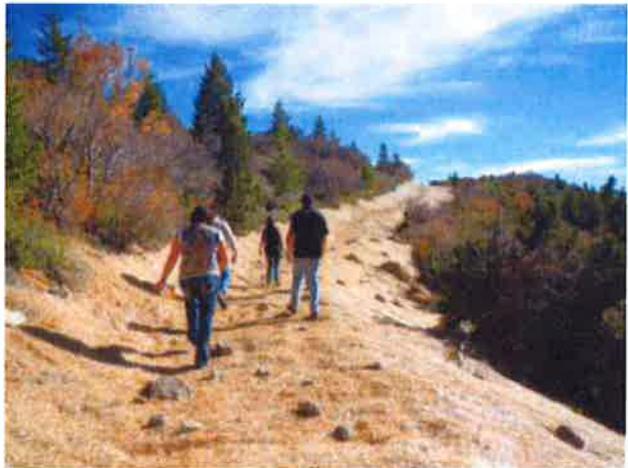
G16 Access Road (~475 feet): Phase 1 bond release recommended

G16: Phase I bond release recommended as the site appears stable with minimal signs of erosion through the reclaimed area and along the disturbed/undisturbed boundary. Approximately 475 feet of access road associated with the pad is also recommended for Phase I bond release.

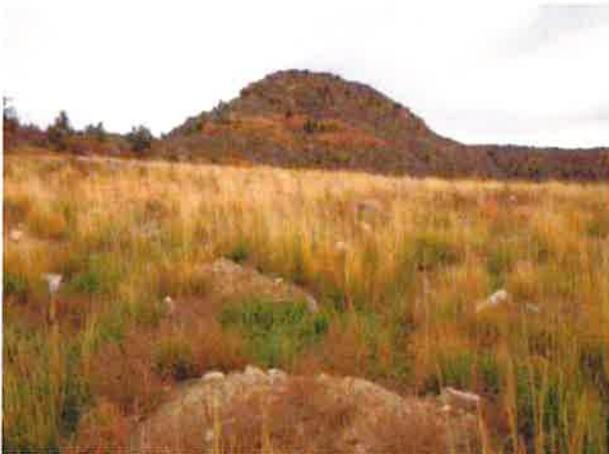
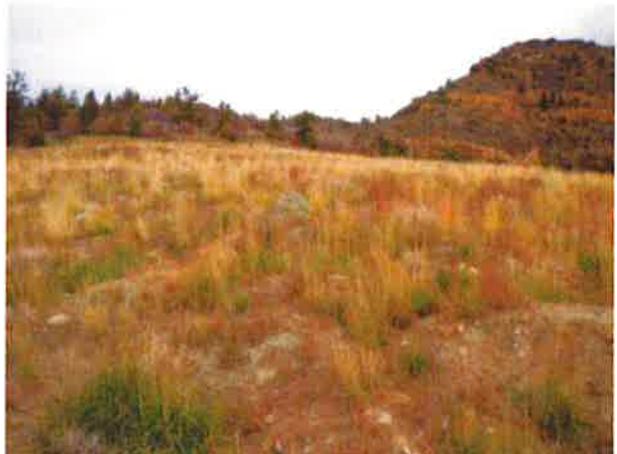
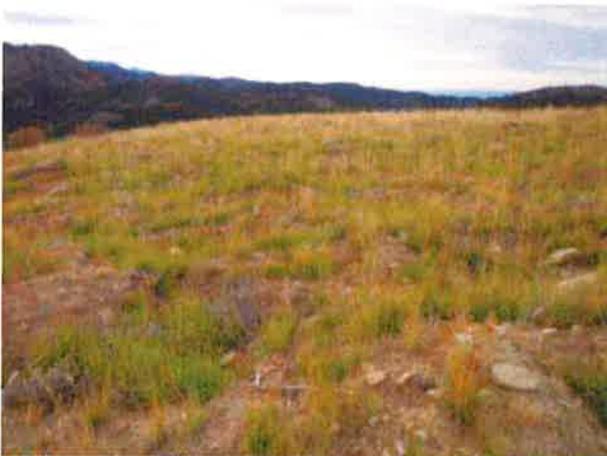
G18: Phase 2 bond release recommended

G18:Site has been re contoured, seeded and vegetation is established. It is enhanced for habitat for wildlife by the establishment of vegetation for wildlife food, cover, and breaks up large blocks of monoculture habitat. Phase 2 bond release recommend.

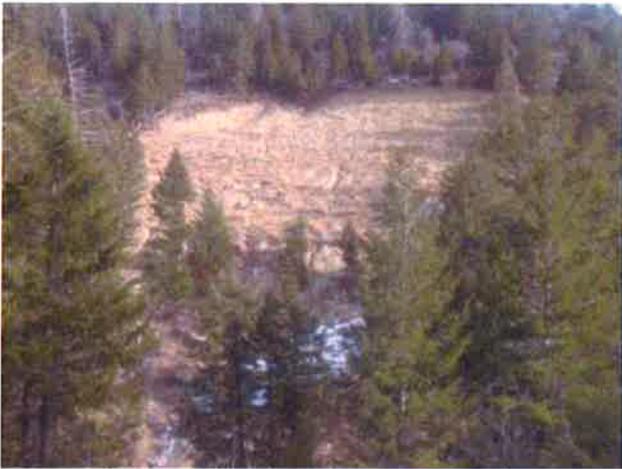
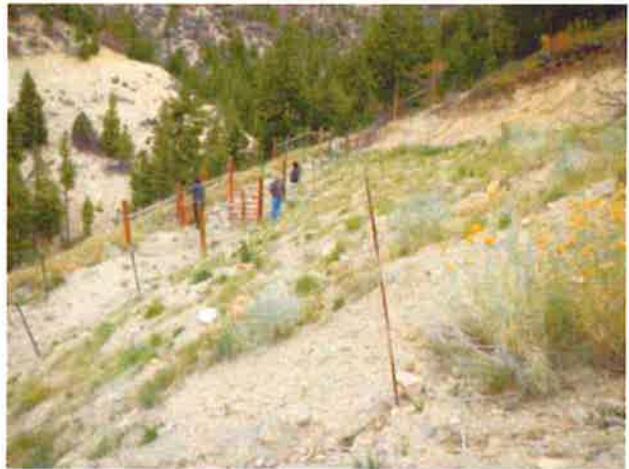
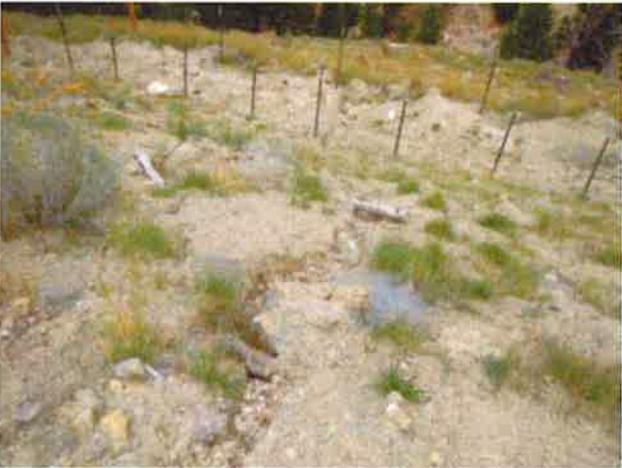
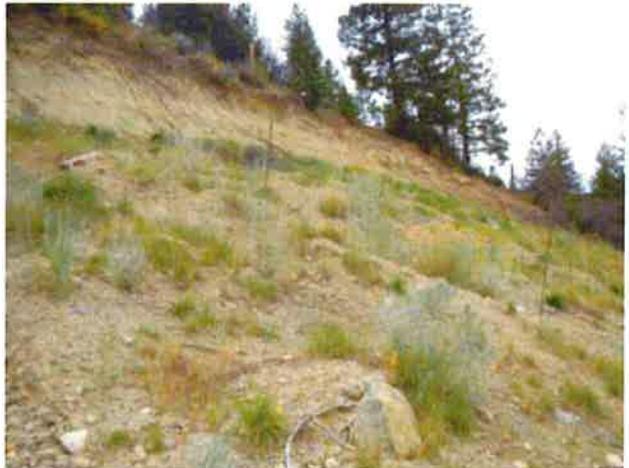
G19: Site has been re contoured, seeded and vegetation is establishing but requires additional erosion control and monitoring. Phase 1 bond release recommend. A portion (1200 feet) of the AMV road has been recontoured and seeded.

- G19: Site has been re contoured, seeded and vegetation is establishing but requires additional erosion control and monitoring. Phase 1 bond release recommended with continued maintenance to all the rills along the cut slope. An investigation at the drainage area above this site might be helpful in decreasing the drainage to this area. The cute slope appears to be relatively stable with little to no raveling visible along the top of the exposed cut face. Moderate signs of

erosion and degradation continue to develop through the reclaimed area and along the lower portion of the slope below the reclaimed site. A portion (1200 feet) of the AMV road has been recontoured and seeded.

G19: Phase 1 bond release recommended with continued maintenance to all the rills along the cut slope.

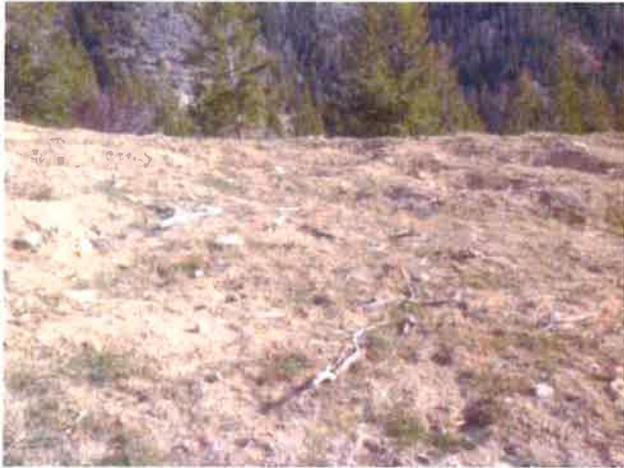
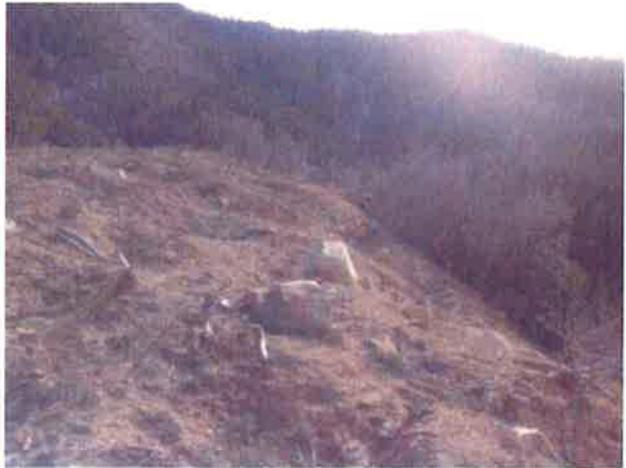
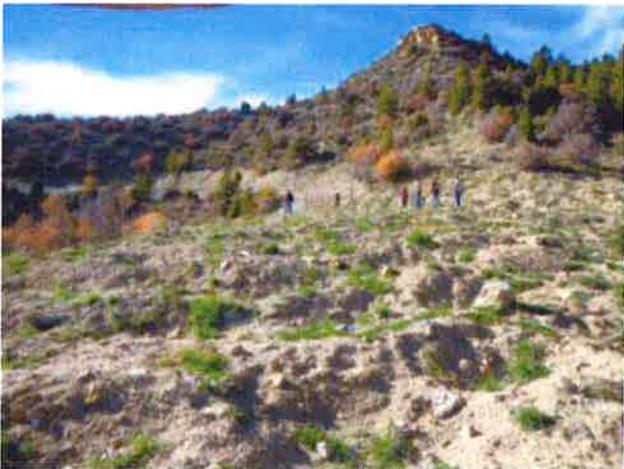
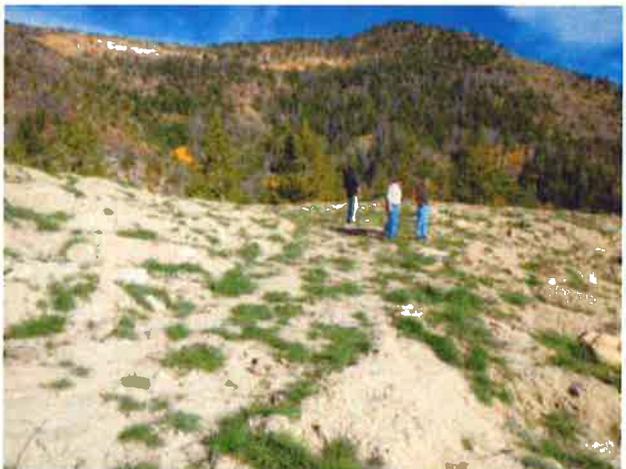
- G22: Phase 1 bond release recommended as the site appears stable with minimal signs of erosion through the reclaimed area and along the disturbed/undisturbed boundary.

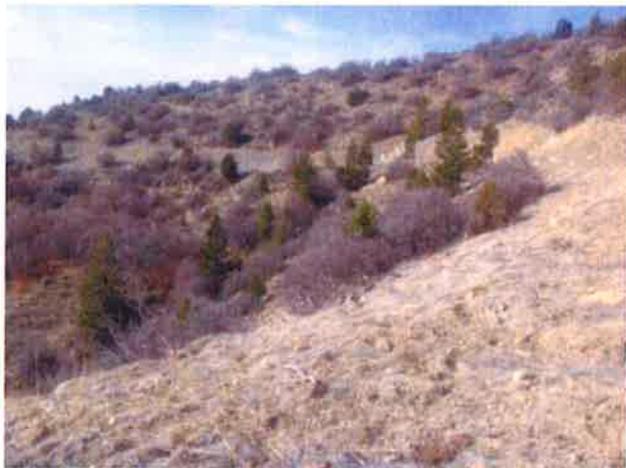
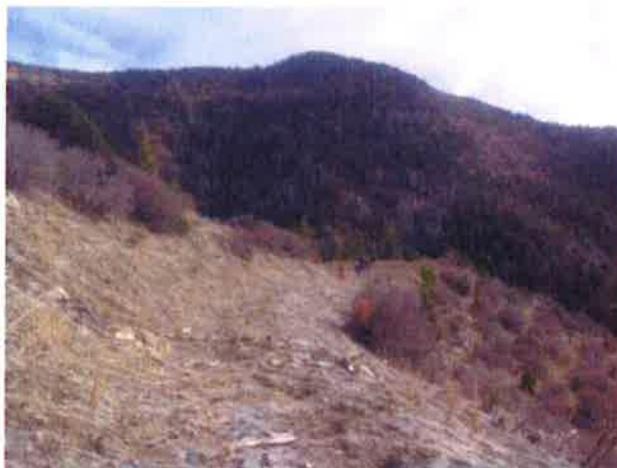
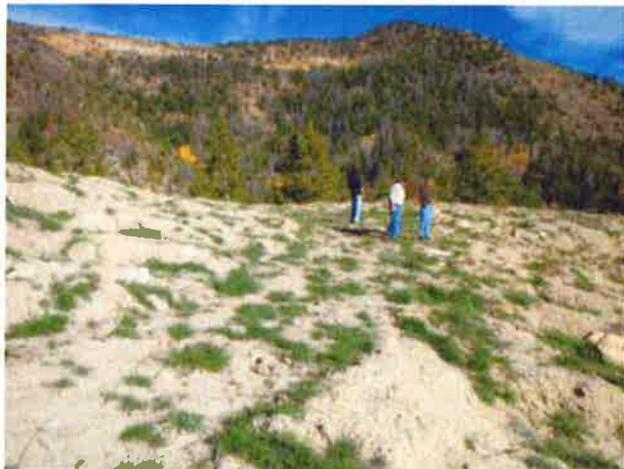
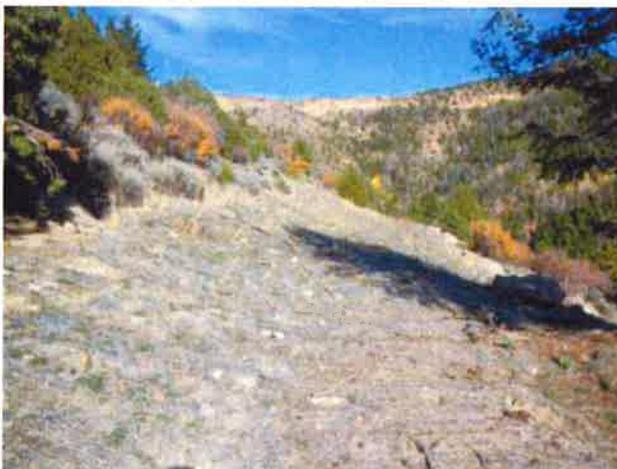
G22 Access Road (~1,200 ft) Phase 1 bond release recommended

G22: Phase I bond release recommended as the site appears stable with minimal signs of erosion through the reclaimed area and along the disturbed/undisturbed boundary. Approximately 1,200 feet of access road associated with the pad is also recommended for Phase I bond release.

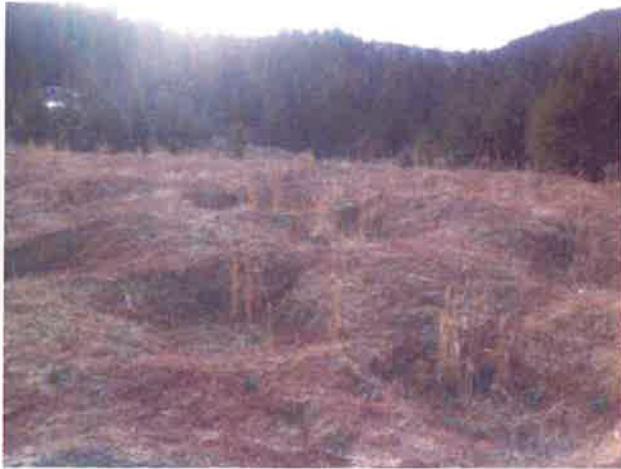
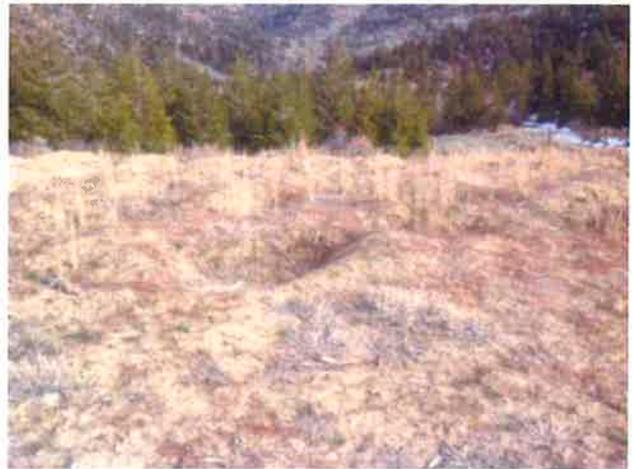
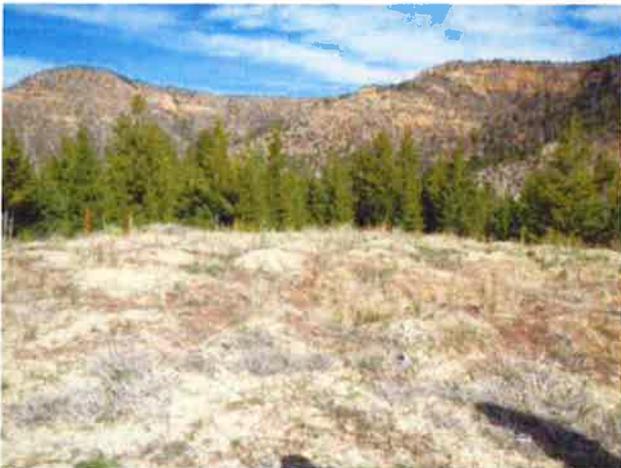
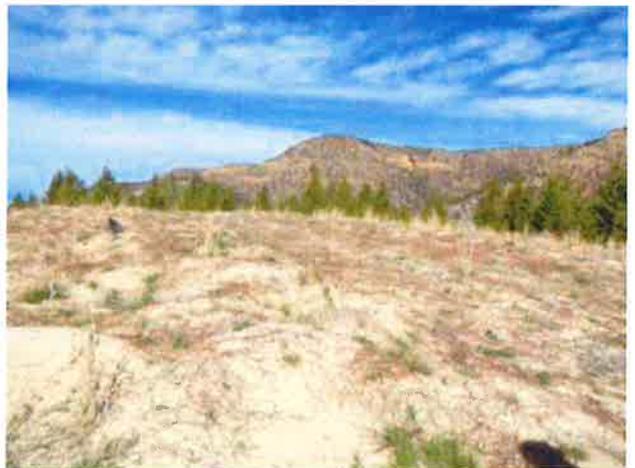
G25: Site has been re contoured and seeded but perennial vegetation from the seed mix is not established. Phase 1 bond release recommend.

- G25: Phase 1 bond release recommended as the site appears stable with minimal signs of erosion through the reclaimed area and along the disturbed/undisturbed boundary.

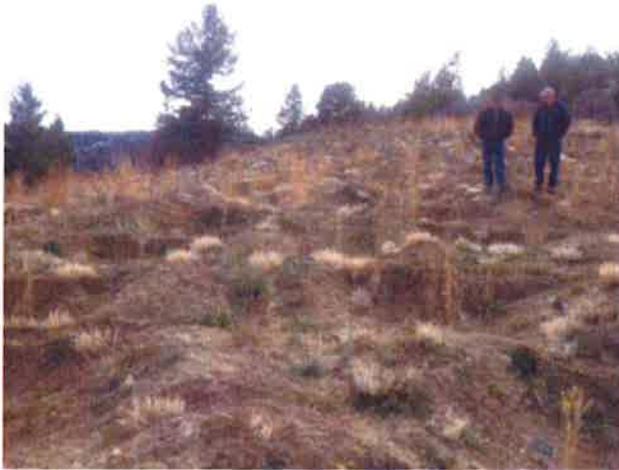
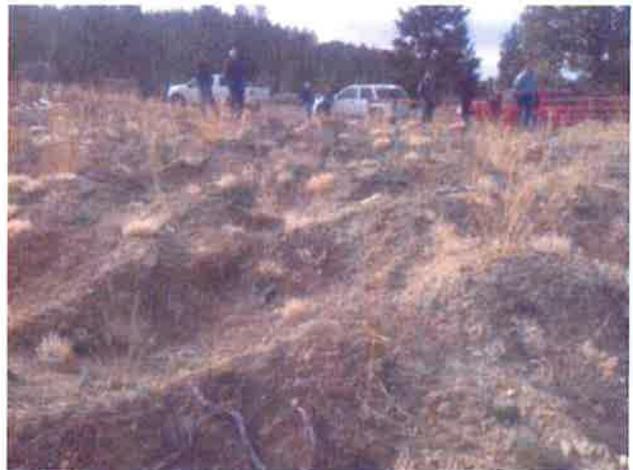
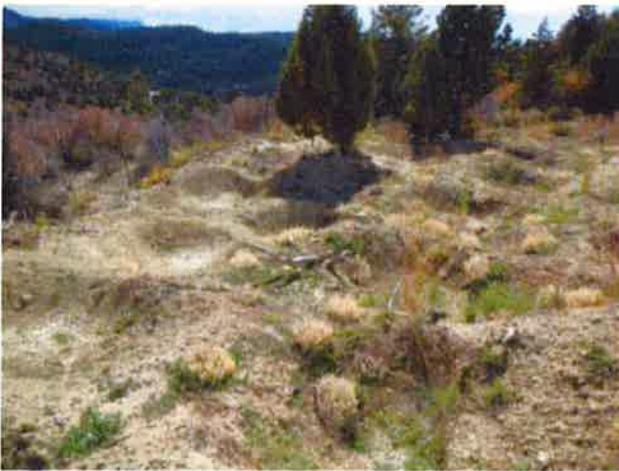
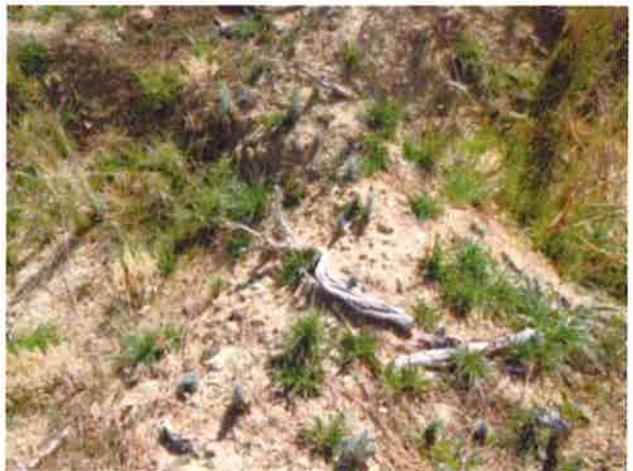
G26: Site has been re contoured and seeded but perennial vegetation from the seed mix is not established. Phase 1 bond release recommend.

- G26: Phase 1 bond release recommended as the site appears stable with minimal signs of erosion through the reclaimed area and along the disturbed/undisturbed boundary.
