Subject: Approval of Phase I & II Bond Release of Select Methane Degasification Well Sites, Task ID #4711, Canyon Fuel Company, LLC, Dugout Canyon Mine, C/007/0039

EXHIBIT “D”

- * Action
- * Background
- * Chronology
- * Summary of Findings
- * Recommendation for Phase I & II Bond Release

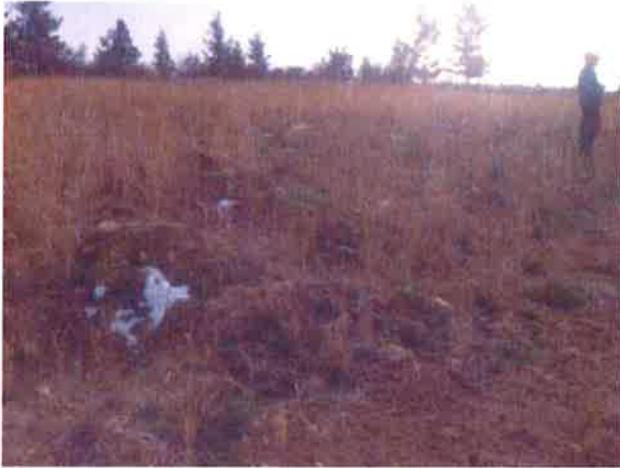
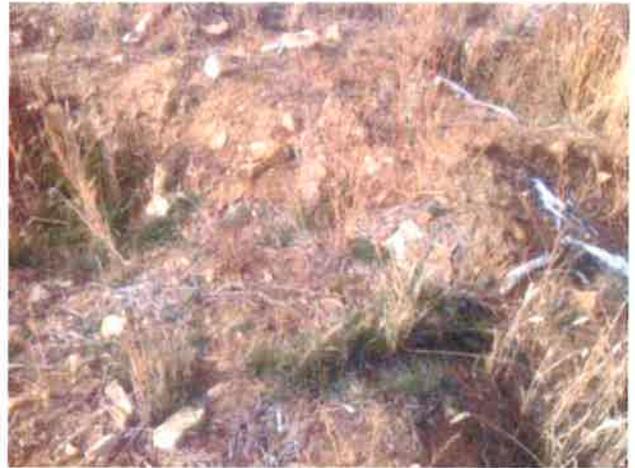
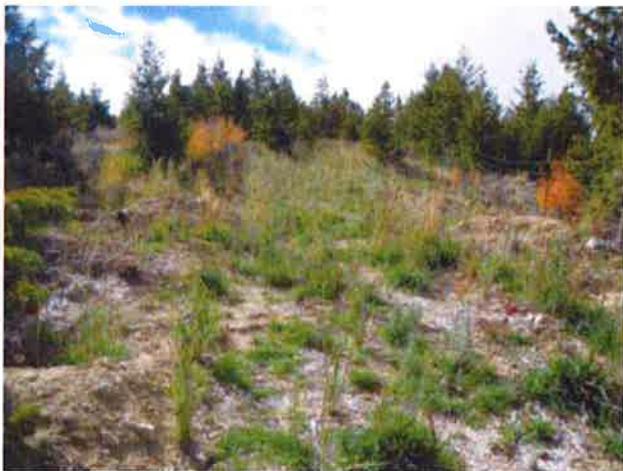
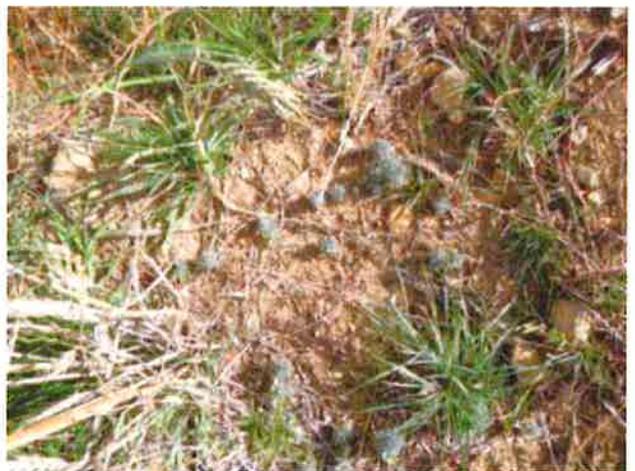
G30: Phase 1 bond release recommended

G30: Site has been re contoured and seeded but perennial vegetation from the seed mix is not established. Exceptional sagebrush seedings are evident. Phase 1 bond release recommend.

- G30: Site has been re contoured and seeded but perennial vegetation from the seed mix is not established. Exceptional sagebrush seedings are evident. Phase 1 bond release recommended.

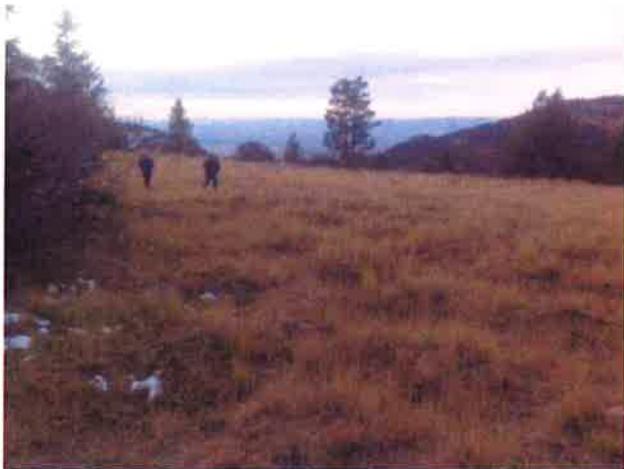
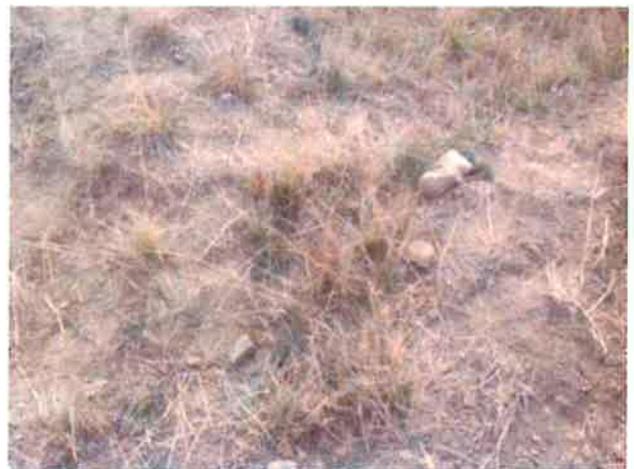
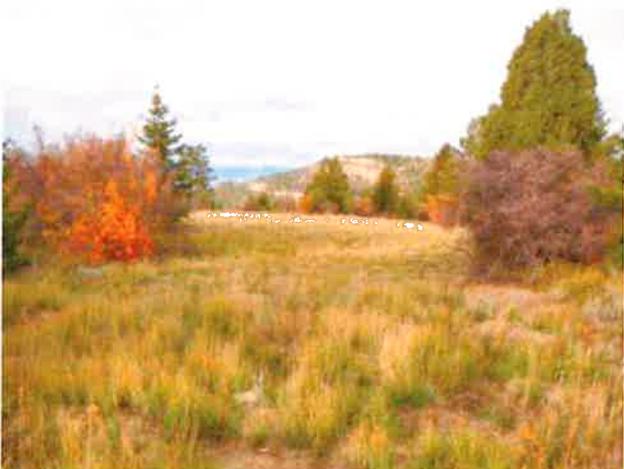
G31: Phase 2 bond release recommended

G31: Site has been re contoured, seeded and vegetation is established. It is enhanced for habitat for wildlife by the establishment of vegetation for wildlife food, cover, and breaks up large blocks of monoculture habitat. Phase 2 bond release recommend.

- G31: Site has been re contoured, seeded and vegetation is established. It is enhanced for habitat for wildlife by the establishment of vegetation for wildlife food, cover, and breaks up large blocks of monoculture habitat. Phase 2 bond release recommended.

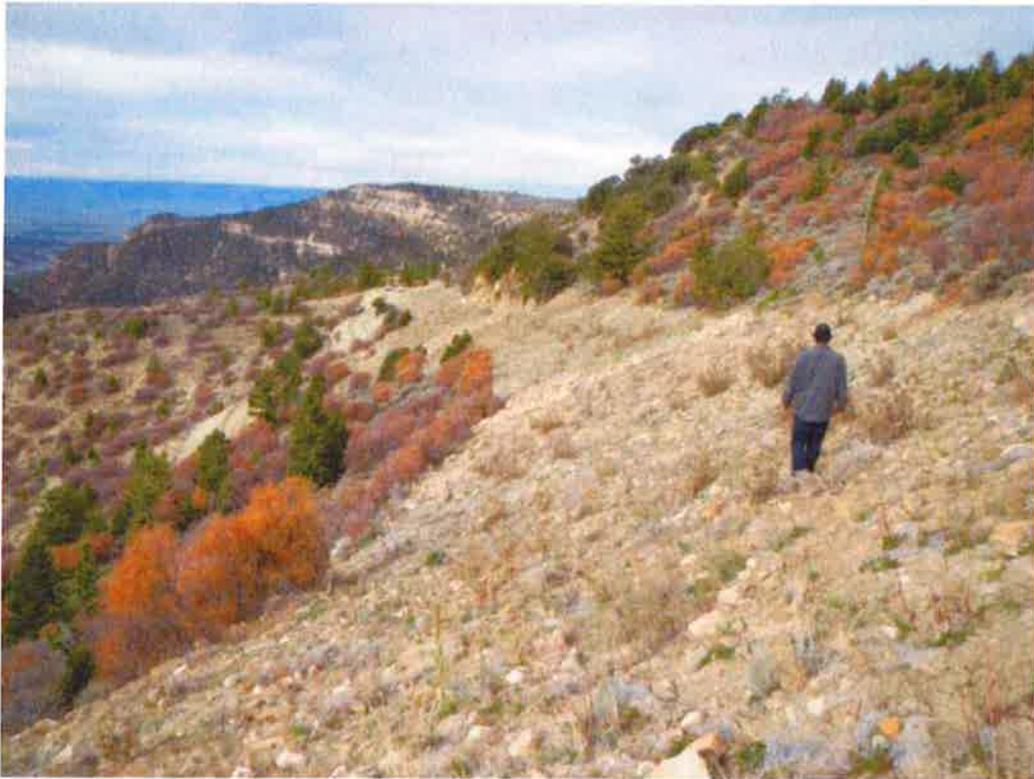
~1,350 feet of AMV Road: Phase 1 bond release recommended

AMV Road: Phase I bond release Approximately 1,350 feet of the AMV Road is recommended for Phase I bond release.
