RE: 2016 Annual Report for Dugout Canyon Mine

# Annual Report

Company Name	Canyon Fuel Company, LLC	Mine Name	Dugout Mine
Permit Number	C/007/0039	Permit expiration Date	March 3, 2018
Operator Name	Same	Phone Number	+1 (435) 637-6360
Mailing Address	P.O. Box 1029	Email	dspillman@bowieresources.com
City	Wellington		
State	Utah	Zip Code	84542

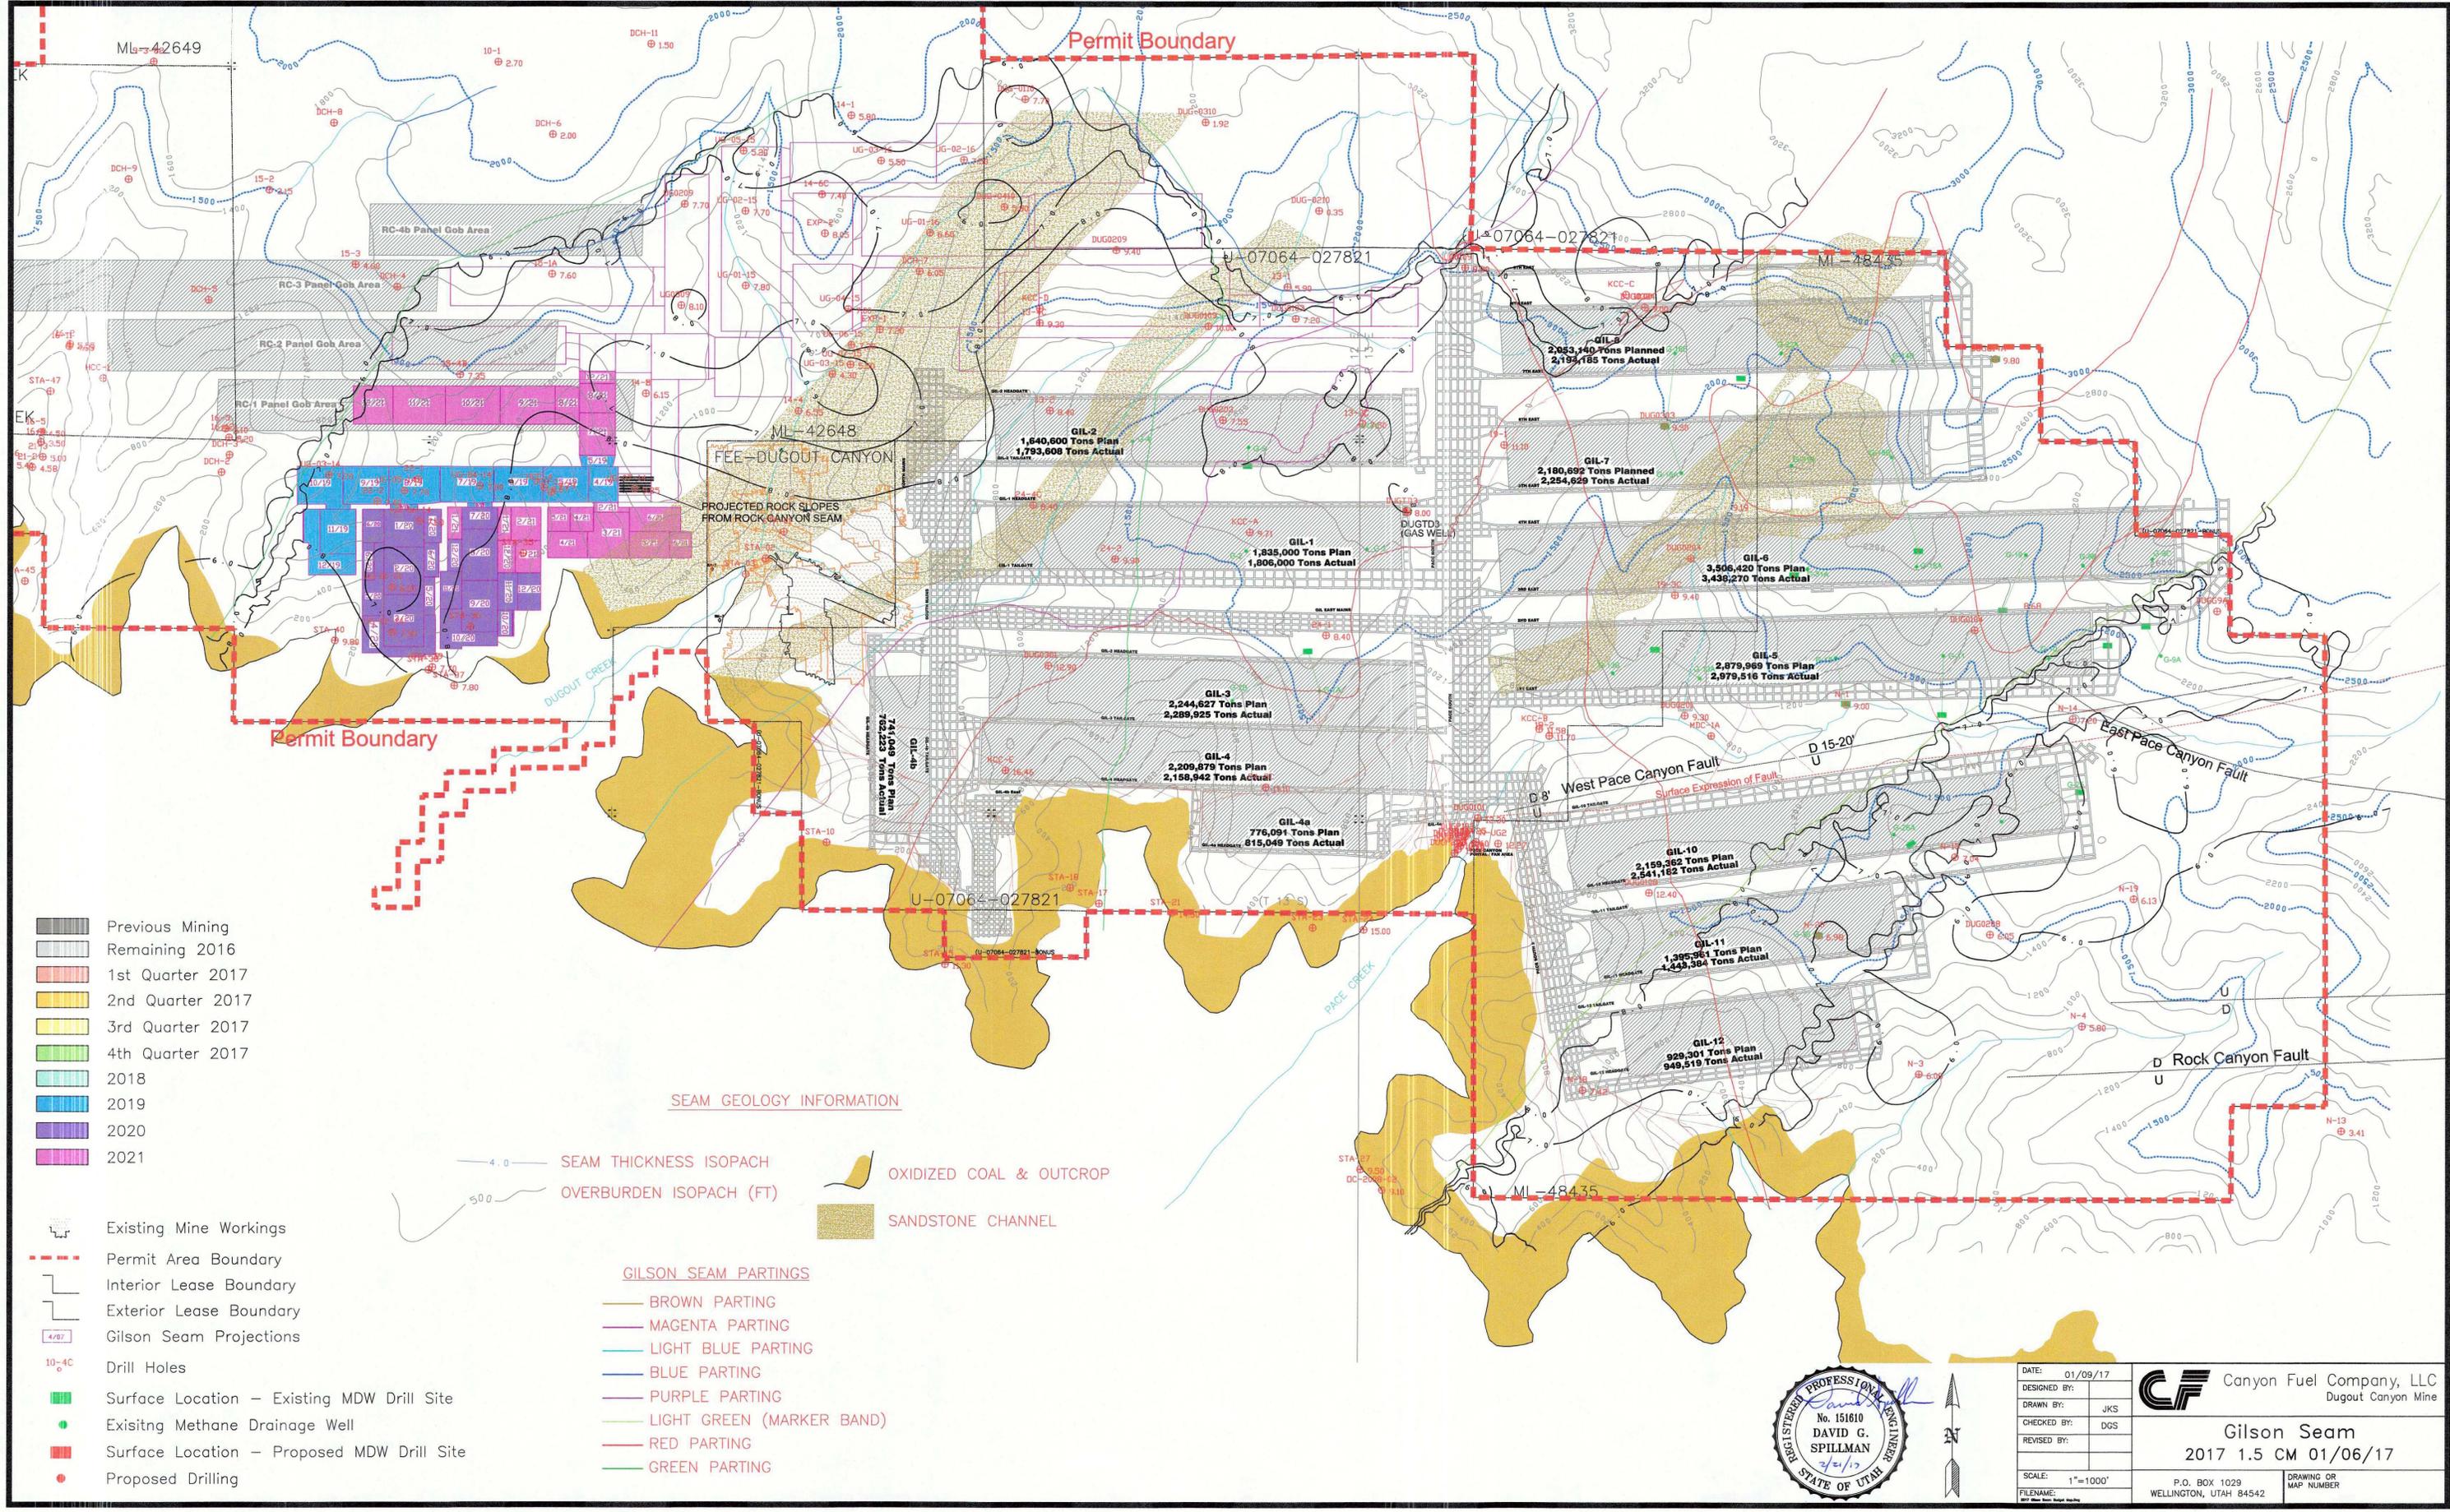
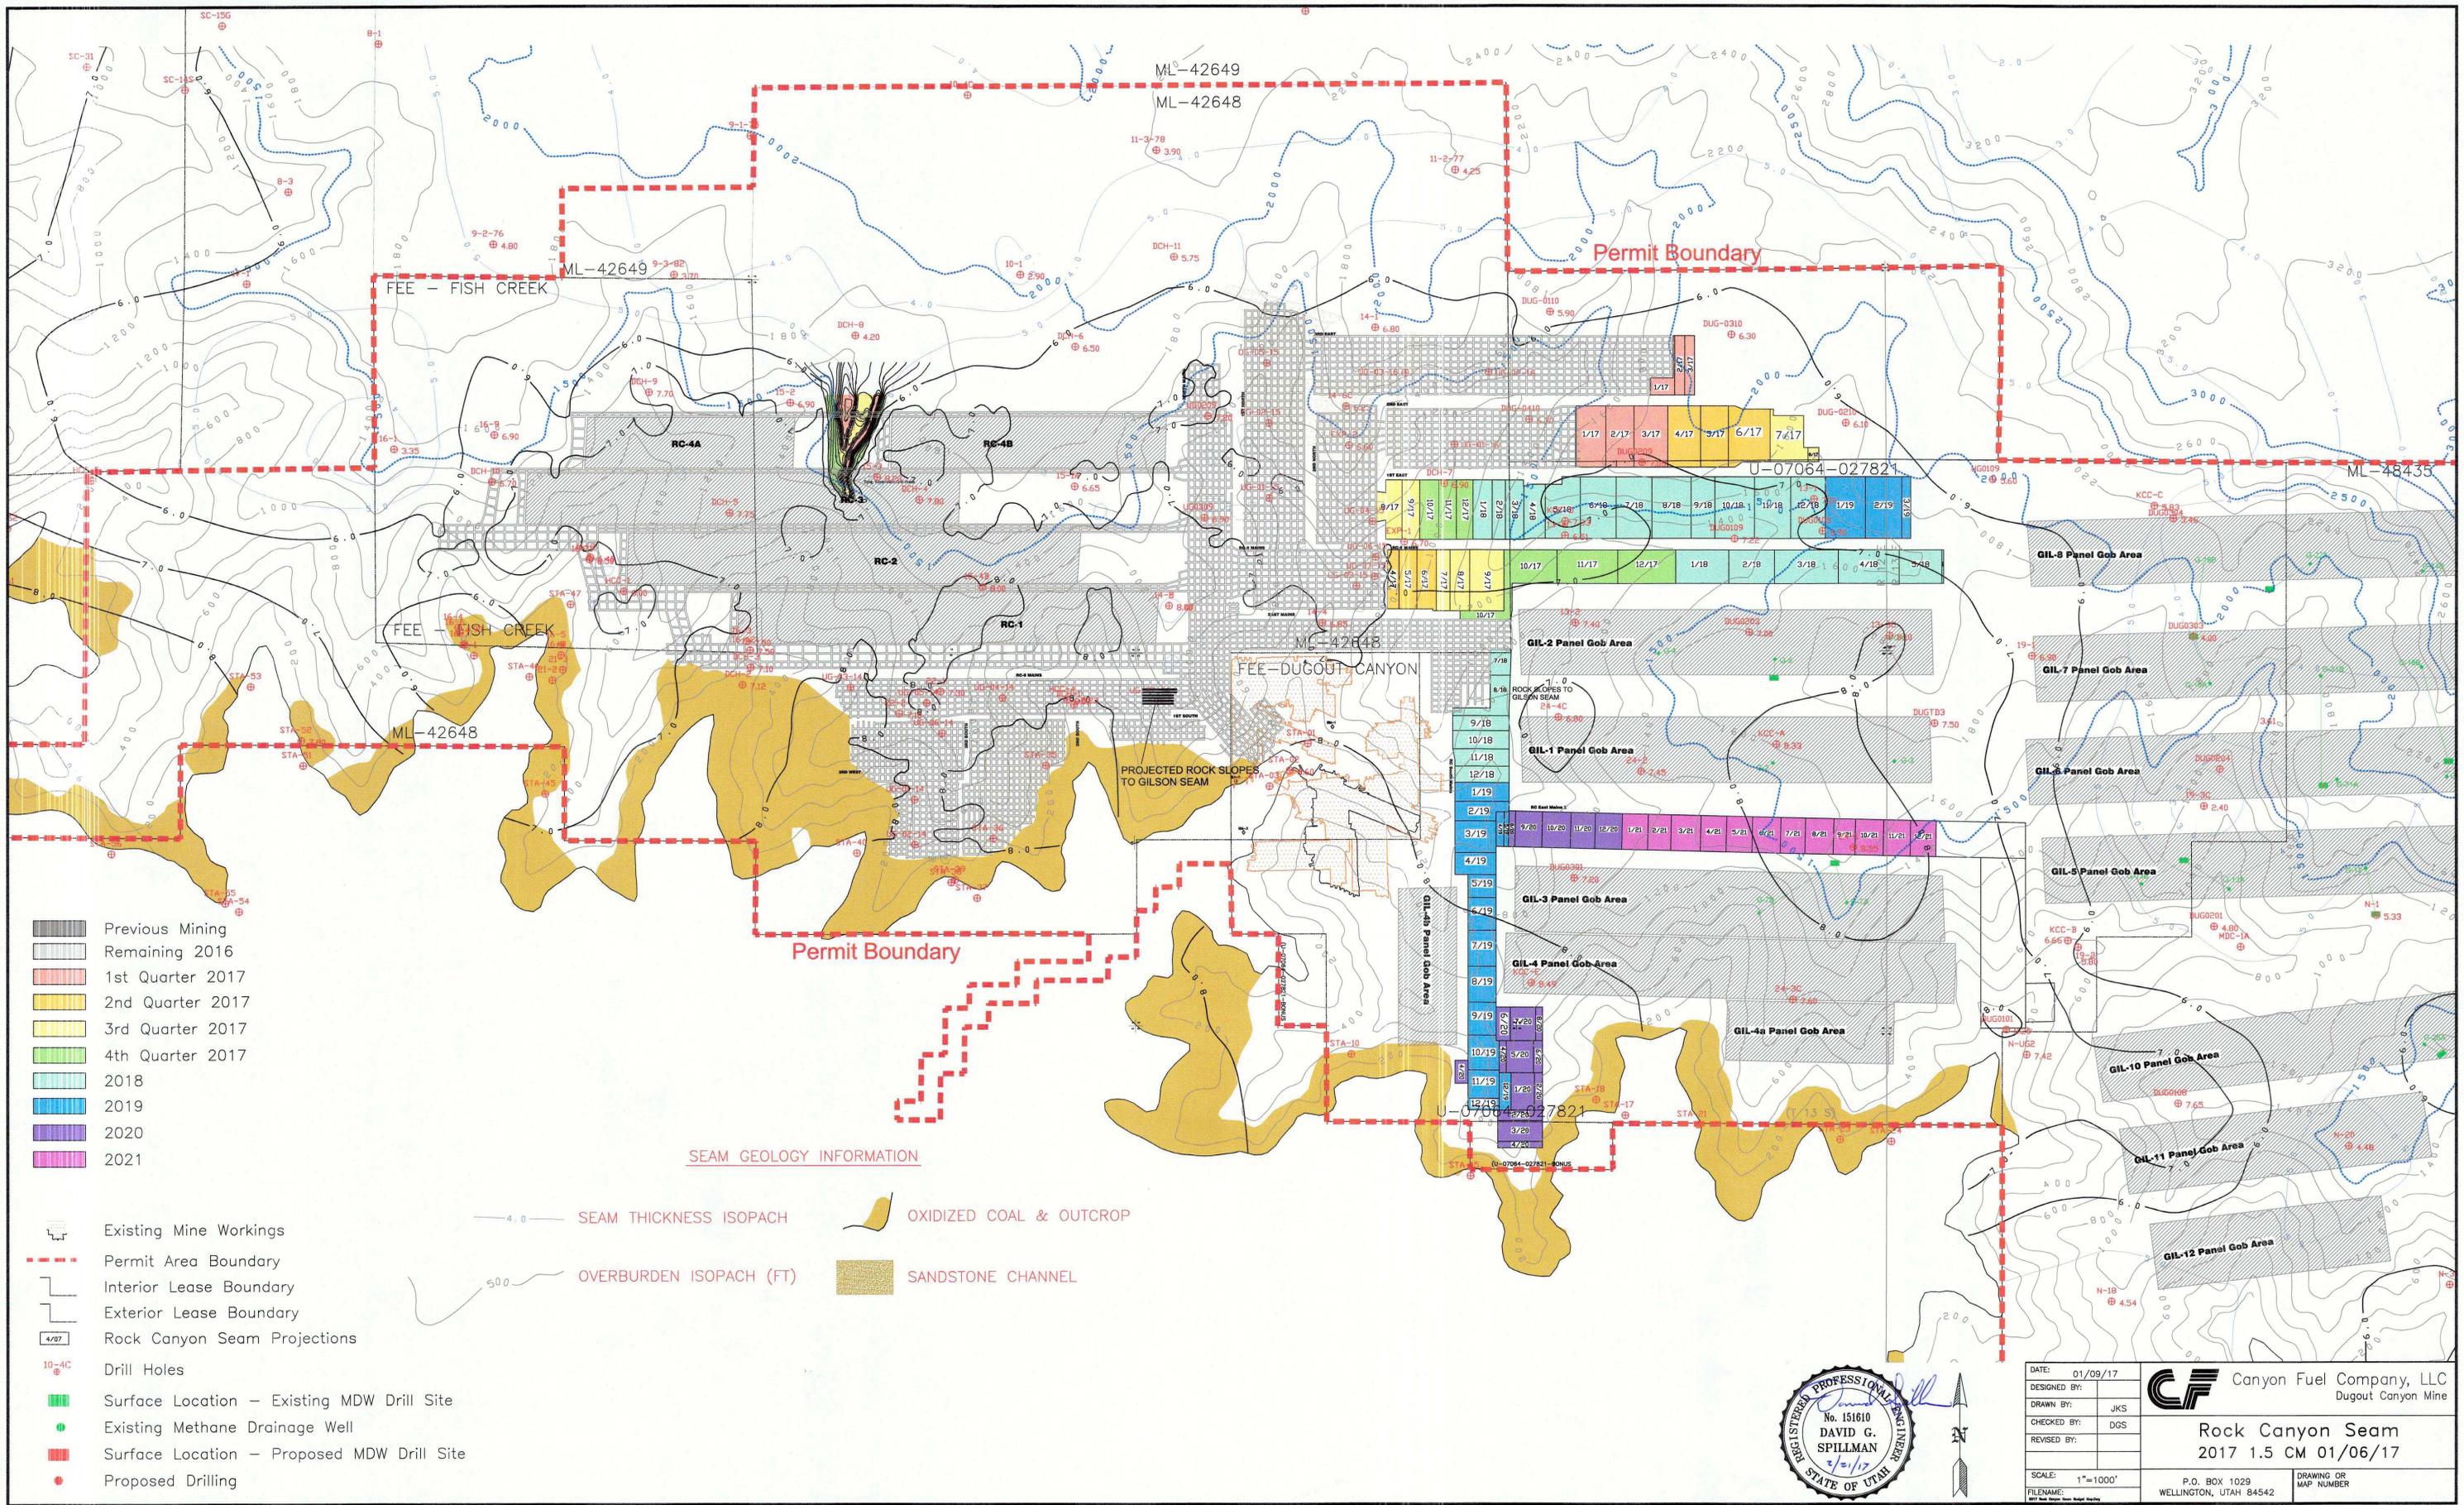
**Mine Map – Gilson Seam**

**Mine Map – Rock Canyon Seam**

- Previous Mining
- Remaining 2016
- 1st Quarter 2017
- 2nd Quarter 2017
- 3rd Quarter 2017
- 4th Quarter 2017
- 2018
- 2019
- 2020
- 2021
