**U.S. DEPT. OF THE INTERIOR
OFFICE OF SURFACE MINING
Mine Site Evaluation
State Program**

Mine Site Inspection

Mine Name: Dugout Canyon Mine

Inspection Date: November 14, 2017 9:30 – 12:30

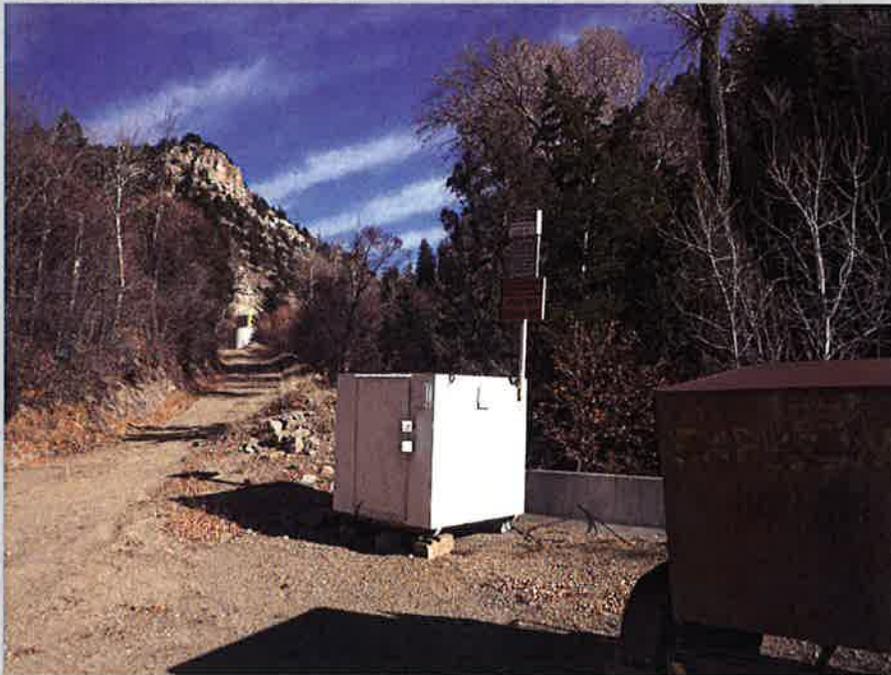
Photo ID: 35738

Well-maintained, signs in place.

Subject: Explosives storage area

Explosives storage: The explosives storage area was orderly and in good repair. Proper signage is in place. No problems were noted.

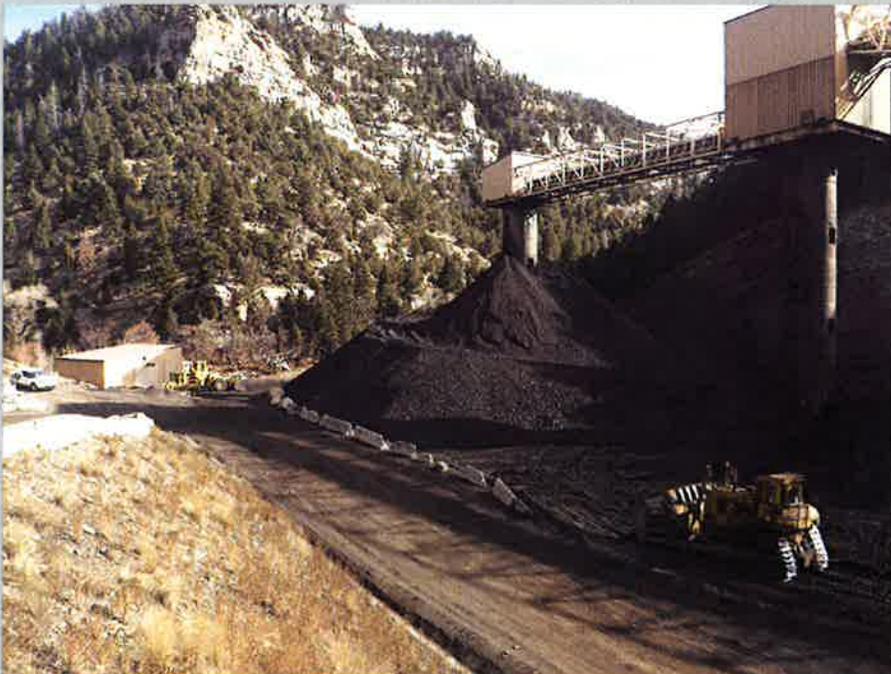
Photo ID: 35739

All coal storage activity confined within approved disturbed area boundary.

Subject: Coal stack tube silos

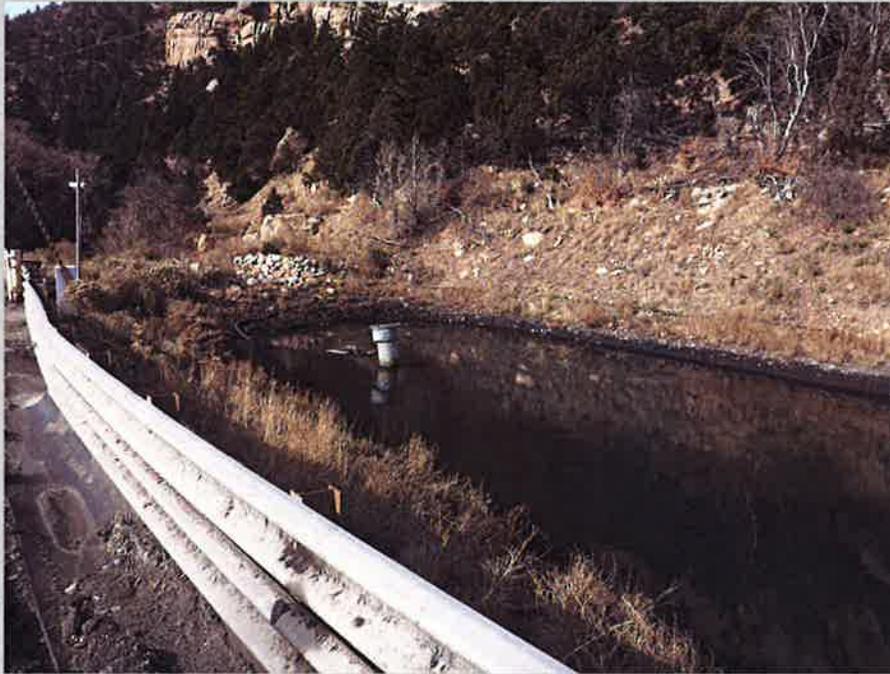
Photo ID: 35740

Recently cleaned.

Subject: Facilities area pond

The facilities area pond was recently cleaned and holding water at the time of inspection. The refuse area pond was recently reworked and dry at the time.

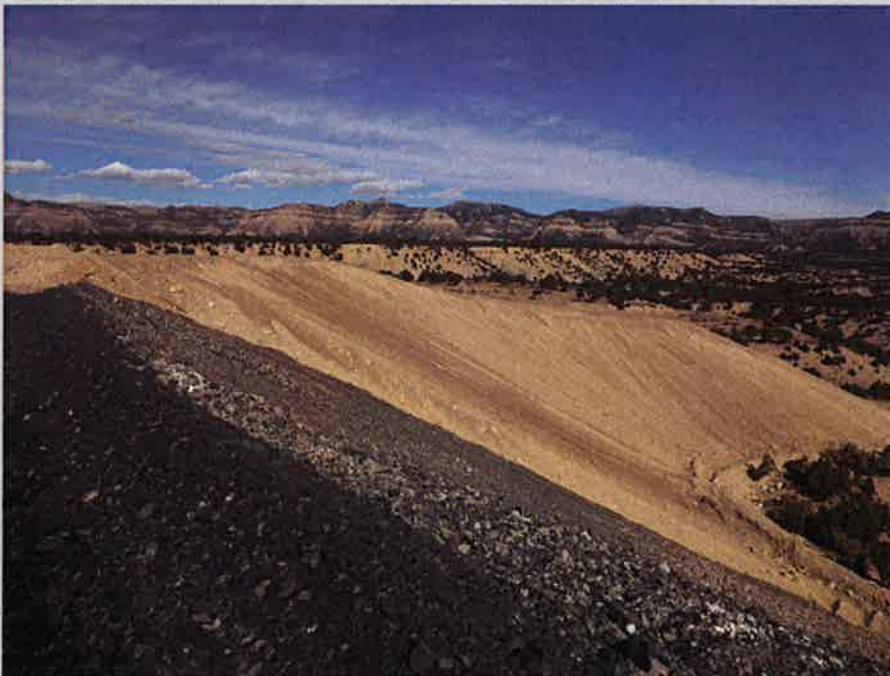
Photo ID: 35741

Subsoil and topsoil recently placed on refuse pile. To be seeded and covered with curlex degradation matting this year.

Subject: Refuse pile reclamation

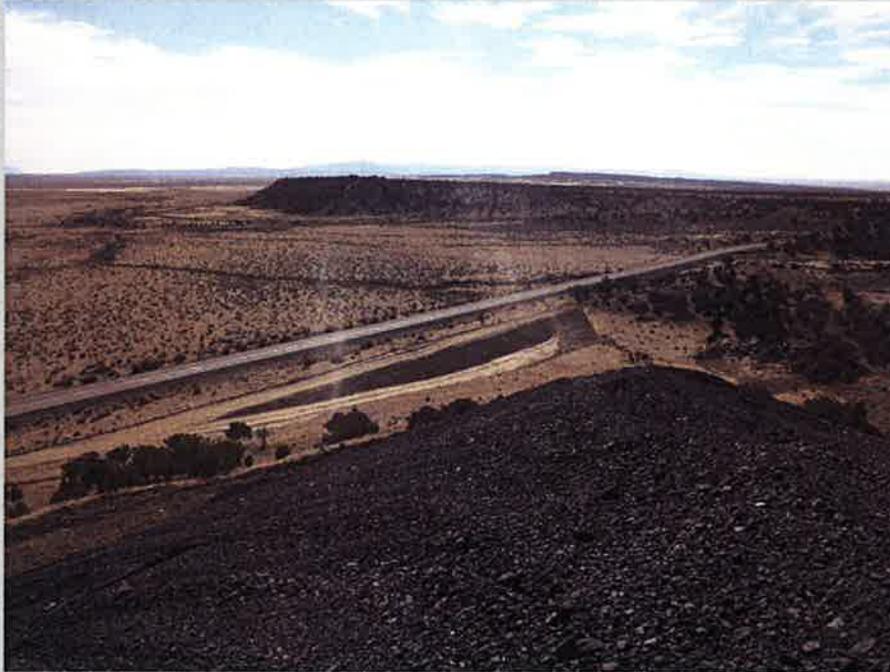
Photo ID: 35742

Dry and in good repair.

Subject: Refuse pile pond

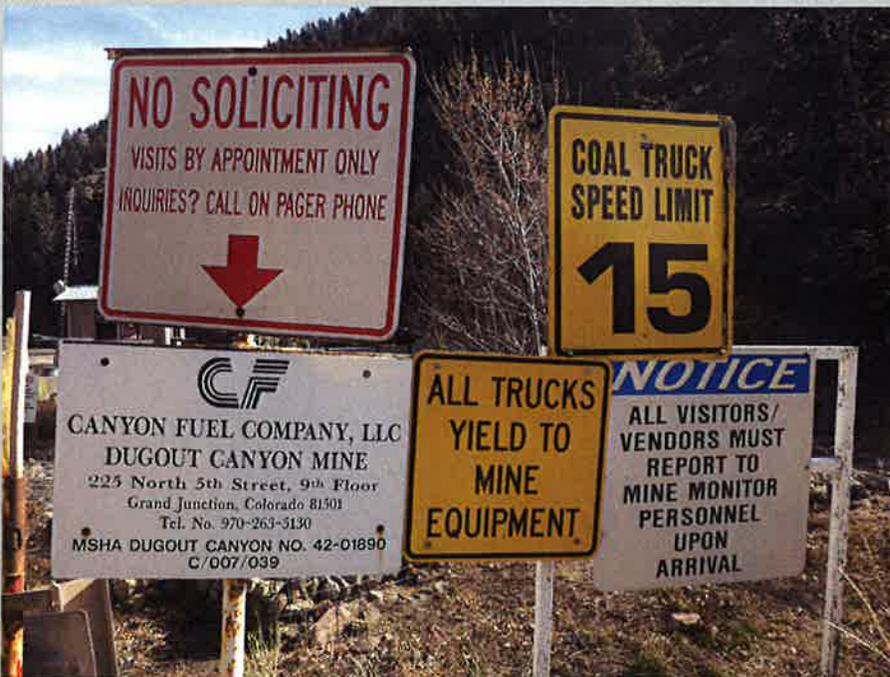
Photo ID: 35743

Mine identification signs contain all requisite information and are in good repair. Signs are in place at all permit area entries from public roads.

Subject: Mine ID sign

Signs and markers: Mine identification signs are in place at all points of entrance from public roads and contain all information as required under R645-301-521.200 through -.244. Painted t-posts marked the disturbed perimeter as required under R645-301-521.251.
