Inspection Report

Permit Number:	C0070039
Inspection Type:	PARTIAL
Inspection Date:	Tuesday, September 8, 2020
Start Date/Time:	9/8/2020 9:30:00 AM
End Date/Time:	9/8/2020 1:00:00 PM
Last Inspection:	Tuesday, August 4, 2020

Permitee: **CANYON FUEL COMPANY**
 Operator: **CANYON FUEL COMPANY**
 Site: **DUGOUT CANYON MINE**
 Address: **PO BOX 1029, WELLINGTON UT 84542**
 County: **CARBON**
 Permit Type: **PERMANENT COAL PROGRAM**
 Permit Status: **ACTIVE**

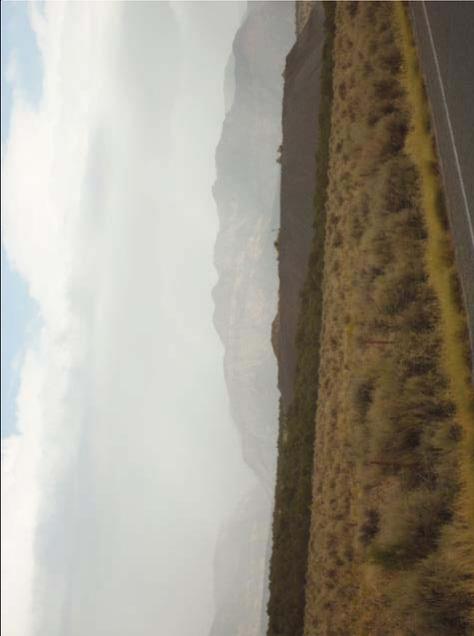
Active work on reclamation of part of the waste rock was taking place during the inspection. The pile appeared stable. Surfaces were graded and compacted.

<p>PHOTO 1</p> <p>Dugout Waste Rock Site Overview</p>

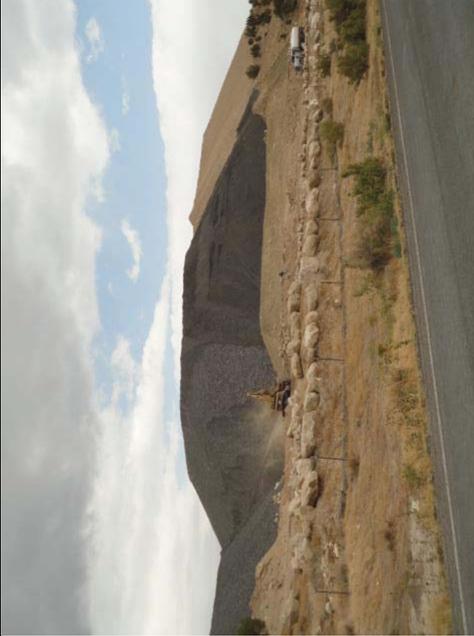
<p>PHOTO 2</p> <p>Dugout Waste Rock Site Overview</p>

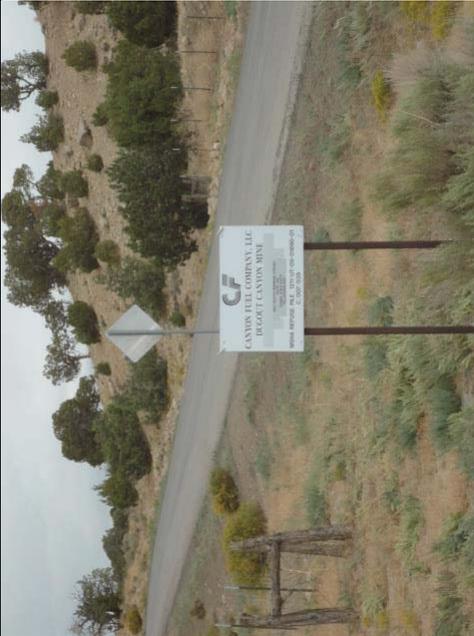
The identification signs at the Dugout Waste Rock Site and at the Dugout Mine were inspected during the partial inspection. Both of these signs post the name, address, phone number and mining permit in accordance with the requirements of the law. The signs are in compliance with the law.

<p>PHOTO 3</p> <p>Dugout Waste Rock Site Identification Sign</p>

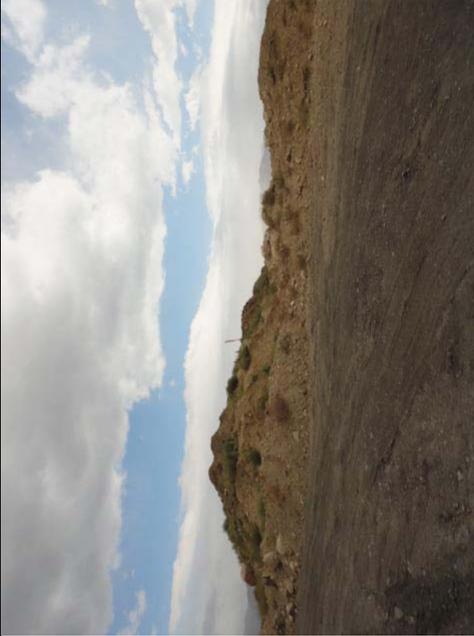
A topsoil pile still remains on top of the waste rock pile. All of the subsoil piles have been used from this location for reclamation.

<p>PHOTO 4</p> <p>Dugout Waste Rock Site Topsoil Pile on Top of Waste</p>

During the partial inspection soil was been live hauled from a soil pit at the base of the new expansion area. This soil will be spread over a portion of the top of the waste rock pile that has recently been brought to final grade.

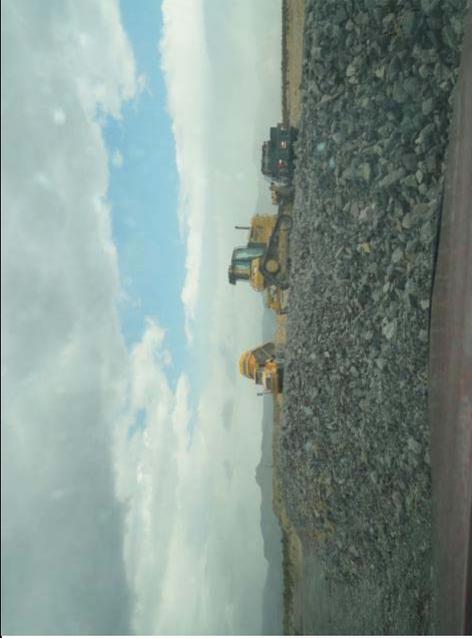
PHOTO 5

Dugout Waste Rock Site Final Lift on Top of Pile

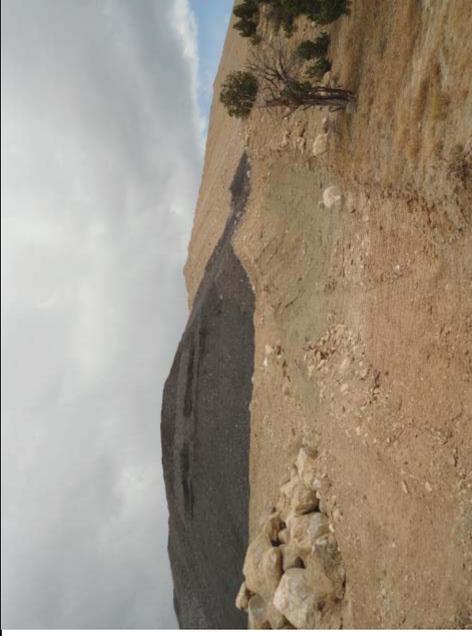
PHOTO 6

Diversion channel construction from the top of the waste rock pile down the out slope has been roughed in. Soil placement and rip rap still need to be done.

Dugout Waste Rock Site Slope Diversion Construction

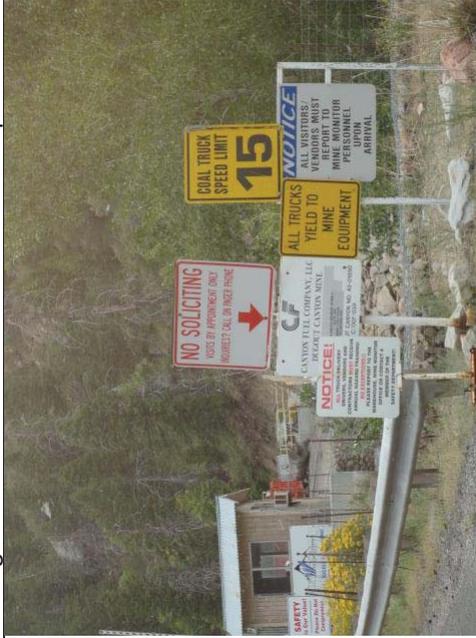
PHOTO 7

Dugout Identification Sign
