Re: West Ridge Mine C/007/041
WR16-002 Midterm Review Task ID# 5416

Please find attached the application to correct deficiencies found for the West Ridge Midterm Review.

*Vegetation Reference Areas
at the
West Ridge Mine
2016*

*in
Carbon County
Utah*

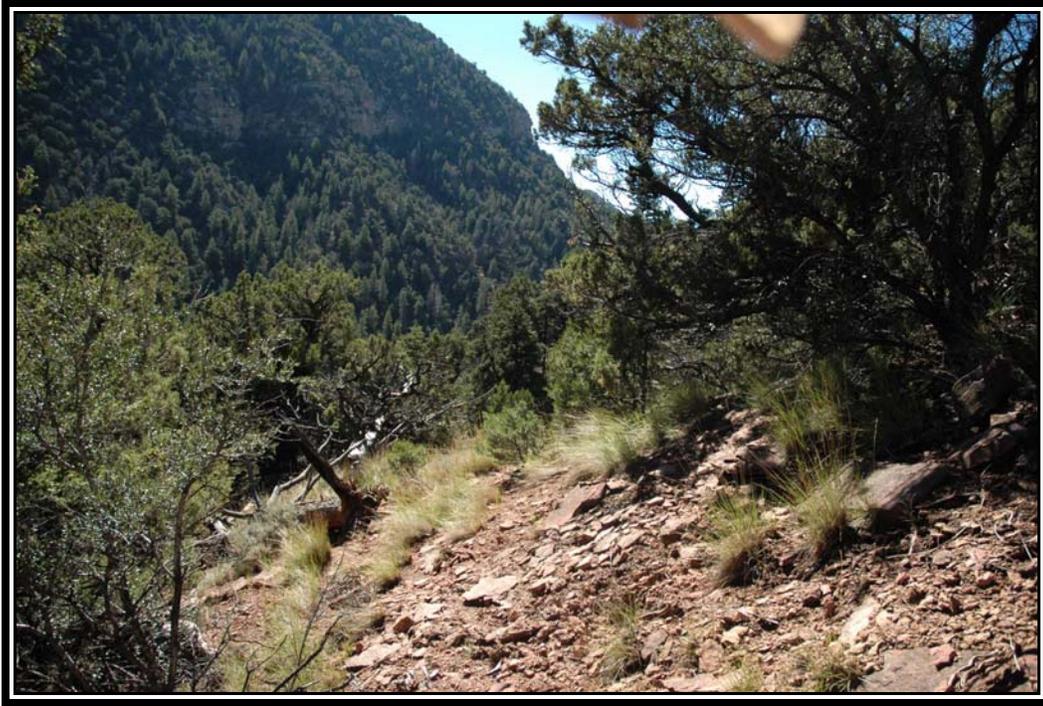
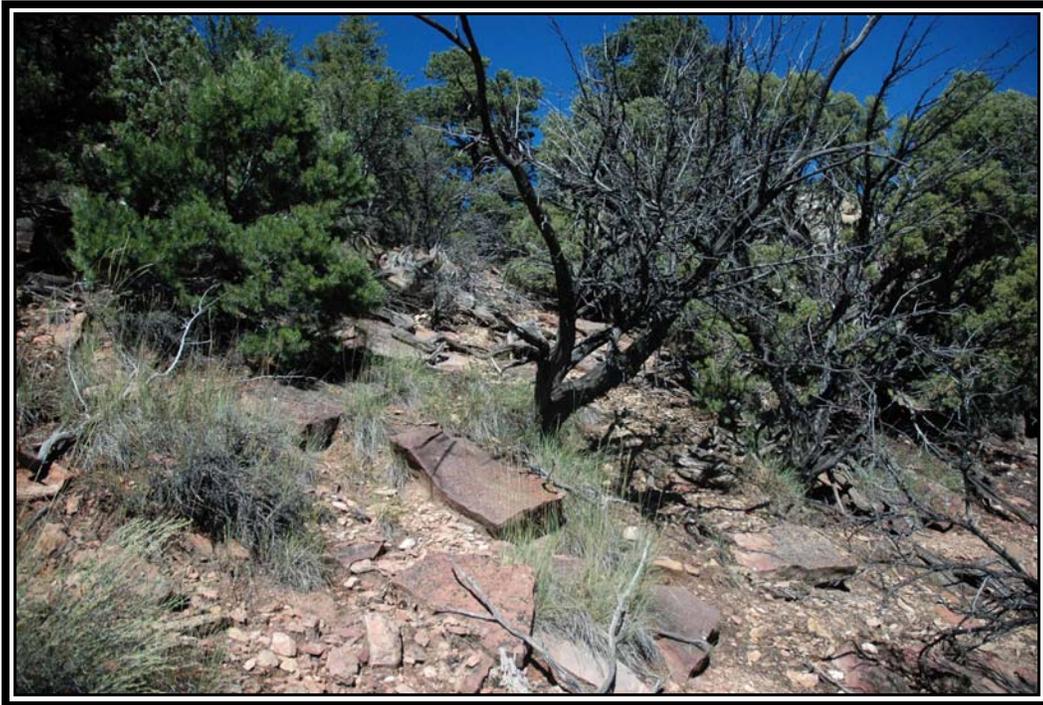
Pinyon-Juniper Reference Area

All reference areas were in good condition and remain viable as revegetation success standards at the time of final reclamation of the mine site. When the site was visited by OSMRE and UDOGM, it was thought that a rock slide may have covered the Douglas Fir/Maple Reference Area. However, when the site was visited by the author, this reference area was located up-canyon and beyond the rock slide area.
