Inspection Report

Permit Number:	C0070041
Inspection Type:	COMPLETE
Inspection Date:	Monday, August 10, 2020
Start Date/Time:	8/10/2020 10:30:00 AM
End Date/Time:	8/10/2020 2:30:00 PM
Last Inspection:	Tuesday, June 16, 2020

Permitee: **WEST RIDGE RESOURCES**
 Operator: **WEST RIDGE RESOURCES**
 Site: **WEST RIDGE MINE**
 Address: **PO BOX 910, EAST CARBON UT 84520-0910**
 County: **CARBON**
 Permit Type: **PERMANENT COAL PROGRAM**
 Permit Status: **INACTIVE**

ATTACHMENT A – Photos West Ridge August 10, 2020 site visit

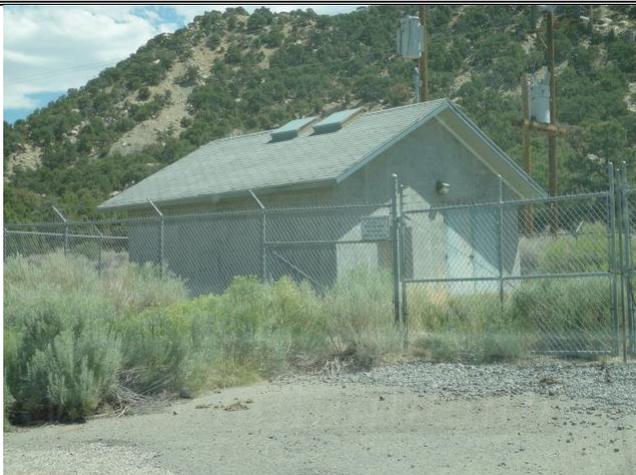
PHOTO 1

West Ridge Pump House

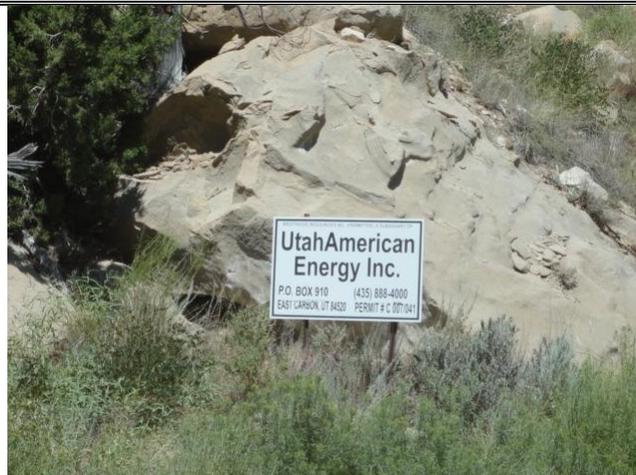
PHOTO 2

There is an identification sign posted at the pump house on the fence and one posted at the entrance in the mine site. The signs identify the Owner/Operator, their address, phone number and mining permit number. This information is required by law to be posted for public information. The signs are in compliance.

West Ridge Identification Sign

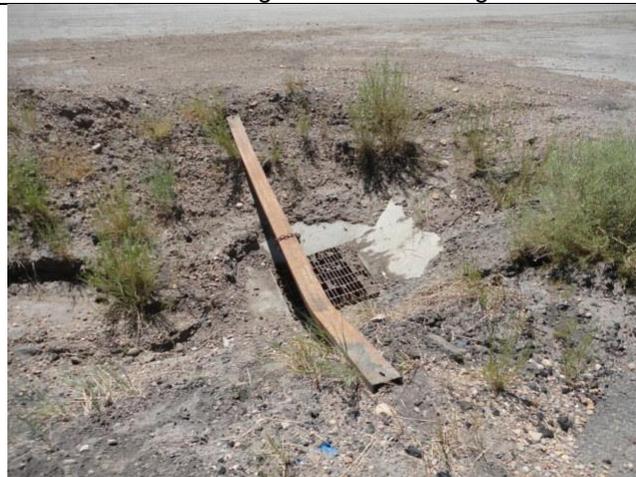
PHOTO 4

Diversions throughout the mine site were inspected and all were found to be open and fully functional. The diversions are well maintained.

West Ridge Drop Inlet Right Side Looking Up-Canyon (Open)

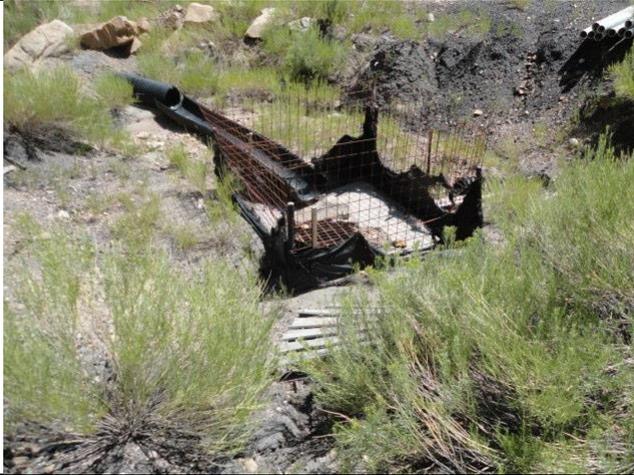
PHOTO 5

West Ridge Drop Inlet Left Side Looking Up-Canyon
(Open)

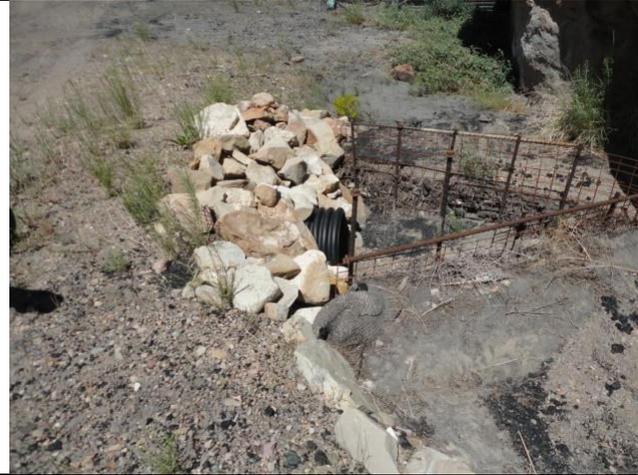
PHOTO 6

West Ridge Culvert Inlet Belt Transfer Pad
(Open)

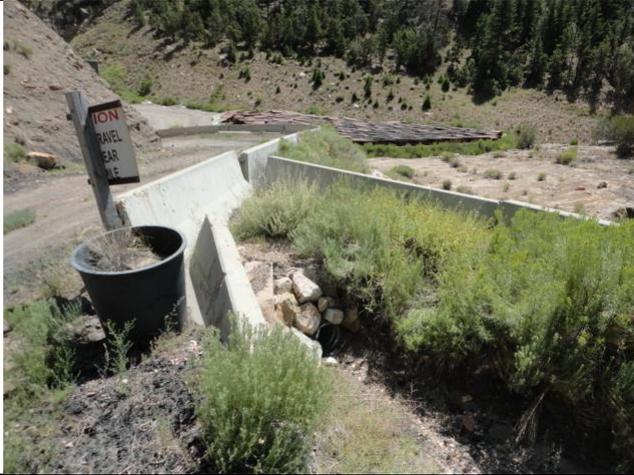
PHOTO 9

West Ridge Culvert Inlet Coal Storage Pad
(Open)

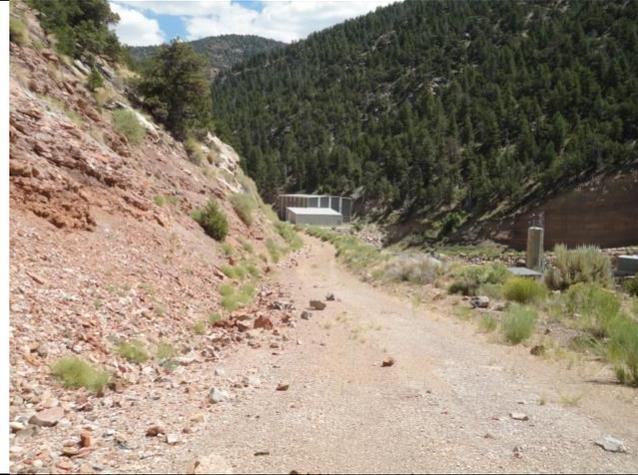
PHOTO 10

The access road to the end of the ROM belt drop to the coal storage pad below has numerous rocks along the roadway that have sloughed off the hill side that borders the roadway. The rocks should be removed from the roadway.

West Ridge Access Road to ROM Belt Drop to Coal Storage Pad
Below (Rock on Road needs to be Removed)

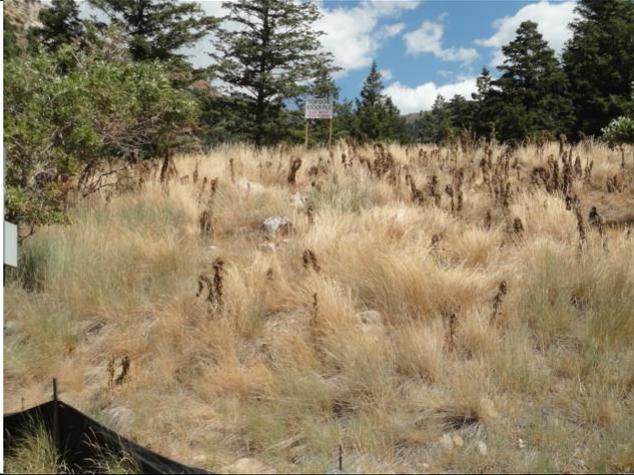
PHOTO 13

Thistle in the mine site had been sprayed and is dead. The dead thistle is especially noticeable on the topsoil pile..

Thistle was identified on the prior inspection conducted on June 16, 2020. The thistle was sprayed on the same day as the inspection. Pictures of the topsoil pile were taken during today's inspection. The thistle is dead.

Topsoil Pile
(Dead Thistle. Sprayed After Prior Inspection)

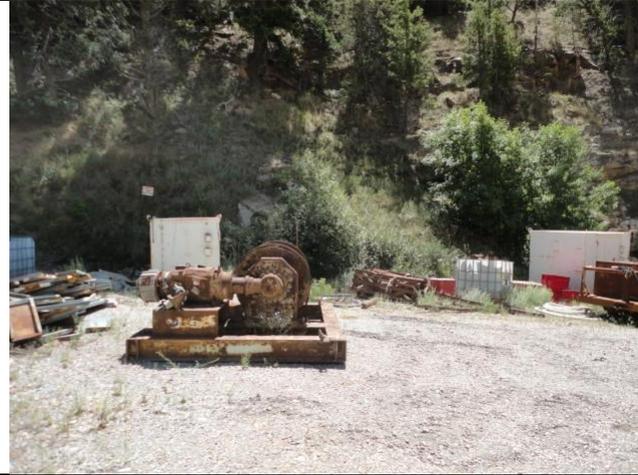
PHOTO 14

The explosive storage was inspected during the complete inspection. The powder and cap magazines are still present. Both magazines are grounded against a lightning strike. The area is signed to identify that explosives are stored in that area. Currently there is no powder or caps being storage in this storage area.

West Ridge Explosive Storage Area
(Grounded & Signed. No Powder or Caps)

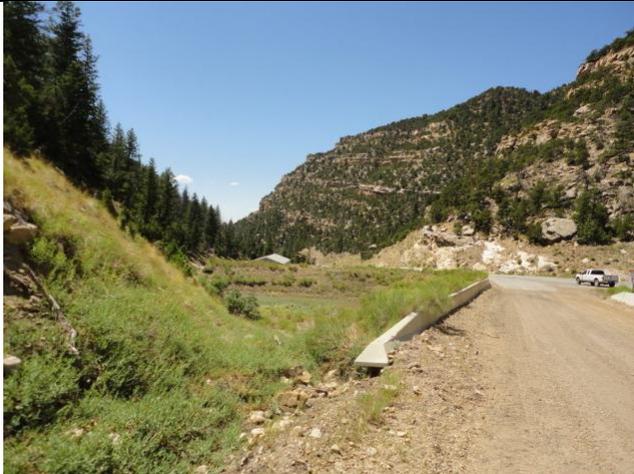
PHOTO 15

The sediment pond at the West Ridge mine consists of two ponds. Cell A and Cell B. Any drainage water will enter cell A first and if the pond fills to a certain elevation it will then spill into cell B. At the time of the complete inspection both cell A and Cell B were dry. The sediment pond was inspected for second quarter 2020 on 06/09/2020. No problems were noted on the inspection report.

West Ridge Sediment Pond Cell A

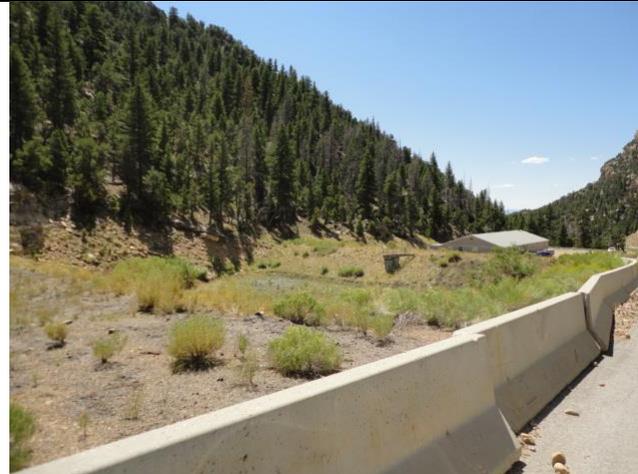
PHOTO 16

West Ridge Sediment Pond Cell B
