**1998 UTAH OIL, GAS AND MINING EARTH DAY AWARDS  
Nomination Form**

## J. B. KING

### Nomination

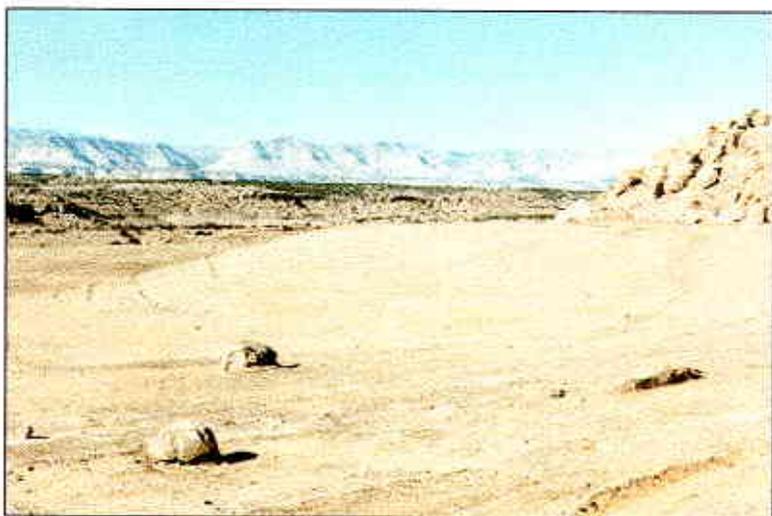
**Figure 1.** Reclamation in 1985

Reclamation initiated in 1982 consisted of removing 6 inches to 4 feet of contaminated surface material from the coal stockpile area and the slurry/sedimentation ponds. This material was placed around the toe of the existing coarse refuse area. The refuse area was then graded to a rolling topography with a maximum slope of 4H:1V. Four feet of topsoil and substitute topsoil, located within the disturbed area boundary, was then excavated and placed on the regraded refuse

pile. Contour furrows were constructed, at regular intervals, along the smoothed outslope of the pile. The pile was then seeded, fertilized and mulched.

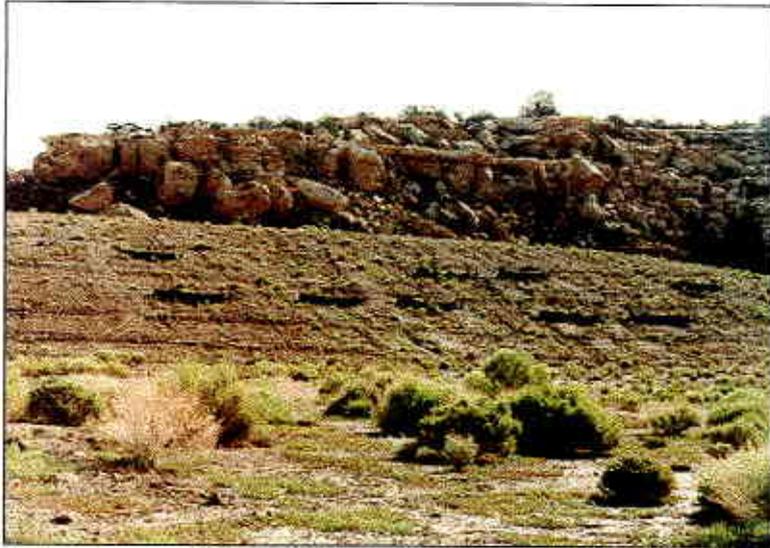
**Figure 2.** The refuse pile in 1991.

Post-reclamation monitoring concerns have focused on erosion and vegetation success of the refuse pile, specifically the west and southwest facing slopes. In late summer of 1986, the contour furrows became filled with sediment and began to breach after the occurrence of several major storm events. Silt fencing and rock-anchored straw were then placed in the resulting rills and gullies. Reoccurring drought, erosion and southwesterly exposure limited vegetation establishment on the refuse pile. Initial control structures and other erosion control measures

did not limit the erosion process to a reasonable extent. Because of the reclaimed refuse pile's soil type, slope and aspect and the low annual precipitation and high intensity rainfall events in the area it was felt that vegetation cover alone would never be sufficient to decrease erosion to reasonable levels.

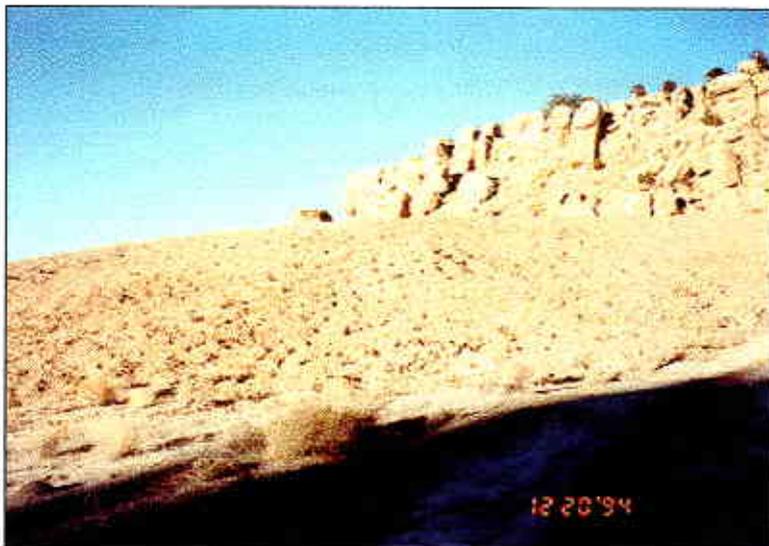
**Figure 3** The refuse pile after surface roughening in 1994.

3. The surface of the treated soil was deeply pocked and/or roughened; in the process of mixing the existing soils with the rock mulch.

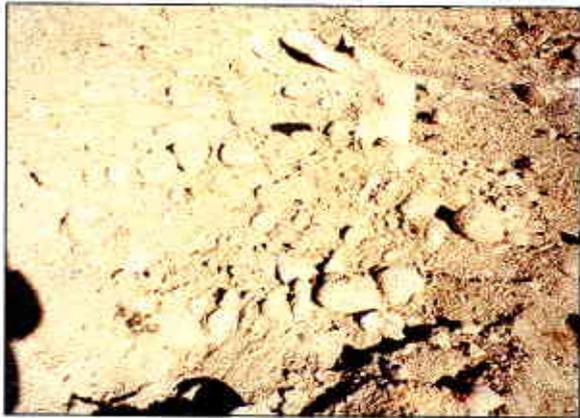
**Figure 4.** Rock mulch in 1994.

2. A rock mulch (rock aggregate, 1474 cubic yds.) was applied to the out slope of the refuse pile. This provided a thickness from 12 to 18 inches over the area covered.

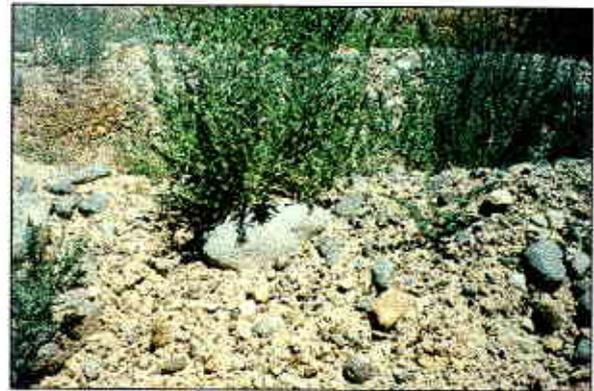
**Figure 5.** Rock mulch in 1997.

1. Fines are washing from the rock mulch resulting in a rock pavement surface.
2. Grasses and Shrubs are growing in the bottoms of most the trackhoe created pocks.
3. Some breaching and piping has occurred between the pocks resulting in rills; but overall, rilling and gulying appears to be minimized.

The results to date are considered outstanding for this harsh environment. The rock mulch appears to be stabilizing the soil surface. The use of surface roughening and pocking has created micro climates conducive to plant establishment. While some rilling and gulying is occurring the previously observed erosion appears to be greatly reduced. The site provides excellent winter habitat for migrating elk herds.
