STATE OF UTAH
NATURAL RESOURCES
Oil, Gas & Mining

Re: Notice of Violation N87-9-1-1, Hidden Valley Mine,
INA/015/007, File #5, Emery County, Utah

notice of violation

RE: Notice of Violation N87-9-1-1, Hidden Valley Mine,
INA/015/007, File #5, Emery County, Utah

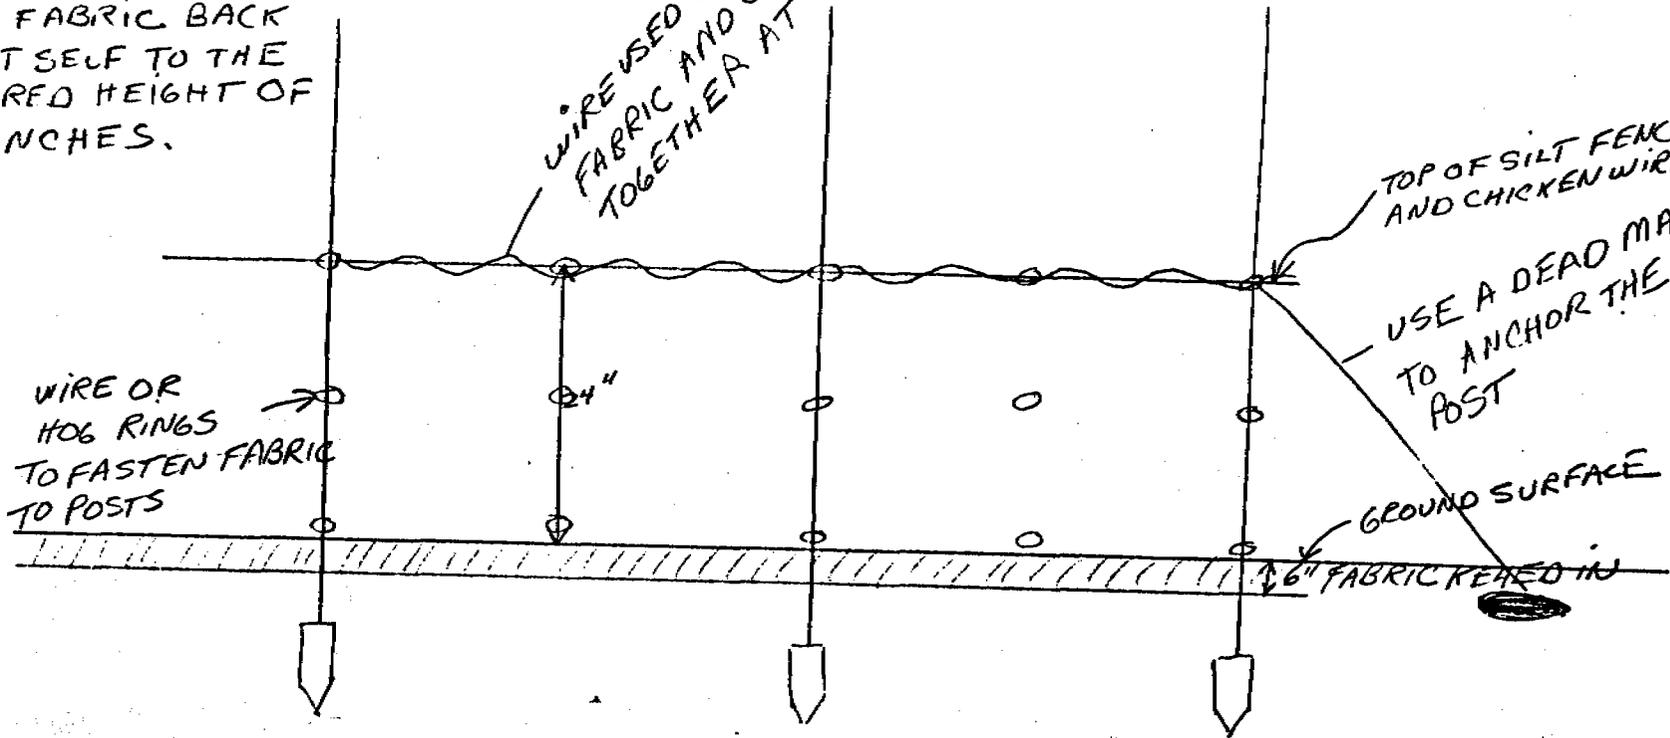
SIDE VIEW

The silt fence as it is currently found has either fallen down or ripped from the posts or chicken wire backing. The best possible method for repairing all the silt fence as it currently exists is stabilize the posts that have fallen over by pounding them back into the soil, putting tension on the outside posts to maintain placements of all the posts, and decreasing the height of the silt fence installation. The following diagram will hopefully provide a guideline for the repair and reinstallation of the silt fences.

--- LEVEL OF CURRENT FENCE MATERIAL

FOLD CHICKEN WIRE AND FABRIC BACK ON ITSELF TO THE DESIRED HEIGHT OF 24 INCHES.

WIRE USED TO SECURE FABRIC AND CHICKEN WIRE TOGETHER AT TOP OF FENCE

WIRE OR HOG RINGS TO FASTEN FABRIC TO POSTS

TOP OF SILT FENCE AND CHICKEN WIRE

USE A DEAD MAN TO ANCHOR THE END POST

GROUND SURFACE

6" FABRIC KEPT IN

The following recommendations concerning the repair of the torn geotextile fabric shall be carried out. The holes or tears in the fabric shall be repaired with heavy tape or the fabric shall be replaced. Care shall be taken when reattaching the fabric to the posts and wire backing, so that the fabric does not tear. Any place where the fabric is not adequately keyed in, it shall be keyed in again. Where the fabric is totally beyond repair, the operator must replace it.
