# Inspection Report

Permittee: **BRONCO UTAH OPERATIONS, LLC**  
 Operator: **BRONCO UTAH OPERATIONS, LLC**  
 Site: **HIDDEN VALLEY MINE**  
 Address: **PO BOX 527, EMERY UT 84522**  
 County: **EMERY**  
 Permit Type: **PERMANENT COAL PROGRAM**  
 Permit Status: **ACTIVE**

**ATTACHMENT A – Photos Hidden Valley August 11, 2020 site visit**

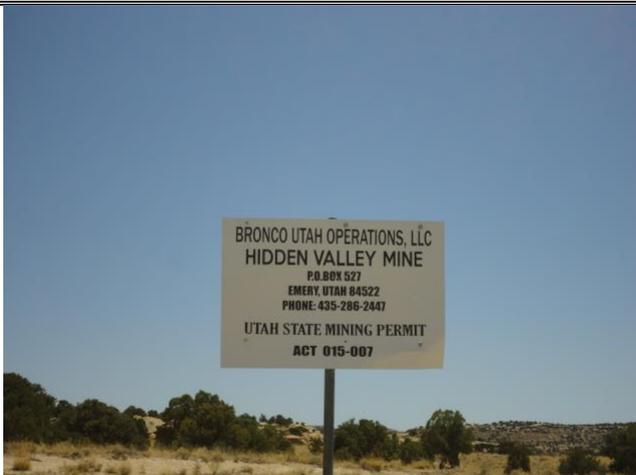
**PHOTO 1**

There is one mine identification sign at this permitted facility. This sign is posted at the end of the Sevier County road and the beginning of the entrance point into the Hidden Valley mine site. The sign posts the name, address, phone number and mining permit number from the Utah Coal Program. These items are required by law to be posted for public information. The sign was inspected and found to be in compliance.

Hidden Valley Identification Sign

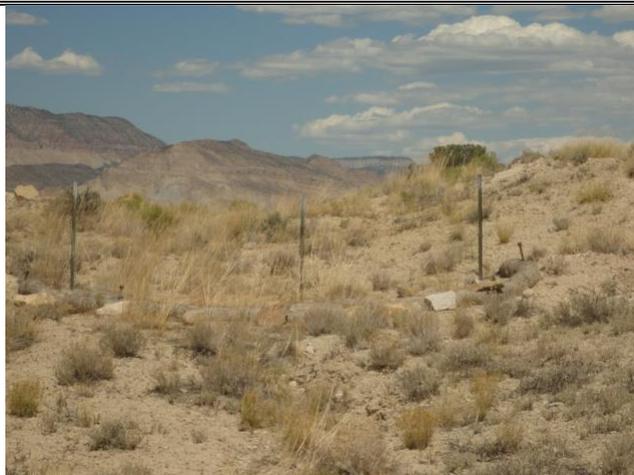
**PHOTO 2**

There is a straw wattle structure near the mine identification sign. This structure is in good repair.

There are silt fences and straw wattles near the base of the old access road in close proximity to the old portal face up. These structures were replaced in the fall of 2019. The structures are still in good shape.

Hidden Valley Alternate Sediment Control Structure

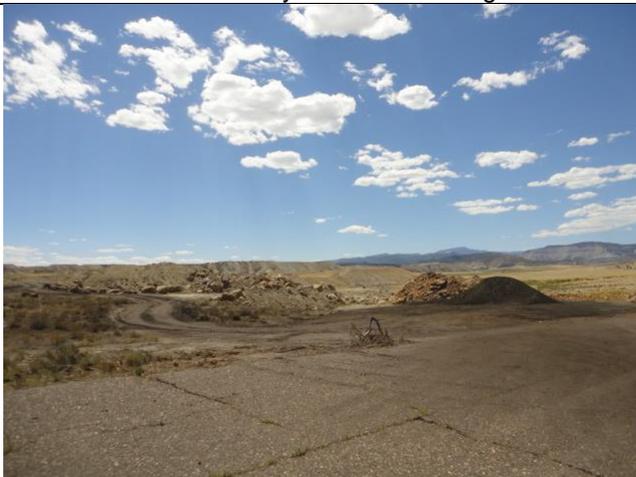
**PHOTO 3**

Pictures were taken of the Miracle Rock mining area. This area is not coal mining related. The mining in this area are associated with the minerals program. At the inception of their mining activity they were in the Hidden Valley permit area. Since that time their mining area has been carved out of the Hidden Valley permit area.

Miracle Rock Site  
(Non Coal. Mineral Site)

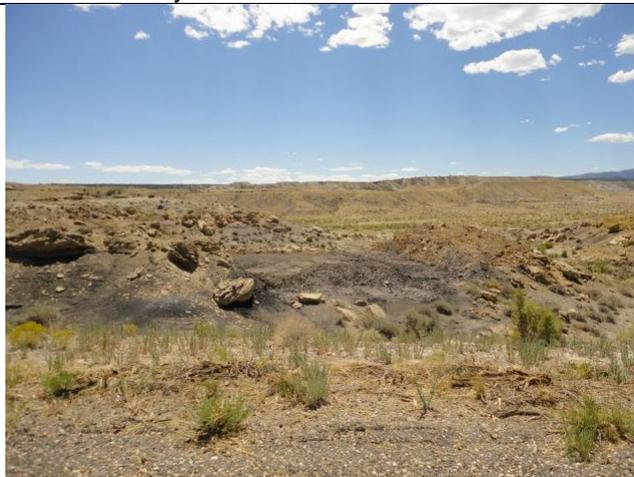
**PHOTO 4**

Miracle Rock Site  
(Non Coal. Mineral Site)
