**1997 SUBSIDENCE
 COTTONWOOD MINE
 6TH & 7TH EAST LONGWALL PANELS**

Area 15

Cottonwood 9th and 12th West Longwall Panels

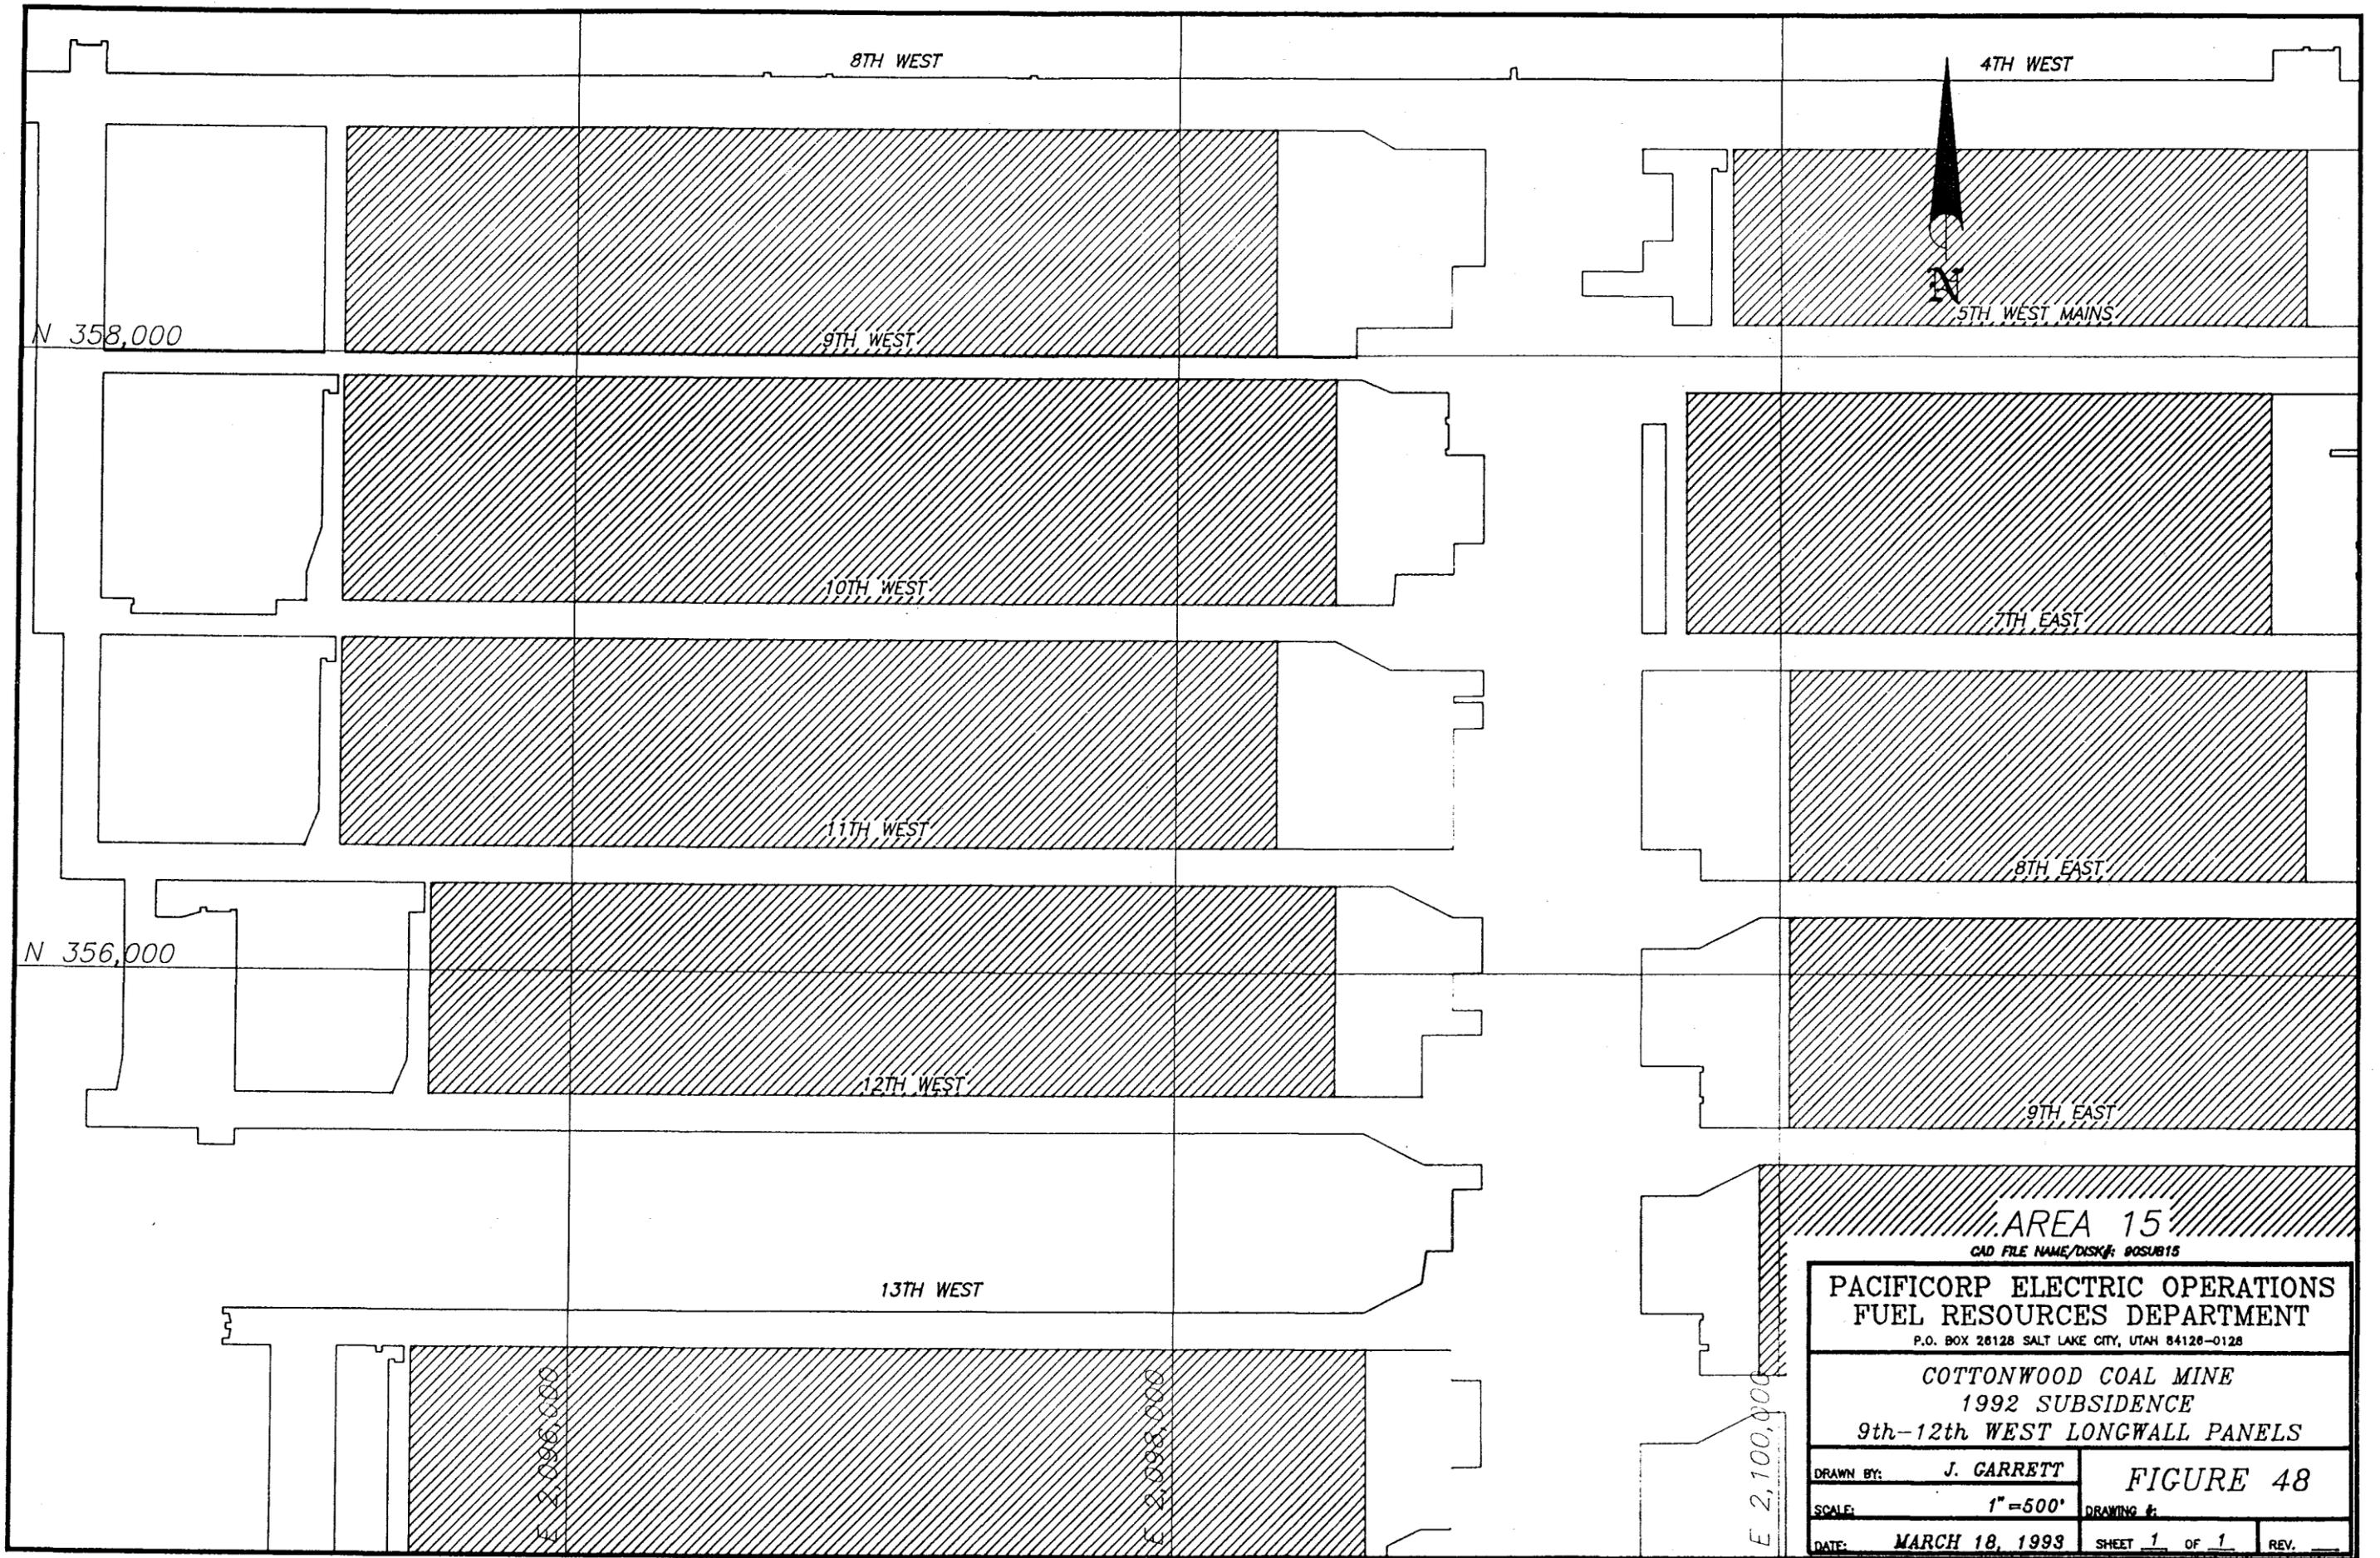
PACIFICORP ELECTRIC OPERATIONS FUEL RESOURCES DEPARTMENT	
P.O. BOX 28128 SALT LAKE CITY, UTAH 84128-0128	
COTTONWOOD COAL MINE 1992 SUBSIDENCE 9th-12th WEST LONGWALL PANELS	
DRAWN BY: J. GARRETT	FIGURE 48
SCALE: 1" = 500'	DRAWING #:
DATE: MARCH 18, 1993	SHEET 1 OF 1 REV. _____

Subsidence in 9th and 10th West was first monitored and detected in 1988 when longwall extraction began there. The 9th through 12th West panels were all completed by fall of 1989 (Figure 48).

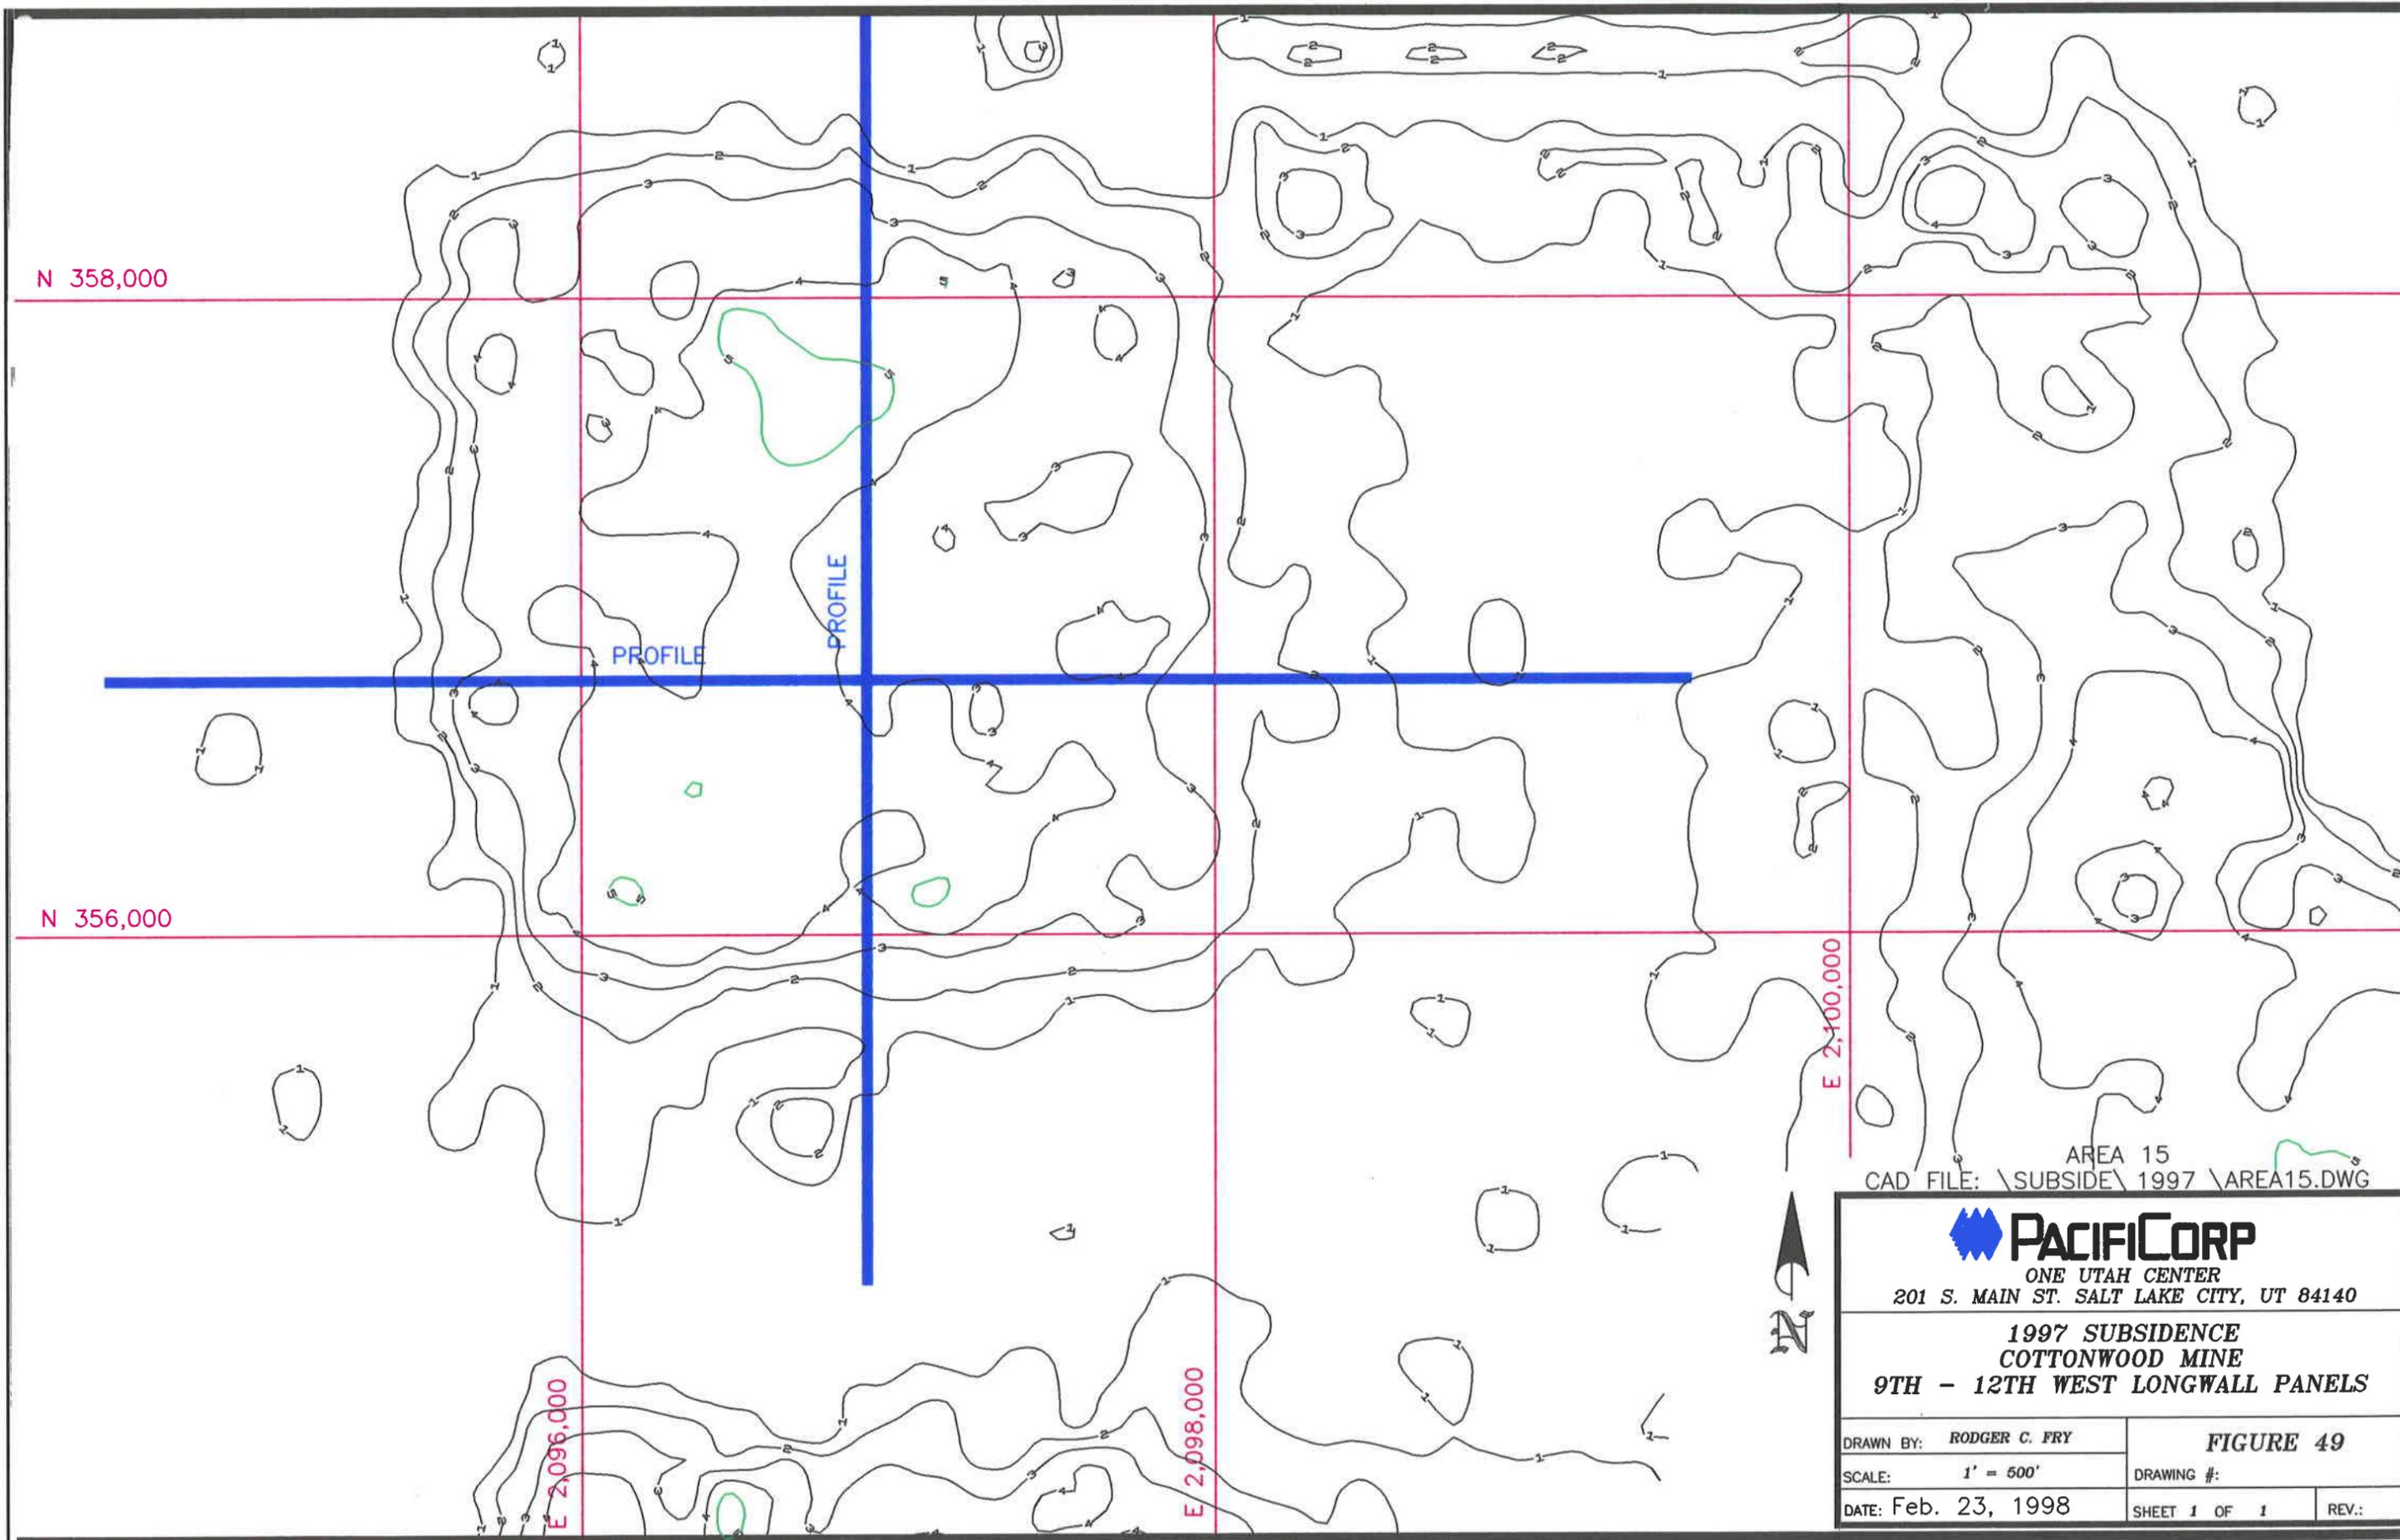
ONE UTAH CENTER 201 S. MAIN ST. SALT LAKE CITY, UT 84140		
1997 SUBSIDENCE COTTONWOOD MINE 9TH - 12TH WEST LONGWALL PANELS		
DRAWN BY: RODGER C. FRY	FIGURE 49	
SCALE: 1' = 500'	DRAWING #:	
DATE: Feb. 23, 1998	SHEET 1 OF 1	REV.:

Maximum measured subsidence in 1997 is slightly over five feet which is similar to that which was measured in 1995 above 11th West (Figures 49, 50, and 51). This area has experienced no additional subsidence in the past six years.

Calculated angle-of-draw is less than zero on the south and east and reaches 20 degrees on the west.

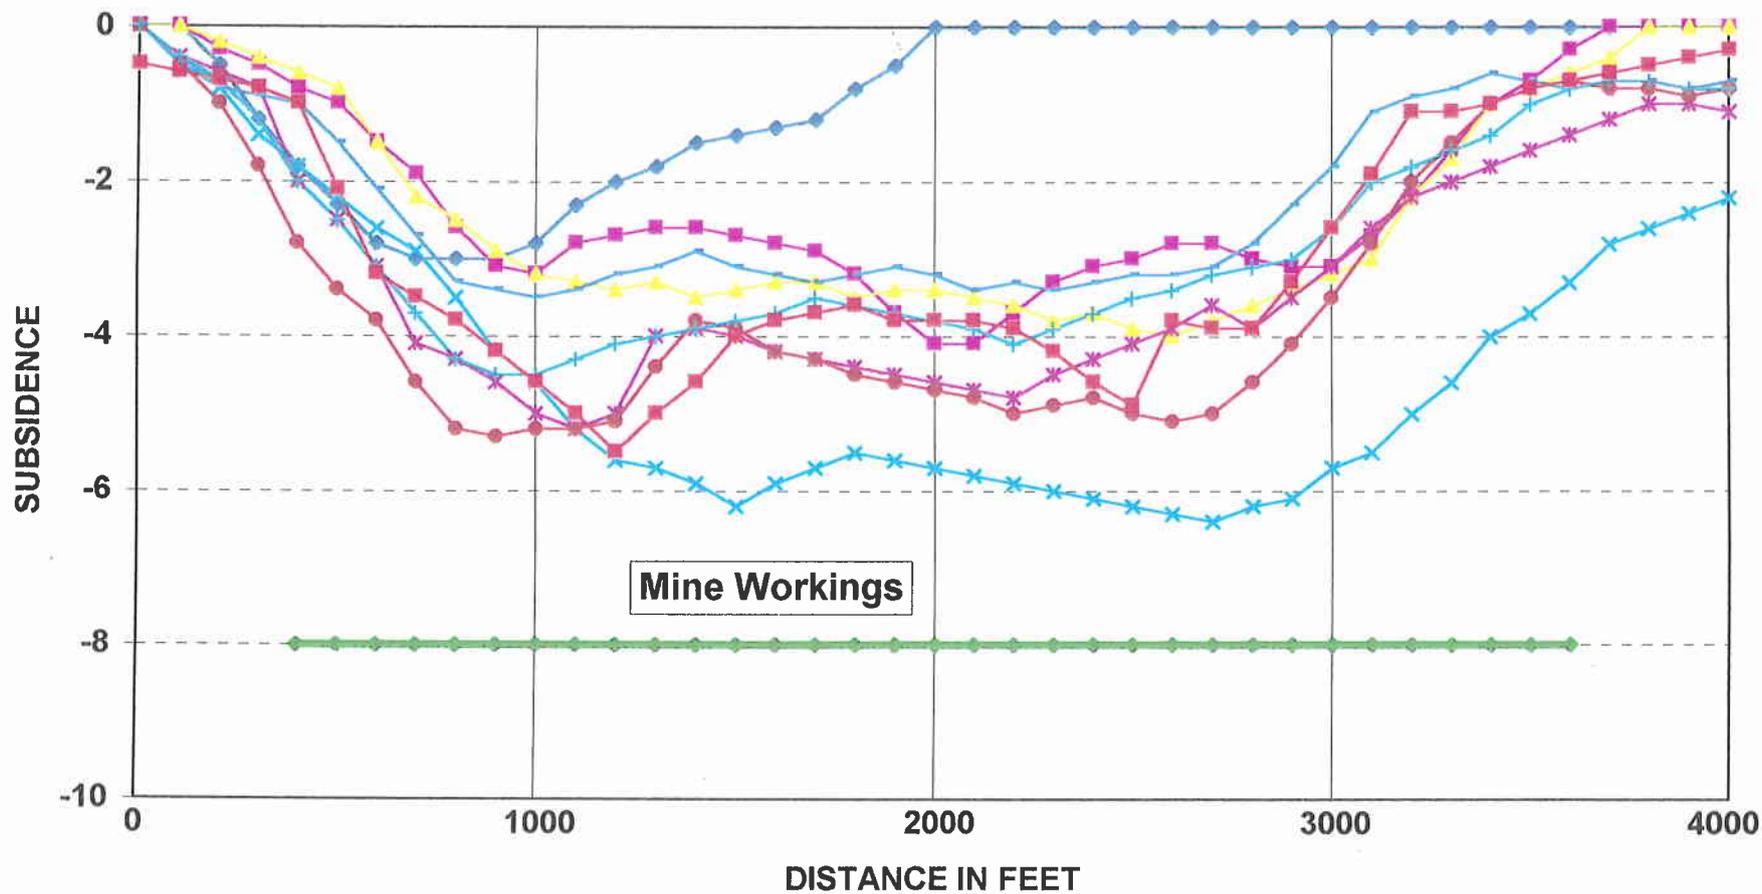
FIGURE 50

Area 15 Subsidence Profile North - South

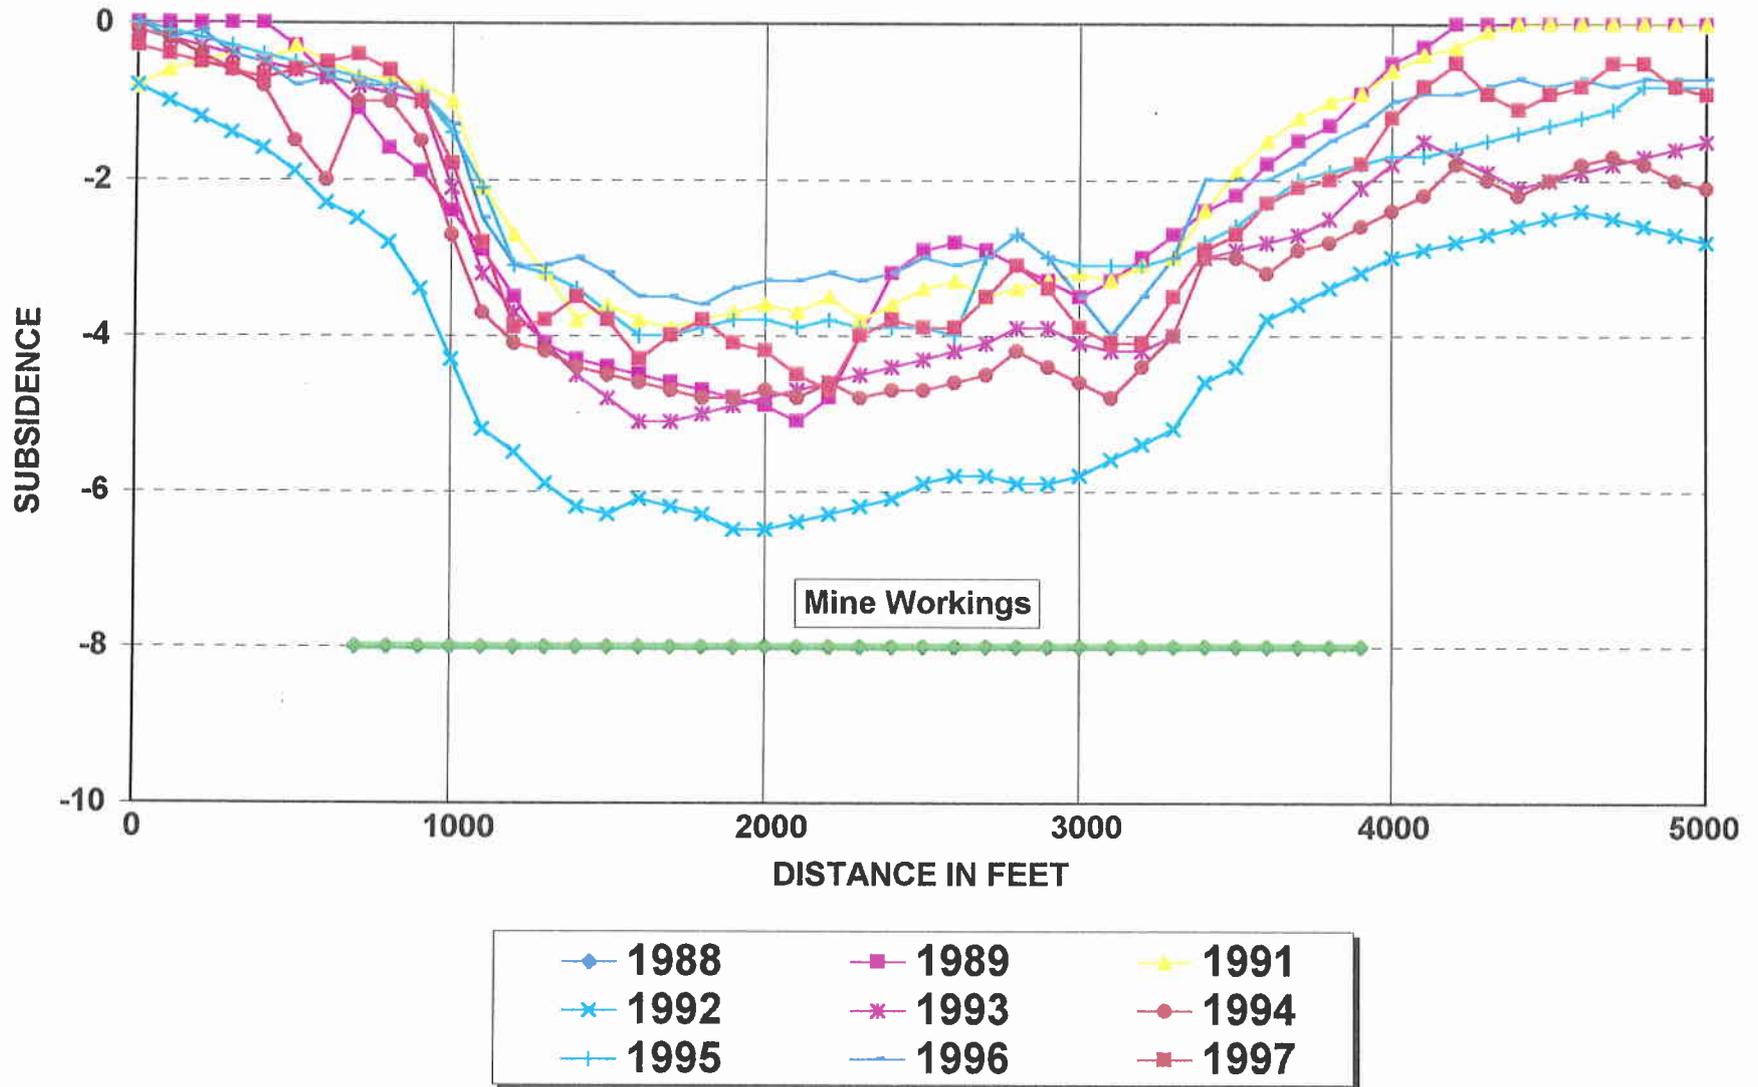
FIGURE 51

Area 15 Subsidence Profile West - East

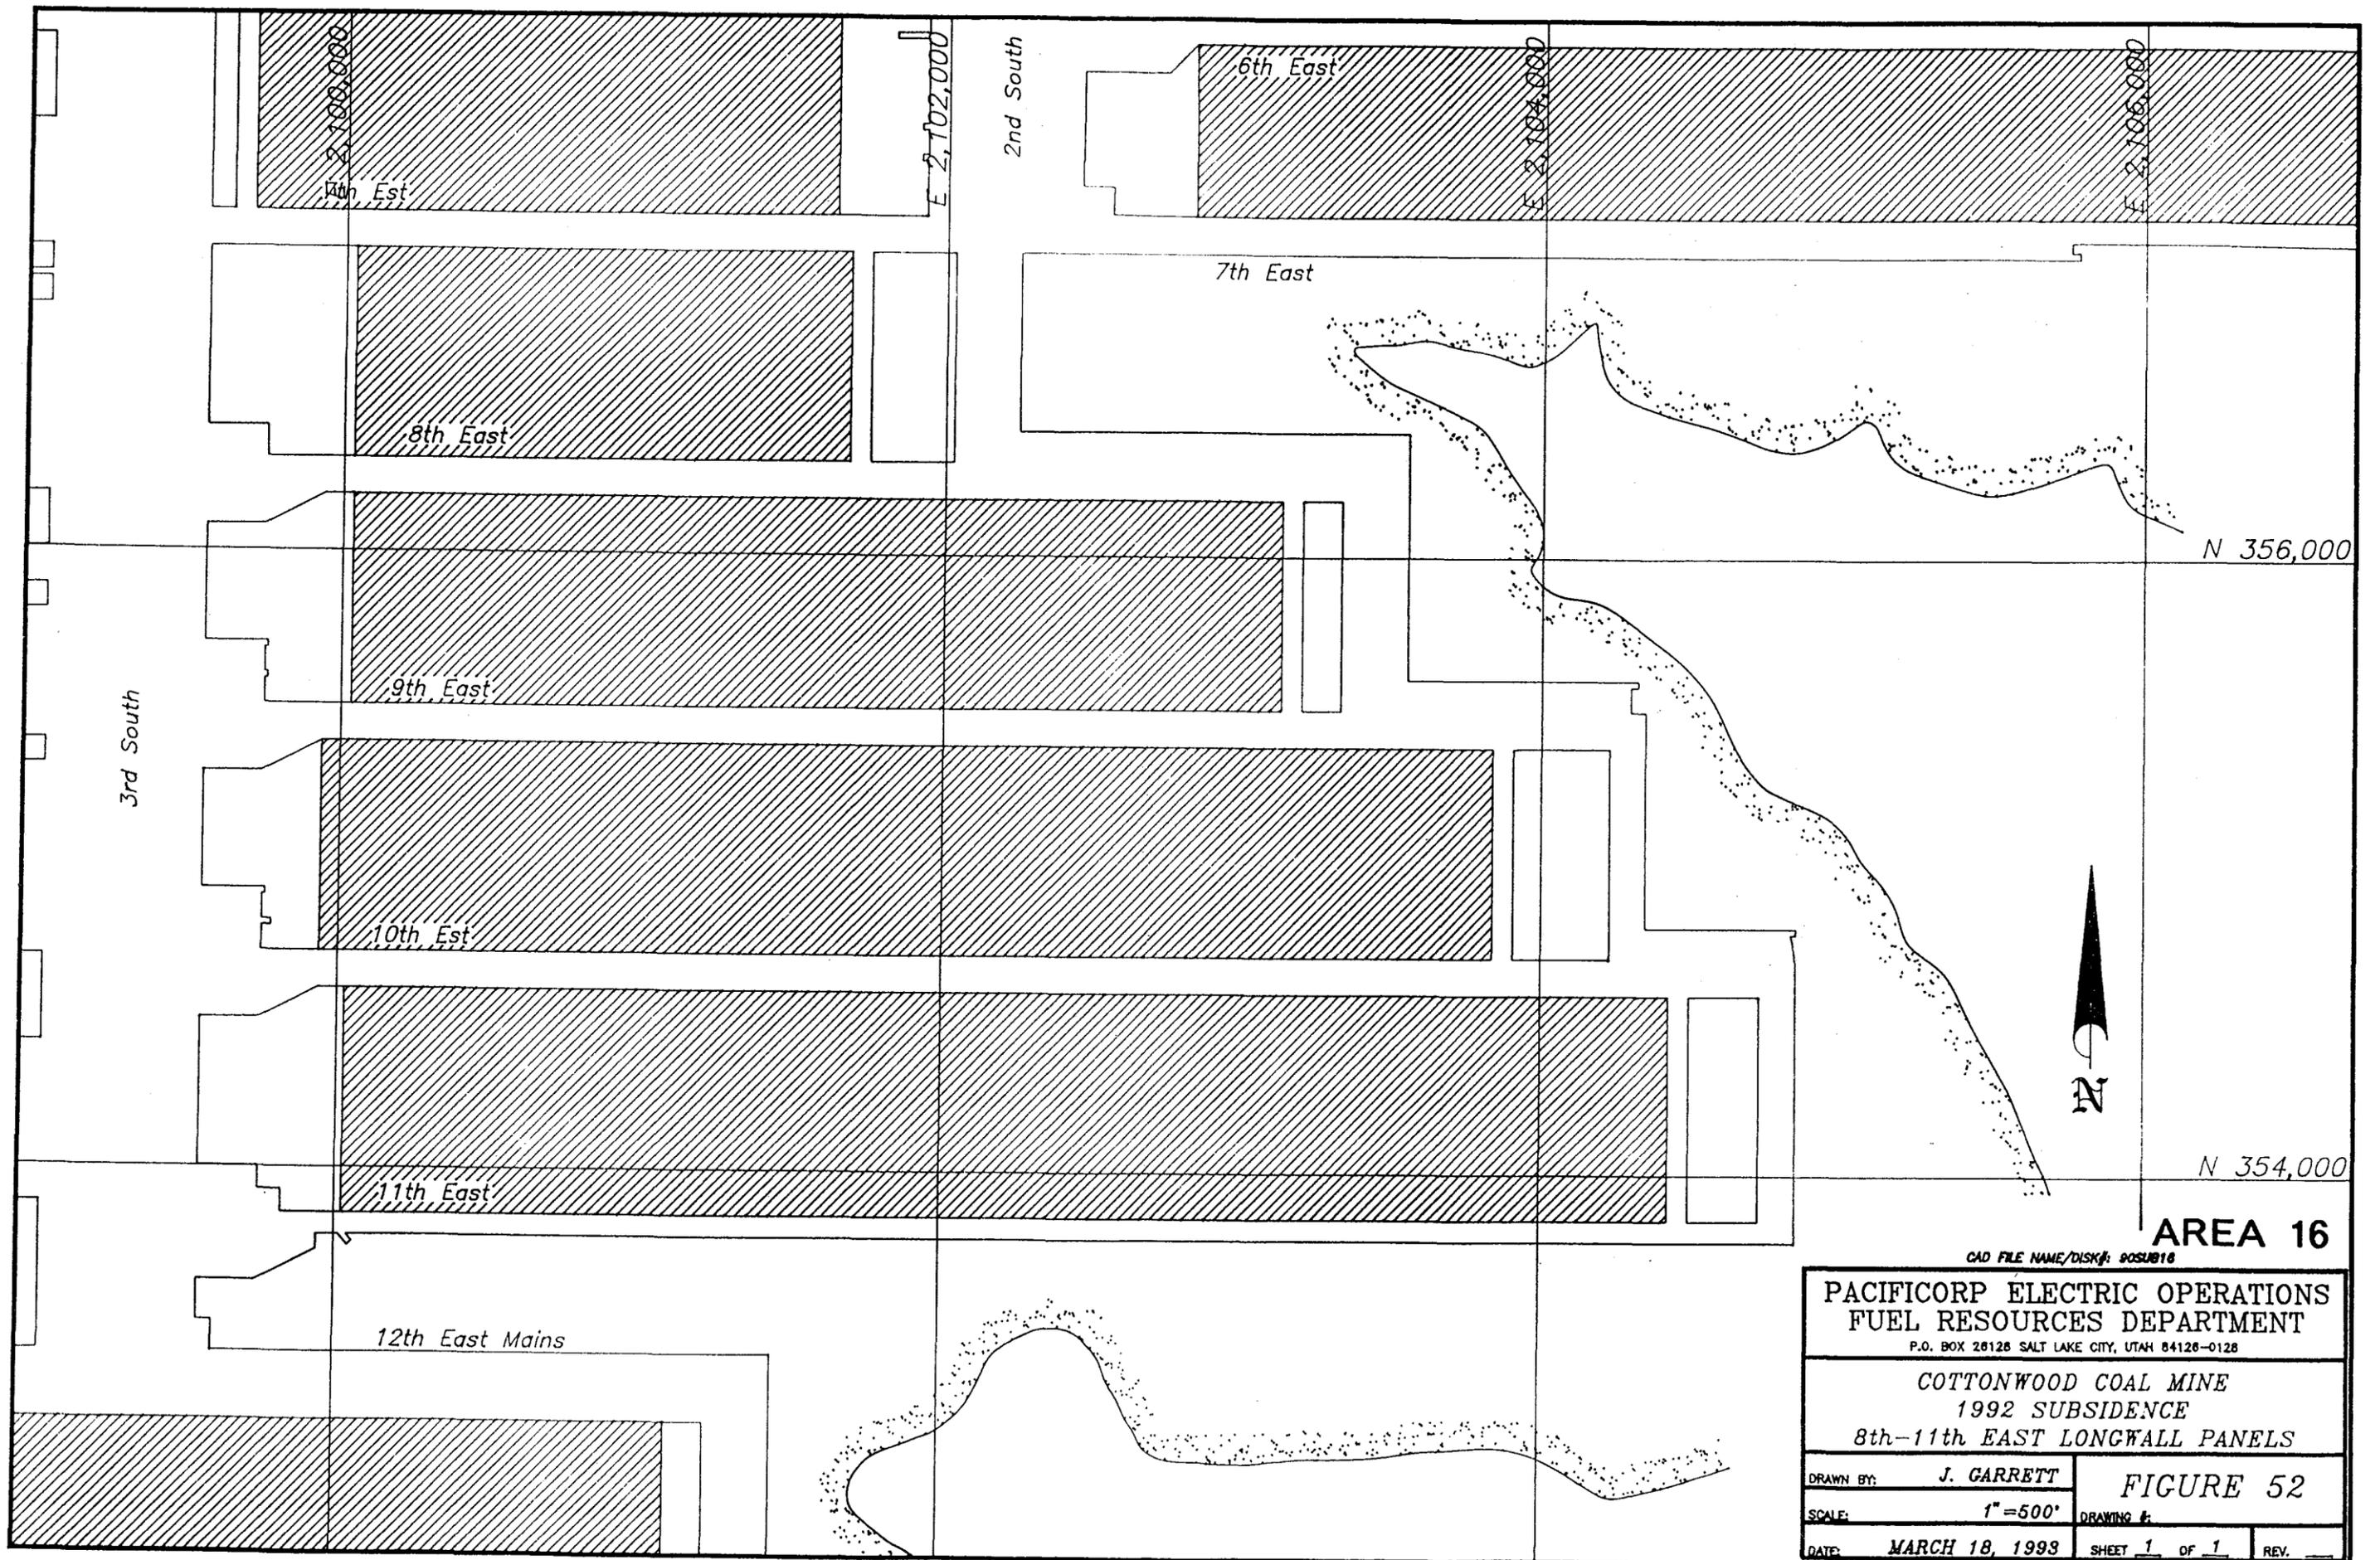
<small>DRAWN BY:</small> J. GARRETT	FIGURE 52
<small>SCALE:</small> 1" = 500'	<small>DRAWING #:</small>
<small>DATE:</small> MARCH 18, 1993	<small>SHEET</small> 1 <small>OF</small> 1 <small>REV.</small>

Mining in Area 16 began in the 8th East panel in June of 1989, and ended in the 8th East panel in May, 1992 (Figure 52).

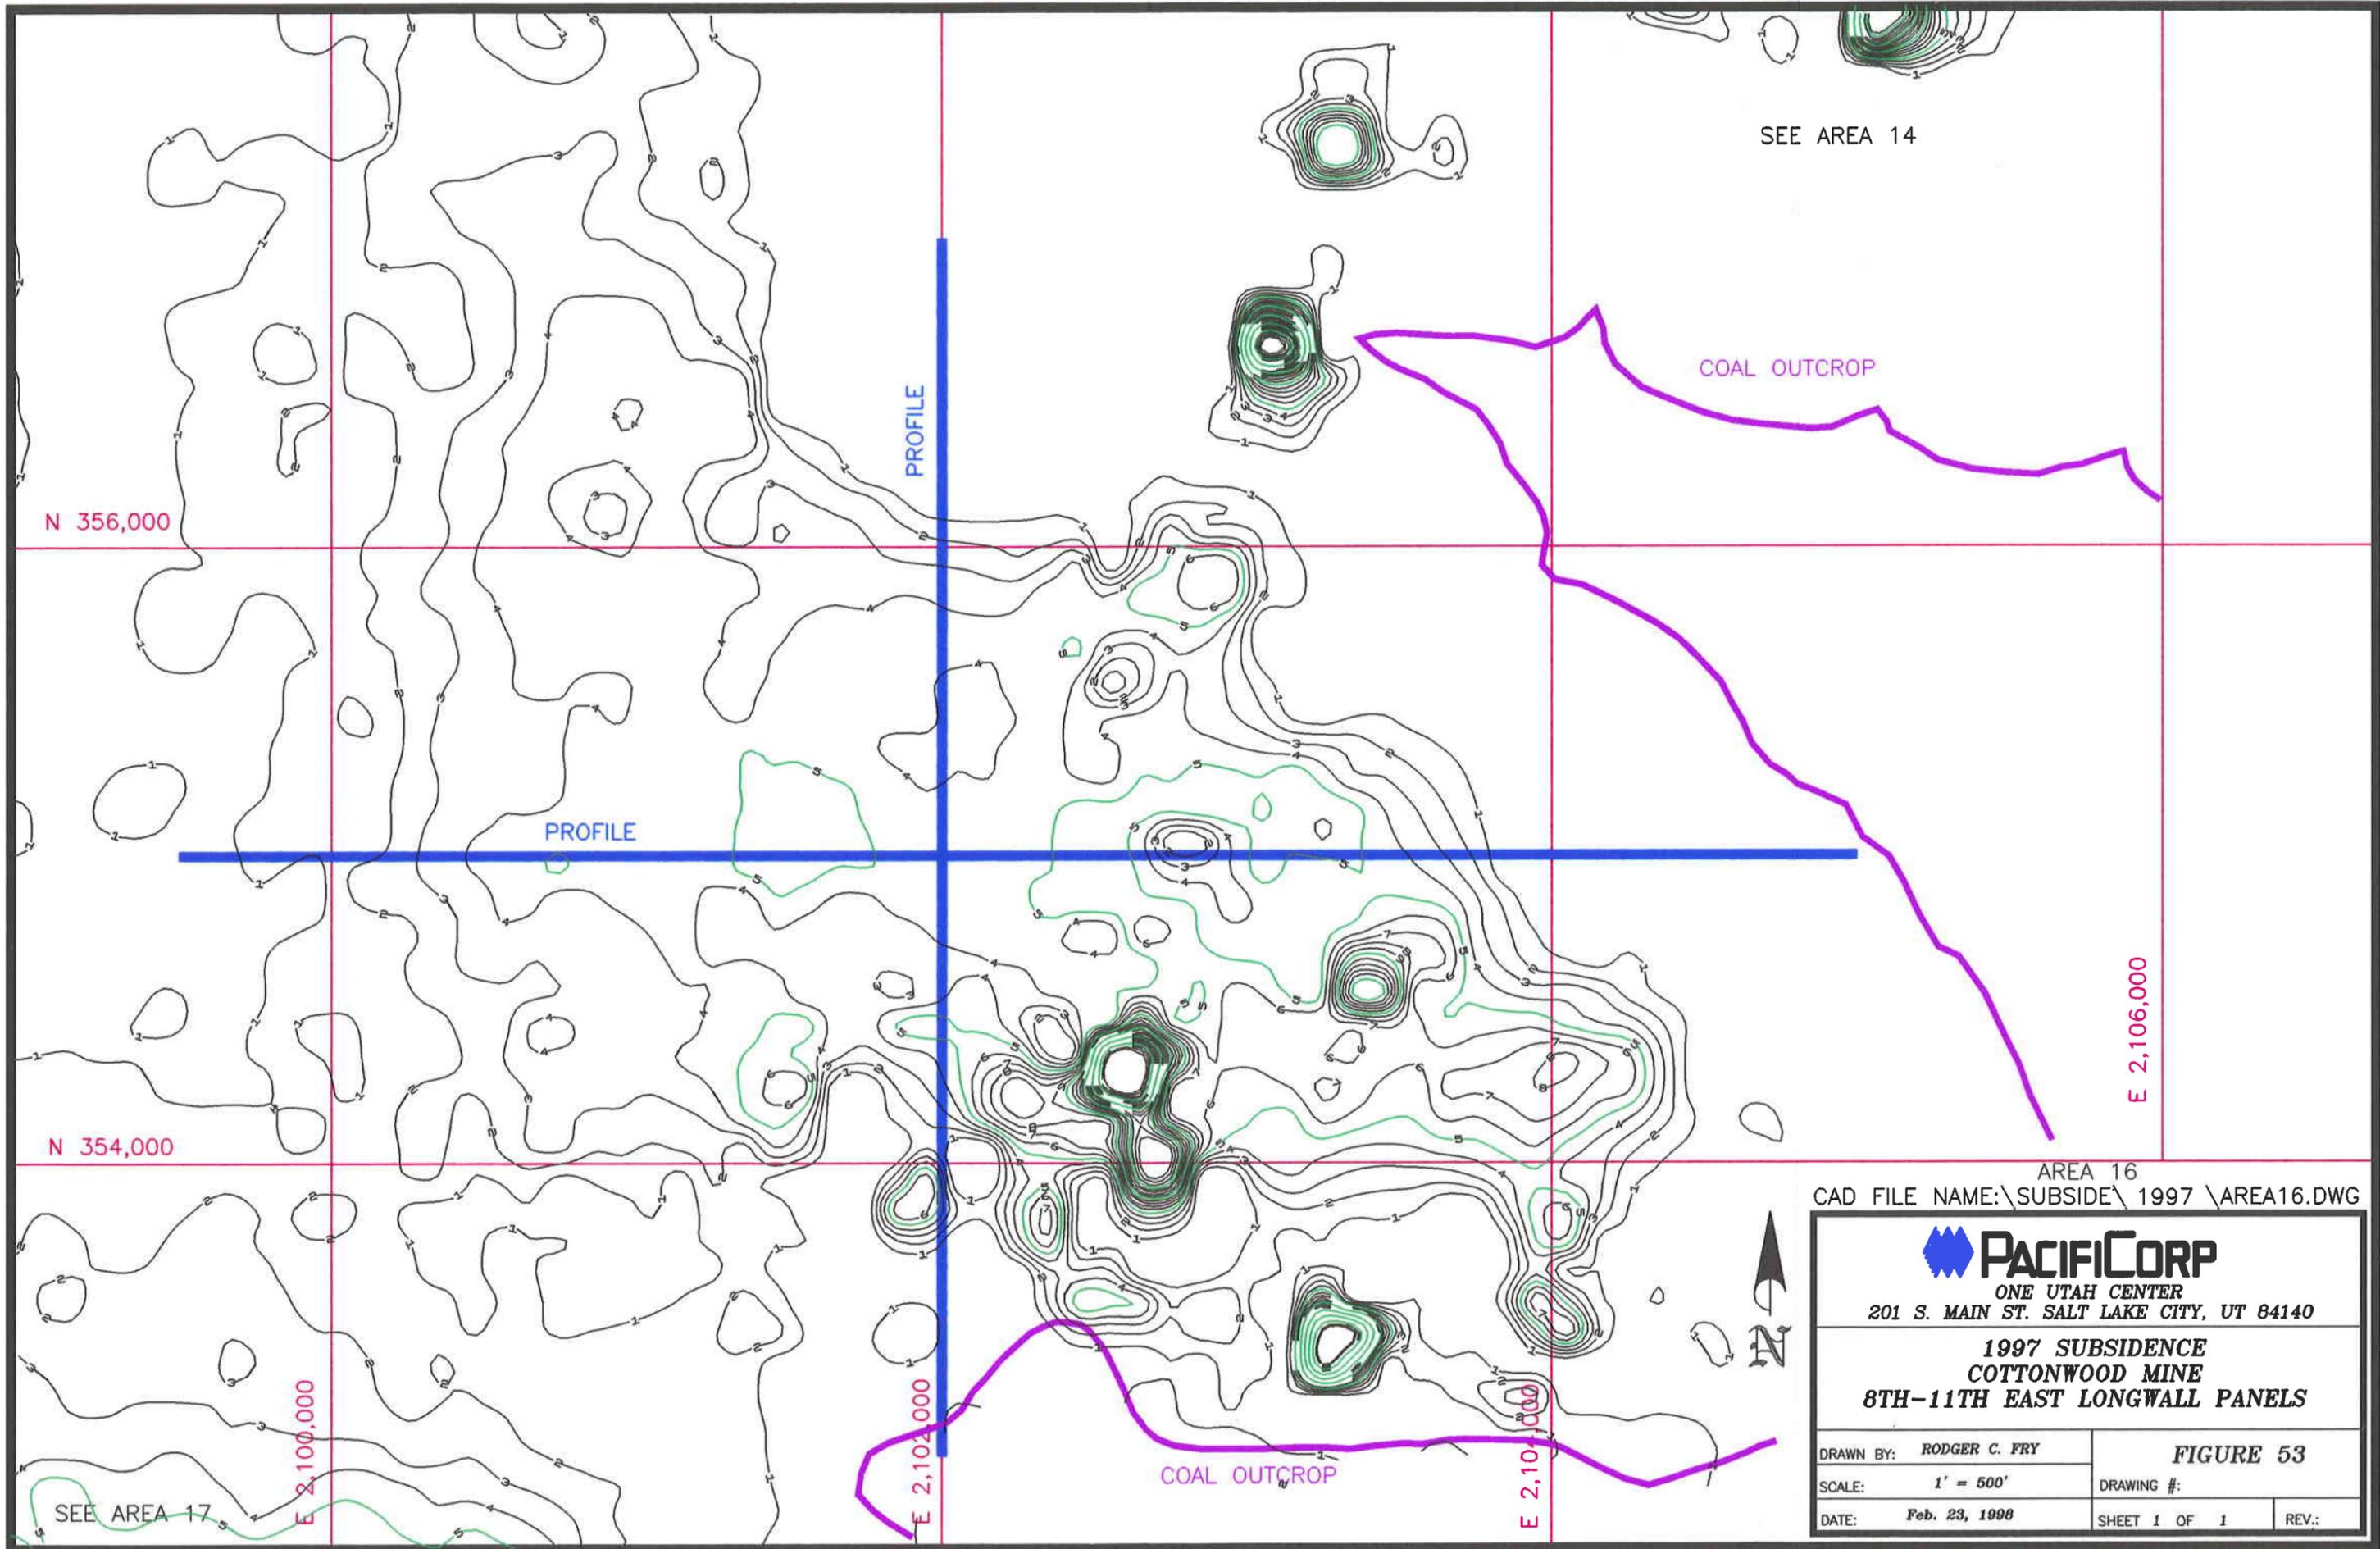
FIGURE 53

Maximum subsidence observed in 1997 is slightly less than the 1996 measurement that exceeded five (5) feet and occurs over the 11th East panel where the overburden is less than 600 feet (Figure 53, 54, and 55). Figure 53 shows several "bulls-eyes" in the area of the Castlegate cliff which are in very steep and rugged areas. The photogrammetric method is not reliable in these areas and it is not felt that the areas have subsided to the extent shown on figure 53. This is supported by the fact that subsidence survey targets placed along the cliff in 1986 have shown no movement in recent years (see appendix).

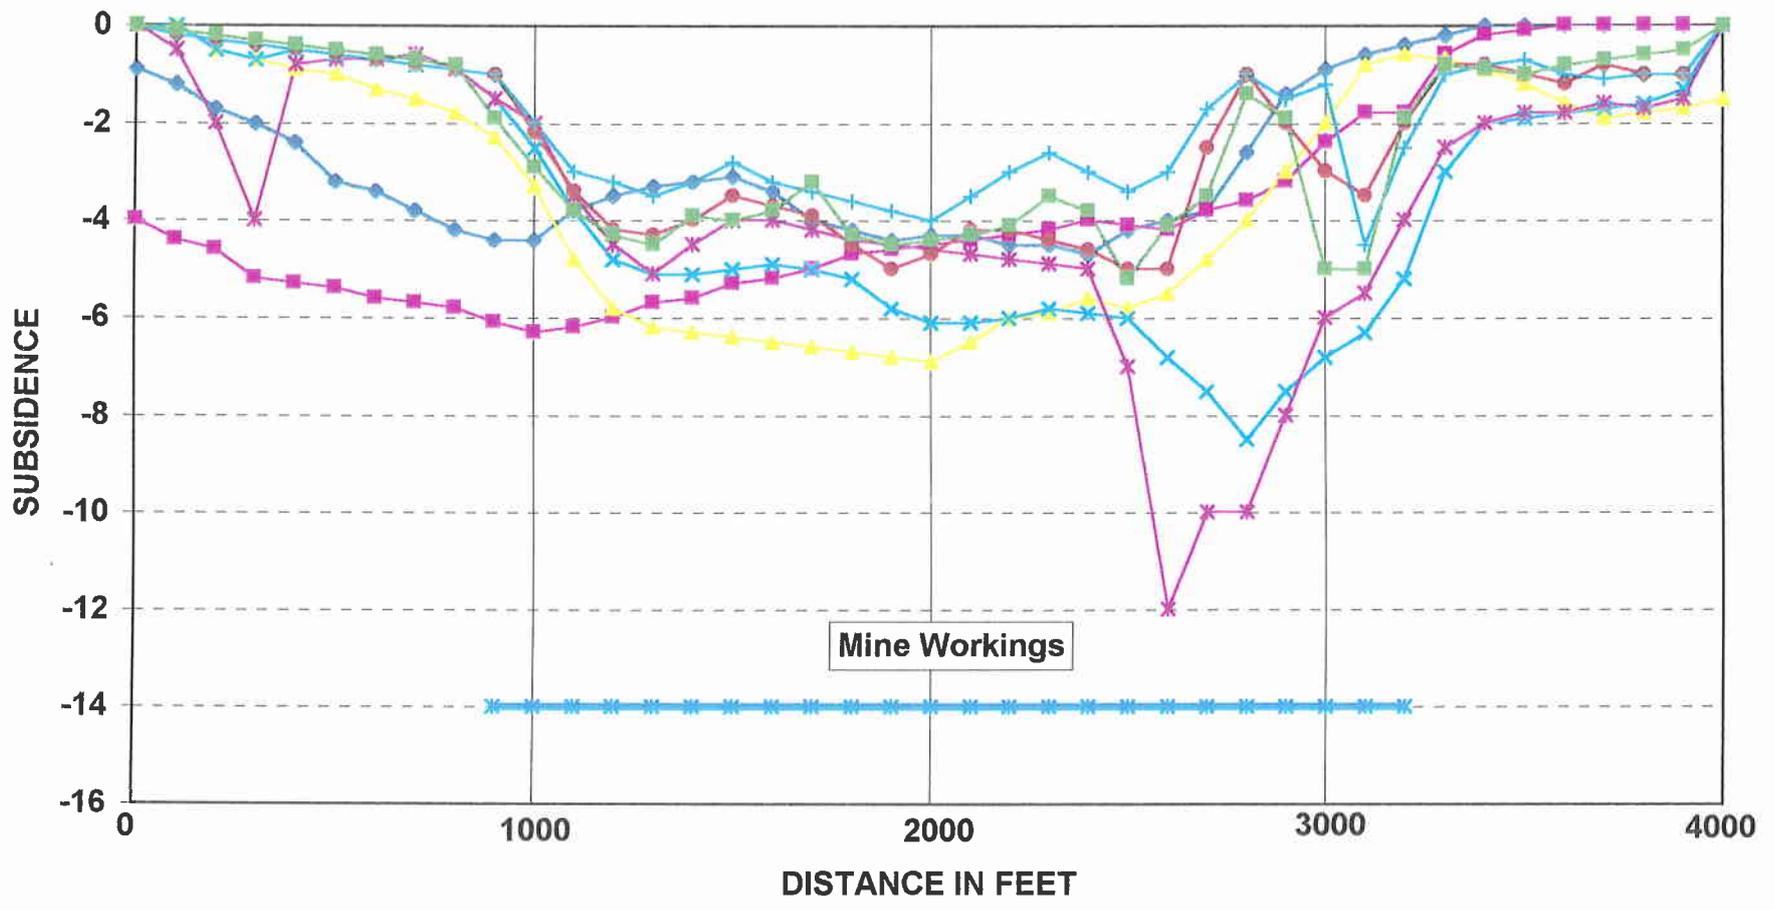
FIGURE 54

Area 16 Subsidence Profile North - South

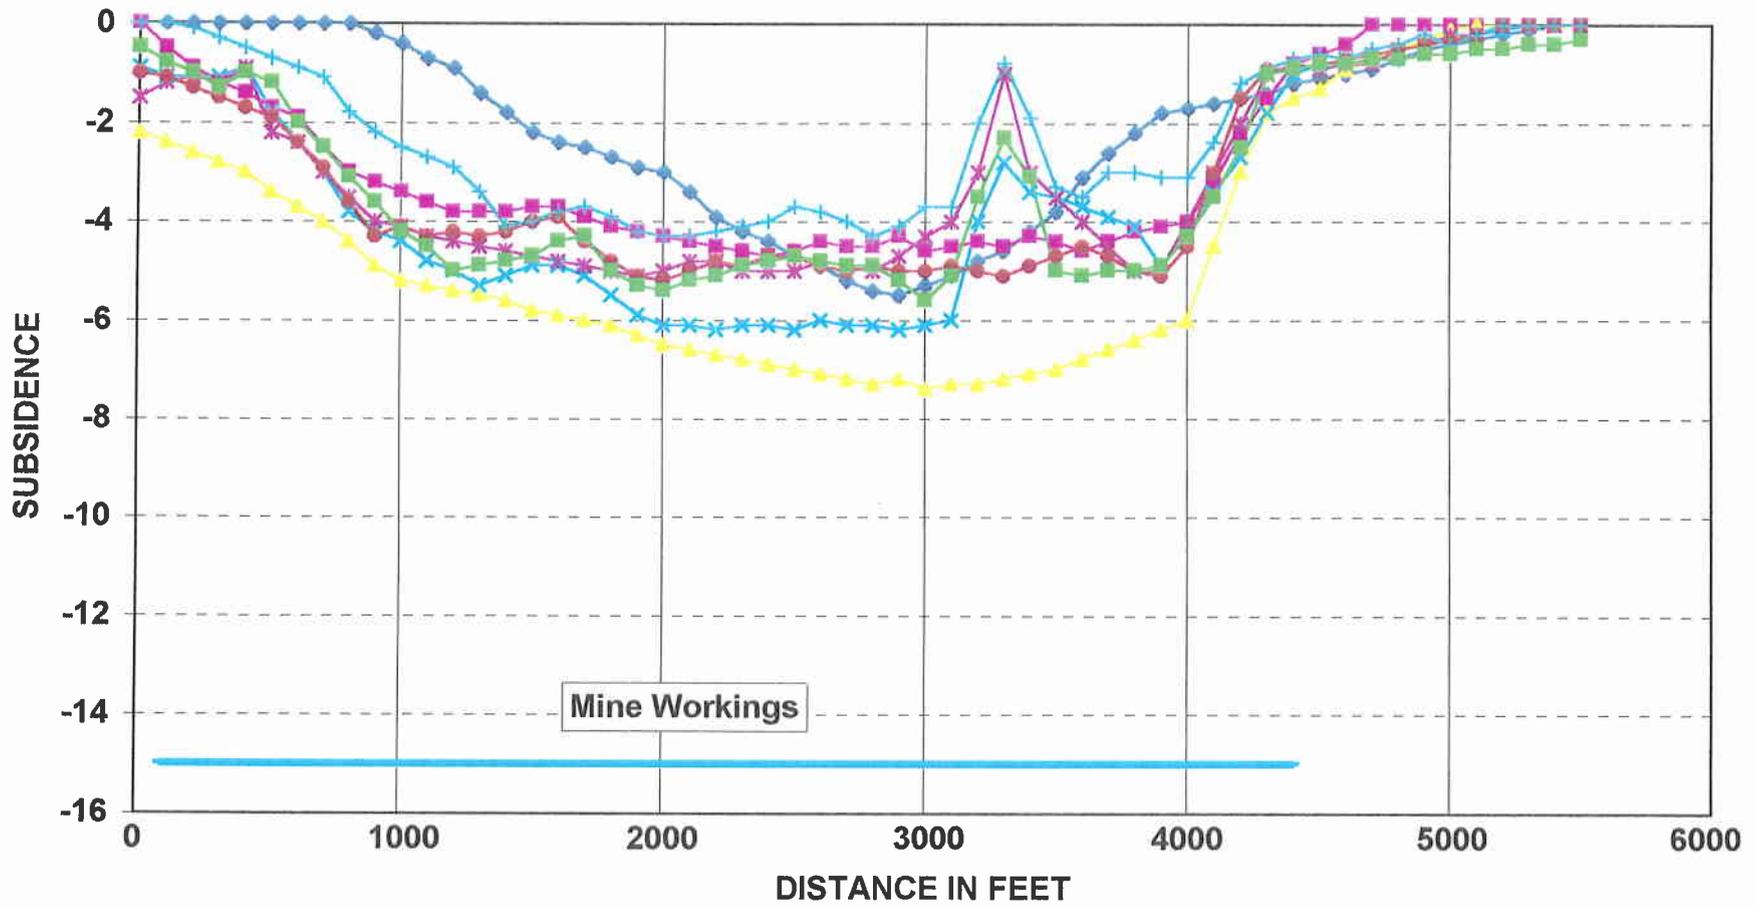
FIGURE 55

Area 16 Subsidence Profile West - East
