**1997 SUBSIDENCE
 COTTONWOOD MINE
 6TH & 7TH EAST LONGWALL PANELS**

Area 15

Cottonwood 9th and 12th West Longwall Panels

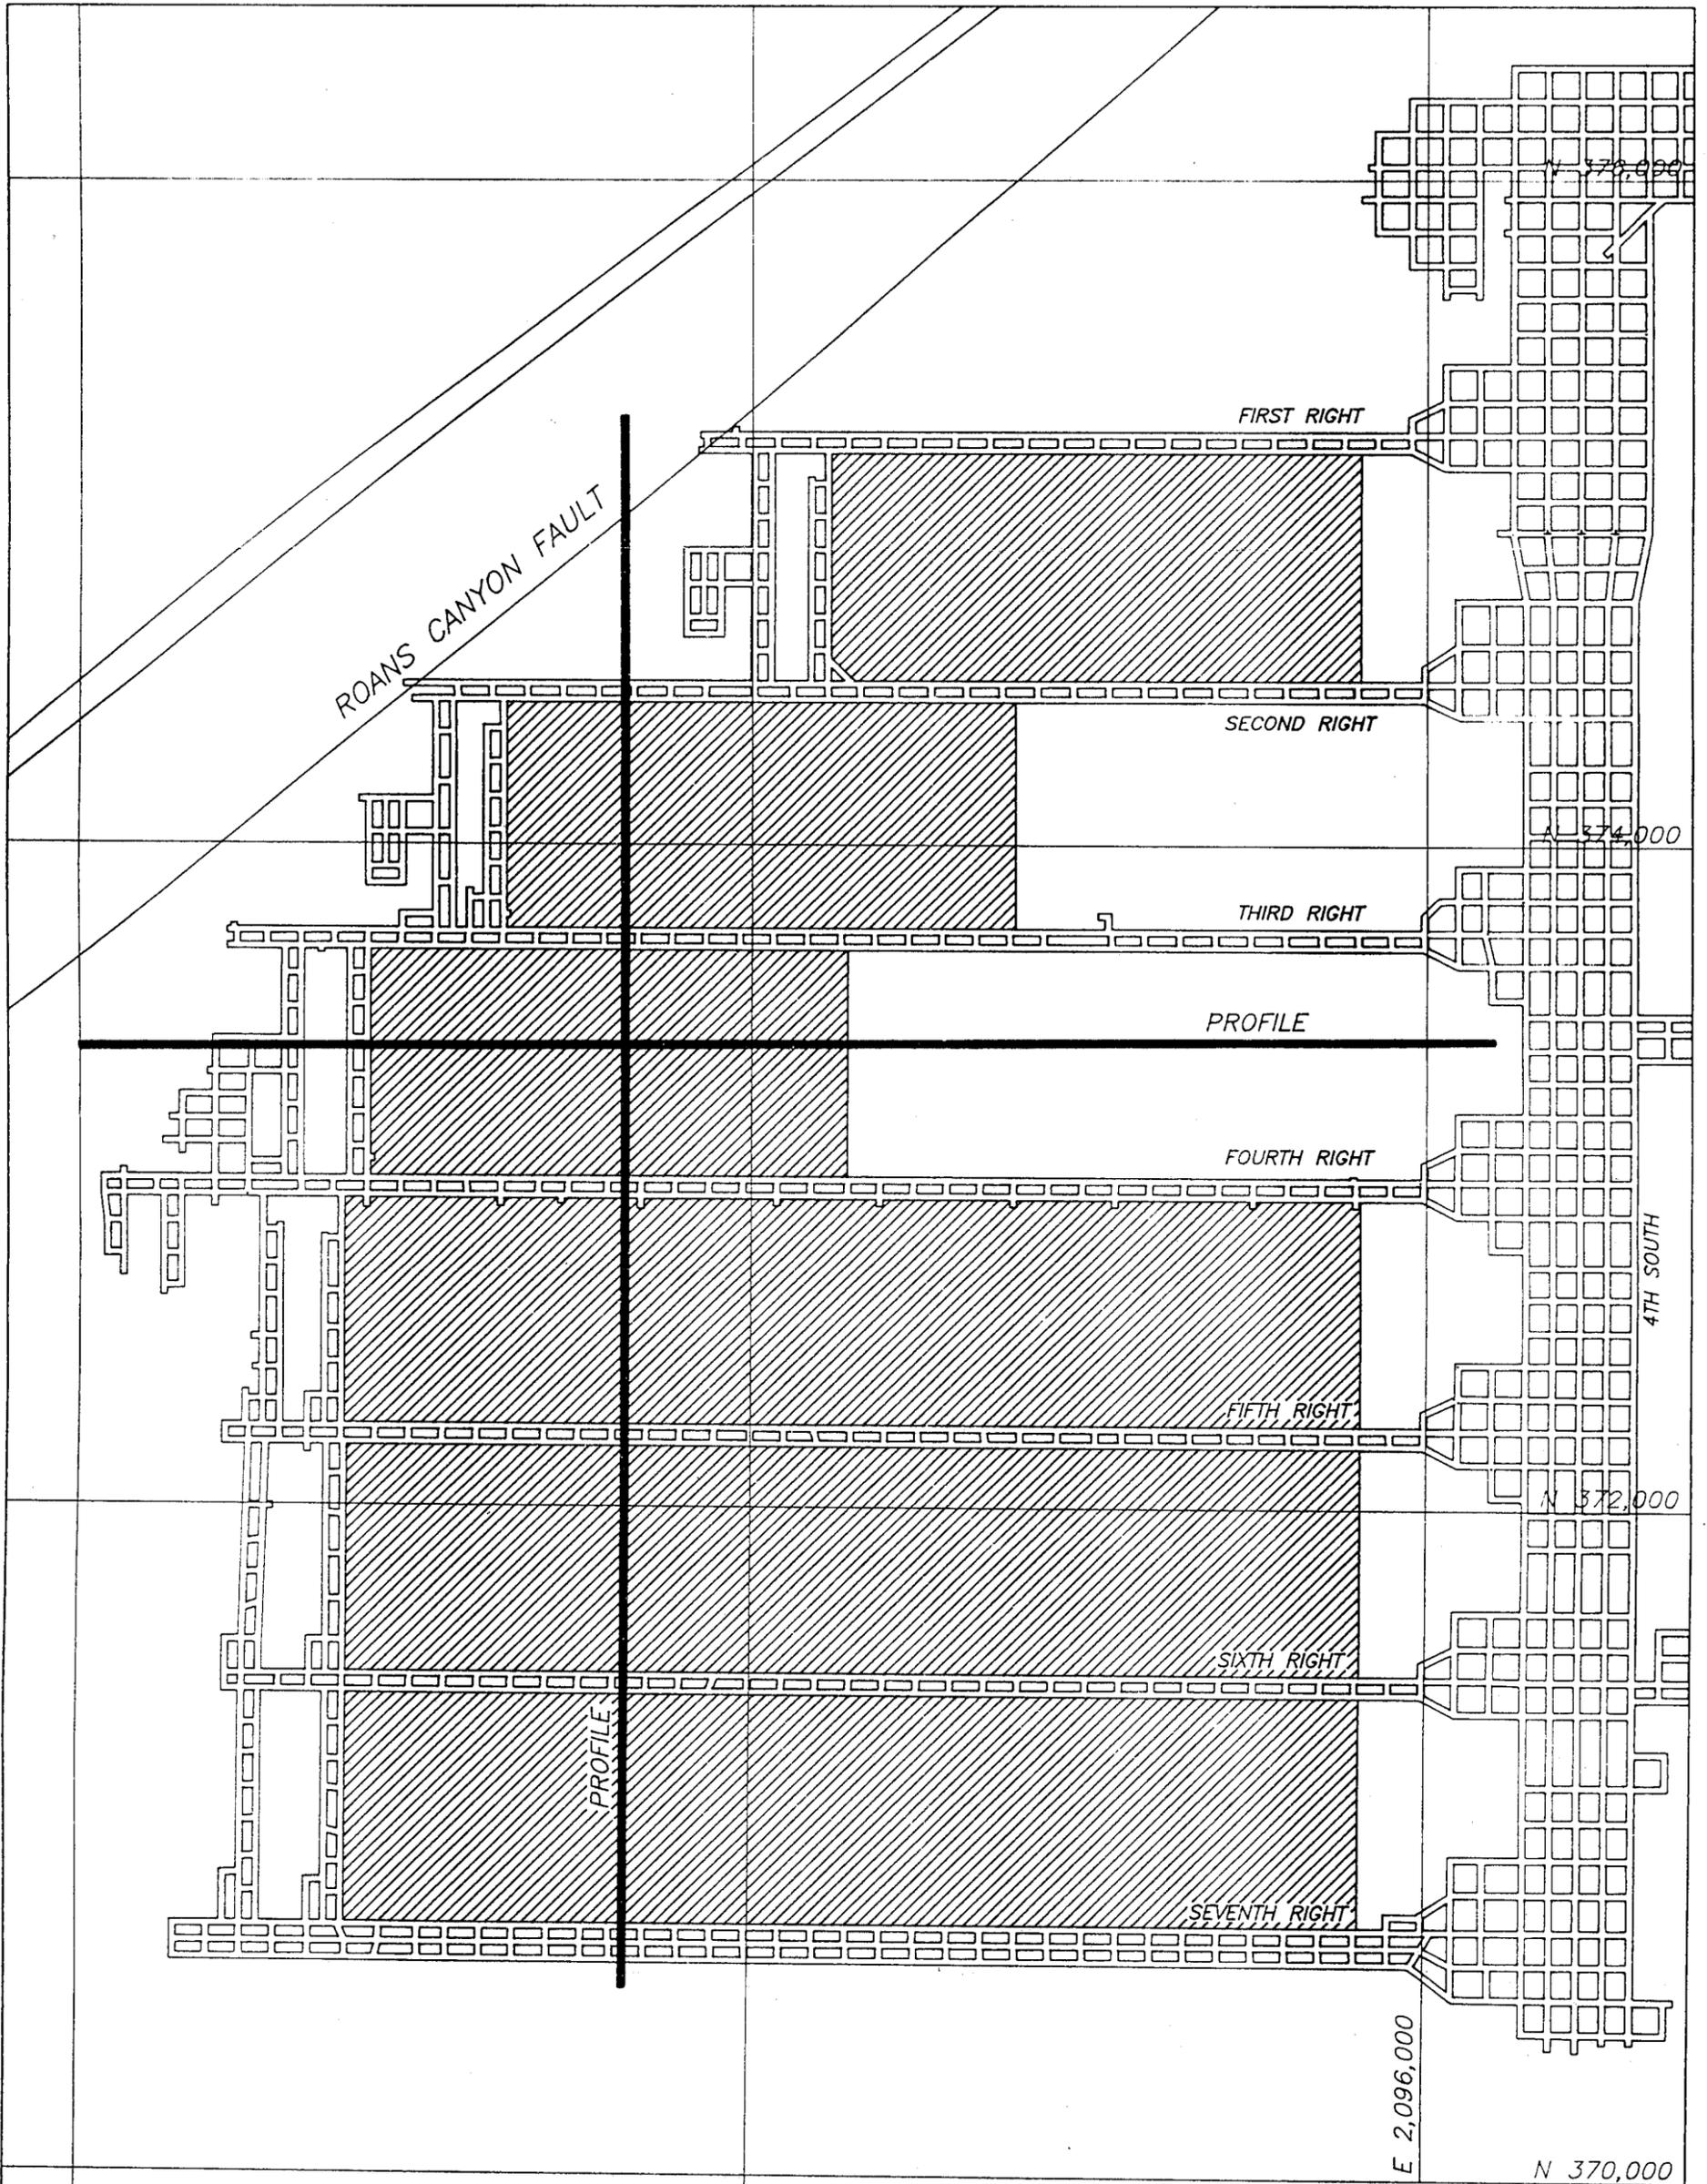
FIGURE 60
 DRAWING #:
 SHEET 1 OF 1 REV.

Longwall mining in this area was completed in May, 1992 with the extraction of six adjacent longwall panels (figure 60). The 3rd and 4th Right panels were terminated short of the entire panel due to geologic complications. The land surface in the area of these panels contains steep slopes covered by conifer and aspen trees, and sagebrush. The longwall panels have overburden ranging from 1,800 feet on the west end of the panels to 2,000 feet on the east side of the panels.

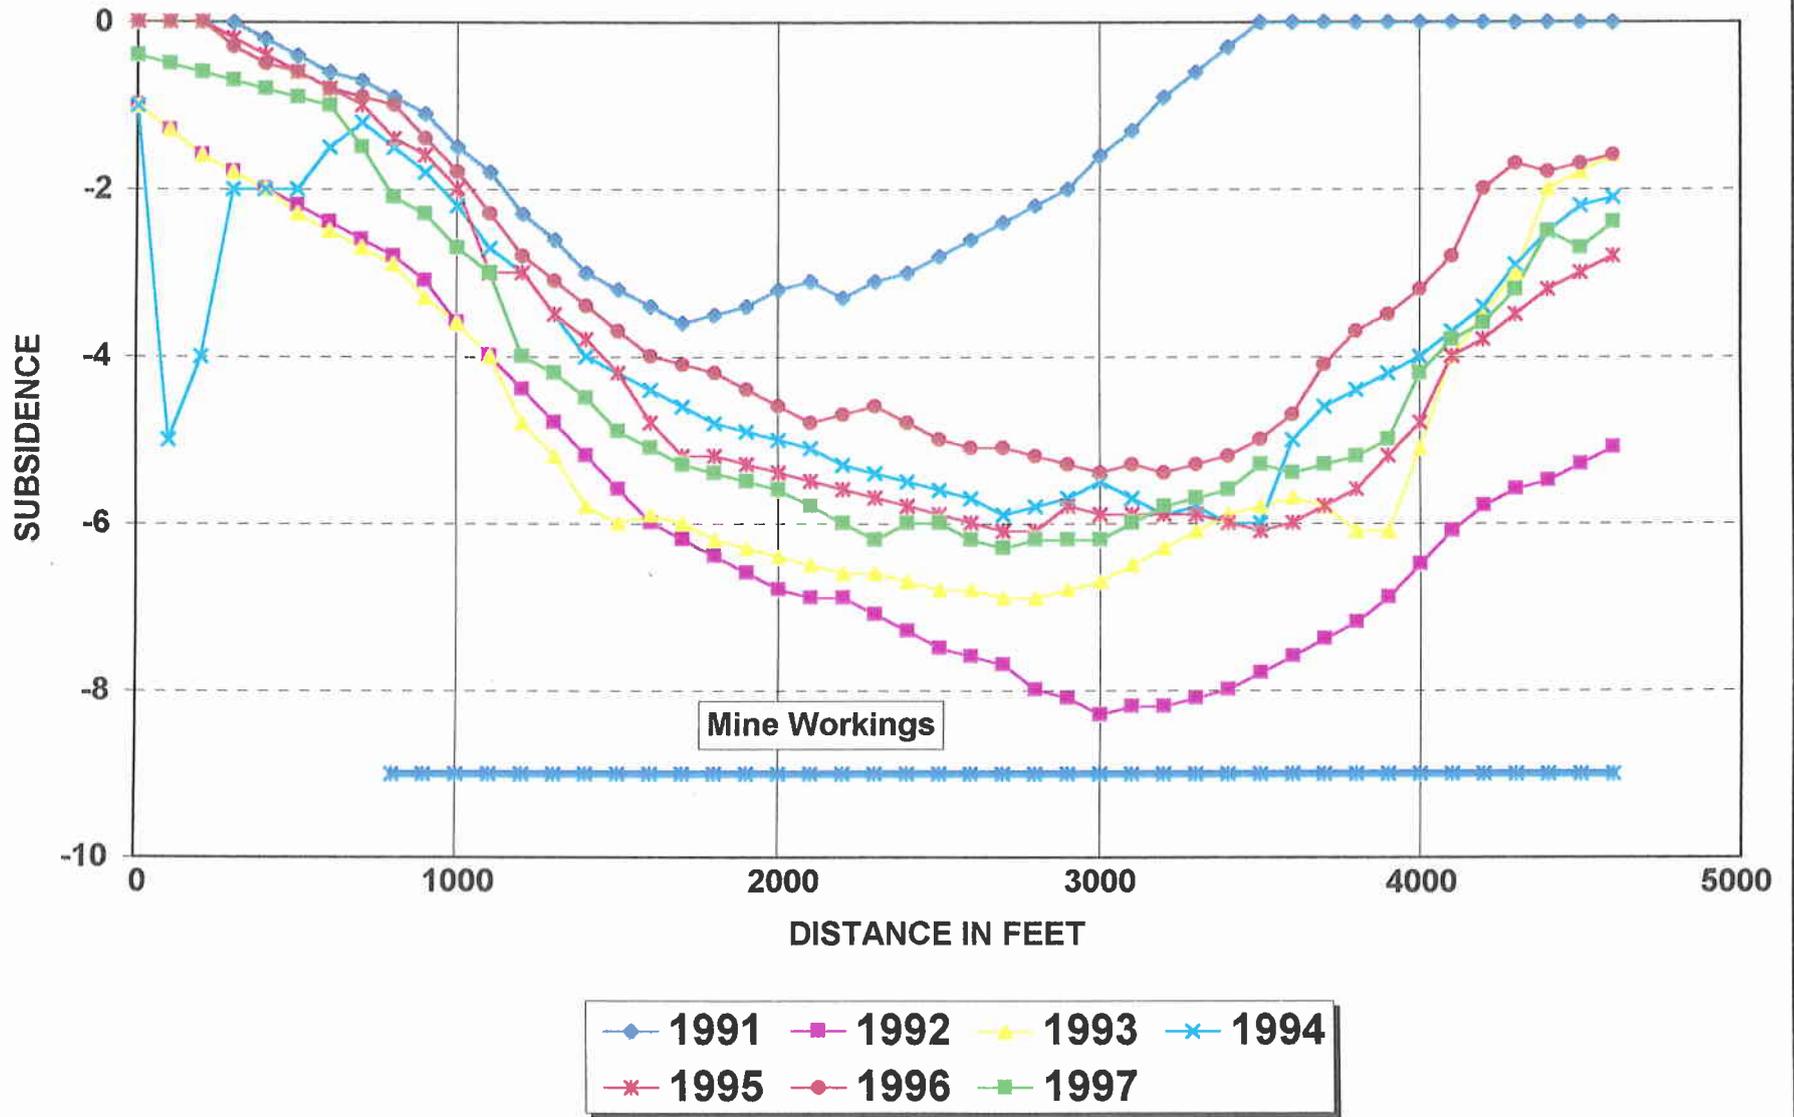
FIGURE 62

Subsidence in this area has reached a maximum of nearly eight (8) feet (Figures 61, 62, and 63) and has been stable since 1992. The subsidence zone is a broad trough running in a north - south direction. This area is overlain by several springs. Monitoring of these springs has shown no change in the quality or quantity of water discharged from them (see appendix and the 1997 Hydrologic Monitoring report).

Area 18 Subsidence Profile North - South

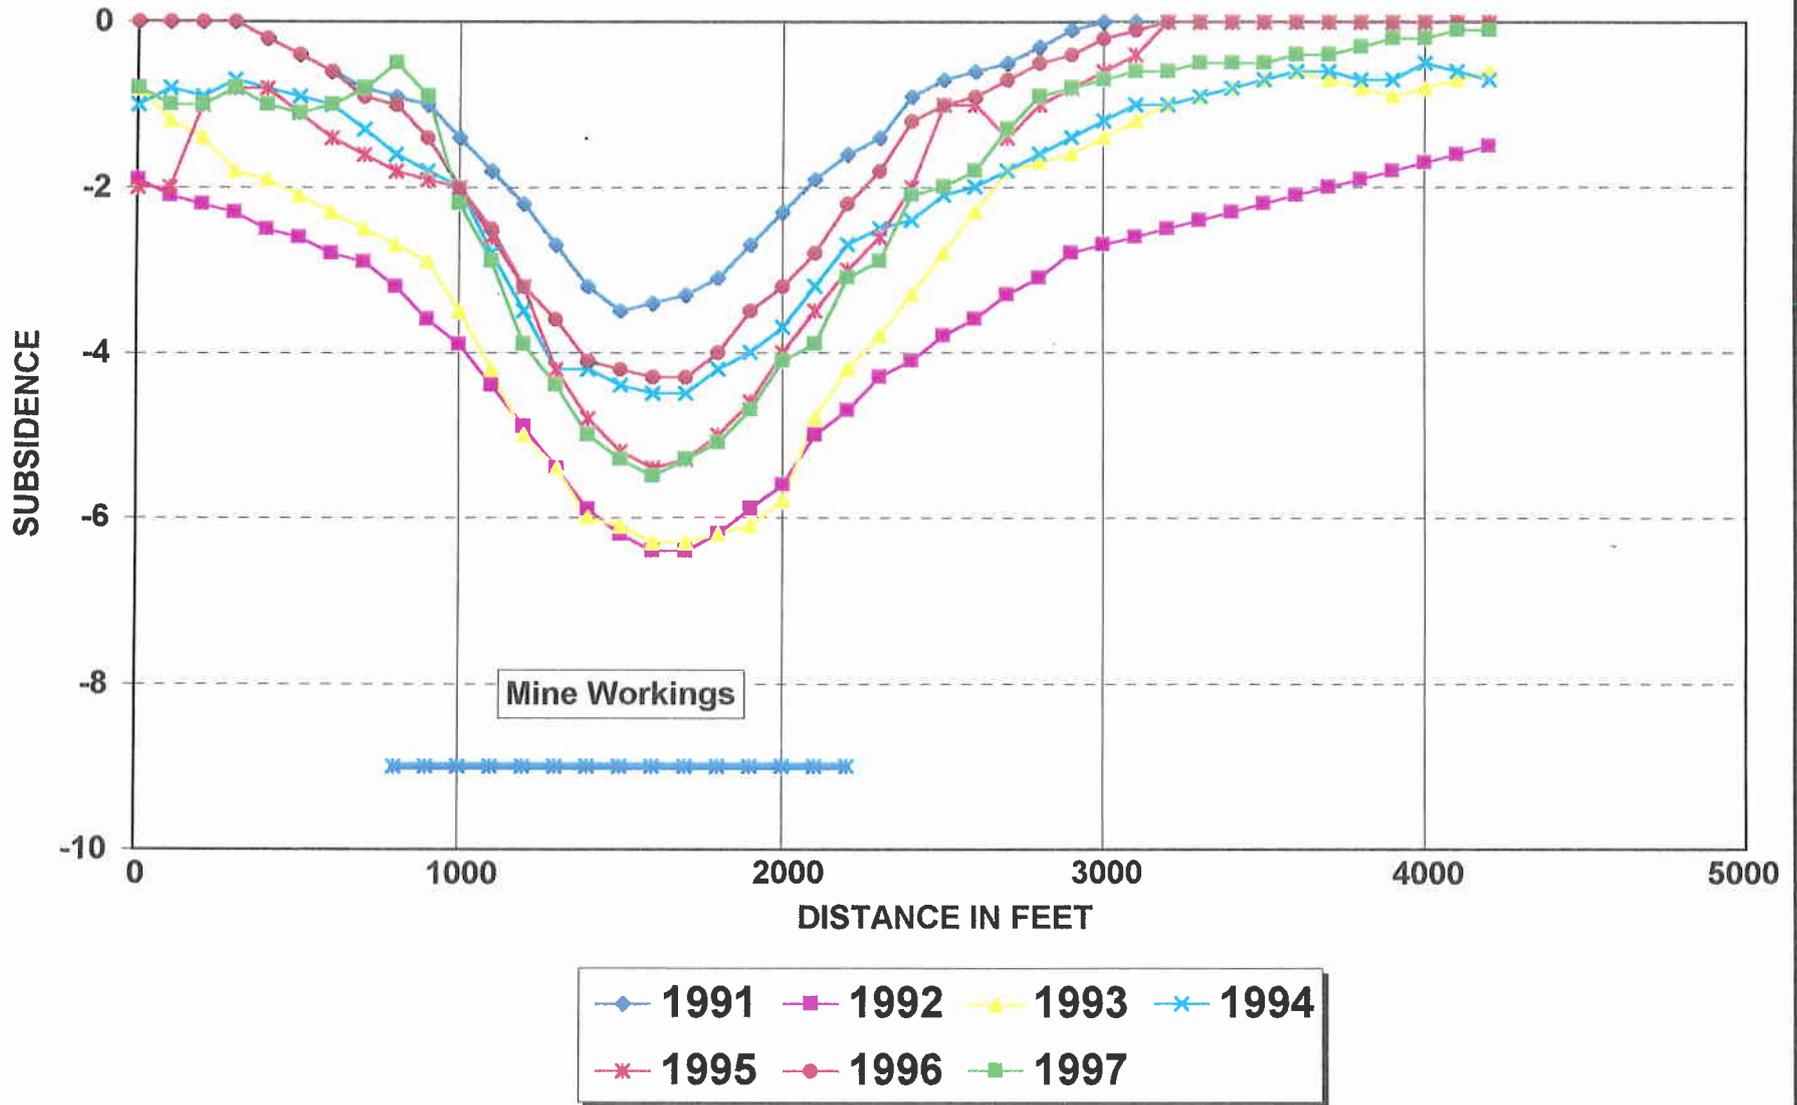
FIGURE 63

Area 18 Subsidence Profile West - East

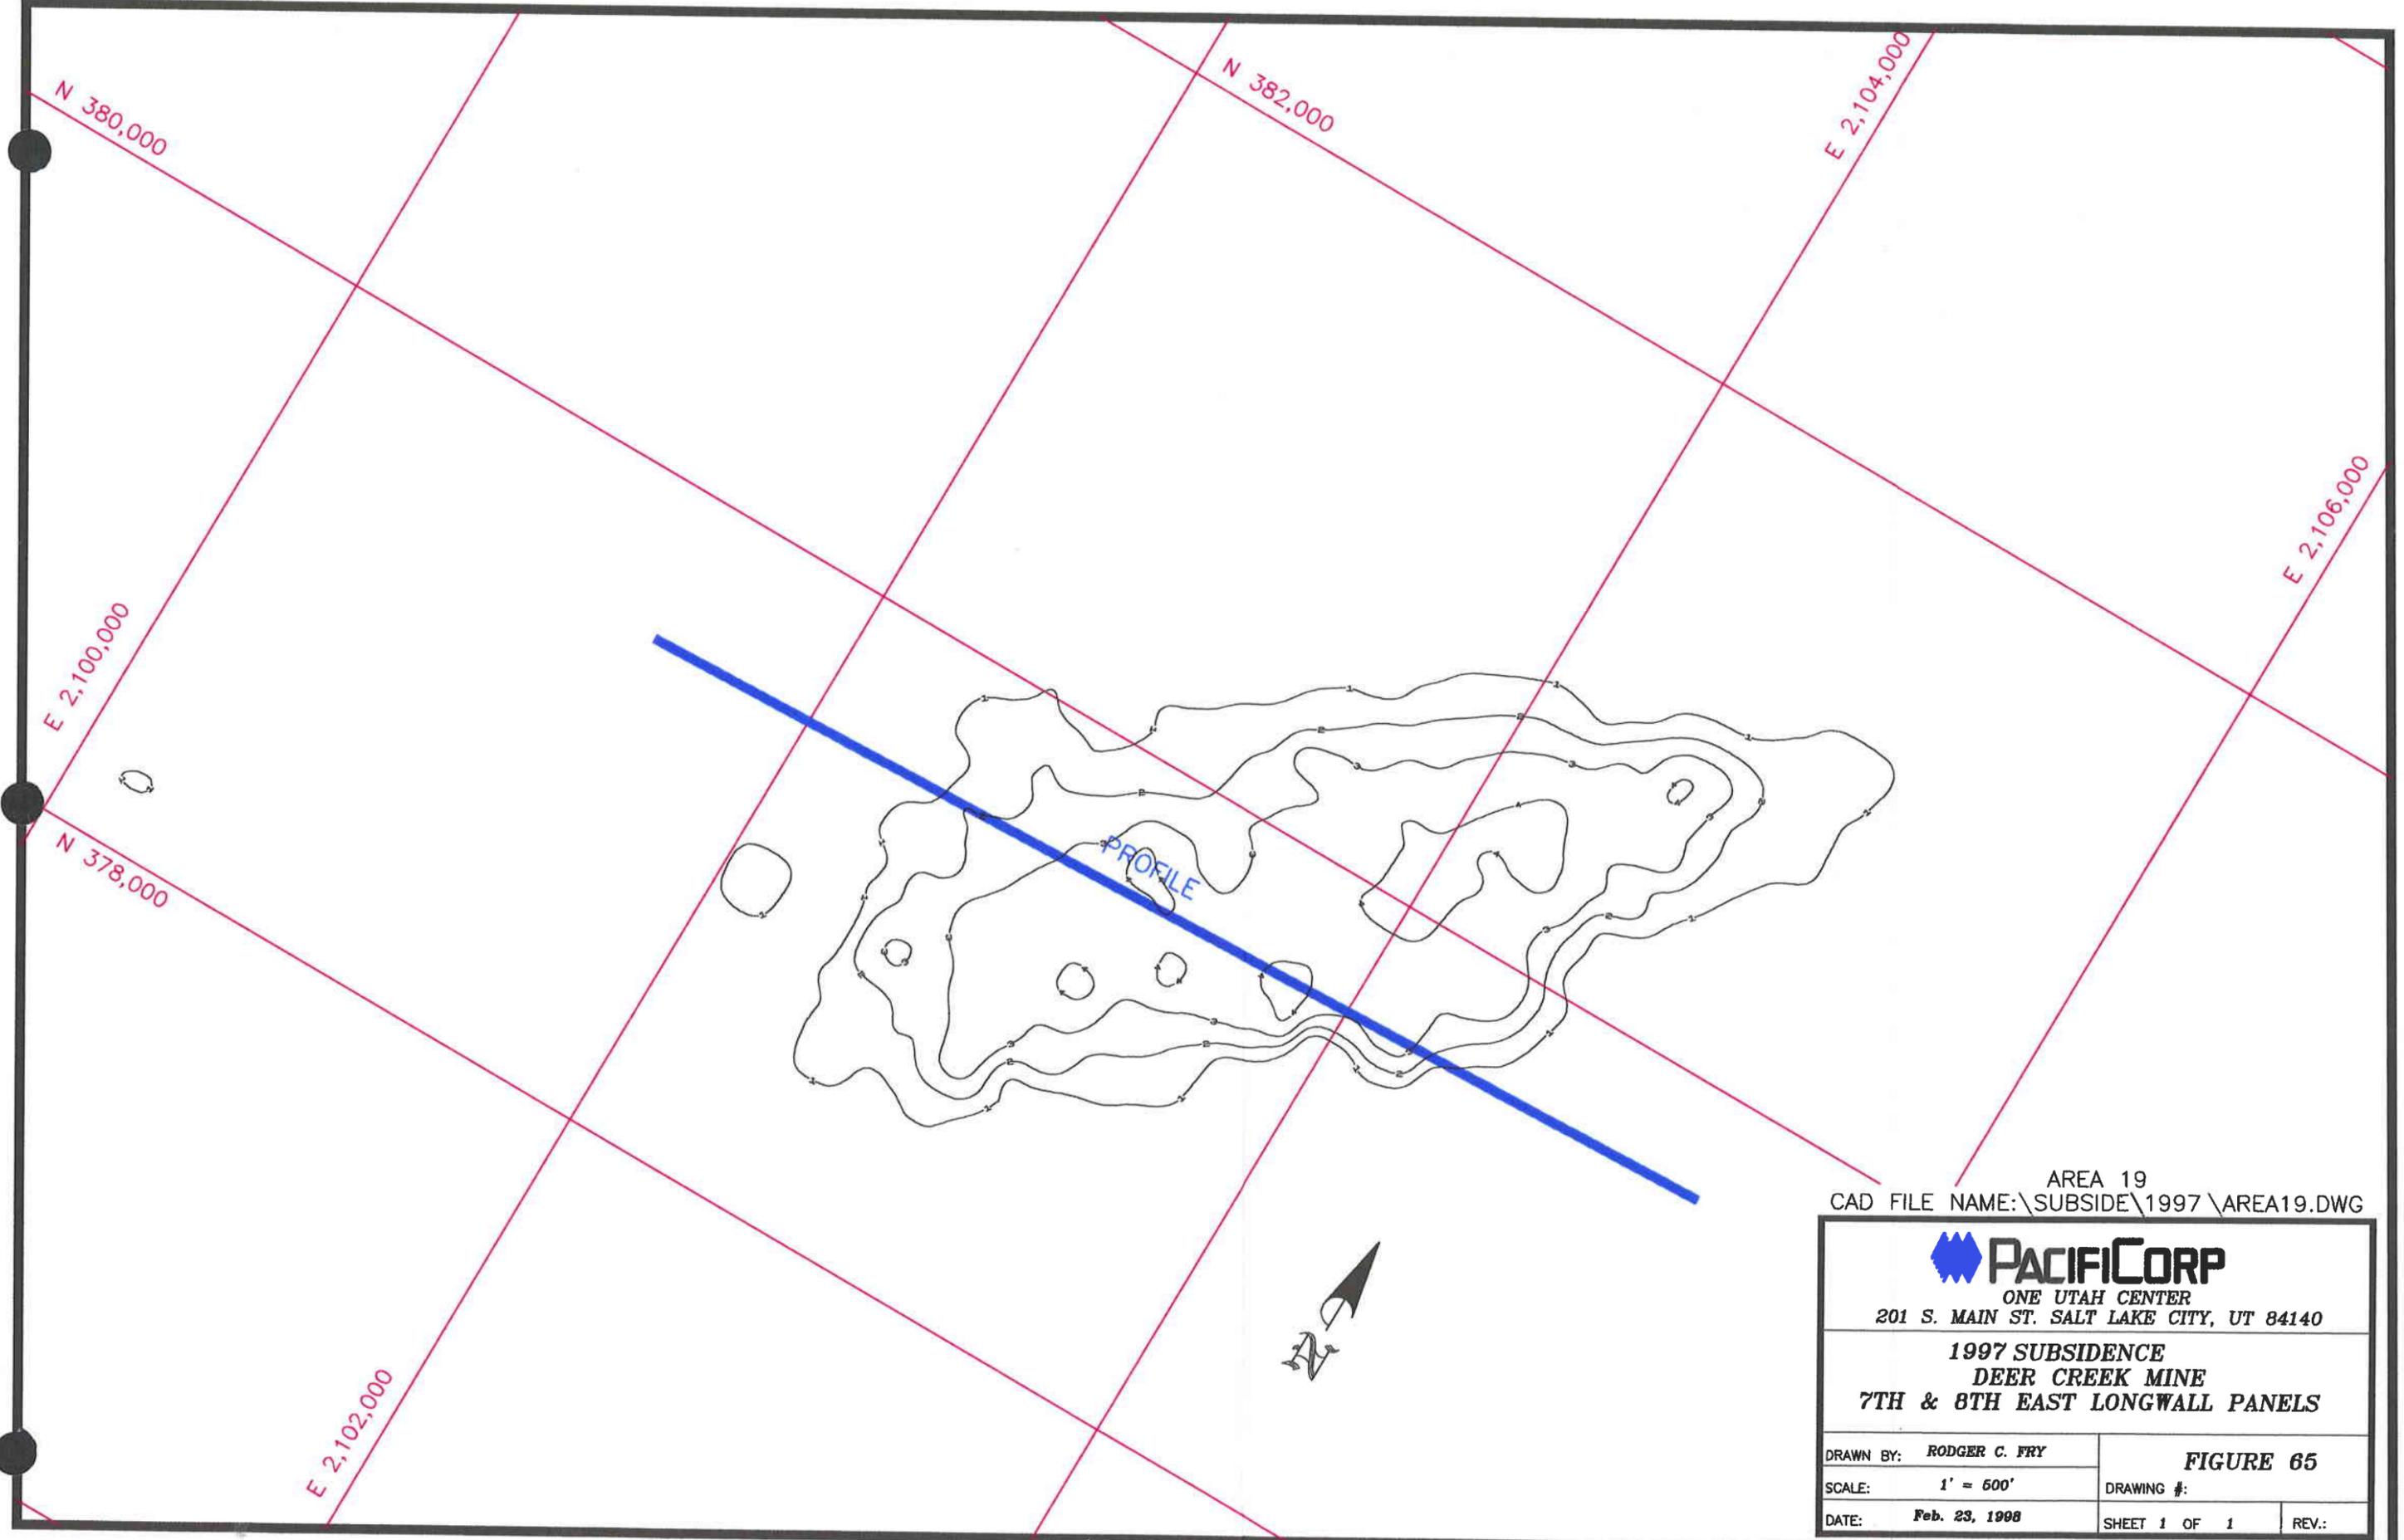
FIGURE 65

Subsidence in this area has increased from slightly over one foot in 1992 to over four feet in 1993 but has been stable between 1993 and 1997 (Figures 65 and 66).

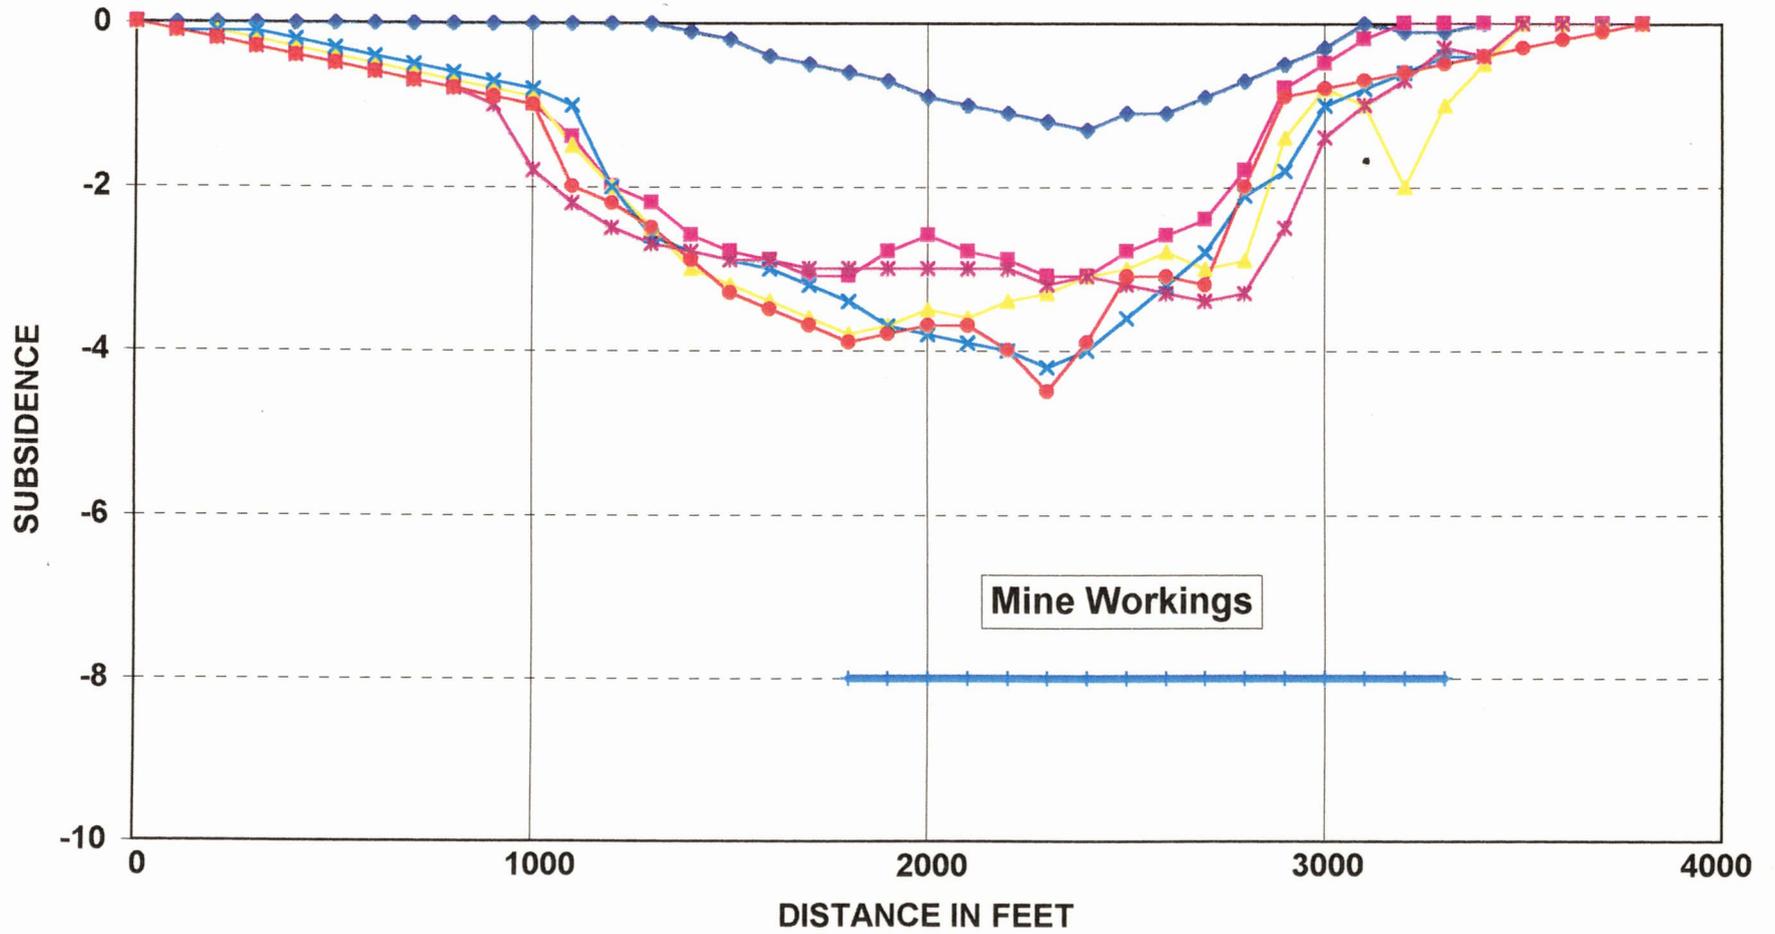
FIGURE 66

Area 19 Subsidence Profile West - East

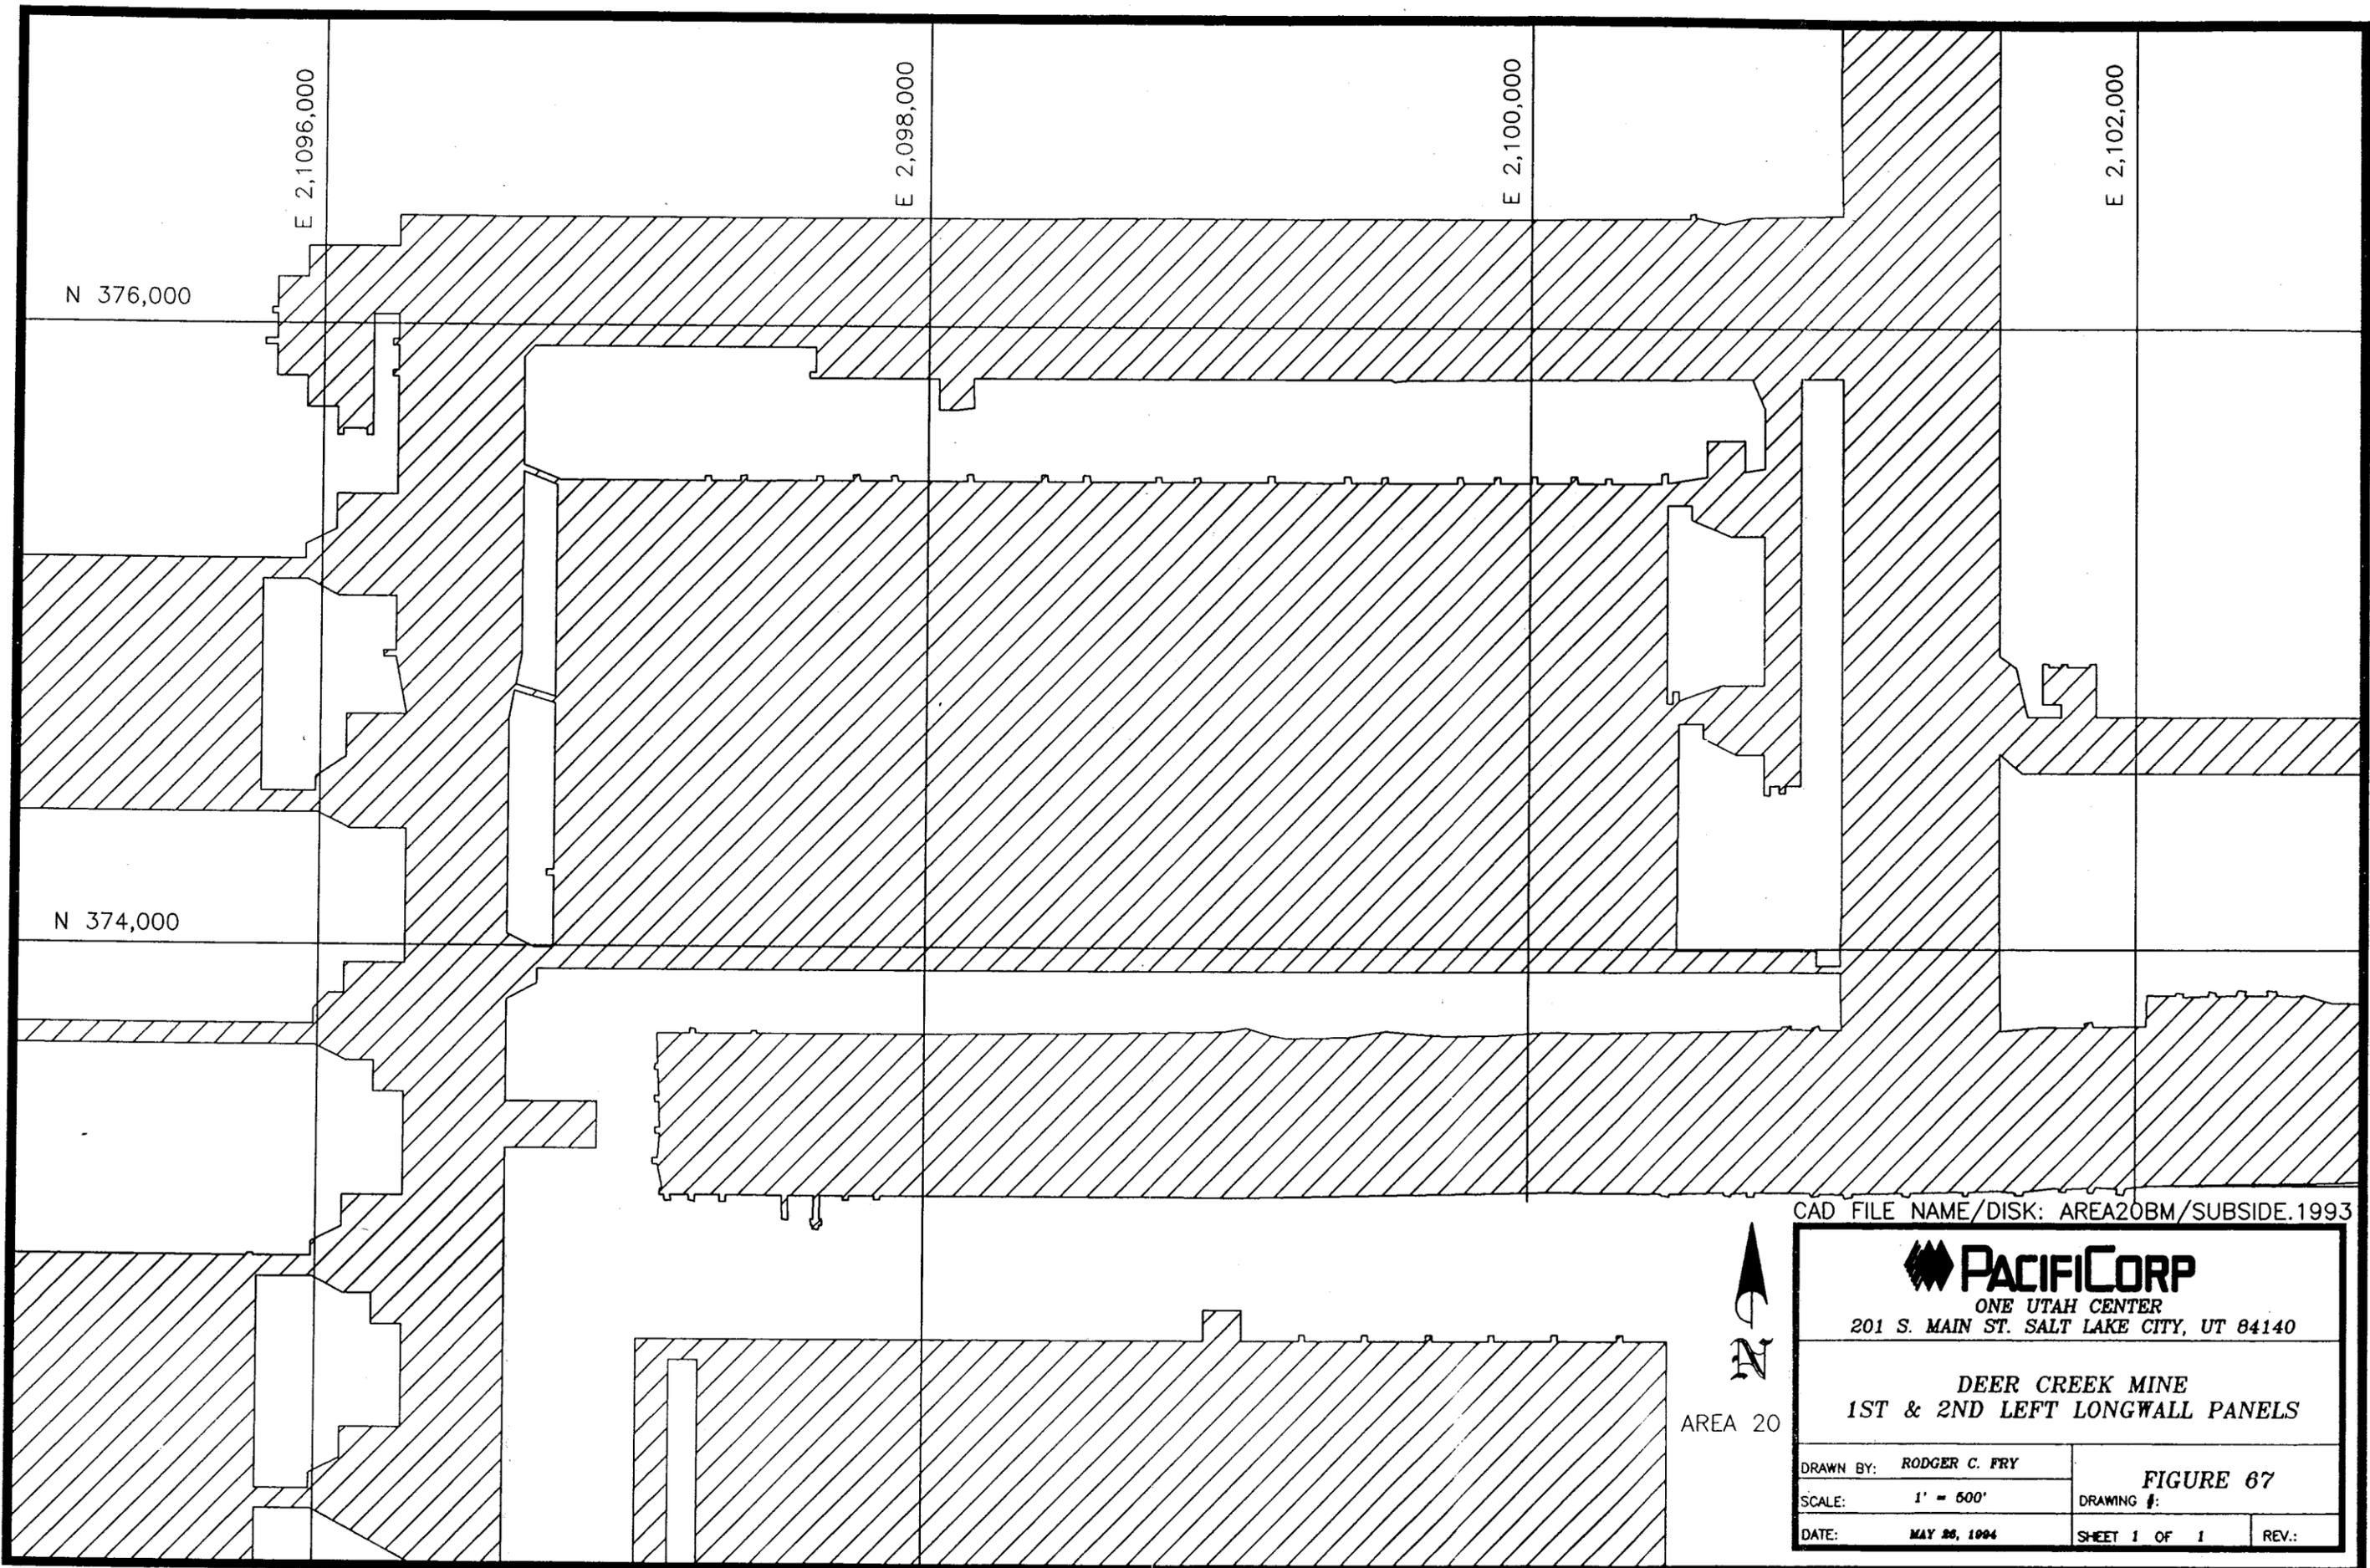
PACIFICORP ONE UTAH CENTER 201 S. MAIN ST. SALT LAKE CITY, UT 84140		
DEER CREEK MINE 1ST & 2ND LEFT LONGWALL PANELS		
DRAWN BY: RODGER C. FRY	FIGURE 67	
SCALE: 1" = 500'	DRAWING #:	
DATE: MAY 26, 1994	SHEET 1 OF 1	REV.:

Mining in the 2nd Left Longwall Panel began in February 1993 and was completed in June 1993. Mining then started in the 1st Left Longwall Panel in July 1993 and was completed in November of 1993 (Figure 67).

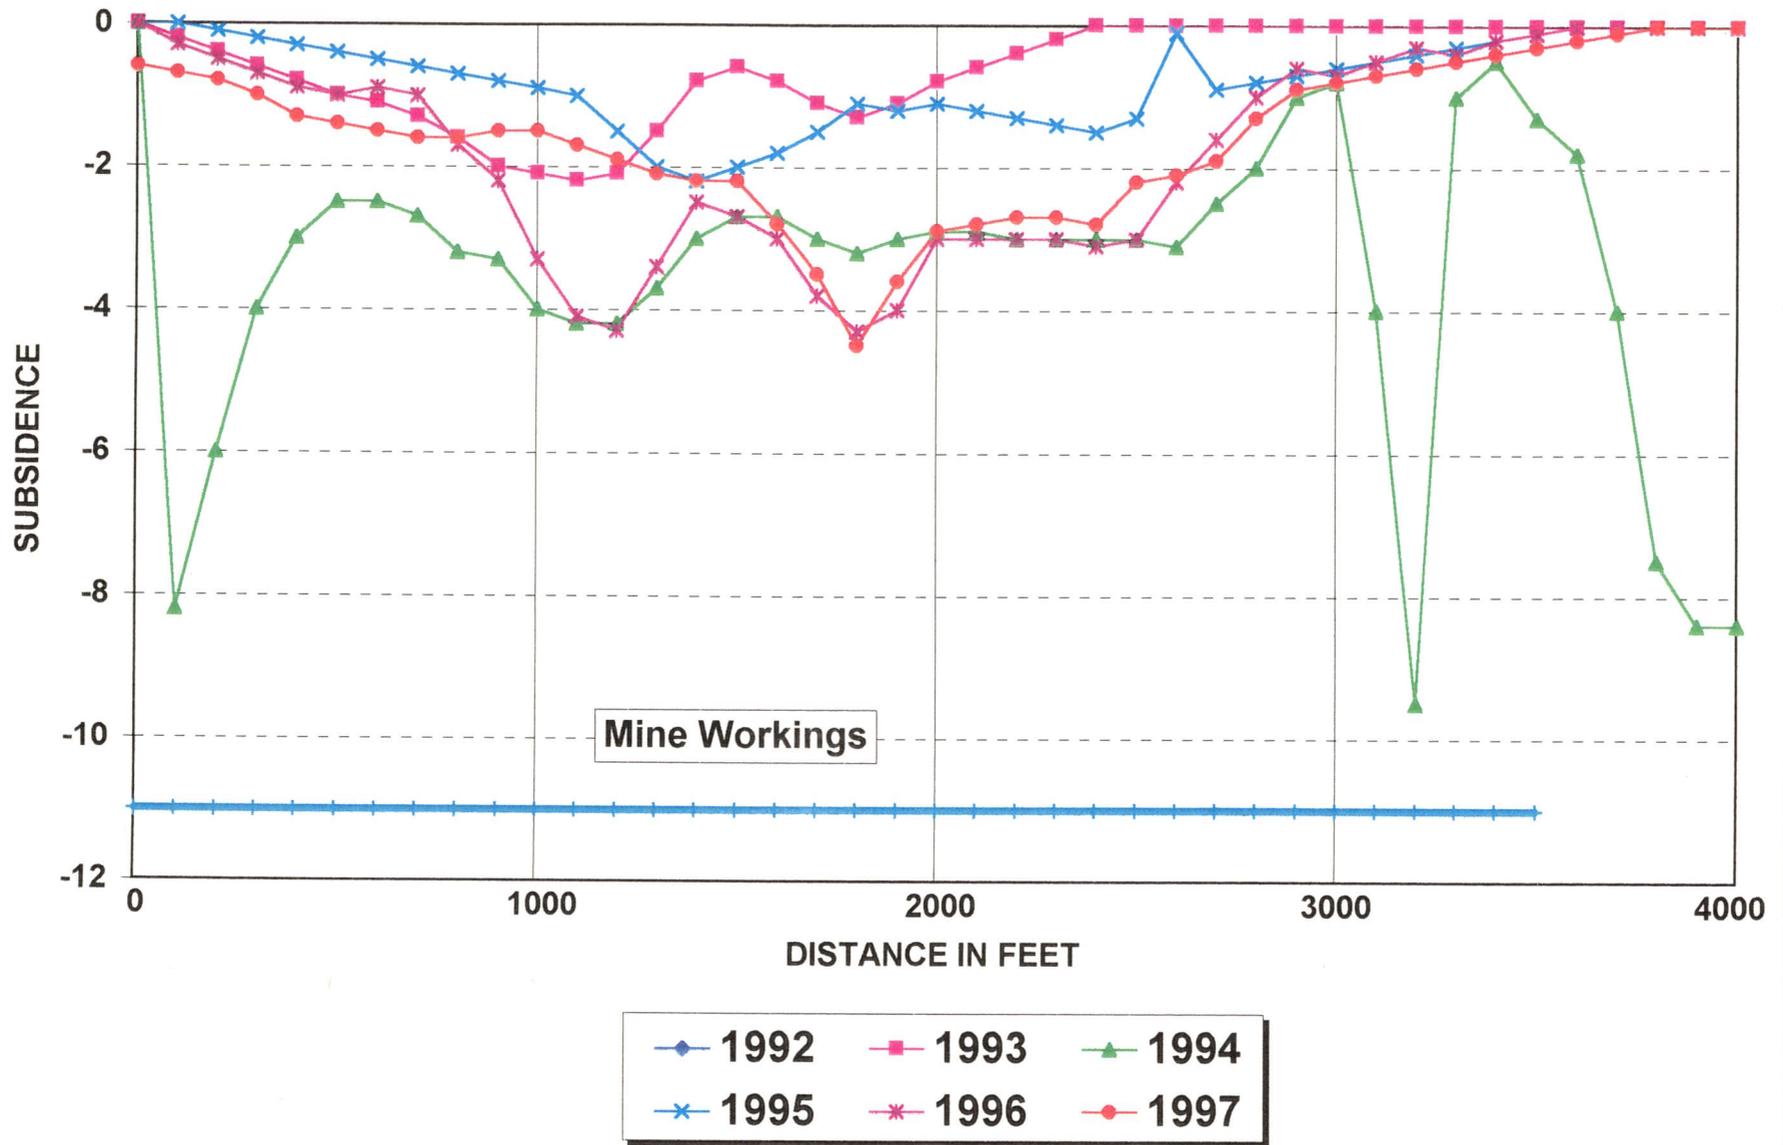
FIGURE 69

The monitoring detected a maximum of slightly over four (4) feet of subsidence in 1997 which is less than the maximum of slightly over six (6) feet of subsidence above the 2nd Left Longwall Panel measured in 1996. The 1996 reading showed an increase from the maximum of slightly over four feet that was measured in 1995 and a foot greater than that measured in 1994 which showed a maximum of five feet of subsidence (Figures 68 and 69).

Area 20 Subsidence Profile West - East
