**1997 SUBSIDENCE
 COTTONWOOD MINE
 6TH & 7TH EAST LONGWALL PANELS**

Area 15

Cottonwood 9th and 12th West Longwall Panels

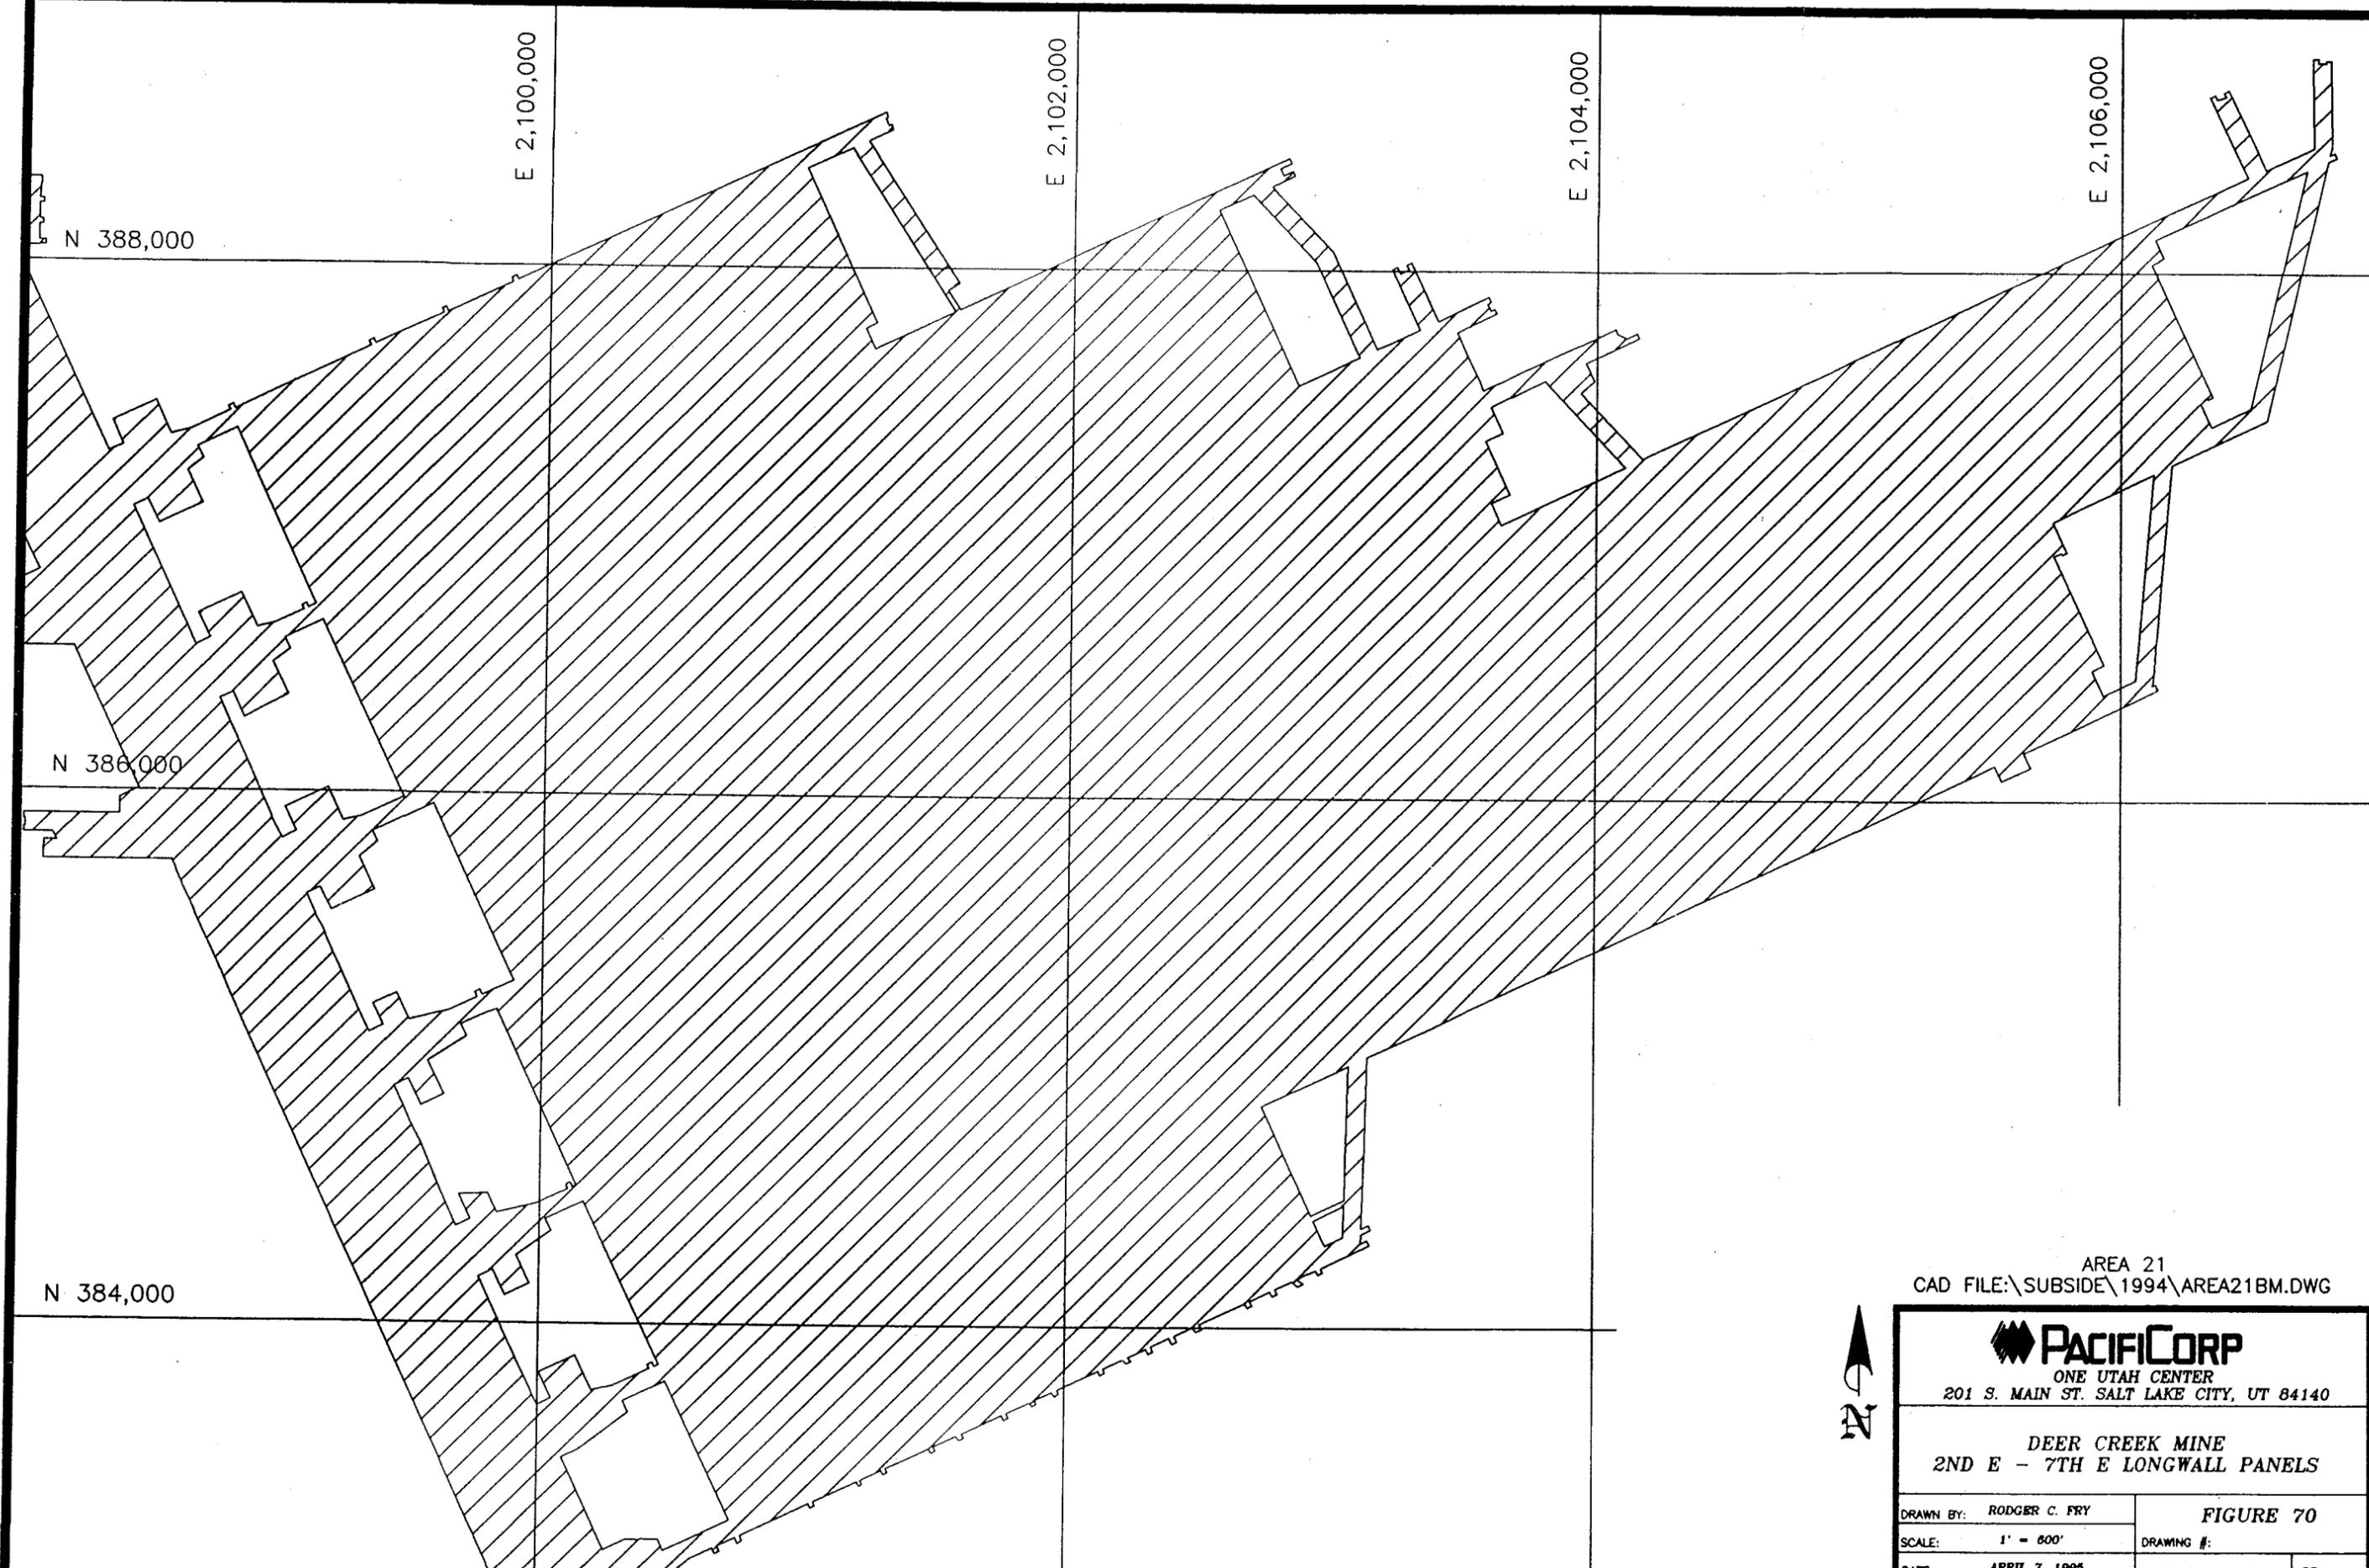
AREA 21
 CAD FILE:\SUBSIDE\1994\AREA21BM.DWG

monitoring indicated that subsidence has increased to slightly over seven (7) feet over the Second and Third East longwall panels in this area. In 1996, this area showed a maximum subsidence of six (6) feet. During the helicopter reconnaissance in 1995, several fractures were identified and several areas were noted where boulders had rolled from the Castlgate cliff. These are shown on figure 71. The area of subsidence is completely contained within the mining area; Therefore, the angle of draw is near verticle.

Several springs are located above these longwall panel. However, hydrologic monitoring has not detected any change to the spring flow that is attributable to mining (see 1997 Hydrologic Monitoring Report).

In Areas 3, 7, 10, 11, 21 and 22 where only minor fracturing has occurred on remote ridges and/or where land use has not been affected, more damage would be done by gaining access to and repairing or fencing fractures than can be justified; therefore, mitigation is counterproductive in those areas and is not planned.

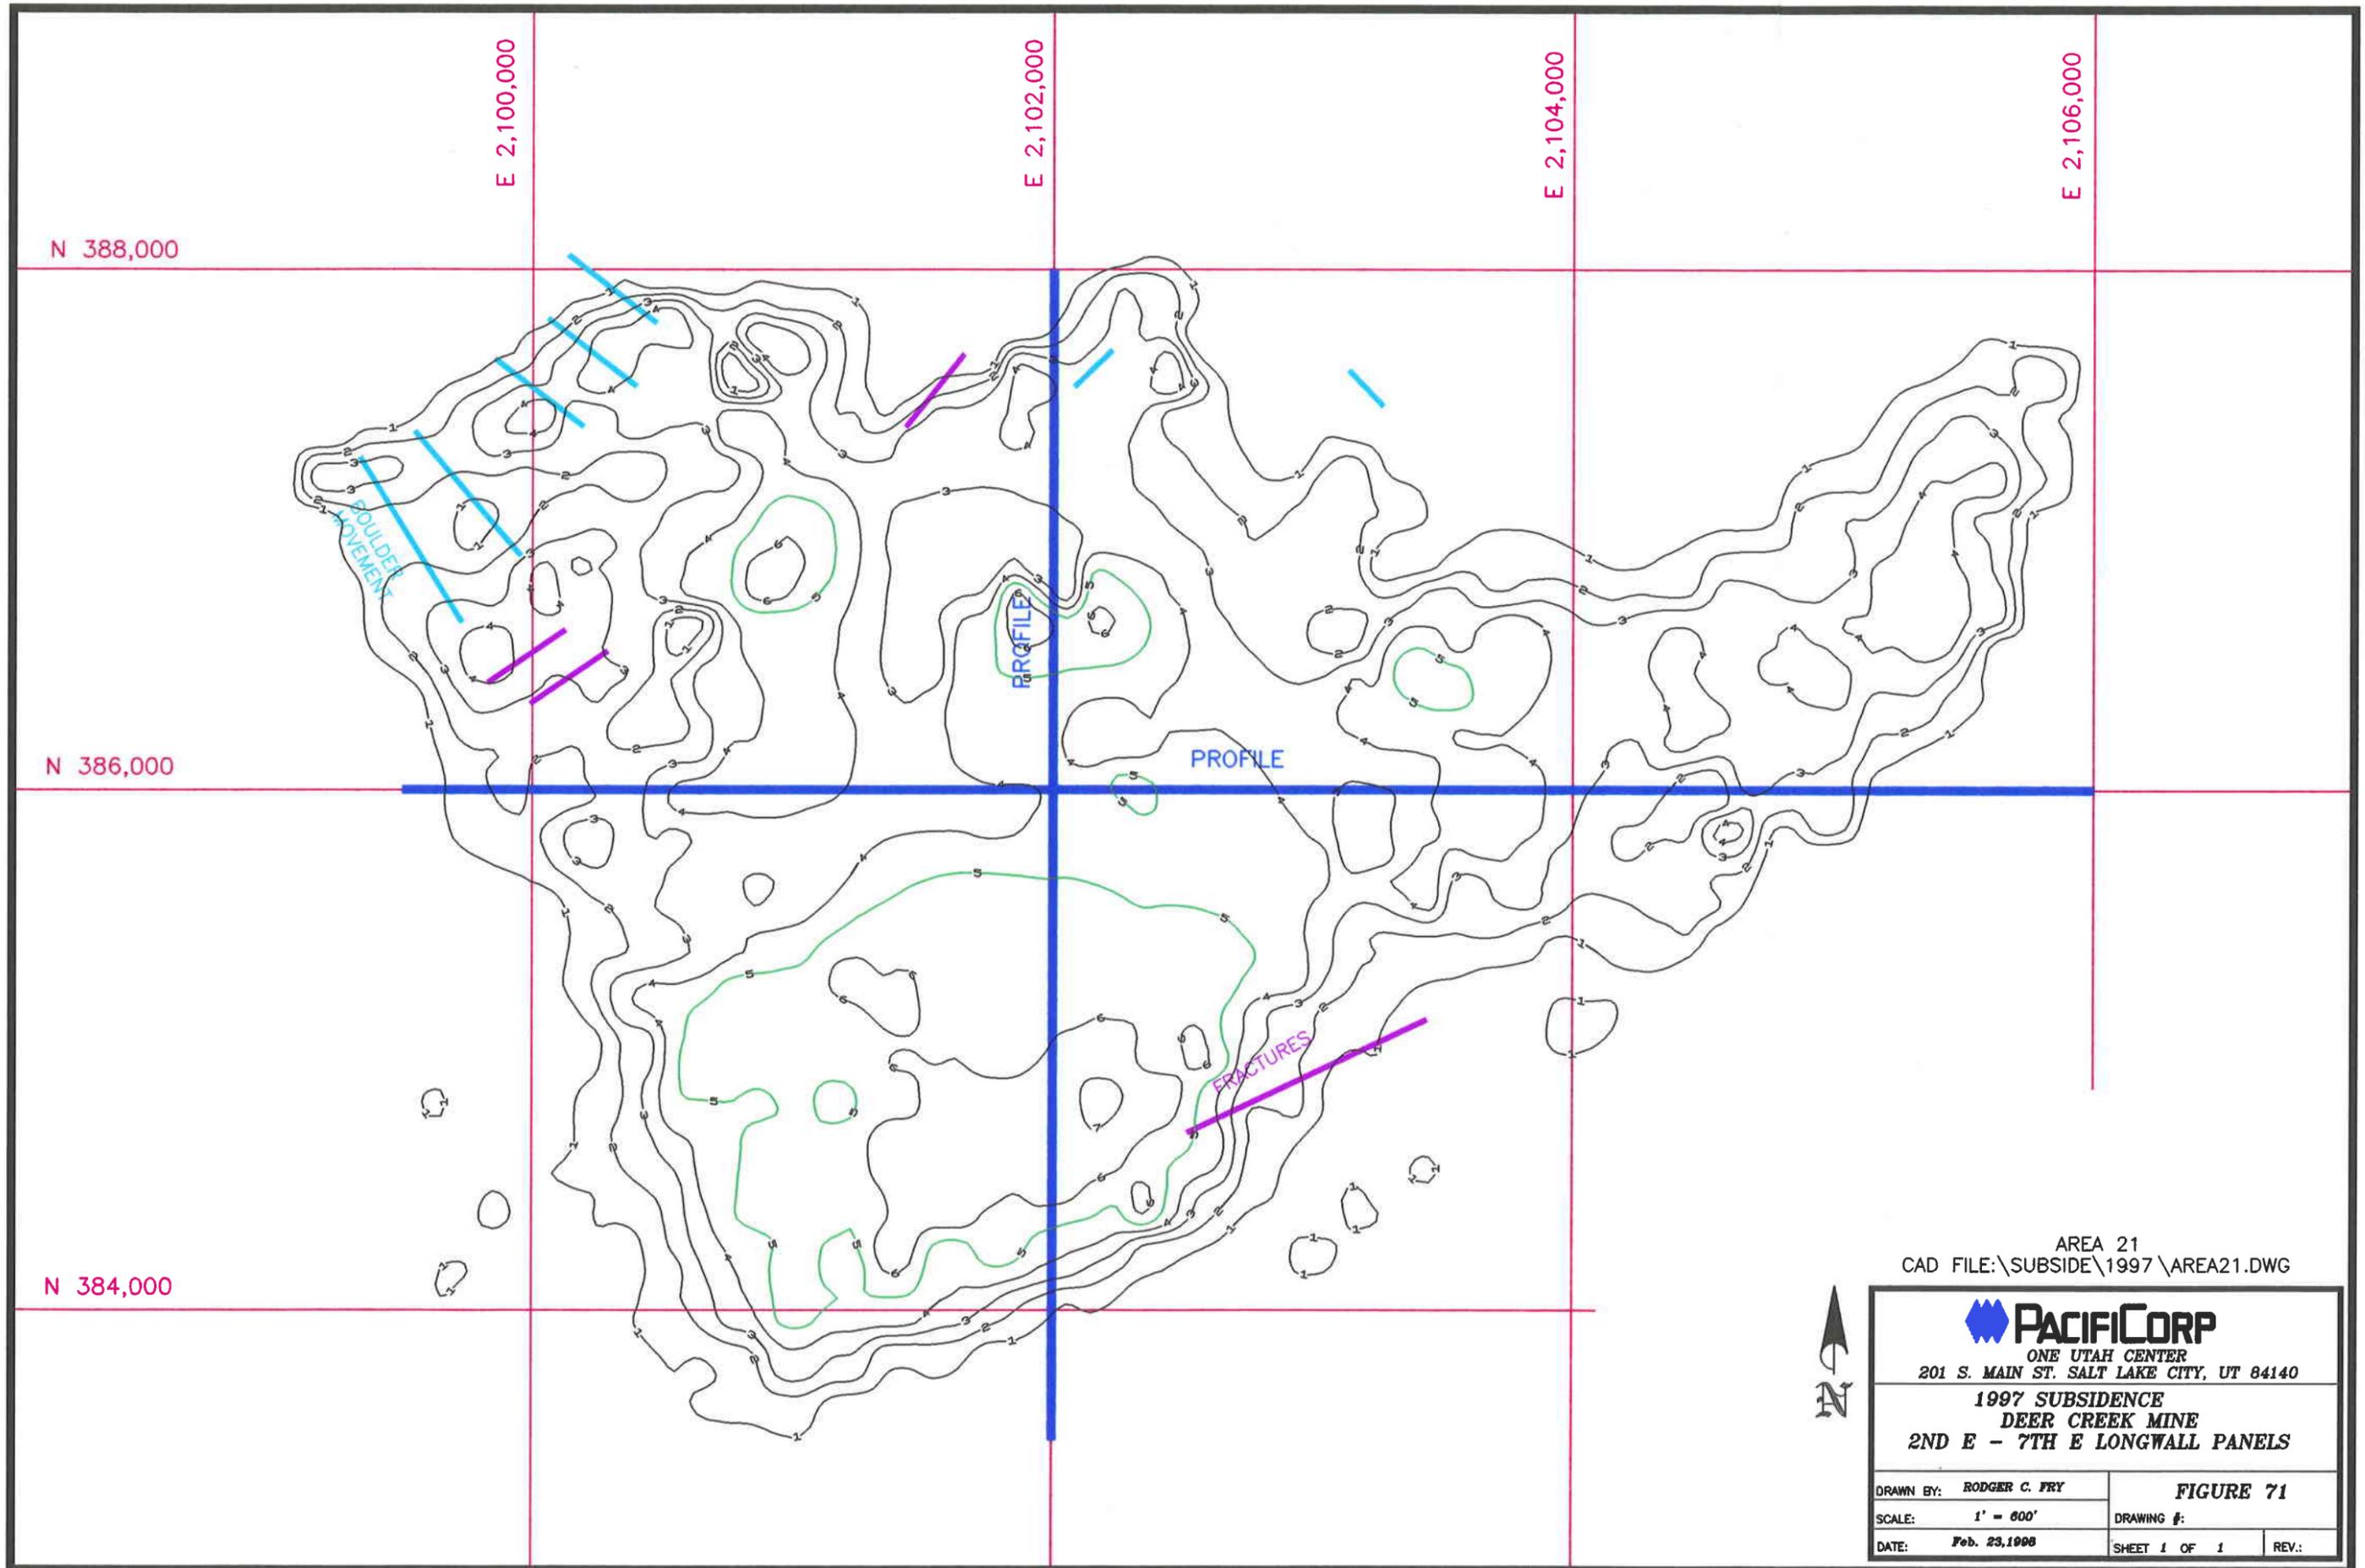
ONE UTAH CENTER 201 S. MAIN ST. SALT LAKE CITY, UT 84140	
1997 SUBSIDENCE DEER CREEK MINE 2ND E - 7TH E LONGWALL PANELS	
DRAWN BY: RODGER C. FRY	FIGURE 71
SCALE: 1' = 800'	DRAWING #:
DATE: Feb. 23, 1998	SHEET 1 OF 1 REV.:

Subsidence detected in 1994 had reached a maximum of over four (4) feet above the 2nd East Longwall Panel (Figures 71, 72 and 73). Subsidence over the 3rd East longwall panel was not detected because this panel is longer than the 2nd East panel and subsidence doesn't usually occur until two panel widths have been mined. In 1995, subsidence had progressed to where most of the areas underlain by the 2nd through 6th East Longwall Panels had subsided between 5 and 6 feet. In 1996, the maximum subsidence that was measured had not increased from that measured in 1995 but an increase in subsidence was noted on the north end of figure 72 and on the western end of figure 73. This is in the area of the 6th and 7th East Longwall Panels that were the last to be extracted. The 1997

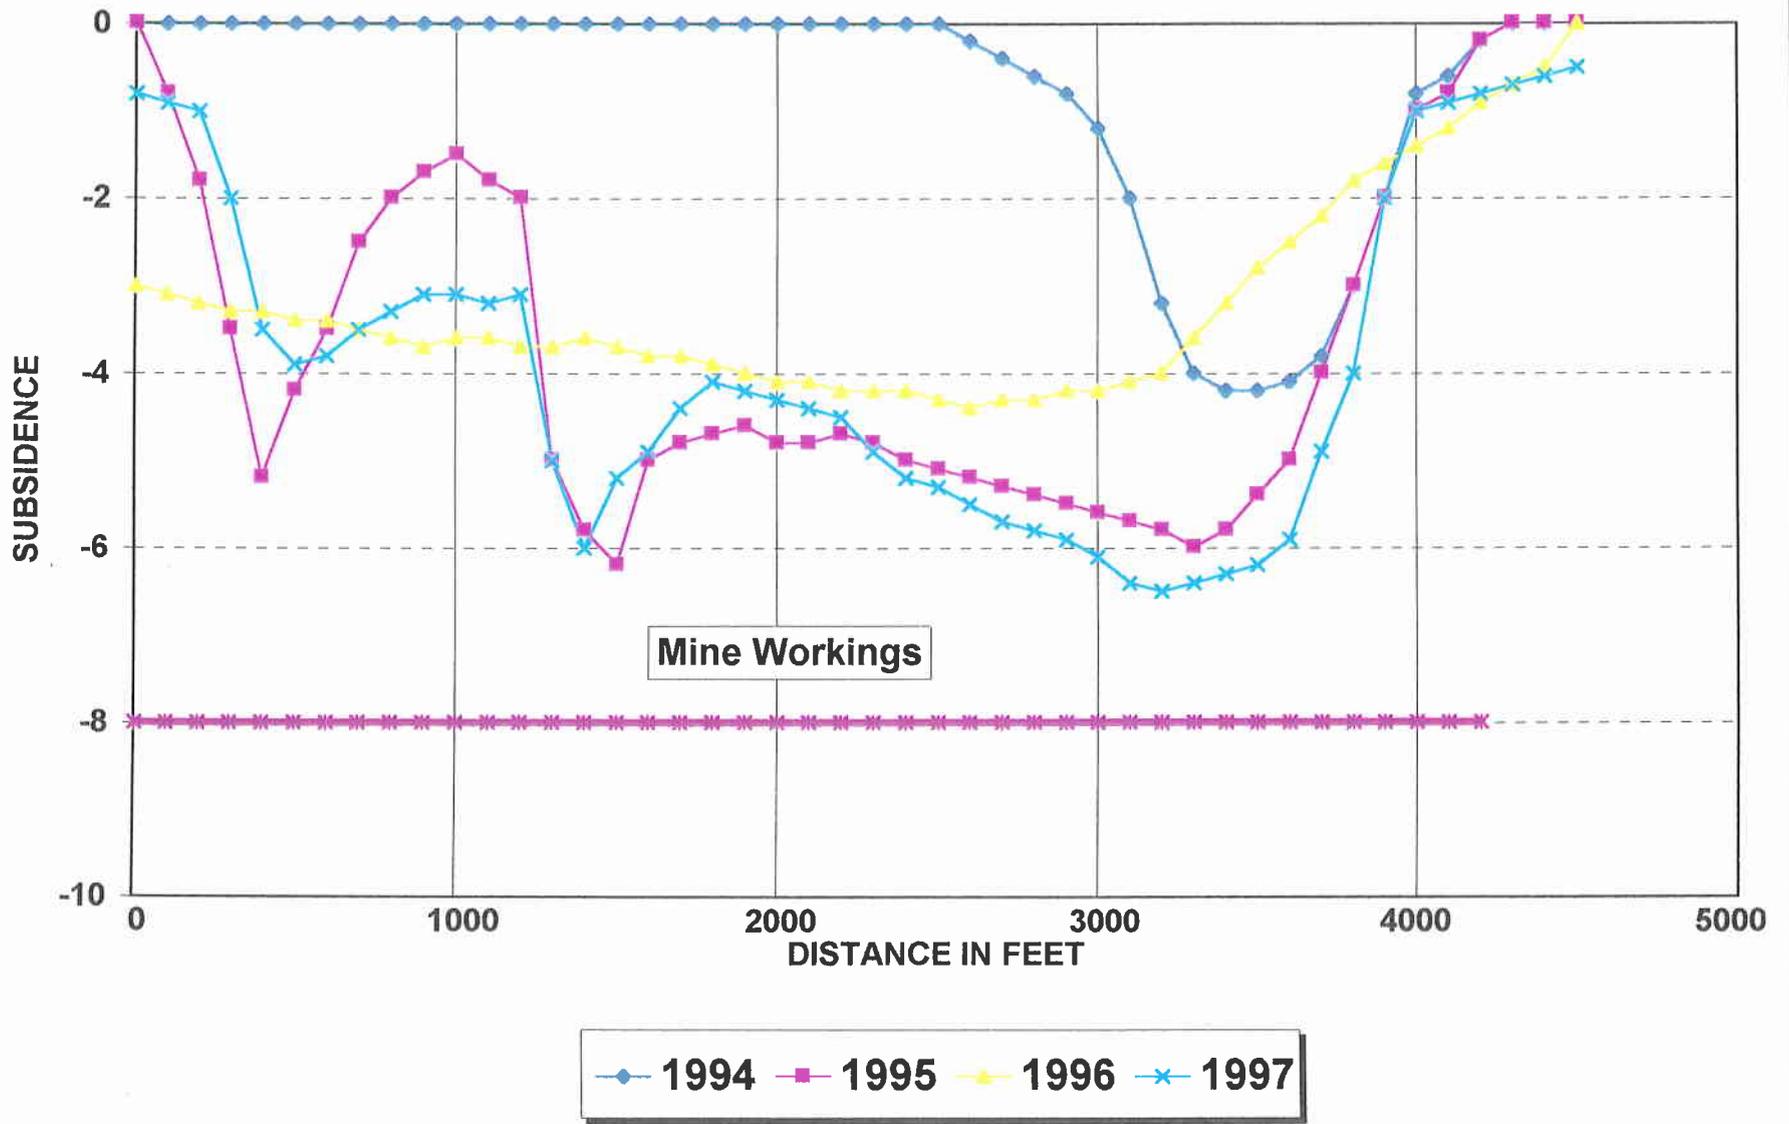
FIGURE 72

Area 21 Subsidence Profile North - South

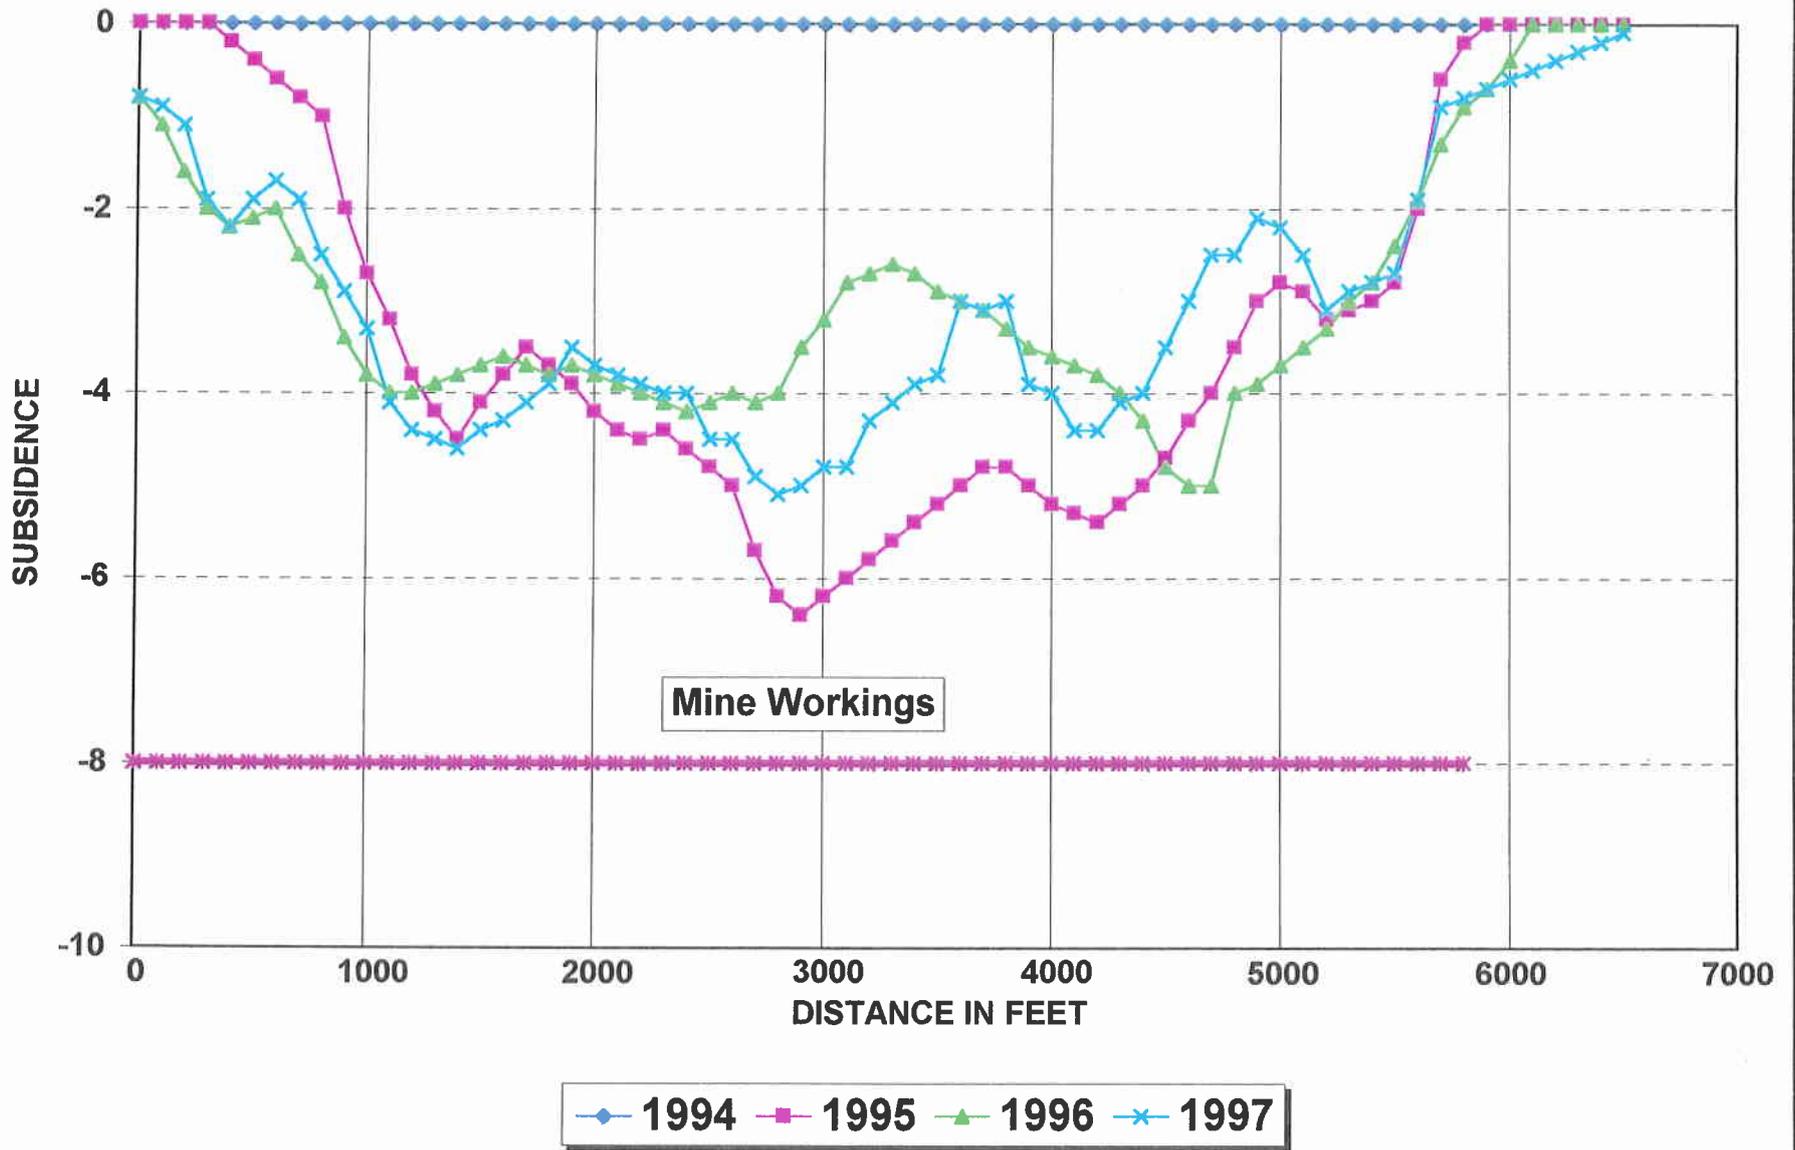
FIGURE 73

Area 21 Subsidence Profile West - East

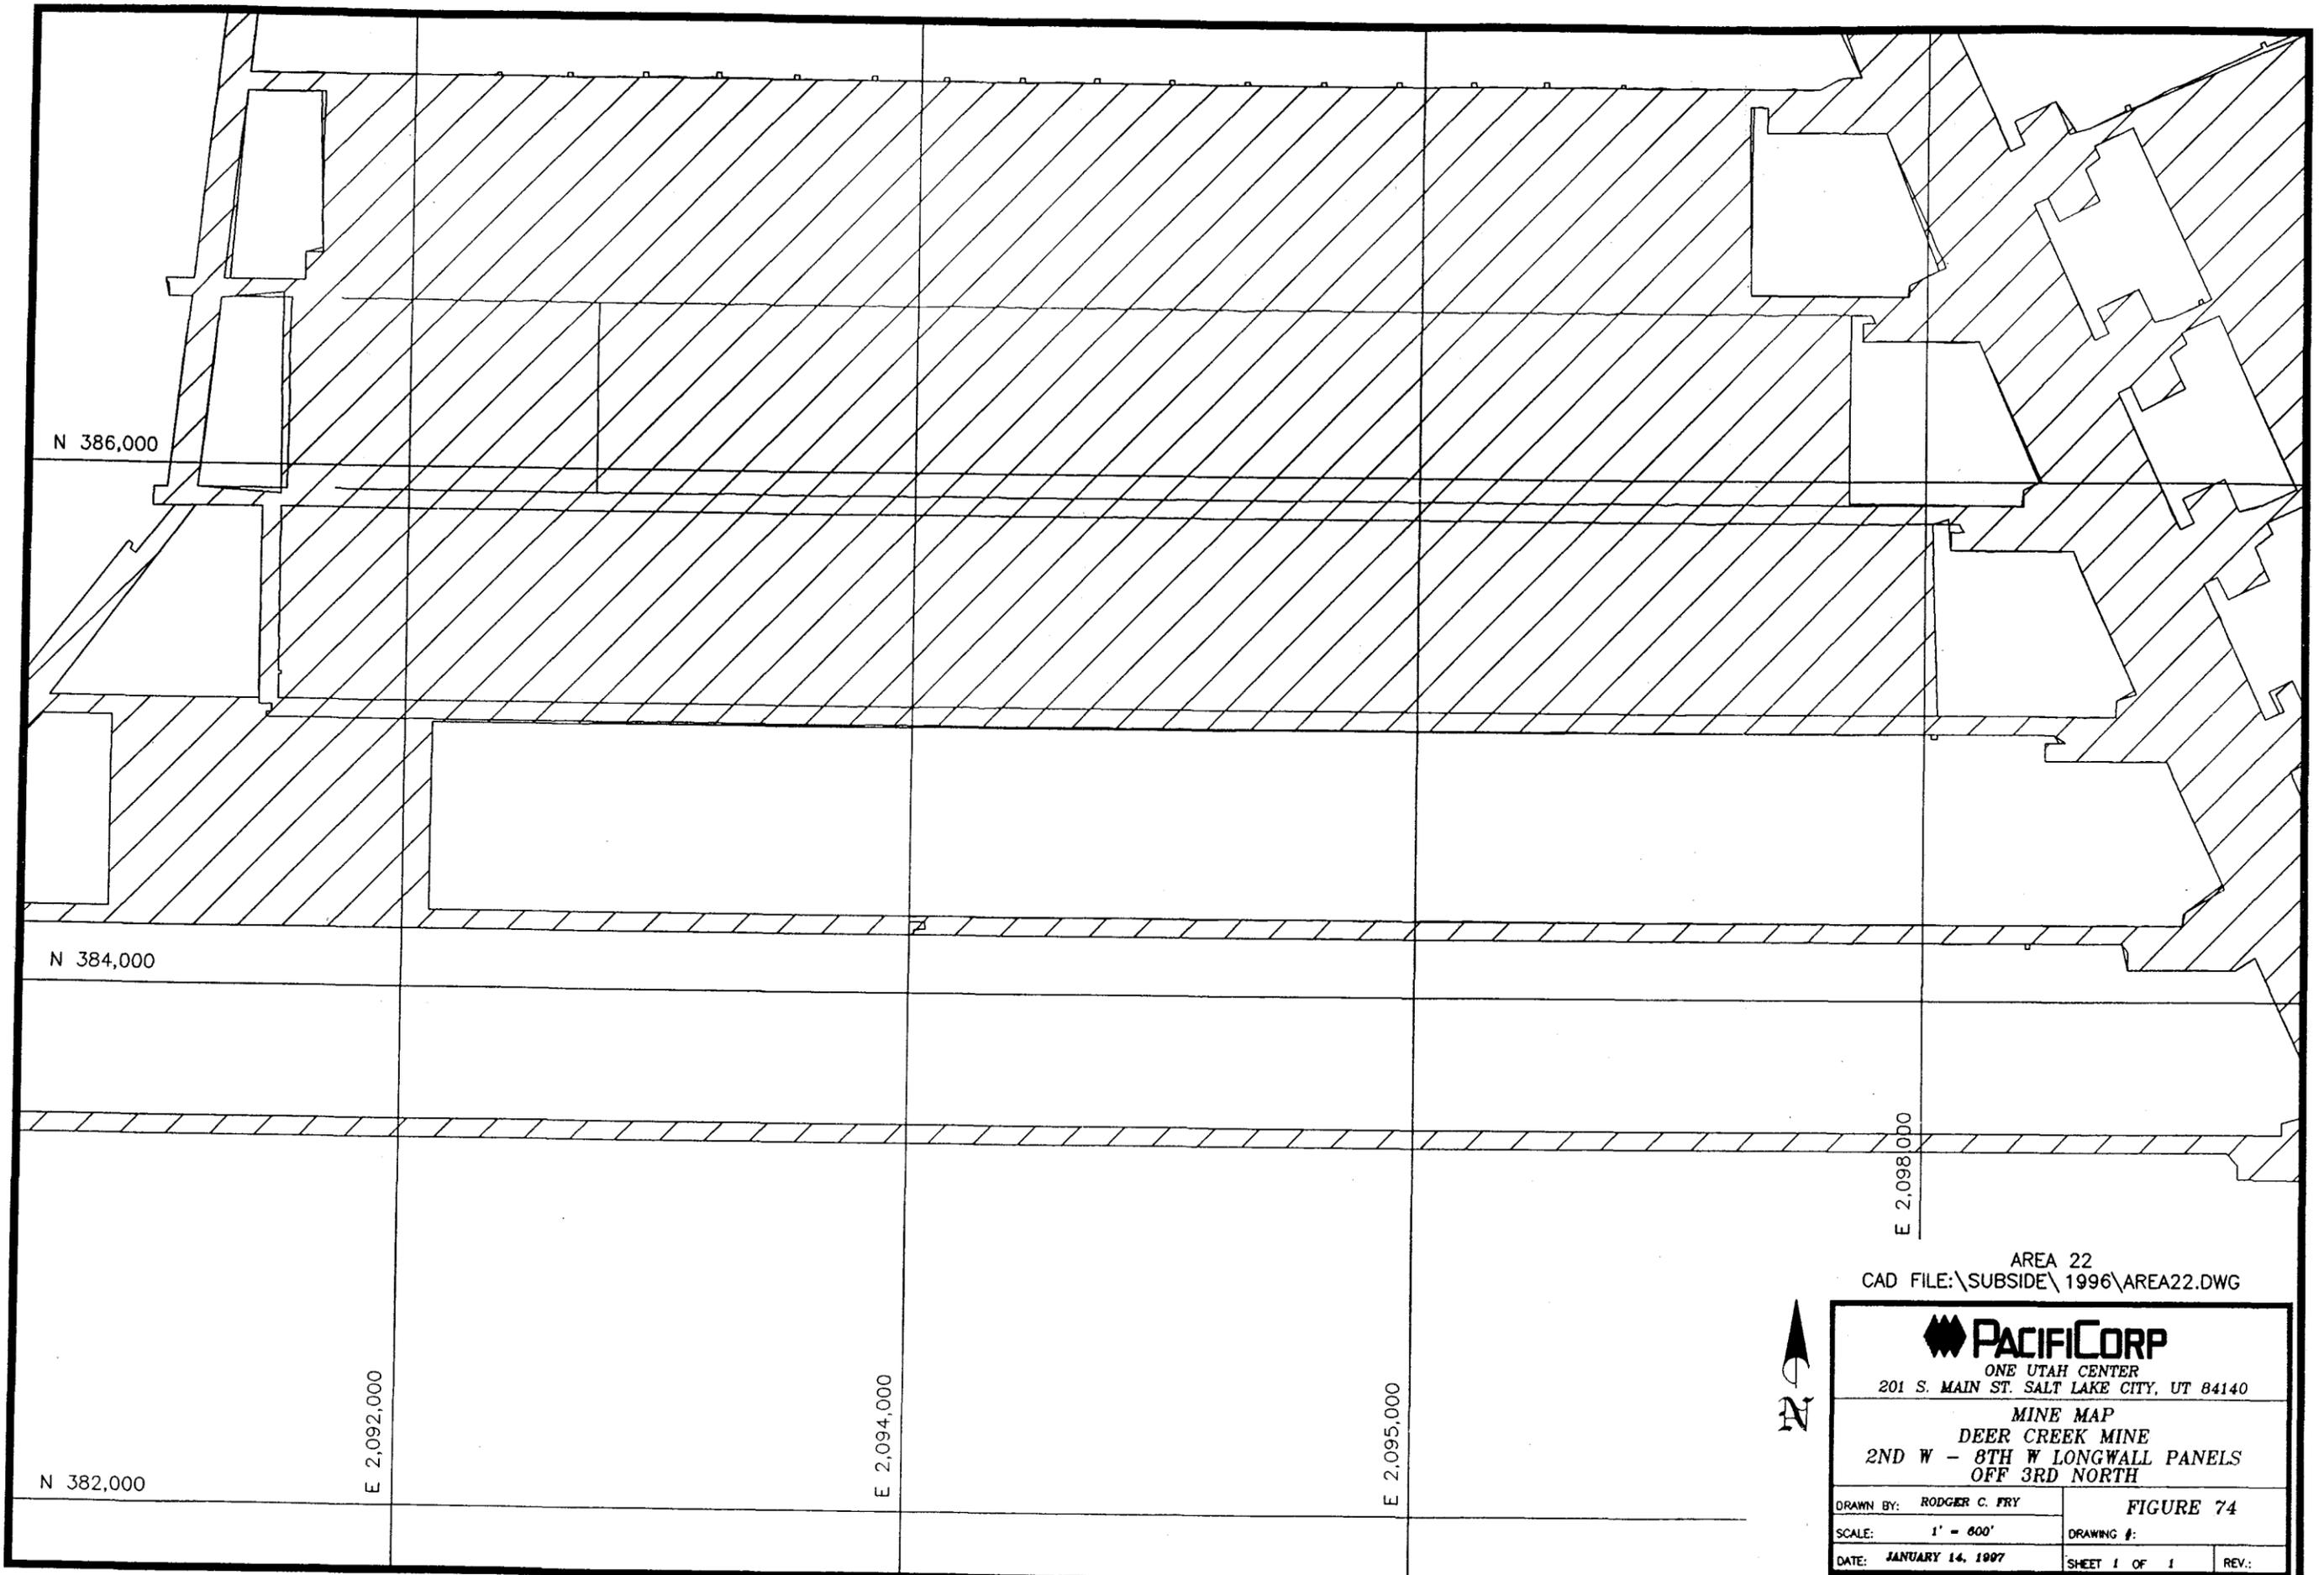
AREA 22
 CAD FILE: \SUBSIDE\1996\AREA22.DWG

monitoring (see figures 75, 76 and 77). It should be expected that as more panels to the south are mined the area of subsidence will broaden.

The subsidence that has occurred to date has had no effect on the springs or groundwater in the area (see 1997 Hydrologic Monitoring Report).

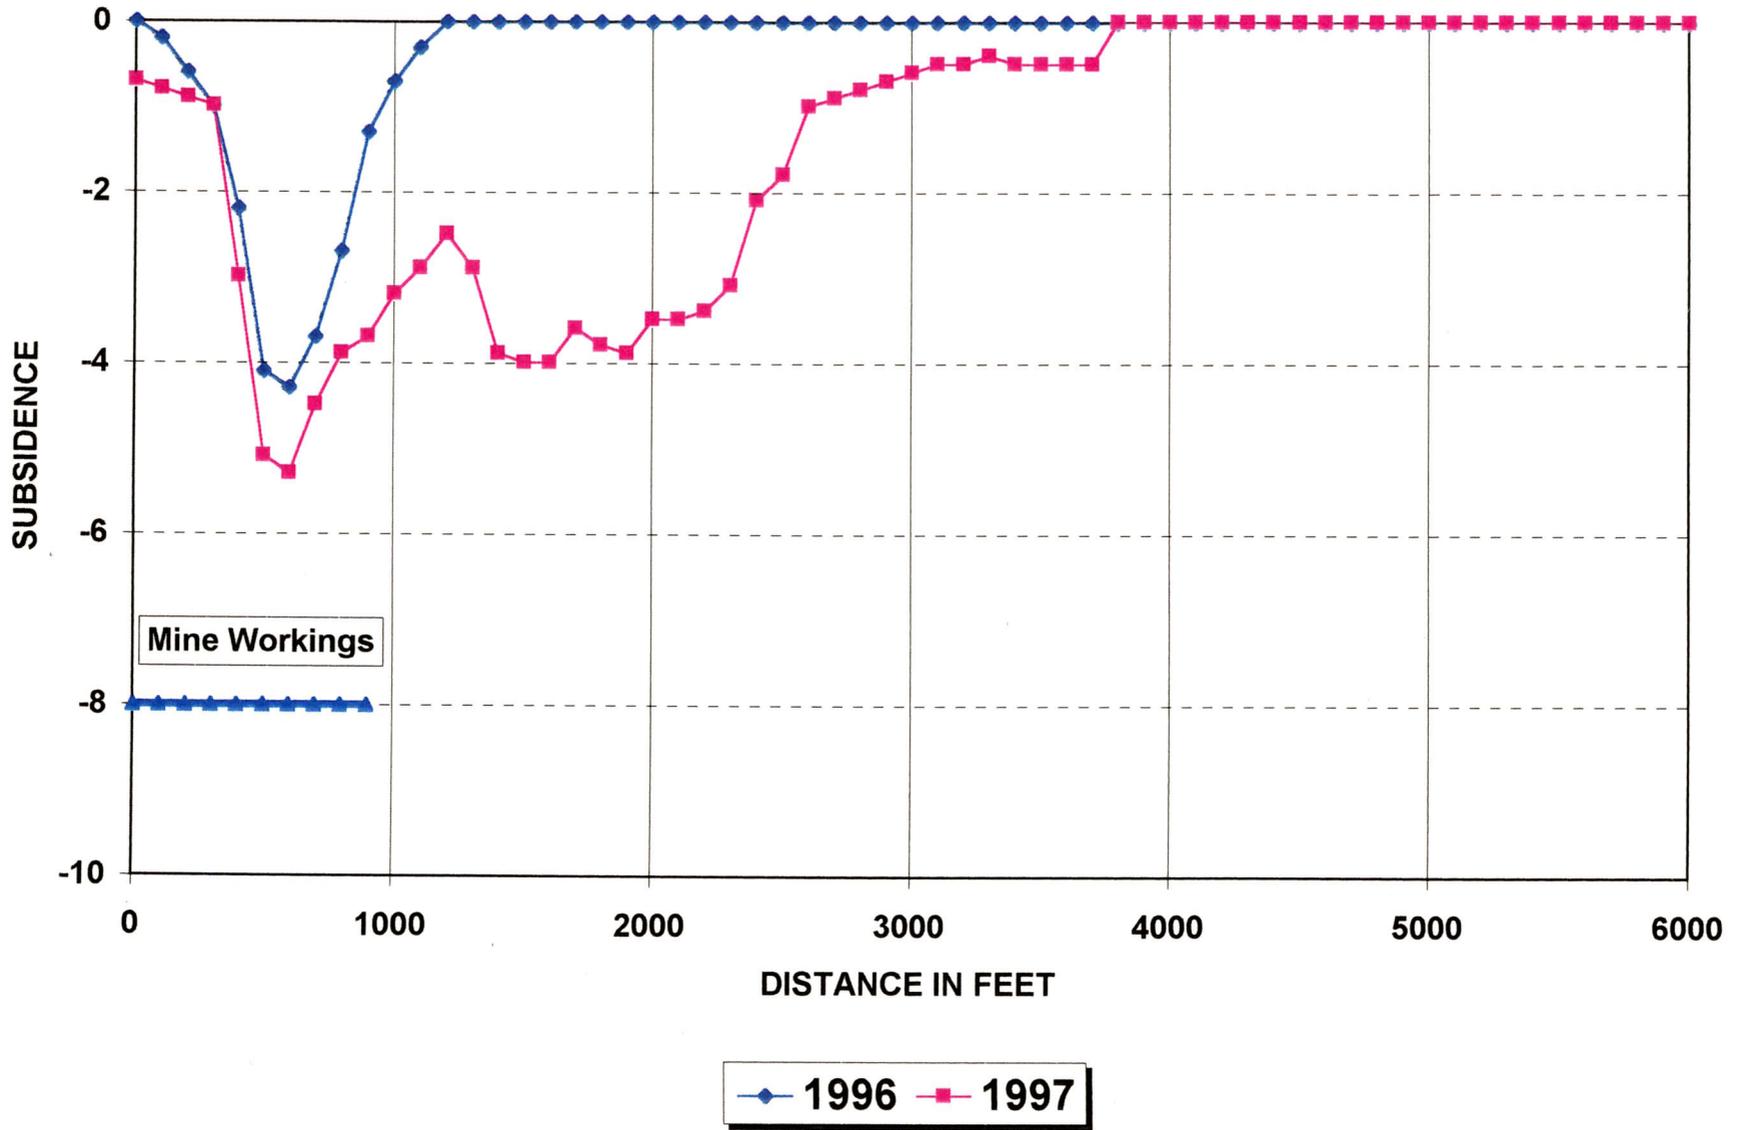
FIGURE 76

Area 22 Subsidence Profile North - South

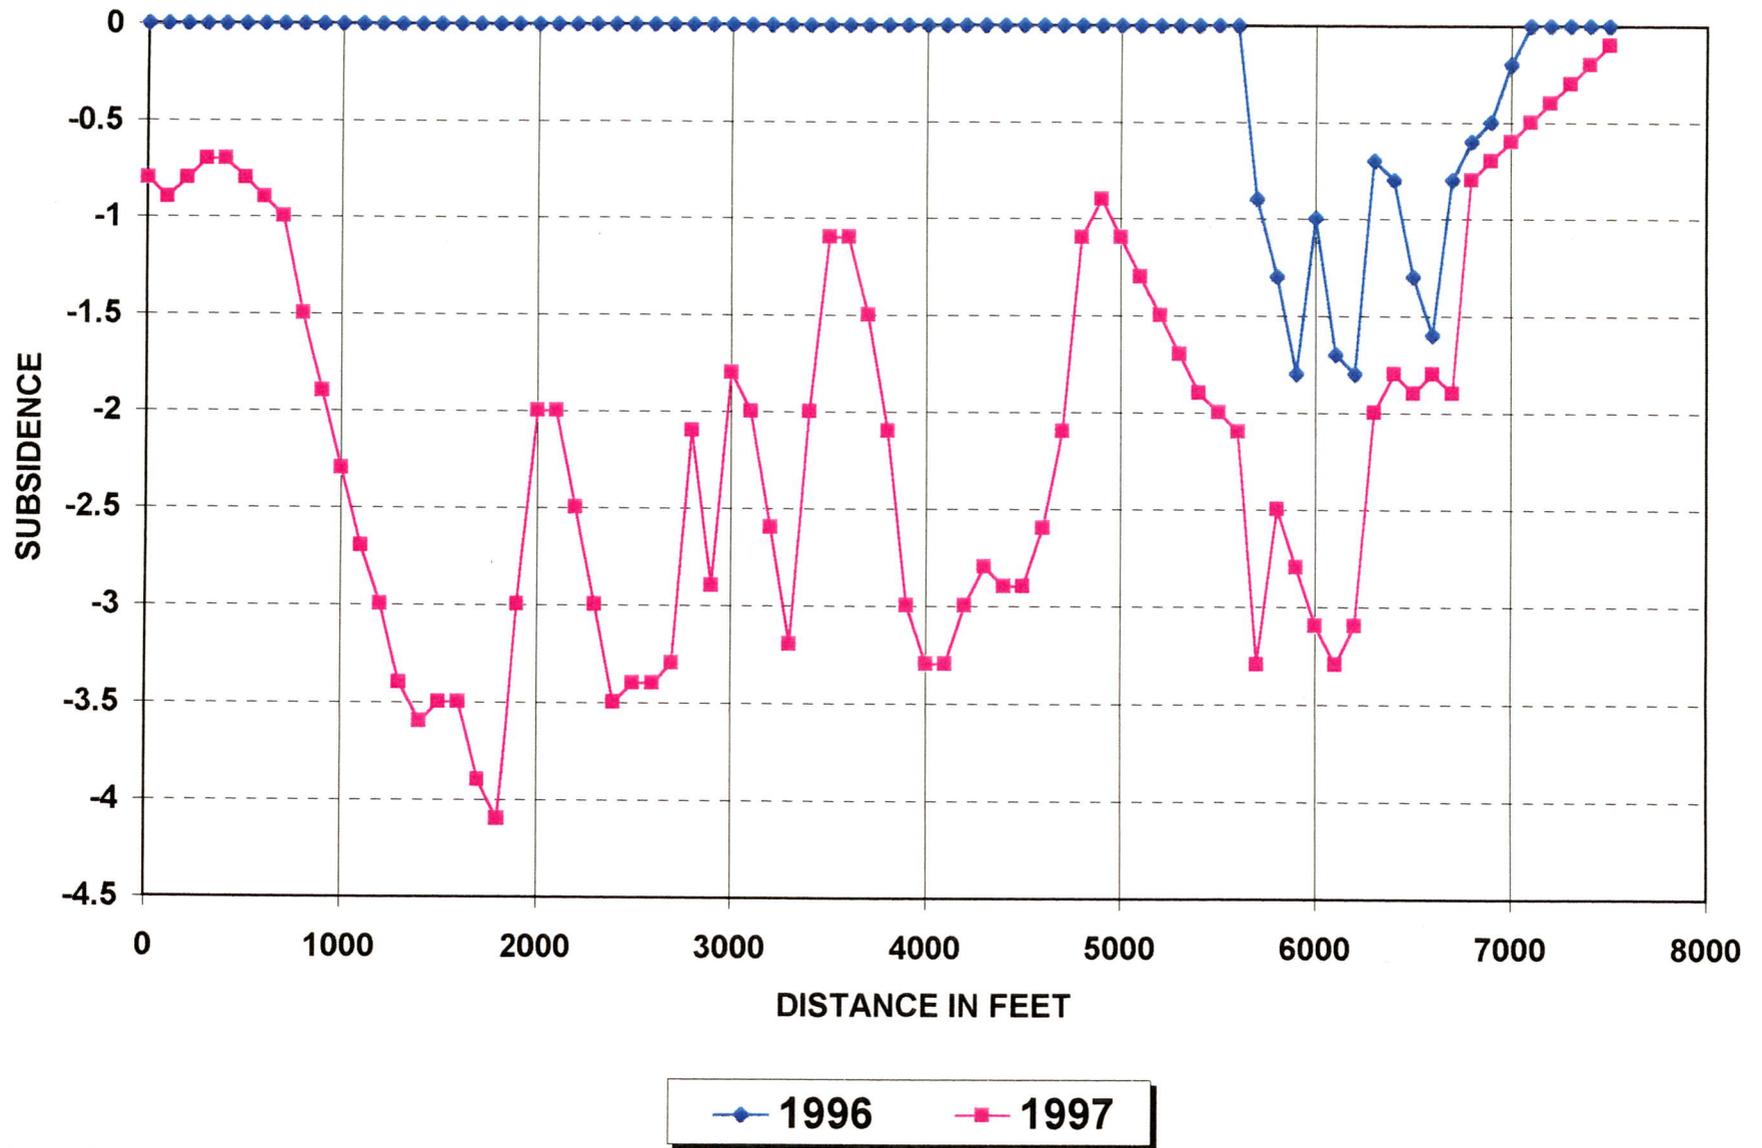
FIGURE 77

Area 22 Subsidence Profile West - East
