**1997 SUBSIDENCE
 COTTONWOOD MINE
 6TH & 7TH EAST LONGWALL PANELS**

Area 15

Cottonwood 9th and 12th West Longwall Panels

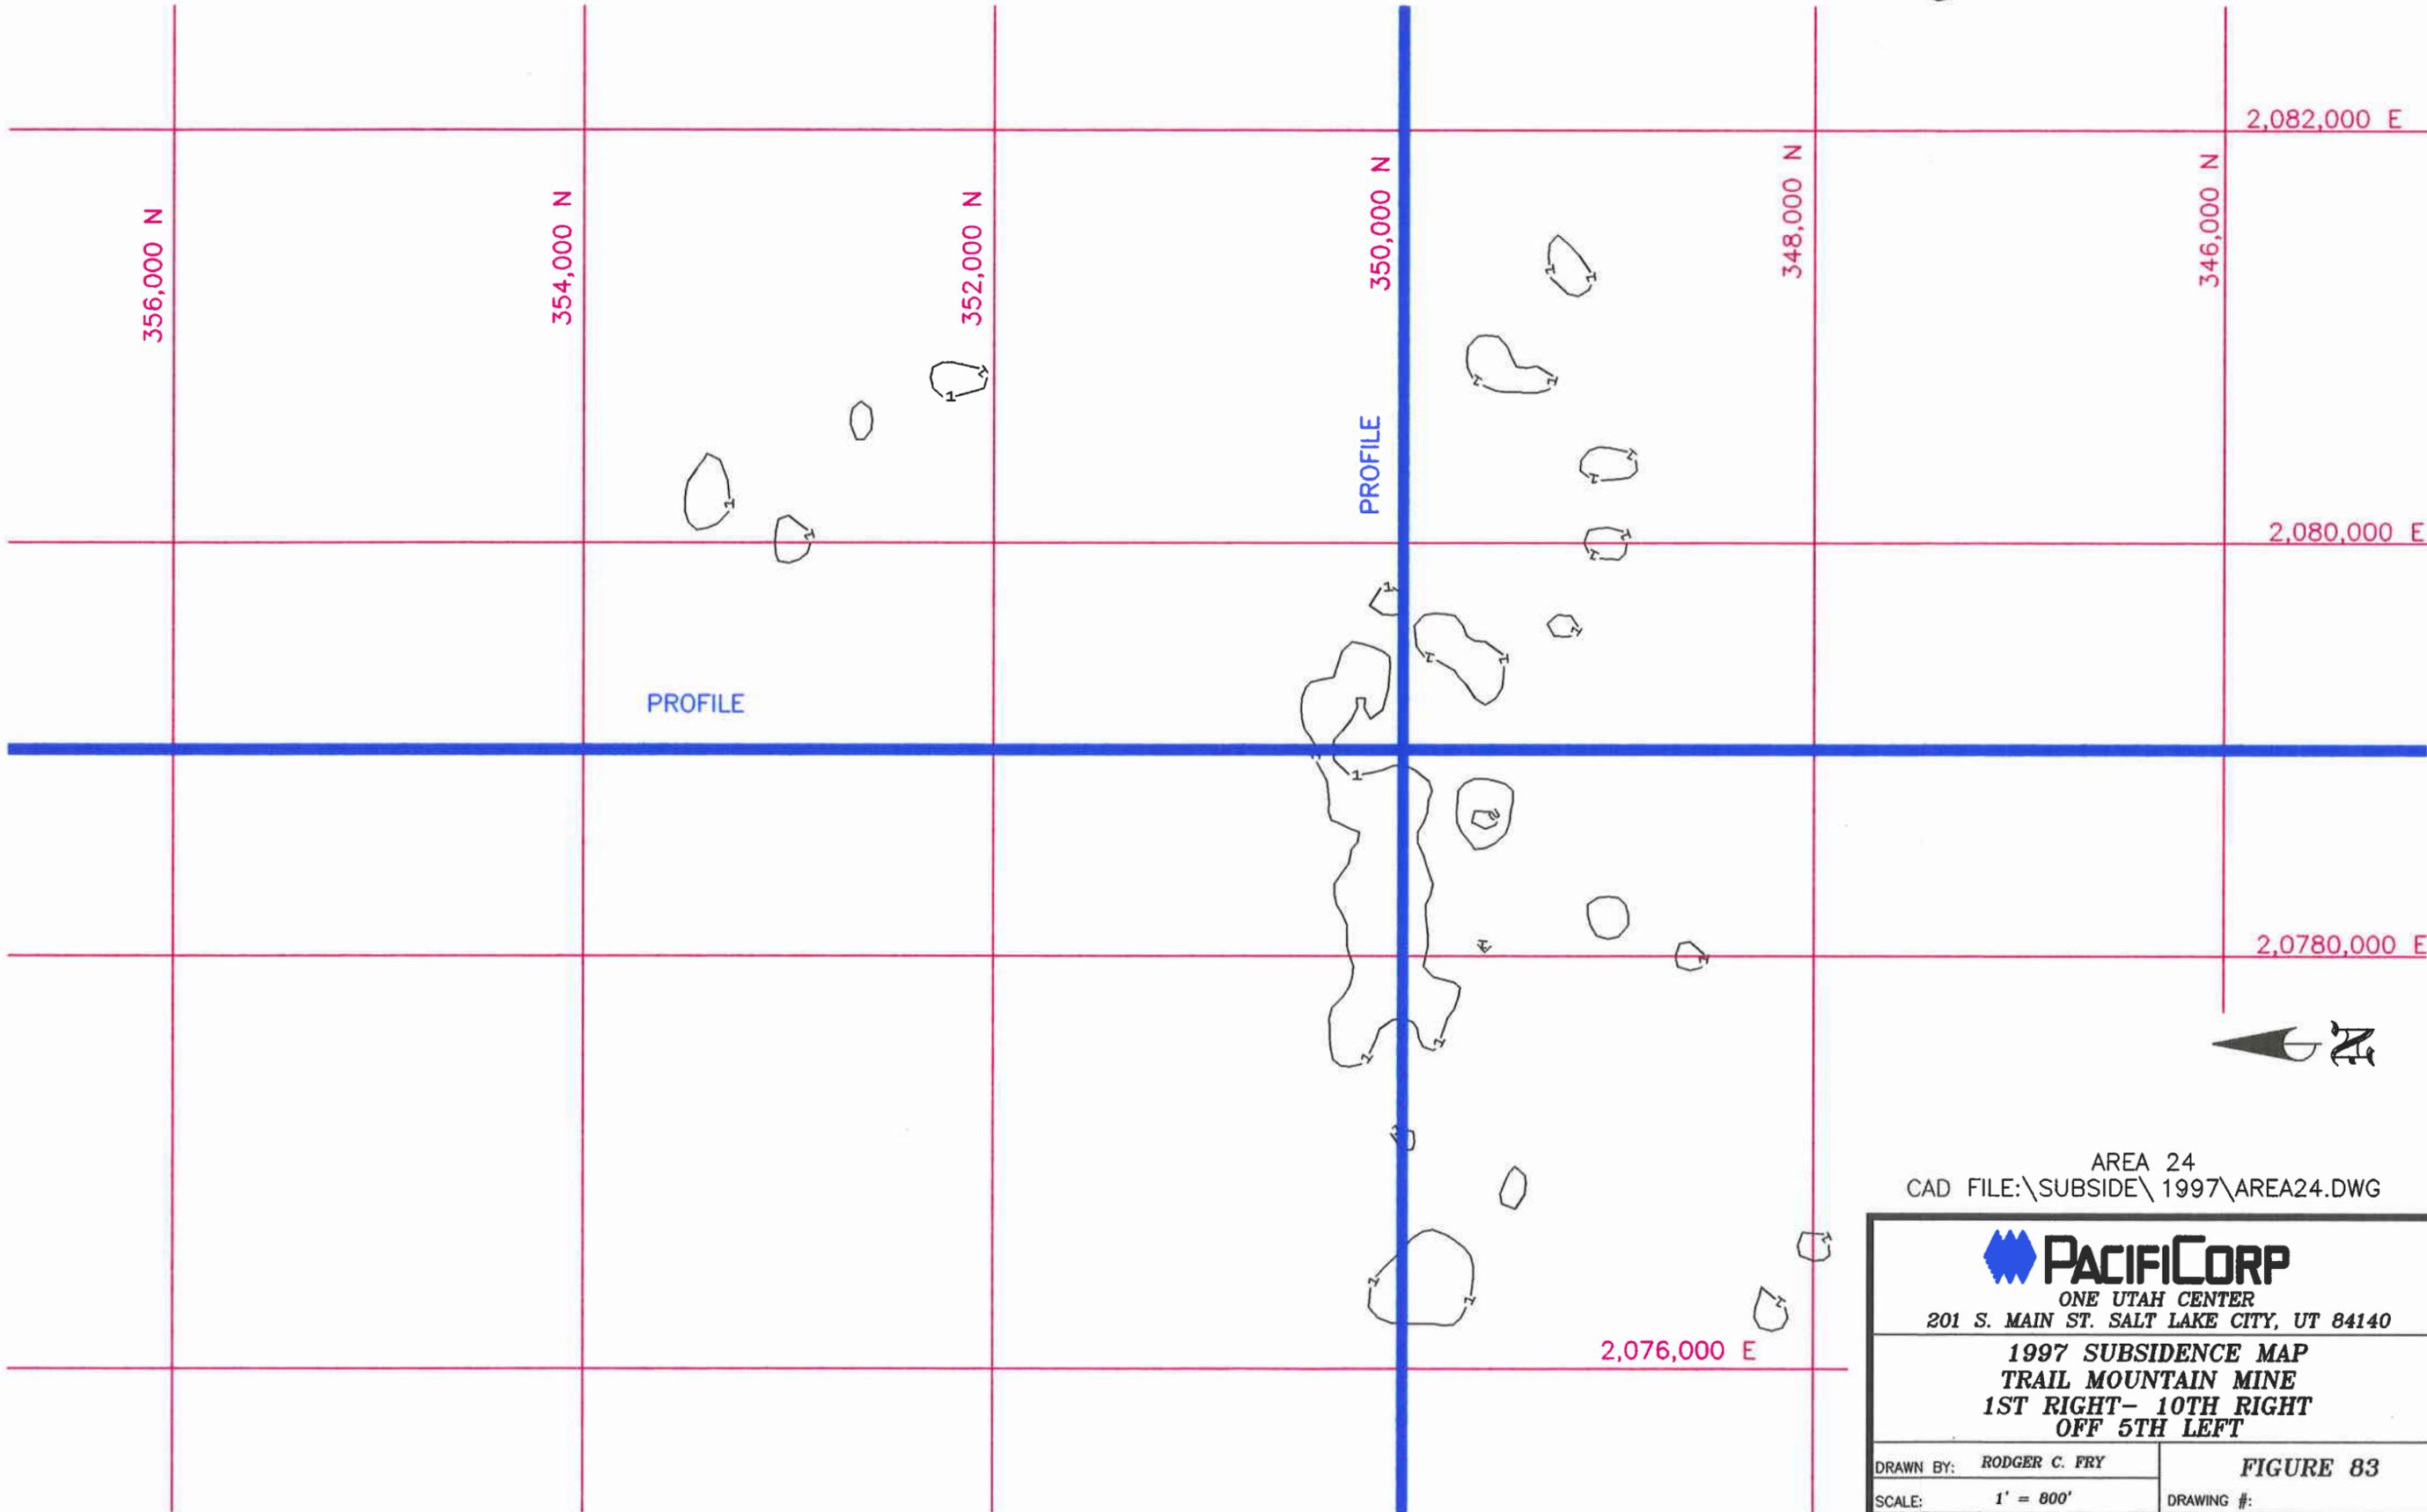
DRAWN BY: RODGER C. FRY	FIGURE 83	
SCALE: 1' = 800'	DRAWING #:	
DATE: March 5, 1998	SHEET 1 OF 1	REV.:

The subsidence monitoring showed that this area has only begun to subside. The maximum subsidence detected was just over two (2) feet (see figures 83, 84 and 85). Most of the area undermined has not begun to subside or has subsided less than one foot. As more panels are extracted, it is expected that the subsidence will increase to well over six feet.

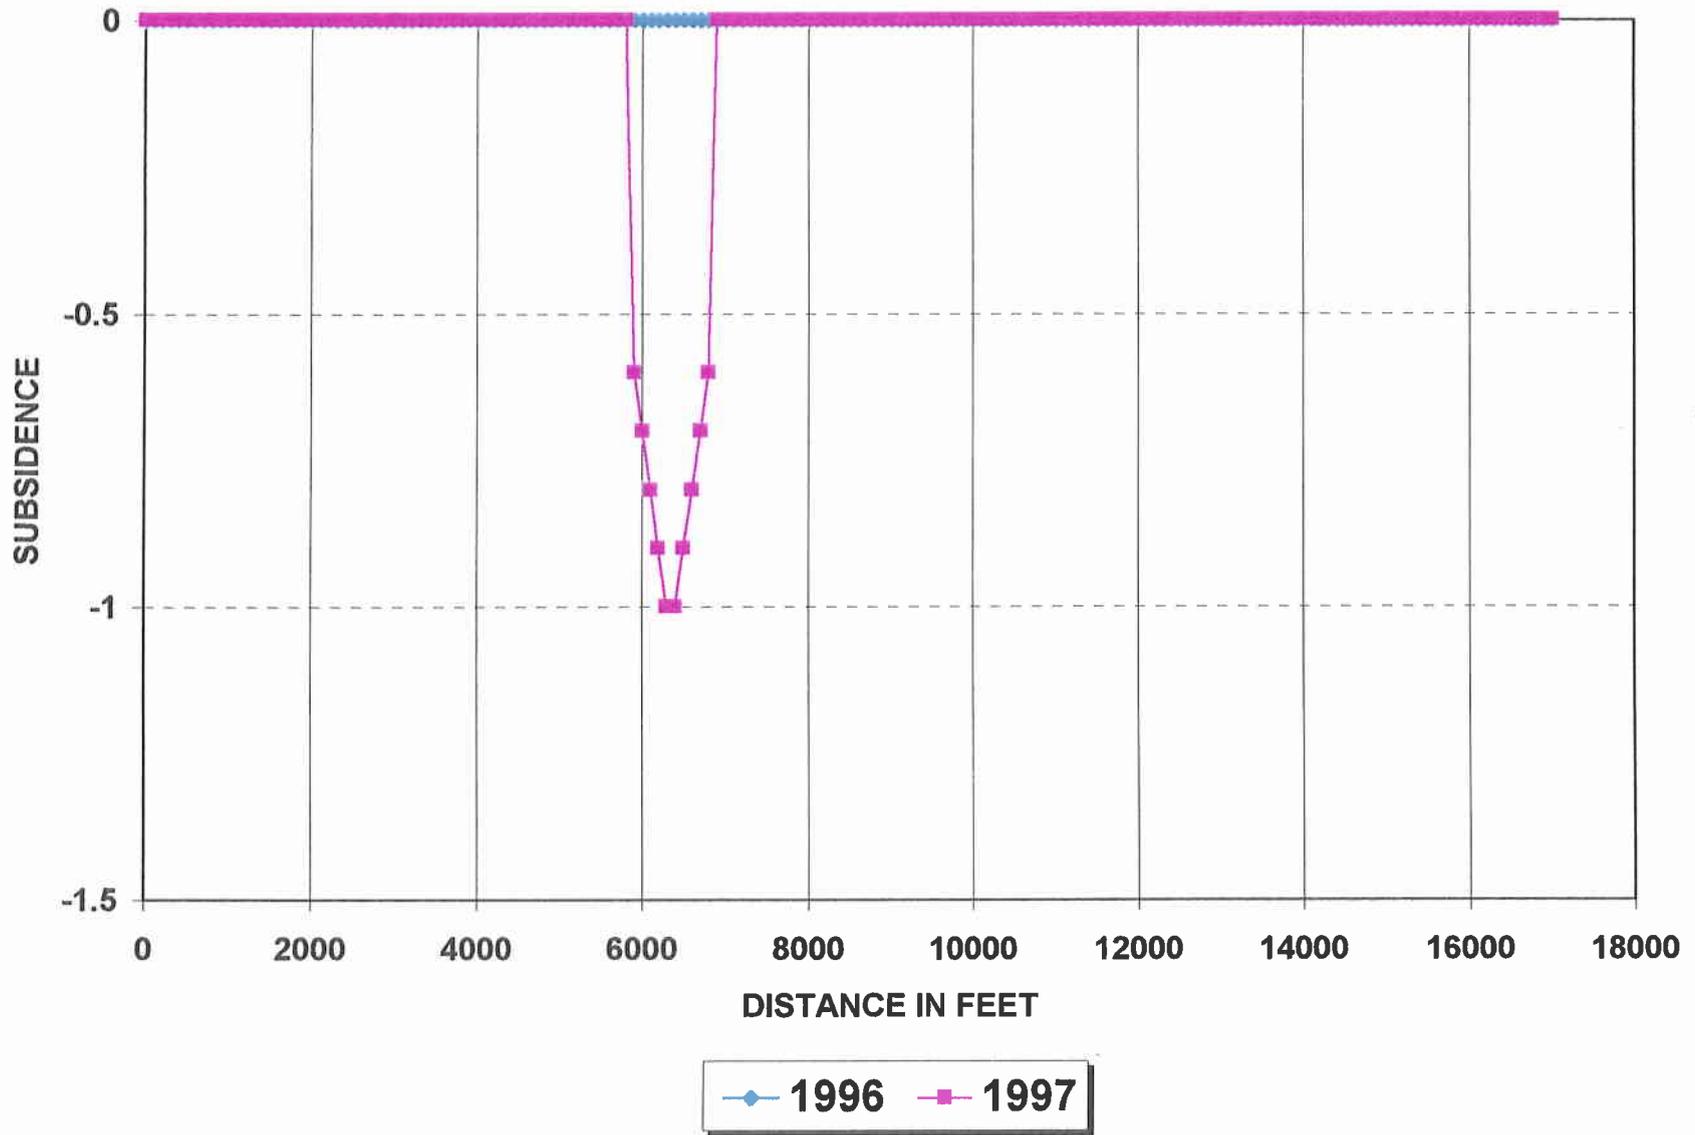
FIGURE 84

Area 24 Subsidence Profile North - South

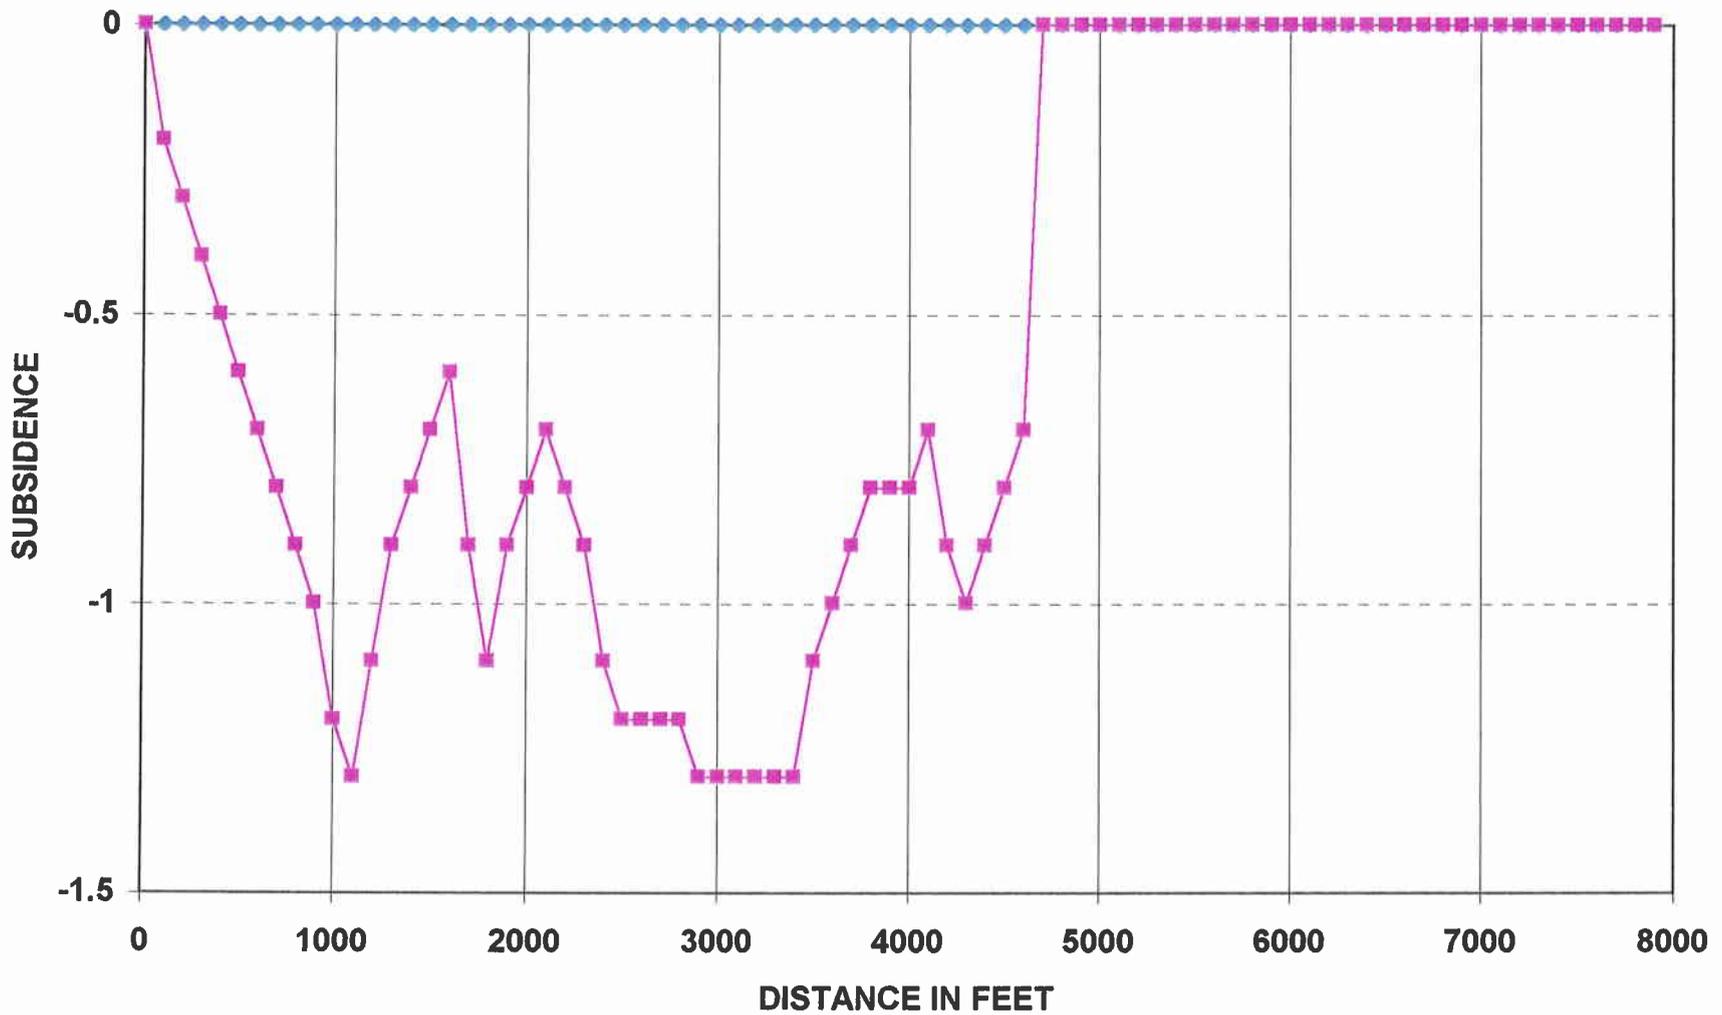
FIGURE 85

Area 24 Subsidence Profile West - East
