PACIFICORP
TECHNICAL SERVICES REPORT
RODGER C. FRY

CENTRAL ENGINEERING
ANNUAL SUBSIDENCE MONITORING REPORT
EAST/TRAIL MOUNTAIN PROPERTIES
2000

MARCH 30, 2001

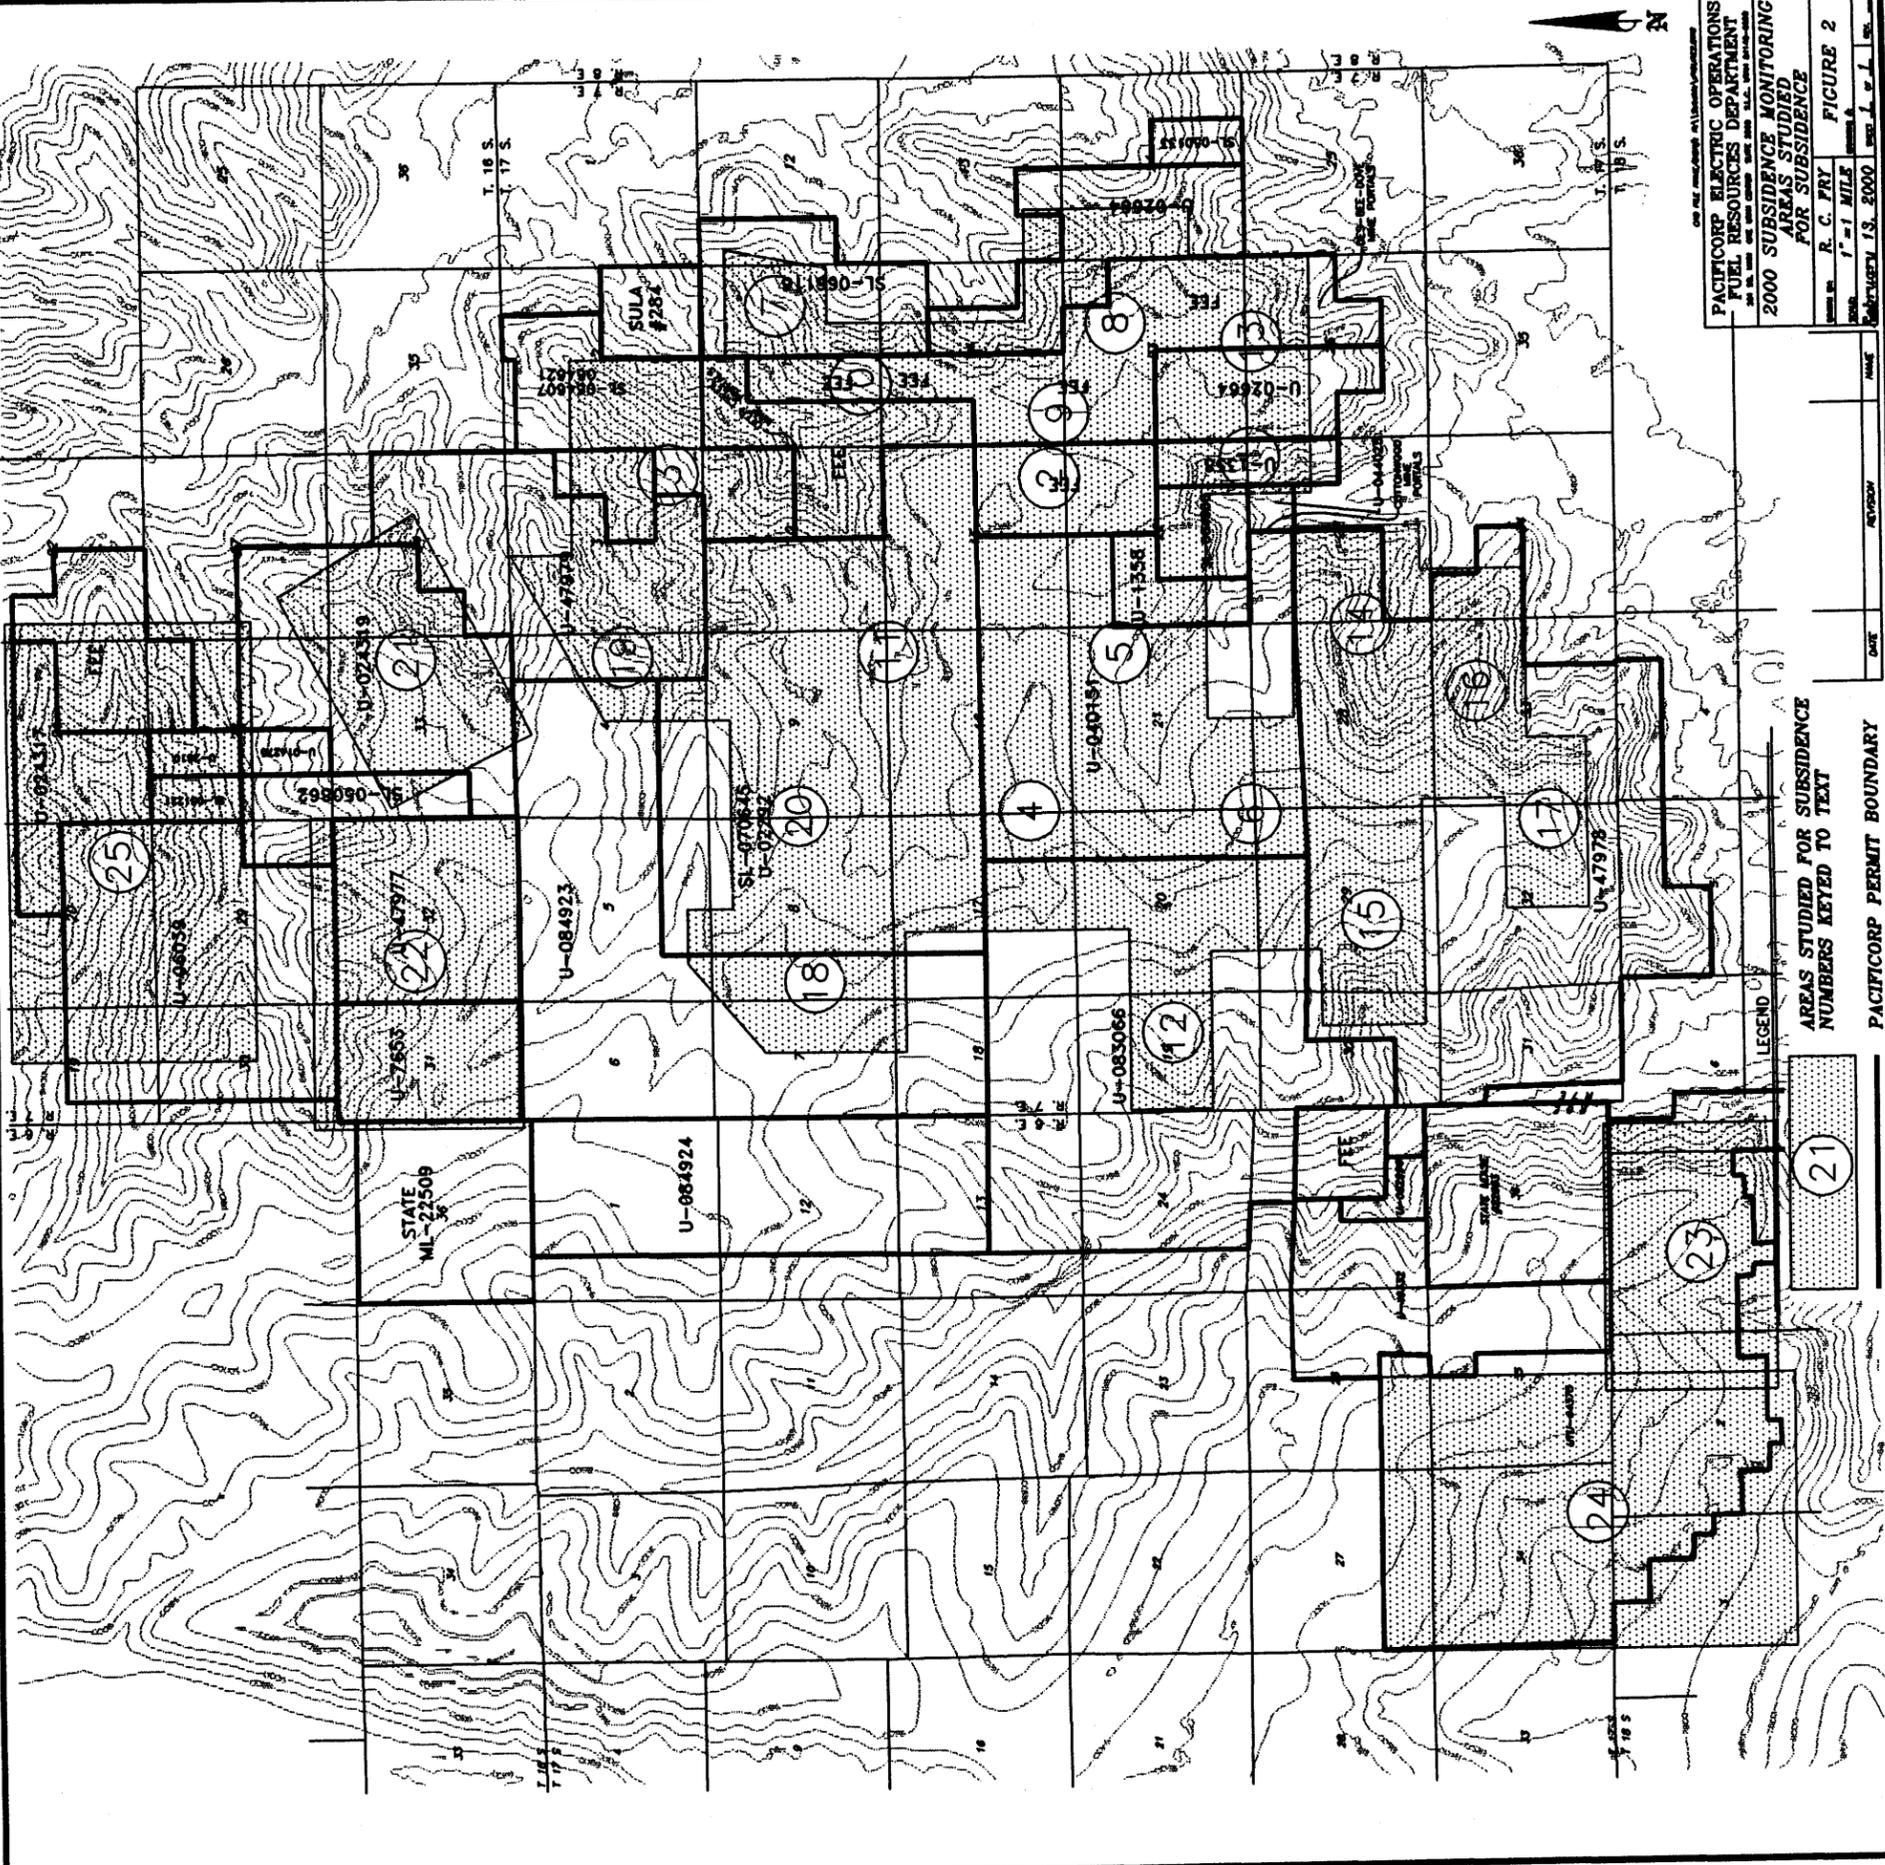
PACIFICORP ELECTRIC OPERATIONS
 FUEL RESOURCES DEPARTMENT
 2000 SUBSIDENCE MONITORING
 AREAS STUDIED
 FOR SUBSIDENCE

Figure 2 shows all areas above PacifiCorp's coal mines which have potential for mining-induced subsidence. In 2000, twenty-five areas of subsidence were monitored and are reported herein. In areas where subsidence has been detected, data is shown in the form of contour maps and profiles. Both indicate elevation change from pre-mining elevations. The profile figures present data for all years monitored with the exception of the 1990 data. The computer data files from that year were damaged rendering them unreadable. At this time it is felt that enough data exists from the other years and the task of regenerating that data is not warranted. In many areas of subsidence the angle-of-draw has been calculated and reported; however, in some of the cases the angle should not be considered the actual final angle-of-draw due to several factors. For example, the zone of subsidence to date may be small and contained within the underlying mined area, suggesting that the subsidence has not yet reached its maximum extent. Also, many mined

sections are surrounded by other older workings which influence the calculation. In a few areas where the mined-out workings are surrounded by burned coal, the failure of clinker beds promotes subsidence outside the mined area resulting in an angle-of-draw greater than might be expected.

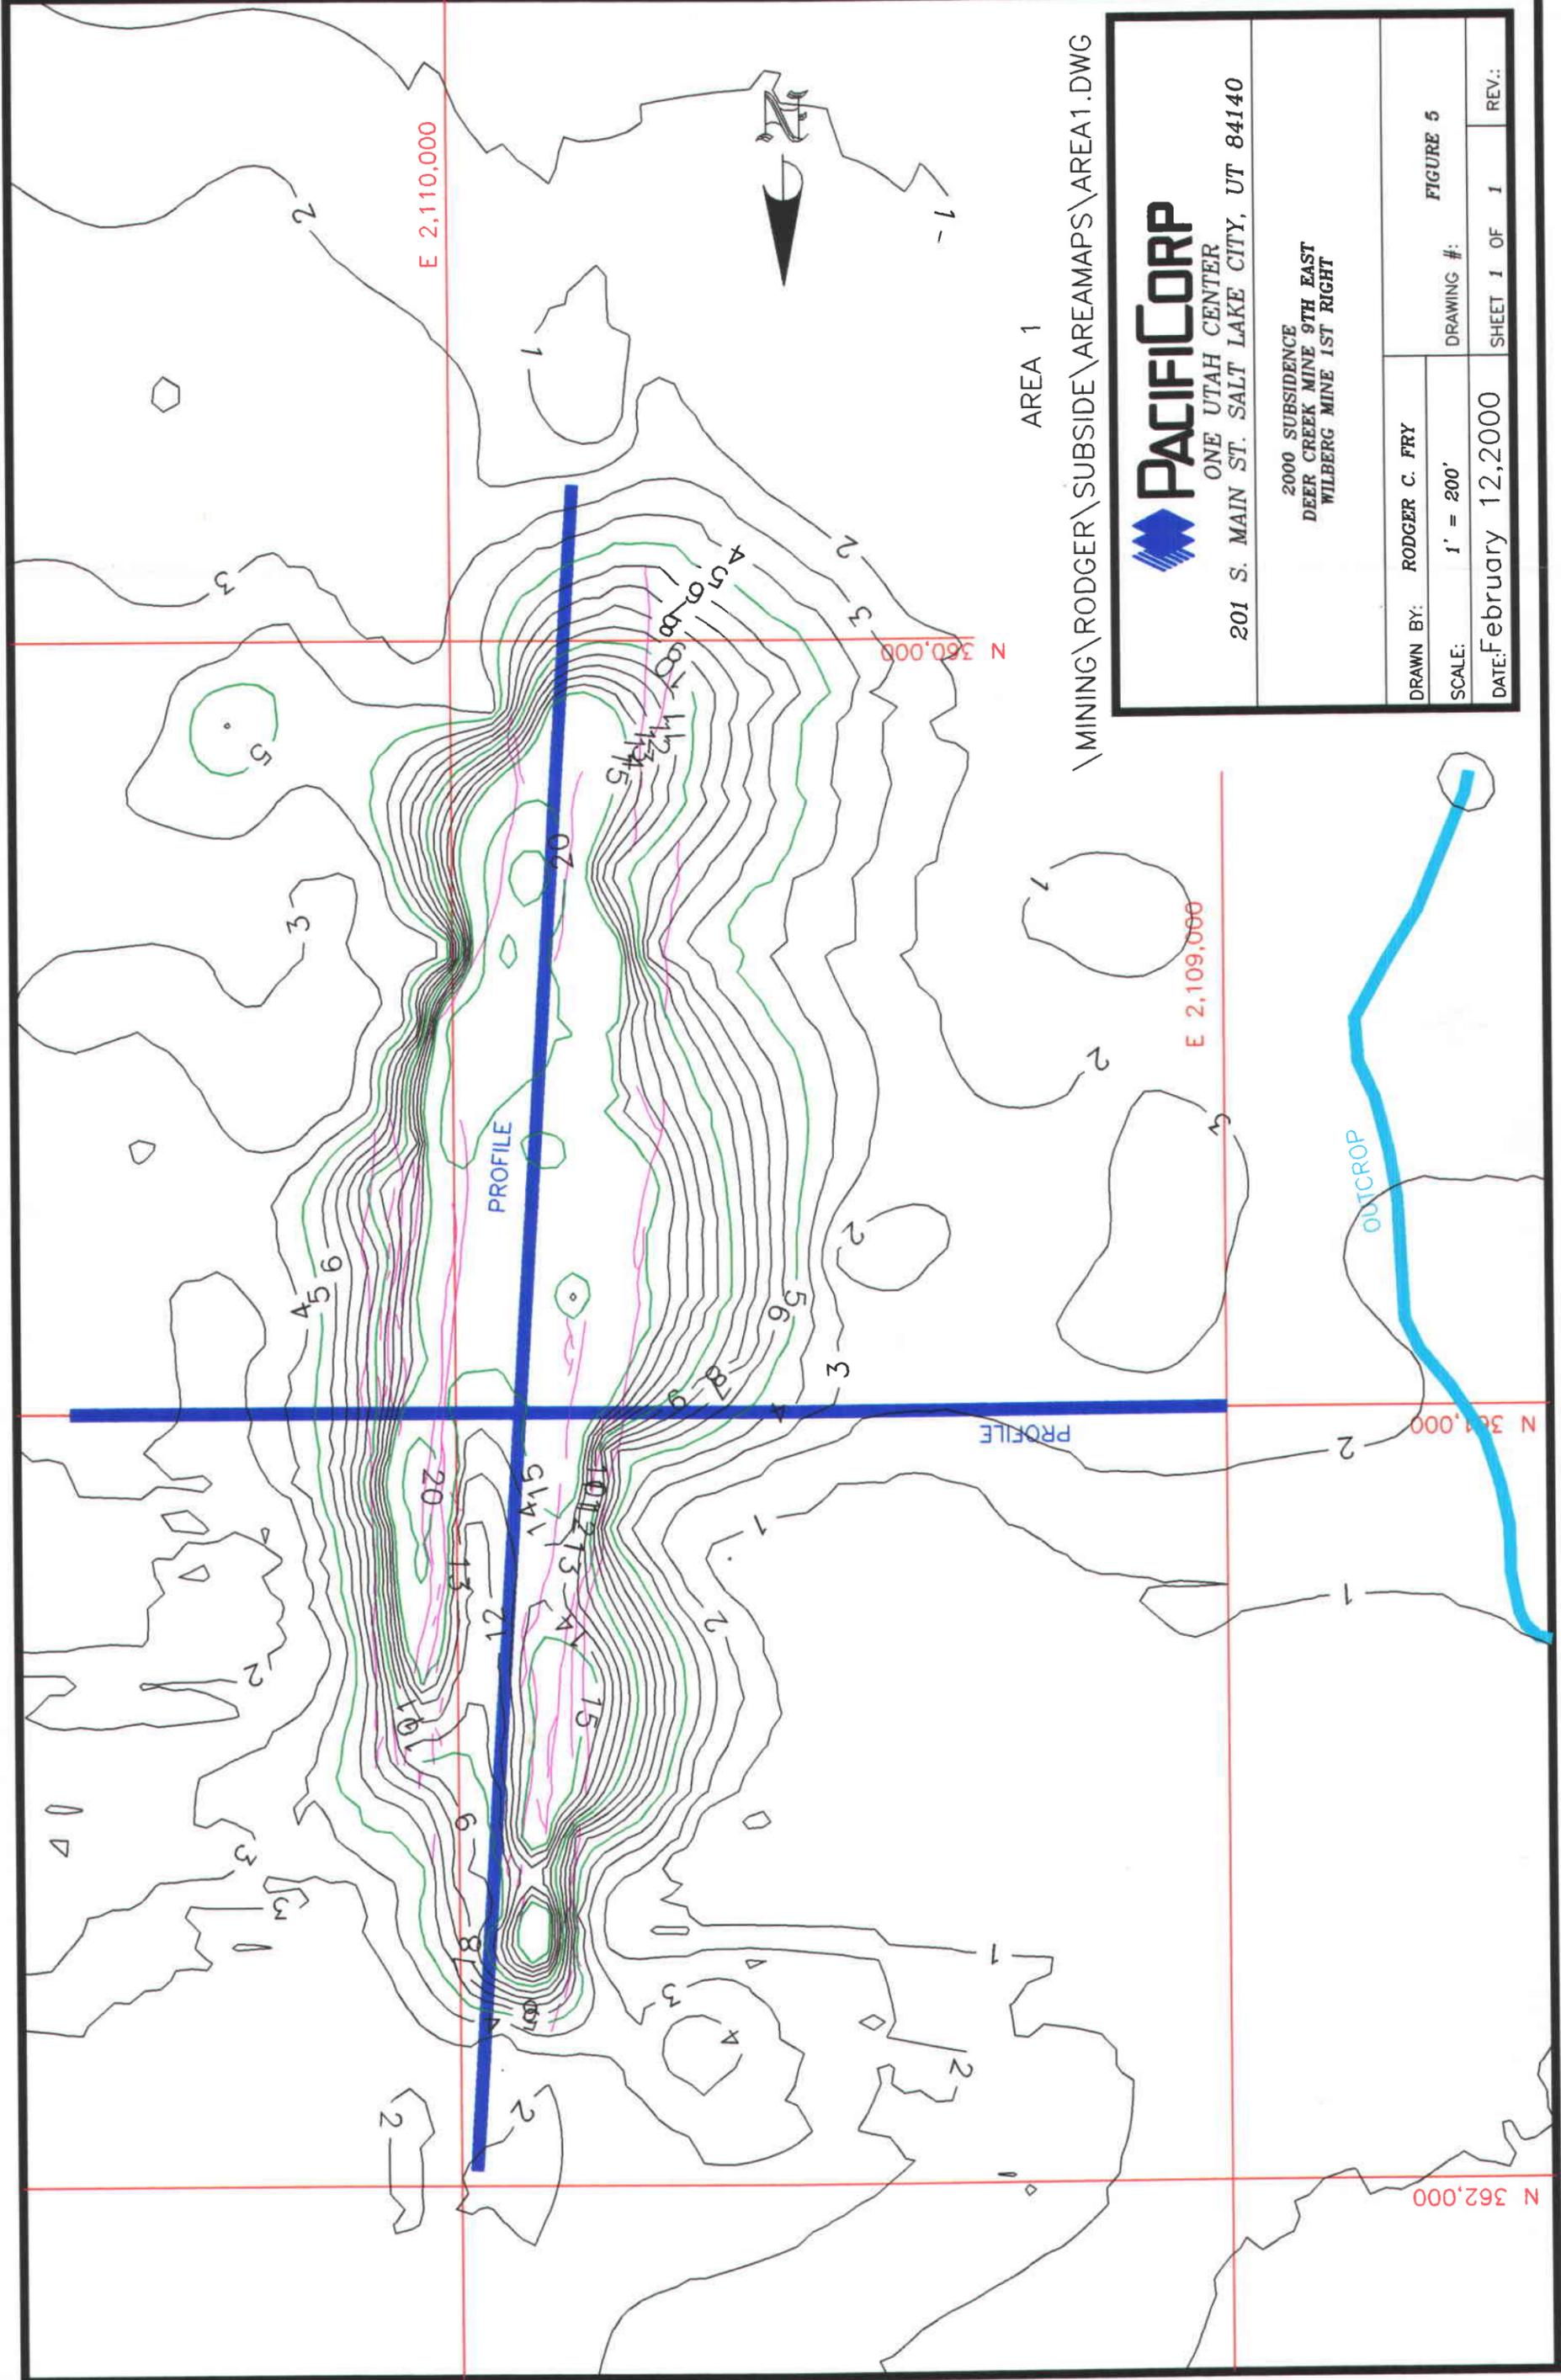
AREA 1

Figures 6 and 7 are north to south and west to east profiles showing the amount of subsidence in this area during the past sixteen years. The location of each line is shown on Figure 5. The area has seen little change since 1985 and appears to have totally stabilized. Maximum subsidence remains at about twenty-eight (28) feet. A detailed look from a helicopter revealed that the subsidence maximum is located on a steep slope, about 200 feet south of the southernmost mining, where a good-sized rotational slump has occurred. The workings here are also surrounded by burned coal. It is probable that the combination of steep slopes and crushing of clinker beds has allowed subsidence to occur well outside the area of mine workings. An inspection of the area from the ground indicates that many of the open fractures forming the graben-like structure have begun to heal and fill in with soil.

Calculation of the angle-of-draw is complicated because the workings are nearly surrounded by faults, burned coal, and other mine workings. Due to this complexity, angle-of-draw was not determined for Area 1.

In the summer of 1997, some of the fractures in this area were reclaimed per the U. S. Forest Service recommendations. This reclamation consisted of knocking down the abrupt escarpments and filling in the fractures in accessible areas. The top soil was then evenly distributed and the area re-seeded. This reclamation was completed by September 1, 1997 and encompassed 1.5 acres. Visual inspection of the area in the summers of 1999 and 2000 indicated that the vegetation has grown over the disturbed area to where it blends in with the surrounding areas.

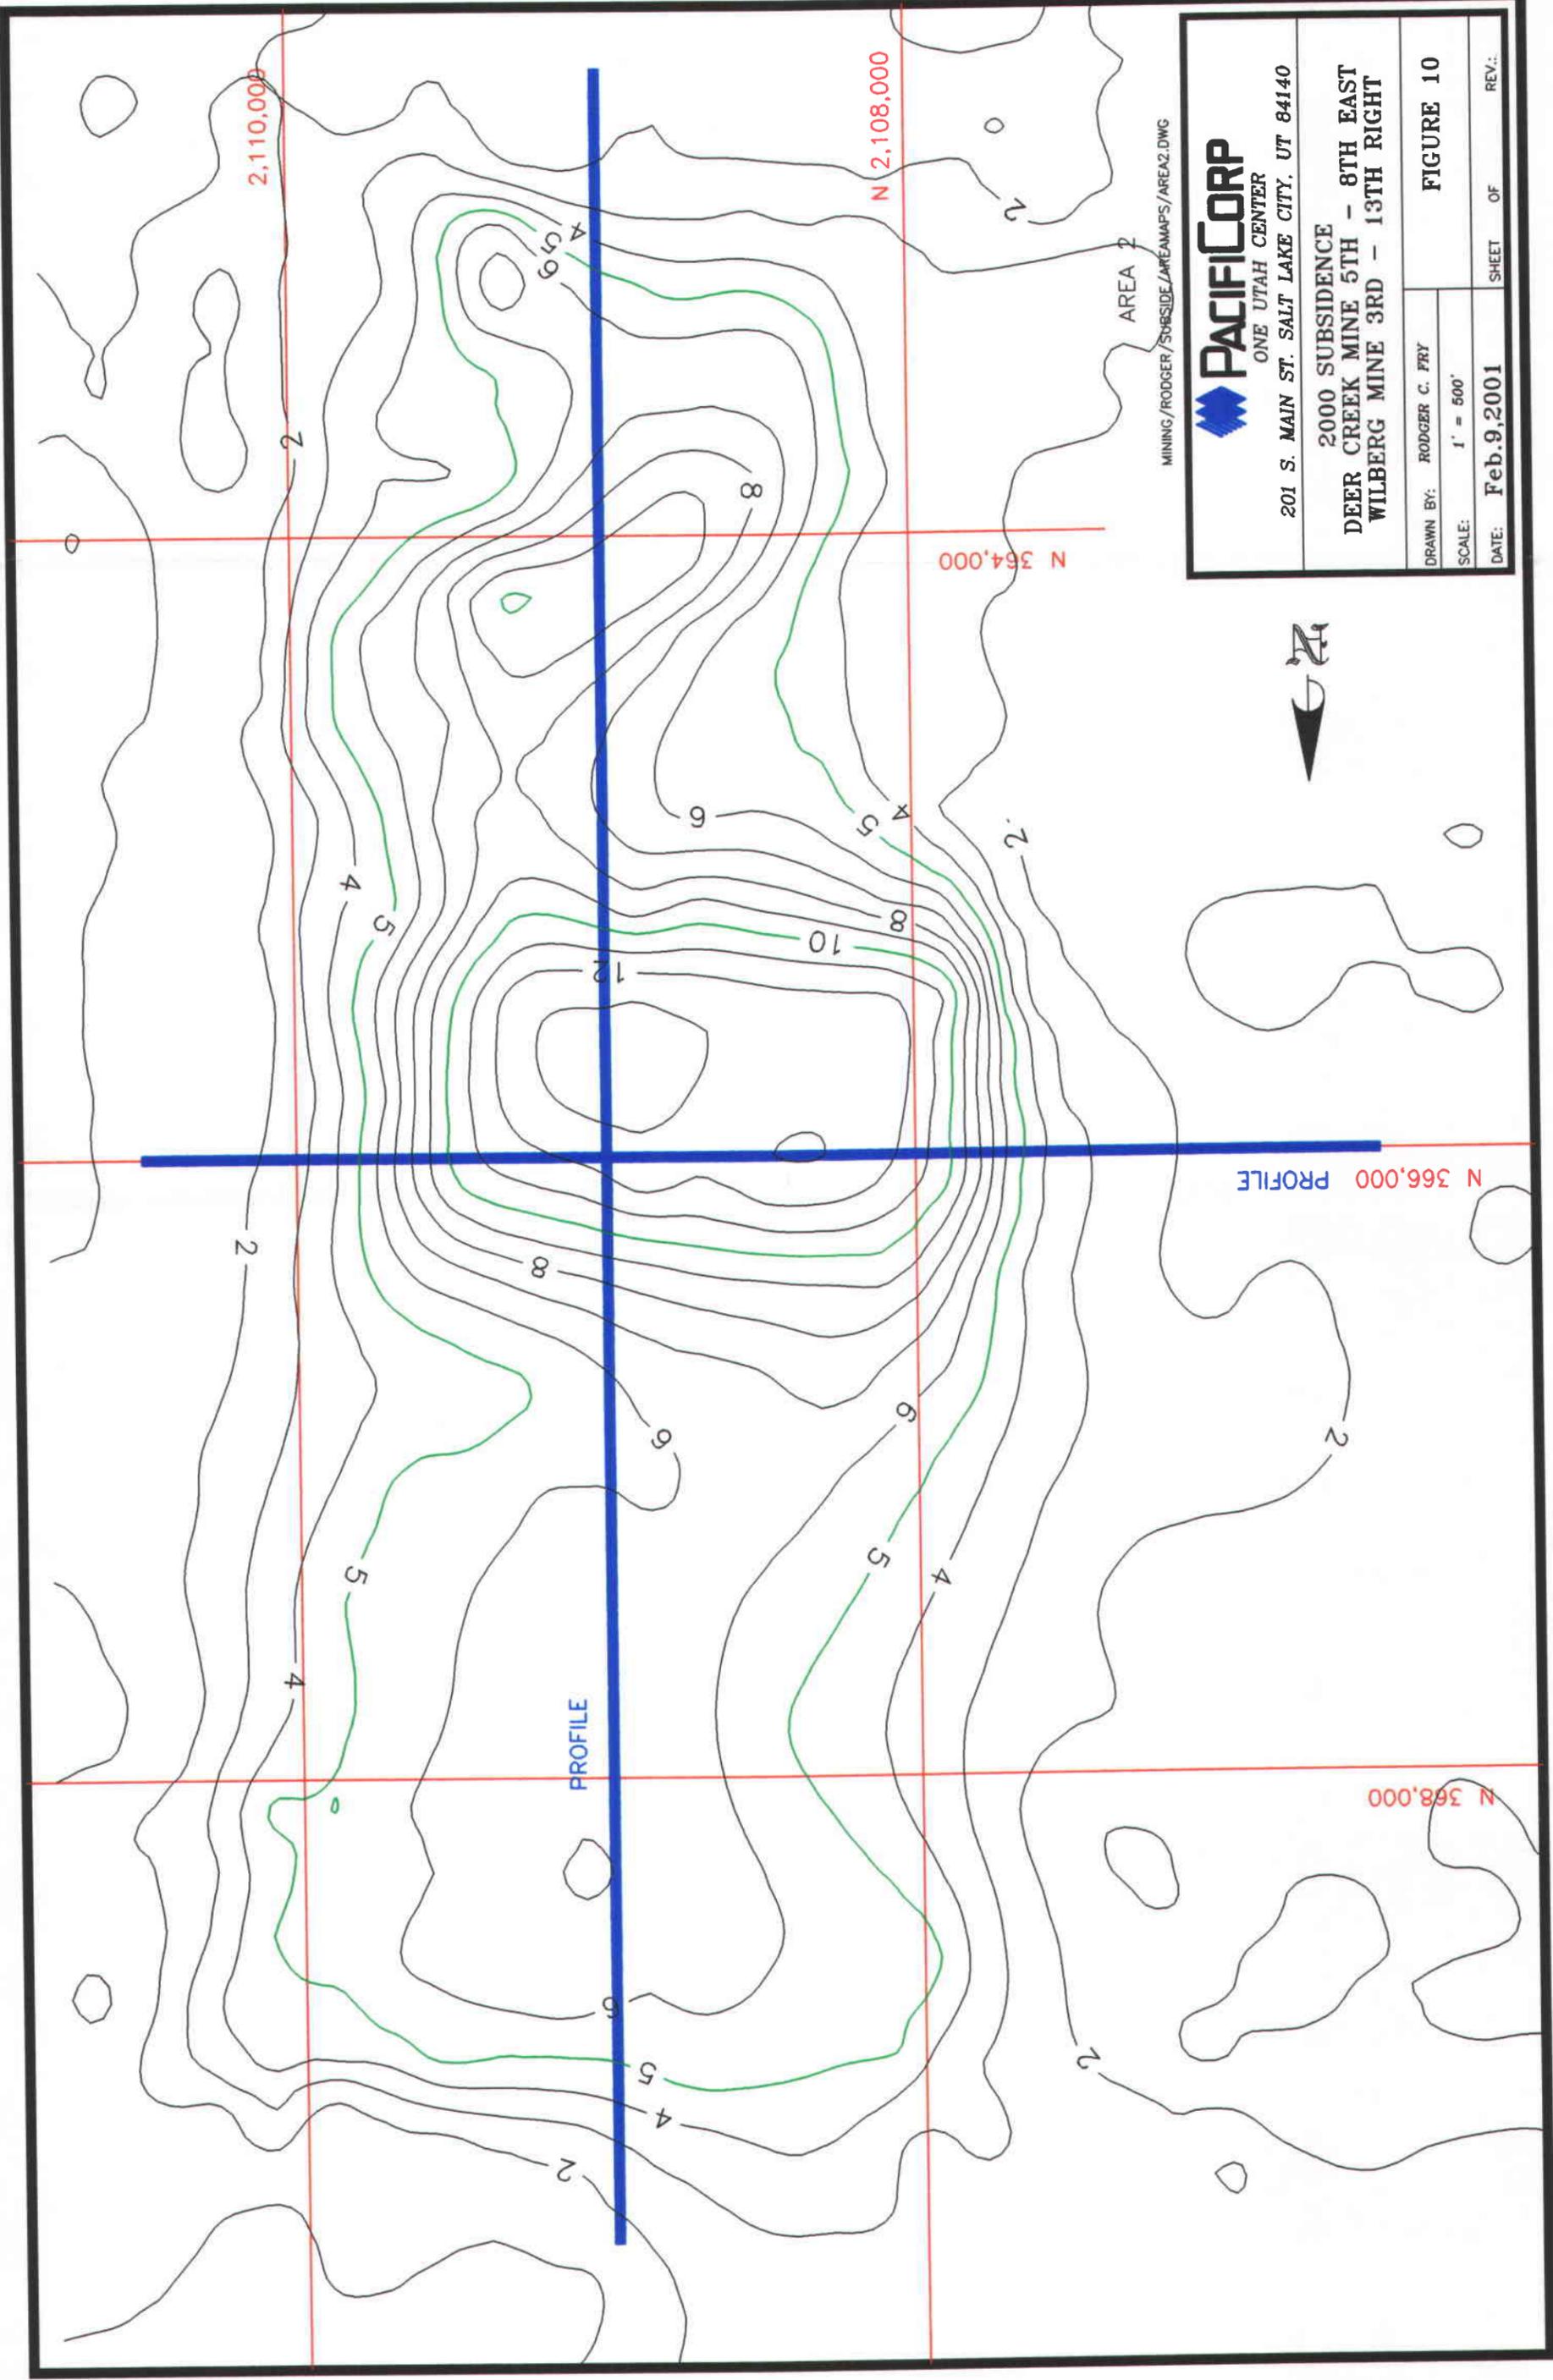
Maximum subsidence in Area 2 has stabilized at <13 feet in one area above the center of the multiple seam mining area (Figure 10). The subsidence profiles (Figures 11 and 12) indicate that the subsidence has been stable for the past 7 years or more. Neither PacifiCorp nor other contracted personnel have detected any surface fissures or other visible disturbance in the area.

Angle-of-draw has been calculated where possible. On the eastern side of Area 2 the angle is influenced by the Deer Creek Fault and the adjacent Little Dove Mine workings across the fault; thus, no angle was calculated. On other sides it ranges from less than zero to 11 degrees.

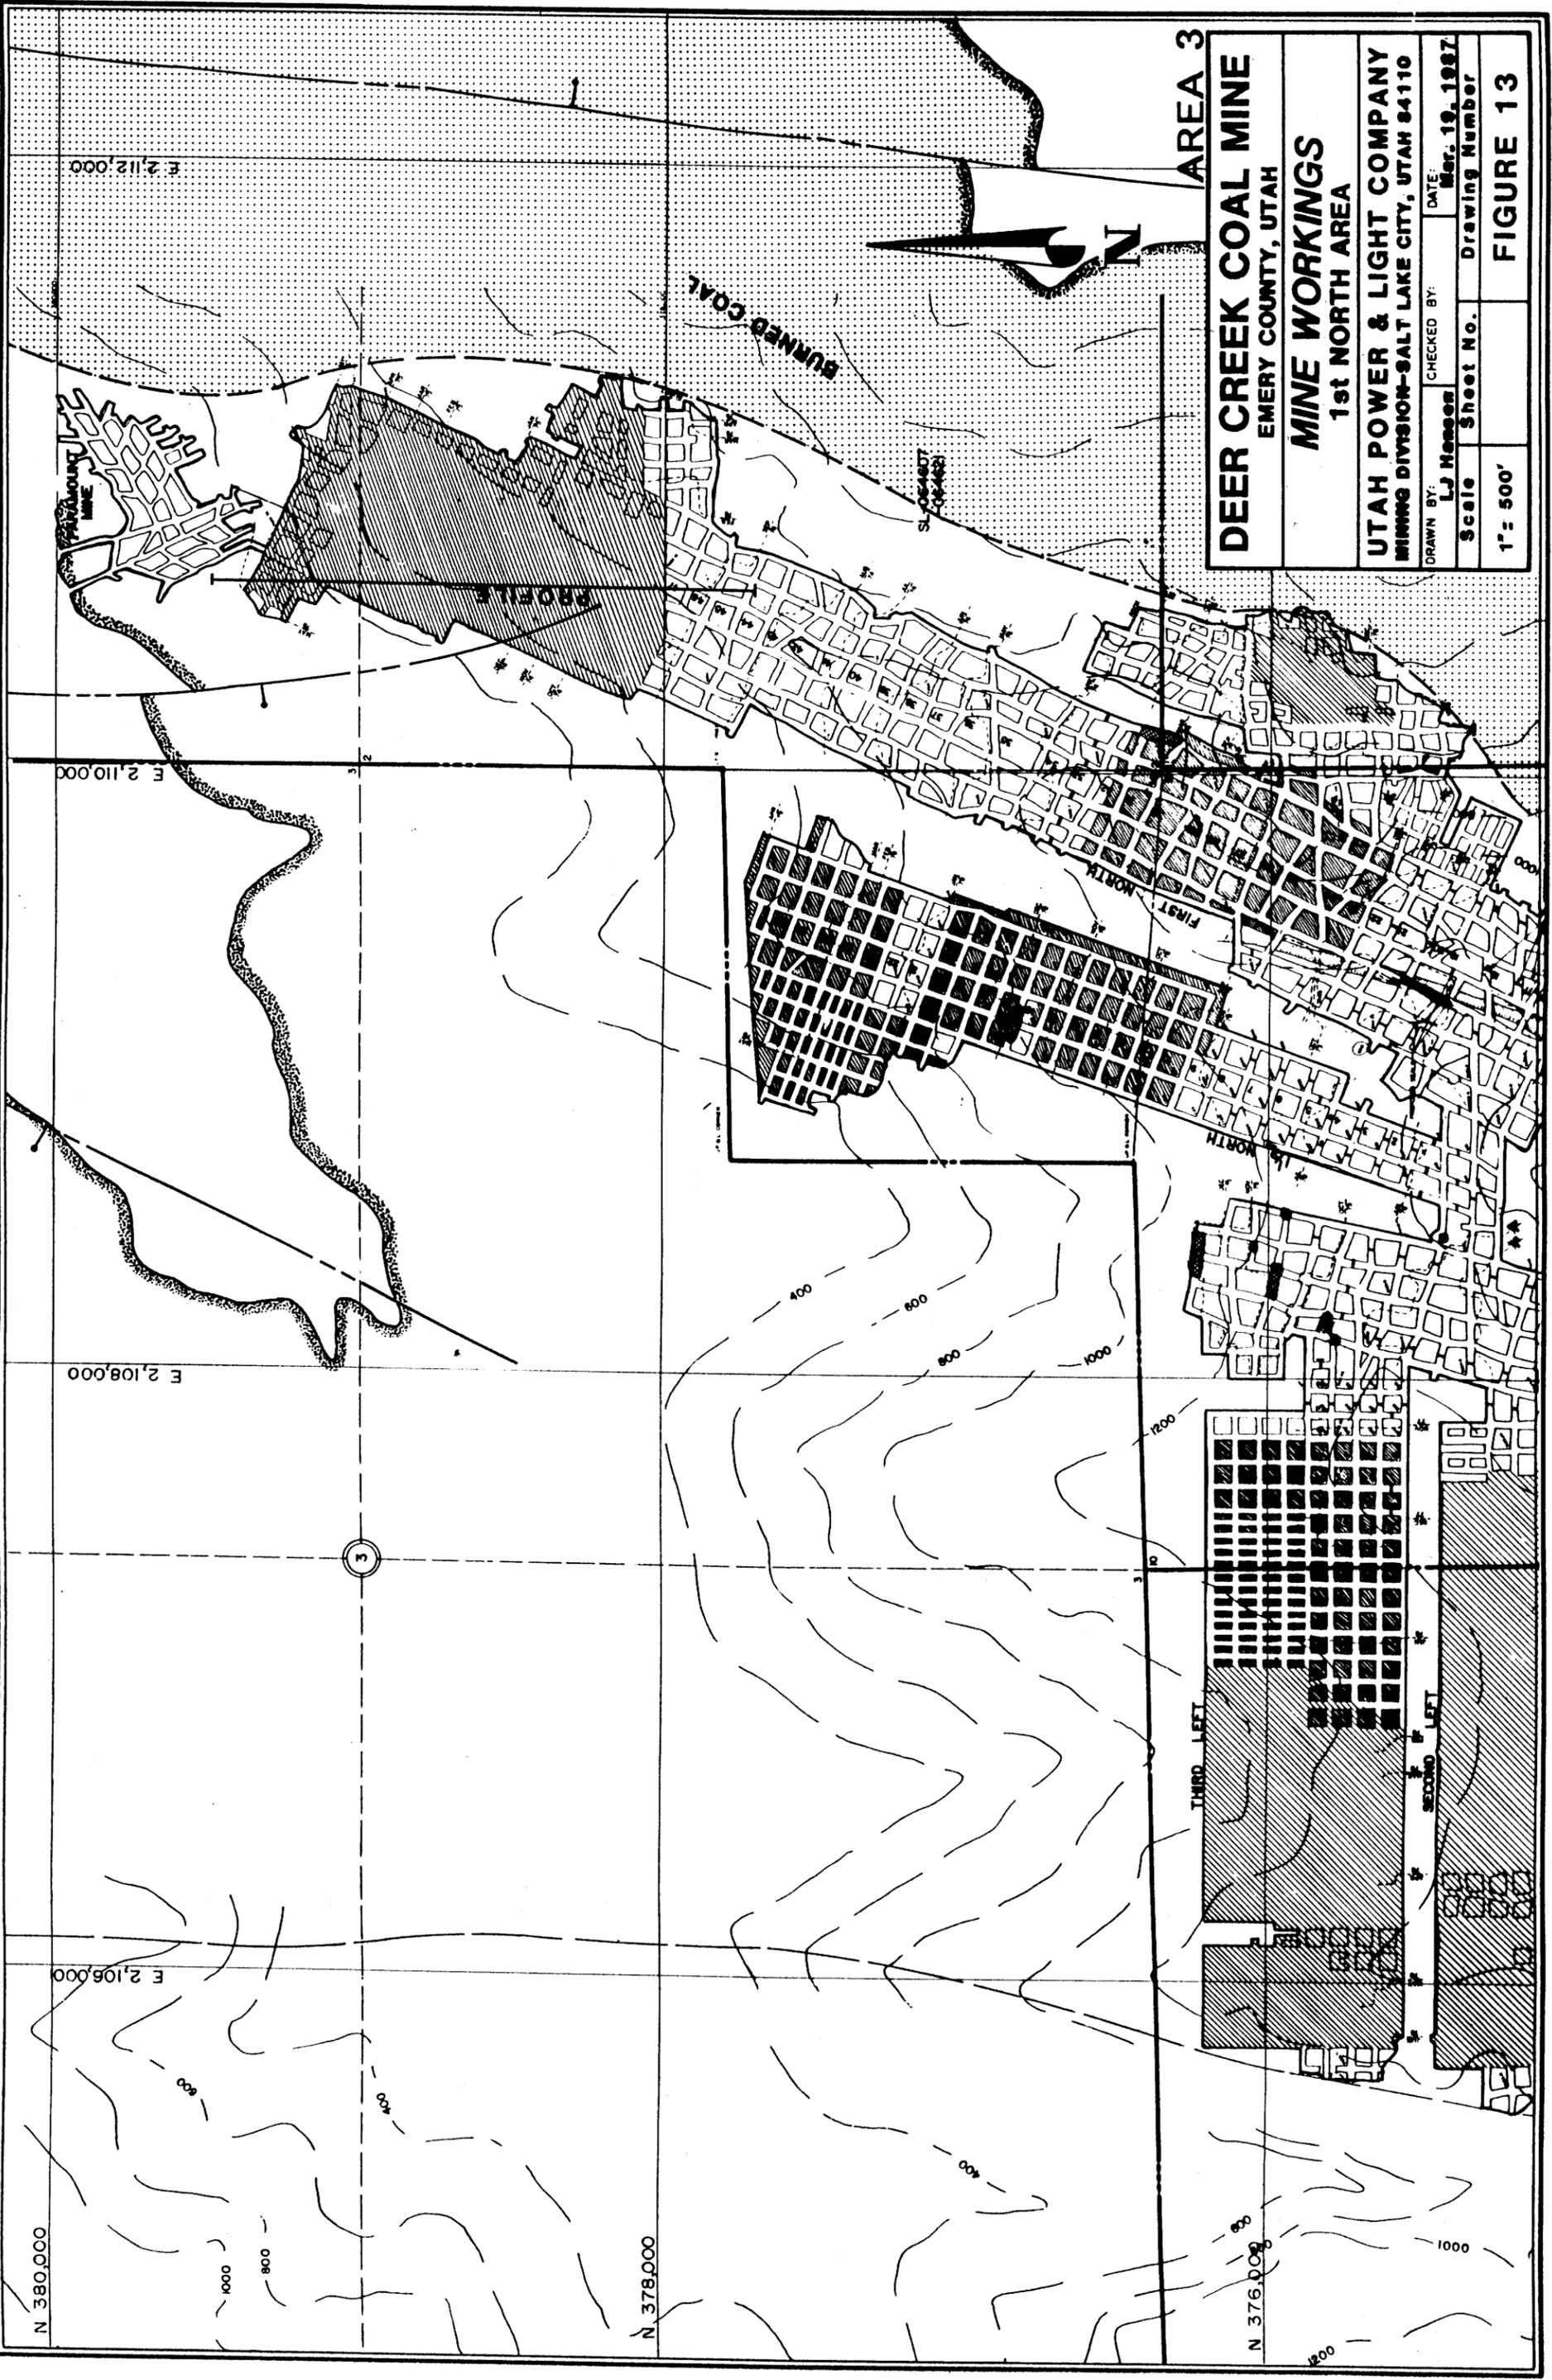
1" = 500'
FIGURE 13

The subsidence above 1st North occurs on a narrow ridge capped by a highly fractured sandstone. The subsidence measured is depicted in Figure 13A. Figure 14 is a profile of total subsidence as it occurred along a line of points above the workings. The subsidence in area 3 has shown no significant change in the past 7 years.

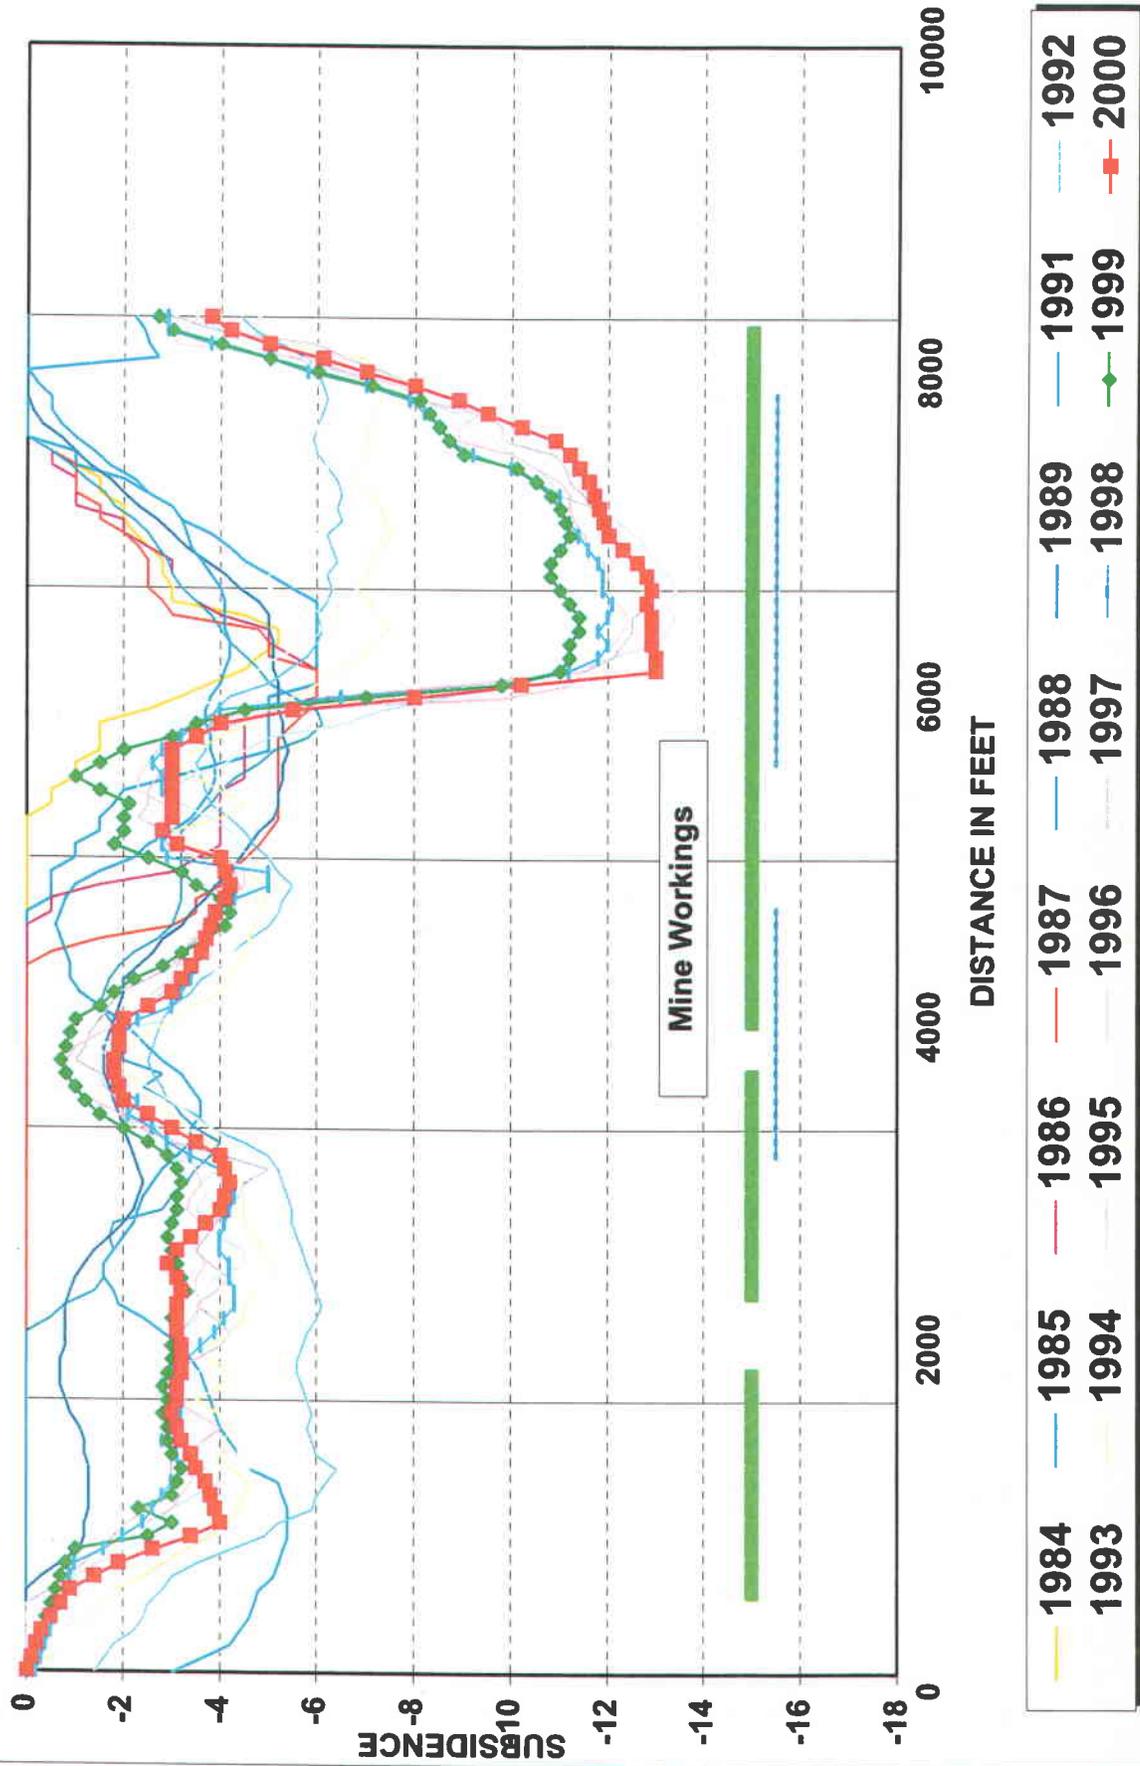
Figure 17

Area 4 Subsidence Profile

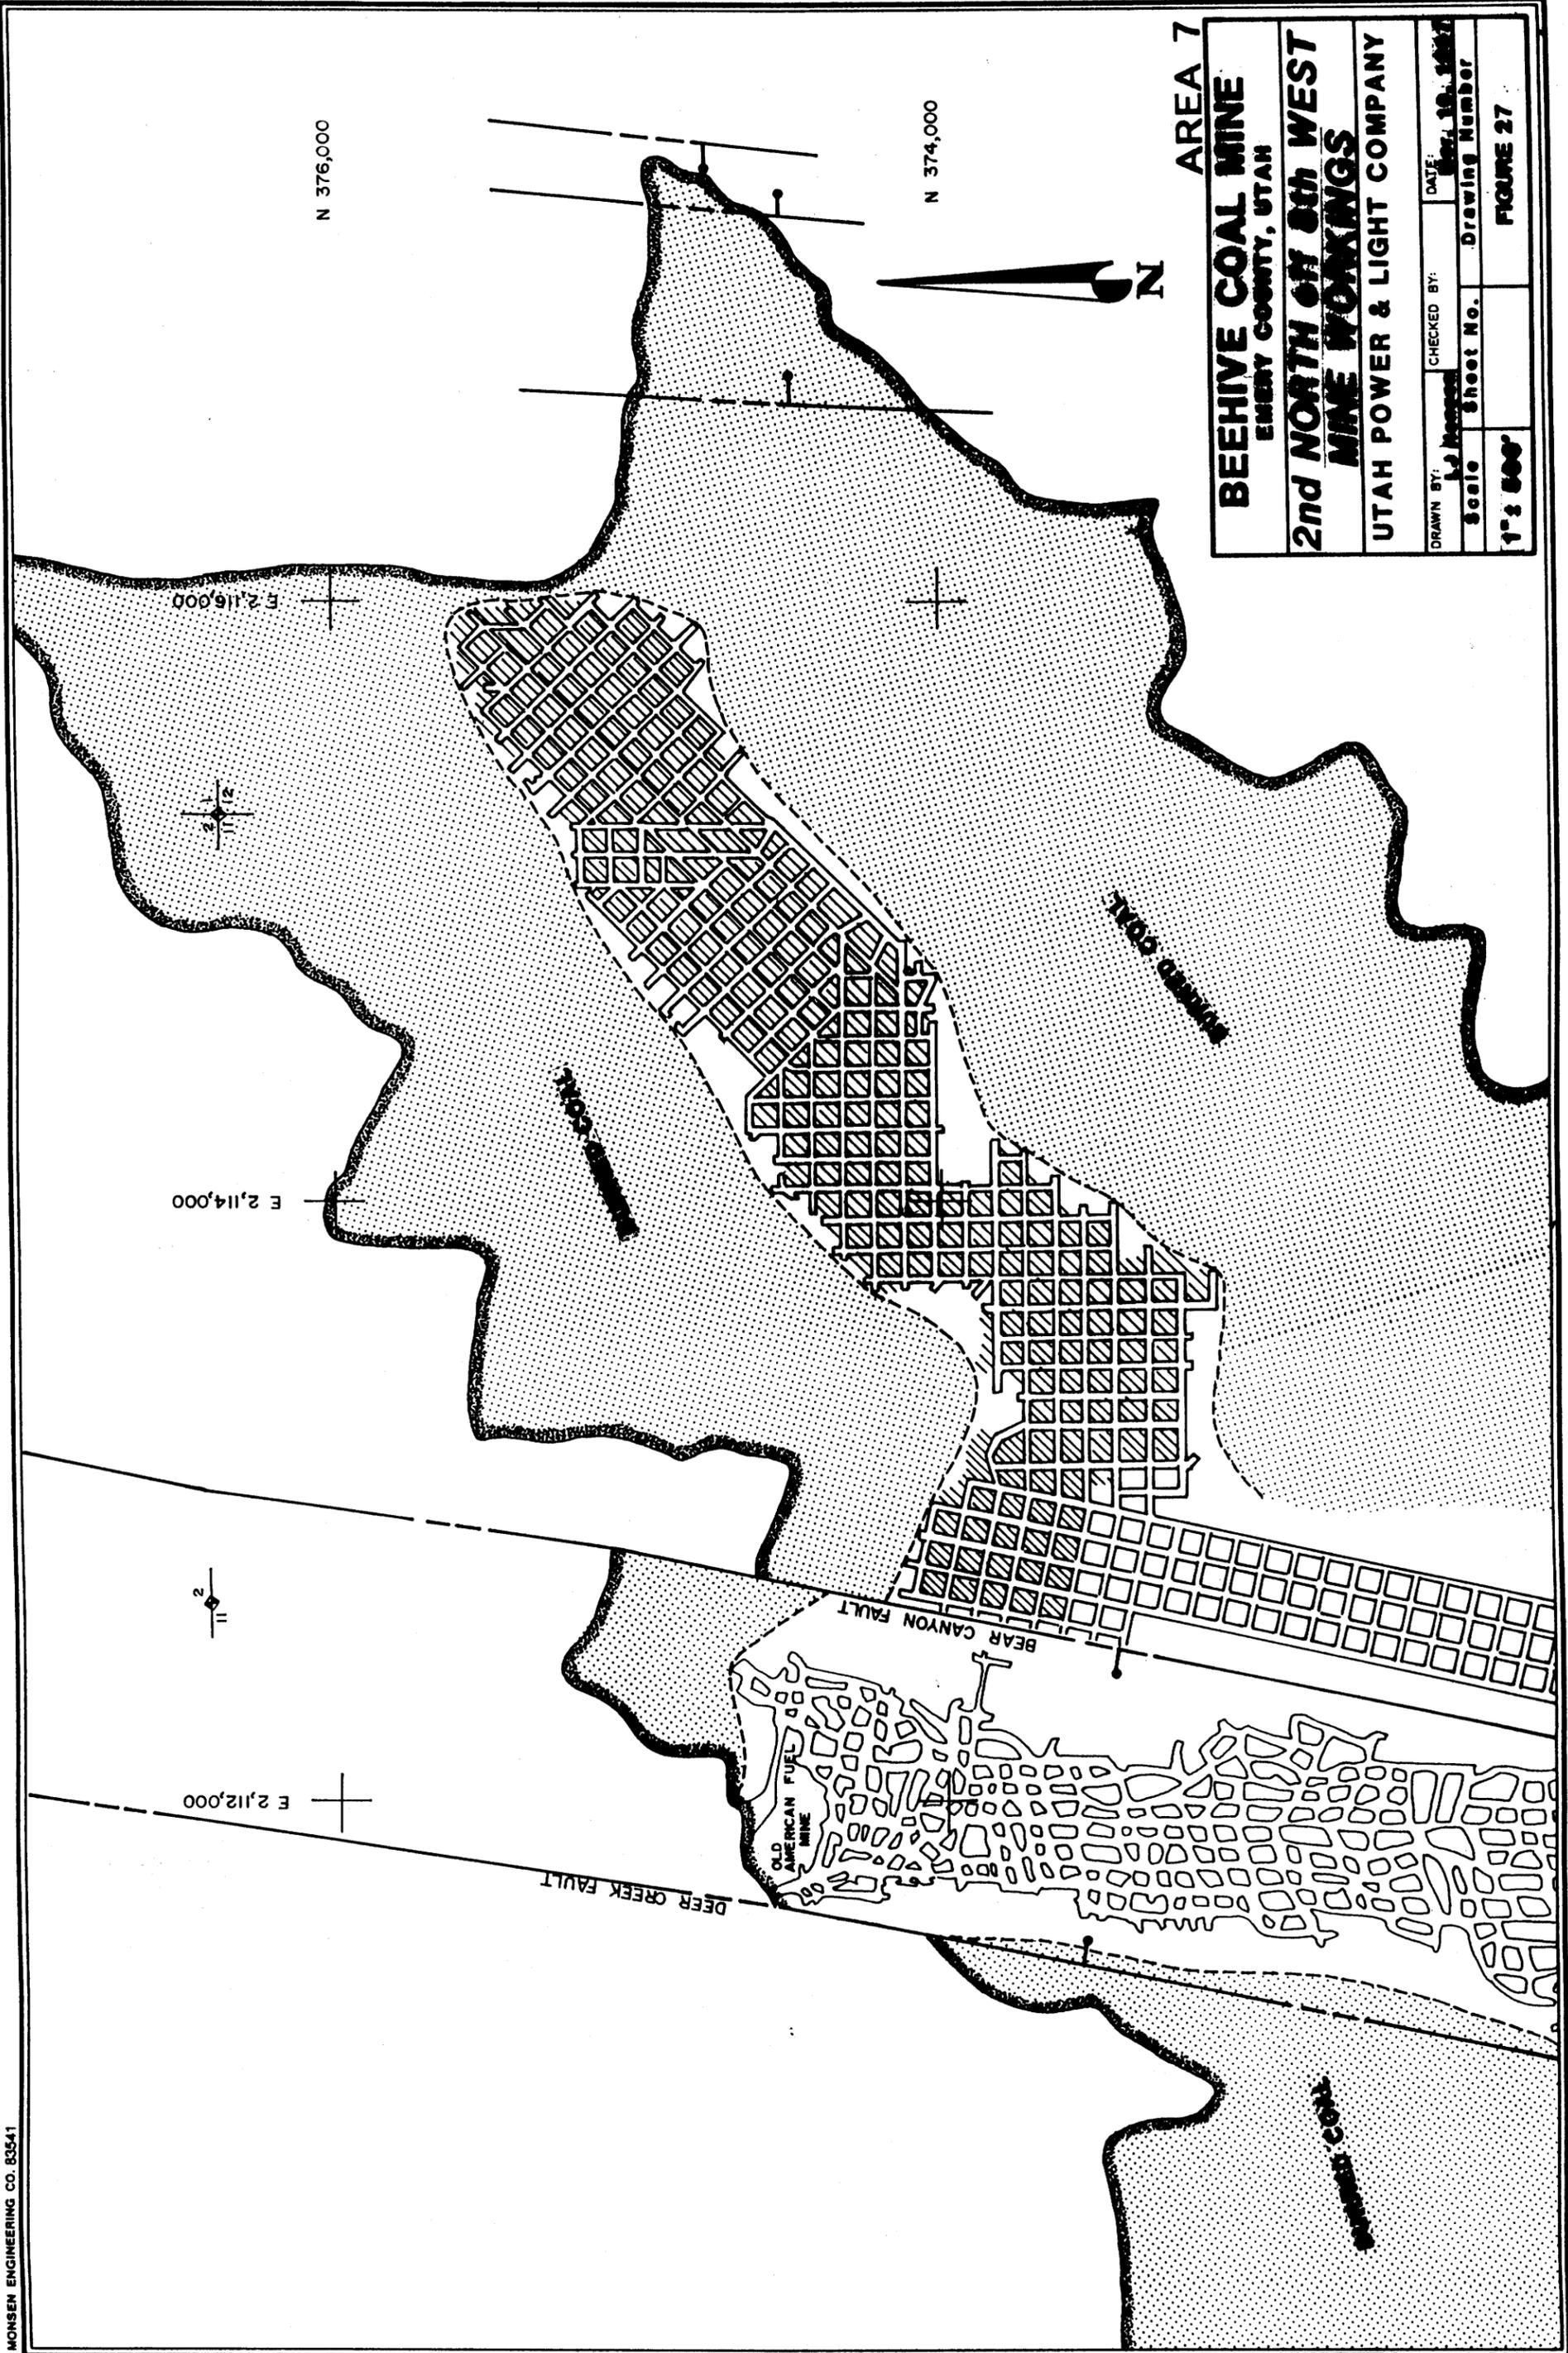
DRAWN BY:	CHECKED BY:	DATE:
J. J. Jensen		April 10, 1957
Scale	Sheet No.	Drawing Number
1" = 500'		FIGURE 27

Pillar extraction mining in 2nd North was completed in 1983 and, as shown in Figures 27, 28, and 29, little additional subsidence has occurred over the workings since 1984. The workings are surrounded by burned coal. Maximum subsidence is as much as seven (7) feet. In examining the area by helicopter and aerial photography, it is apparent that much of the elevation change measured was due to cliff failure and mass wasting on the steep slopes above the workings, where the rocks were highly fractured prior to mining. The profile, Figure 29, shows no measurable subsidence since 1991, this area is however, steep and rugged limiting the accuracy of the photogrammetric monitoring. Hence, the fluctuations in the reading are experienced from year to year.
