PACIFICORP
TECHNICAL SERVICES REPORT
RODGER C. FRY

CENTRAL ENGINEERING
ANNUAL SUBSIDENCE MONITORING REPORT
EAST/TRAIL MOUNTAIN PROPERTIES
2000

MARCH 30, 2001

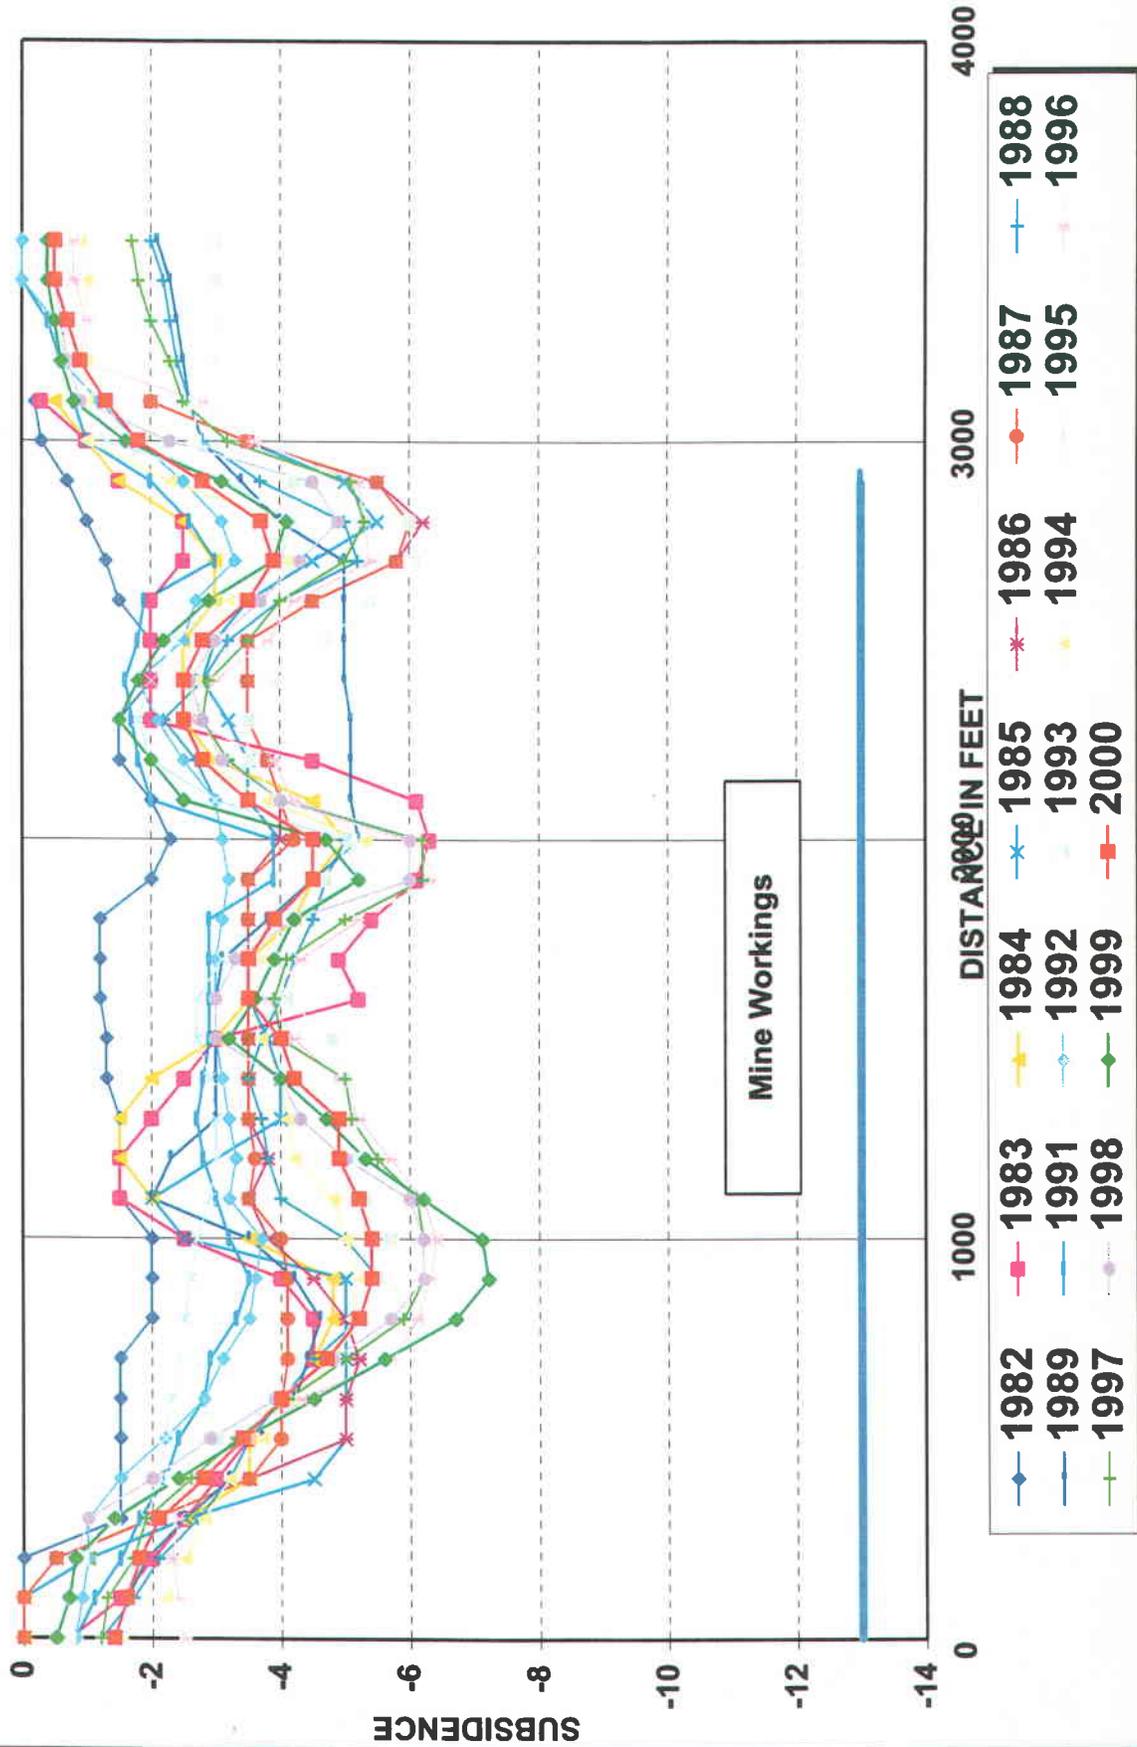
Figure 29

Pillar extraction mining in 2nd North was completed in 1983 and, as shown in Figures 27, 28, and 29, little additional subsidence has occurred over the workings since 1984. The workings are surrounded by burned coal. Maximum subsidence is as much as seven (7) feet. In examining the area by helicopter and aerial photography, it is apparent that much of the elevation change measured was due to cliff failure and mass wasting on the steep slopes above the workings, where the rocks were highly fractured prior to mining. The profile, Figure 29, shows no measurable subsidence since 1991, this area is however, steep and rugged limiting the accuracy of the photogrammetric monitoring. Hence, the fluctuations in the reading are experienced from year to year.

Area 7 Subsidence Profile Southwest - Northeast

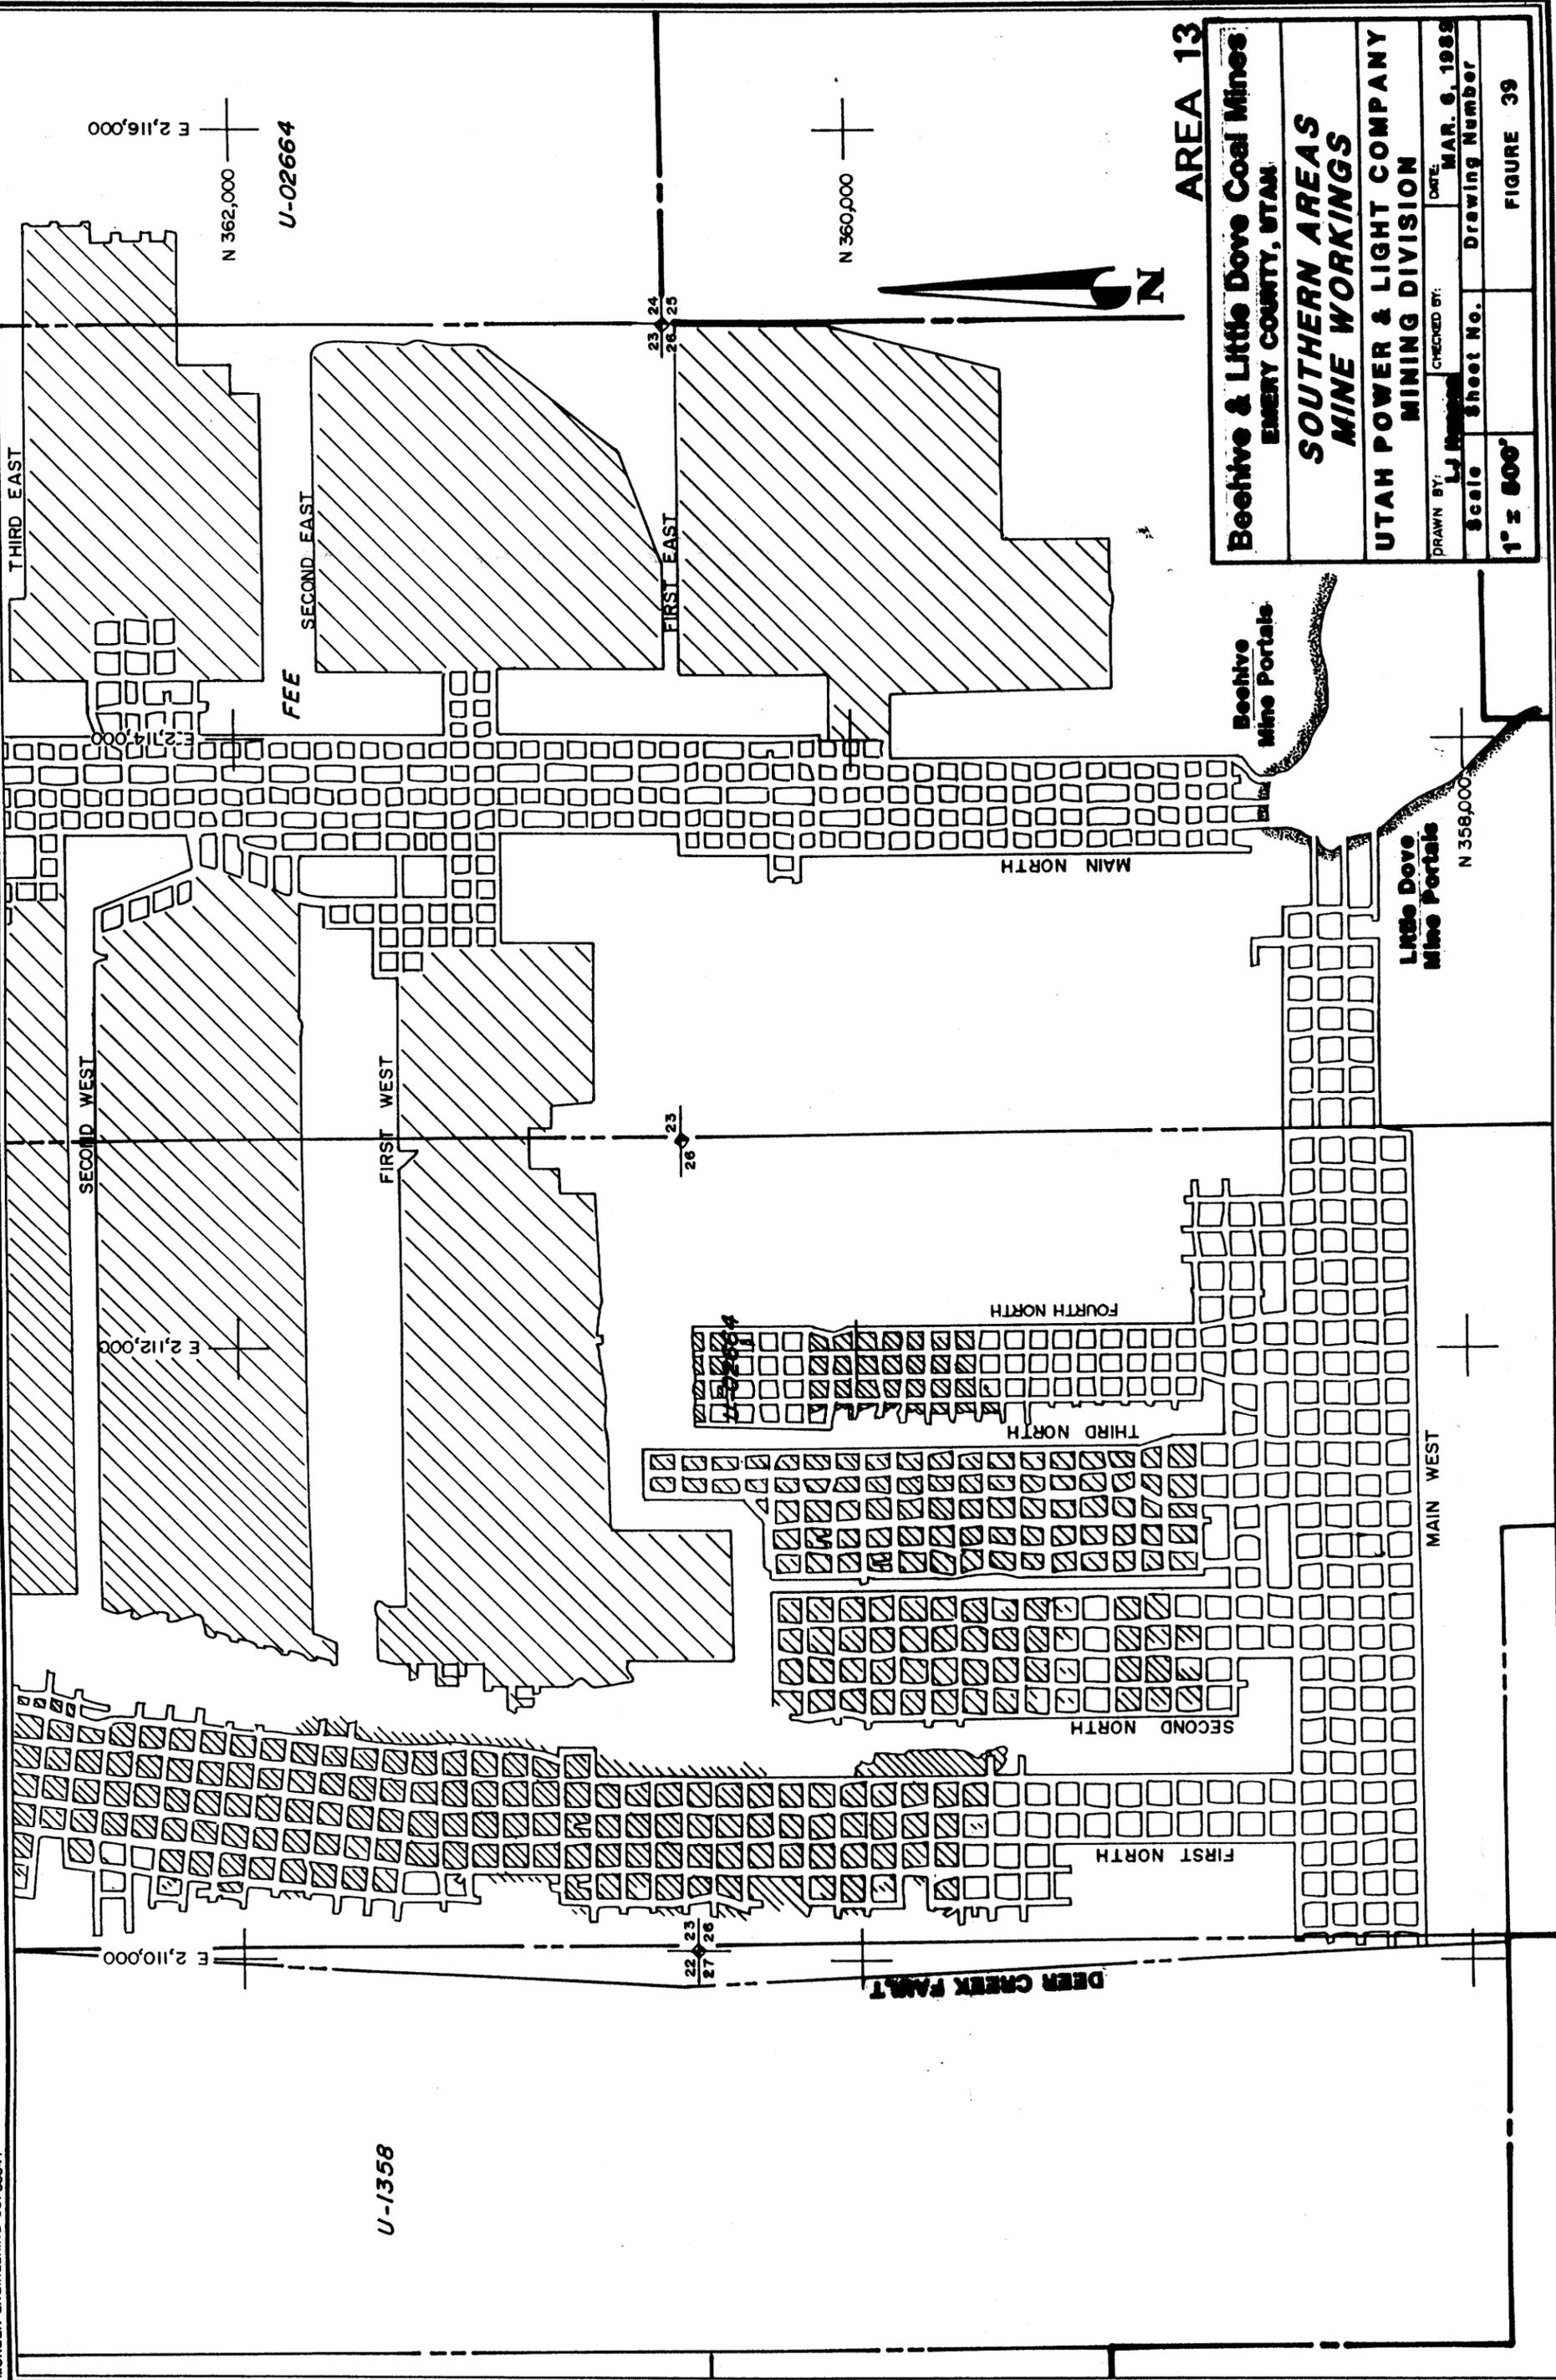
1" = 500' FIGURE 39

Area 13, covering the southern portions of the Deseret, Beehive, and Little Dove Mines, was first monitored for subsidence in 1986. Some of the sections were mined before baseline survey data were established; therefore, subsidence measured over these sections will likely not represent what actually occurred. The 4th North section in the Little Dove Mine was completed in February 1987 (Figures 39 and 40).

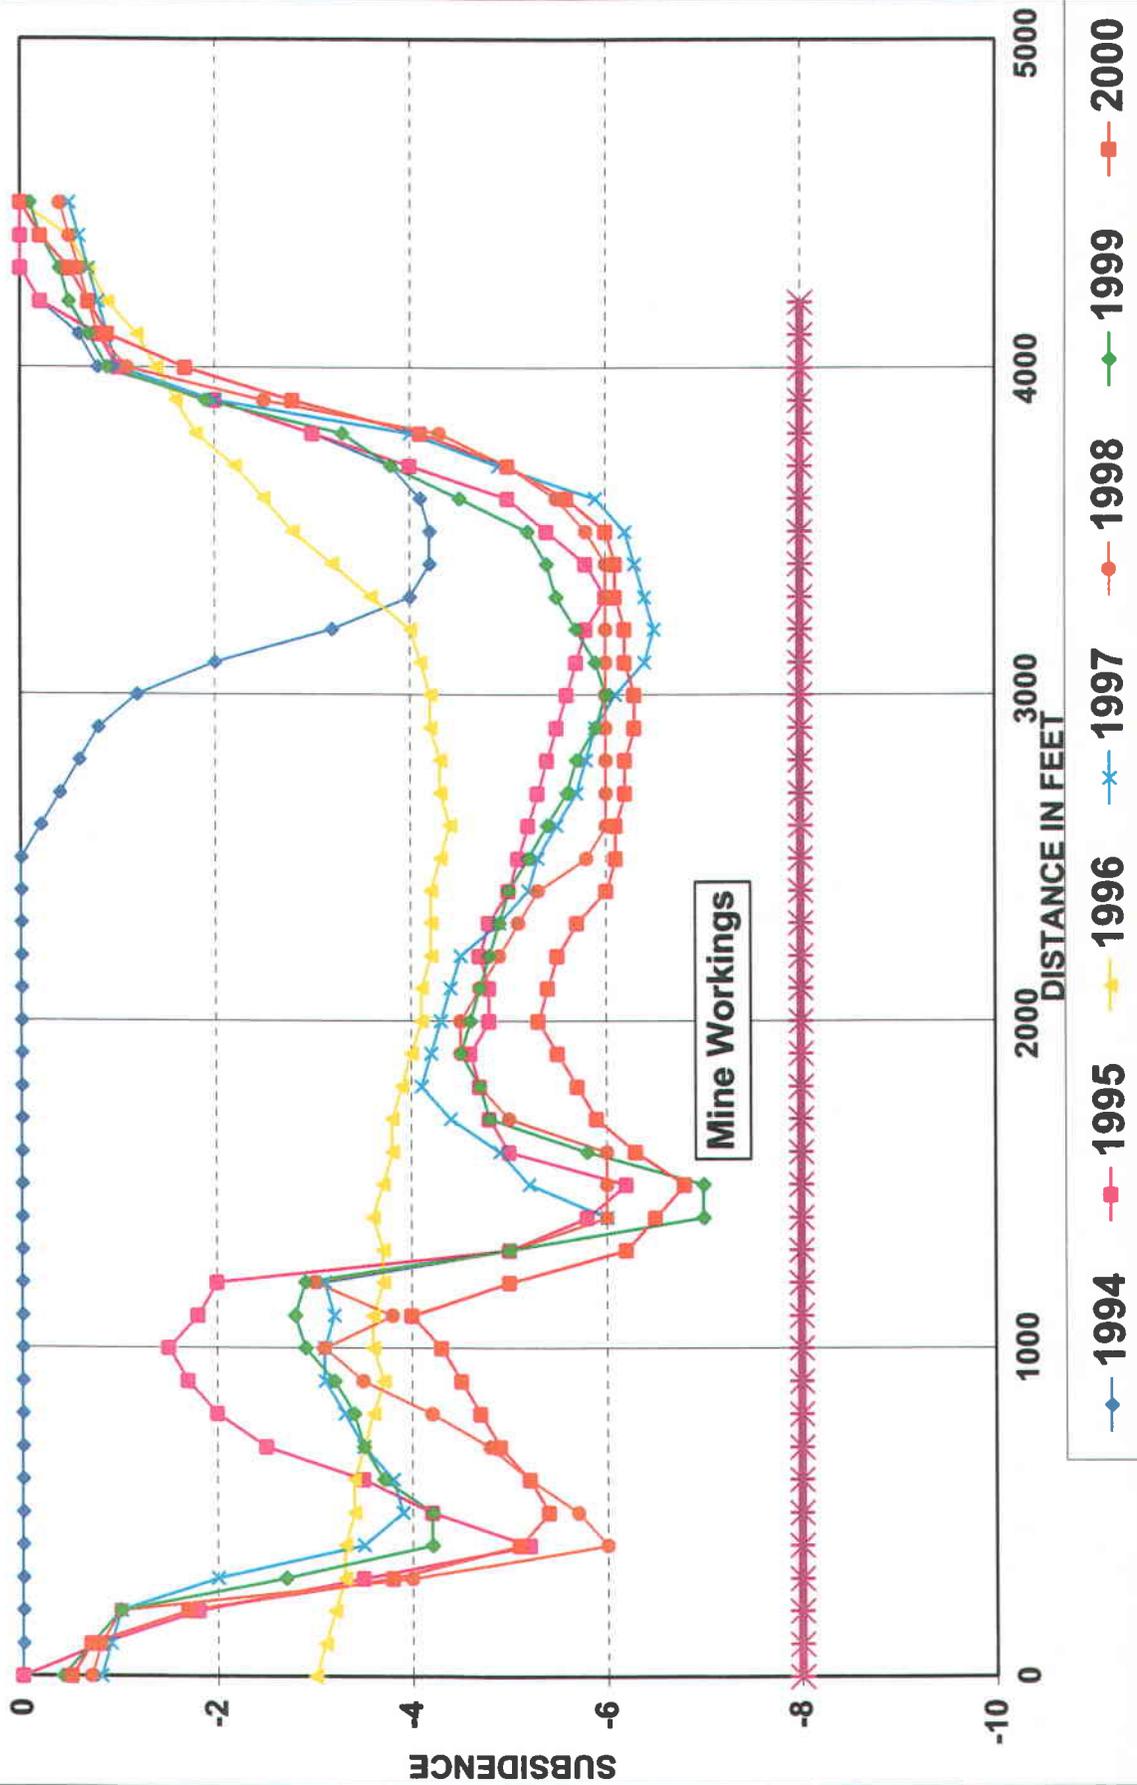
3200

through 1999 monitoring indicated that subsidence has been stable during those years. The 2000 monitoring showed a slight increase in subsidence in the center of the area (see figures 72 and 73). This may be some additional settling that has occurred or may be a slight error in the aerial triangulation. During the helicopter reconnaissance in 1995, several fractures were identified and several areas were noted where boulders had rolled from the Castlgate cliff. These are shown on figure 71. The area of subsidence is completely contained within the mining area; Therefore, the angle of draw is near vertical.
