Inspection Report

Permit Number:	C0150009
Inspection Type:	COMPLETE
Inspection Date:	Wednesday, September 28, 2016
Start Date/Time:	9/28/2016 9:00:00 AM
End Date/Time:	9/28/2016 12:30:00 PM
Last Inspection:

Permittee: **FOSSIL ROCK RESOURCES, LLC**
 Operator: **FOSSIL ROCK RESOURCES, LLC**
 Site: **FOSSIL ROCK MINE**
 Address: **225 North 5th Street, 9th Floor, CO 81501**
 County: **EMERY**
 Permit Type: **PERMANENT COAL PROGRAM**
 Permit Status: **ACTIVE**

ATTACHMENT A – Photos September 28, 2016 site visit

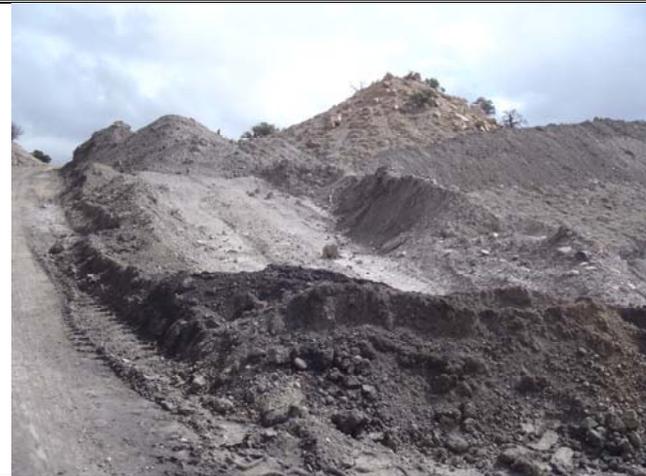
The majority of subsoil has been recovered from the top lift of the waste rock pile. The subsoil has been piled and bermed at the northern end of the 'Subsoil Stock Pile' (Photo 2).

PHOTO 2
 Subsoil stockpile has been bermed.
 September 28, 2016

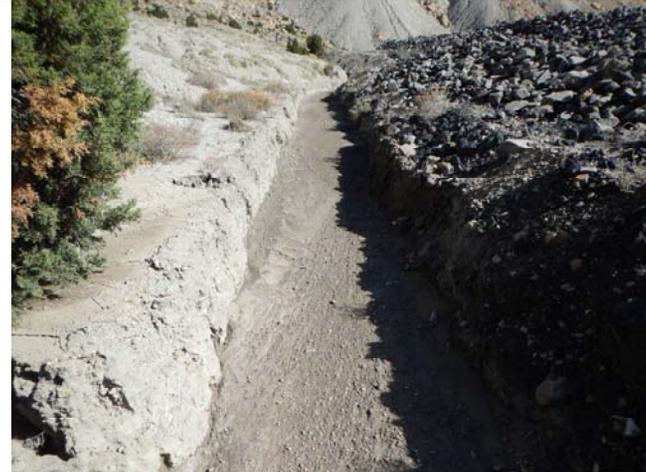
Diversions appeared to be stable and in good condition at the waste rock site (Photo 3).

PHOTO 3
 Ditch DA at waste rock site appears to be stable.
 September 28, 2016

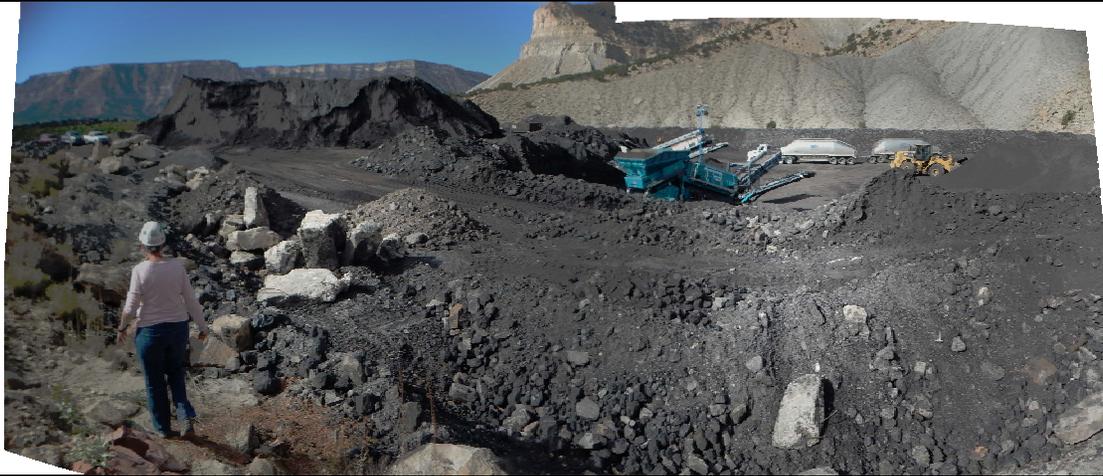
PANORAMA 1

The first lift of the waste rock pile lift has almost been mined out (Panorama 1 and 2). The operator is working to truck the pile of coal fines off site to access the last section of the upper lift.

Coal fines pile seen on left and the working pit on the right.
September 28, 2016

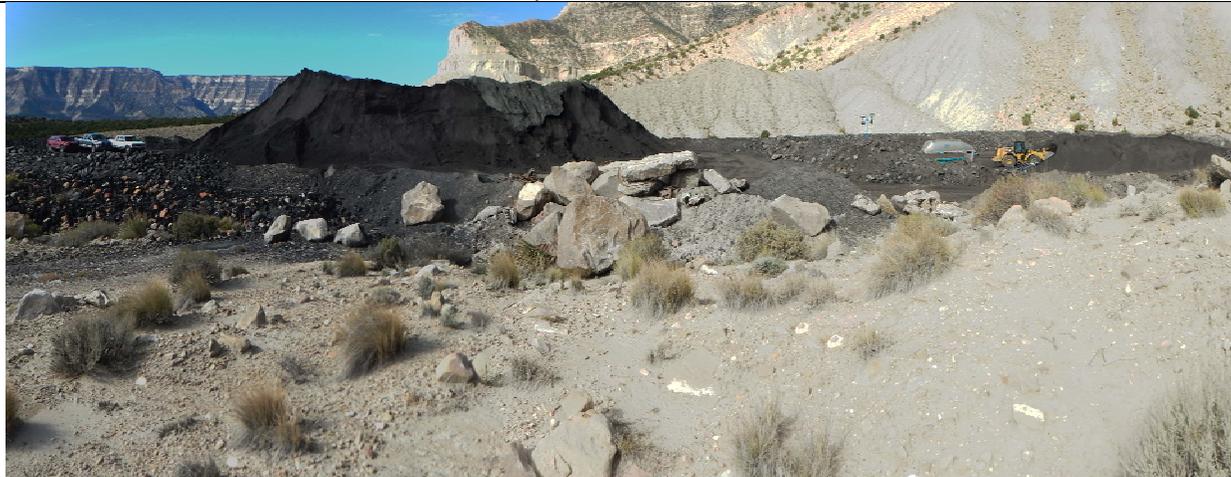
PANORAMA 2

Temporary storage of coal fines piled on top lift. Working pit is on the right.
September 28, 2016

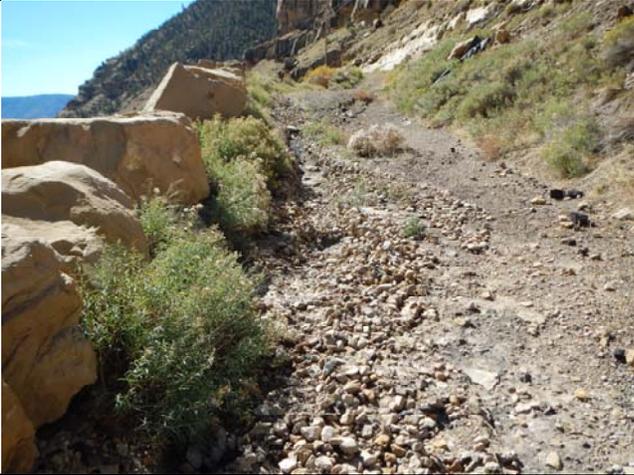
PHOTO 4

The diversion along the ancillary road at the mine site is in need on maintenance (Photo 4). The road pad receiving drainage from the ancillary road ditch appears to be eroding as well (Photo 5).

Drainage ditch along ancillary road is beginning to erode.
September 28, 2016

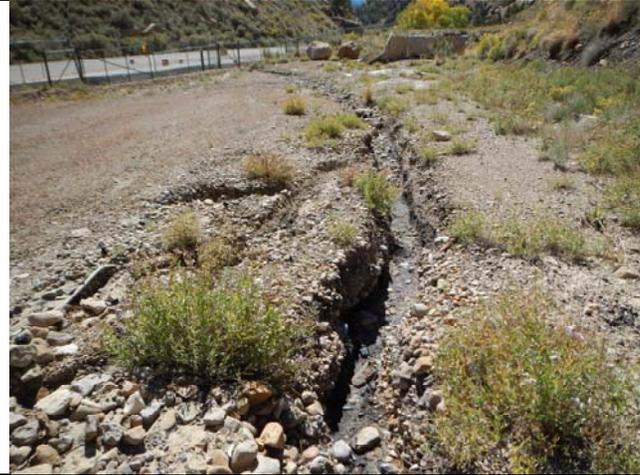
PHOTO 5

Drainage off ancillary road is eroding 'storage area' road bed.
September 28, 2016

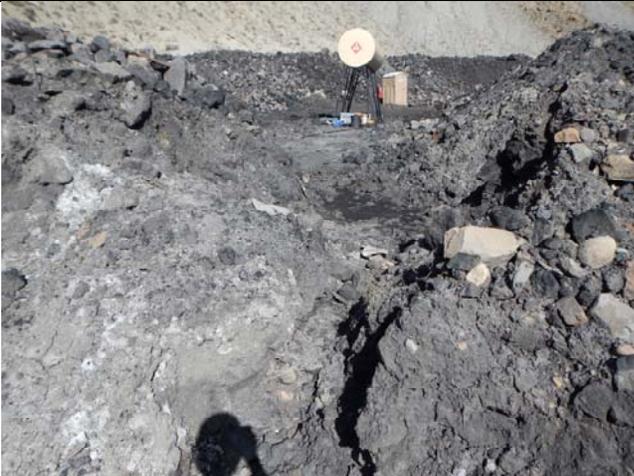
PHOTO 6

The working pit is sloped to drain runoff to the southernmost extent of the pit. Excess runoff is allowed to drain from this low spot through a cut in the berm and into Ditch DA (Photo 6). This appears to be a good solution to deal with runoff while the pile is being re-mined.

Southern end of pit with drainage routed through the cut in the berm.
September 28, 2016

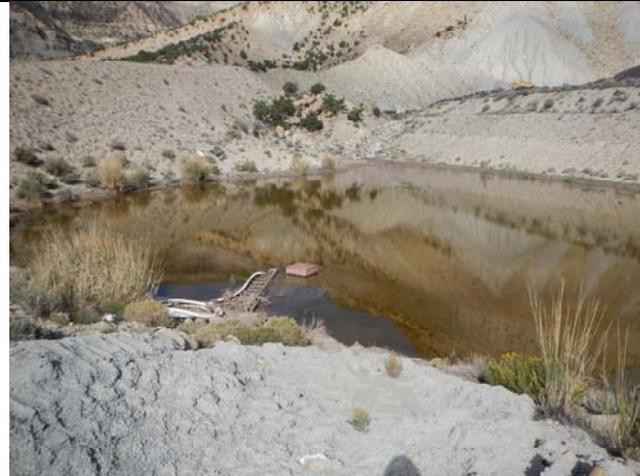
PHOTO 7

The mine sediment pond and waste rock sediment pond have been inspected for 3rd quarter 2016. The ponds are impounding water from mid-September storms (Photo 7 and 8).

Waste rock pond impounding water.
September 28, 2016

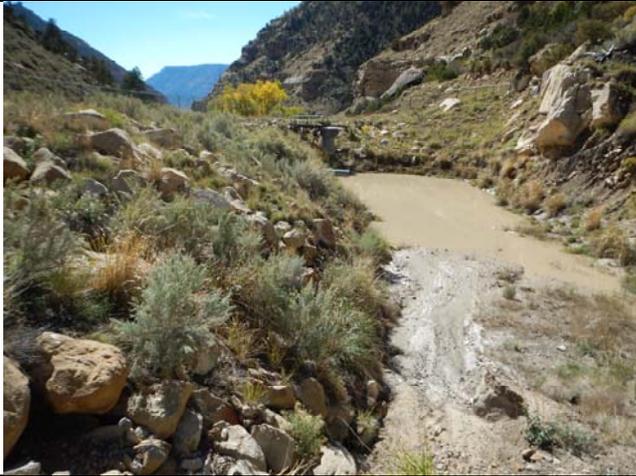
PHOTO 8
Mine site pond impounding water.
September 28, 2016

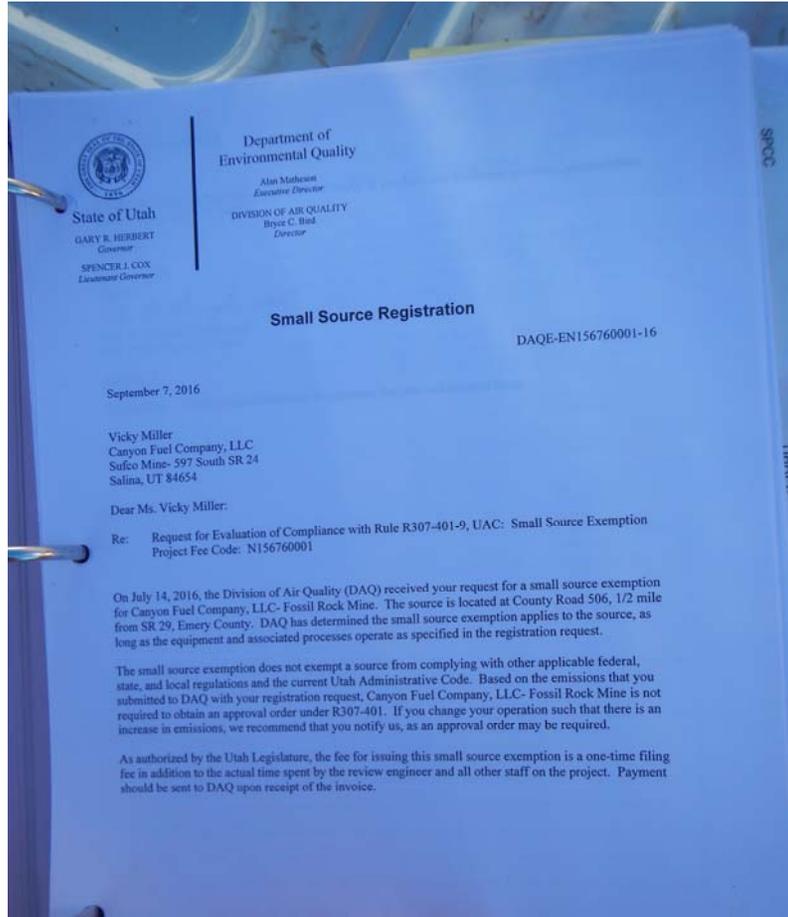
PHOTO 9
Division of Air Quality exemption
September 28, 2016

The Division of Air Quality has determined a 'Small Source Exemption' applies to the Fossil Rock mine. See Photos 9 – 10.
