Inspection Report

Permit Number:	C0150009
Inspection Type:	COMPLETE
Inspection Date:	Tuesday, December 19, 2017
Start Date/Time:	12/19/2017 10:30:00 AM
End Date/Time:	12/19/2017 1:00:00 PM
Last Inspection:	Thursday, November 30, 2017

Permittee: **FOSSIL ROCK RESOURCES, LLC**
 Operator: **FOSSIL ROCK RESOURCES, LLC**
 Site: **FOSSIL ROCK MINE**
 Address: **225 North 5th Street, 9th Floor, CO 81501**
 County: **EMERY**
 Permit Type: **PERMANENT COAL PROGRAM**
 Permit Status: **ACTIVE**

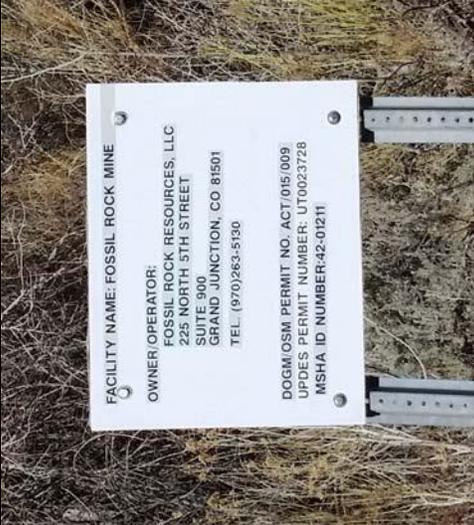
<p>PHOTO 1 – POSTED PERMIT, MAIN SITE Current and in good shape. December 19, 2017</p>	<p>PHOTO 2 – INTAKE CULVERT, MAIN SITE This bypass culvert routes Cottonwood Creek under and through the main mine site. Culvert was clean and free of debris. December 19, 2017</p>

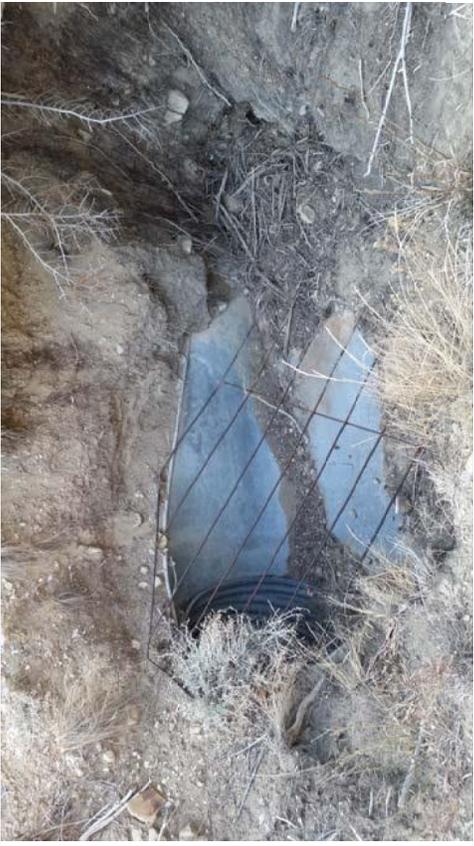
<p>PHOTO 3 – INTAKE CULVERT, MAIN SITE This bypass culvert drains a side canyon to the west of the main site. Culvert was clean with only a small amount of debris at the mouth. December 19, 2017</p>	<p>PHOTO 4 – DIVERSION, MAIN SITE Diversions along the east of the main site and parallel to the county road were clean and free of debris. December 19, 2017</p>

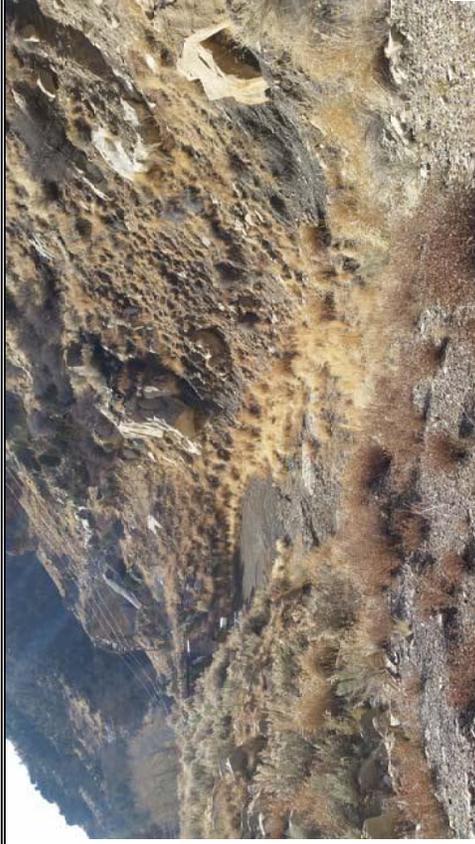
PHOTO 5 – SEDIMENT POND, MAIN SITE

Sediment pond is and has been completely dry for several months.
December 19, 2017

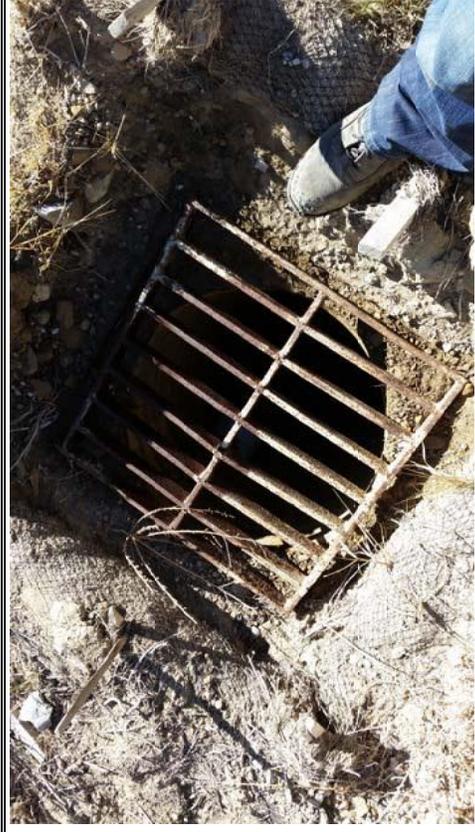
PHOTO 6 – 24” CMP DROP DRAIN

Drop drain which runs under the county road and hooks into buried 66” Cottonwood culvert. Culvert inlet was clear and free of debris.
December 19, 2017

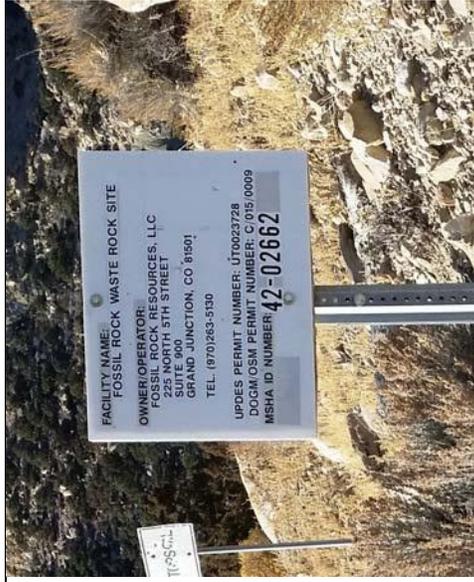
PHOTO 7 – POSTED PERMIT, WASTE ROCK SITE

Current, and in good shape.
December 19, 2017

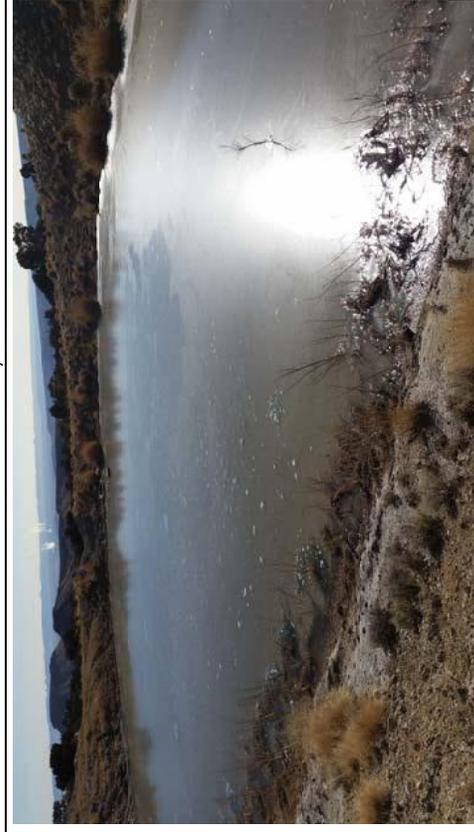
PHOTO 8 – SEDIMENT POND, WASTE ROCK SITE

Pond is maybe half full, and covered by a thin layer of ice.
December 19, 2017

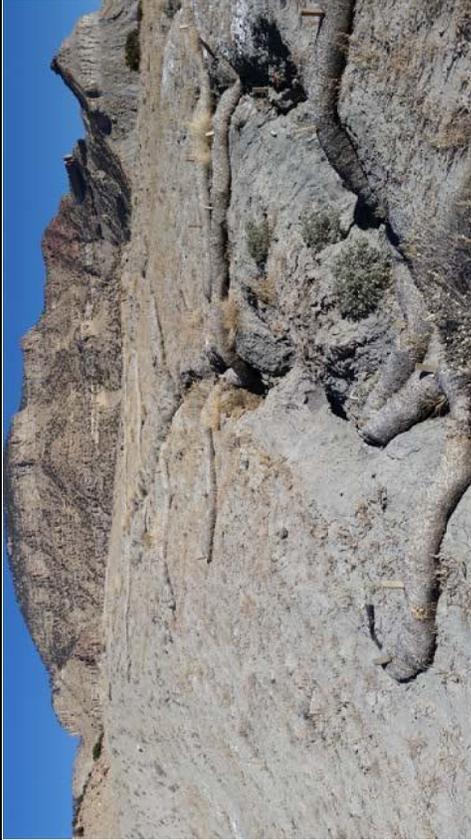
PHOTO 9 – SUBSOIL STOCKPILE, WASTE ROCK SITE
 Deeply cut drainage channels with wattles running perpendicular.
 December 19, 2017

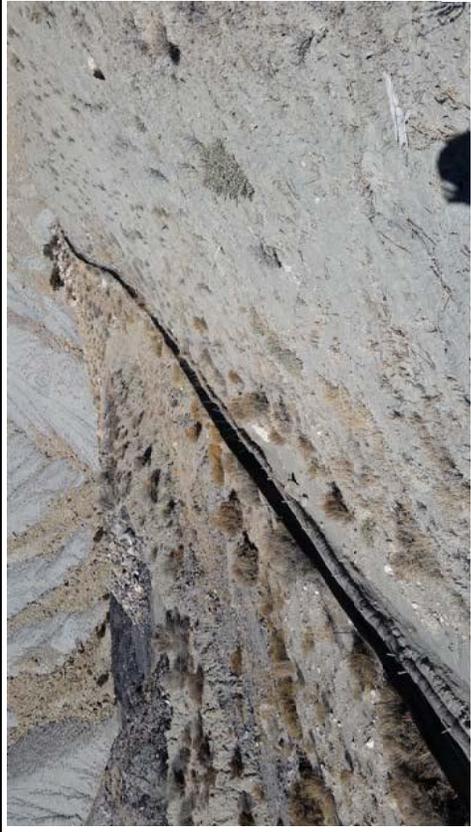
PHOTO 10 – SILT FENCES, WASTE ROCK SITE
 This silt fence at the base of the subsoil stockpile appeared to be in good shape.
 December 19, 2017

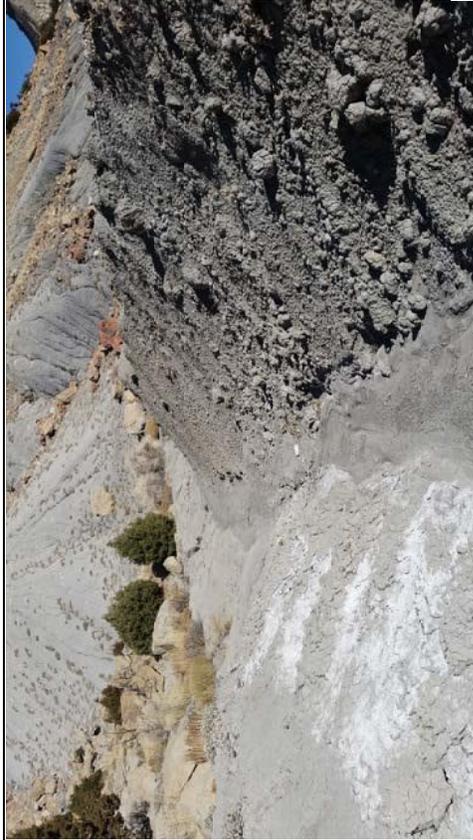
Diversions appeared to be in good working order. All runoff is being properly conveyed to the sediment ponds at both the waste rock site and the mine site. The diversions at the waste rock site were approximately 2/3 full of sediment from the nearby slopes, but the diversion channels are still stable and functioning.

PHOTO 11 – DIVERSION DITCH, WASTE ROCK SITE
 This diversion ditch on the west of the disturbed area is gradually filling with sediment from nearby slopes, but is still functioning.
 December 19, 2017

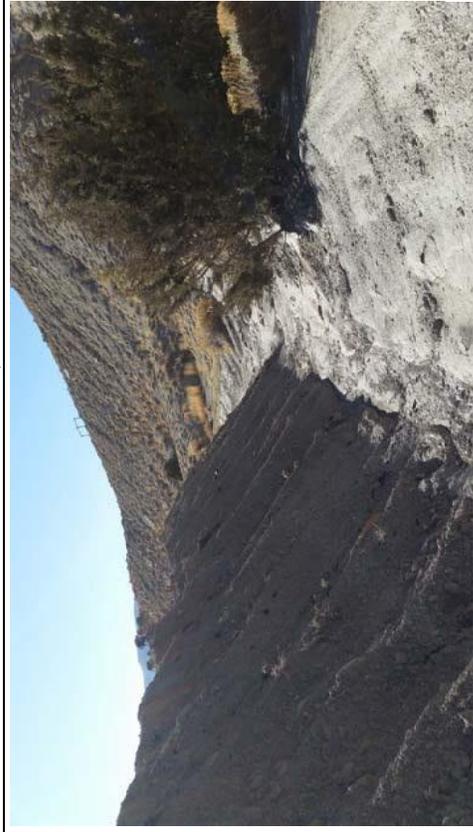
PHOTO 12 - DIVERSION DITCH, WASTE ROCK SITE
 This diversion ditch on the west of the disturbed area is gradually filling with sediment from nearby slopes, but is still functioning.
 December 19, 2017
