Inspection Report

Permit Number:	C0150009
Inspection Type:	PARTIAL
Inspection Date:	Thursday, February 22, 2018
Start Date/Time:	2/22/2018 11:00:00 AM
End Date/Time:	2/22/2018 1:00:00 PM
Last Inspection:	Wednesday, January 24, 2018

Permittee: **FOSSIL ROCK RESOURCES, LLC**
 Operator: **FOSSIL ROCK RESOURCES, LLC**
 Site: **FOSSIL ROCK MINE**
 Address: **225 North 5th Street, 9th Floor, CO 81501**
 County: **EMERY**
 Permit Type: **PERMANENT COAL PROGRAM**
 Permit Status: **ACTIVE**

ATTACHMENT A – February 28, 2018 partial inspection of Fossil Rock Waste Rock Site

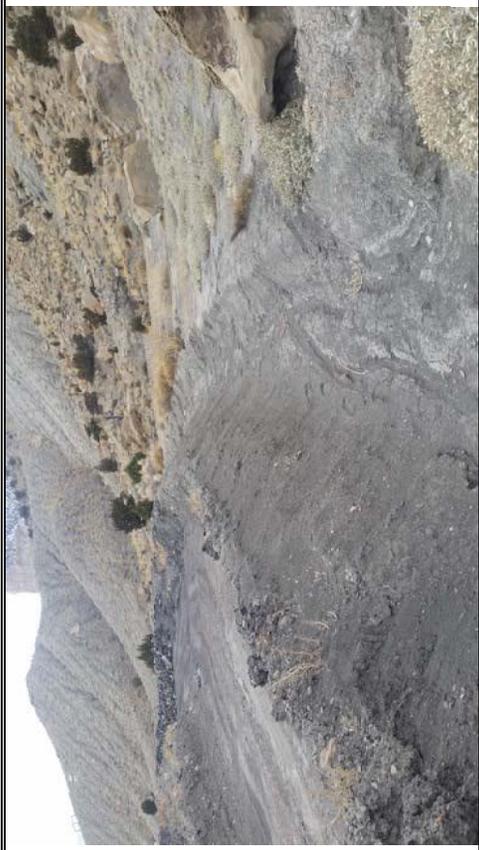
PHOTO 1 – SOUTHWEST DIVERSION DITCH
Filling in with sediment.
February 28, 2018

Diversions appear to be functioning, although most are in need of some light maintenance. Over the course of the winter months sediments have started to fill in diversions and drainage ditches, and a cleanout would be recommended. Check dams along the access road appear that they could also benefit from some light maintenance.

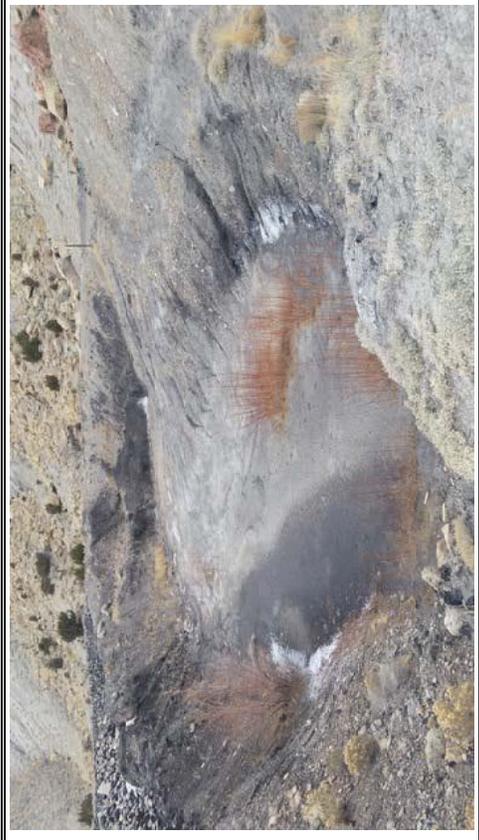
PHOTO 2 – SEDIMENT BASIN
The sediment basin was almost completely dry. Some young Tamarisk have taken hold.
February 28, 2018

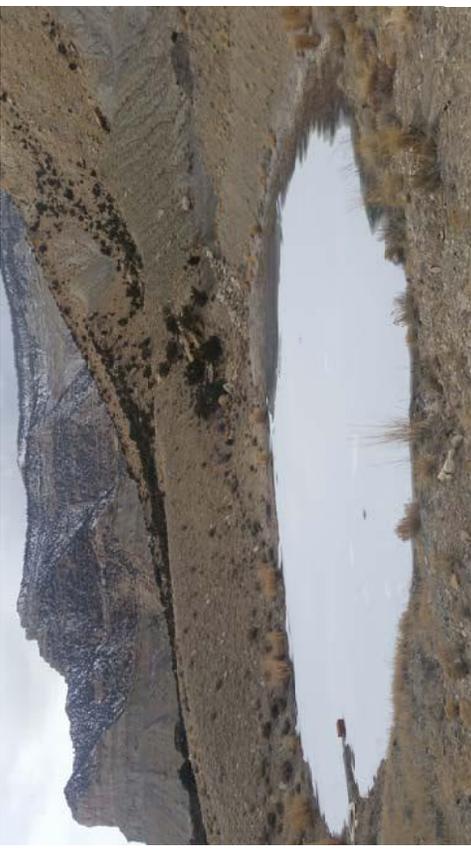
The sediment pond was completely frozen over with a thick layer of ice.

PHOTO 3 – SEDIMENT POND
The sediment pond was completely frozen over with a thick layer of ice.
February 28, 2018

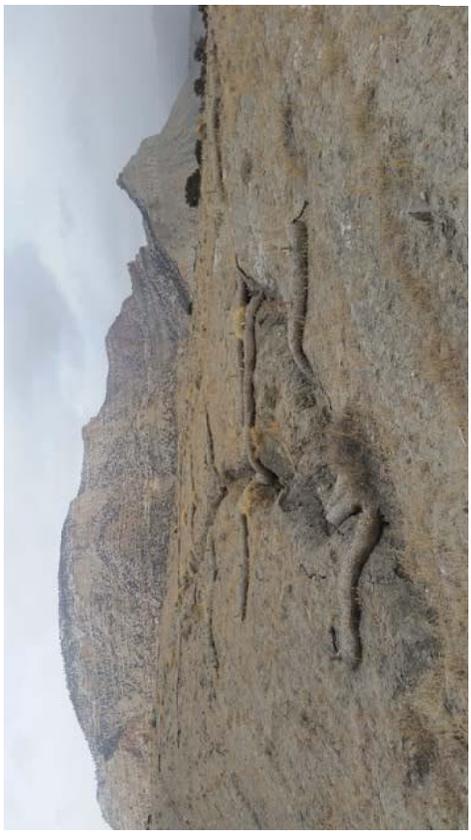
The wattles on top of the subsoil stockpile appear to be slowing down preferential drainage patterns within the southfacing rills.

PHOTO 4 – RILLING ON SUBSOIL STOCKPILE
Waddles placed perpendicular to these south facing rills appear to have slowed the velocity of flow within the drainage channels.
February 28, 2018
