**Inspection Report**

Permit Number:	C0150009
Inspection Type:	PARTIAL
Inspection Date:	Thursday, April 26, 2018
Start Date/Time:	4/26/2018 11:30:00 AM
End Date/Time:	4/26/2018 1:00:00 PM
Last Inspection:	Wednesday, March 21, 2018

Permittee: **FOSSIL ROCK RESOURCES, LLC**  
 Operator: **FOSSIL ROCK RESOURCES, LLC**  
 Site: **FOSSIL ROCK MINE**  
 Address: **225 North 5th Street, 9th Floor, CO 81501**  
 County: **EMERY**  
 Permit Type: **PERMANENT COAL PROGRAM**  
 Permit Status: **ACTIVE**

This partial inspection of the Fossil Rock Waste Rock Site was completed on Thursday, April 26, 2018. Most of the site was surveyed on foot, and the condition of the facilities were assessed.

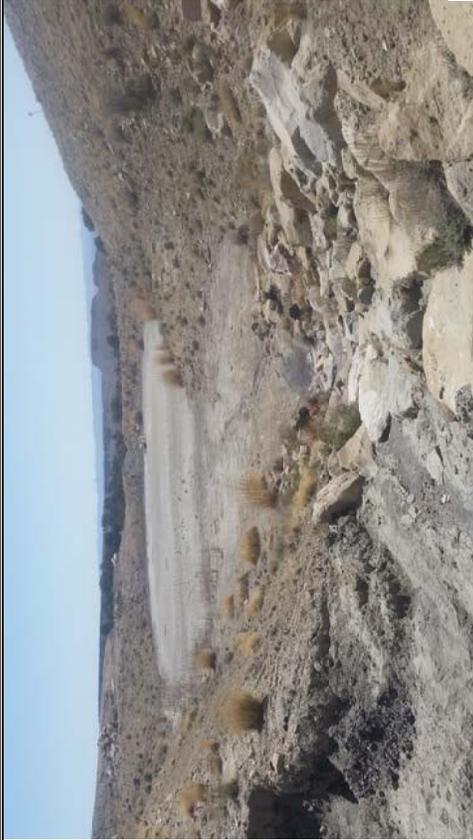
**PHOTO 1 – LOOKING EAST TOWARDS SEDIMENT POND**  
Subsoil stockpile on the left, topsoil stockpile on the right.  
April 26, 2018

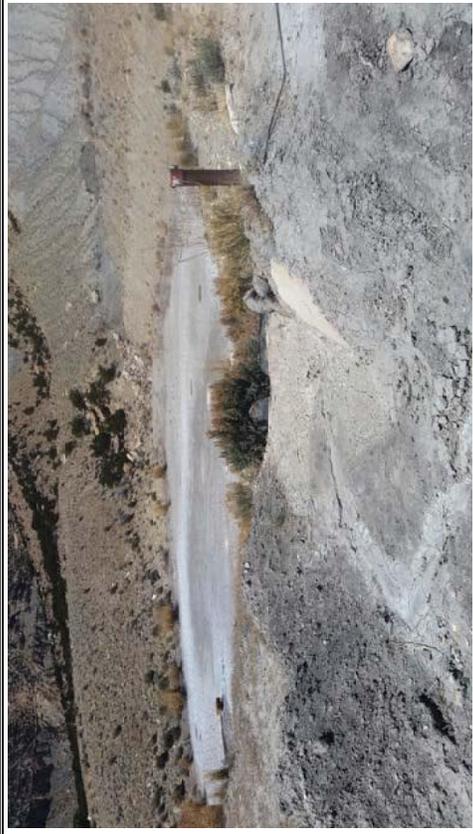
**PHOTO 2 – SEDIMENT POND**  
Topsoil stockpile just behind the pond.  
April 26, 2018

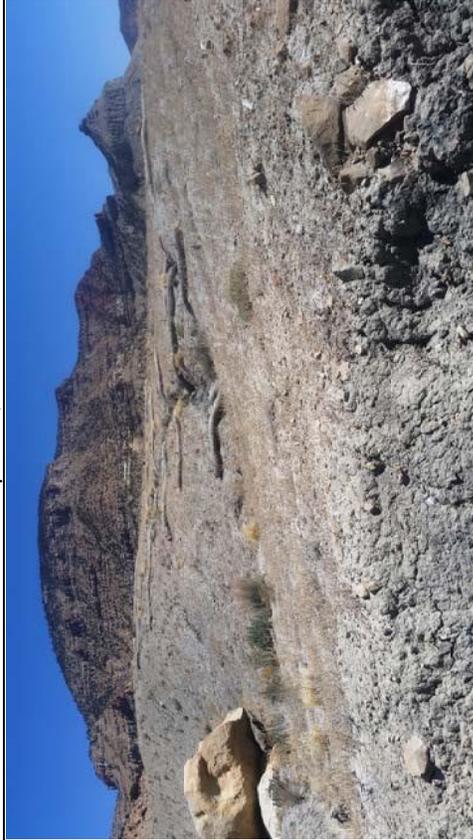
The topsoil piles appear to be moderately vegetated, and the main topsoil pile on the South of the permit area doesn't have as many erosional features as the subsoil stockpile on the other side of the sediment pond.

**PHOTO 3 – SUBSOIL STOCKPILE**  
Wattles placed perpendicular to rilling to arrest sediment transport.  
April 26, 2018

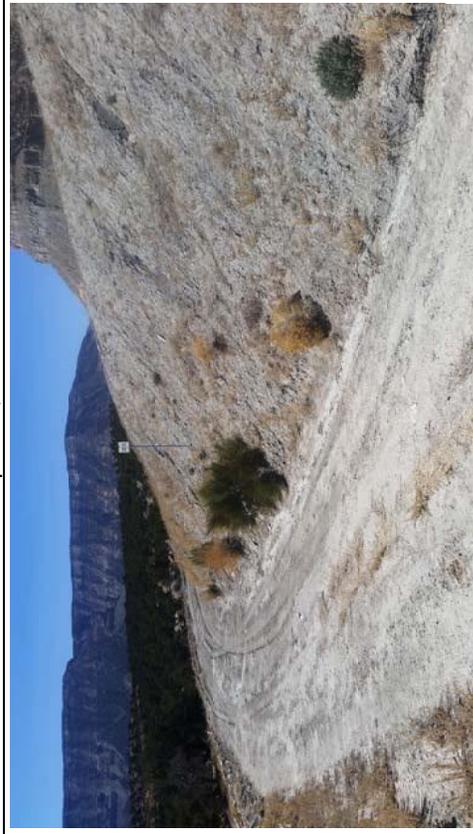
The north facing slopes of the subsoil pile are naturally draining and following the curve of the dirt road that wraps around the perimeter of the subsoil pile itself. As the road and the drainage channel curve around towards the sediment pond, a small drainage ditch is recommended to assist the course of the drainage into the sediment pond instead of flowing over the road and off of the property.

**PHOTO 4 – SUBSOIL STOCKPILE**  
A small channel here may assist runoff into the sediment pond.  
April 26, 2018

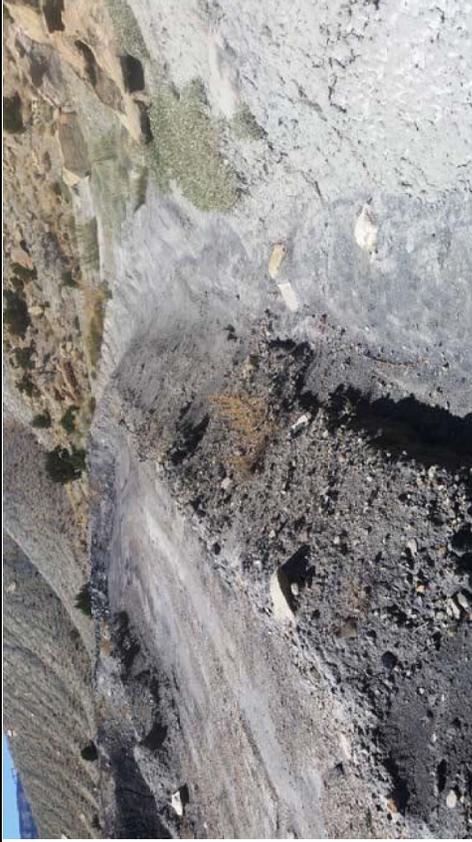
**PHOTO 5 – DIVERSION ALONG PRIMARY ROAD**

Diversions at the Waste Rock Site are stable and appear to be functioning properly, although most diversions are in need of some maintenance to clear out accumulating silt.

Check dams along primary road into the Waste Rock Site will be cleaned out some time in the next few months.

Scheduled maintenance in the next couple of months will remove the accumulating silt.  
April 26, 2018

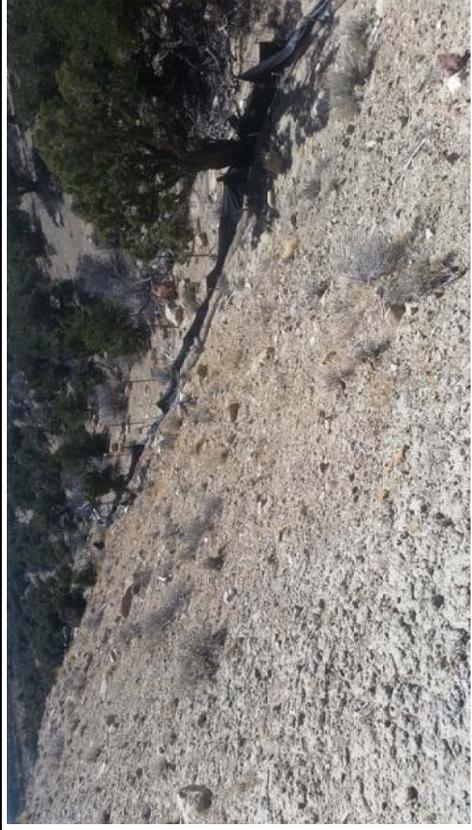
**PHOTO 6 – SOUTH SIDE OF TOPSOIL STOCKPILE**

The silt fences along the South of the topsoil pile appear to be in good operating condition.

Silt fences appear to be intact and performing as intended.  
April 26, 2018

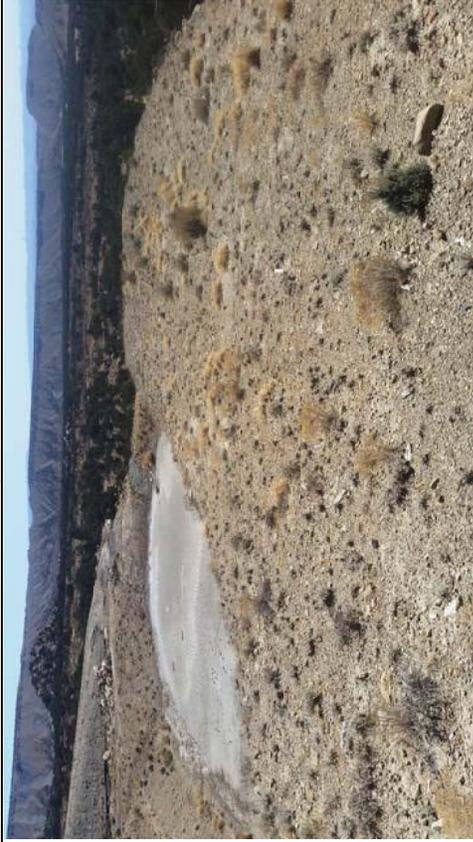
**PHOTO 7 – THE TOP OF THE TOPSOIL STOCKPILE**

Not as much rilling has occurred here compared to the subsoil stockpile.  
April 26, 2018

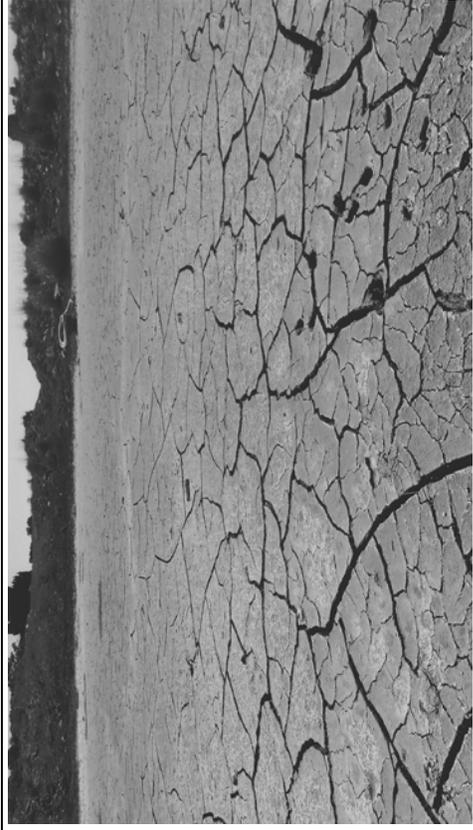
**PHOTO 8 – SEDIMENT POND**

The sediment pond is completely dry.

It's dry.
