# Inspection Report

| Permit Number: | <b>C0150009</b> |

Site: **FOSSIL ROCK MINE**

**ATTACHMENT A – May 13, 2019 Partial Oversight inspection**

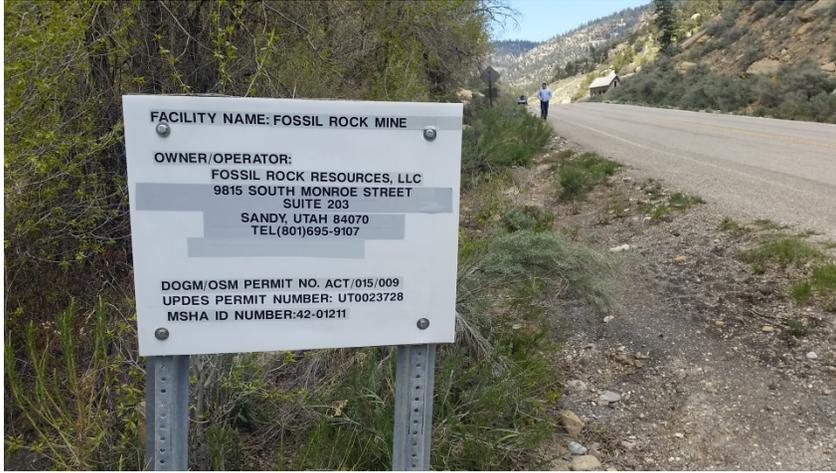
**PHOTO 1 – POSTED PERMIT, MAIN SITE**  
Posted along the County road just south of the Permit area.

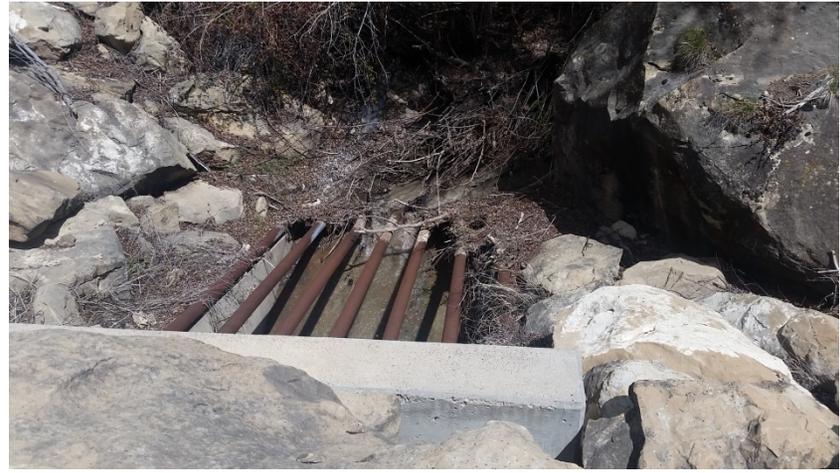
**PHOTO 2 – INTAKE CULVERT, MAIN SITE**  
Looking due north. Culvert intake appears clear. Snowmelt runoff is currently flowing through the culvert.

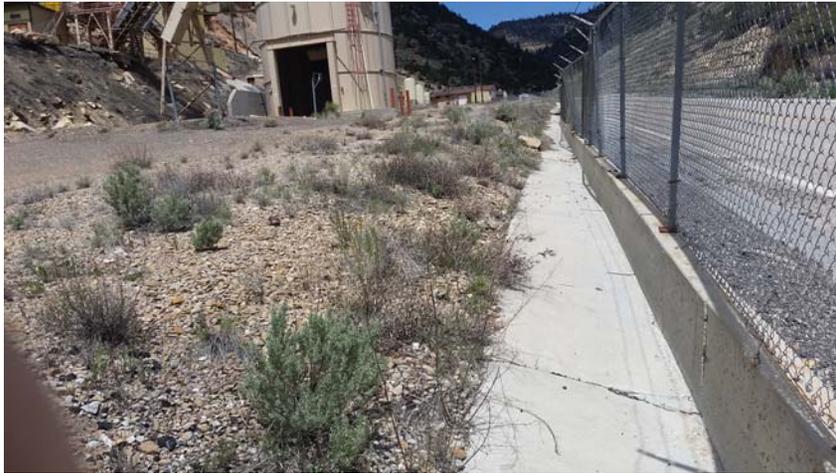
**PHOTO 3 – CONCRETE GUTTER, MAIN SITE**  
The gutters that run parallel to the County road were clean and clear of debris.

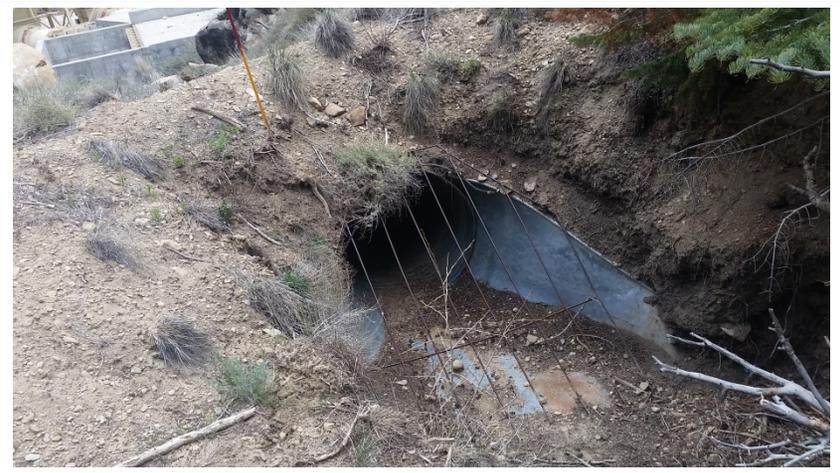
Diversions appeared clear and free of debris. The 24" CMP riser that collects Cottonwood Mine discharge water also appeared clear and free of debris. The minewater flow appeared higher than usual.

**PHOTO 4 – DIVERSION, MAIN SITE**  
The inlet of the 48” CMP culvert that diverts runoff underneath the topsoil stockpile west of the buildings.

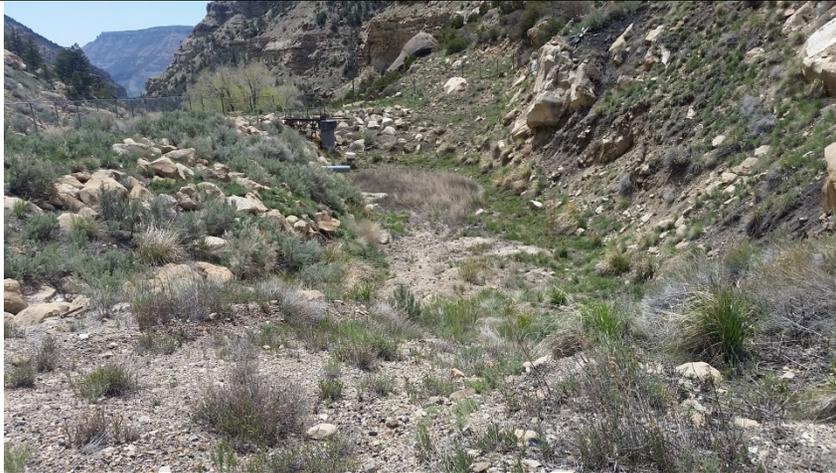
The sediment pond was dry.

**PHOTO 5 – SEDIMENT POND, MAIN SITE**  
Winter snows have melted, and the pond is completely dry.

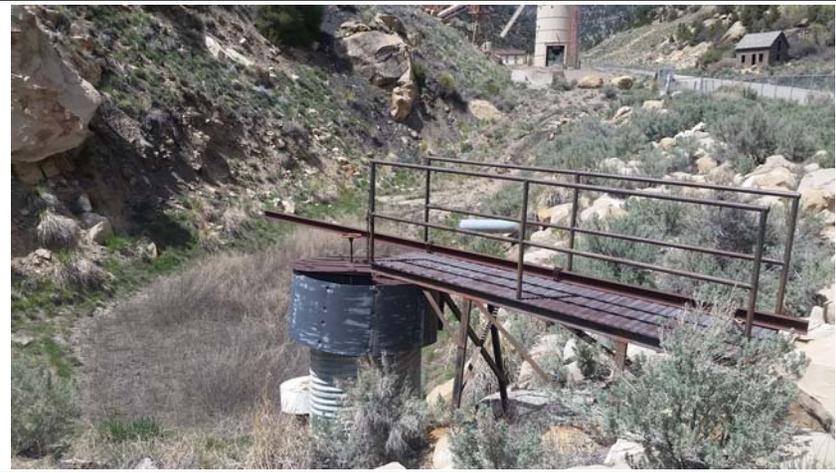
**PHOTO 6 – SEDIMENT POND, MAIN SITE**  
An alternate view looking north.

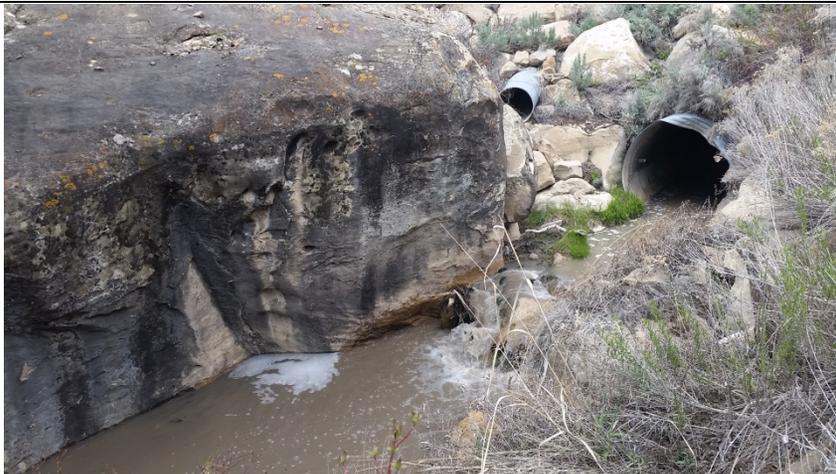
**PHOTO 7 – 66" CULVERT OUTLET, MAIN SITE**  
The water flowing from the culvert is Cottonwood mine water discharge plus snowmelt runoff.

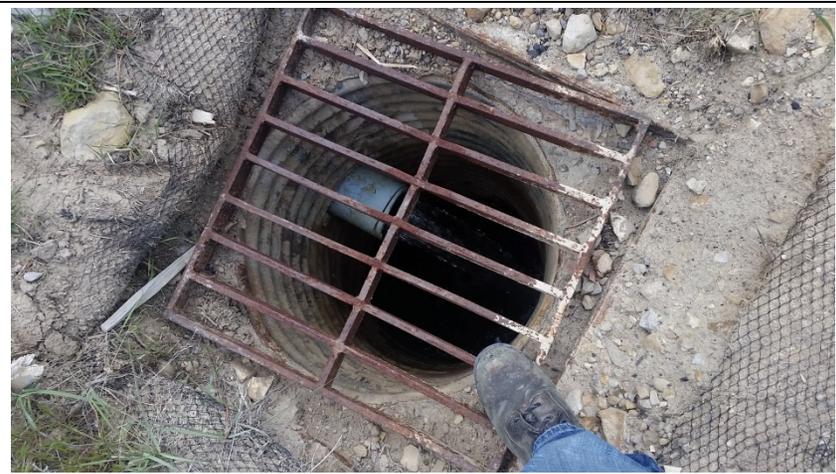
**PHOTO 8 – COTTONWOOD MINE DRAINAGE**  
This 24" drop culvert captures the Cottonwood Mine water drainage in route to Cottonwood Creek.
