Inspection Report

Permit Number:	C0150009
Inspection Type:	COMPLETE
Inspection Date:	Monday, June 24, 2019
Start Date/Time:	6/24/2019 1:00:00 PM
End Date/Time:	6/24/2019 4:00:00 PM
Last Inspection:	Monday, May 13, 2019

Permitee: **FOSSIL ROCK RESOURCES, LLC**
 Operator: **FOSSIL ROCK RESOURCES, LLC**
 Site: **FOSSIL ROCK MINE**
 Address: ,
 County: **EMERY**
 Permit Type: **PERMANENT COAL PROGRAM**
 Permit Status: **INACTIVE**

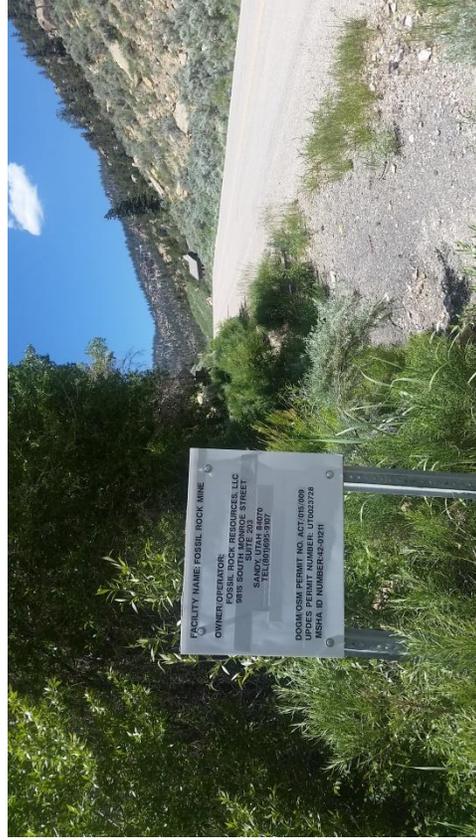
PHOTO 1 – POSTED PERMIT, MAIN SITE
 Posted along the County road just south of the Permit area.

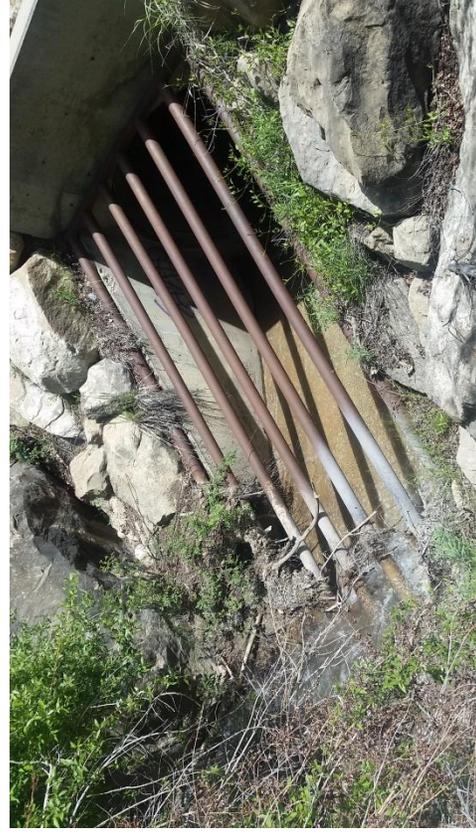
PHOTO 2 – INTAKE CULVERT, MAIN SITE
 Culvert intake appears mostly clear. Snowmelt runoff is currently flowing through the culvert.

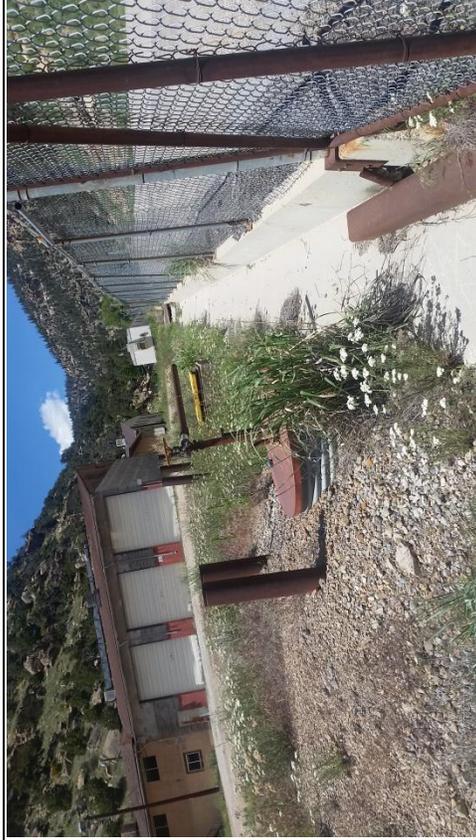
PHOTO 3 – CONCRETE GUTTER, MAIN SITE
 The gutters that run parallel to the County road were clean and clear of debris.

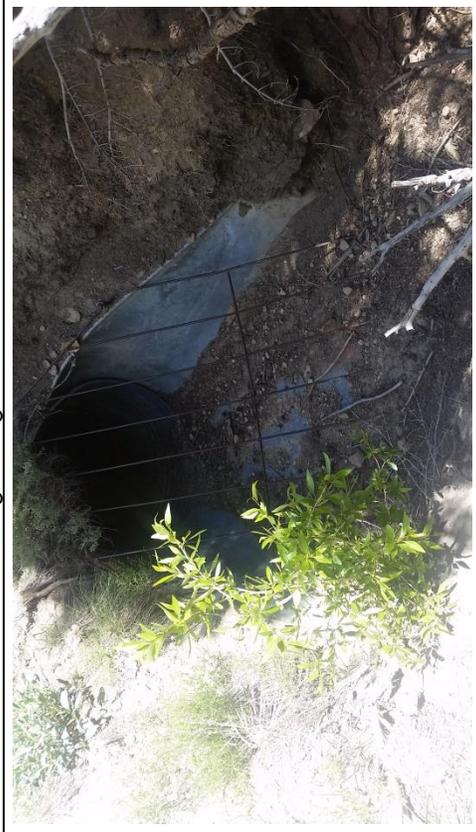
PHOTO 4 – DIVERSION, MAIN SITE
 The inlet of the 48" CMP culvert that diverts runoff underneath the topsoil stockpile west of the buildings.

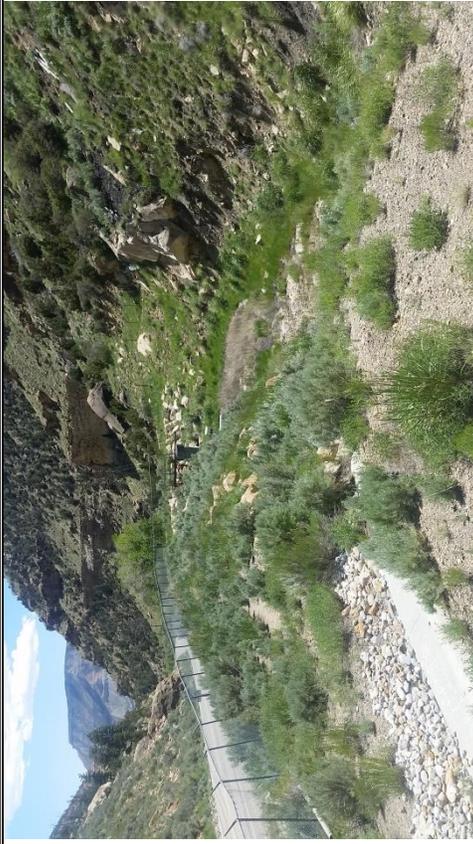
PHOTO 5 – SEDIMENT POND, MAIN SITE
Winter snows have melted, and the pond is completely dry.

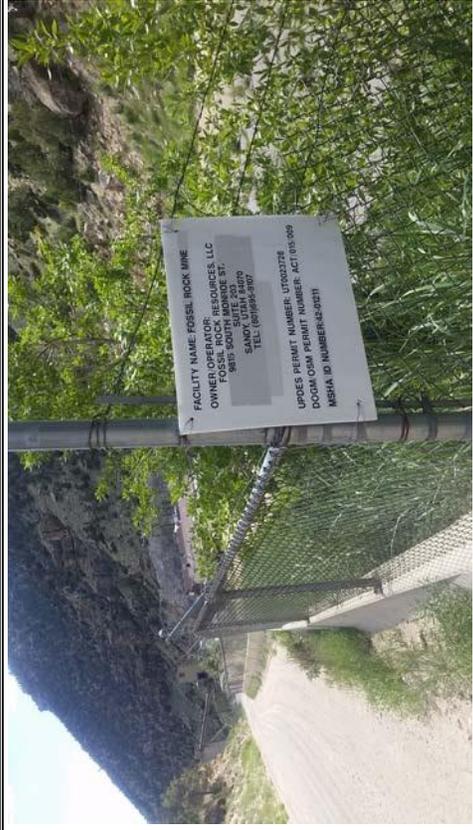
PHOTO 6 – POSTED PERMIT, MAIN SITE
Posted along the County road just north of the Permit area.

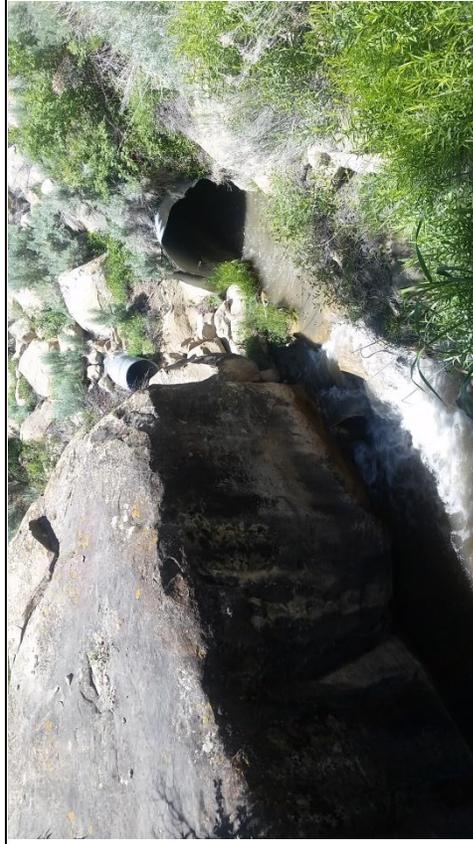
PHOTO 7 – 66” CULVERT OUTLET, MAIN SITE
The water flowing from the culvert is Cottonwood mine water discharge plus snowmelt runoff.

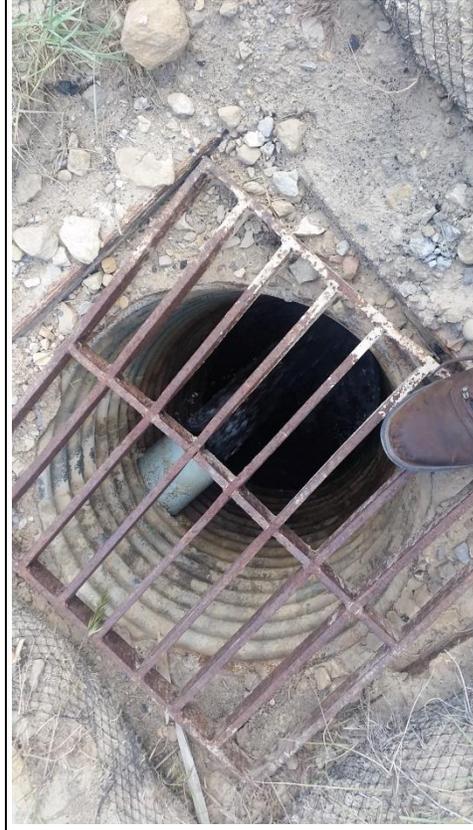
PHOTO 8 – COTTONWOOD MINE DRAINAGE
This 24” drop culvert captures the Cottonwood Mine water drainage in route to Cottonwood Creek.

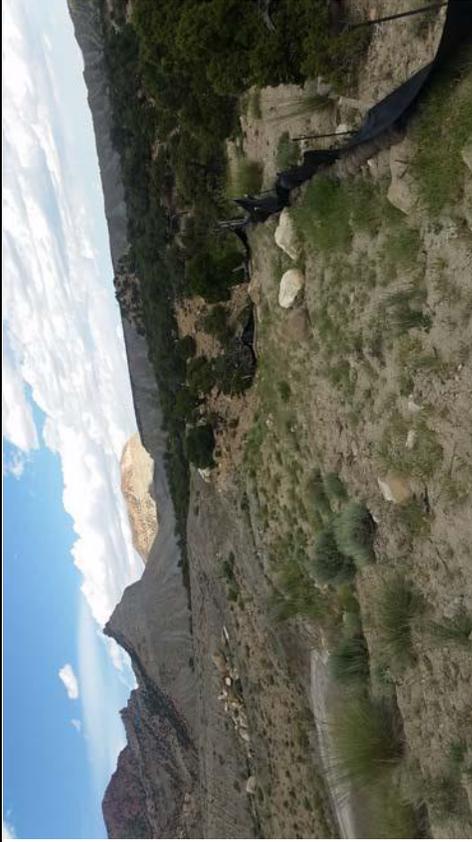
PHOTO 9 – SILT FENCE, WASTE ROCK SITE
Looking North - The newly installed silt fence at the base of Topsoil pile #1. The sediment pond is on the left.

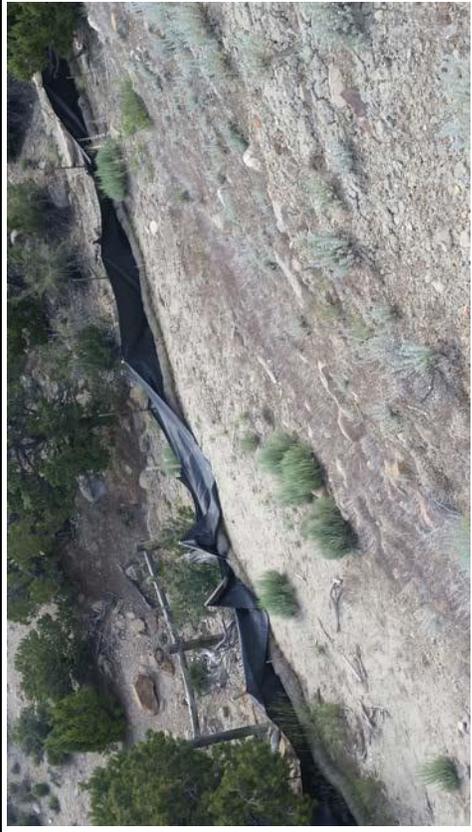
Recently installed silt fences on the south of Topsoil Pile #1 at the waste rock site appear to be in good condition, although a few sections have started to fall over.

PHOTO 10 – SILT FENCE, WASTE ROCK SITE
Newly installed silt fence at the base of Topsoil pile #1 appears to be falling down in places.

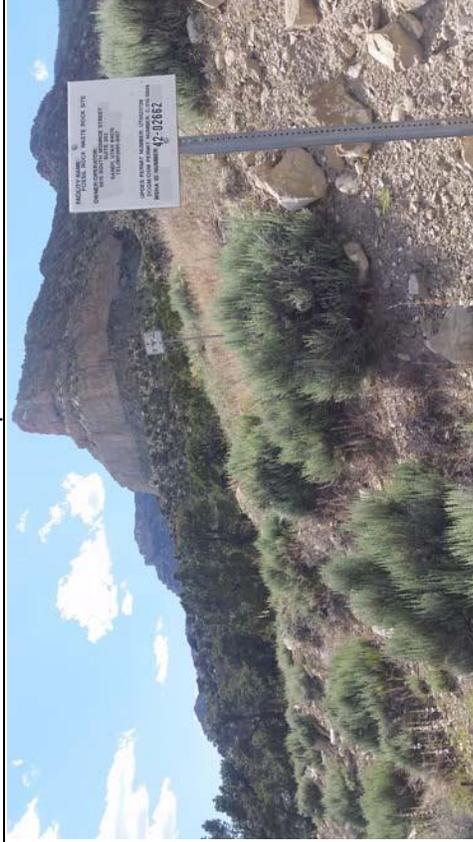
PHOTO 11 – PERMIT SIGN, WASTE ROCK SITE
Topsoil pile #3 just behind this sign.

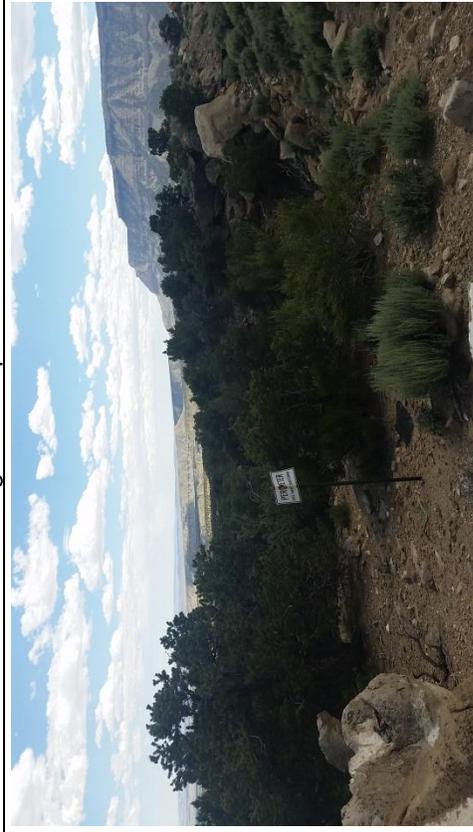
PHOTO 12 – PERIMETER SIGN, WASTE ROCK SITE
Installed parallel to the primary road, looking South.

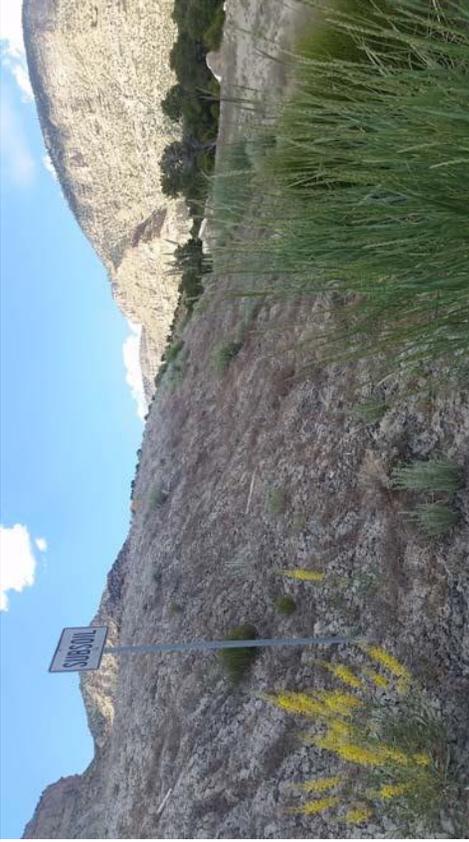
PHOTO 13 – SUBSOIL STOCKPILE, WASTE ROCK SITE
Native vegetation taking hold at the base.

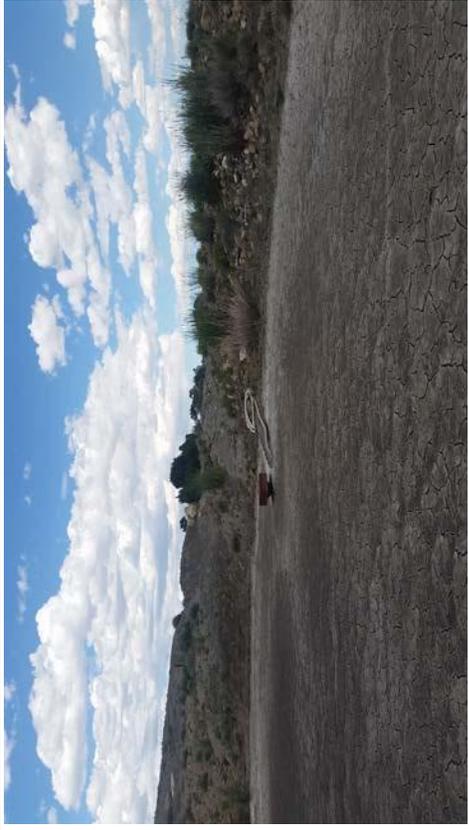
PHOTO 14 – SEDIMENT POND, WASTE ROCK SITE
Completely dry.

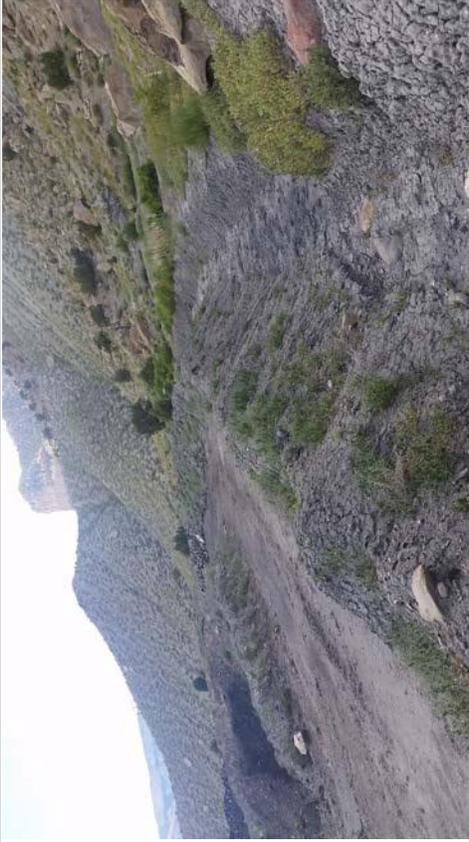
Diversions at the waste rock site appeared to be in stable condition, although some of the wider diversions on the west side were beginning to fill with silt. The diversions at the main site were clean and clear of debris.

PHOTO 15 – DIVERSION DITCH, WASTE ROCK SITE
This runs along the west side of the disturbed area. This particular ditch collects a lot of silt.

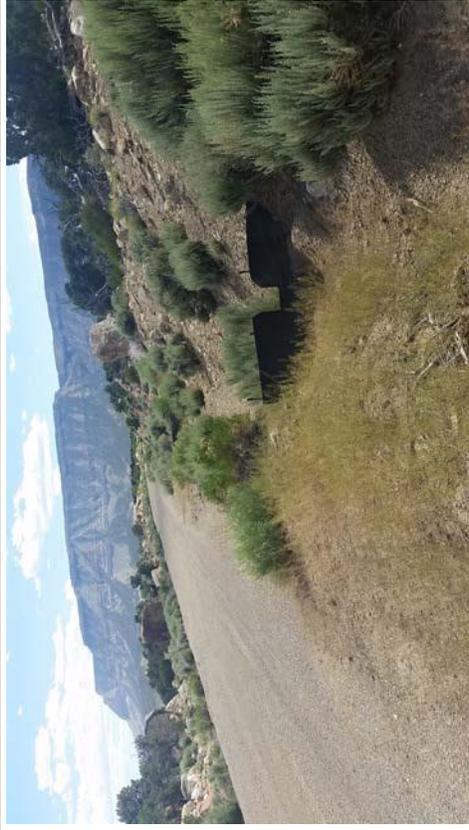
PHOTO 16 – DIVERSION DITCH, WASTE ROCK SITE
This diversion runs parallel to the primary road, and check dams like this are installed at periodic intervals.
