re: Apparent Completeness Review - Preparation Plant and Loadout

783.12 General Environmental Resources Information

REFUSE HAULAGE ROAD
 QUITCHUPAH CREEK CROSSING

HYDRAULICS OF CULVERTS

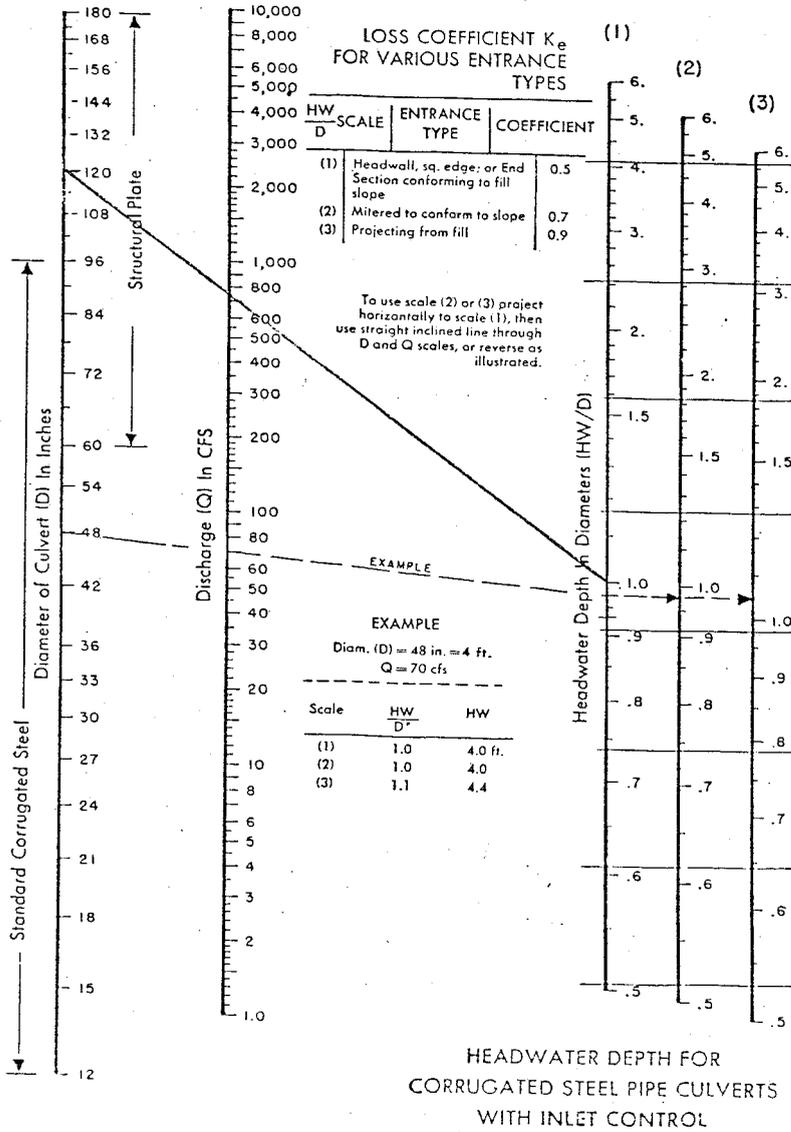
Fig. 4.18. Inlet control nomograph for corrugated steel pipe culverts. The manufacturers recommend keeping HW/D to a maximum of 1.5 and preferably to no more than 1.0.

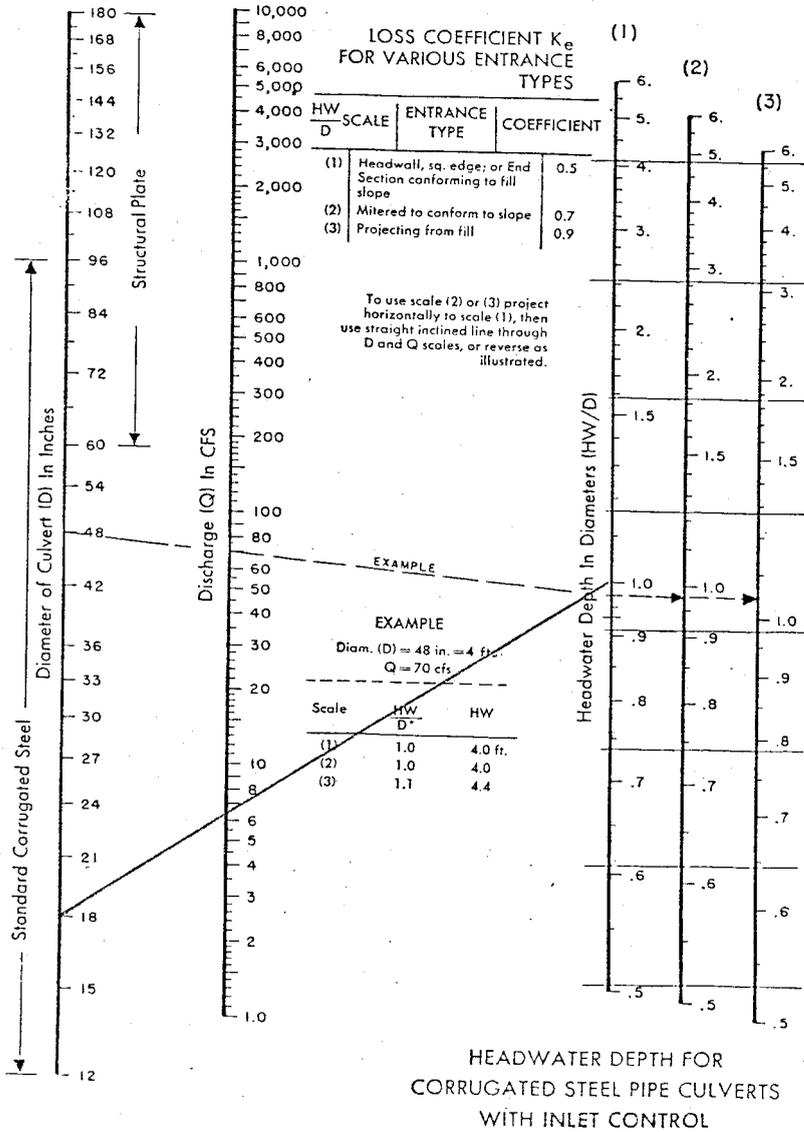
REFUSE HAULAGE ROAD
CROSS CULVERT

Fig. 4-18. Inlet control nomograph for corrugated steel pipe culverts. The manufacturers recommend keeping HW/D to a maximum of 1.5 and preferably to no more than 1.0.
