Re: Emery Mine
Electromagnetic Gradiometer Detection of Coal Mine Voids
Stolar/MSHA/Consol research project

STOLAR/MSHA
ELECTROMAGNETIC GRADIOMETER
DETECTION OF COAL MINE VOIDS

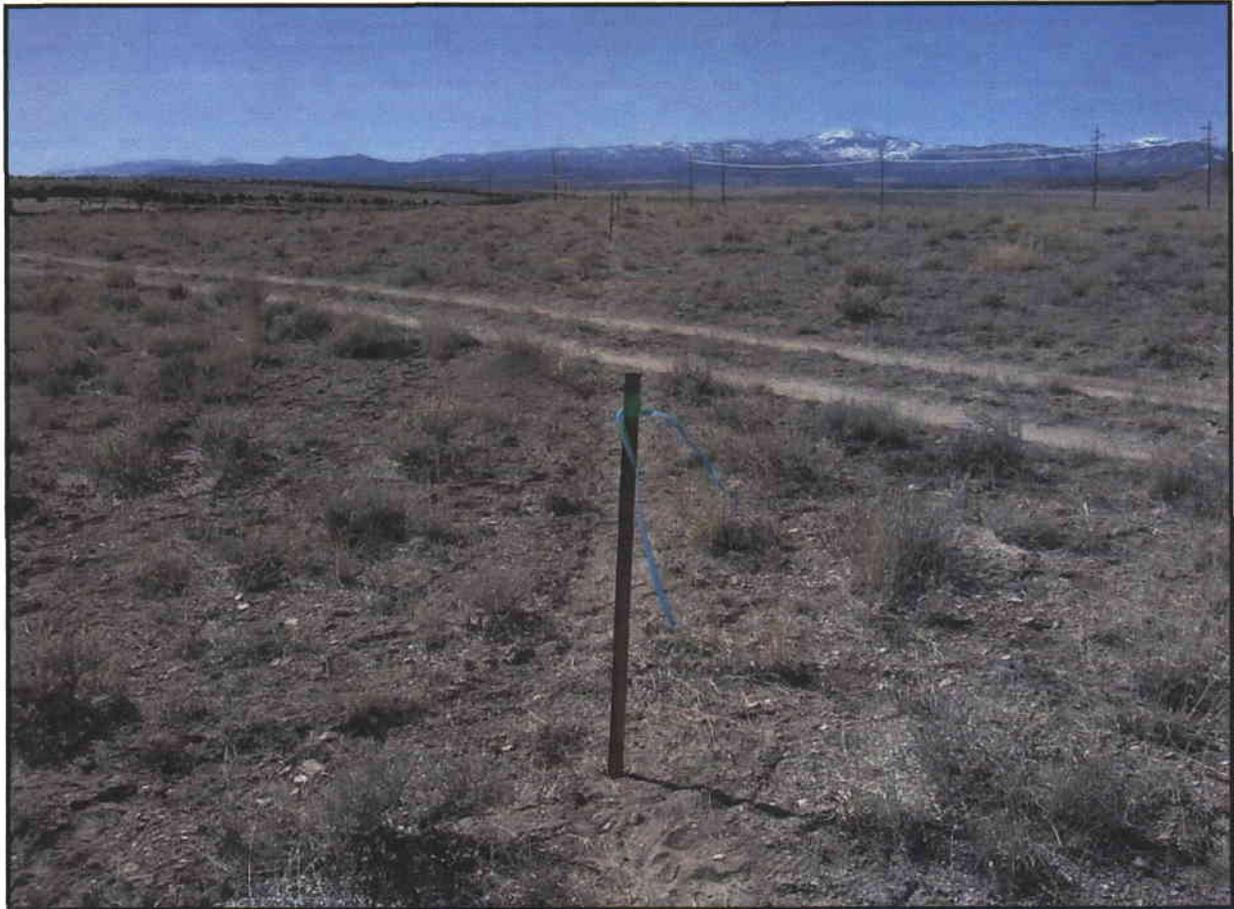
Figure 5. Test site surface location over the Emery Coal mine

Figure 5 shows the test site surface location and the survey path line.
