Re: Emery Deep Mine Permit C/015/015  
Revegetation and Dust Control Revision Deficiency Response Task ID 4700

**Title:** Revegetation and Dust Control Revision

# Emery Mine Coal Dust Plots Monitoring Summary

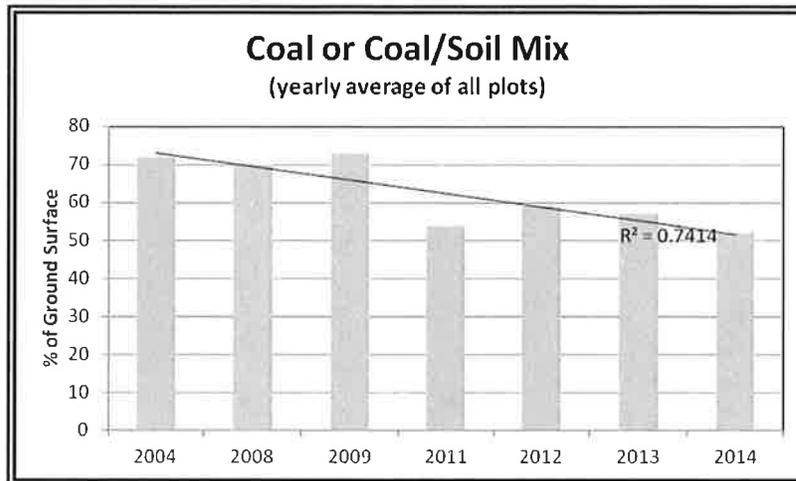
The following bar chart shows the trend in percent of the ground surface covered by coal fines or coal/soil mixture, again using the average of the plots for each year. As noted above, year 2010 was somewhat anomalous in that the JBR observer collaborated with the Division representative in assessing the plots, rather than making independent estimates. The result of this collaboration was that the data at most of the sites showed a significantly reduced coverage of coal fines present when compared to data from prior or subsequent years. Rather than making an interpretation that the sites experienced a significant reduction in coal fines in 2010, followed by four years of increased concentrations of coal fines, the more likely conclusion is that the 2010 observations were skewed due to input from an additional observer. While valid on its own and meeting the intent of the yearly requirement, the 2010 data should probably not be used in making final conclusions. Thus, the 2010 data is excluded from the chart.

In spite of inherent issues associated with applying the methodology, and the fact that it has become more difficult to implement over time as site conditions change, the data clearly show that the quantity of coal dust on the ground surface near the Emery Mine's 4<sup>th</sup> East Portal has diminished since the original plot observations were made in 2004. Coal appears to be generally incorporated into the soil matrix – likely due to frost heave, livestock trampling, erosion, runoff, and/or other mechanisms. There is no indication that coal continues to be introduced to the plots. These conclusions are supported by the estimated percent coal cover data (see the previous bar chart and associated trendline) as well as the visual observations of mixing and color changes. Further, vegetative growth appears to be sustained though influenced by weather cycles as typical of the environment around the Emery Mine.

Therefore, it appears that the dust control plan has been successful. As the mine has been idle since December 2011, and with no coal production expected in the near future, it appears that the annual coal dust monitoring has served its purpose. We recommend that it be discontinued at this time.

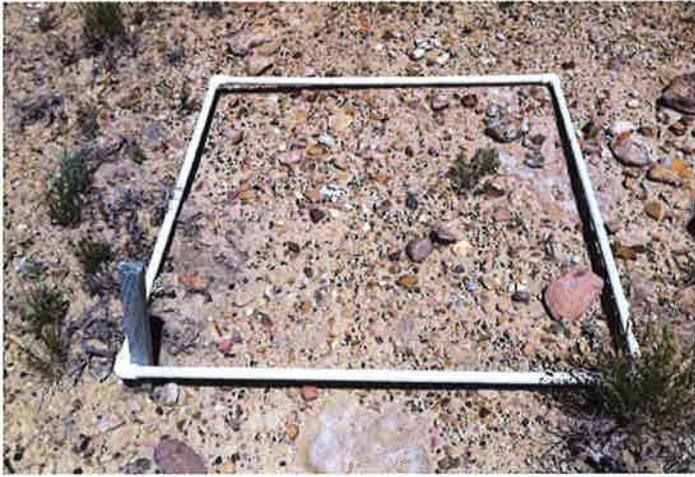
1c

Throughout the years of study, vegetation appeared to be greatly affected by precipitation and temperature patterns. For example, notes in the 2012 report stated "*Very dry conditions for this time of year: vegetation lacking, appears stressed*". The following year's report, conversely, noted "*Overall, vegetation looks much more robust than previous couple of years*". Between 2004 and 2014, the average percent vegetative cover has ranged between 10 and 20 percent. While the data may indicate a slight decline (the two highest percentages were in 2004 and 2008) during the study period, it cannot be attributed to the presence of the coal fines with any certainty. Again, the subjective nature of the observations, as well as the noted weather-related effects, obscure the results. What can be said with certainty is that all types of vegetation continue to be present and growing: shrubs, cacti, perennial forbs, grasses, and annual/colonizer forbs have been noted throughout the monitoring period. Photos from May 2014, provided in Appendix B, reflect these conditions.
