## Inspection Report

Permit Number:	C0150015
Inspection Type:	COURTESY
Inspection Date:	Tuesday, August 30, 2016
Start Date/Time:	8/30/2016 3:00:00 AM
End Date/Time:	8/30/2016 4:30:00 AM
Last Inspection:	Tuesday, August 16, 2016

Permitee: BRONCO UTAH OPERATIONS, LLC  
 Operator: BRONCO UTAH OPERATIONS, LLC  
 Site: EMERY DEEP MINE  
 Address: PO BOX 527, EMERY UT 84522  
 County: EMERY  
 Permit Type: PERMANENT COAL PROGRAM  
 Permit Status: ACTIVE

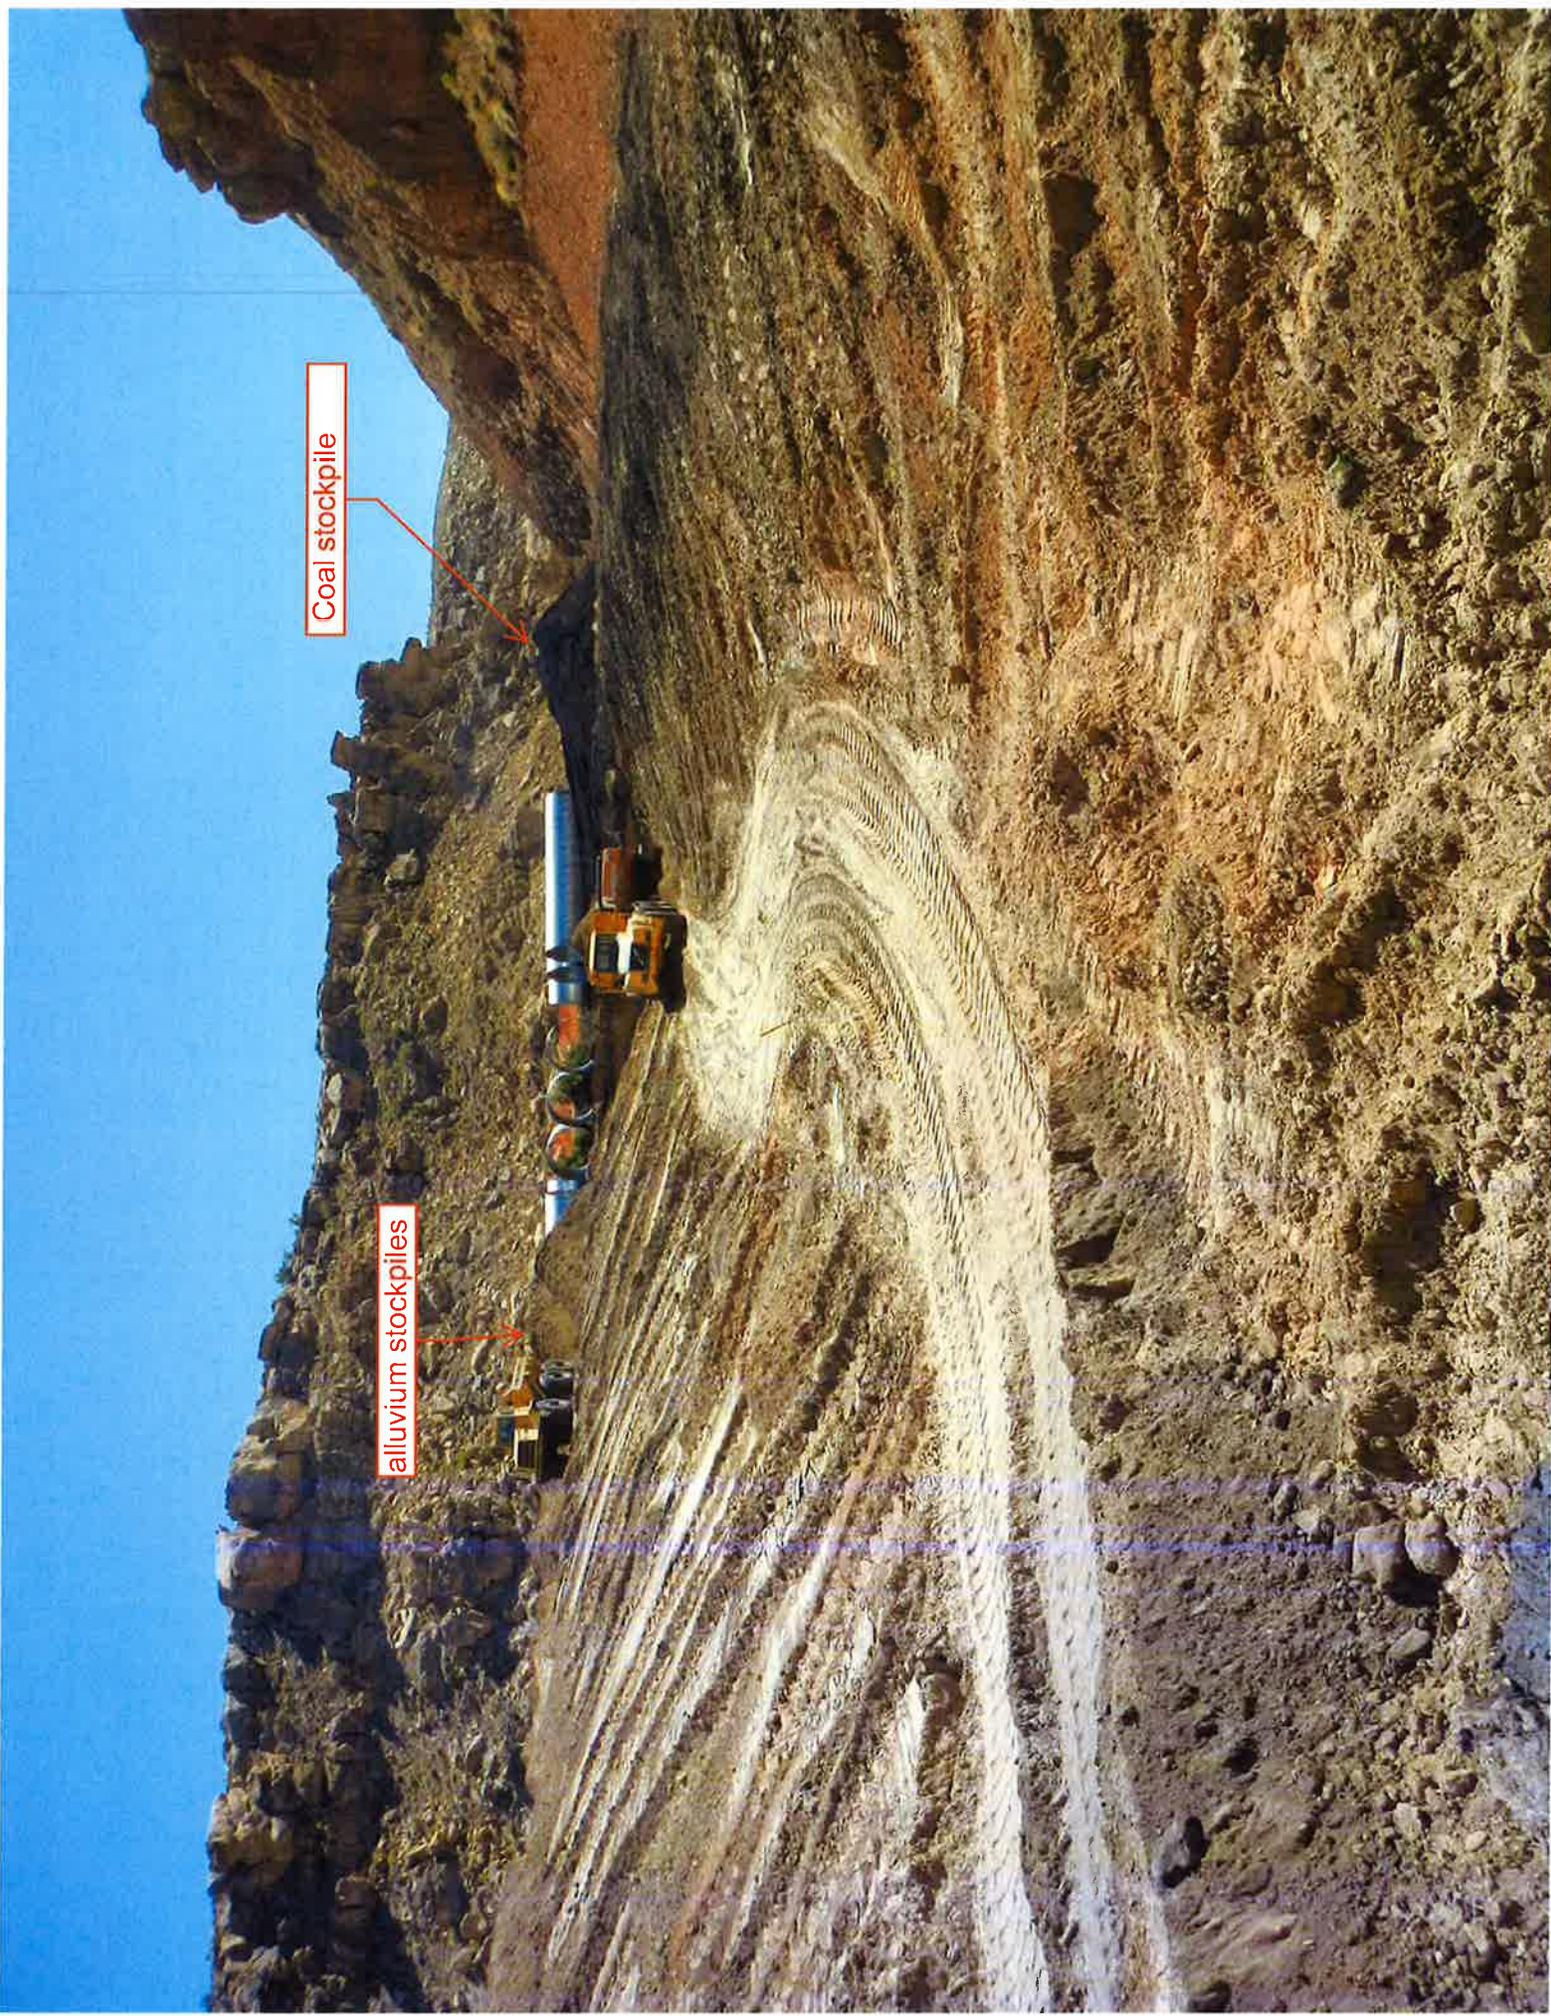
Coal stockpile

alluvium stockpiles

About 9,000 CY of coal was removed from the disturbed area pad has been stockpiled at the south end of the reclaim tunnel. (Volume is based on dimensions of the pad (200 ft x 400 ft) and the average 3 ft. depth of the coal.)

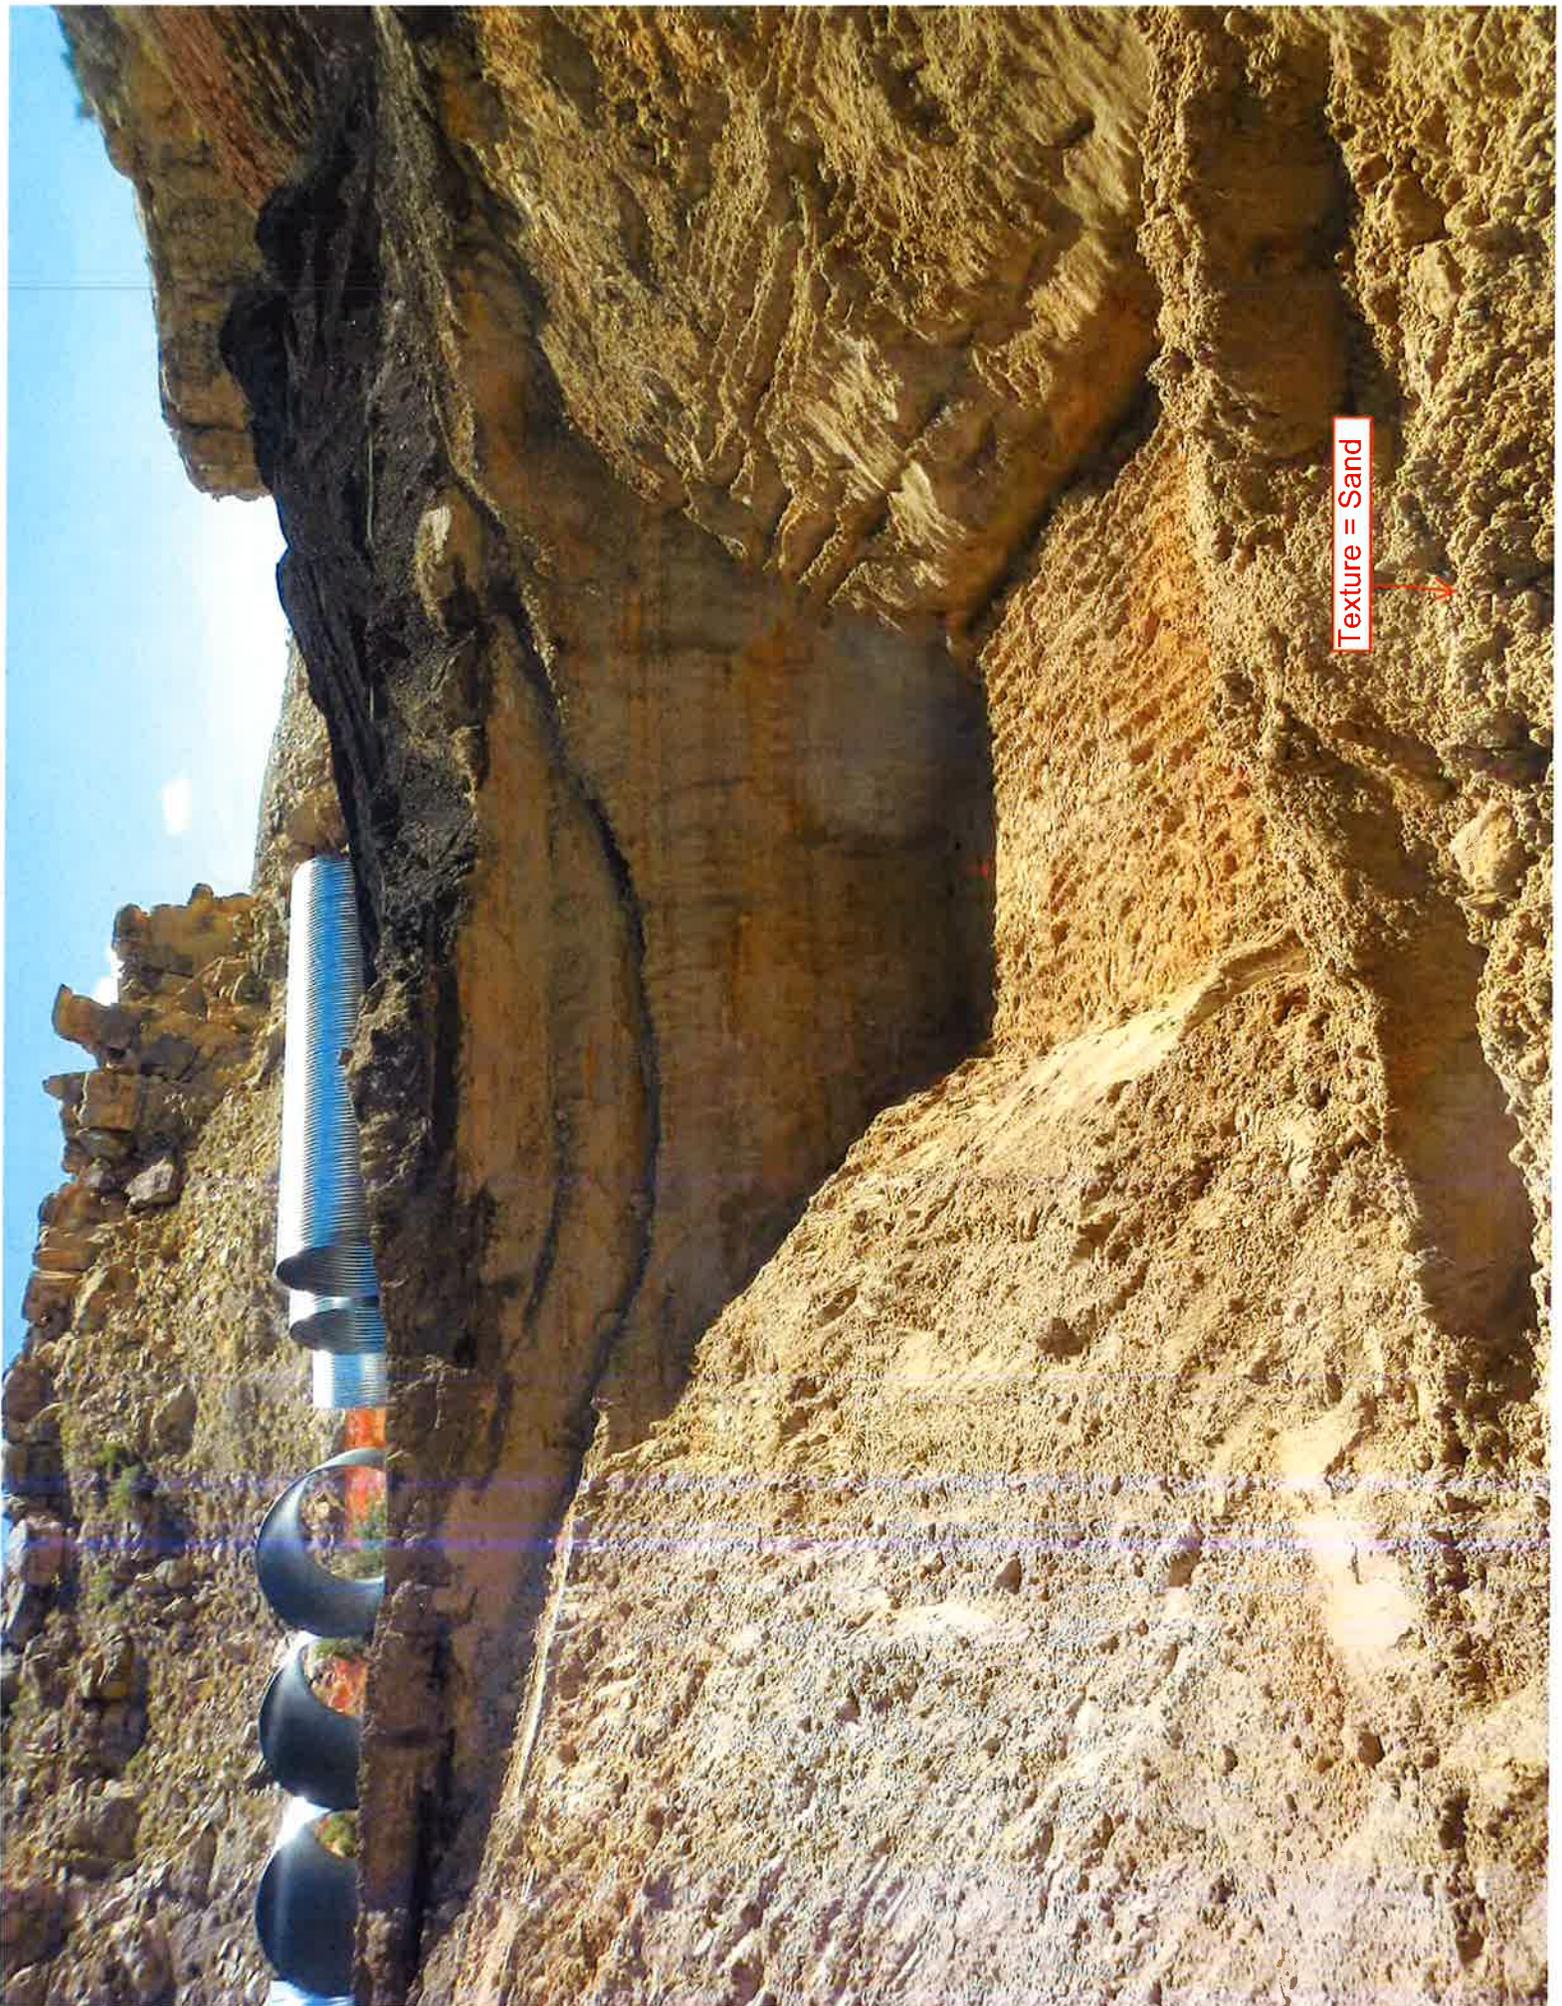
Texture = Sand

The reclaim tunnel location has been excavated to twenty foot depth at the south end. It will rise at 2% grade over 300 ft to the north end. Surface coal was approximately 3 feet deep. Beneath the surface coal, the face of the excavation reveals uniform alluvial deposition of sand. Approximately 210 Tons of this alluvium (six, 35 T truck loads) has been stockpiled adjacent to the excavation for use in burying the reclaim tunnel. The remainder of the excavated alluvium is being stockpiled at the temporary waste rock location.

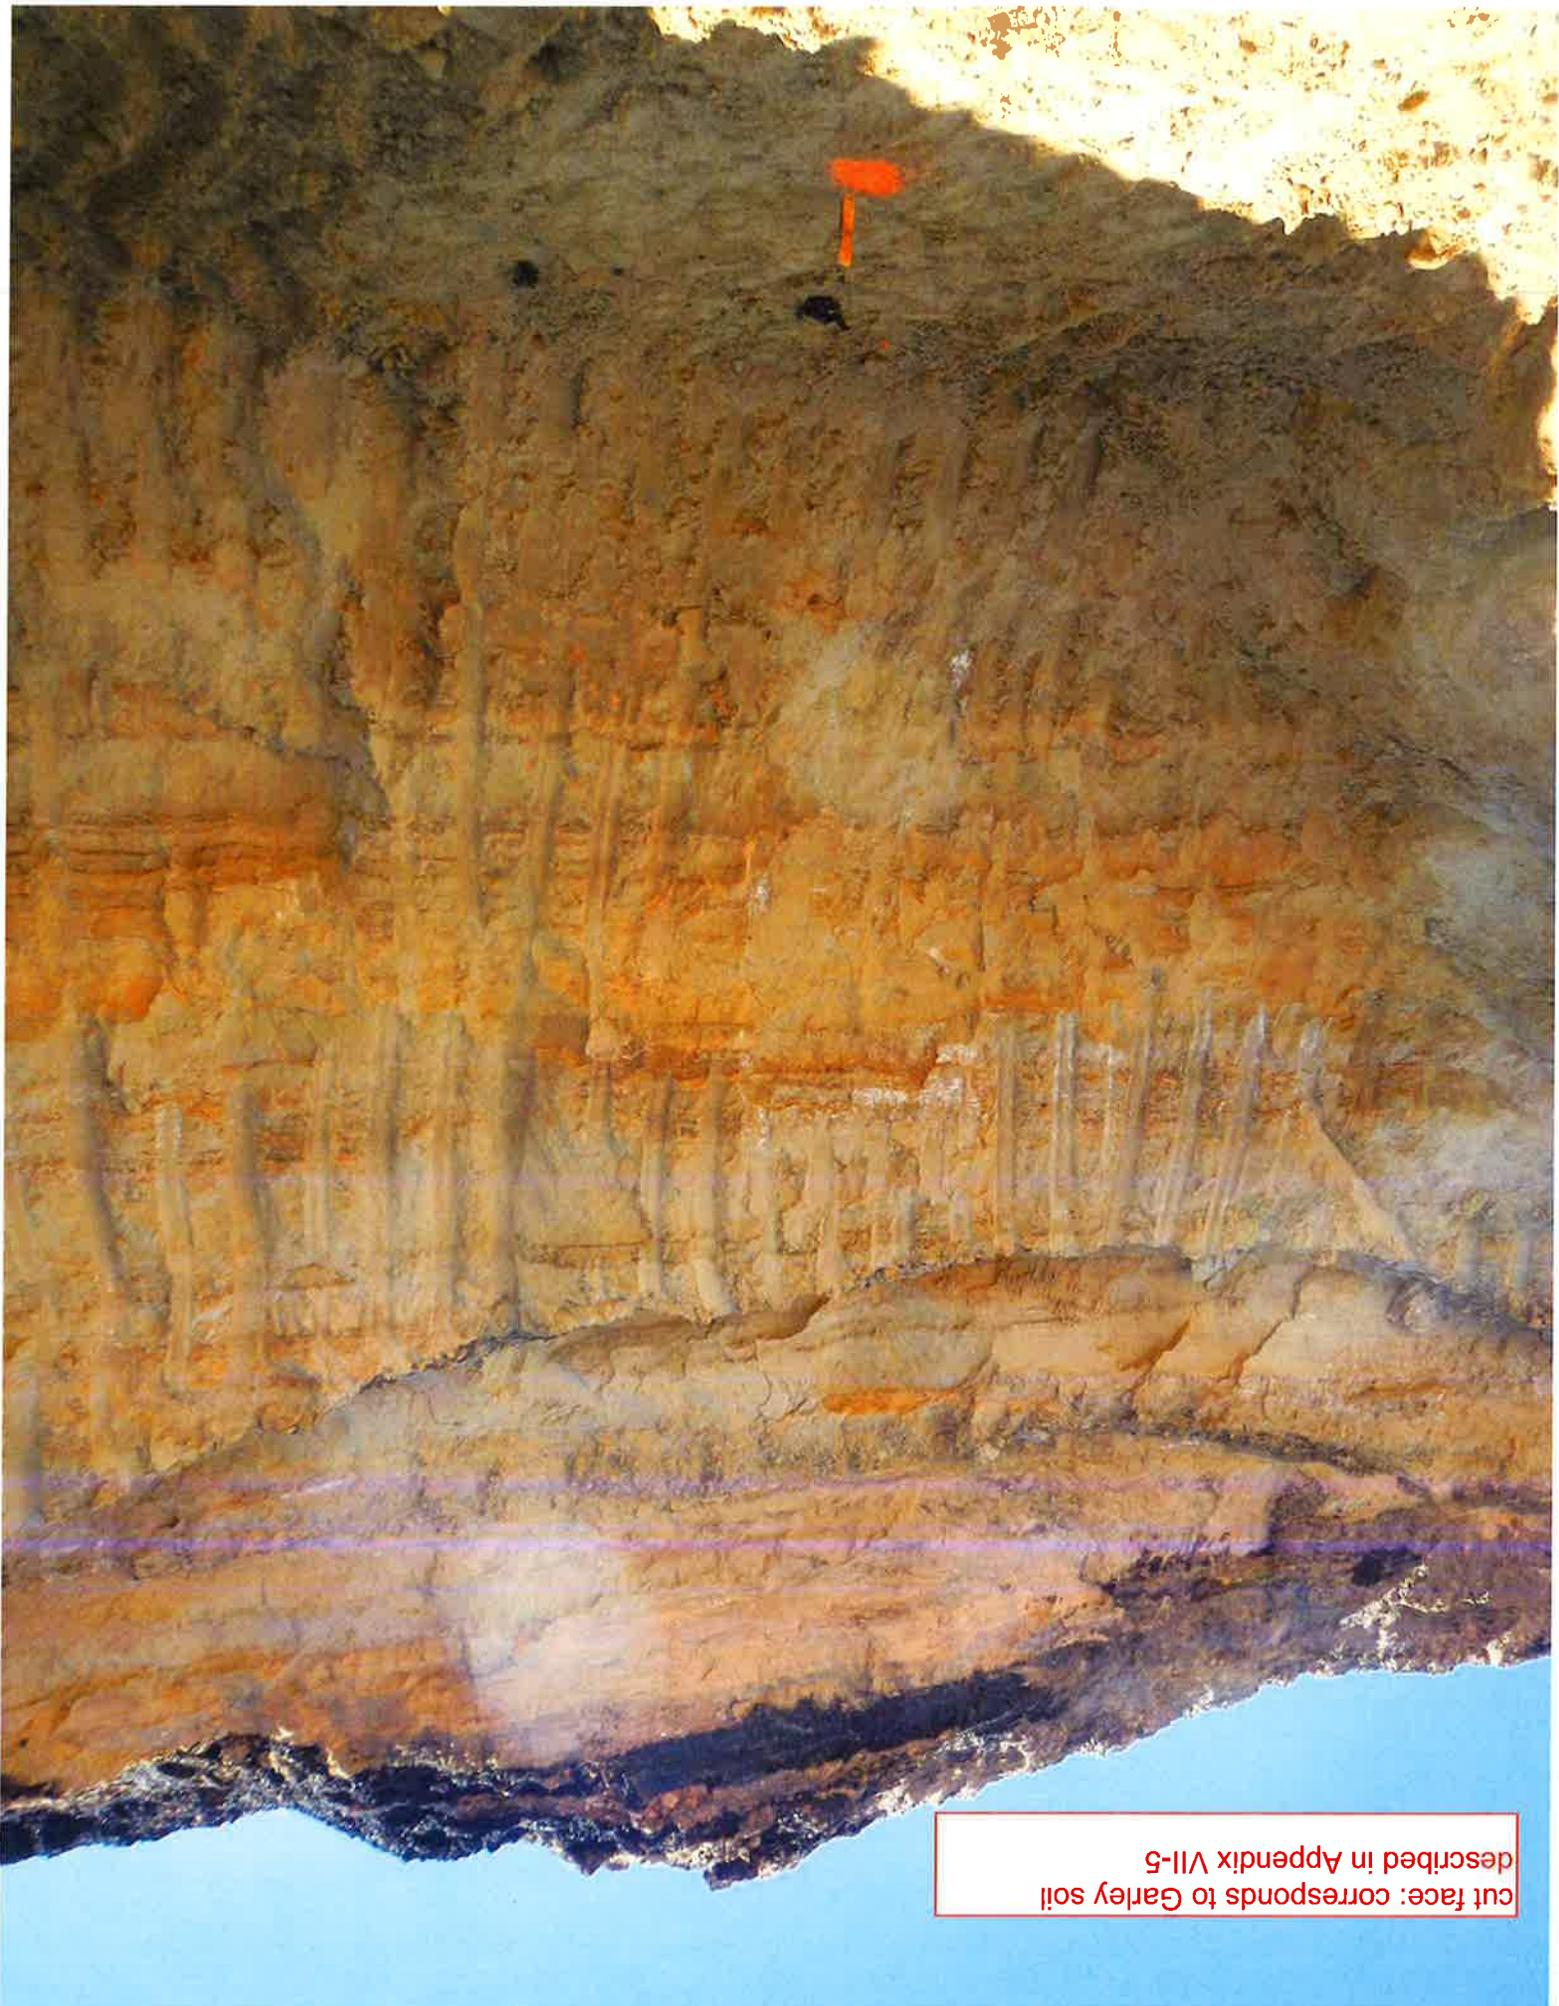
cut face: corresponds to Garley soil described in Appendix VII-5

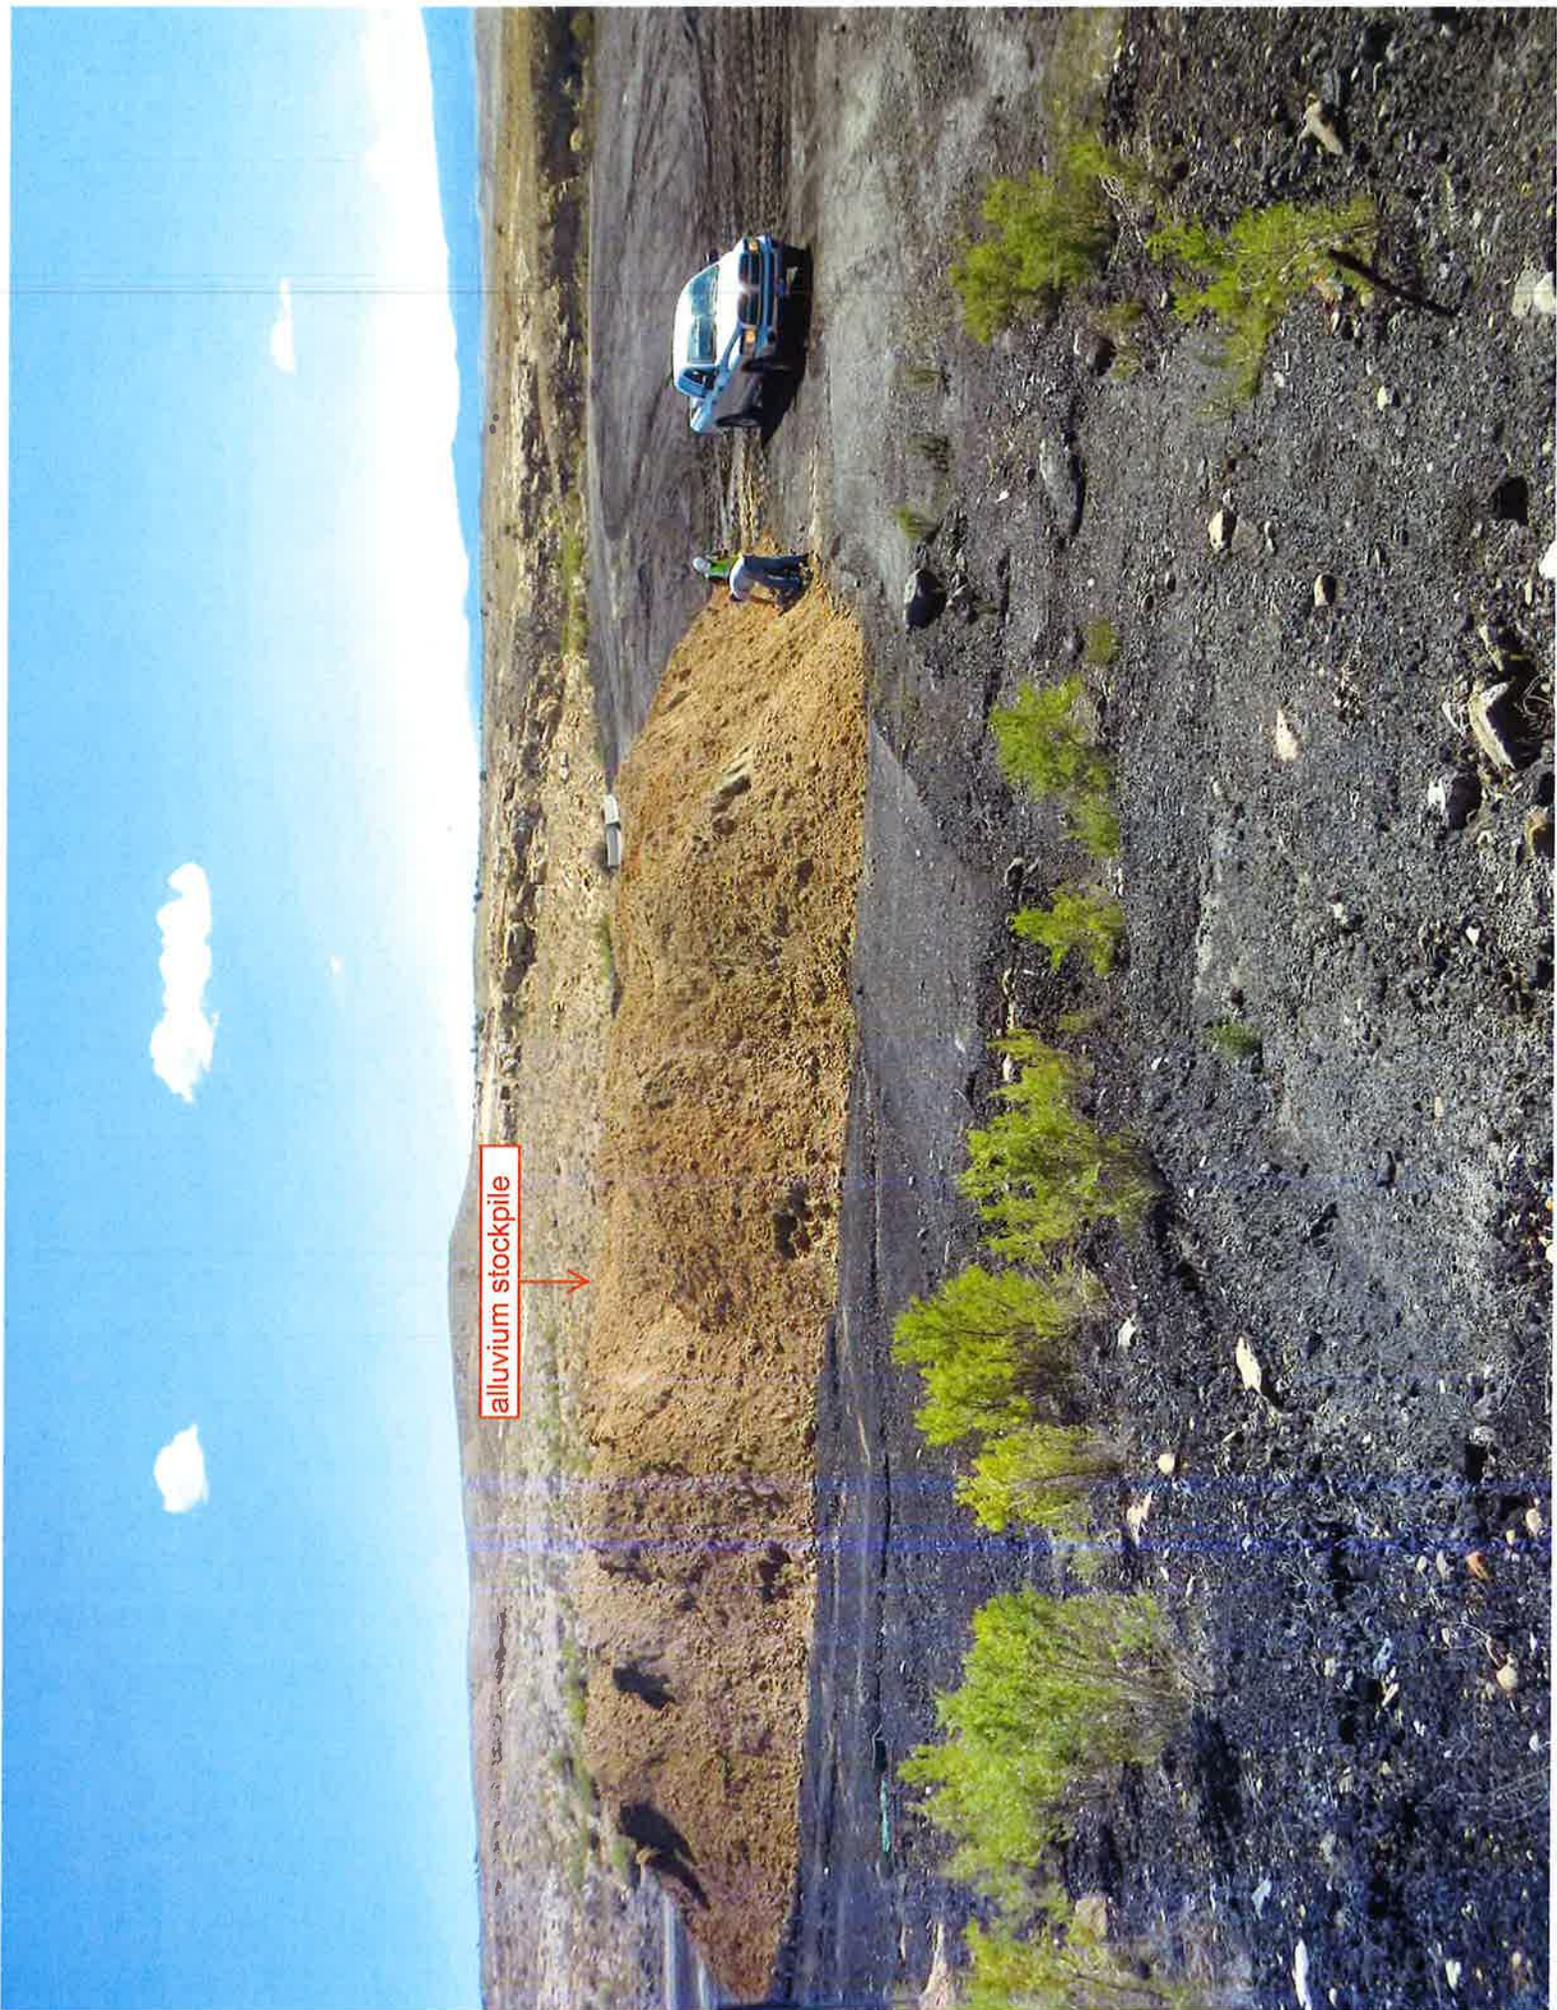
alluvium stockpile

sampling the  
alluvium stockpile

During this inspection, the stockpiled alluvium and the stockpiled disturbed area cut soil (refer to inspection report 5609) and the sediments removed from pond 3 were sampled for suitability characteristics.

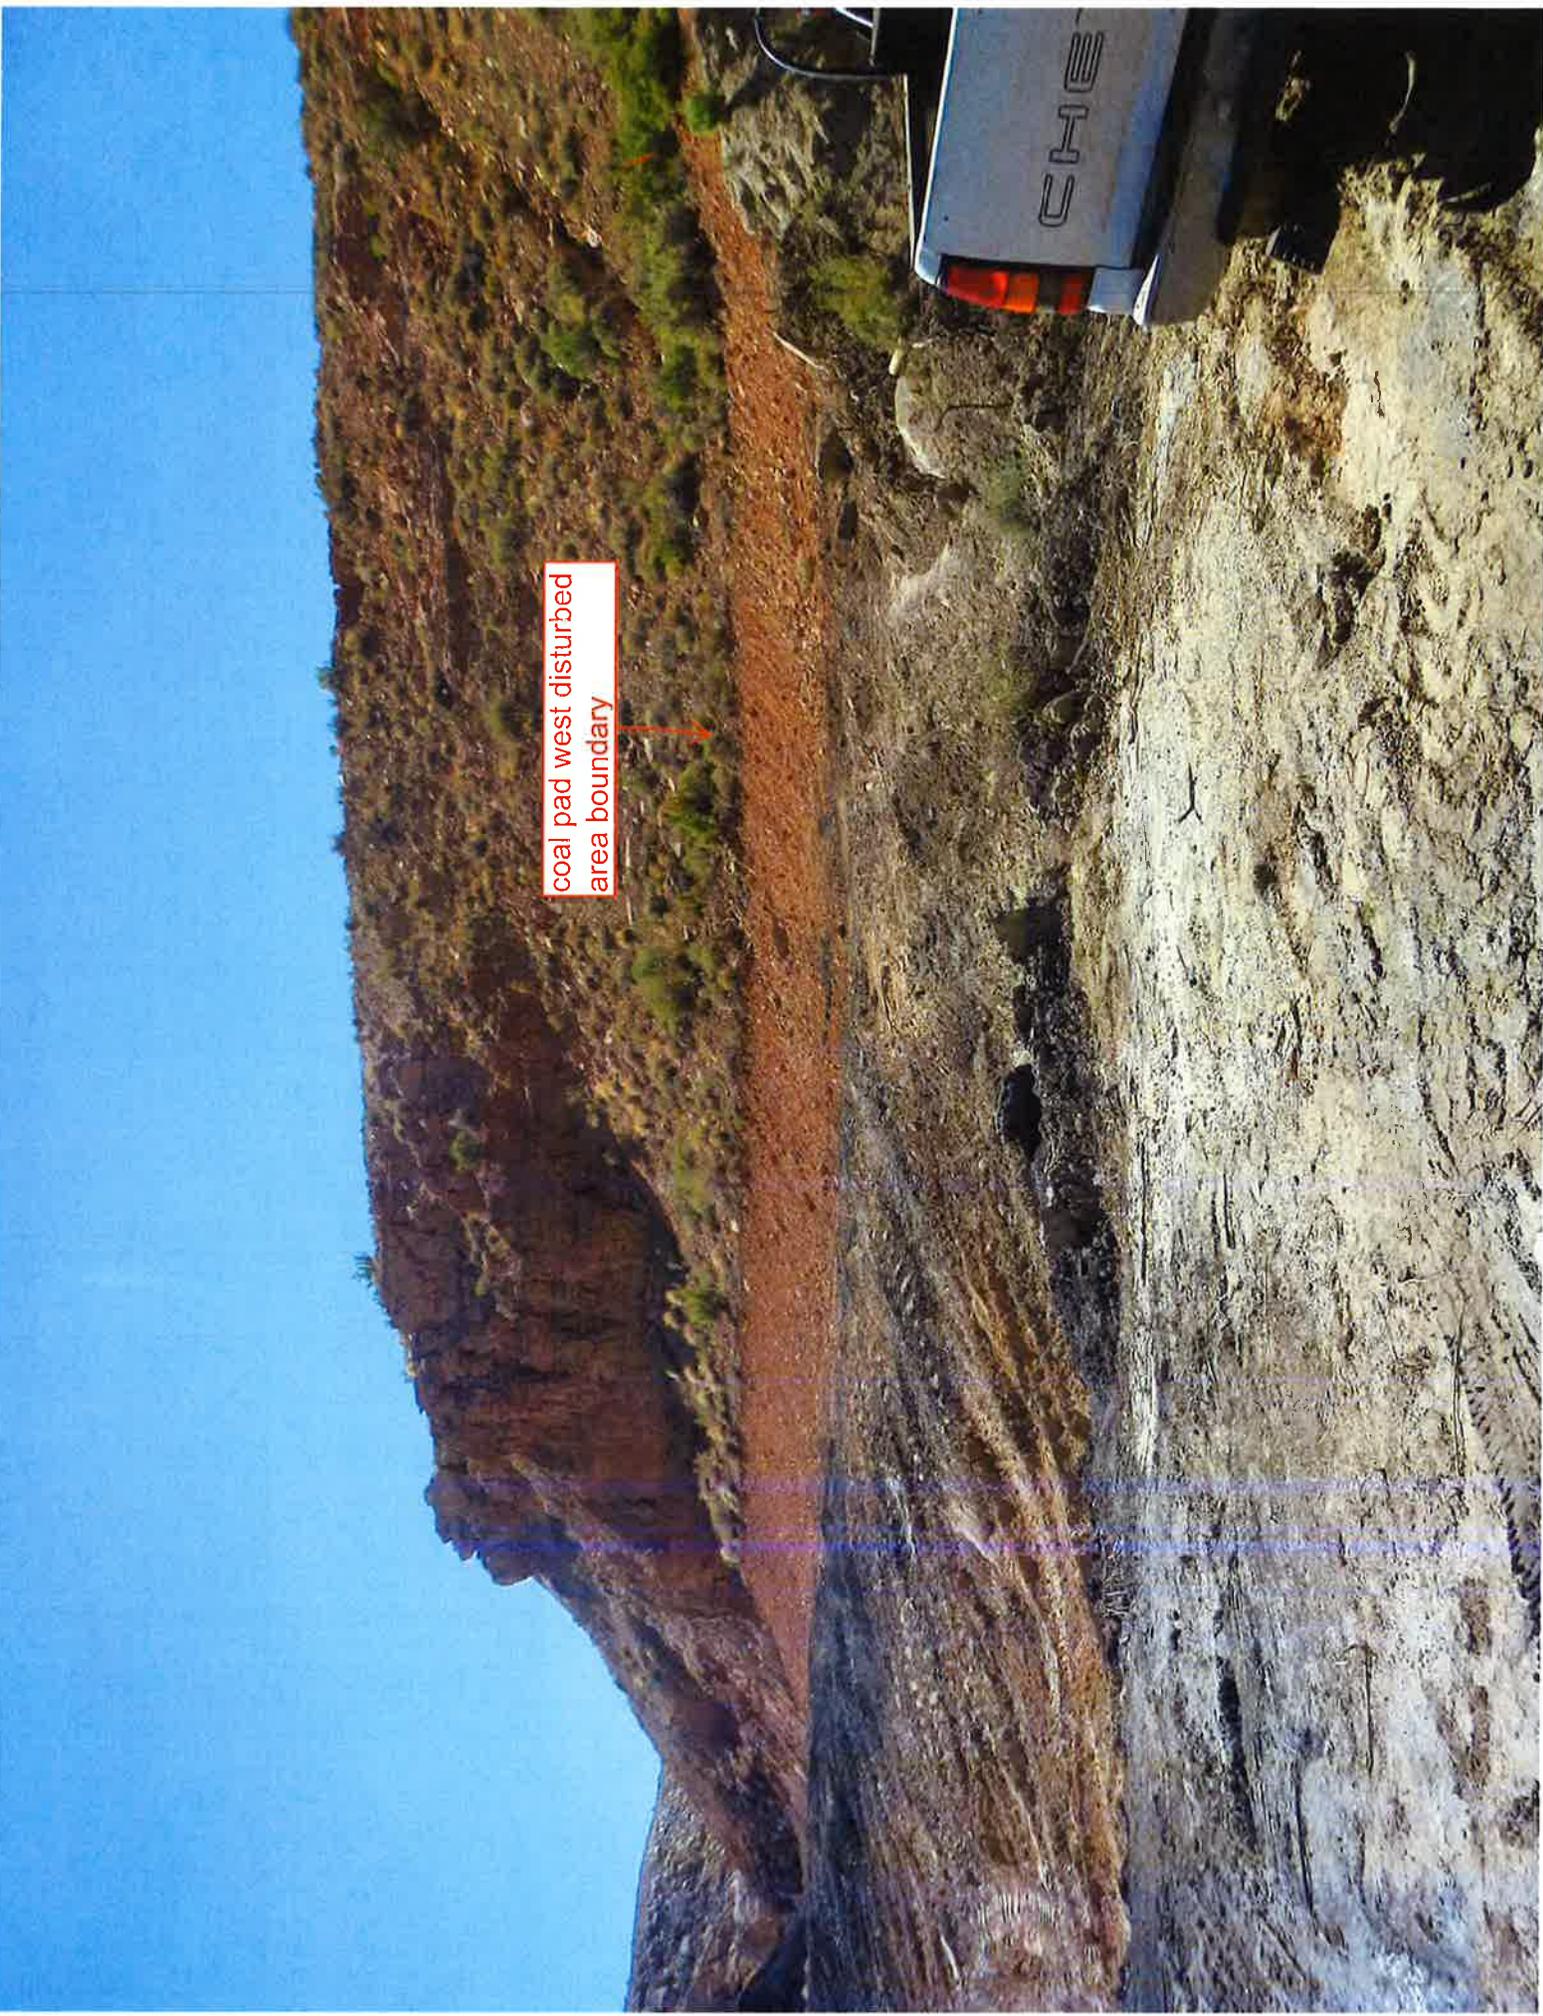
coal pad west disturbed  
area boundary

Sampling the cut from the west coal pad boundary

Stockpile volumes for all three piles will be reported using truck counts. The disturbed area cut (red) soil covered an area of 0.23 acres (GPS area calculation.) and was approximately 8 ft high. The alluvium stockpile was not completed, but during the time of the inspection it covered 0.11 acres (GPS.area calculation) and was also approximately 8 ft high.

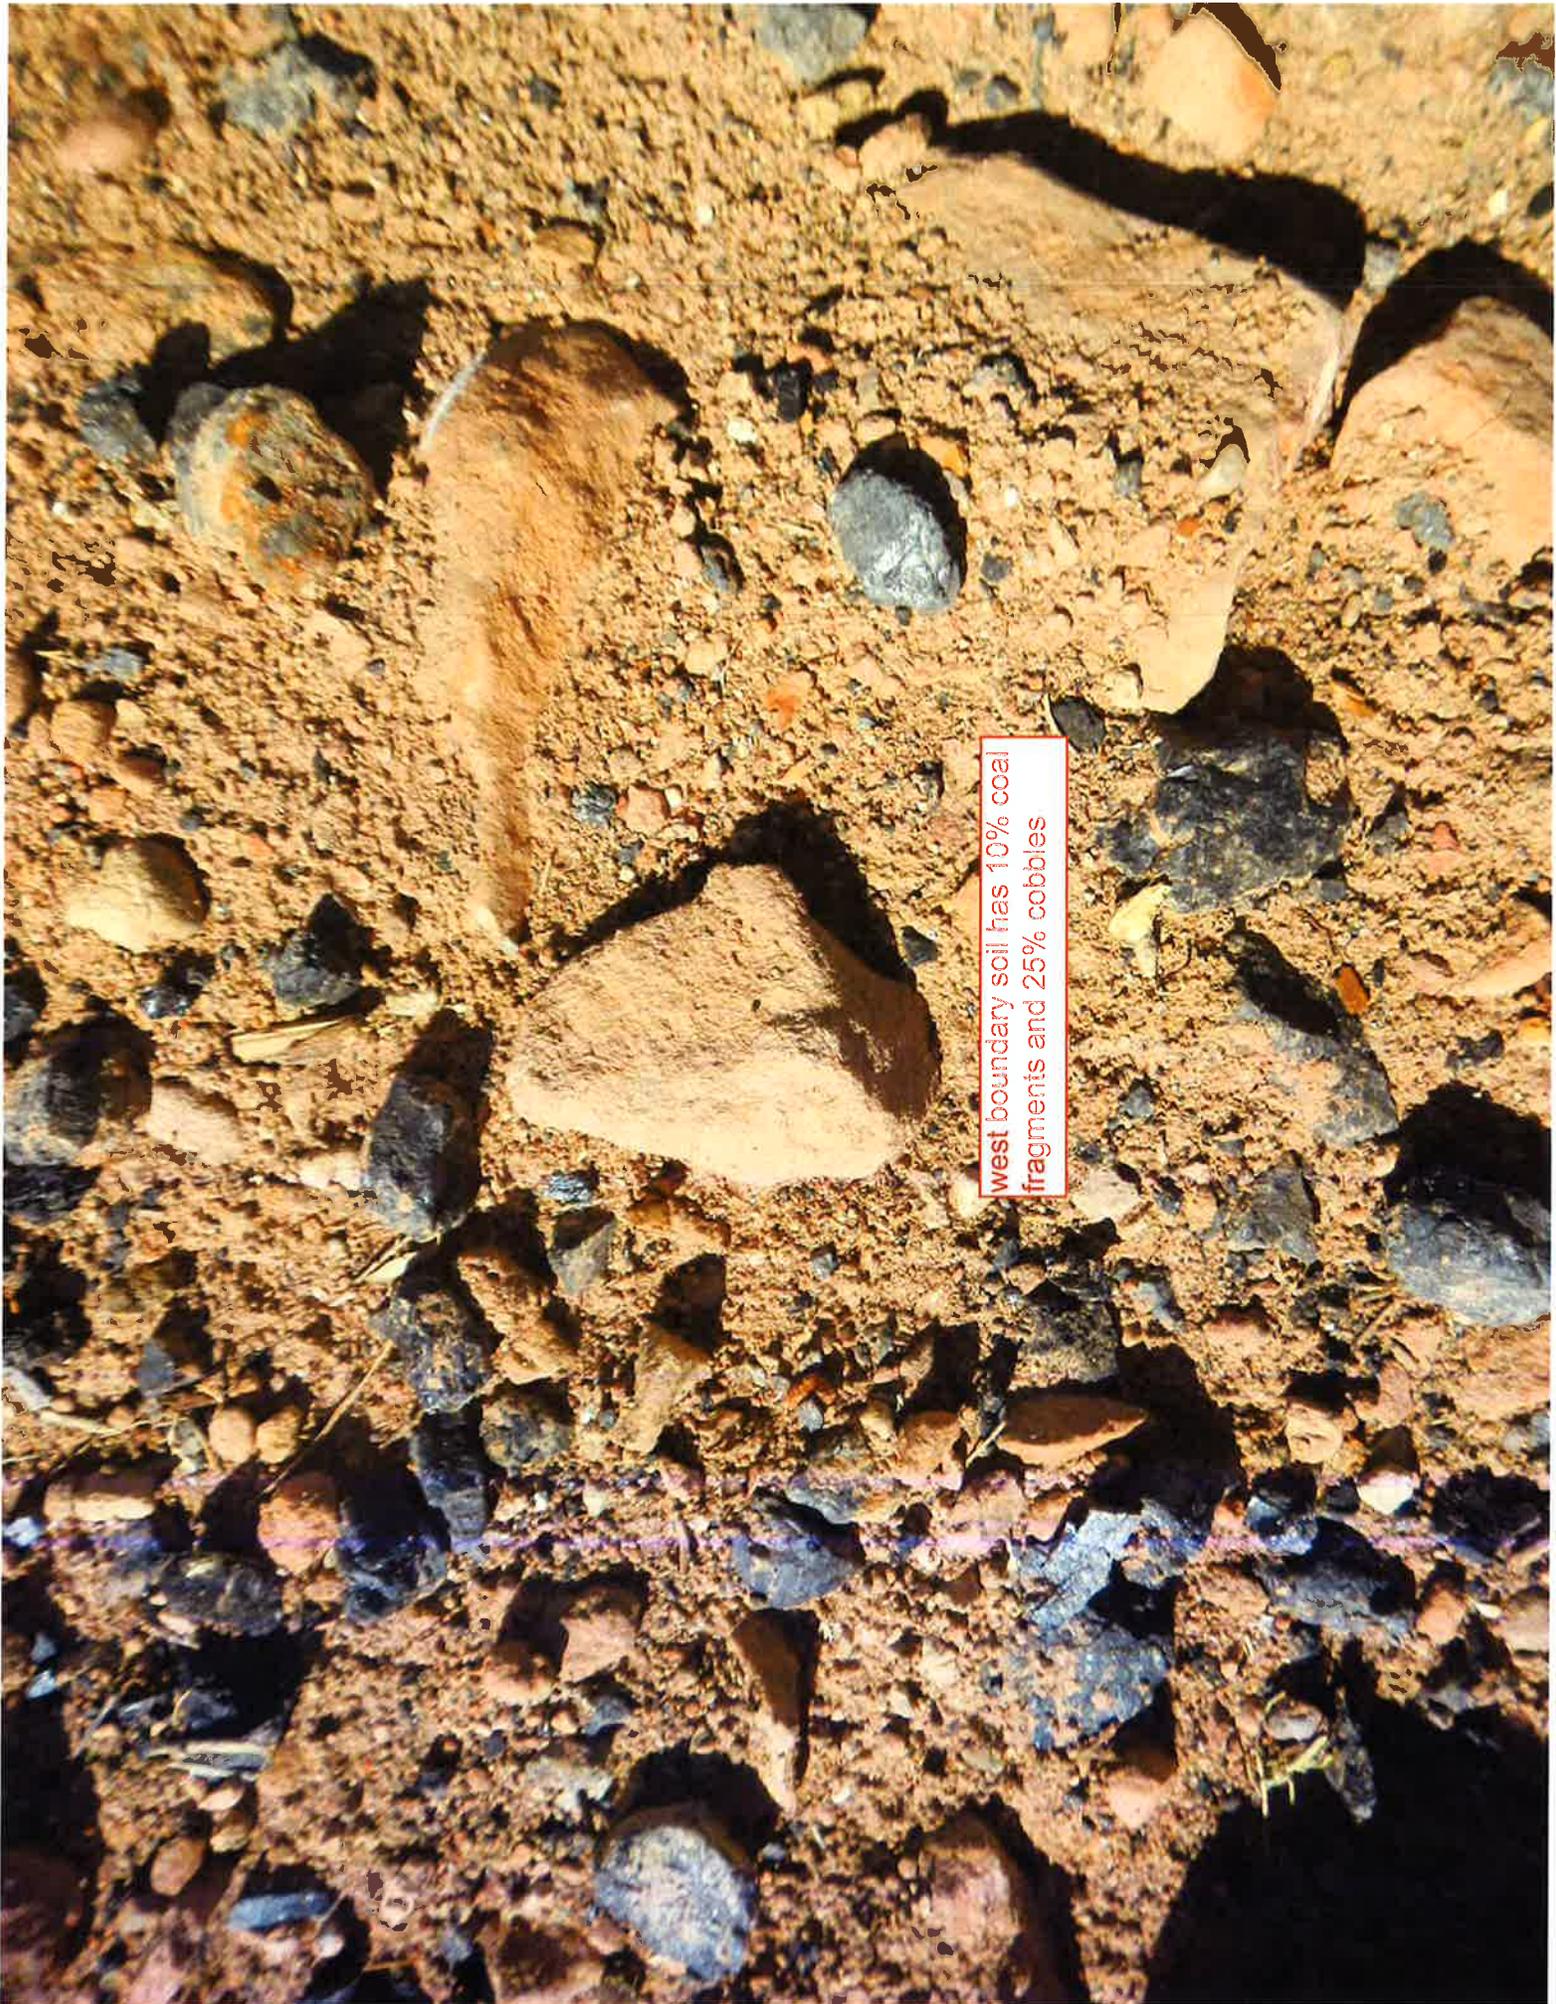
west boundary soil has 10% coal fragments and 25% cobbles

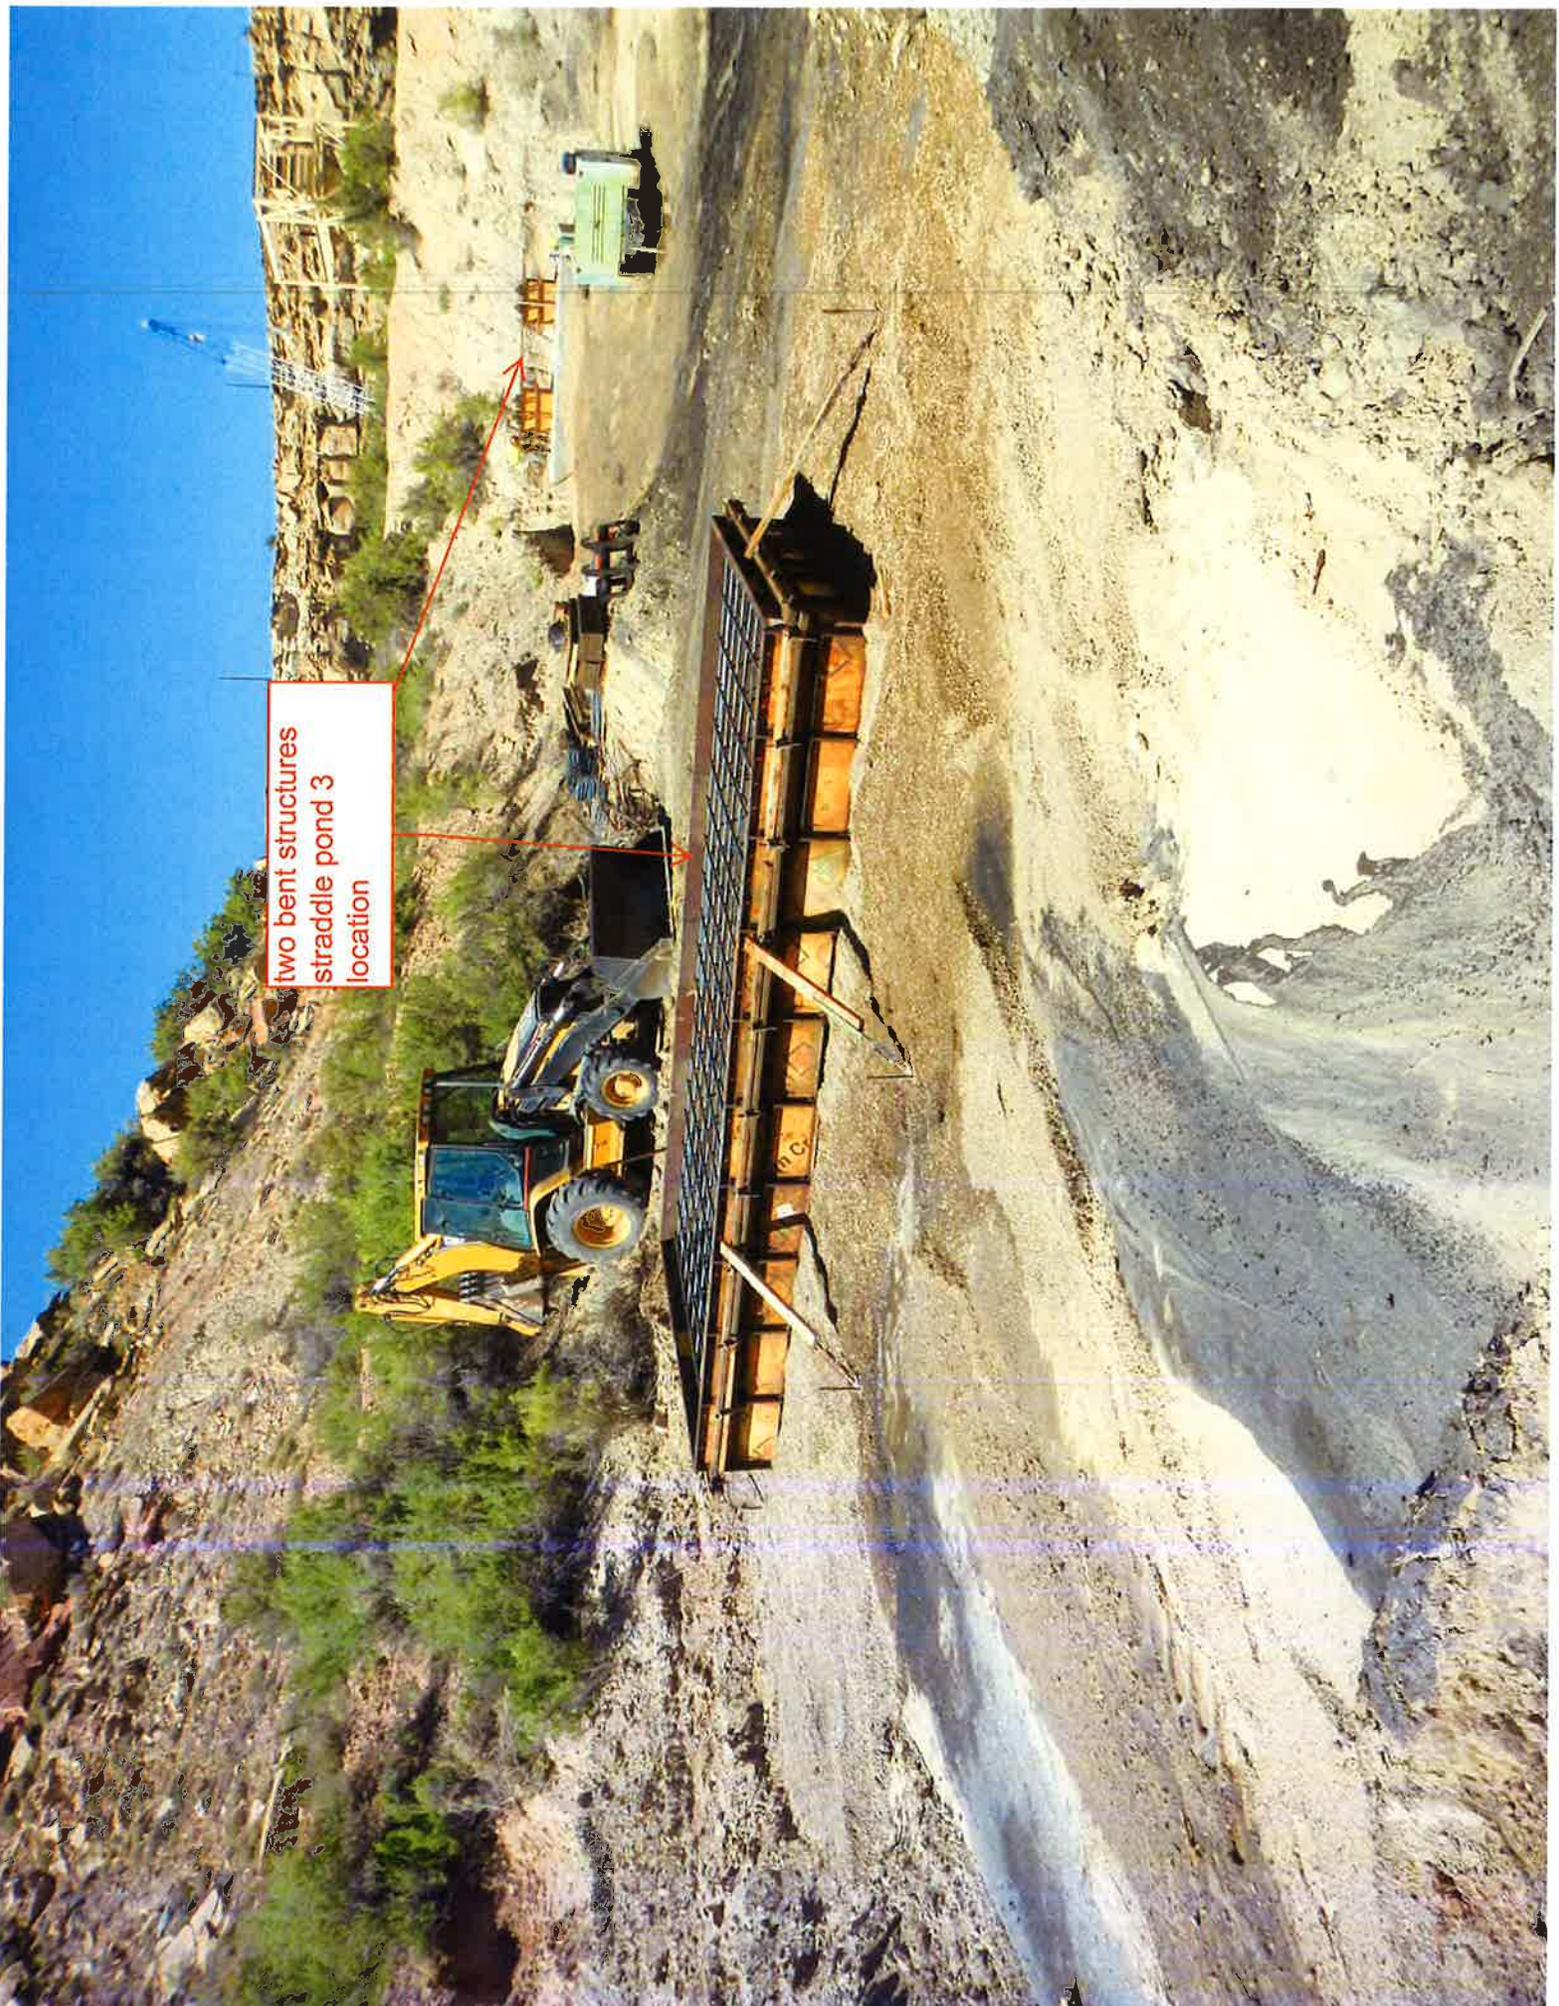
two bent structures  
straddle pond 3  
location

Pond 3 will be excavated to create more storage volume. Sediments recently removed from pond 3 are temporarily stockpiled next to pond 3 between the two new bent structures. When pond 3 is excavated the soil will be removed and stockpiled.
