## Inspection Report

Permit Number:	C0150015
Inspection Type:	COURTESY
Inspection Date:	Tuesday, August 30, 2016
Start Date/Time:	8/30/2016 3:00:00 AM
End Date/Time:	8/30/2016 4:30:00 AM
Last Inspection:	Tuesday, August 16, 2016

Permitee: BRONCO UTAH OPERATIONS, LLC  
 Operator: BRONCO UTAH OPERATIONS, LLC  
 Site: EMERY DEEP MINE  
 Address: PO BOX 527, EMERY UT 84522  
 County: EMERY  
 Permit Type: PERMANENT COAL PROGRAM  
 Permit Status: ACTIVE

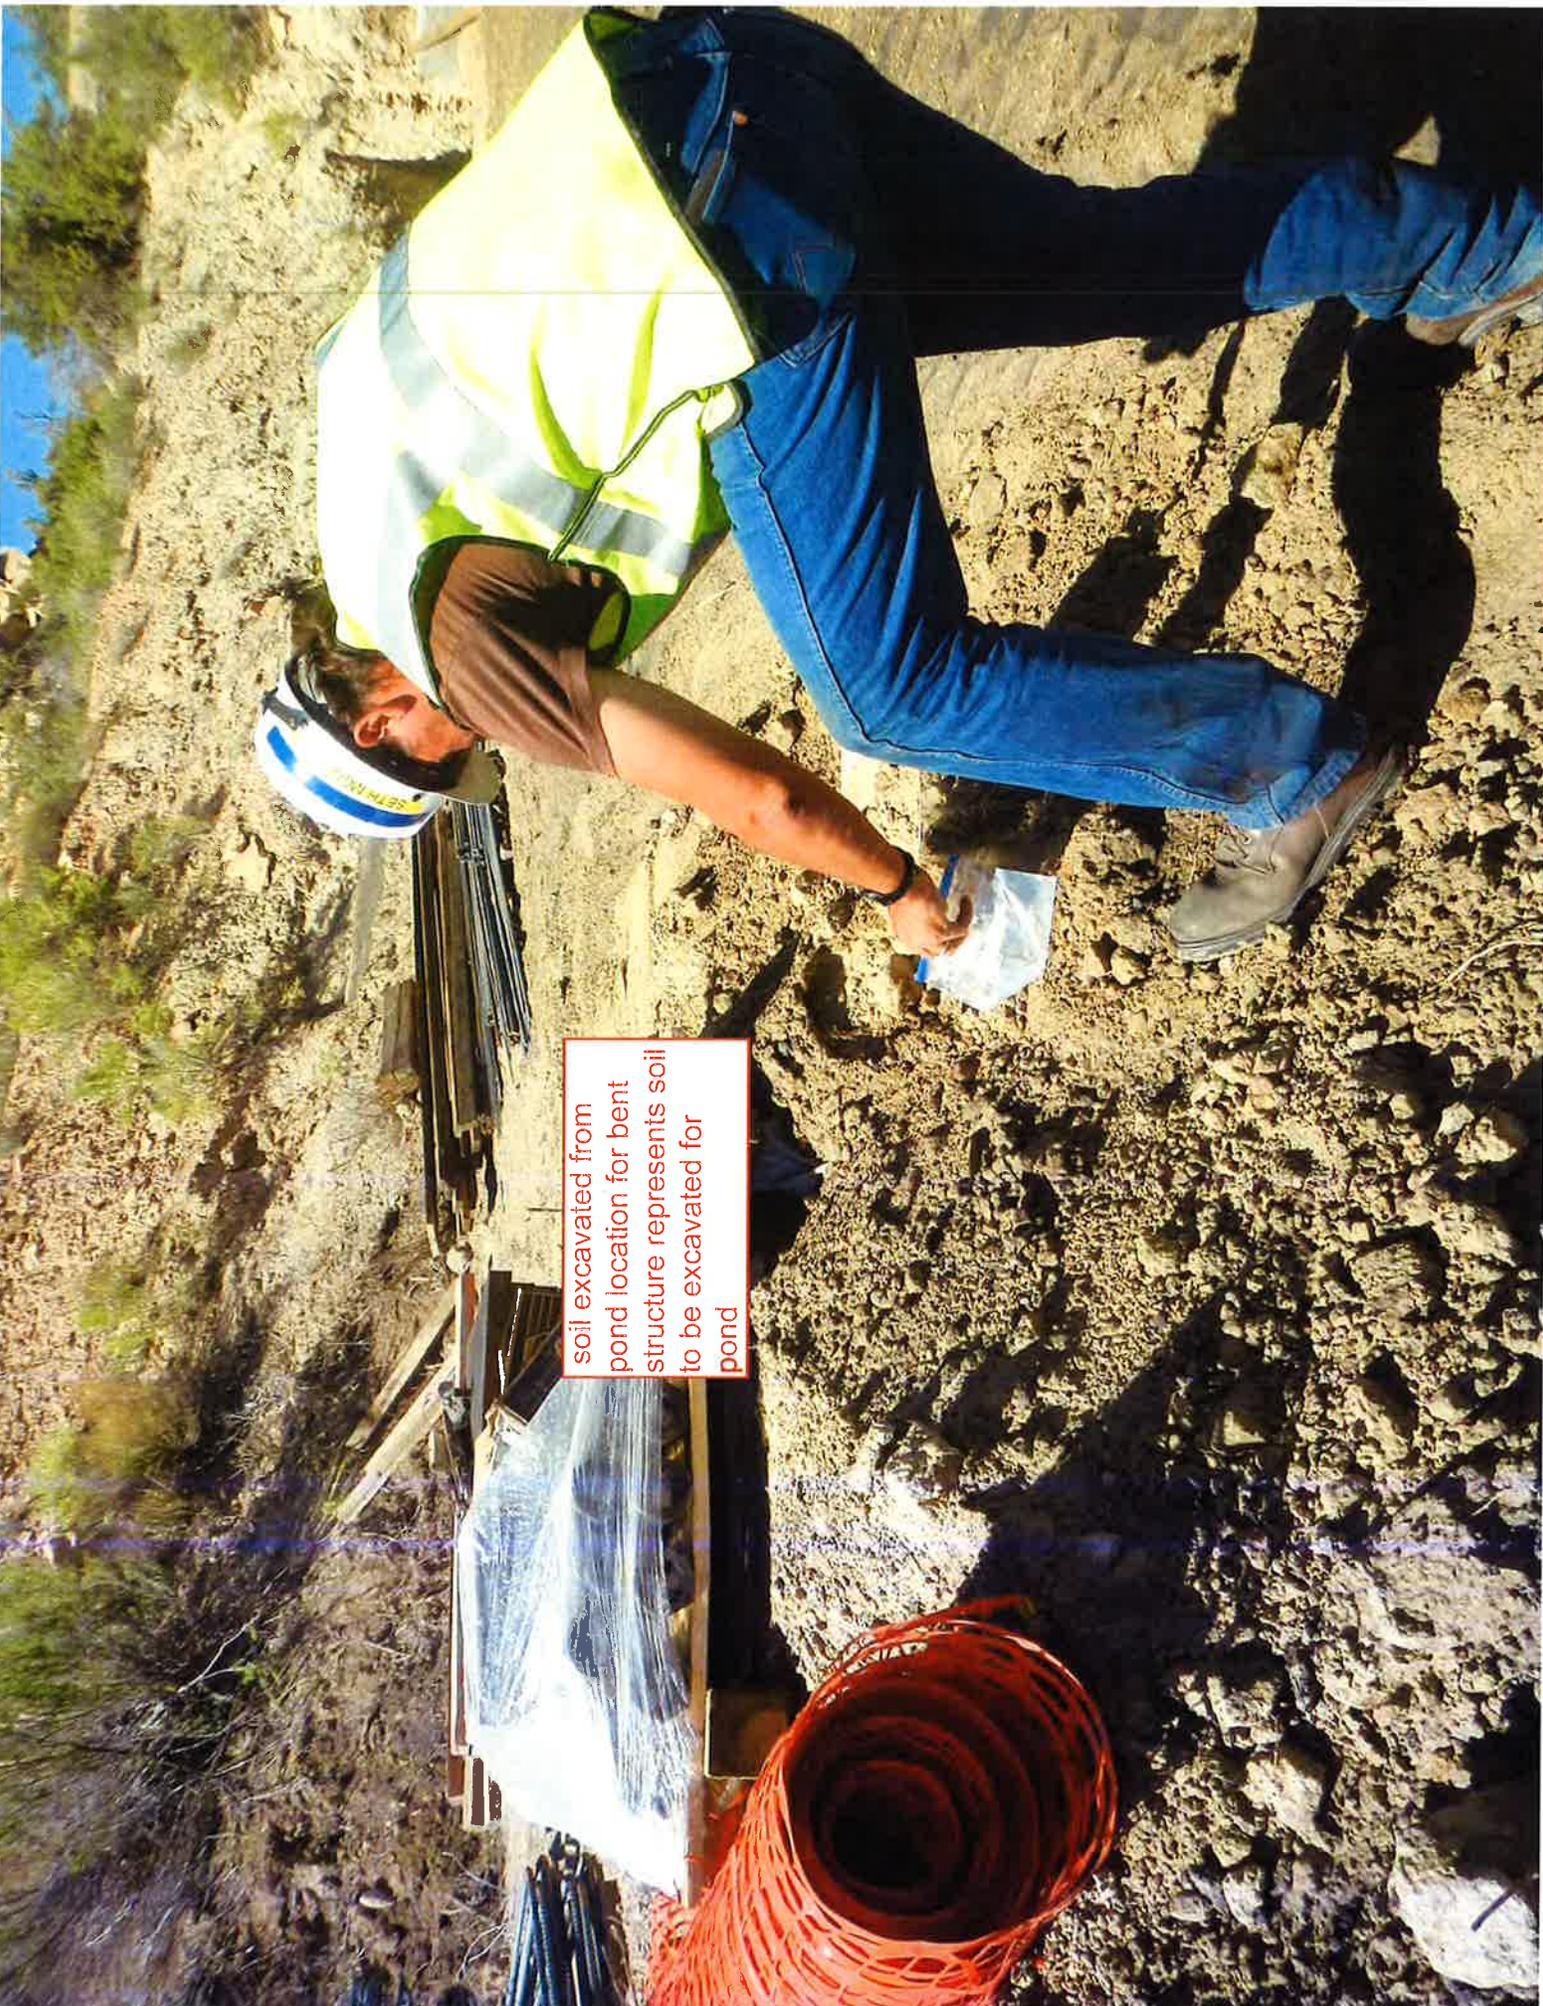
soil excavated from  
pond location for bent  
structure represents soil  
to be excavated for  
pond

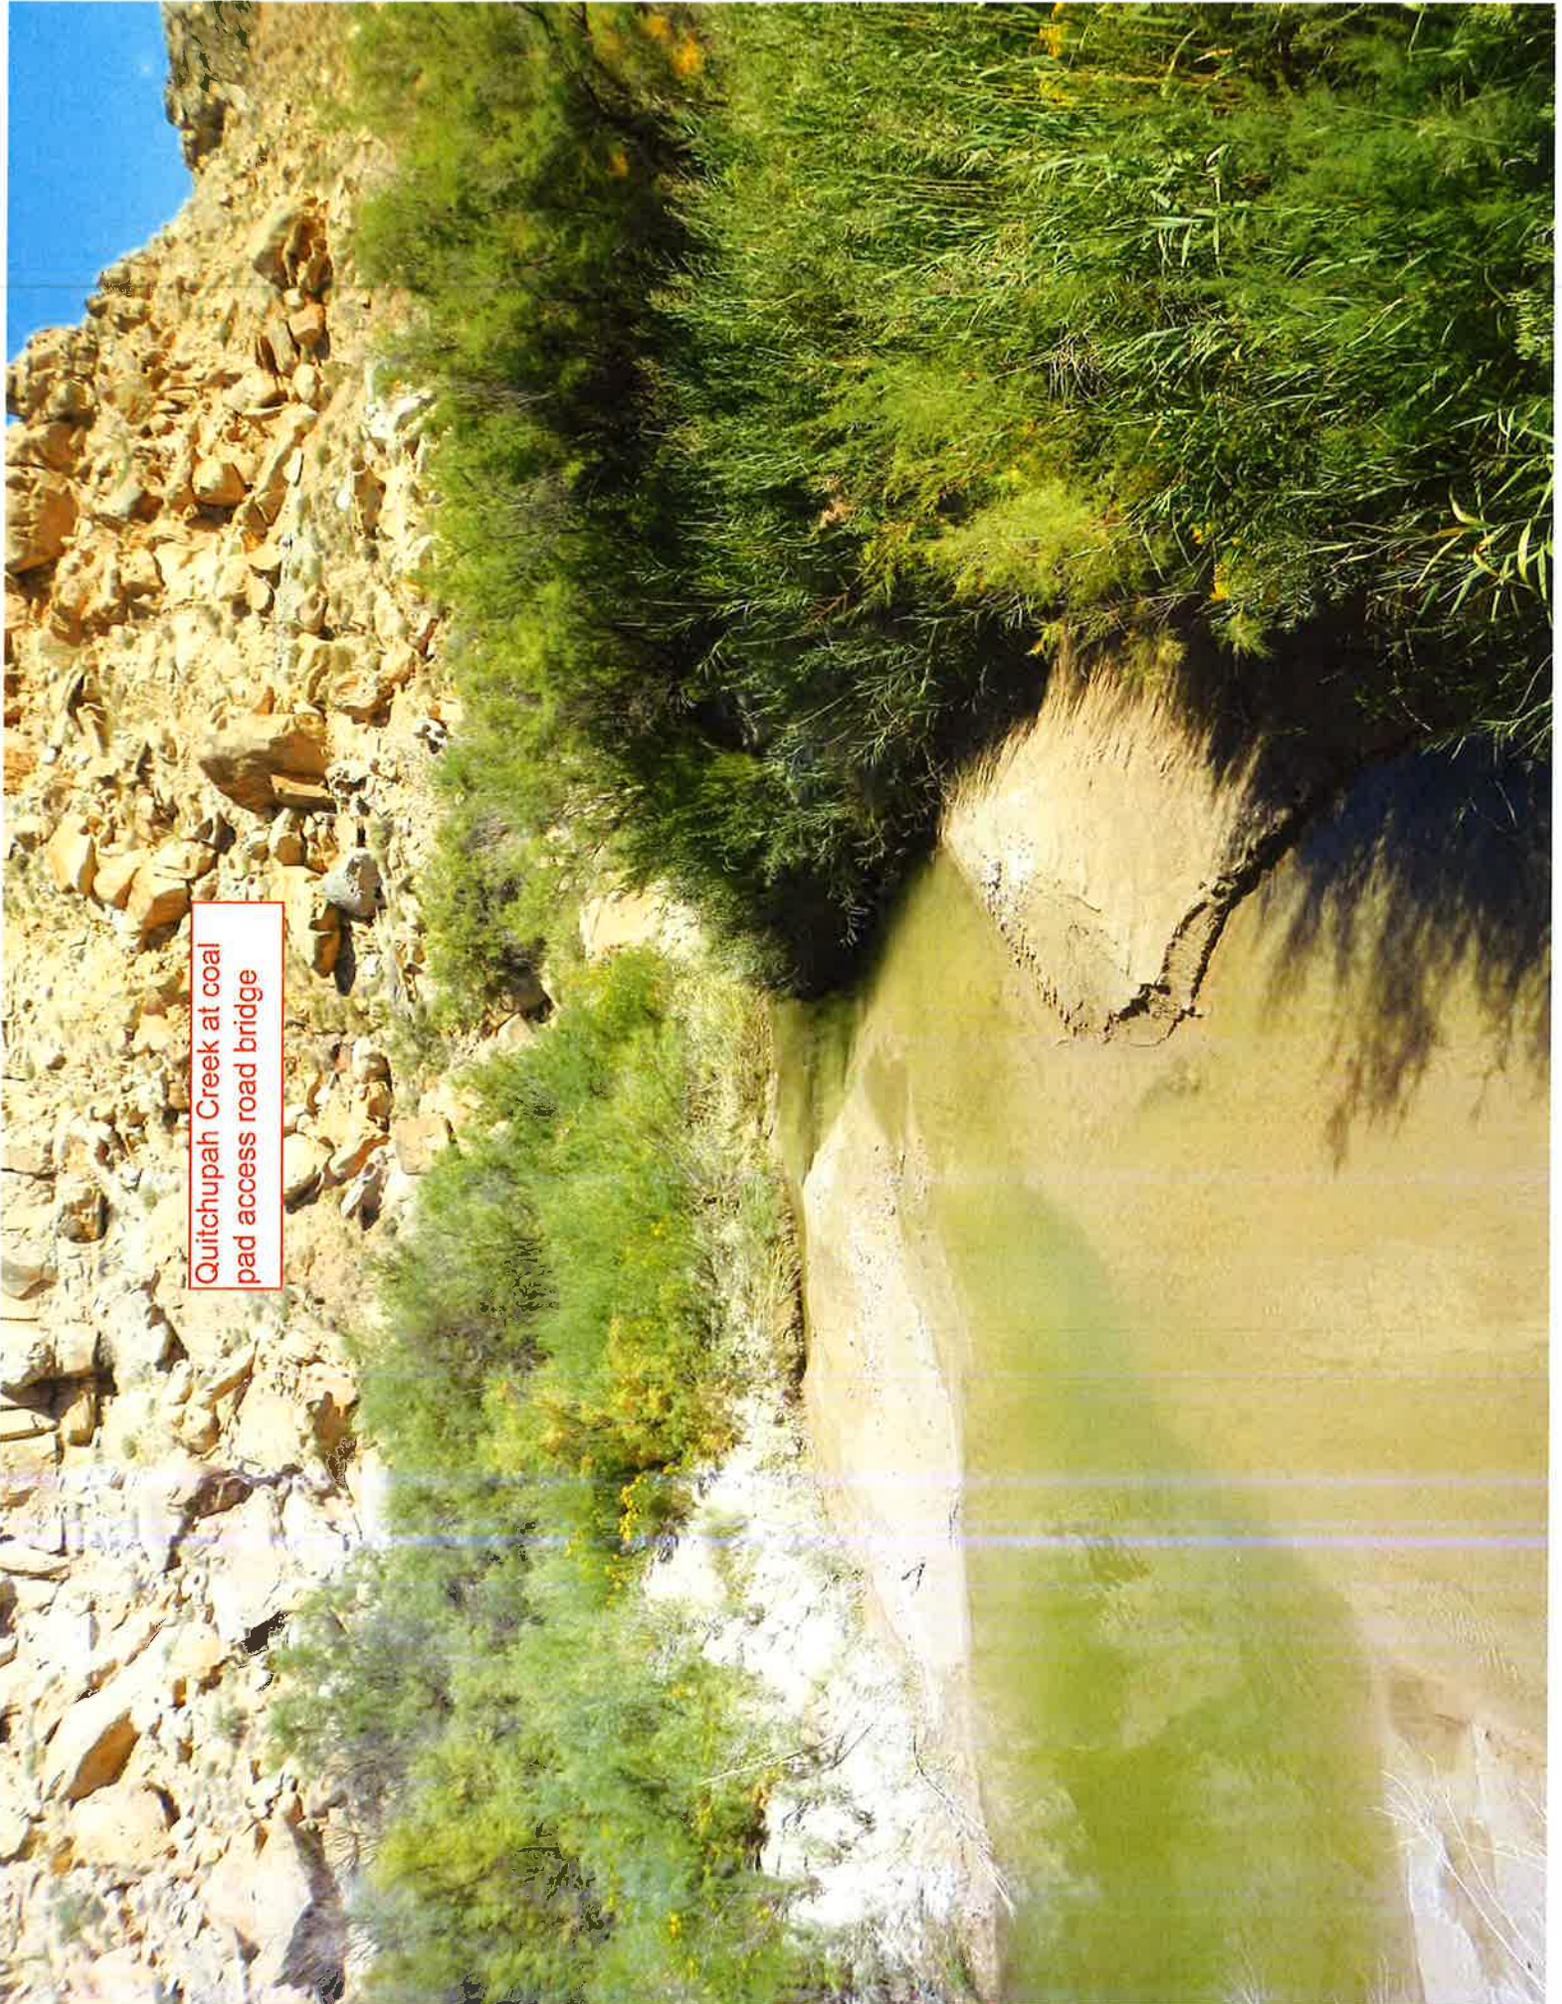
Quitcupah Creek at coal  
pad access road bridge

Plate II-1 shows the Quitchupah Creek bank elevation to be 5, 900 ft. The elevation of the disturbed area pad is 5925. The excavation for the reclaim tunnel is 20 ft below existing contour at the far south end, which would be 5905 ft. That is five feet above the creek bank elevation. At the time of the inspection, the trench was dry and there appeared to be no connectivity between the excavated trench and Quitchupah Creek which was at low water flow.
