State of Utah  
DEPARTMENT OF NATURAL RESOURCES  
DIVISION OF OIL, GAS AND MINING

RE: Significant E-mail. Reclamation of Deseret and Beehive Portals, Energy West Mining, Des Bee Dove Mine, C015/017- AM01A

**Attachment A2 to E\_pwb040501**

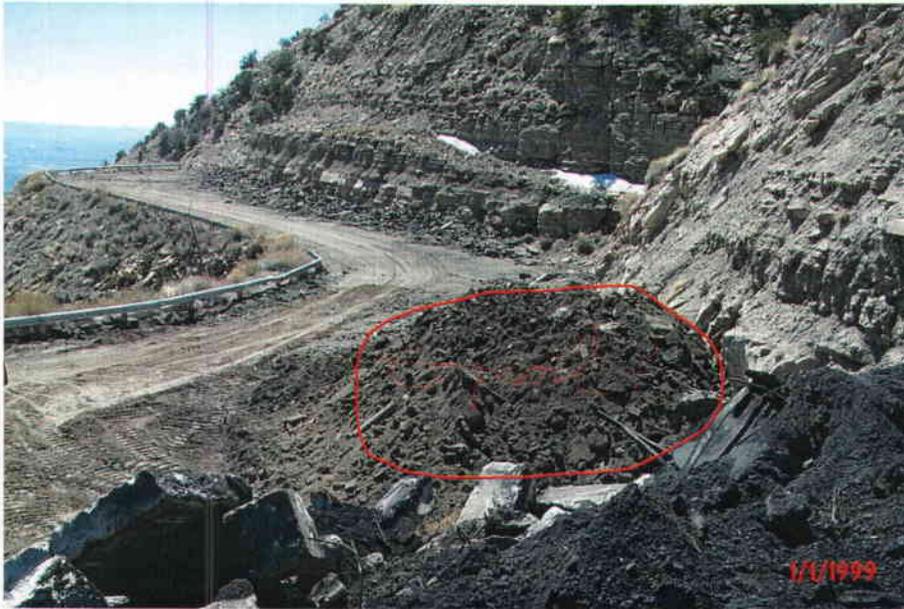
**P0002279a.bmp**

Attached are photos of soil which may be your substitute topsoil. Both photos are taken of material stockpiled on the bathhouse pad. On both photos, I have outlined in red what might be the substitute soil. Would you please take a look at these photos to confirm my understanding of the location of the substitute topsoil on the bathhouse pad?

Photo #1 (P0002279a) Highlighted Area: combination of roadbase, concrete & asphalt.

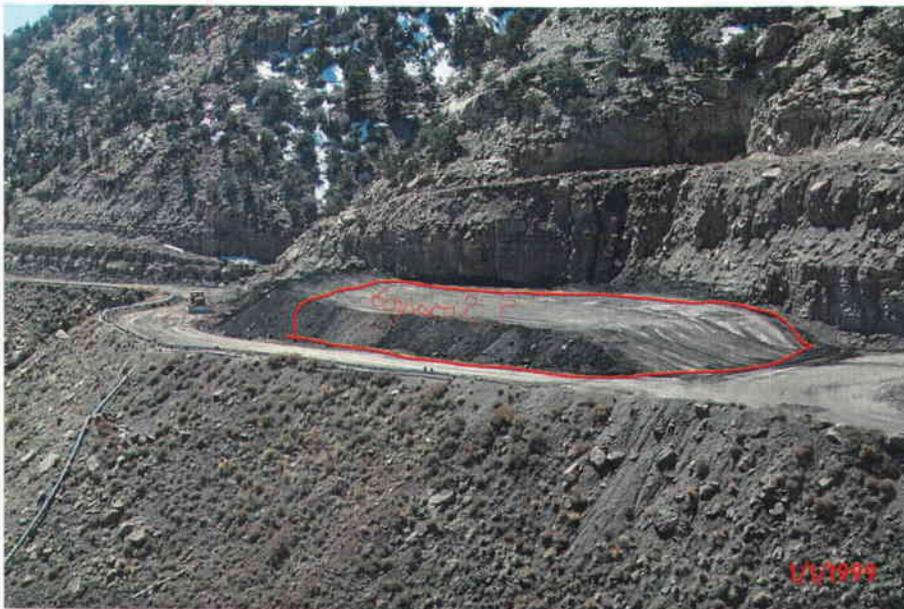
**P0002290a.bmp**

Attachment A3 is Mr. Chuck Semborski's response on April 4, 2001. In his response, he identifies the material in each photograph. Mr. Semborski confirmed that photograph P0002290a.bmp is of the spoil material which will be "substitute topsoil" pending laboratory sampling.

Photo #2 (P0002290a) Highlighted Area: Spoil material (referred to as "North End of Bathhouse") which I plan on sampling after the valley fill project is completed.

Please be reminded that during our telephone conversation, I requested that these substitute topsoil piles be marked with signs identifying them as TOPSOIL.
