**RE: NOMINATION FOR OSM SURFACE COAL MINING RECLAMATION  
 AWARD - ENERGY WEST MINING COMPANY**

# Reclamation of the Des-Bee-Dove Mine Complex

- A Detailed Soils Assessment for a Pre-SMCRA Site -  
2008 Office of Surface Mining Awards Presentation  
March 15, 2008

## **Reclamation of the Des-Bee-Dove Mine Complex- A Detailed Soils Assessment for a Pre-SMRCA Site**

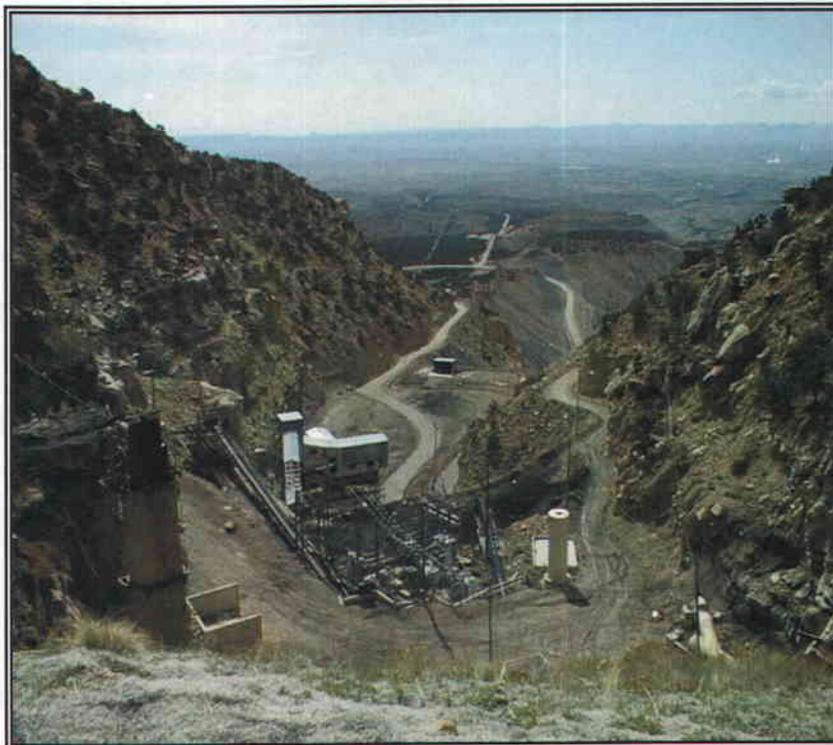
Des-Bee-Dove Mine site prior to reclamation 1999.

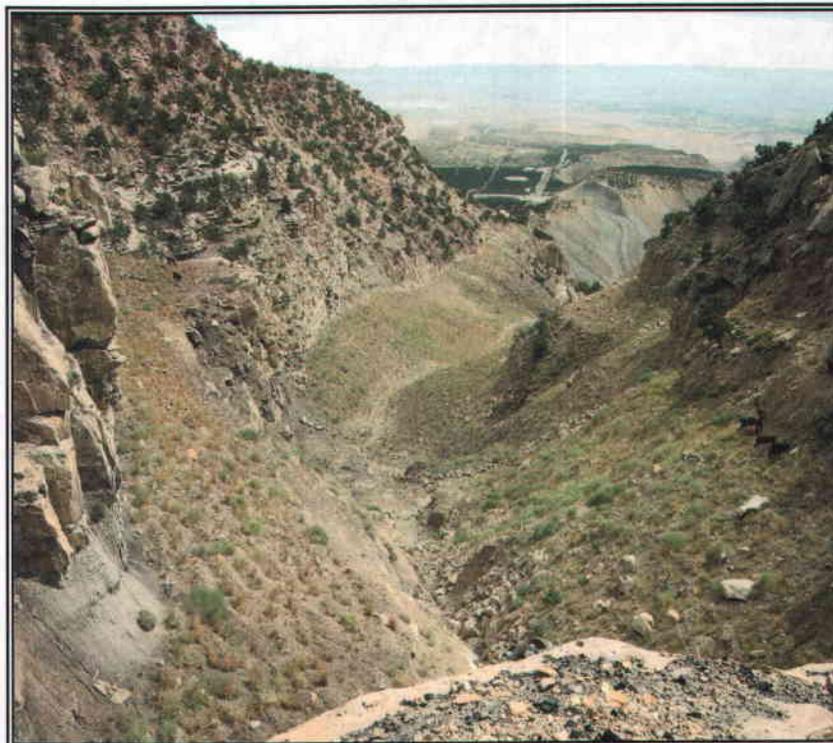
Des-Bee-Dove Mine site in September 2007 after reclamation.

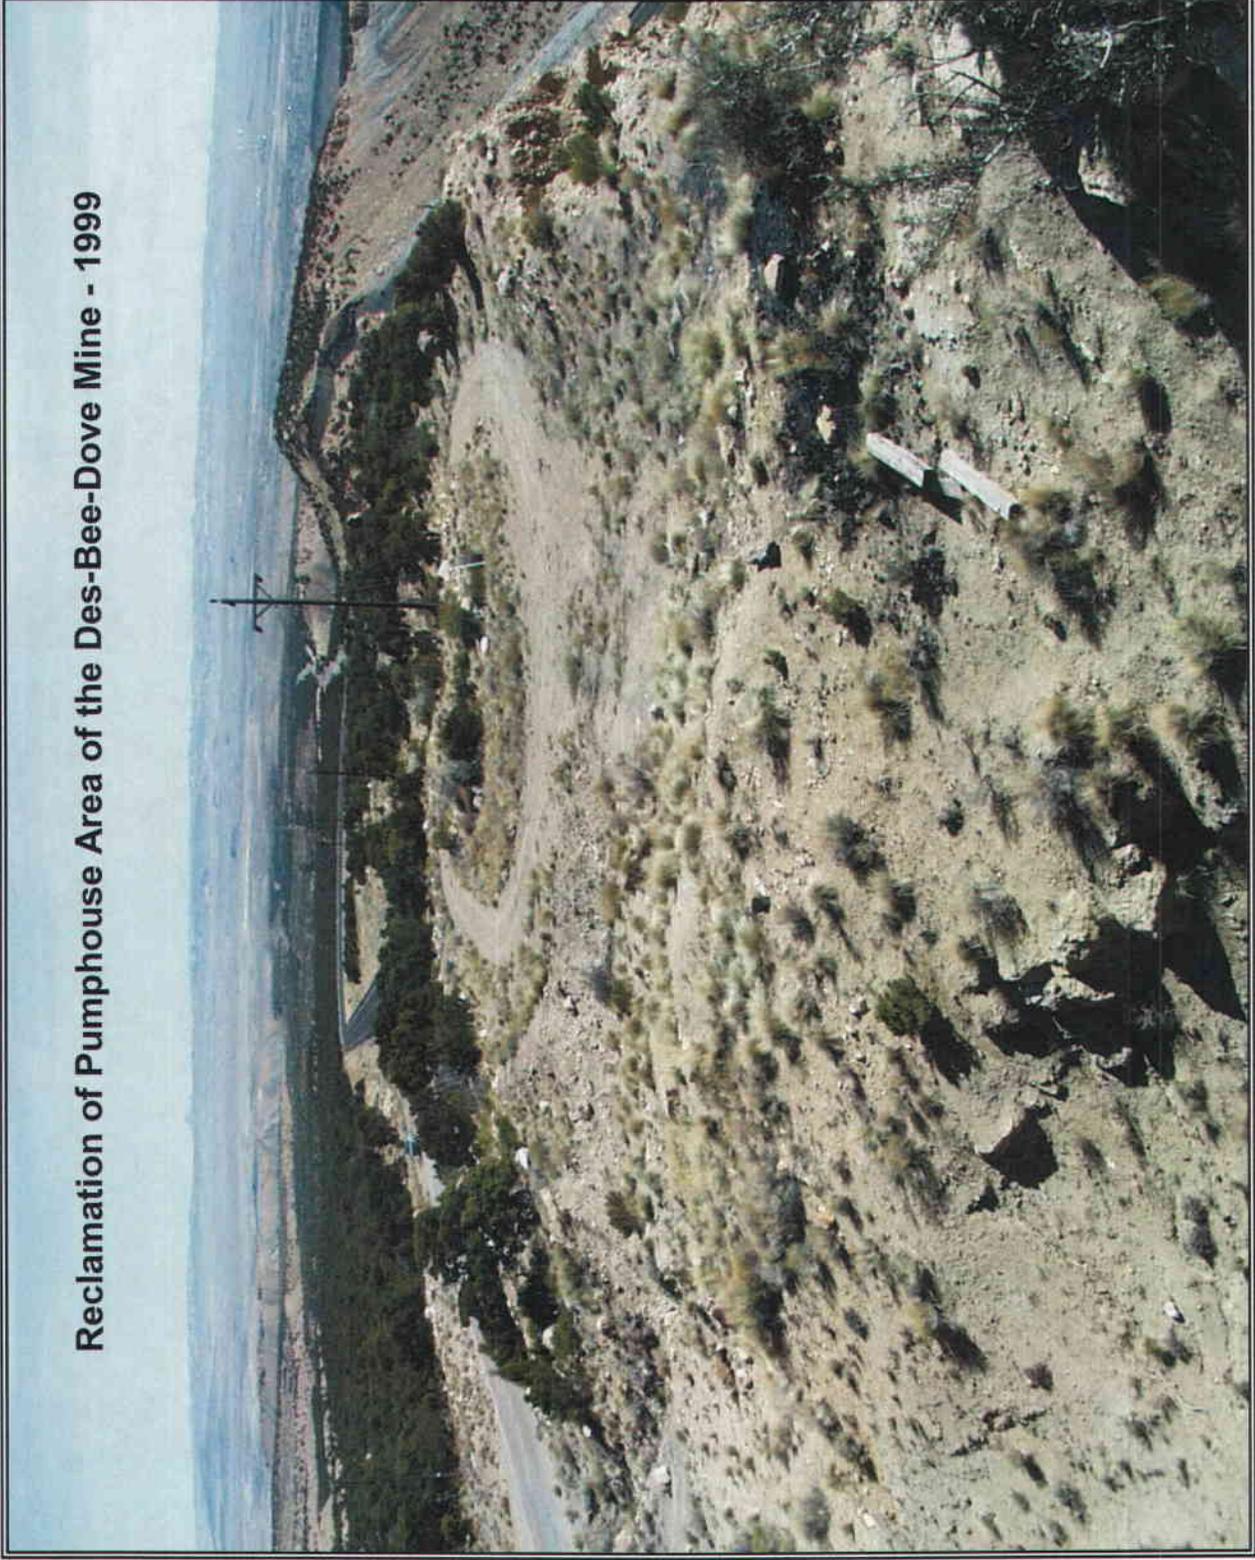
**Figure 2:** Pumphouse disturbed area without structures.

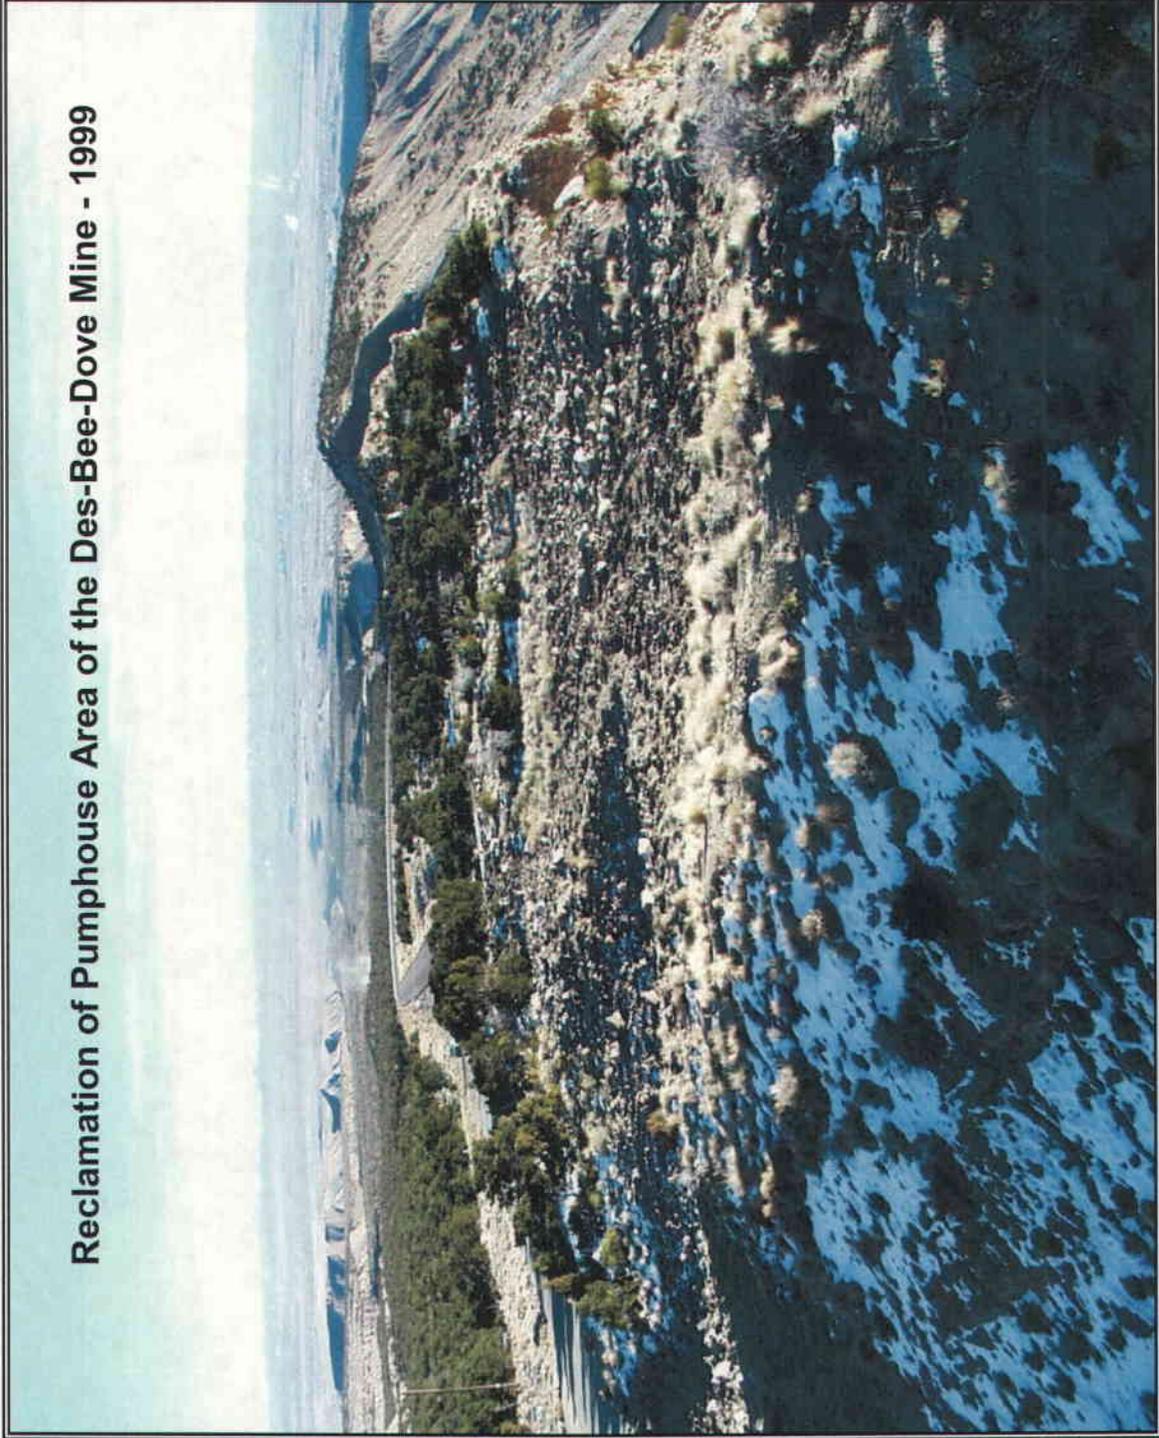
**Figure 3:** Pumphouse disturbed area after reclamation.

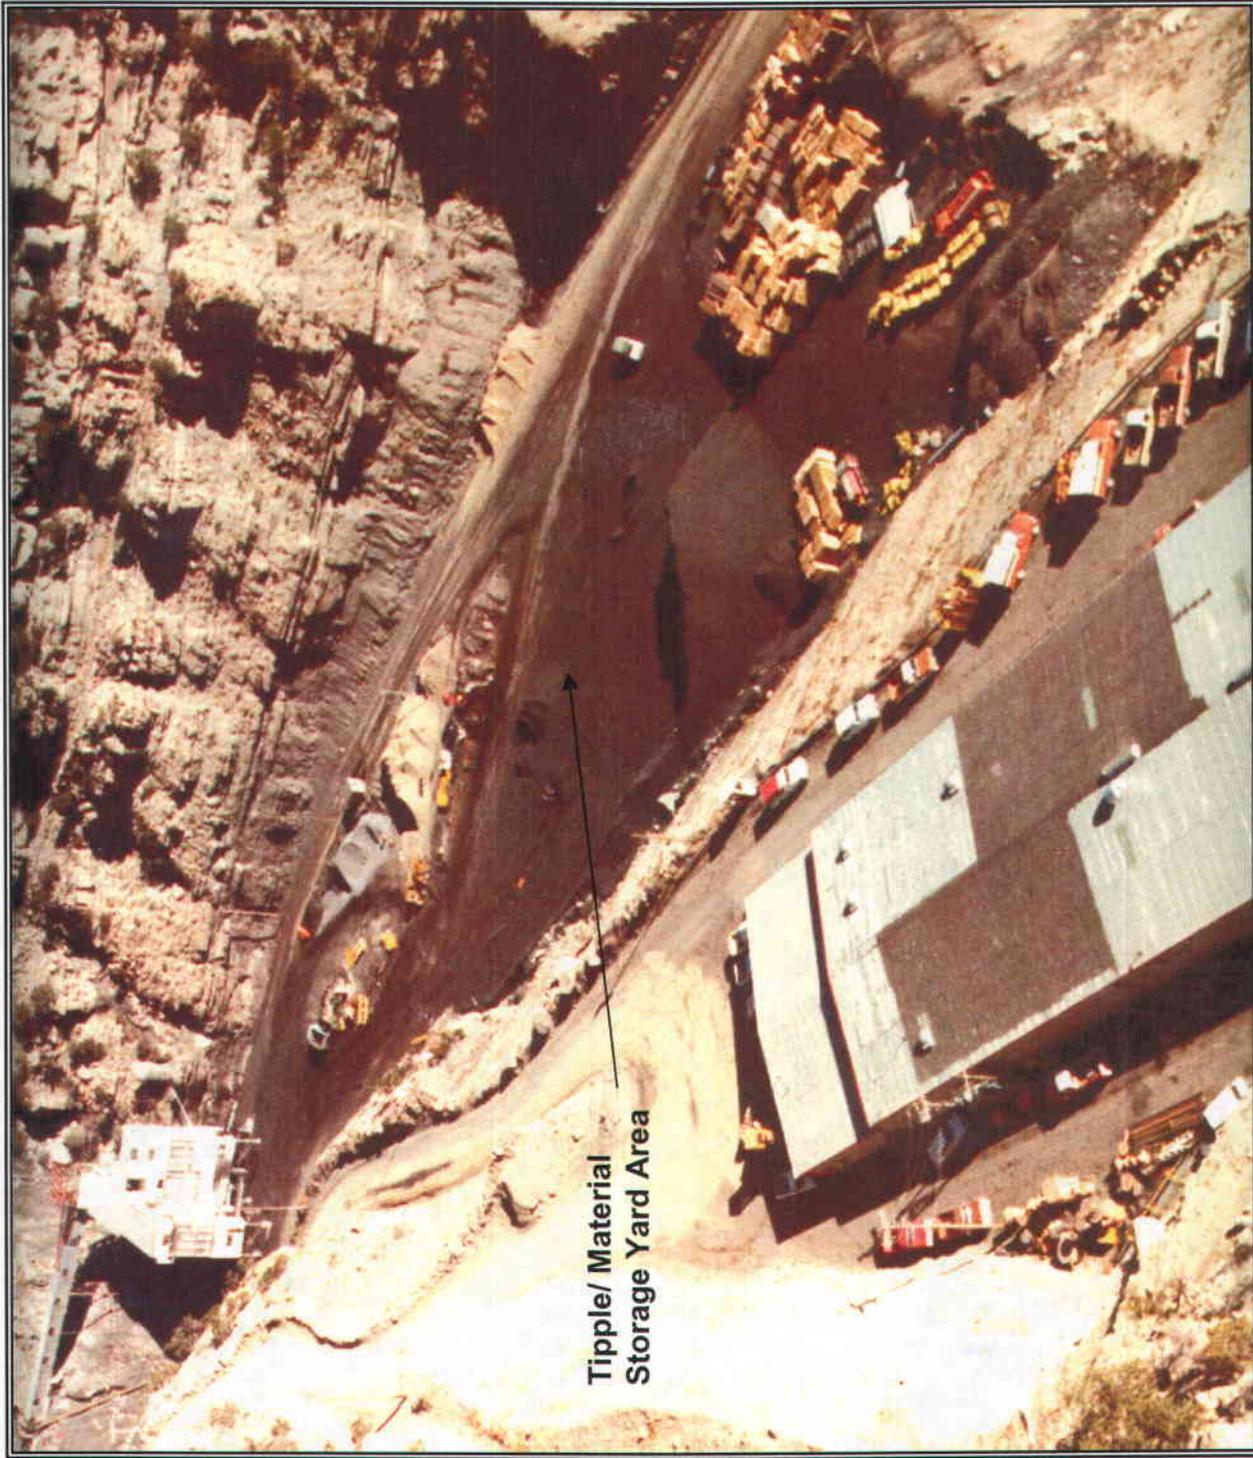
**Figure 4:** Tipple/material storage yard area where a high potential for soil contamination was prevalent.

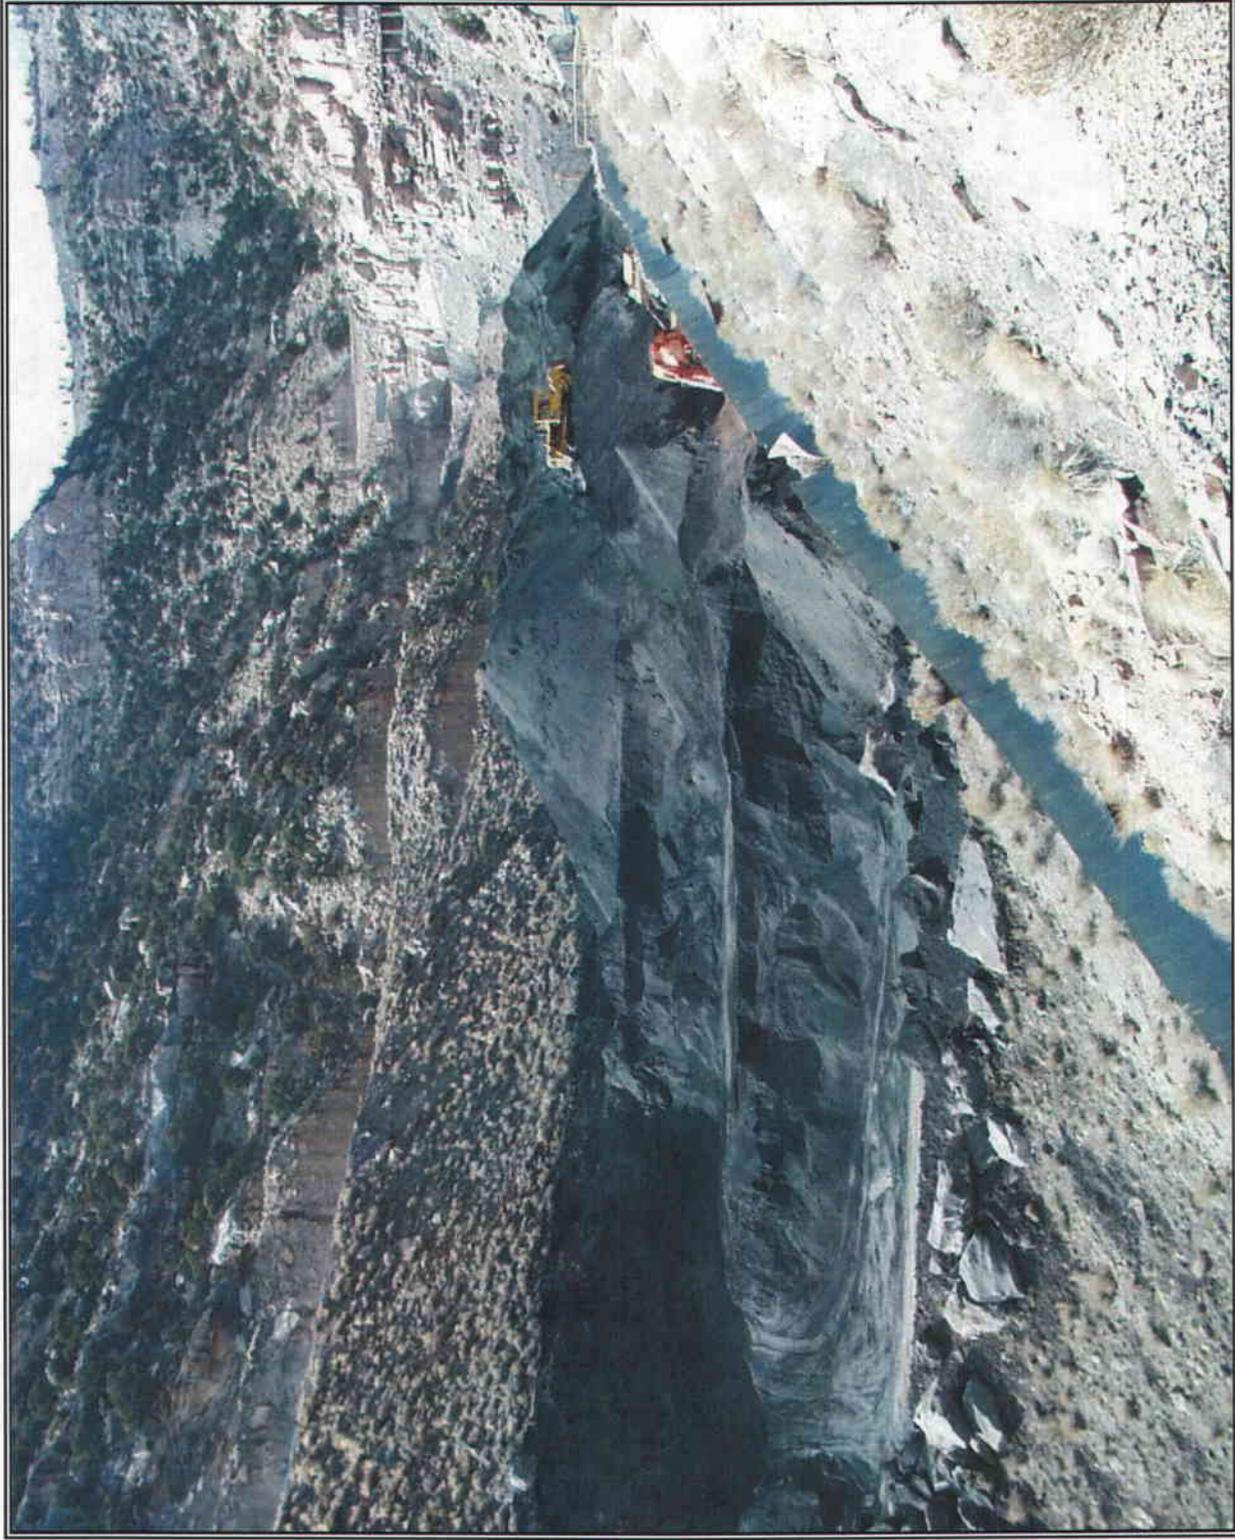
**Figure 5:** Extent of coal buried at the tippel/material storage yard. Note the size of the pile compared to the D8 Caterpillar dozer. Approximately 108,000 tons of high BTU, low ash coal was removed from canyon.

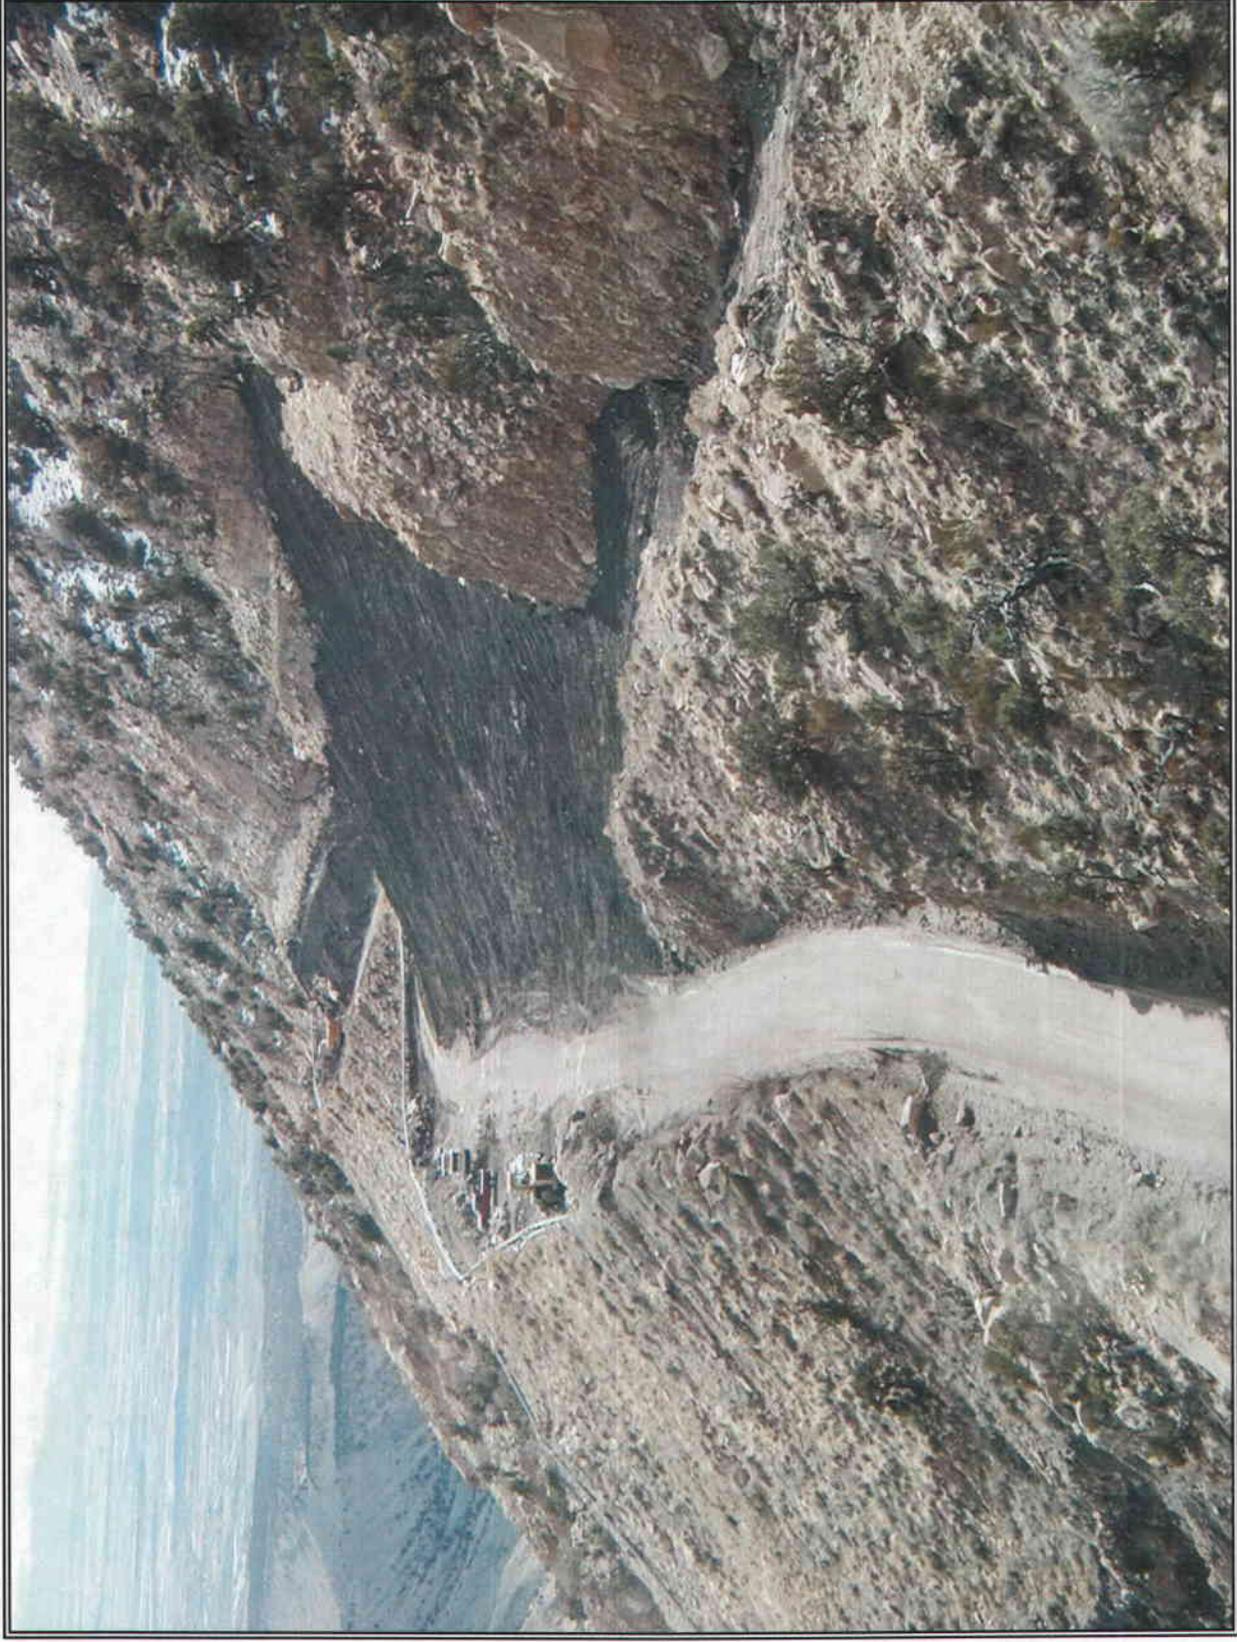
**Figure 6:** Coal waste material to fill cut on bathhouse pad. Approximately 17,000 yards of material was utilized.

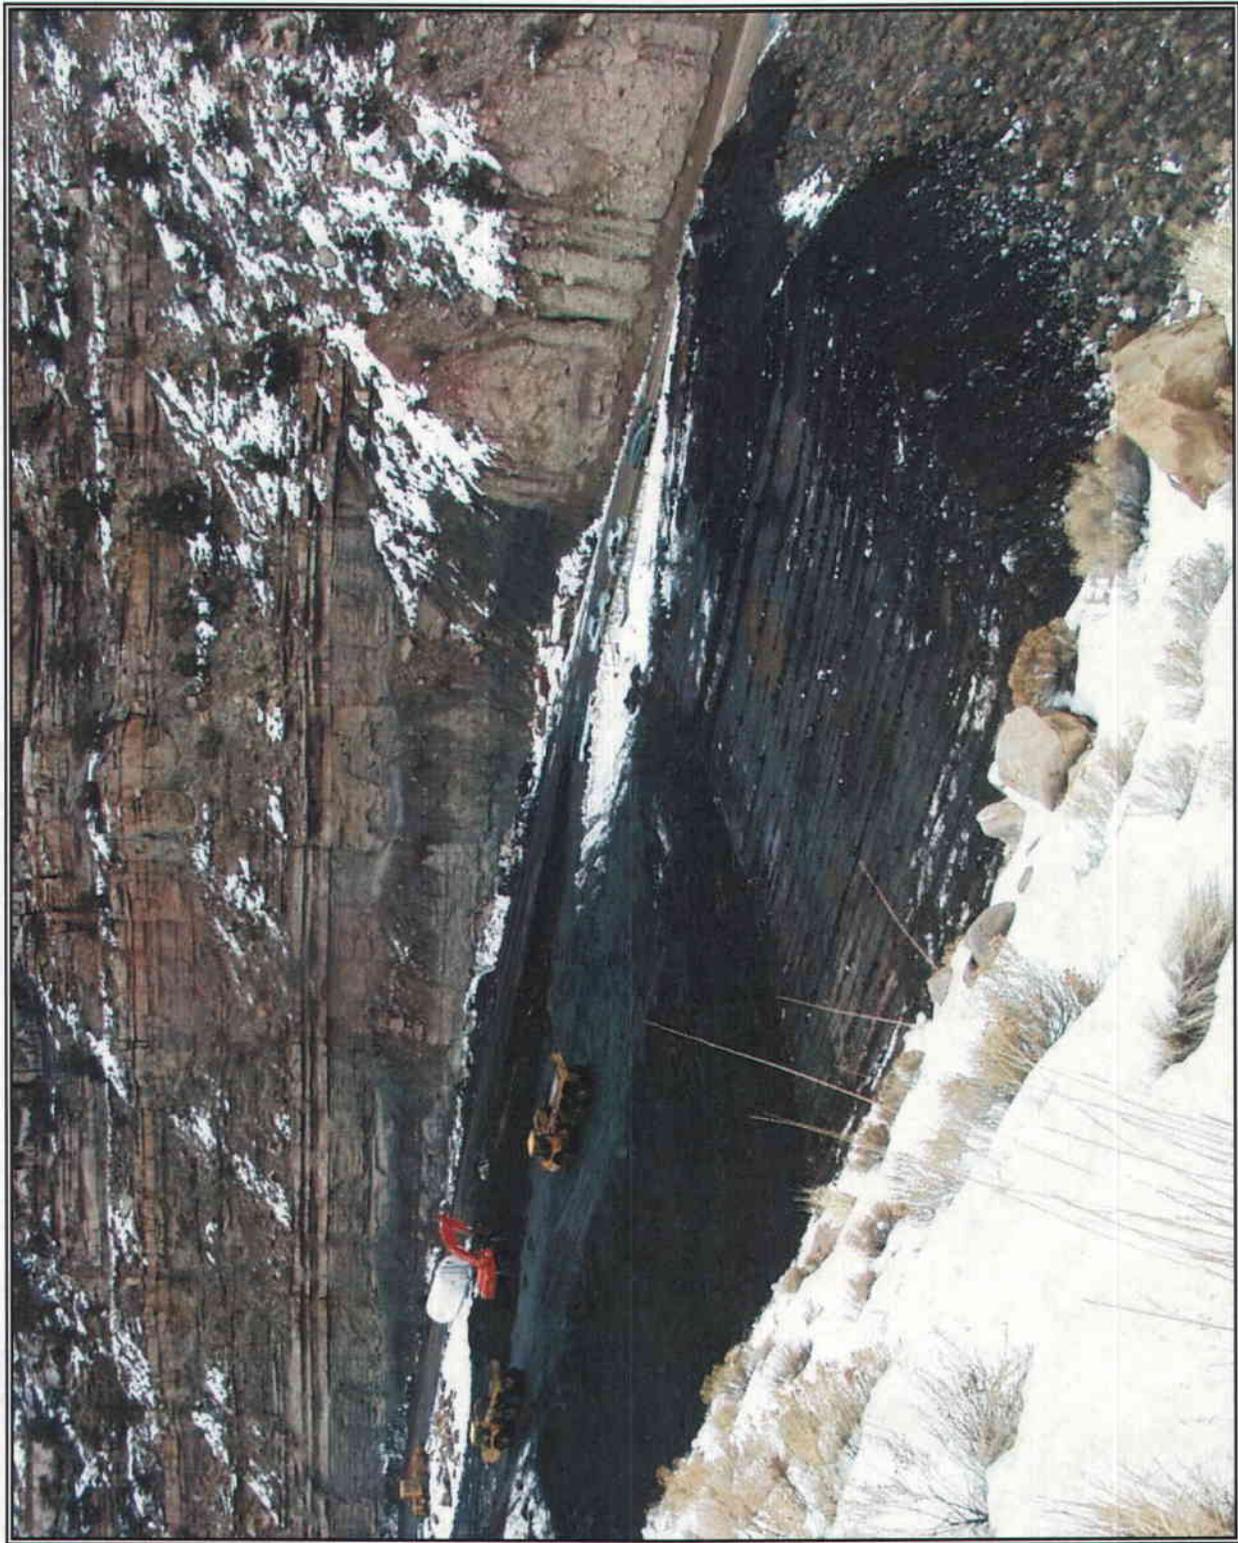
**Figure 8:** Surface layer being scraped off to expose raw coal material.

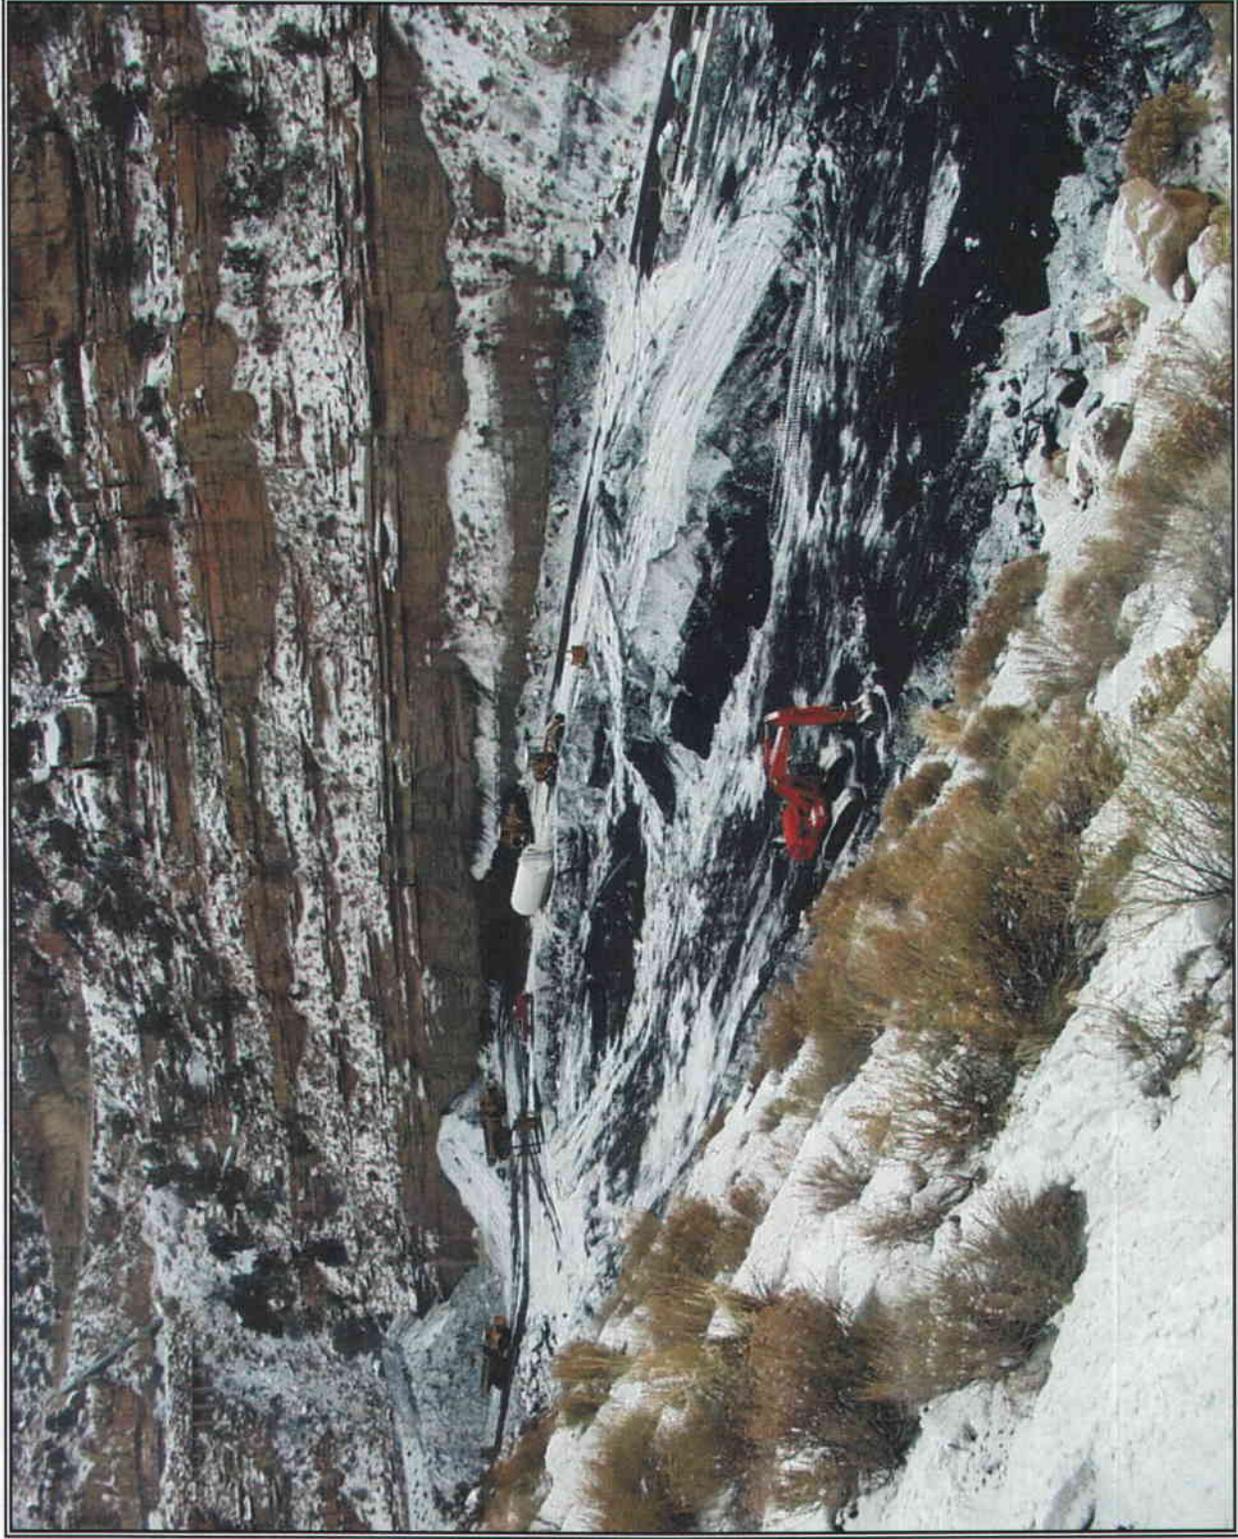
**Figure 9:** Segregation of clean coal into piles for loading and transportation activities.

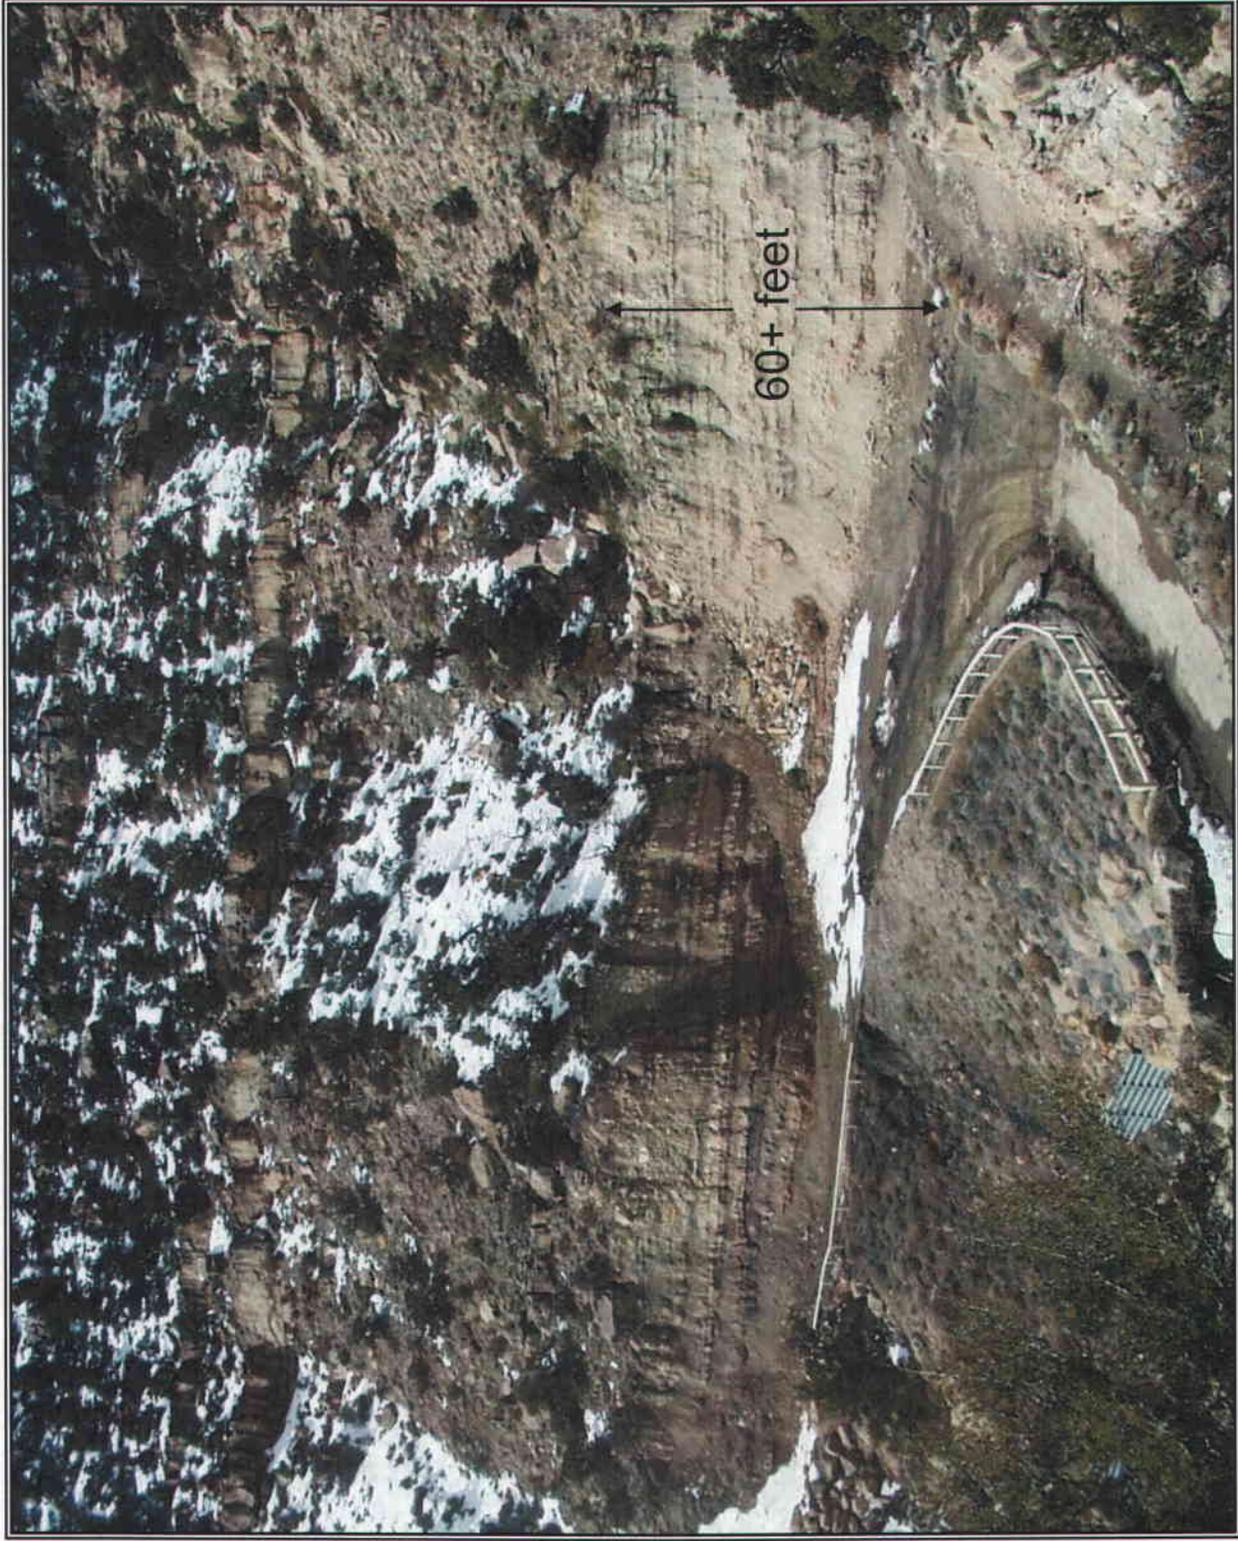
**Figure 13:** Upper mine pad (Little Dove and Beehive mines) with facilities removed and portals backfilled.

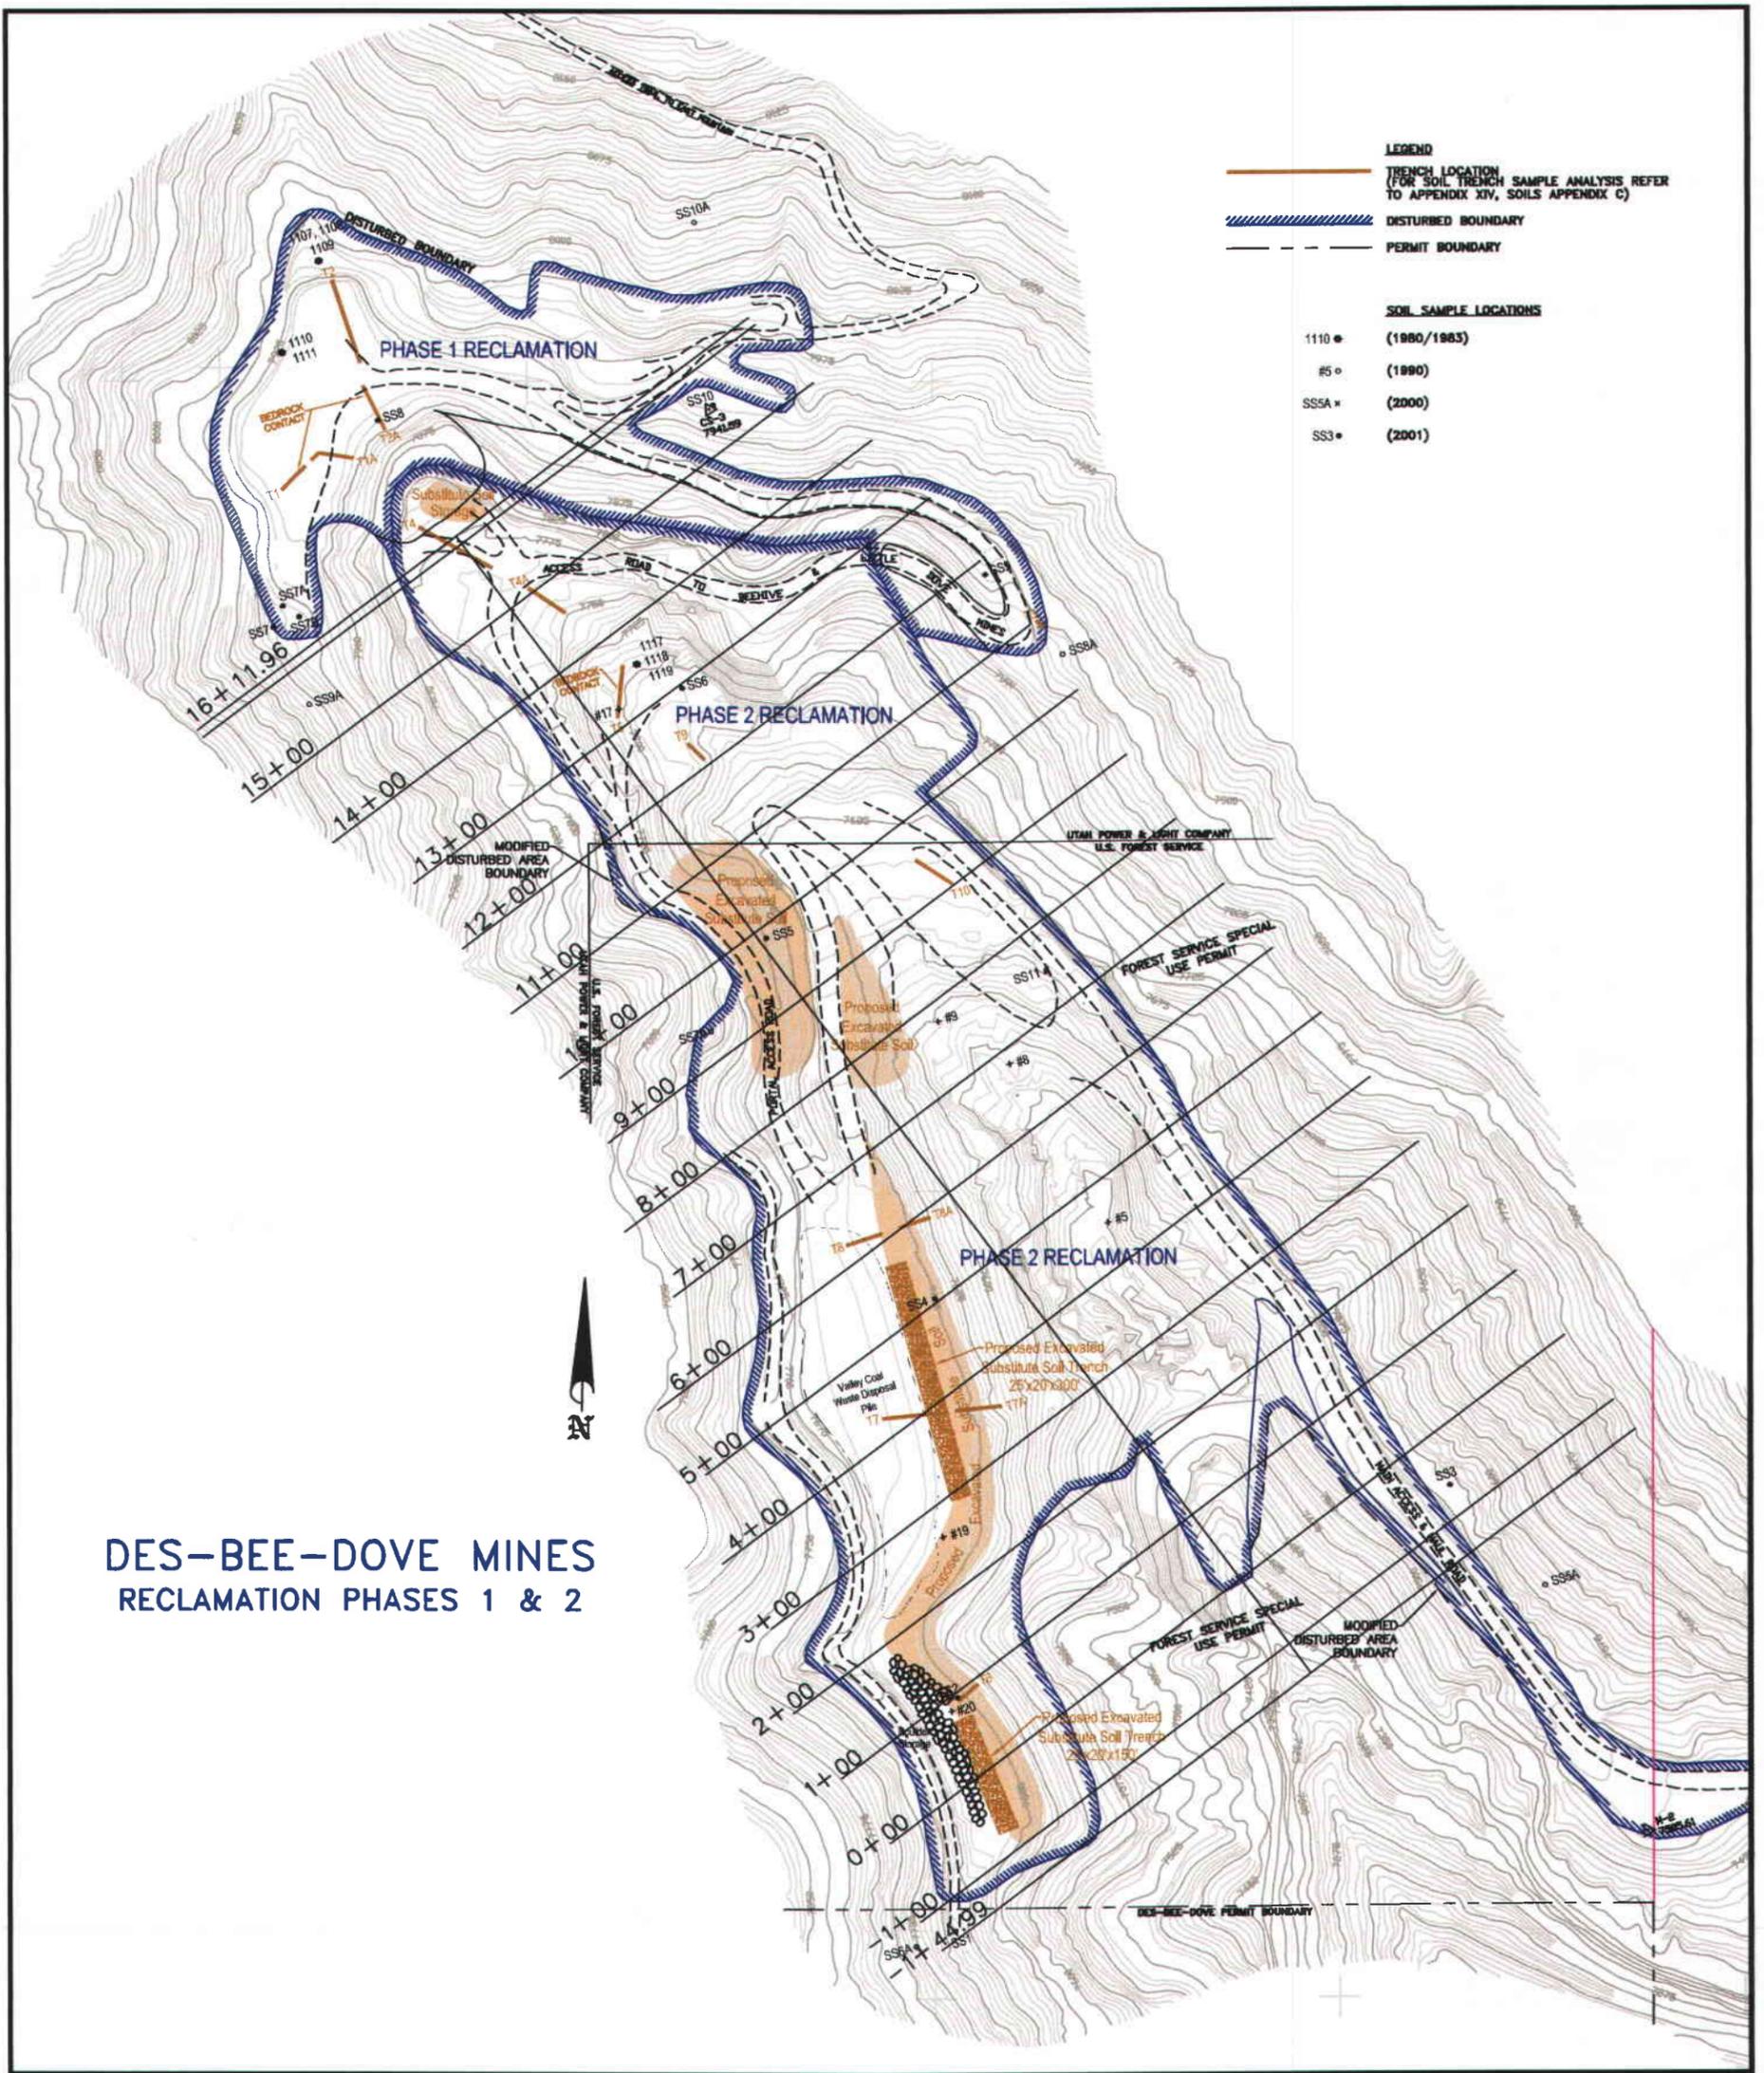
Figure 19: Map of the Des Bee Dove Mine site. Area shows trench locations.

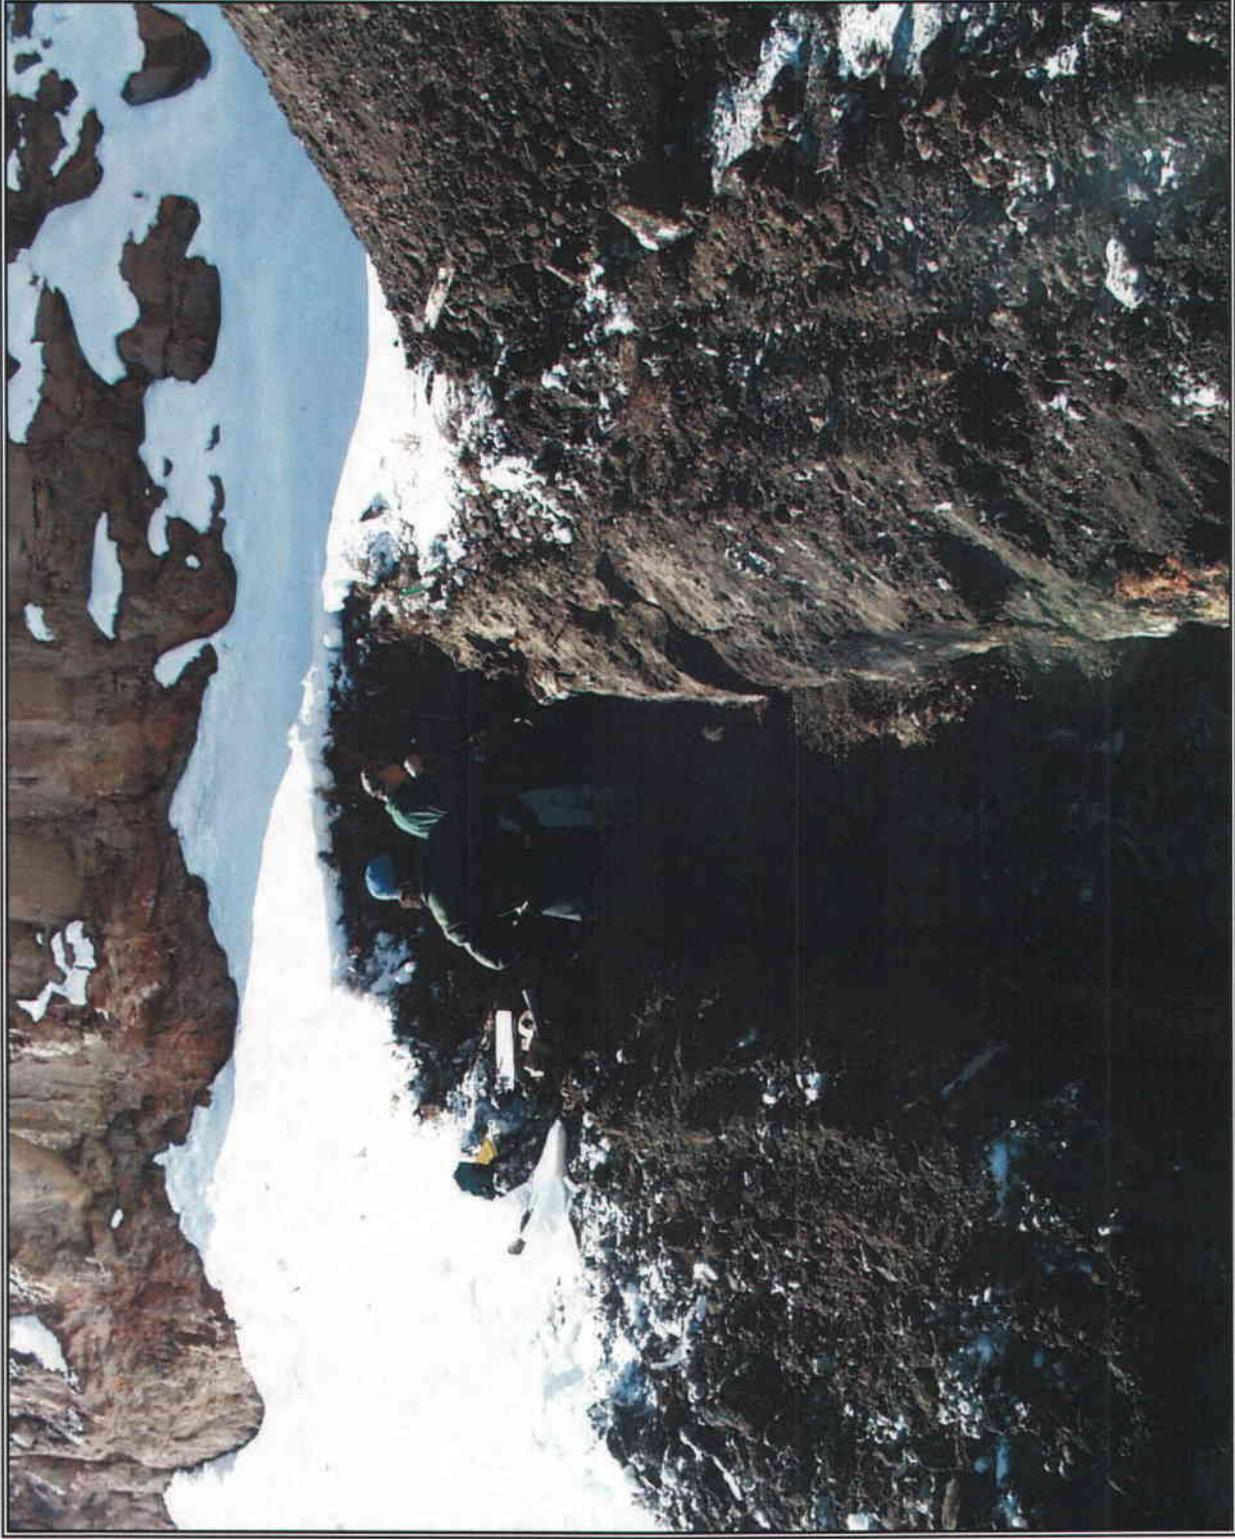
Figure 20: Soil sampling in Trench #1.
