**RE: NOMINATION FOR OSM SURFACE COAL MINING RECLAMATION  
 AWARD - ENERGY WEST MINING COMPANY**

# Reclamation of the Des-Bee-Dove Mine Complex

- A Detailed Soils Assessment for a Pre-SMCRA Site -  
2008 Office of Surface Mining Awards Presentation  
March 15, 2008

## **Reclamation of the Des-Bee-Dove Mine Complex- A Detailed Soils Assessment for a Pre-SMRCA Site**

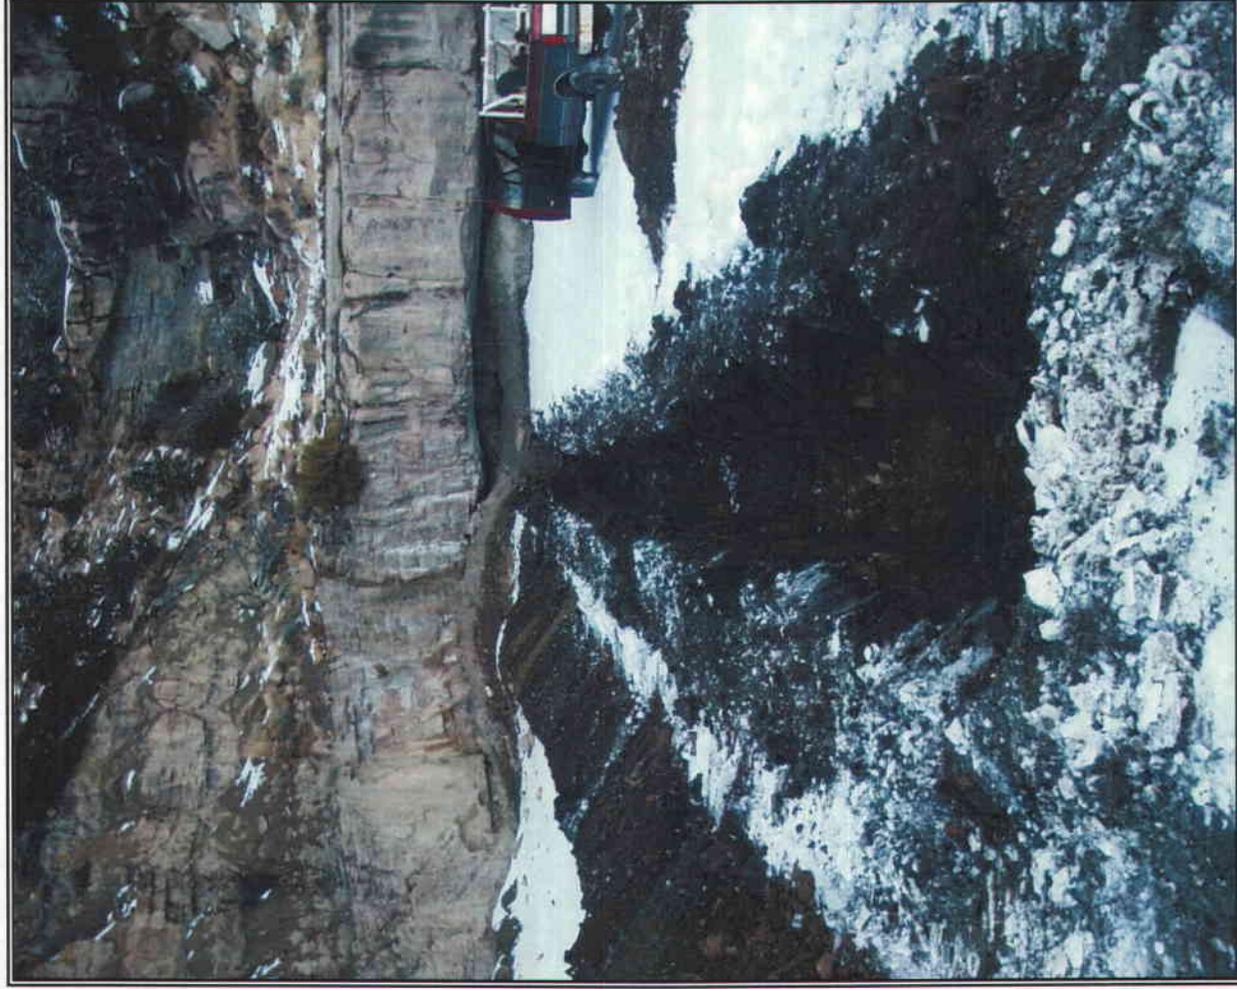
**Figure 21:** Location of the bedrock contact in Trench #2

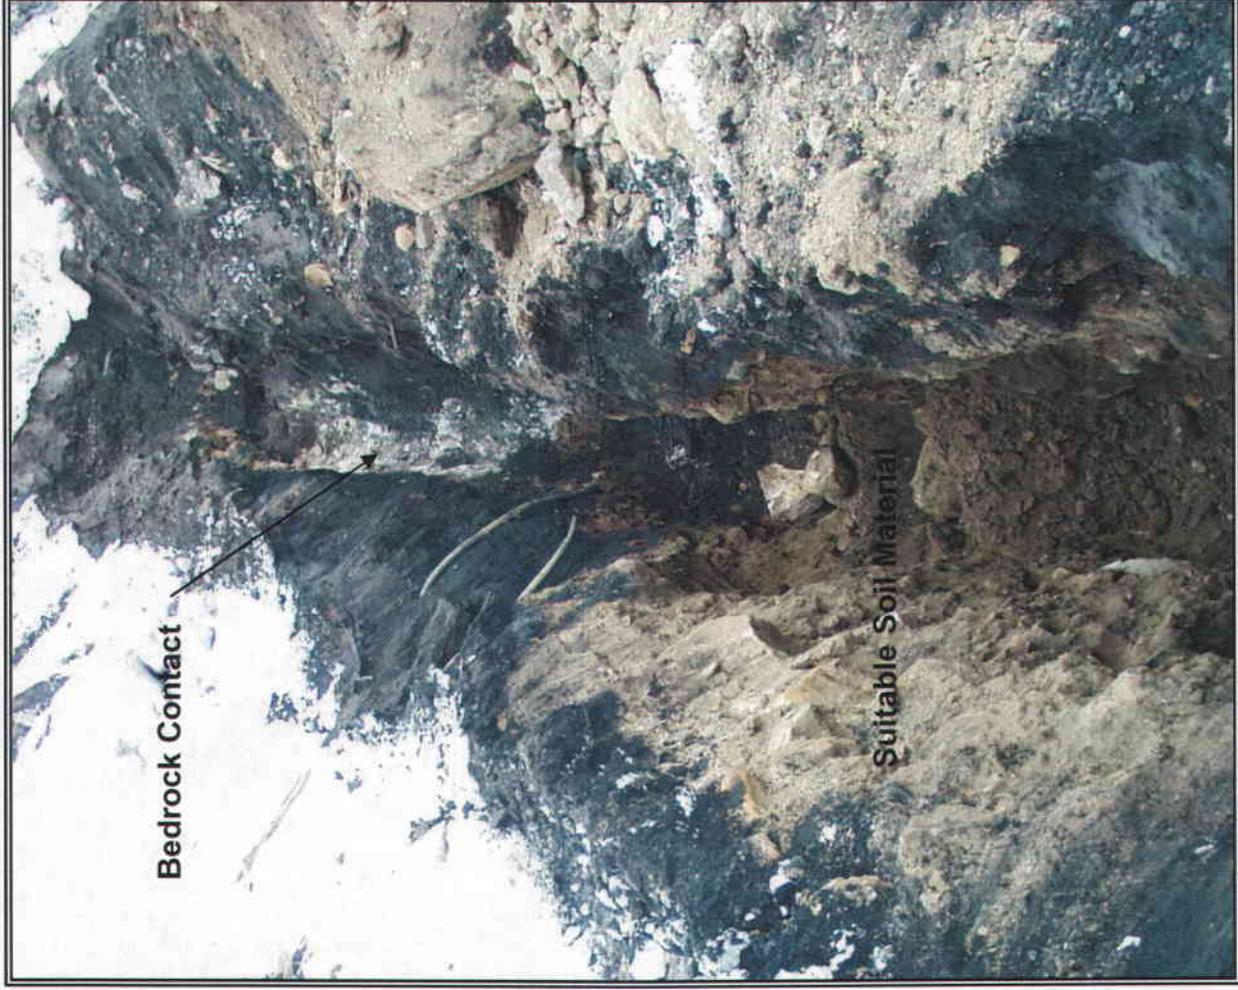
**Figure 22:** Location of the bedrock contact and suitable soils below coal waste material in Trench #5

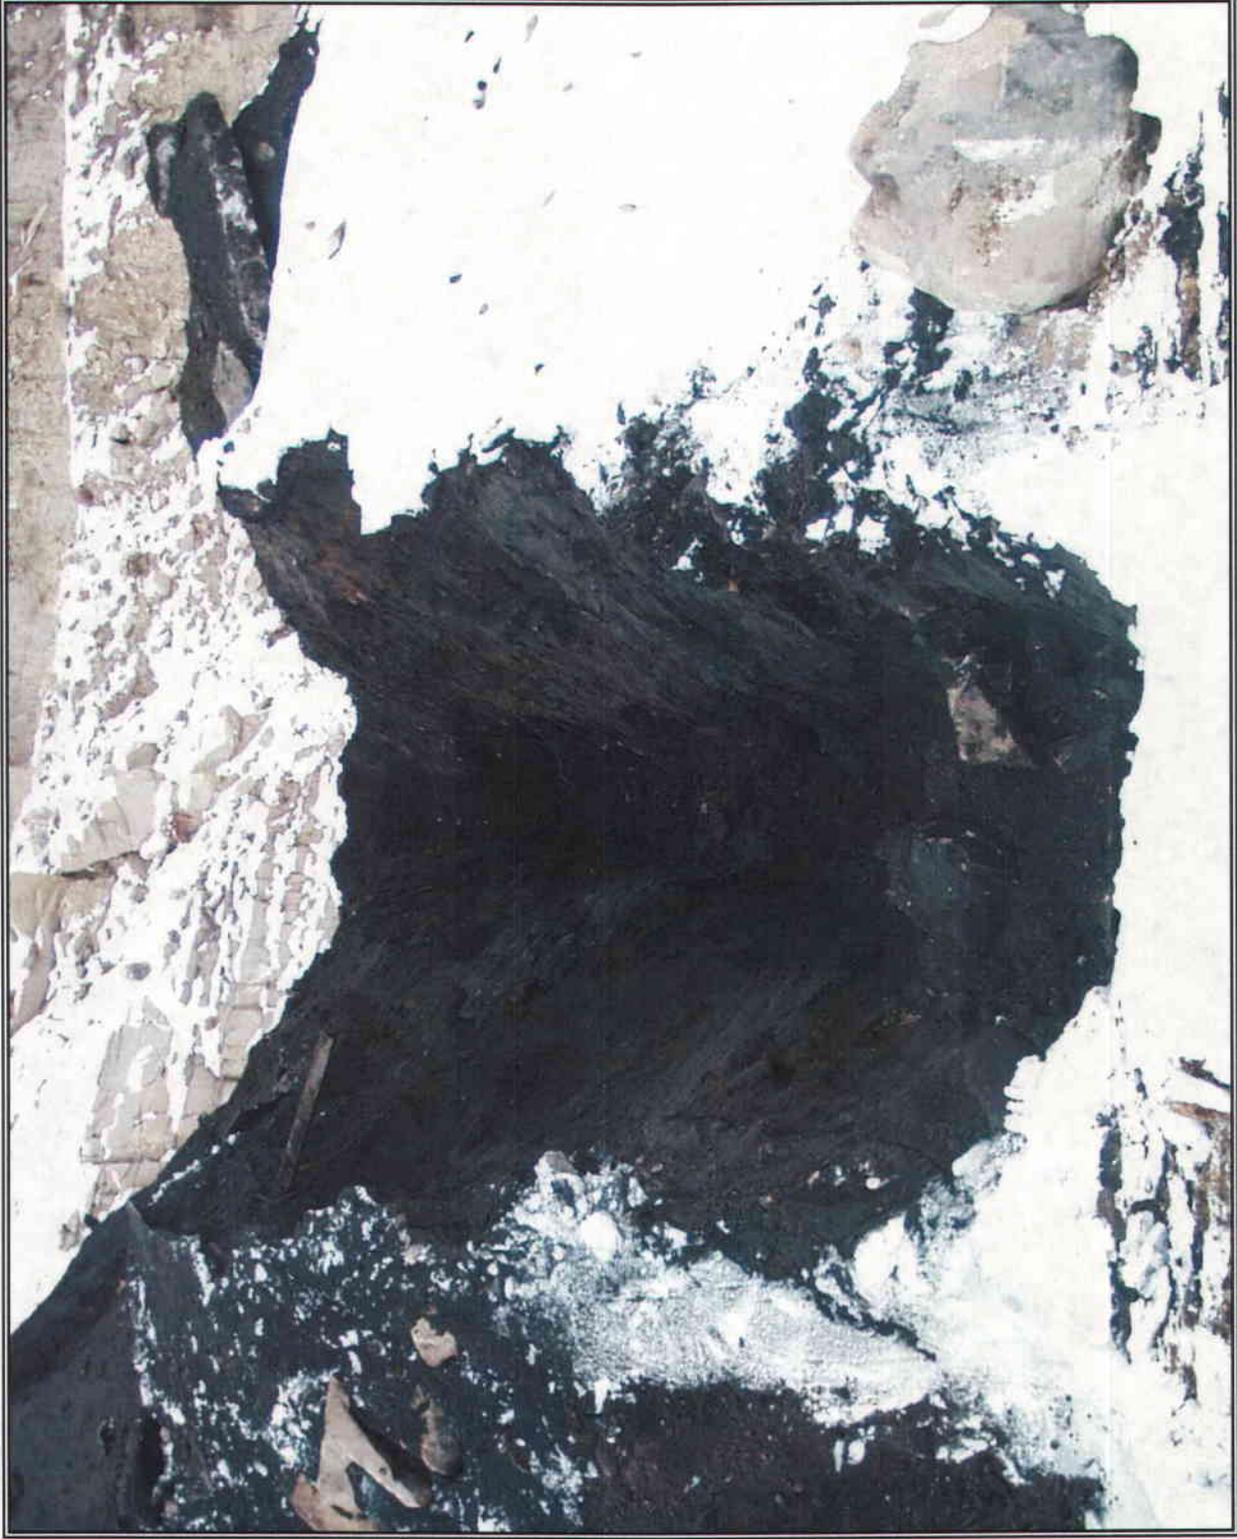
**Figure 23:** Unsuitable soil in Trench #9. This material was used as fill at the base of cut slopes.

Variegated clayey material of reddish and yellowish colors such as those noted at the Little Dove Mine pad site (T1) and the access road (T3) was marked to be buried and not allowed to be used as surface (topsoil) material due to its physical and chemical characteristics.

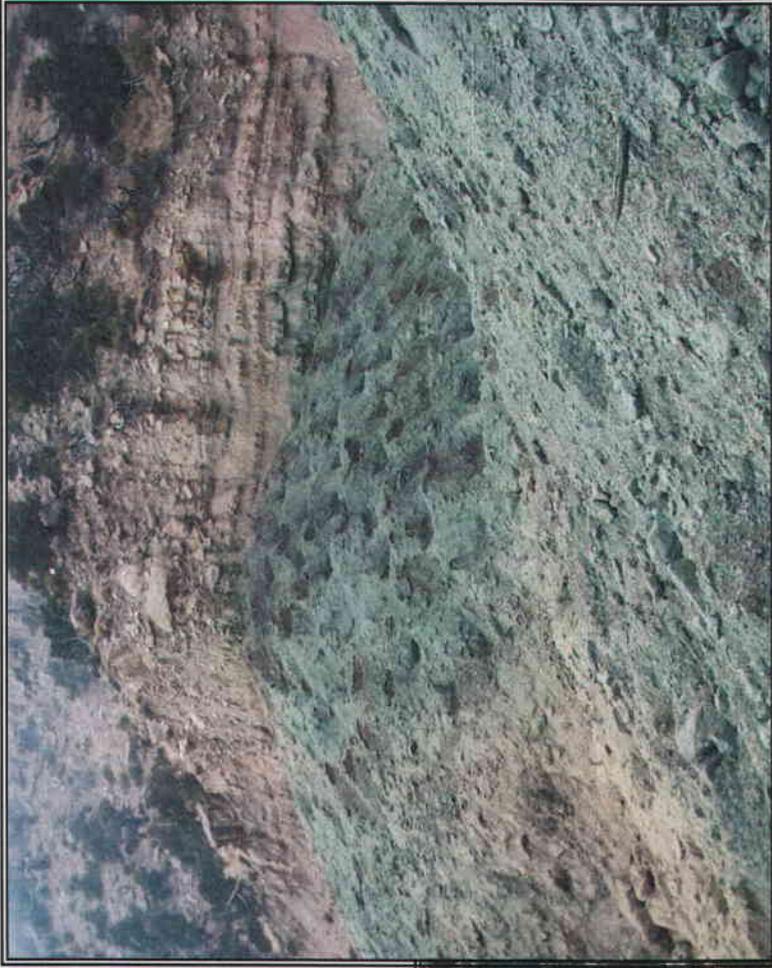
**Figure 28:** Hydromulching/tackifying reclaimed slopes.

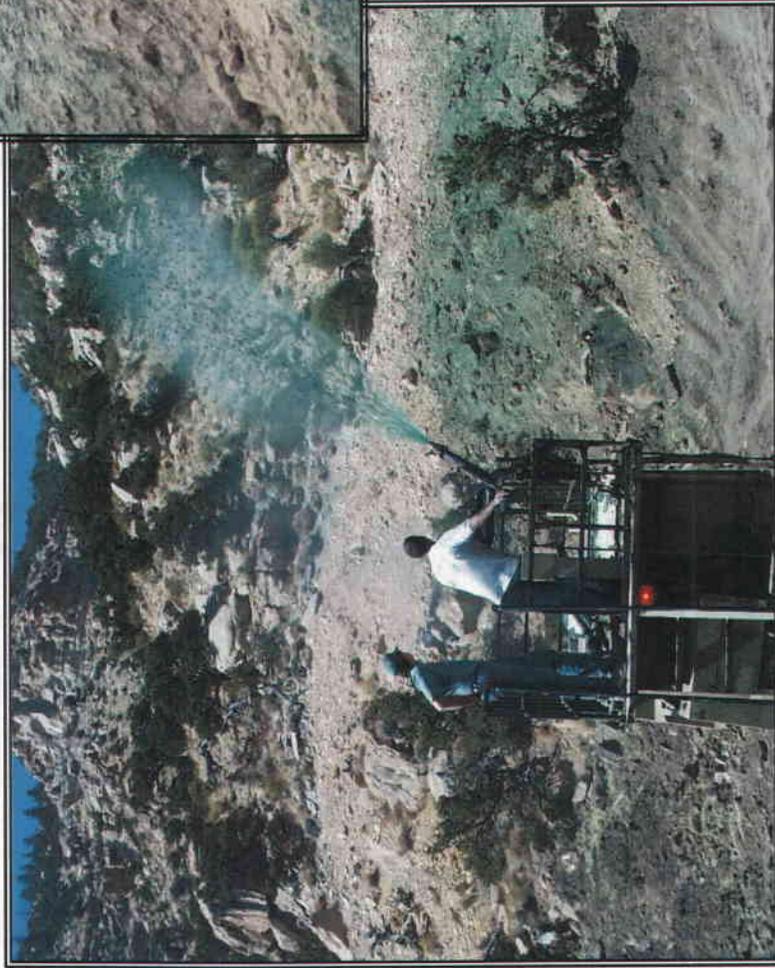
**Figure 29:** Deep “pocks” were constructed in slopes to control erosion, catch runoff, and enhance vegetation growth.

Note: Because of slope stability concerns, slopes were limited to a 2h:1v configuration and compacted to a 95% proctor. The narrowness of the pad prohibited complete elimination of highwalls in this area.

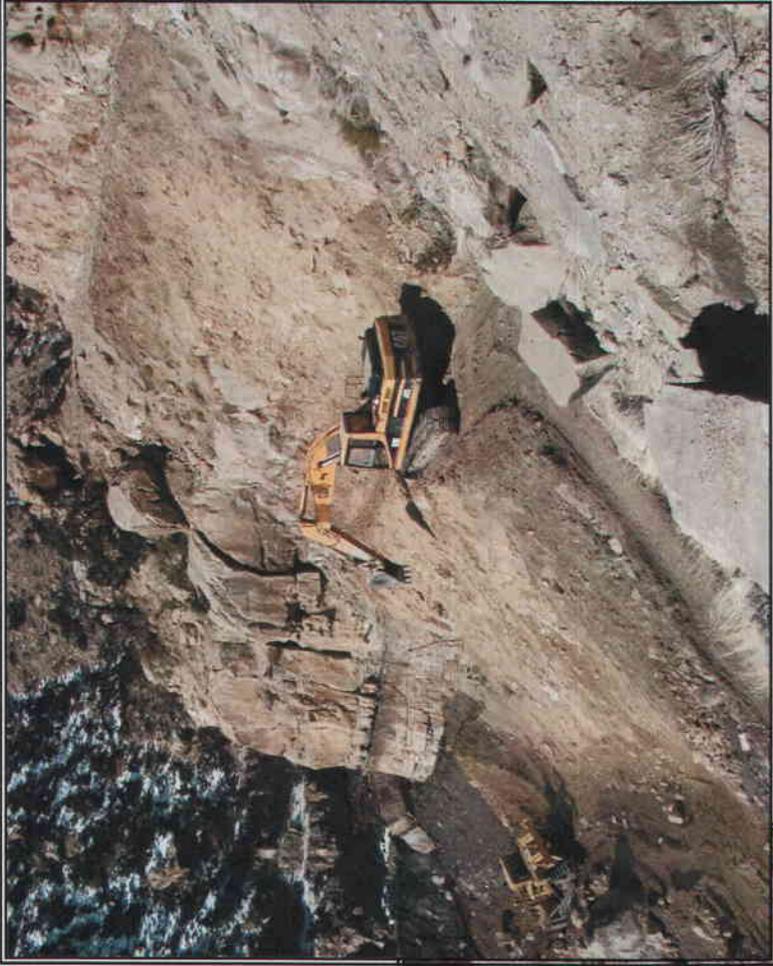
Figure 32: Dozer utilizing the excavated soil material to cover the coal waste fill.

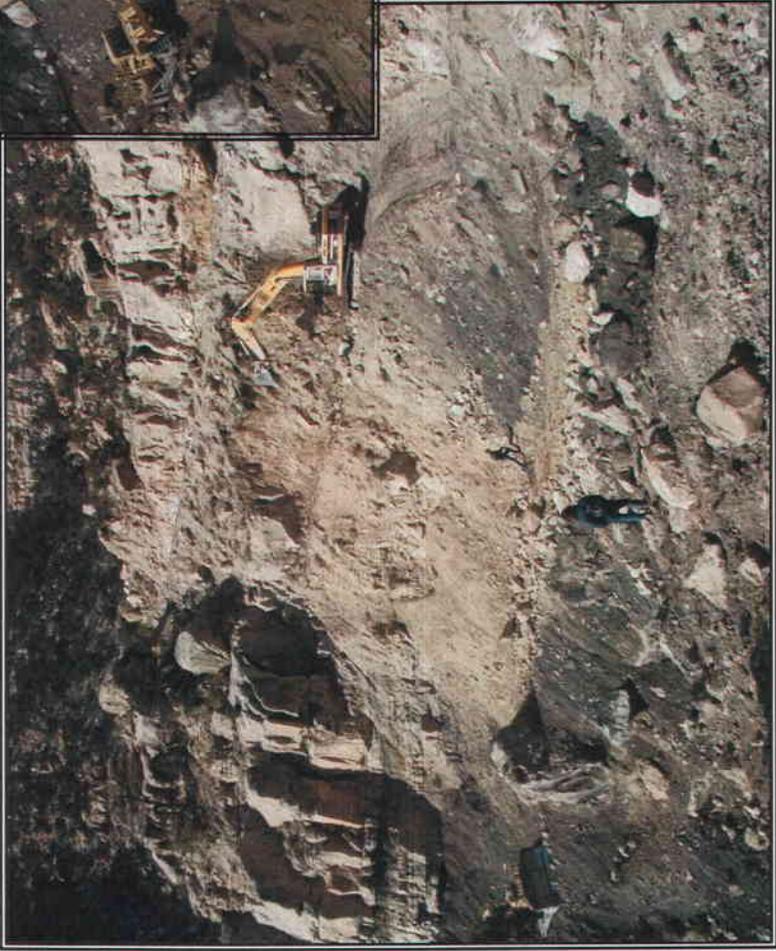
Figure 31: Track-hoe excavating good soil material and exposing bedrock.

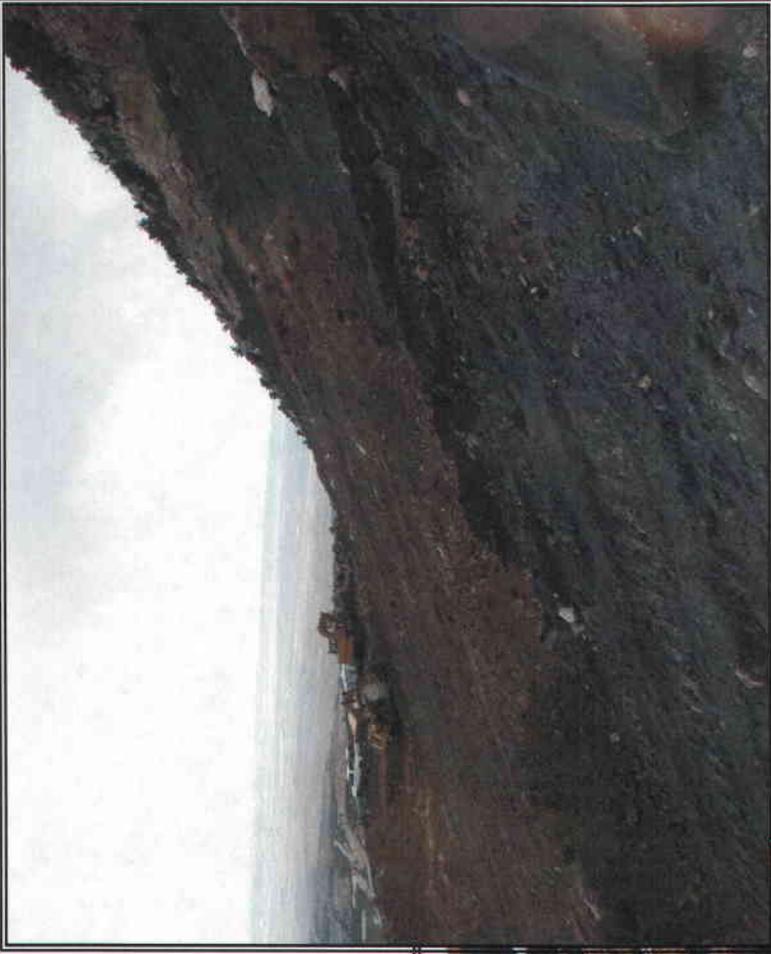
Figure 36: Covering coal waste fill on bathroom pad with substitute topsoil.

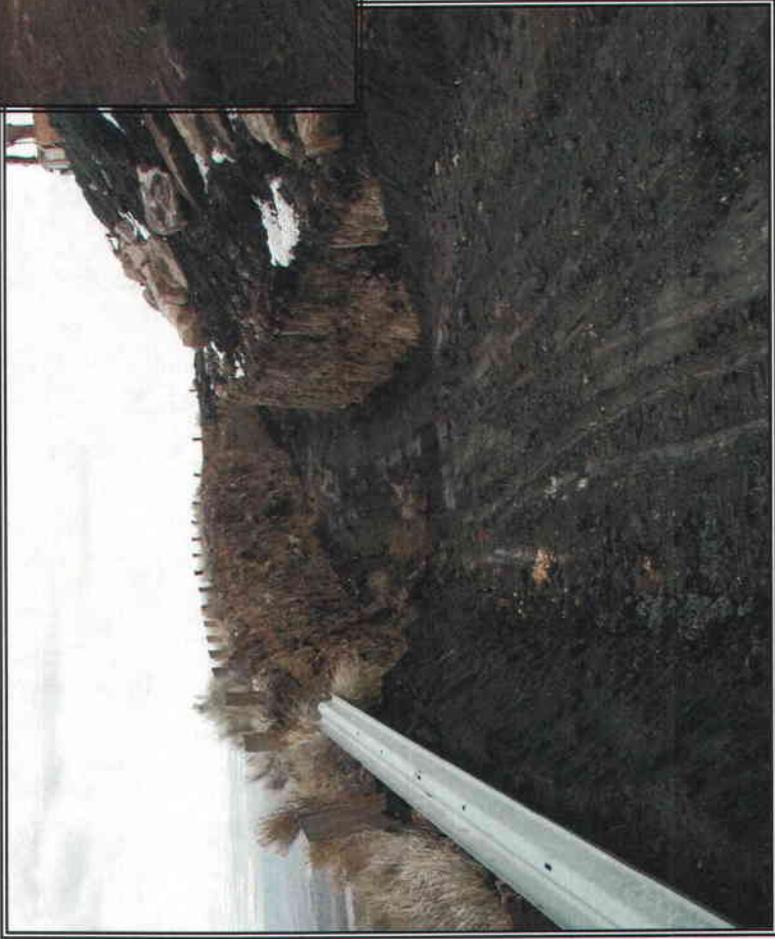
Figure 35: Substitute topsoil excavated from trench on bathroom pad. Trench is backfilled with coal waste.

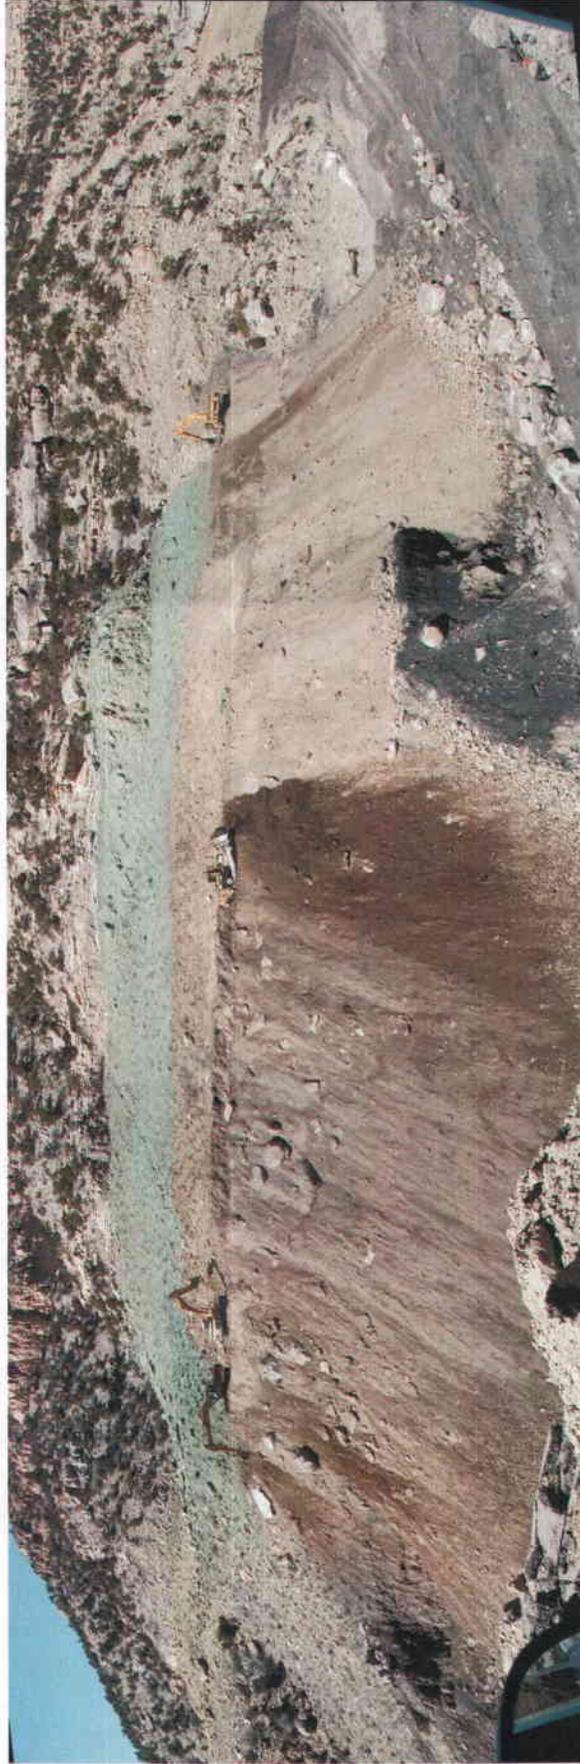
**Figure 37:** Final reclamation of bathhouse pad. The track-hoes and dozer work to reclaim down slope to canyon bottom. An additional 20,500 yards of substitute topsoil material was gained from two excavated bathhouse pad trenches and the bathhouse outslope. Rock and soil from this work was used to riprap the main channel and cover the opposite side of the canyon with a substitute topsoil material.

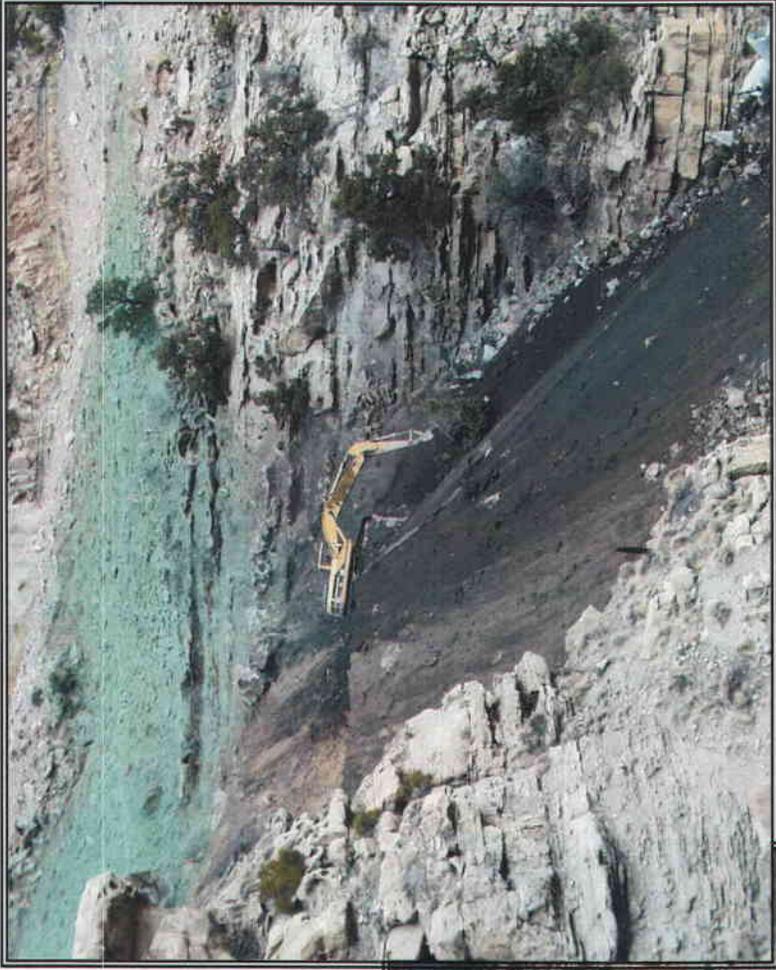
**Figure 39:** Simultaneously, as crews are working to finish bathhouse pad, and operator takes a track-hoe off the face of the slope below the upper mine access road to remove all coal waste from this slope. Final reclamation is completed as the operator descends the slope.

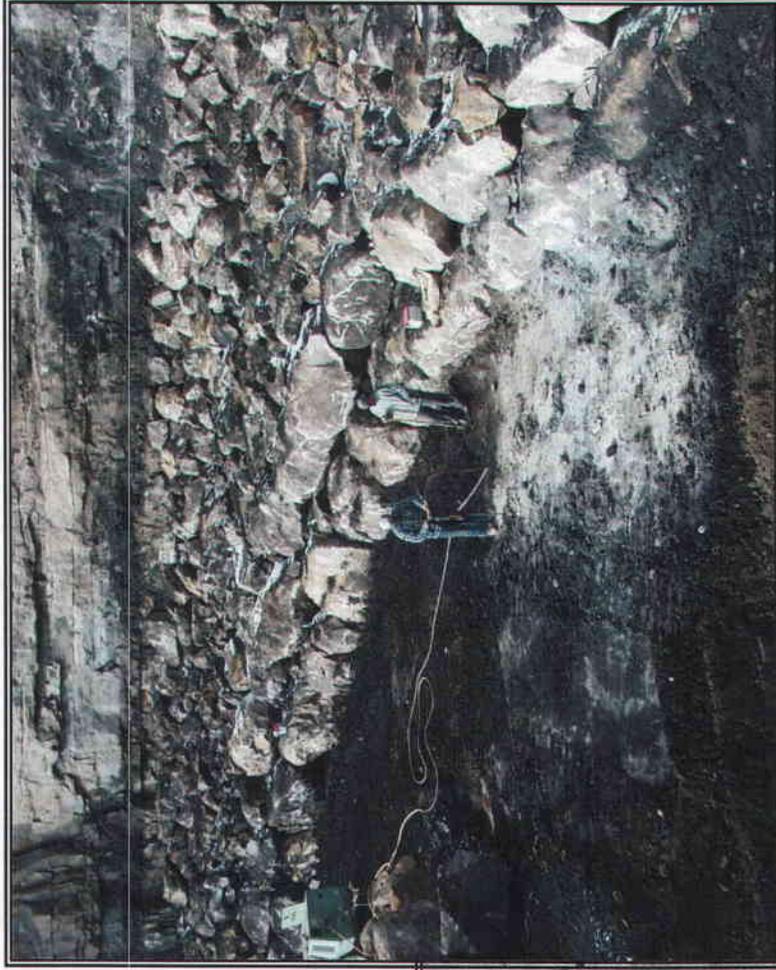
**Figure 41:** Crews drilling holes that will eventually be loaded with explosives to blast a keyway to anchor in the riprap apron.

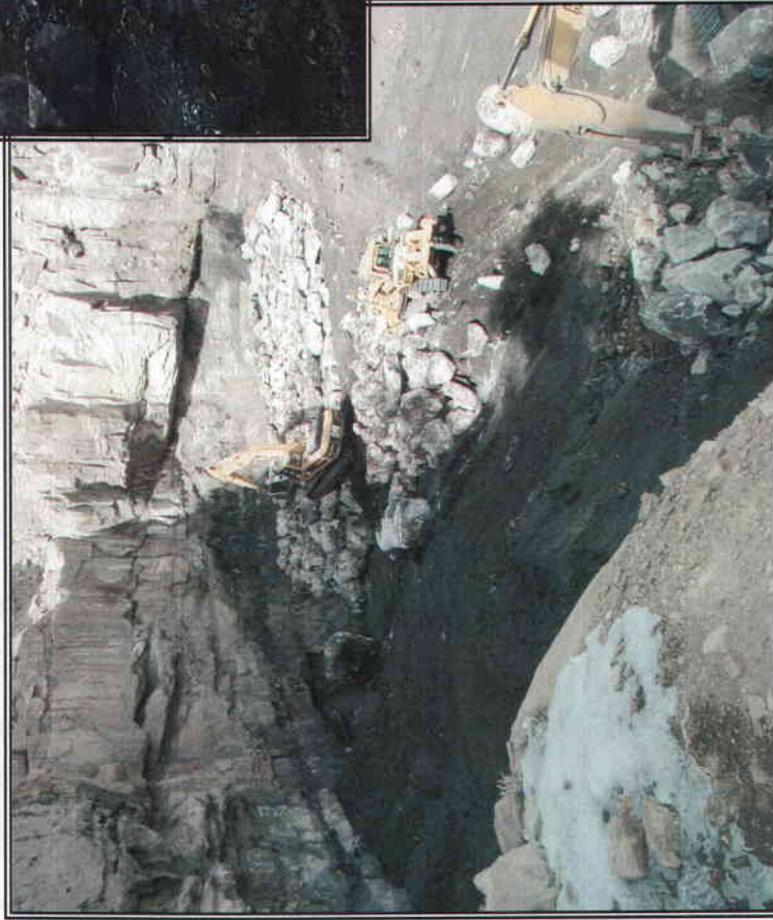
**Figure 40:** Deseret Mine pad. A riprap apron is being built where ephemeral flows from the upper mine area fall onto the lower mine pad.

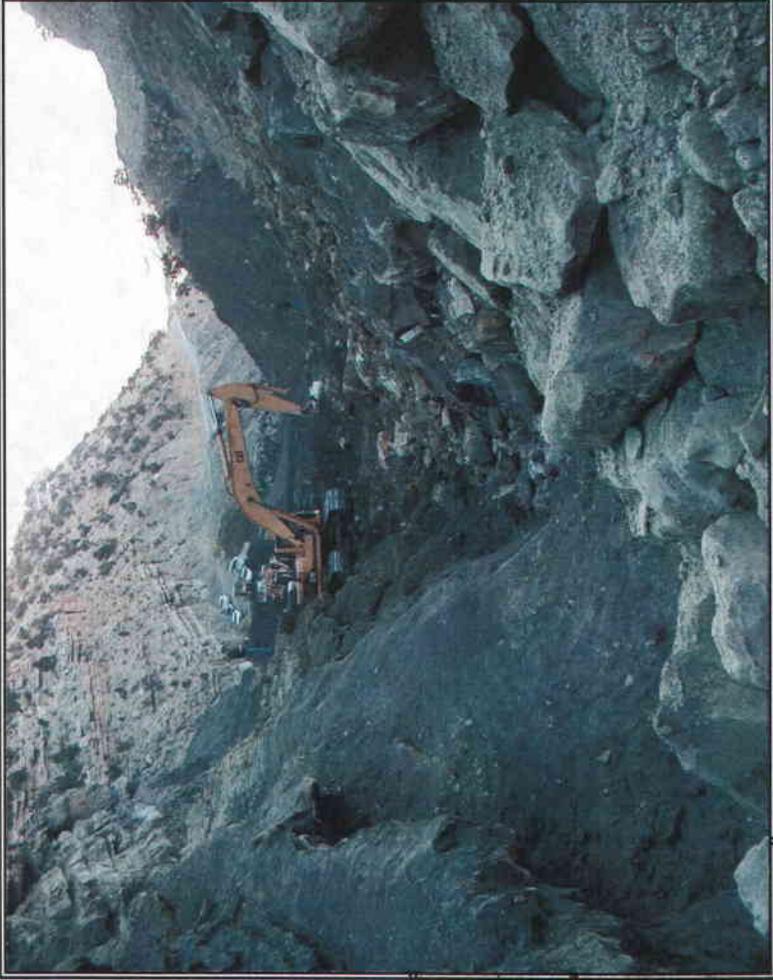
Figure 43: Continued construction of main channel down channel. Note the outcropping rock on the left side of channel.

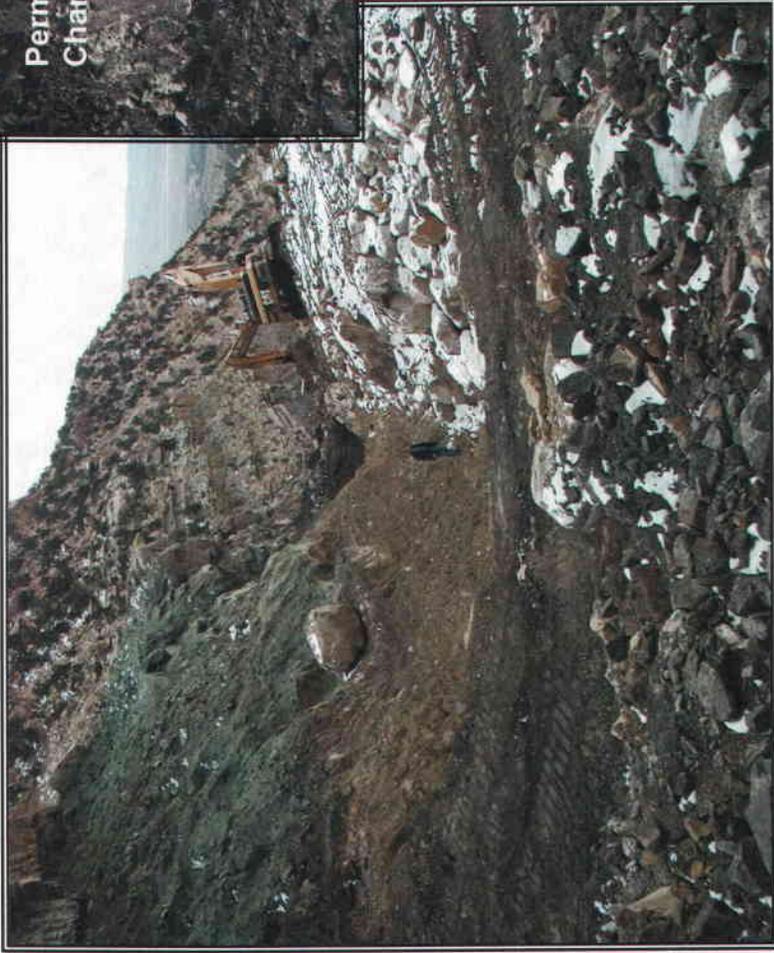
**Figure 44:** Deseret Mine pad looking down canyon. Main channel construction. On left side of channel rock outcrop is exposed. On right side of channel large boulders are placed against fill.

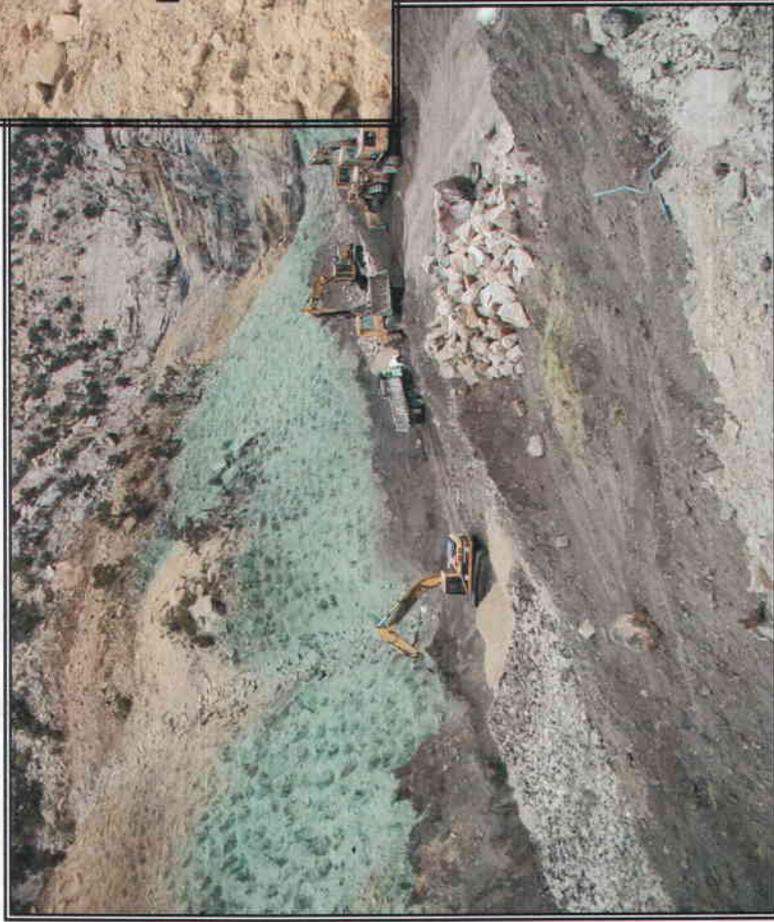
Figure 48: The construction of the main channel worked from the top down and the bottom up. This photo shows where construction crews connected the channel before continuing reclamation down the main access road.

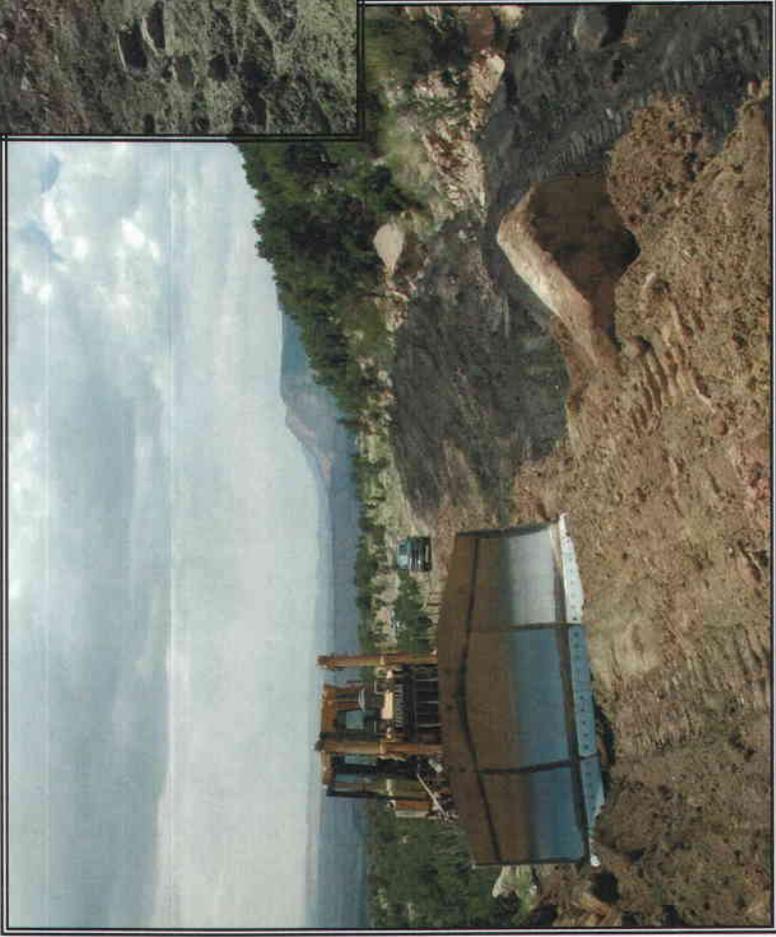
**Figure 50:** Spreading Substitute topsoil material over fill of main access road.
