April 12, 1985

TO: Coal File, Enforcement and Inspection Folder
FROM: Sandy Pruitt, Mining Field Specialist *SP*
RE: Deer Creek Mine, Utah Power & Light Company, ACT/015/018, #2,
#7, Emery County, Utah

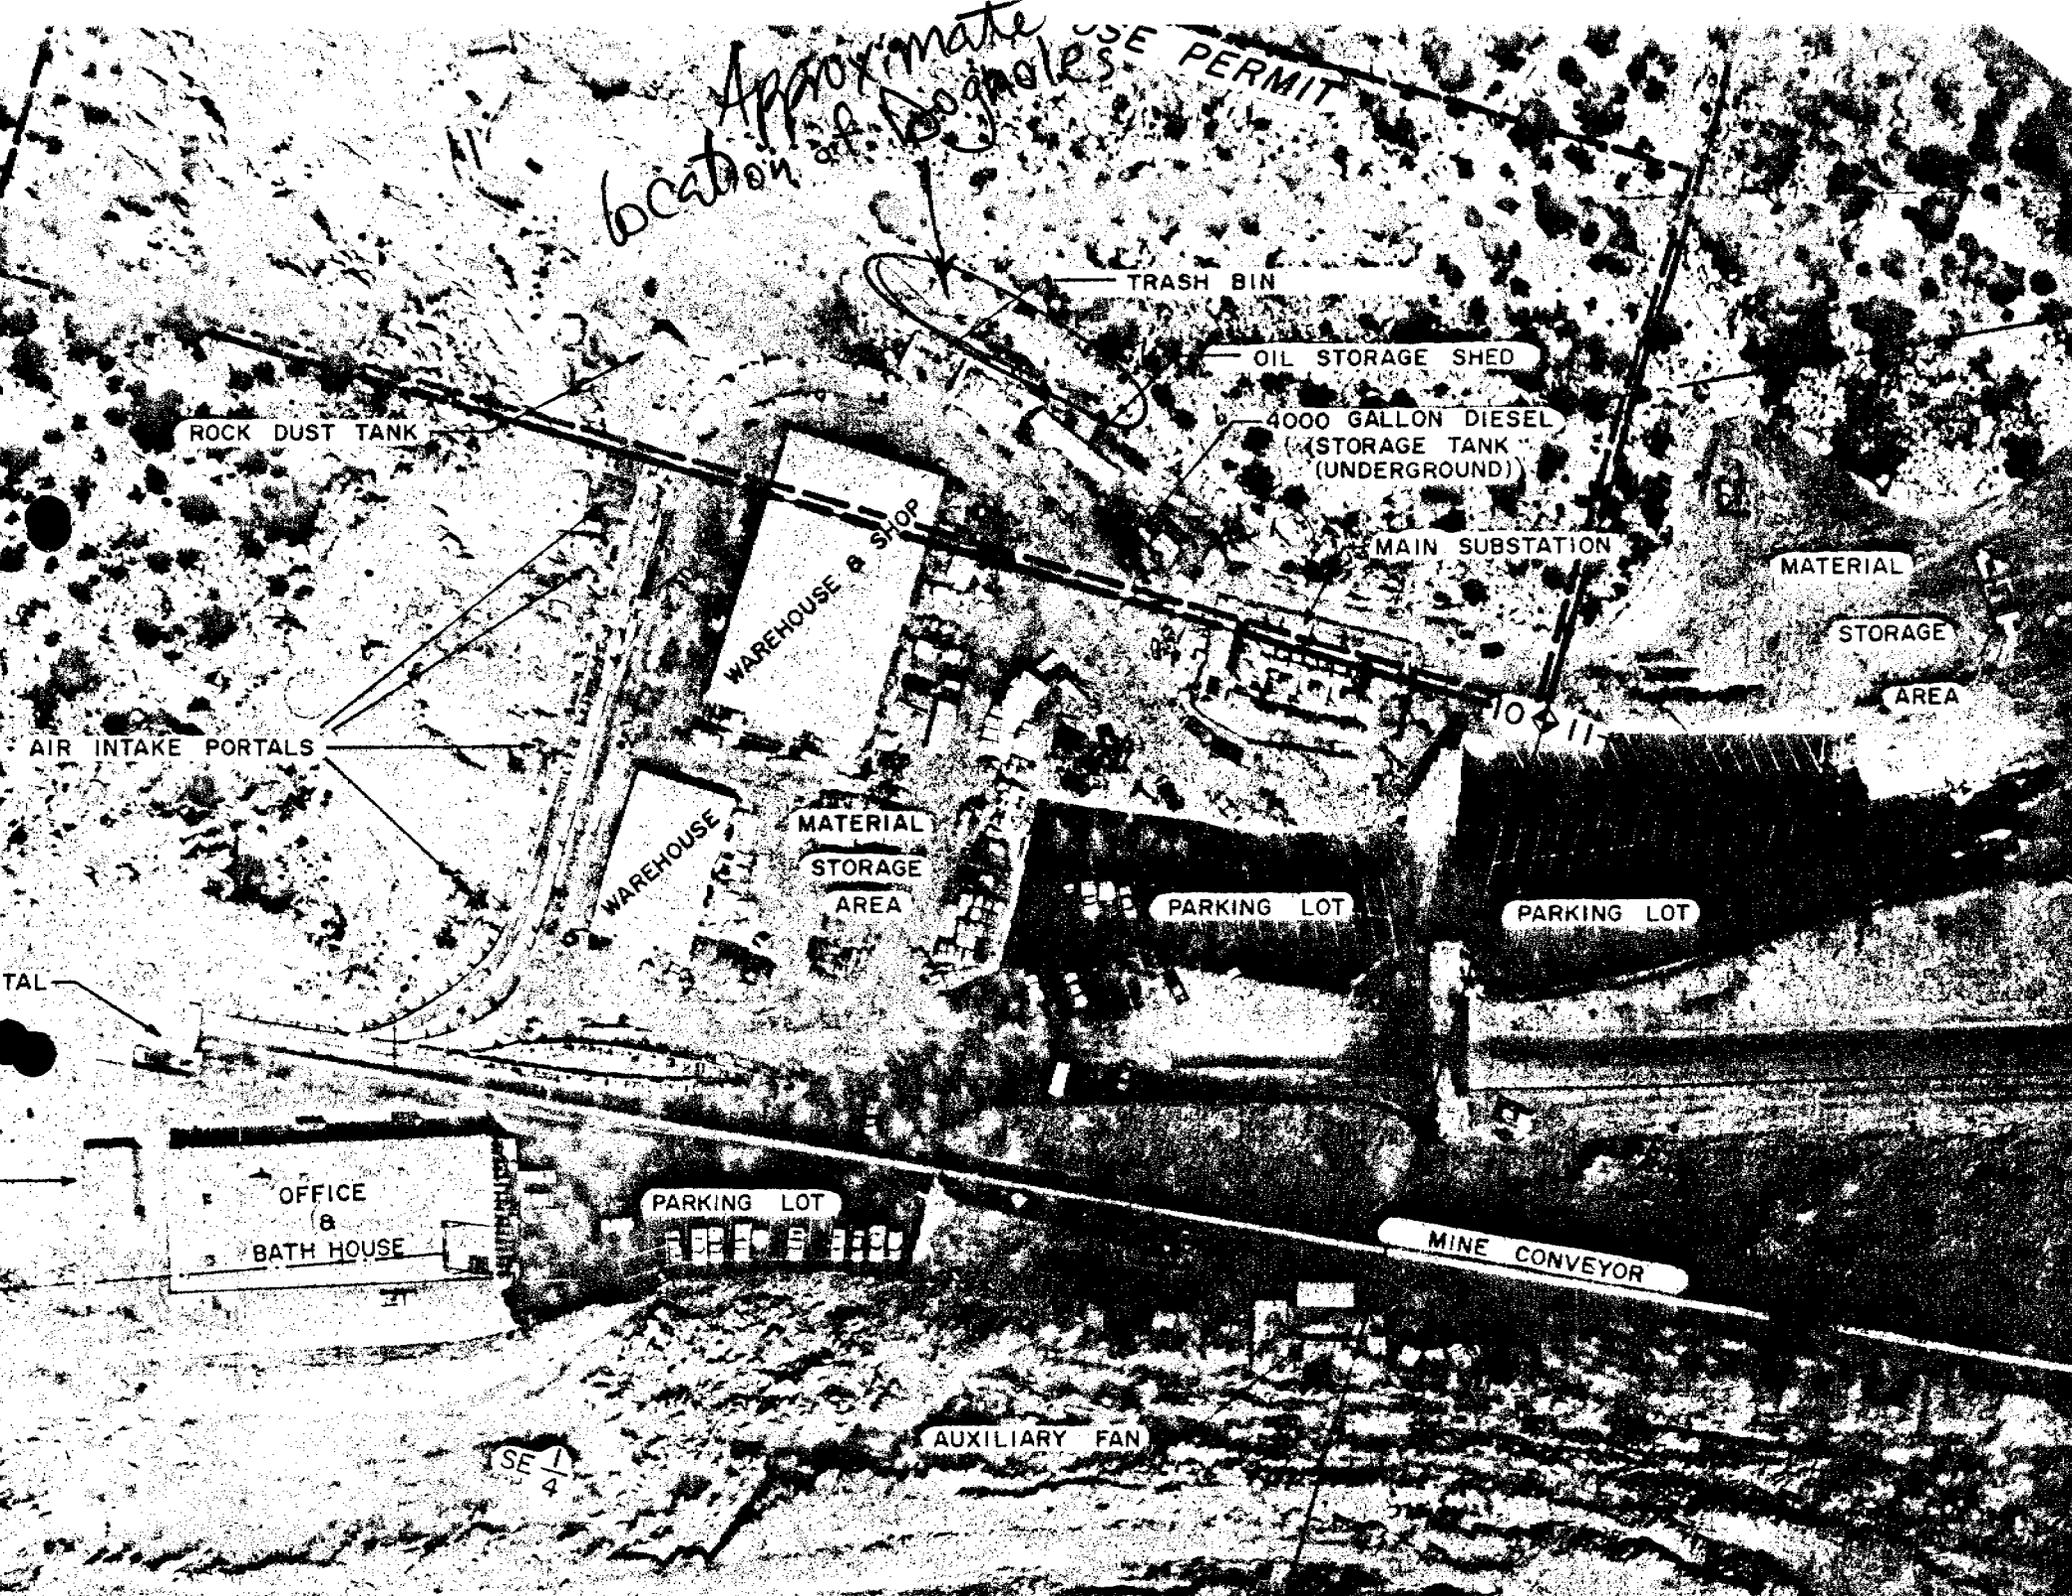
Attachment

A small pre-Act mine opening has become exposed by sloughage off the cliff along the Deer Creek Mine yard. The doghole is located near the trash bin next to the warehouse/shop building. The approximate location is indicated on both attachments.

Down canyon from the mine, there is an old mine development on the west side of the canyon, evident from the road by scattered timbers and a spoil pile. This pre-Act development is not indicated on the "existing mine workings" map submitted in the Deer Creek Mine permit application. I've circled the approximate location of this development, also, Area B.

Approximate location of bogholes
