## OGMCOAL - Fwd: Small Rock Fall at Deer Creek

Date: October 11, 2010  
From: Ken Fleck  
To: File  
Subject: Rock Fall at Deer Creek Mine 10/11/10

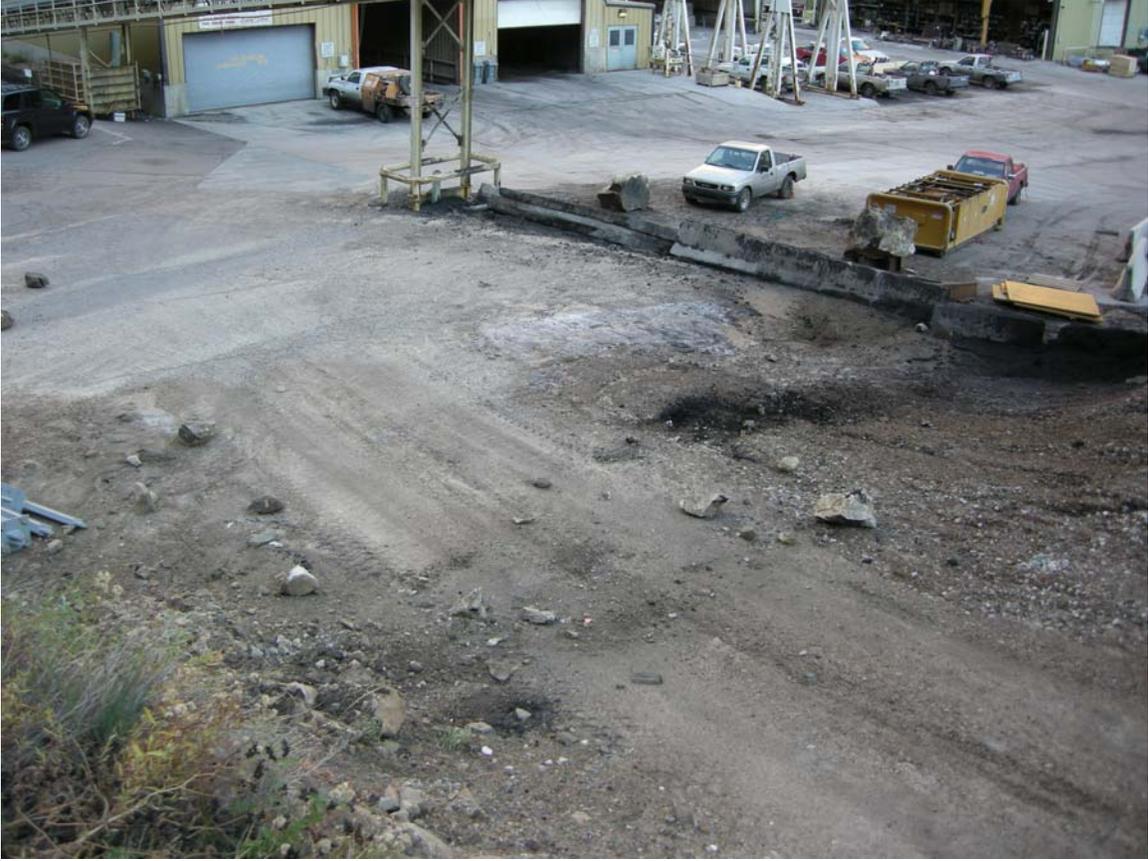
At approximately 6:15 a.m. on October 11, 2010, a small rock fall occurred at the Deer Creek Mine. Two rocks, each approximately 3 feet on a side (possibly 1 larger rock that broke in half) fell from about 80 feet up the highwall, rolled down the slope, bounced across the roadway and struck 2 jersey barriers under the R.O.M Belt. One of the barriers was knocked over. The rock that knocked the barrier over came to rest a few feet away from a parked Isuzu truck. The other rock struck a barrier, bounced over it, and came to rest on top of a belt scraper apparatus, denting it slightly. This rock came within about 5 feet of an underground transformer but did not hit it.

Photo #1. 2 rocks in background, near Isuzu truck and transformer, impact marks in foreground.

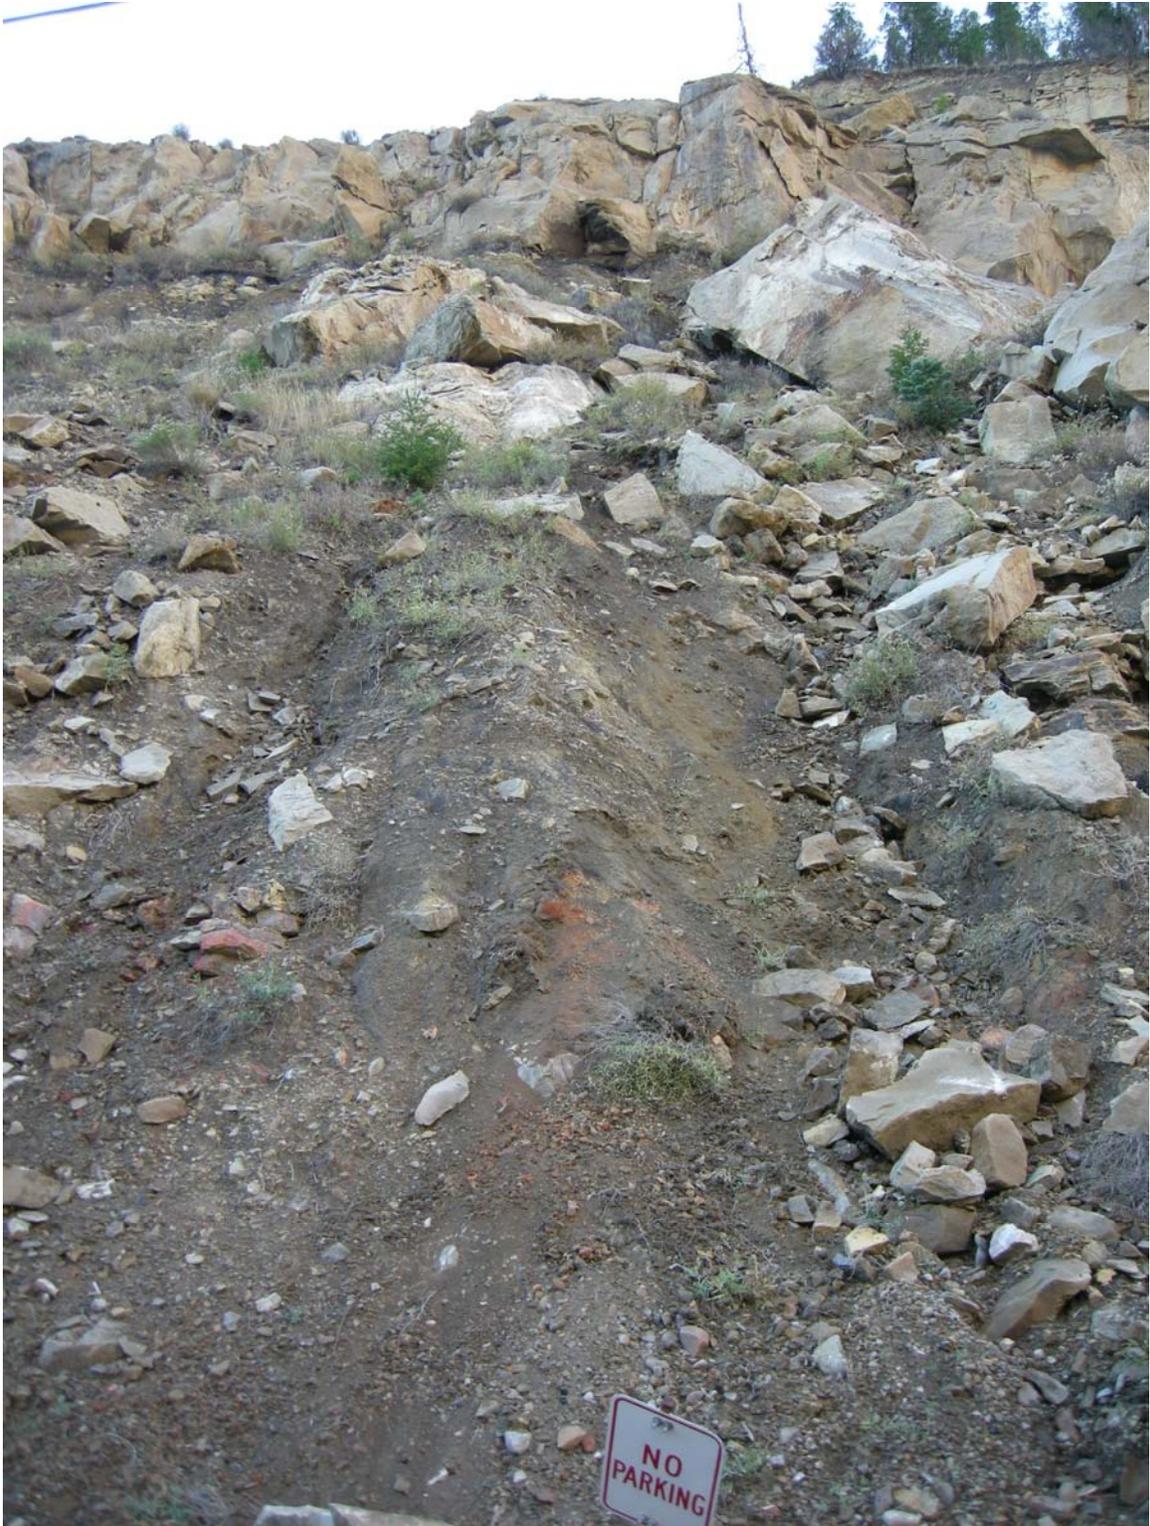
The rock, or rocks, originated at the base of one of the ledges that forms the terraced highwall to the south of the office building and R.O.M. belt. There is no more loose material at this spot. An inspection walk-around above and below the fall area did not reveal any other impending activity.

The fall may have been related to the heavy rains that concluded on Thursday of last week.

Photo #2. Origin of rock fall – dark area at base of ledge.
