Annual Report 2009

Cottonwood Coal Mine
C/015/019

Deer Creek Mine
C/015/018

Trail Mountain Mine
C/015/009

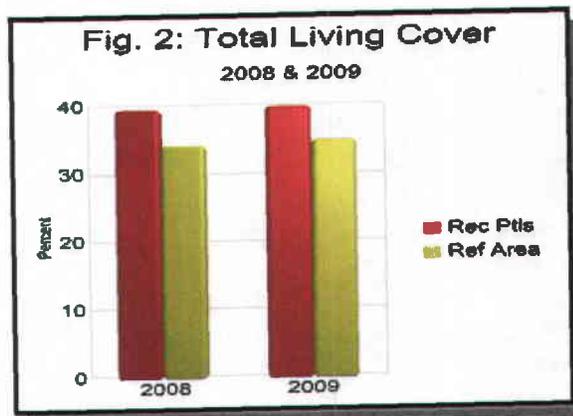
results were found for this parameter in 2008.] A graphical comparison of the 2008 and 2009 datasets for **total living cover** is shown on Fig. 2.

Next, **diversity indices** of the two areas were compared. *MacArthur's Index*

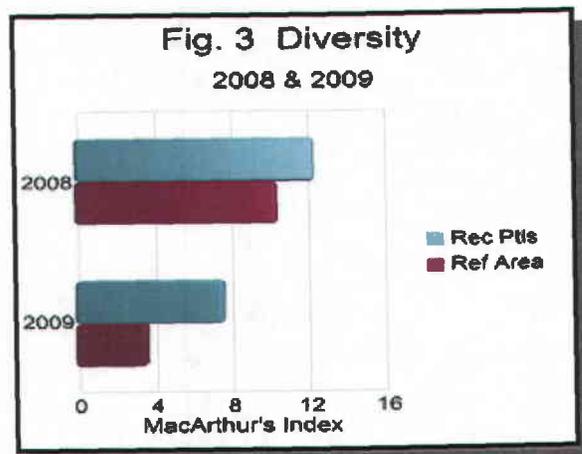
suggested that the reclaimed portals were more diverse than the reference area (Fig. 3).

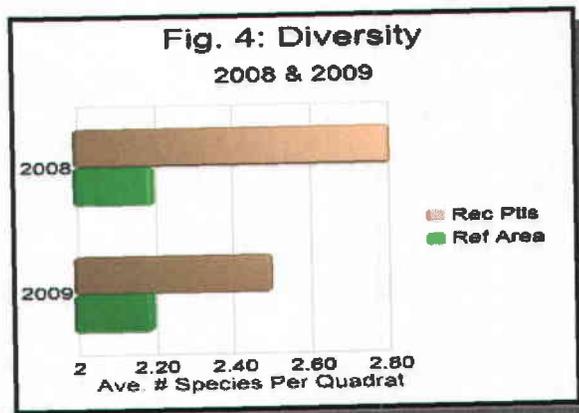
Furthermore, the *average number of plant species per quadrat* was higher in the reclaimed portals compared to the reference area both years (Fig. 4).
