OGMCOAL - Fwd: Rock Fall at Deer Creek

Date: October 09, 2011
From: Ken Fleck
To: File
Subject: Rock Fall at Deer Creek Mine 10/06/11

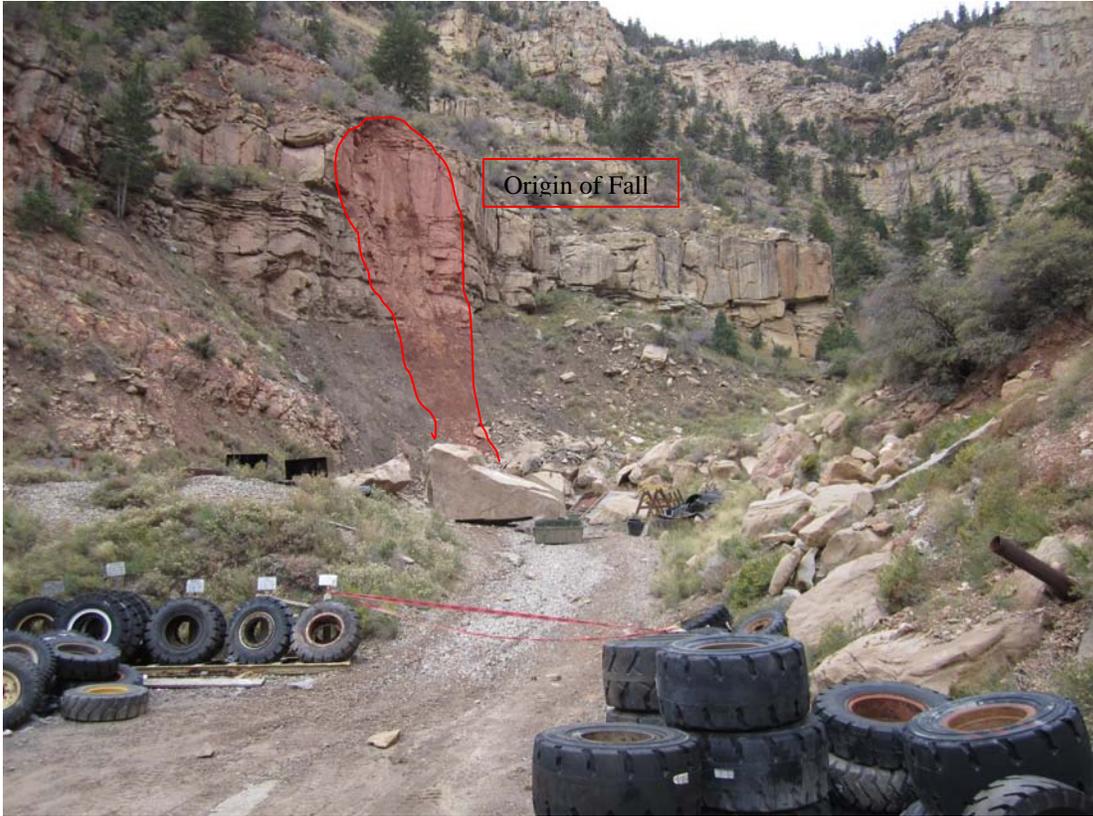
The rocks originated at the top of one of the ledge that forms the terraced hillside that rises above the storage area on the west. The other cliffs in the area display the typical jointed characteristics of the outcrops in the area and do contain fractures. There is no more loose material at this spot (all the material appears to have fallen from the point of origin. An inspection walk-around above and below the fall area did not reveal any other impending activity. This storage area is on the fringes of the Deer Creek mine yard and is not an area that is visited or traveled through frequently.

Photo 1 - from entrance road, looking northwest showing origin and direction of fall.

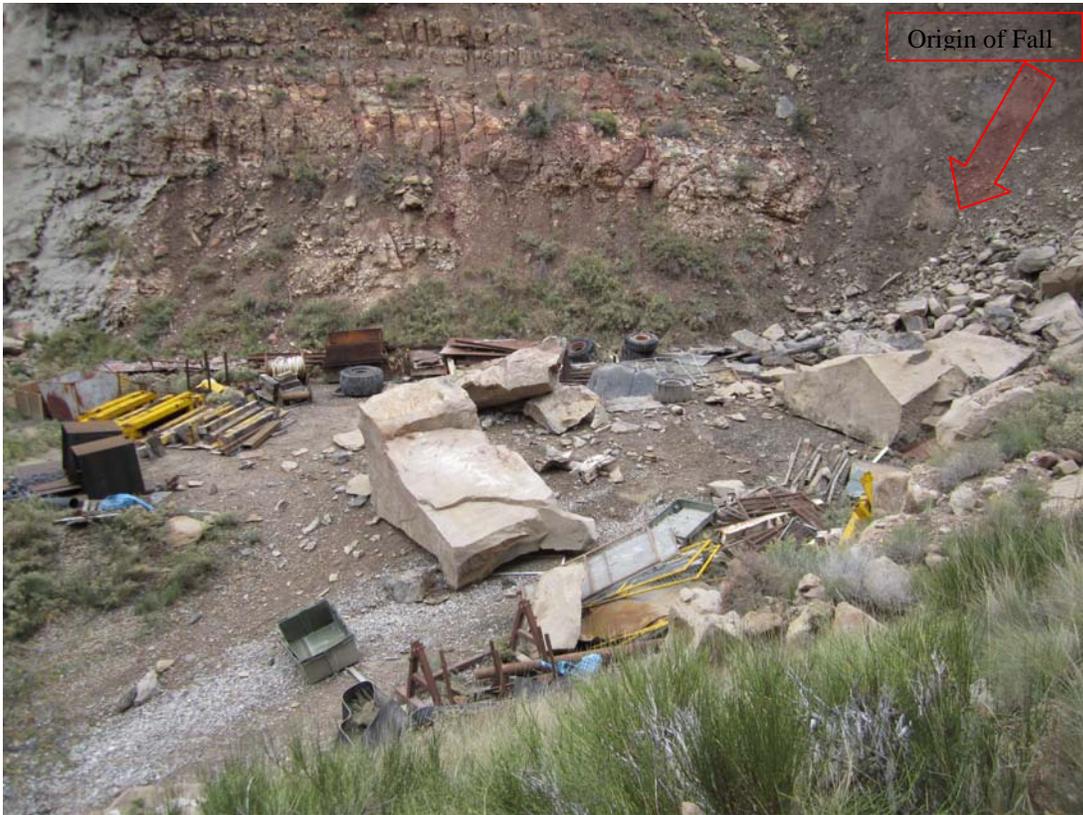
At approximately 2:00 a.m. on October 06, 2010, a rock fall occurred at the Deer Creek Mine. Several rock fragments, as large as 15 feet across, fell from a cliff about 80 feet up on the west side of Deer Canyon, slid down the slope, and rolled into the small storage area where belt and other miscellaneous items are stored. The most serious damage was to an empty belt reel, which was smashed by the largest rock (the one that rolled the farthest). Most of the rock fragments came to rest in the center of the storage area that is mostly empty (for vehicle access). The area was dangered off immediately.

Photo 2 – from east, looking west, showing rock fragments in yard. Belt reel is at center of photo.
