Re: Submittal of Annual and Subsidence Reports for 2012, PacifiCorp, Trail Mountain Mine, C/015/009, Cottonwood Mine, C/015/019, Deer Creek Mine, C/015/018, Des-Bee-Dove, C/015/017, Emery County, Utah.

PacifiCorp, by and through its wholly-owned subsidiary, Energy West Mining Company as mine operator, herewith submits the Annual, Hydrology, and Subsidence Reports for 2012.

Annual Report

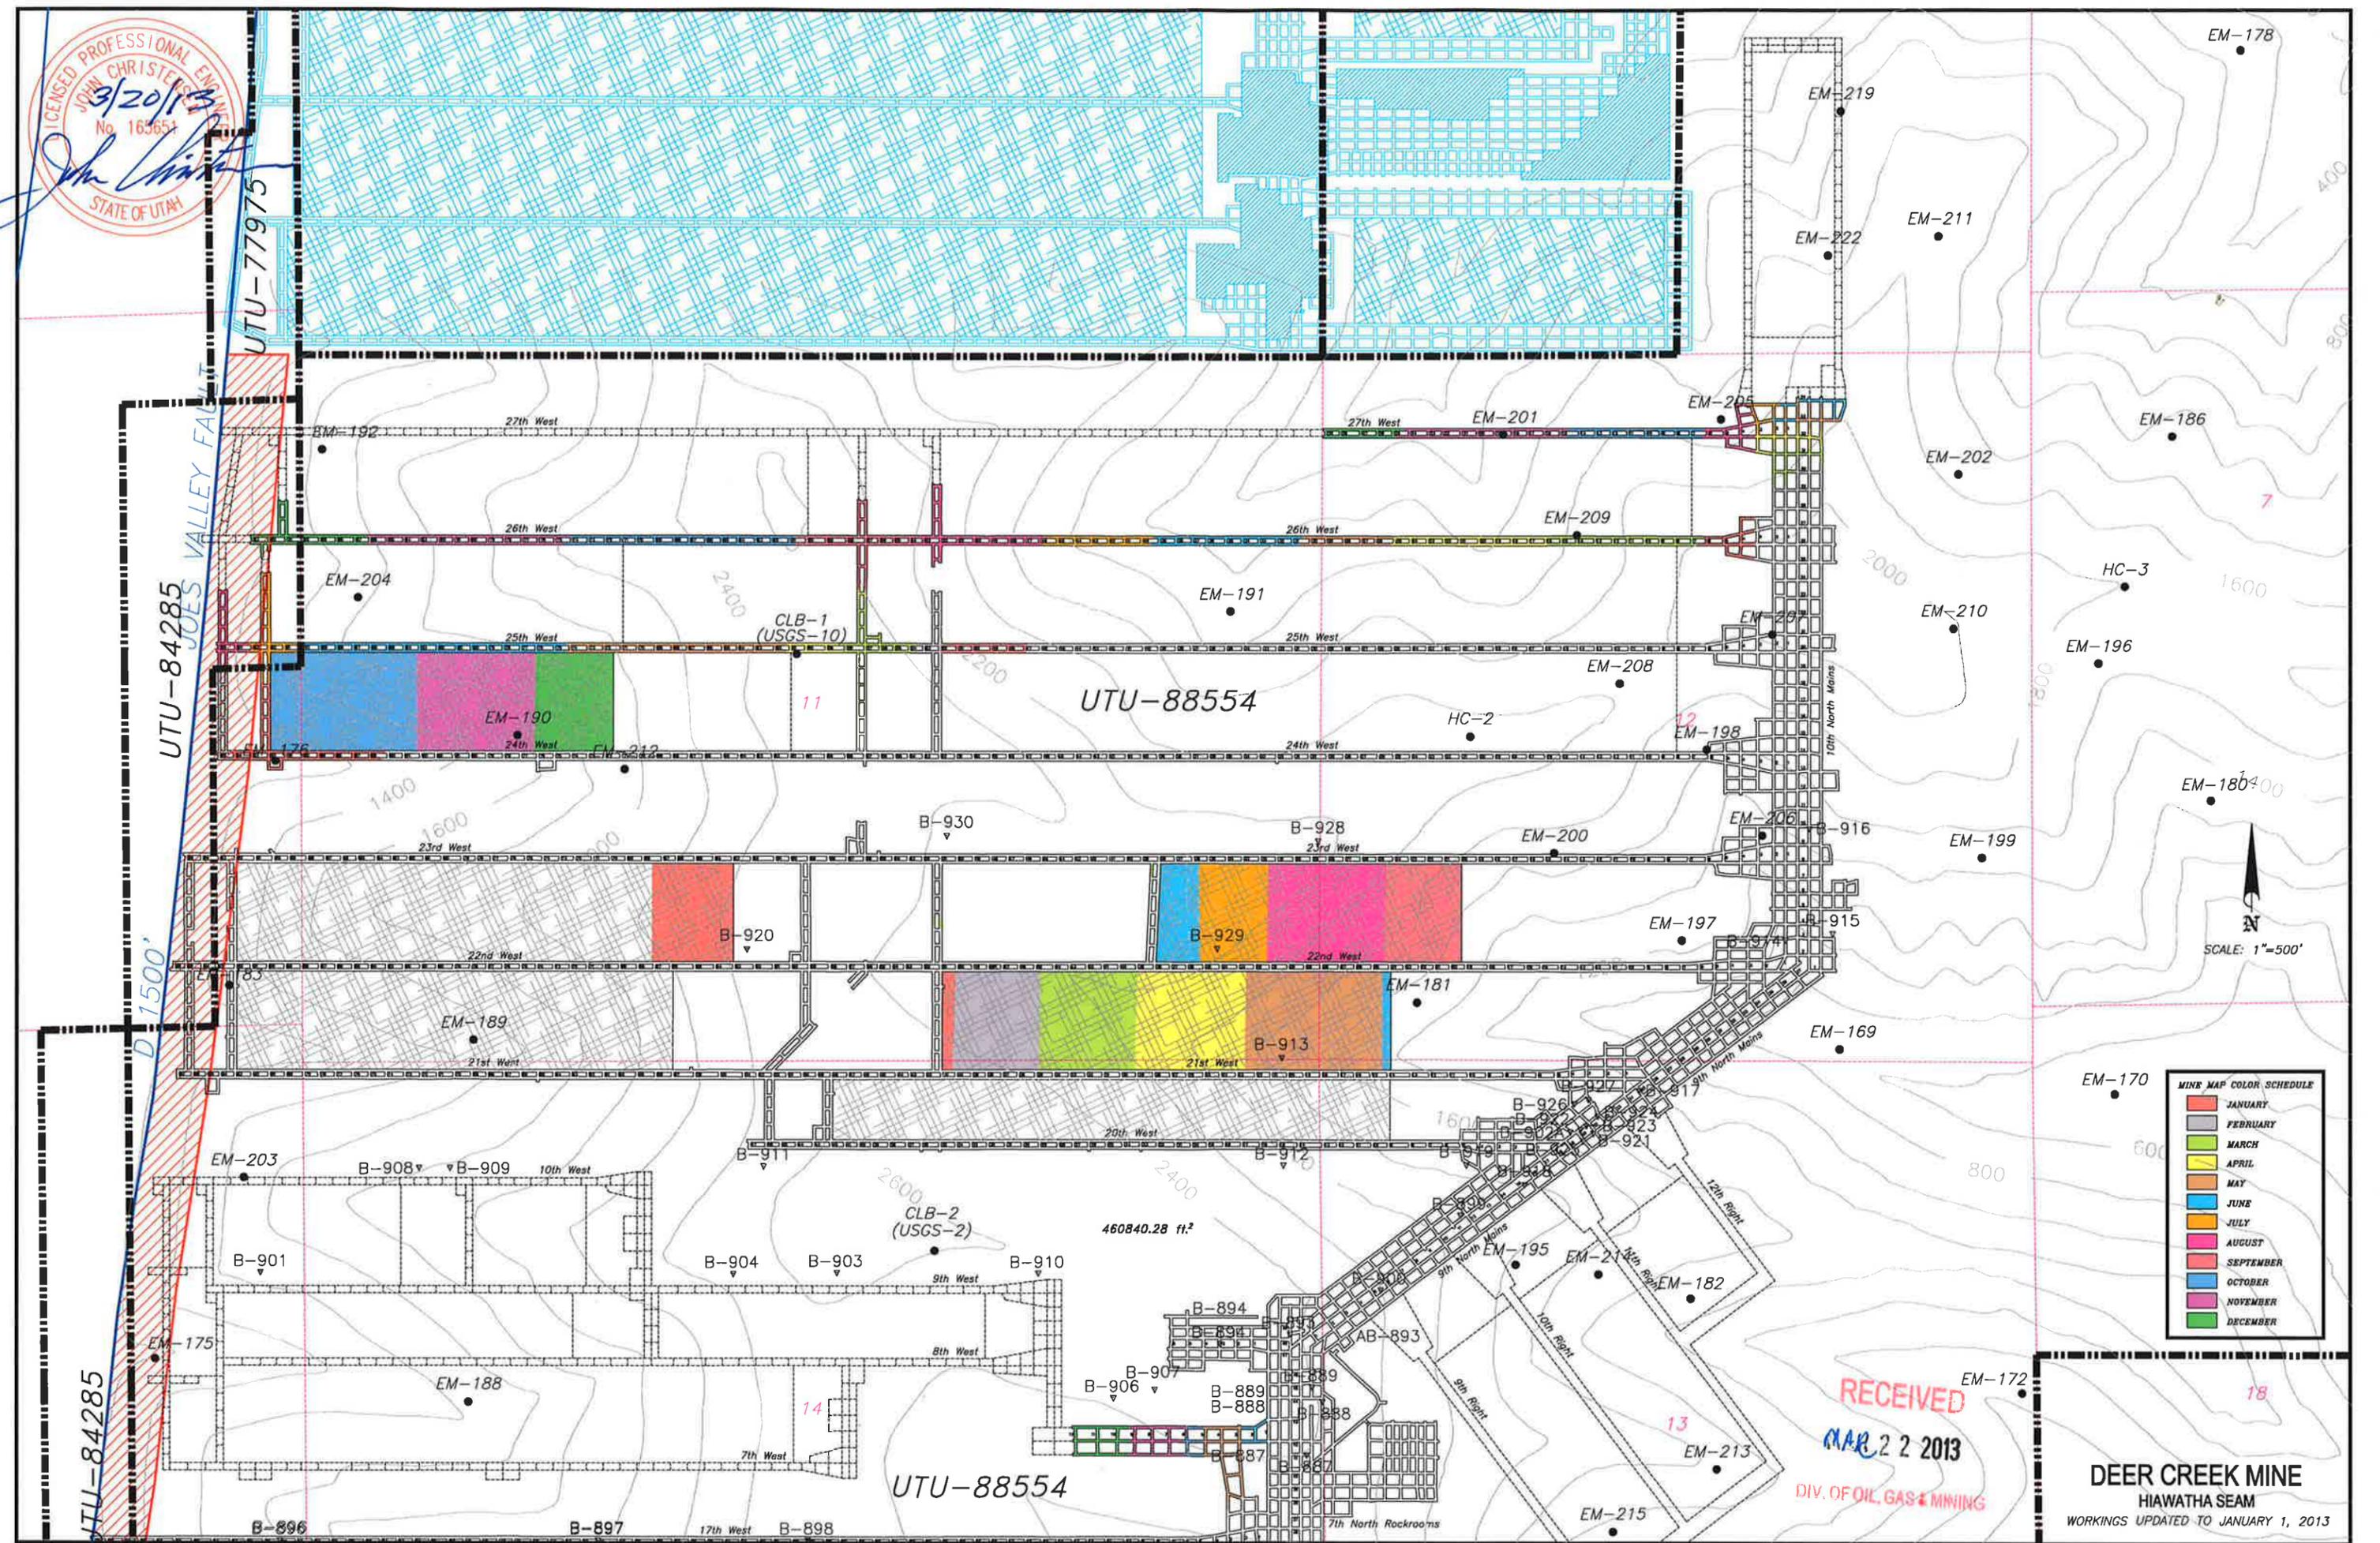
Annual Subsidence Map, refer to Subsidence Report
 Mine Map, refer to Attachment C

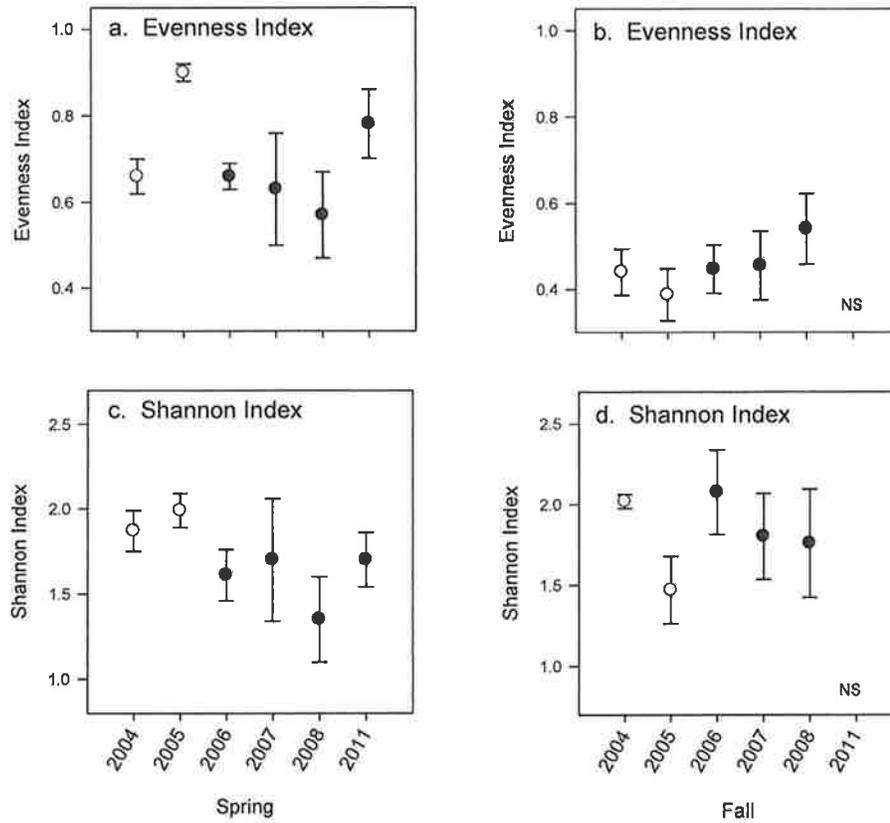
Figure 4. Evenness (a,b) and Shannon diversity (c,d), indexes for spring (left figures) and fall (right figures) macroinvertebrate surveys at Rilda Creek, Emery County, Utah, conducted during pre- (white circles) and post- (black circles) disturbance conditions (2004-2011). Circles represent the mean. Lines show standard errors.

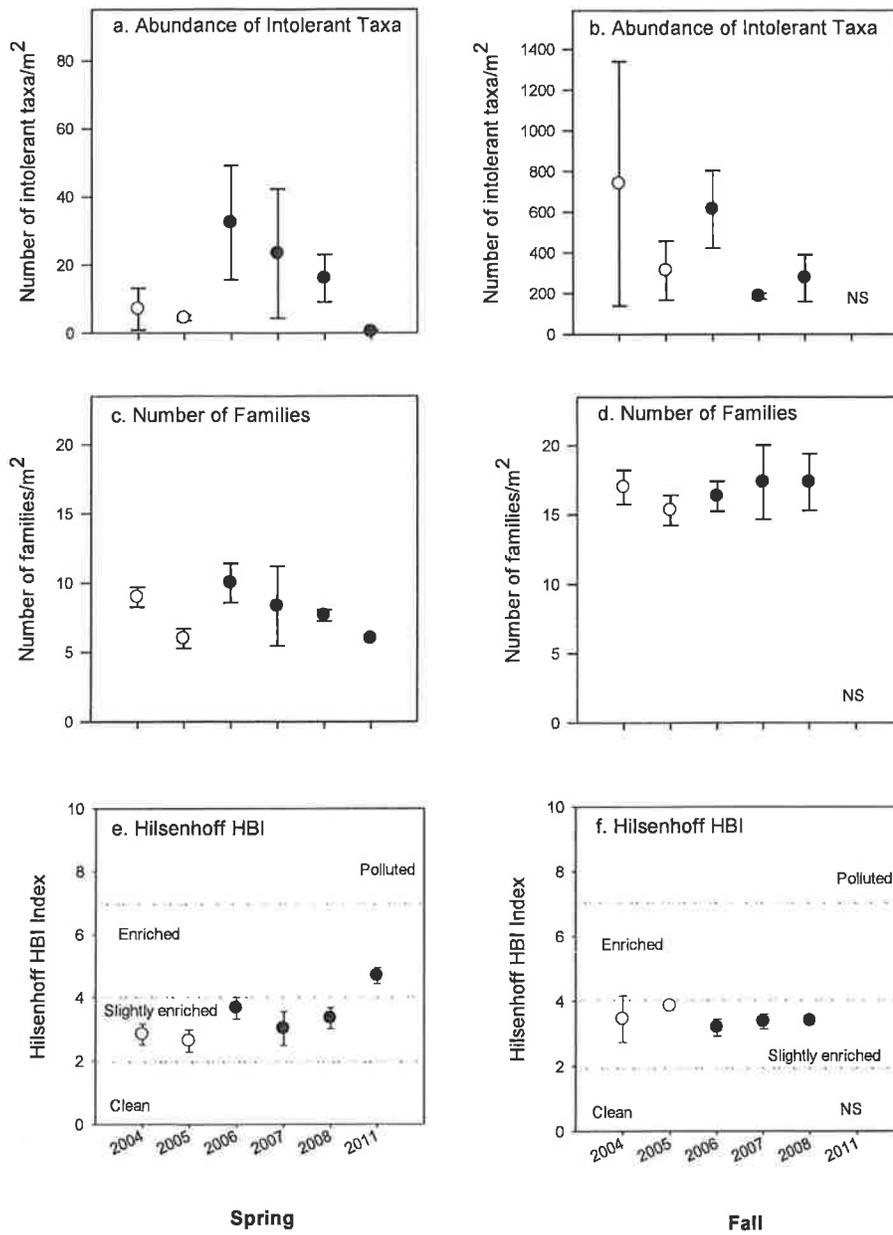
Figure 5. Abundance of intolerant taxa (a,b), number of families (c,d), and Hilsenhoff HBI (e,f) in Rilda Creek for spring (left figures) and fall (right figures) macroinvertebrate surveys at Rilda Creek, Emery County, Utah, conducted during pre- (white circles) and post- (black circles) disturbance conditions (2004-2011). Circles represent the mean. Lines show standard errors.

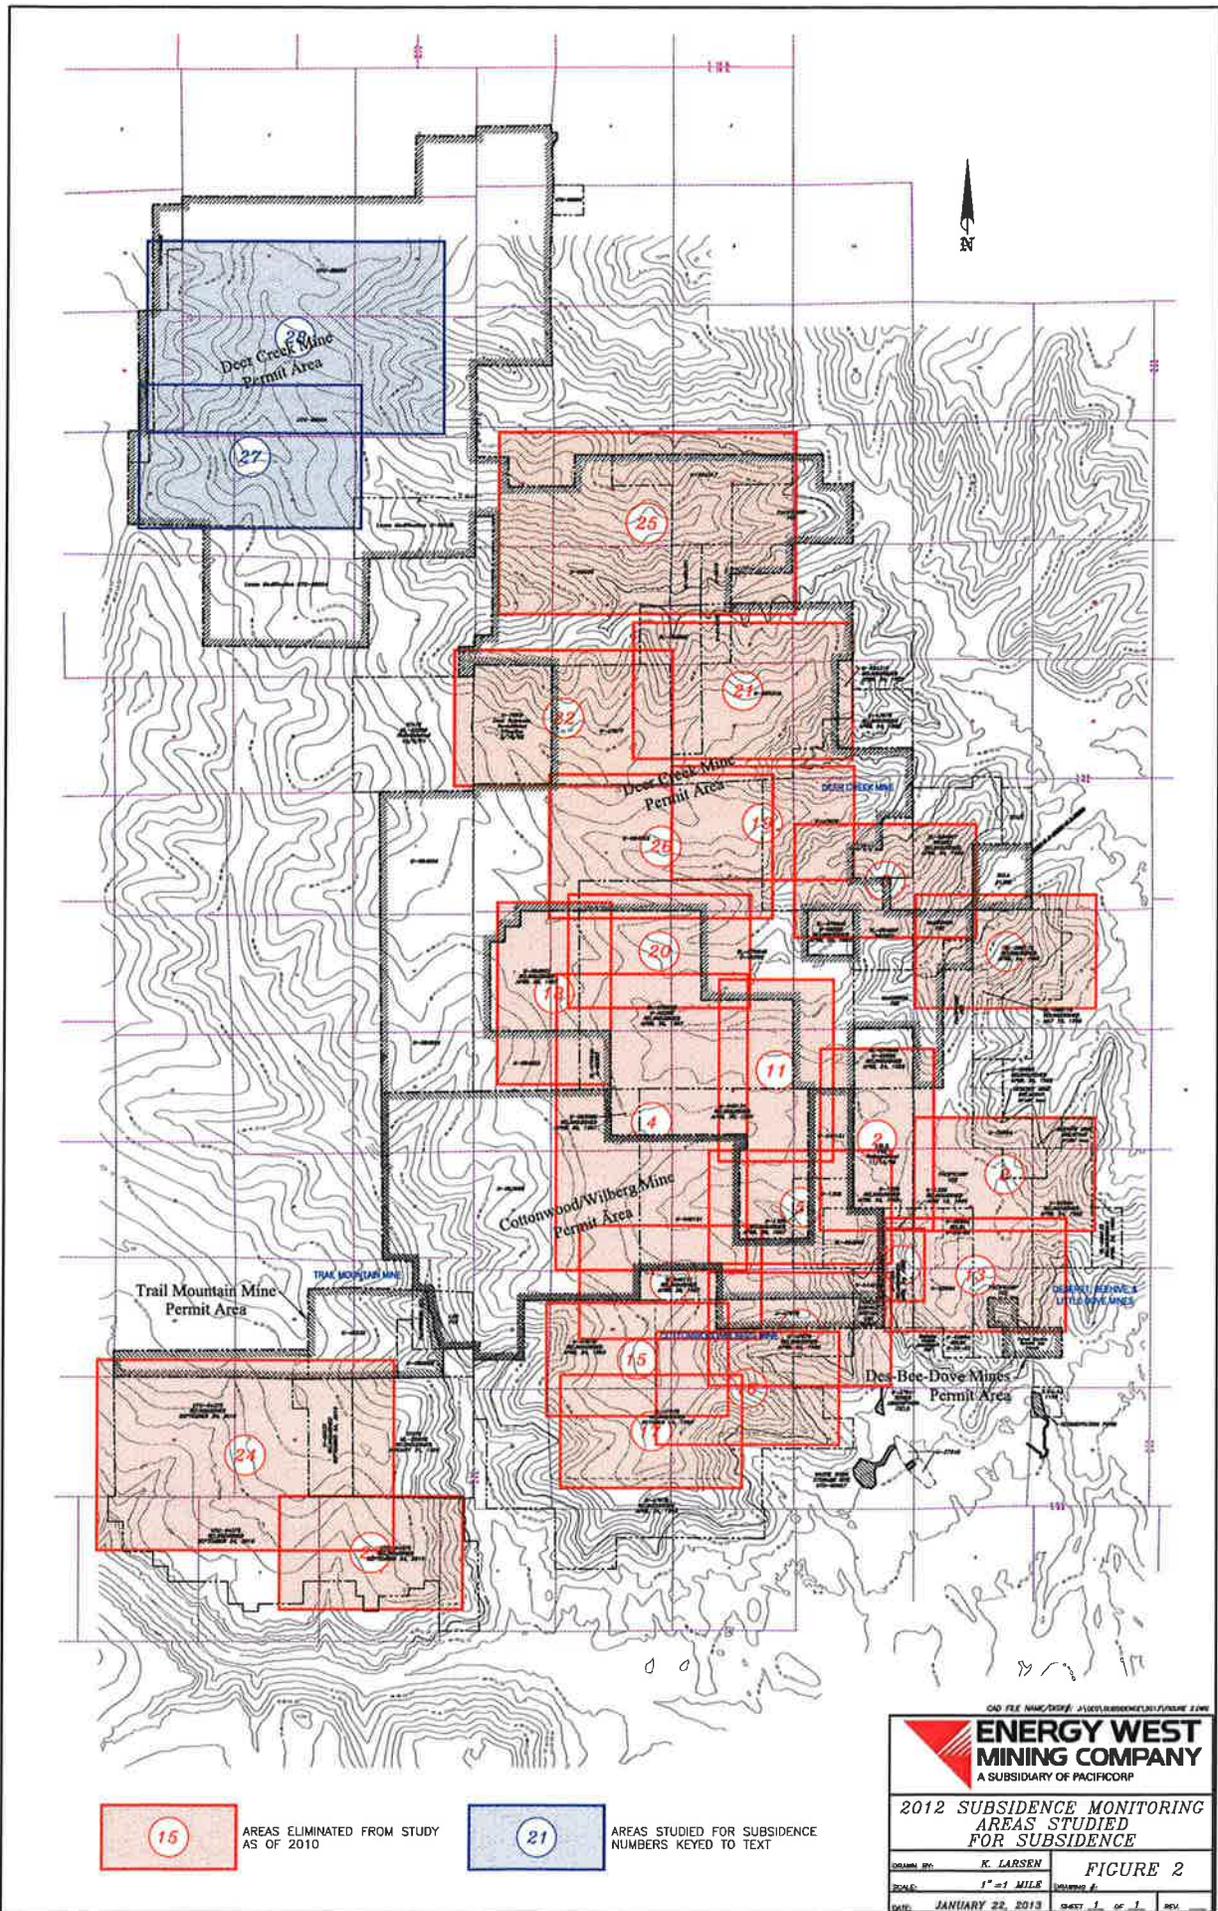
DRAWN BY: K. LARSEN	FIGURE 2
SCALE: 1" = 1 MILE	SHEET #
DATE: JANUARY 22, 2013	SHEET 1 OF 1 REV

AREAS ELIMINATED FROM STUDY AS OF 2010

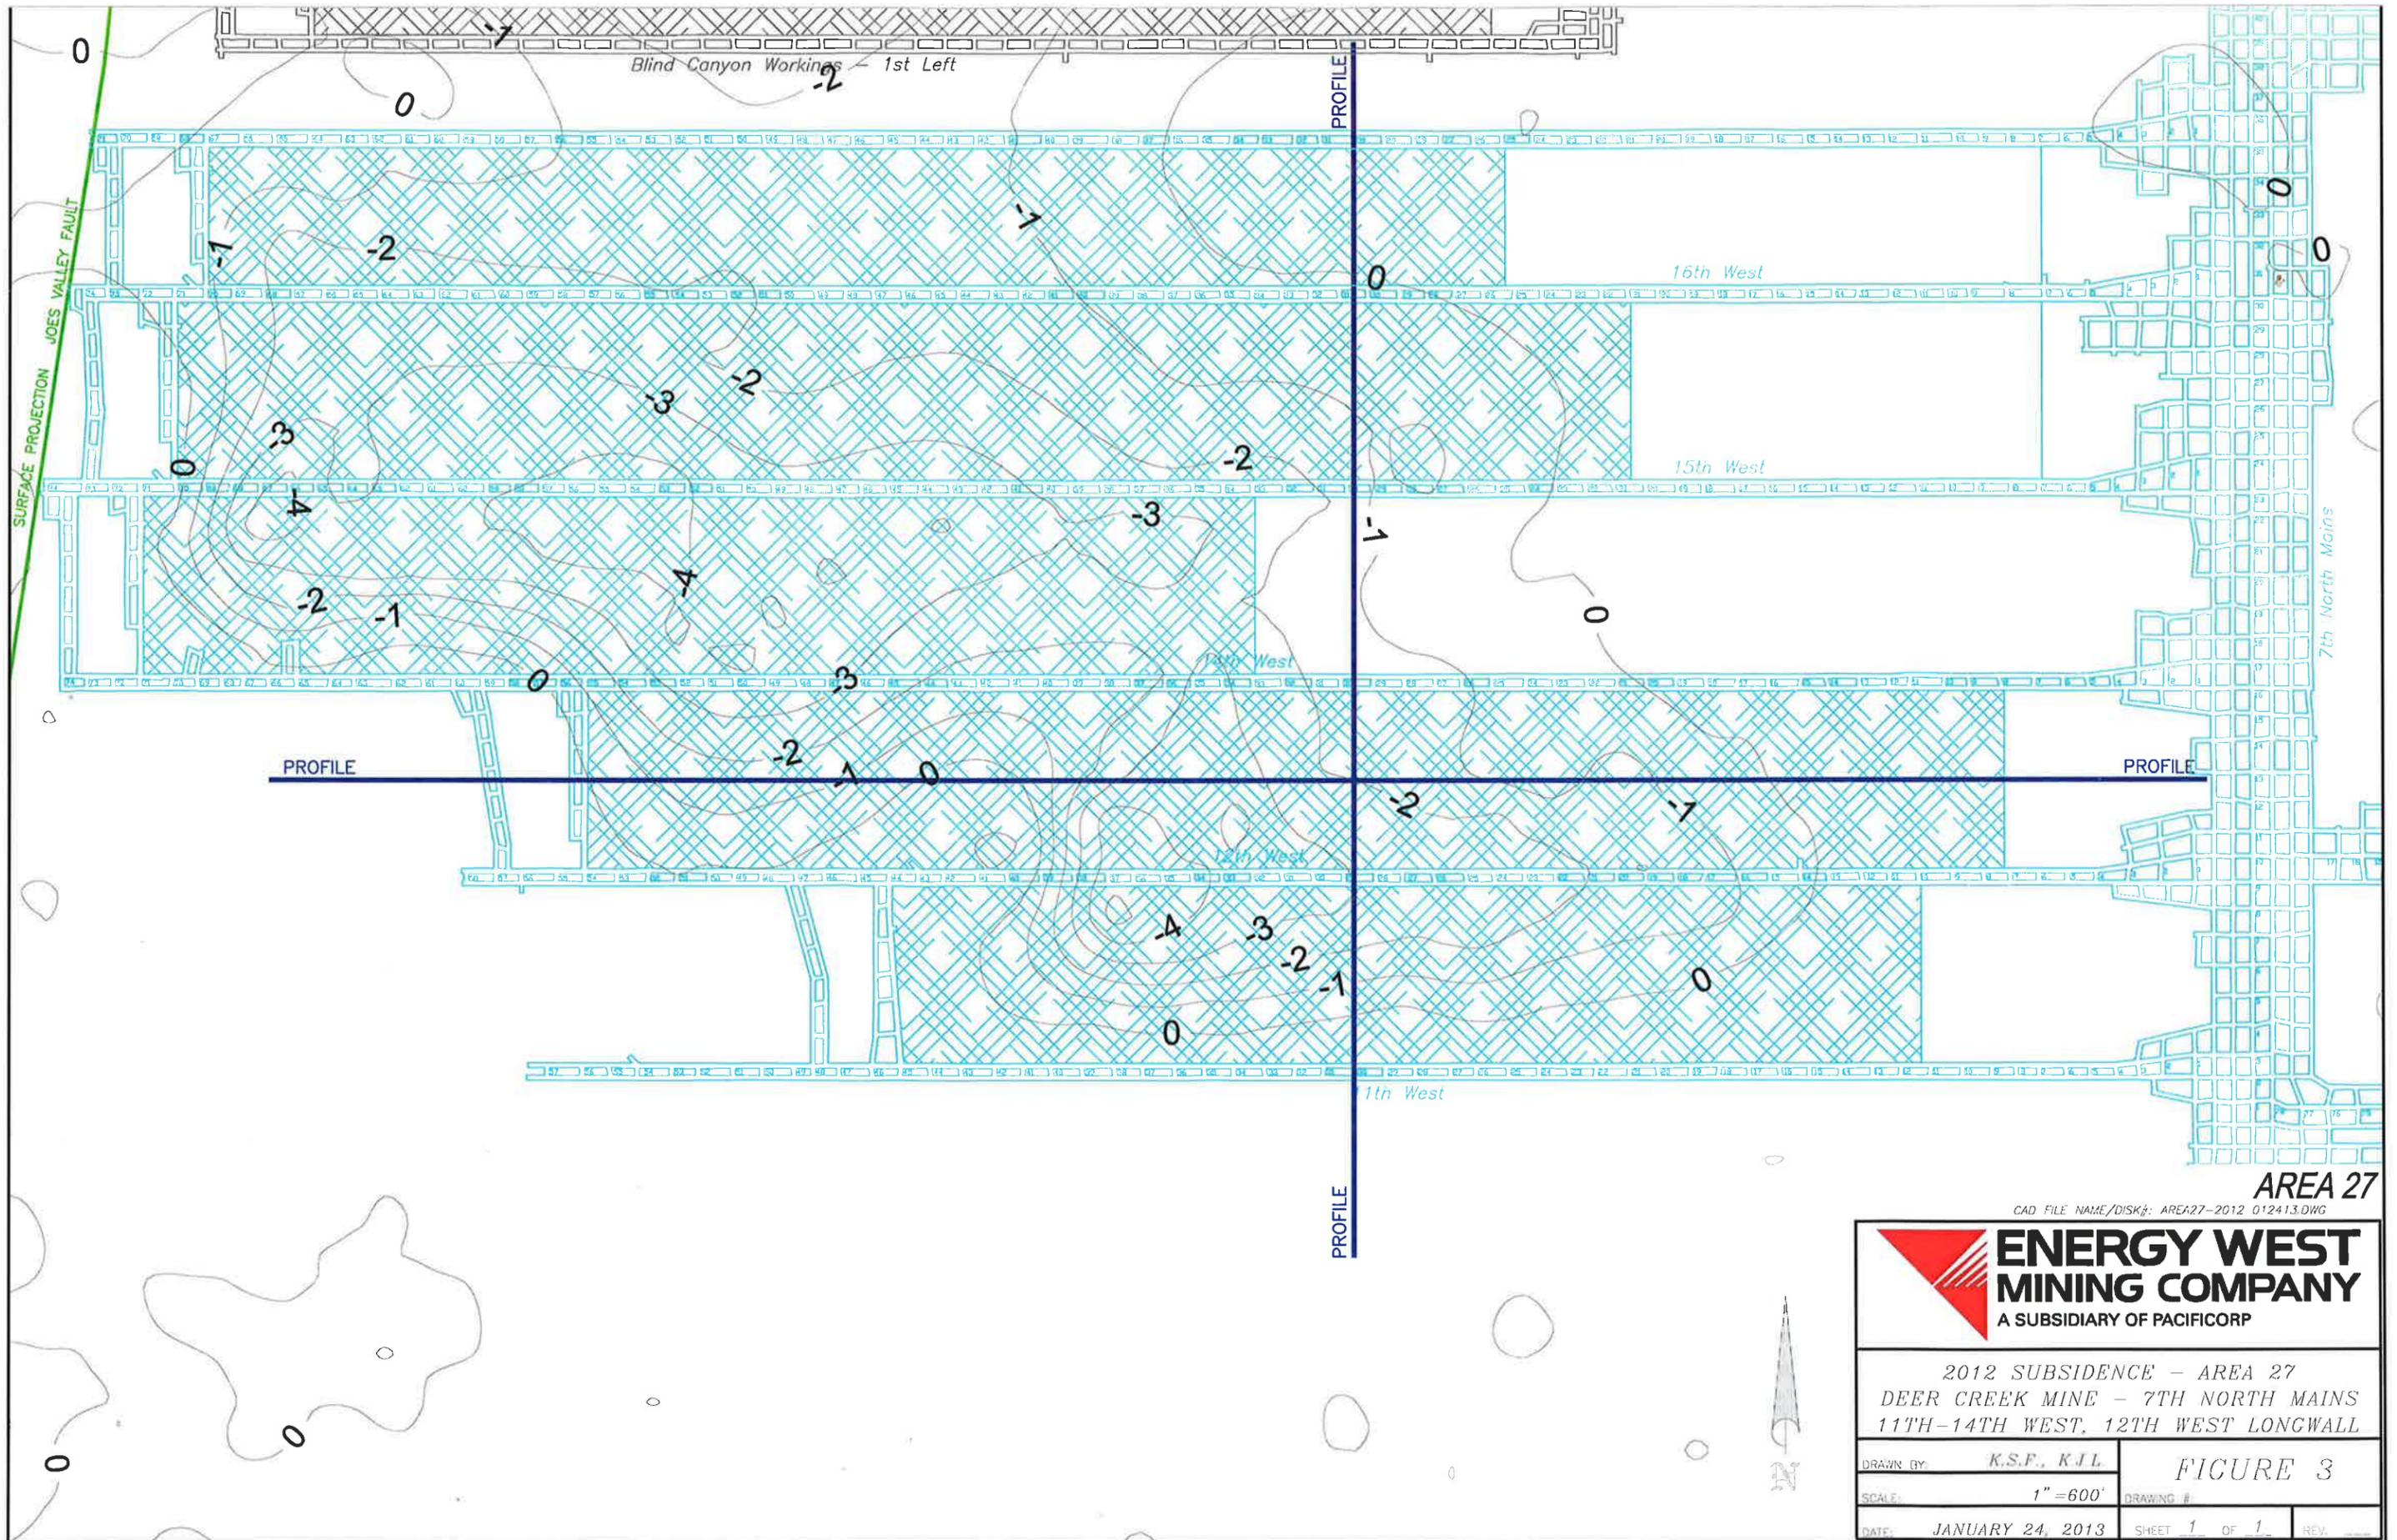
DRAWN BY:	K.S.F., K.J.L.	FIGURE 3	
SCALE:	1" = 600'	DRAWING #	
DATE:	JANUARY 24, 2013	SHEET 1 OF 1	REV.

AREA 27
