**UTAH POWER & LIGHT COMPANY
SUBSIDENCE MONITORING PROGRAM
ANNUAL REPORT FOR 1985**

February 1986

Submitted to: United States Department of the Interior
Office of Surface Mining
Minerals Management Service
Utah Division of Oil, Gas and Mining

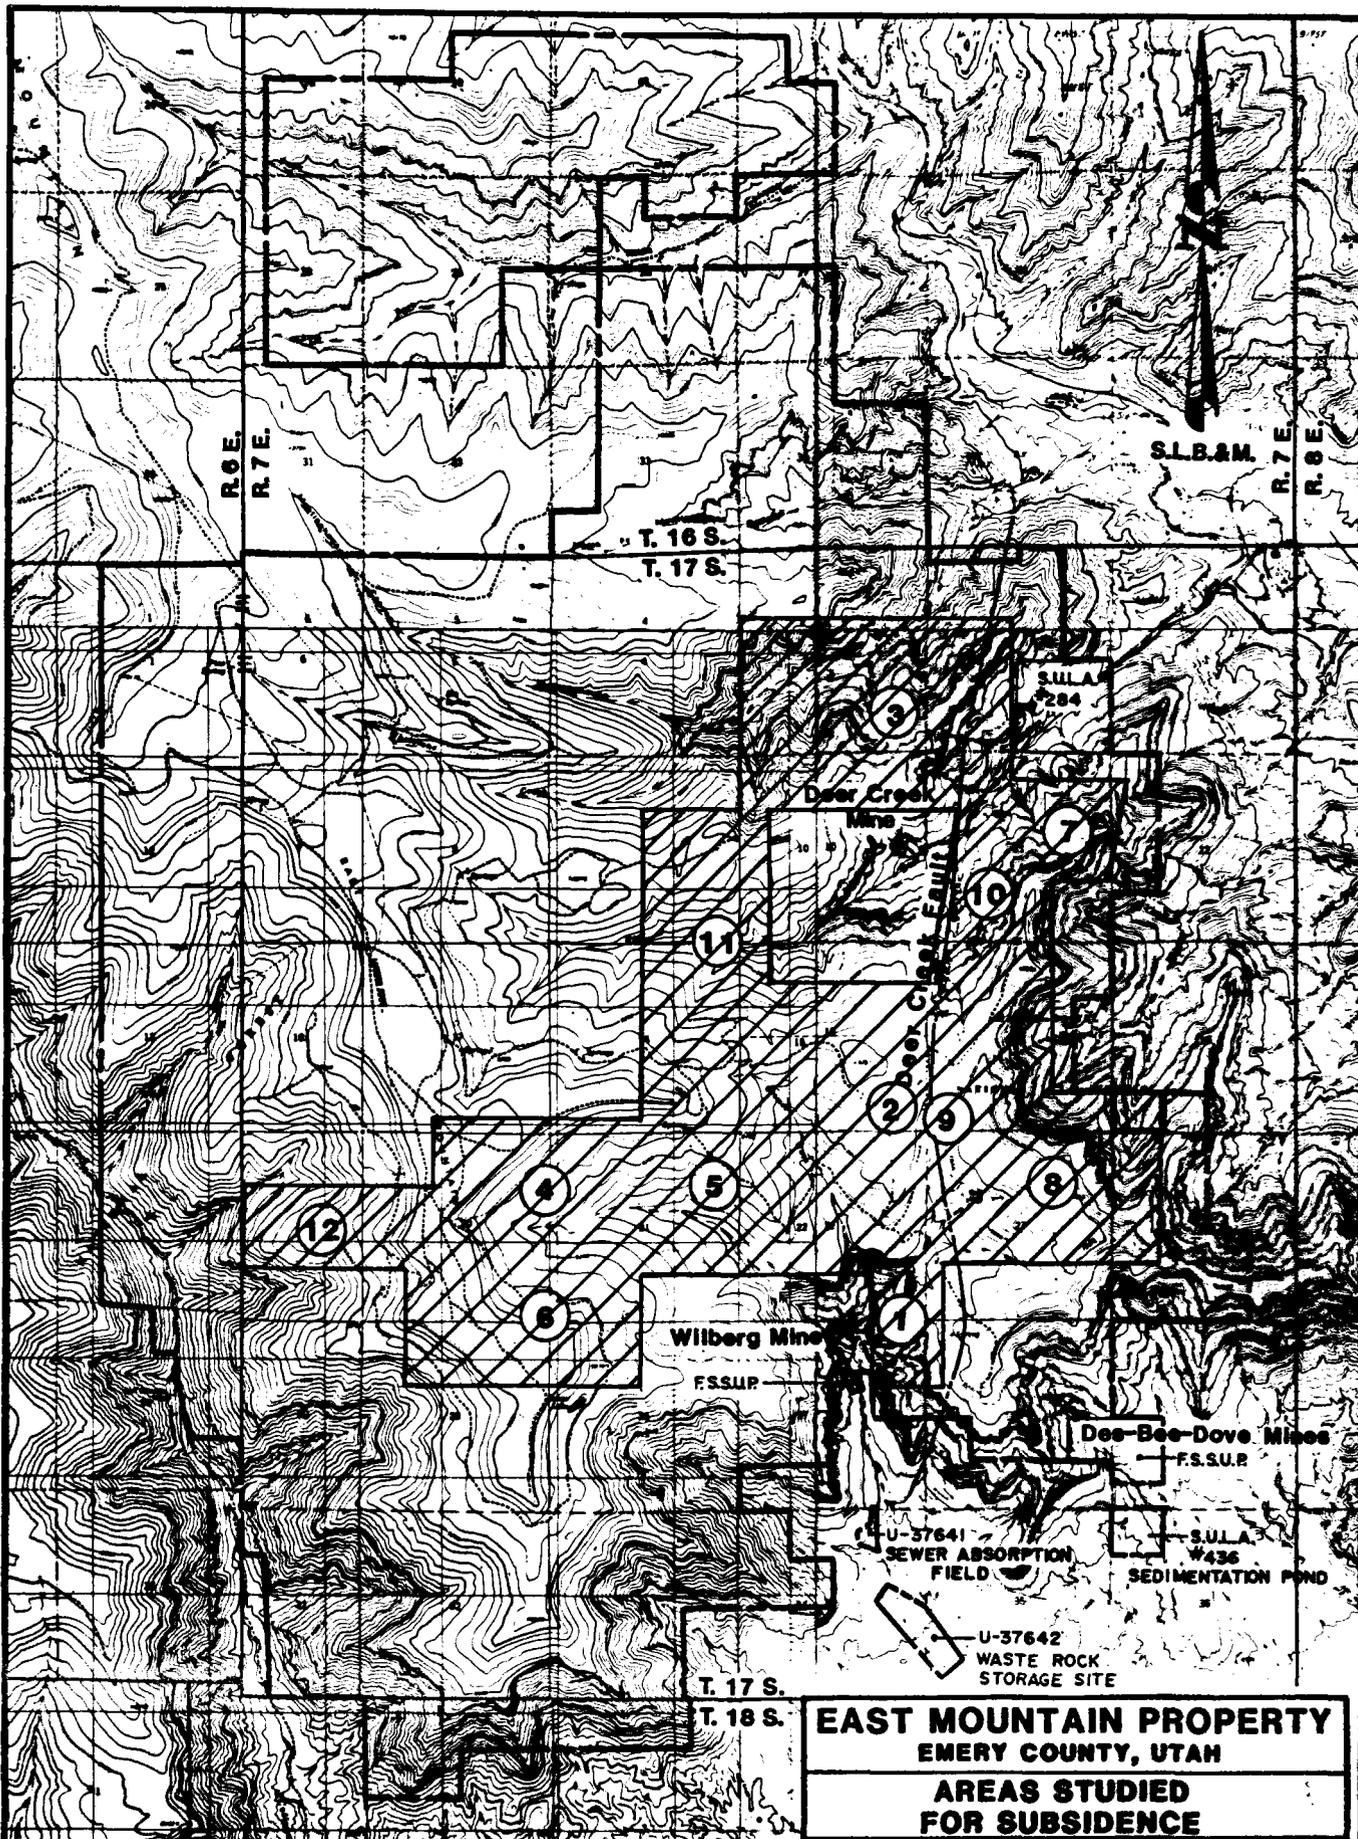
FIGURE 2

Figure 2 shows all areas above UP&L's coal mines which have potential for mining induced subsidence and were studied in 1985 to detect subsidence. A helicopter reconnaissance flight on July 9, 1985 revealed no new areas of fractures or visible surface disturbance. One new

area of subsidence was detected in 1985 by photogrammetric methods. This occurred above the A North and A South room-and-pillar sections in the Deer Creek Mine.

Each of the areas shown in Figure 2 are discussed in detail in the following paragraphs. Previous reports described the topographic and geologic setting of the subsidence areas, thus, mention of such will only be given when necessary in this report. If the reader has questions regarding this information, previous subsidence monitoring reports should be consulted.

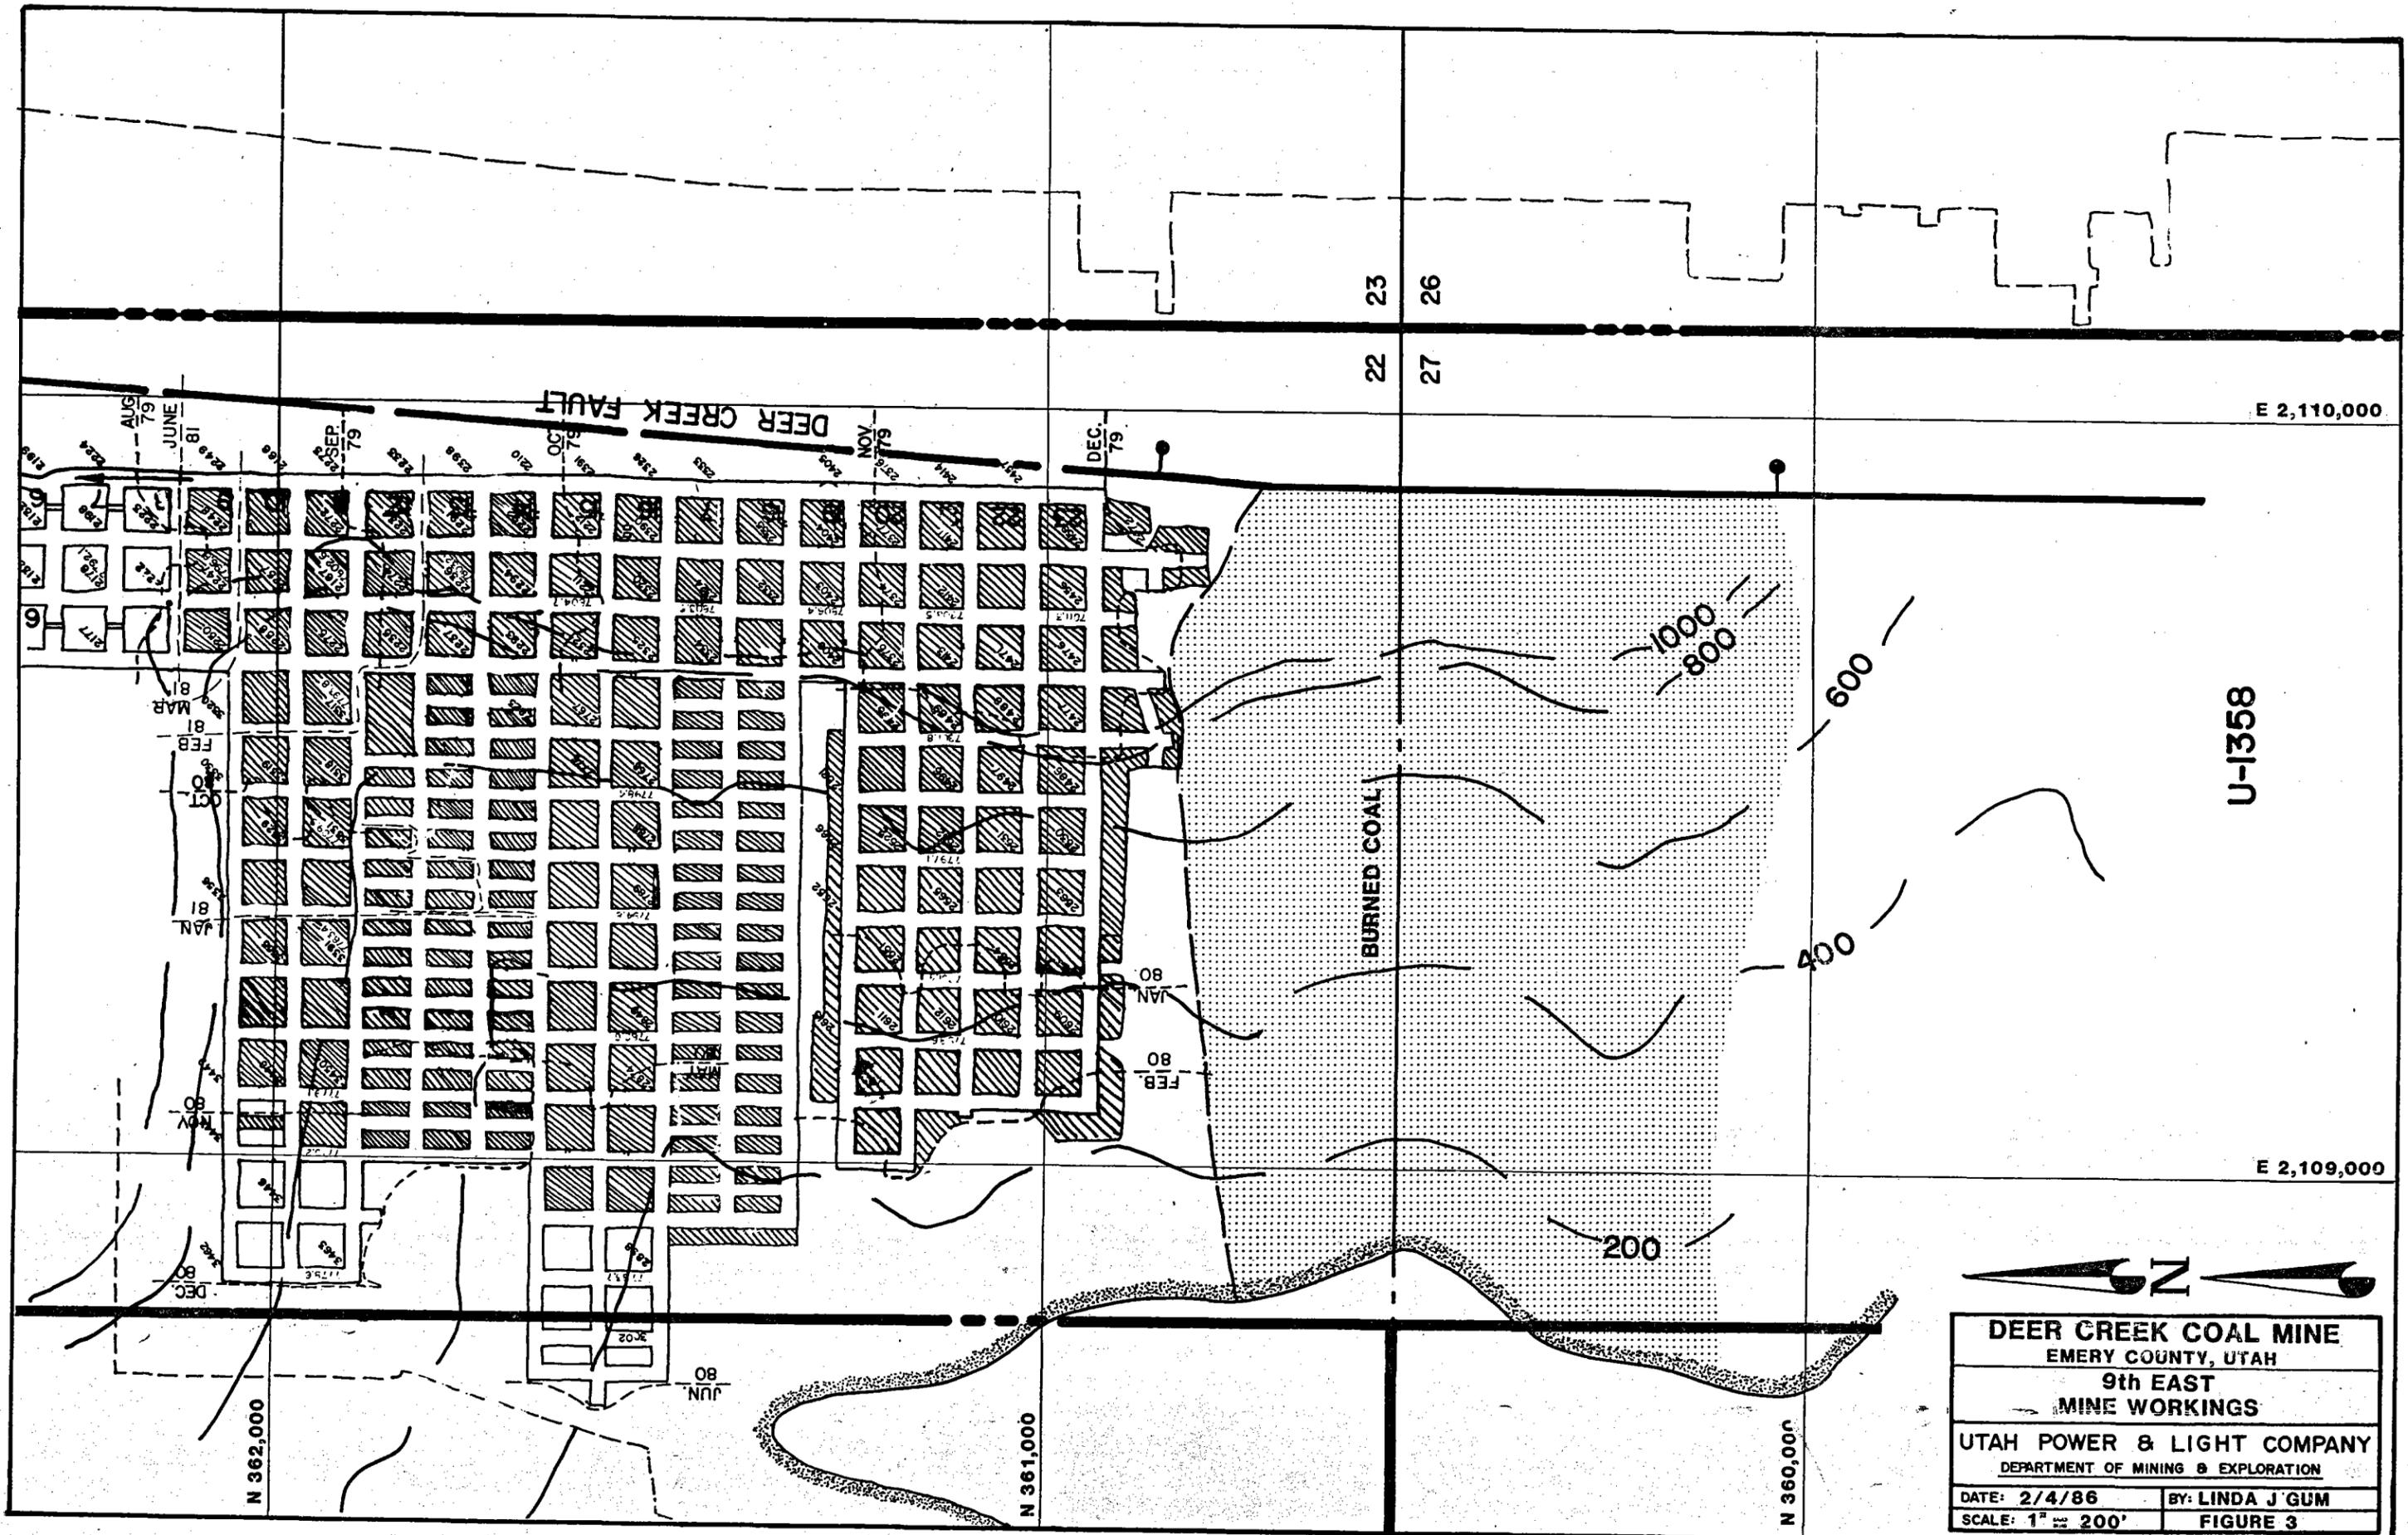
DEER CREEK COAL MINE	
EMERY COUNTY, UTAH	
9th EAST	
MINE WORKINGS	
UTAH POWER & LIGHT COMPANY	
DEPARTMENT OF MINING & EXPLORATION	
DATE: 2/4/86	BY: LINDA J'GUM
SCALE: 1" = 200'	FIGURE 3

Subsidence in this area was first documented in the 1981 subsidence monitoring report submitted in December 1982. The relationship of the area of subsidence with the present Deer Creek and Wilberg Mine workings is shown in Figure 3, 4 and 5. The Deer Creek 9th East workings in this area have been abandoned since 1981 but pillar extraction in Wilberg 1st Right proceeded until June 1984.

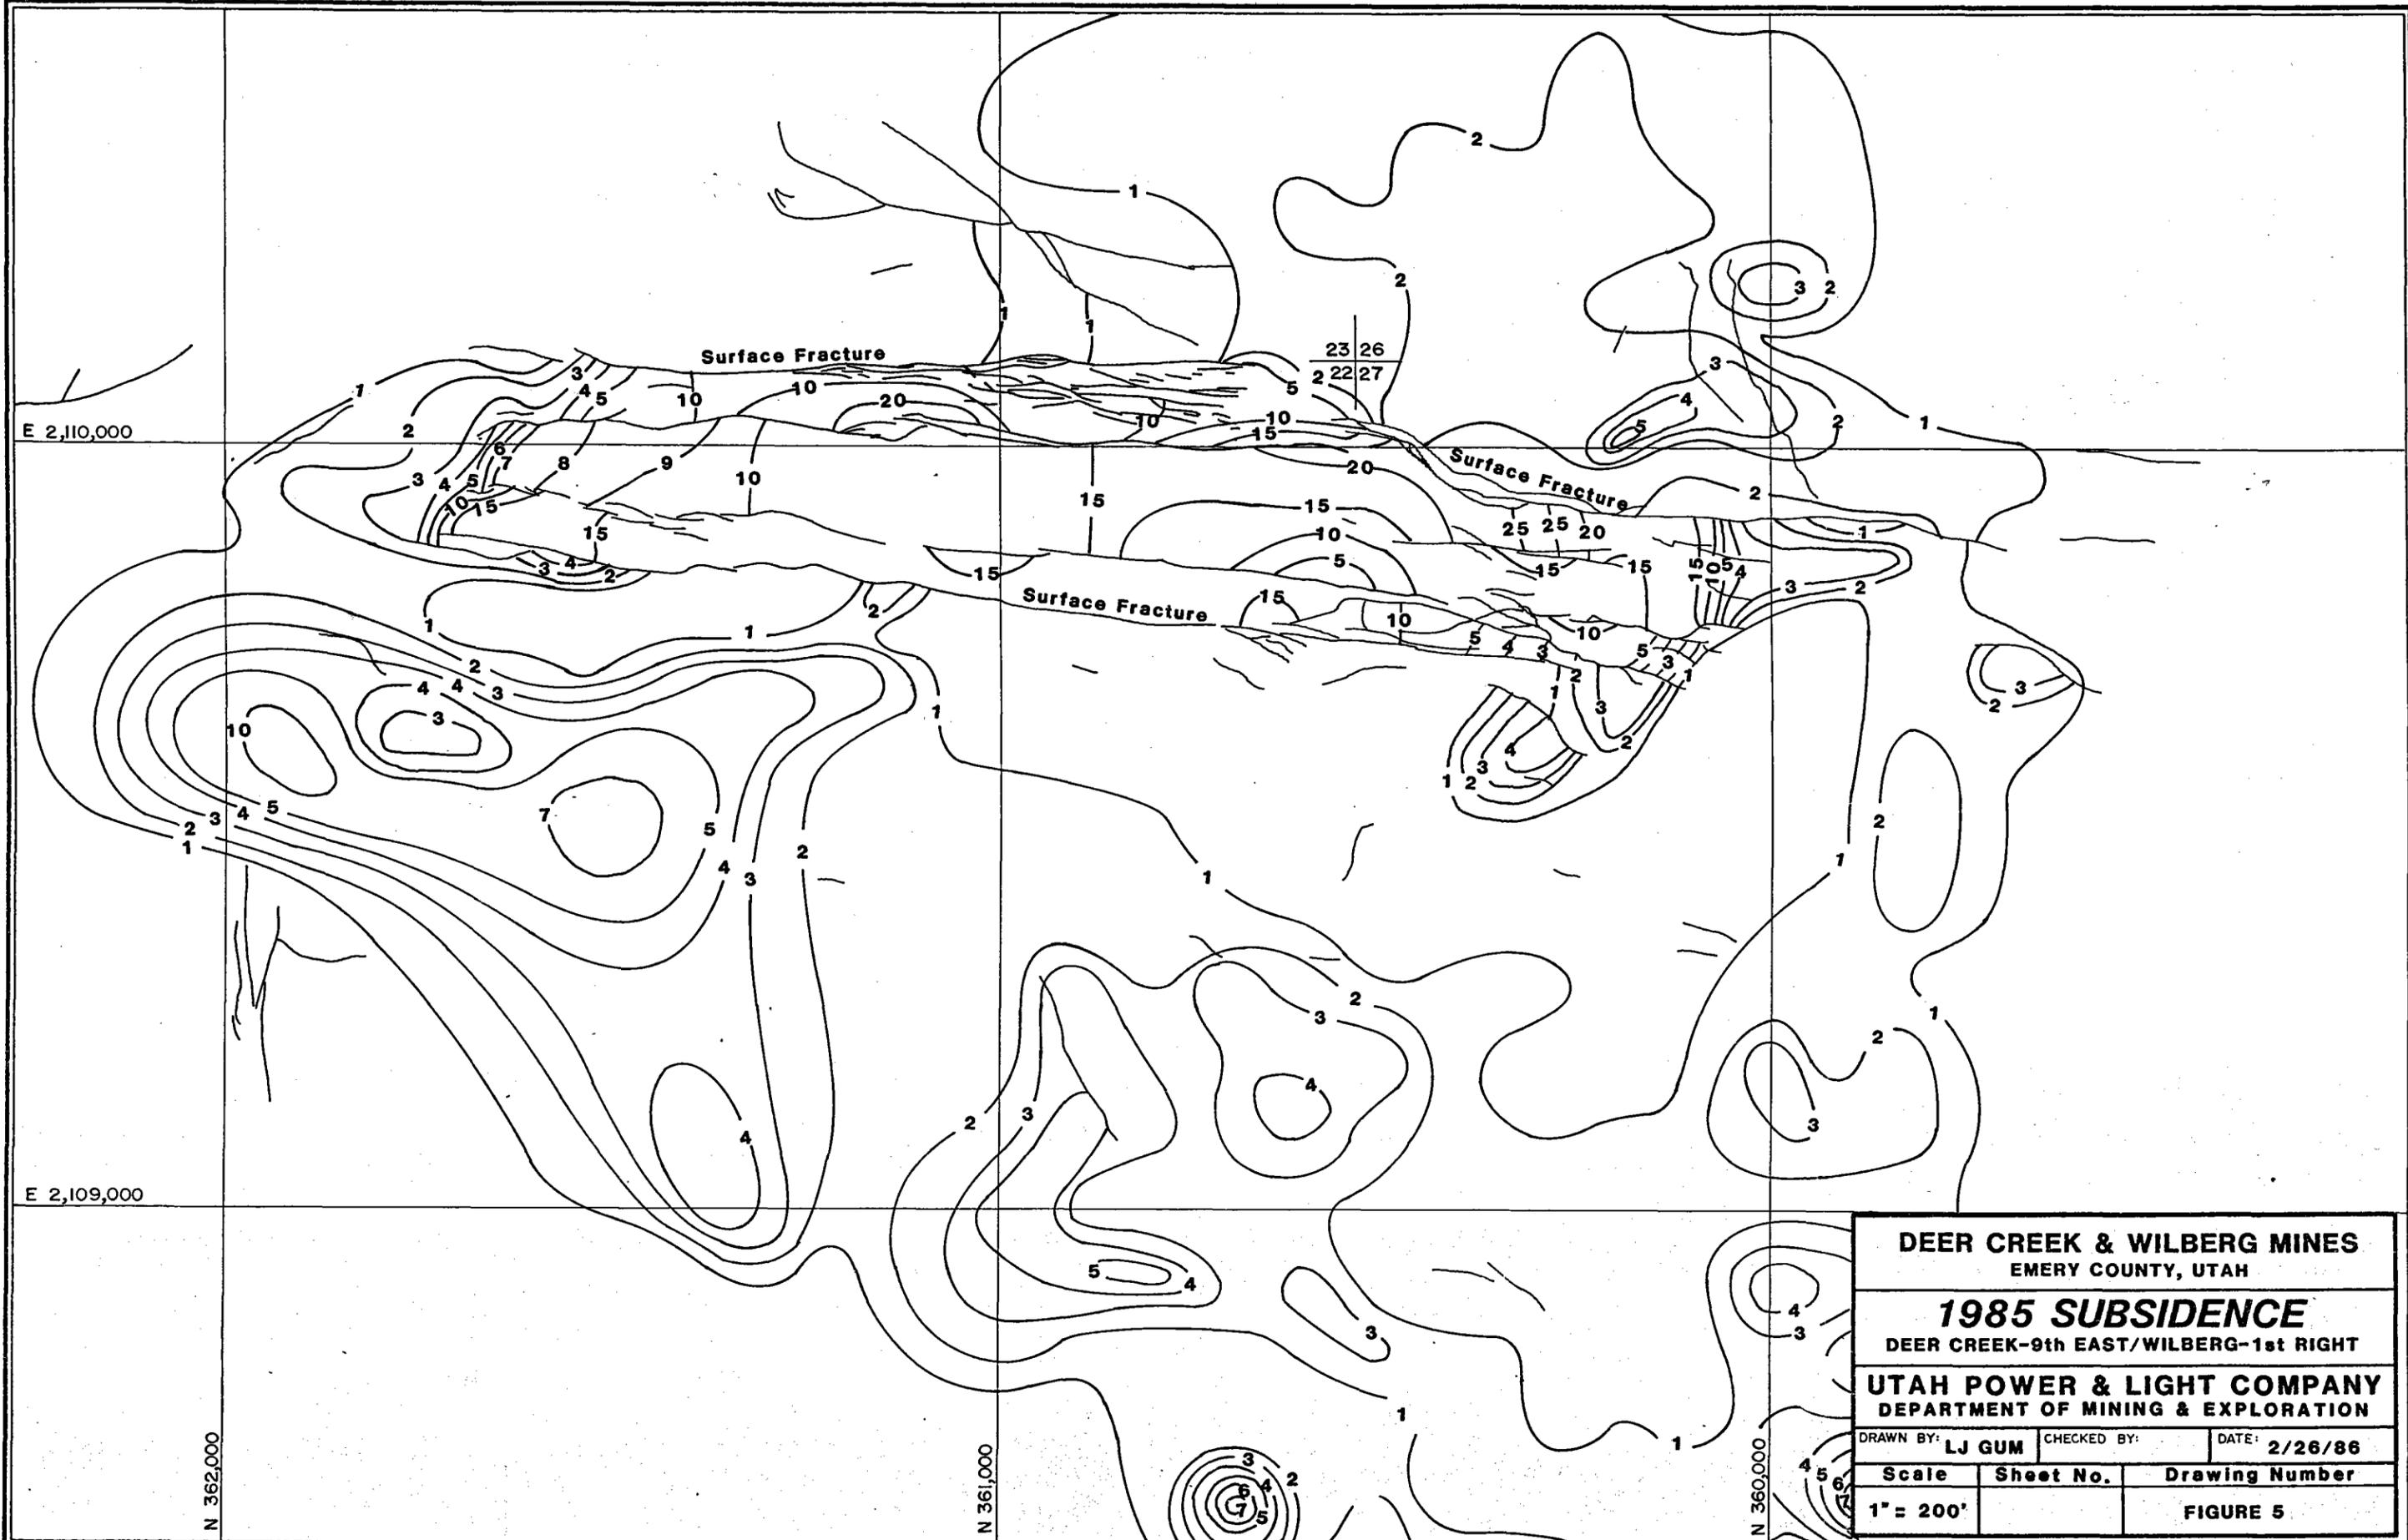
DEER CREEK & WILBERG MINES EMERY COUNTY, UTAH		
1985 SUBSIDENCE DEER CREEK-9th EAST/WILBERG-1st RIGHT		
UTAH POWER & LIGHT COMPANY DEPARTMENT OF MINING & EXPLORATION		
DRAWN BY: LJ GUM	CHECKED BY:	DATE: 2/26/86
Scale	Sheet No.	Drawing Number
1" = 200'		FIGURE 5

Subsidence monitoring during 1985 showed a continuation of subsidence in and around the graben-like structure seen in this area. The maximum subsidence observed to date is 25 feet and occurs about 200 feet south of the southernmost mined-out area in 1st Right Wilberg over an area in which both the Hiawatha and Blind Canyon Seams are burned. This supports the theory that the clinker beds have been crushed allowing subsidence to occur well outside the area of mine workings.

The angle of draw of subsidence in this area appears to be influenced by the Deer Creek Fault plane. On the east side of the mine workings the subsidence abruptly stops in an easterly direction about 200 feet east of the mine workings which coincides with the Deer Creek Fault trace.

In this area the mine workings are covered with 1200 feet of overburden indicating a 9.5° angle of draw on subsidence.

In a few areas, such as areas 1, 3 and 7, fractures have been detected. In order to protect livestock UP&L has erected a fence around area 1 where fractures are of sufficient magnitude to pose a threat to wandering cattle. A reclamation plan is being formulated for this area by the U. S. Forest Service. UP&L's compliance with this plan would mitigate any damages there.

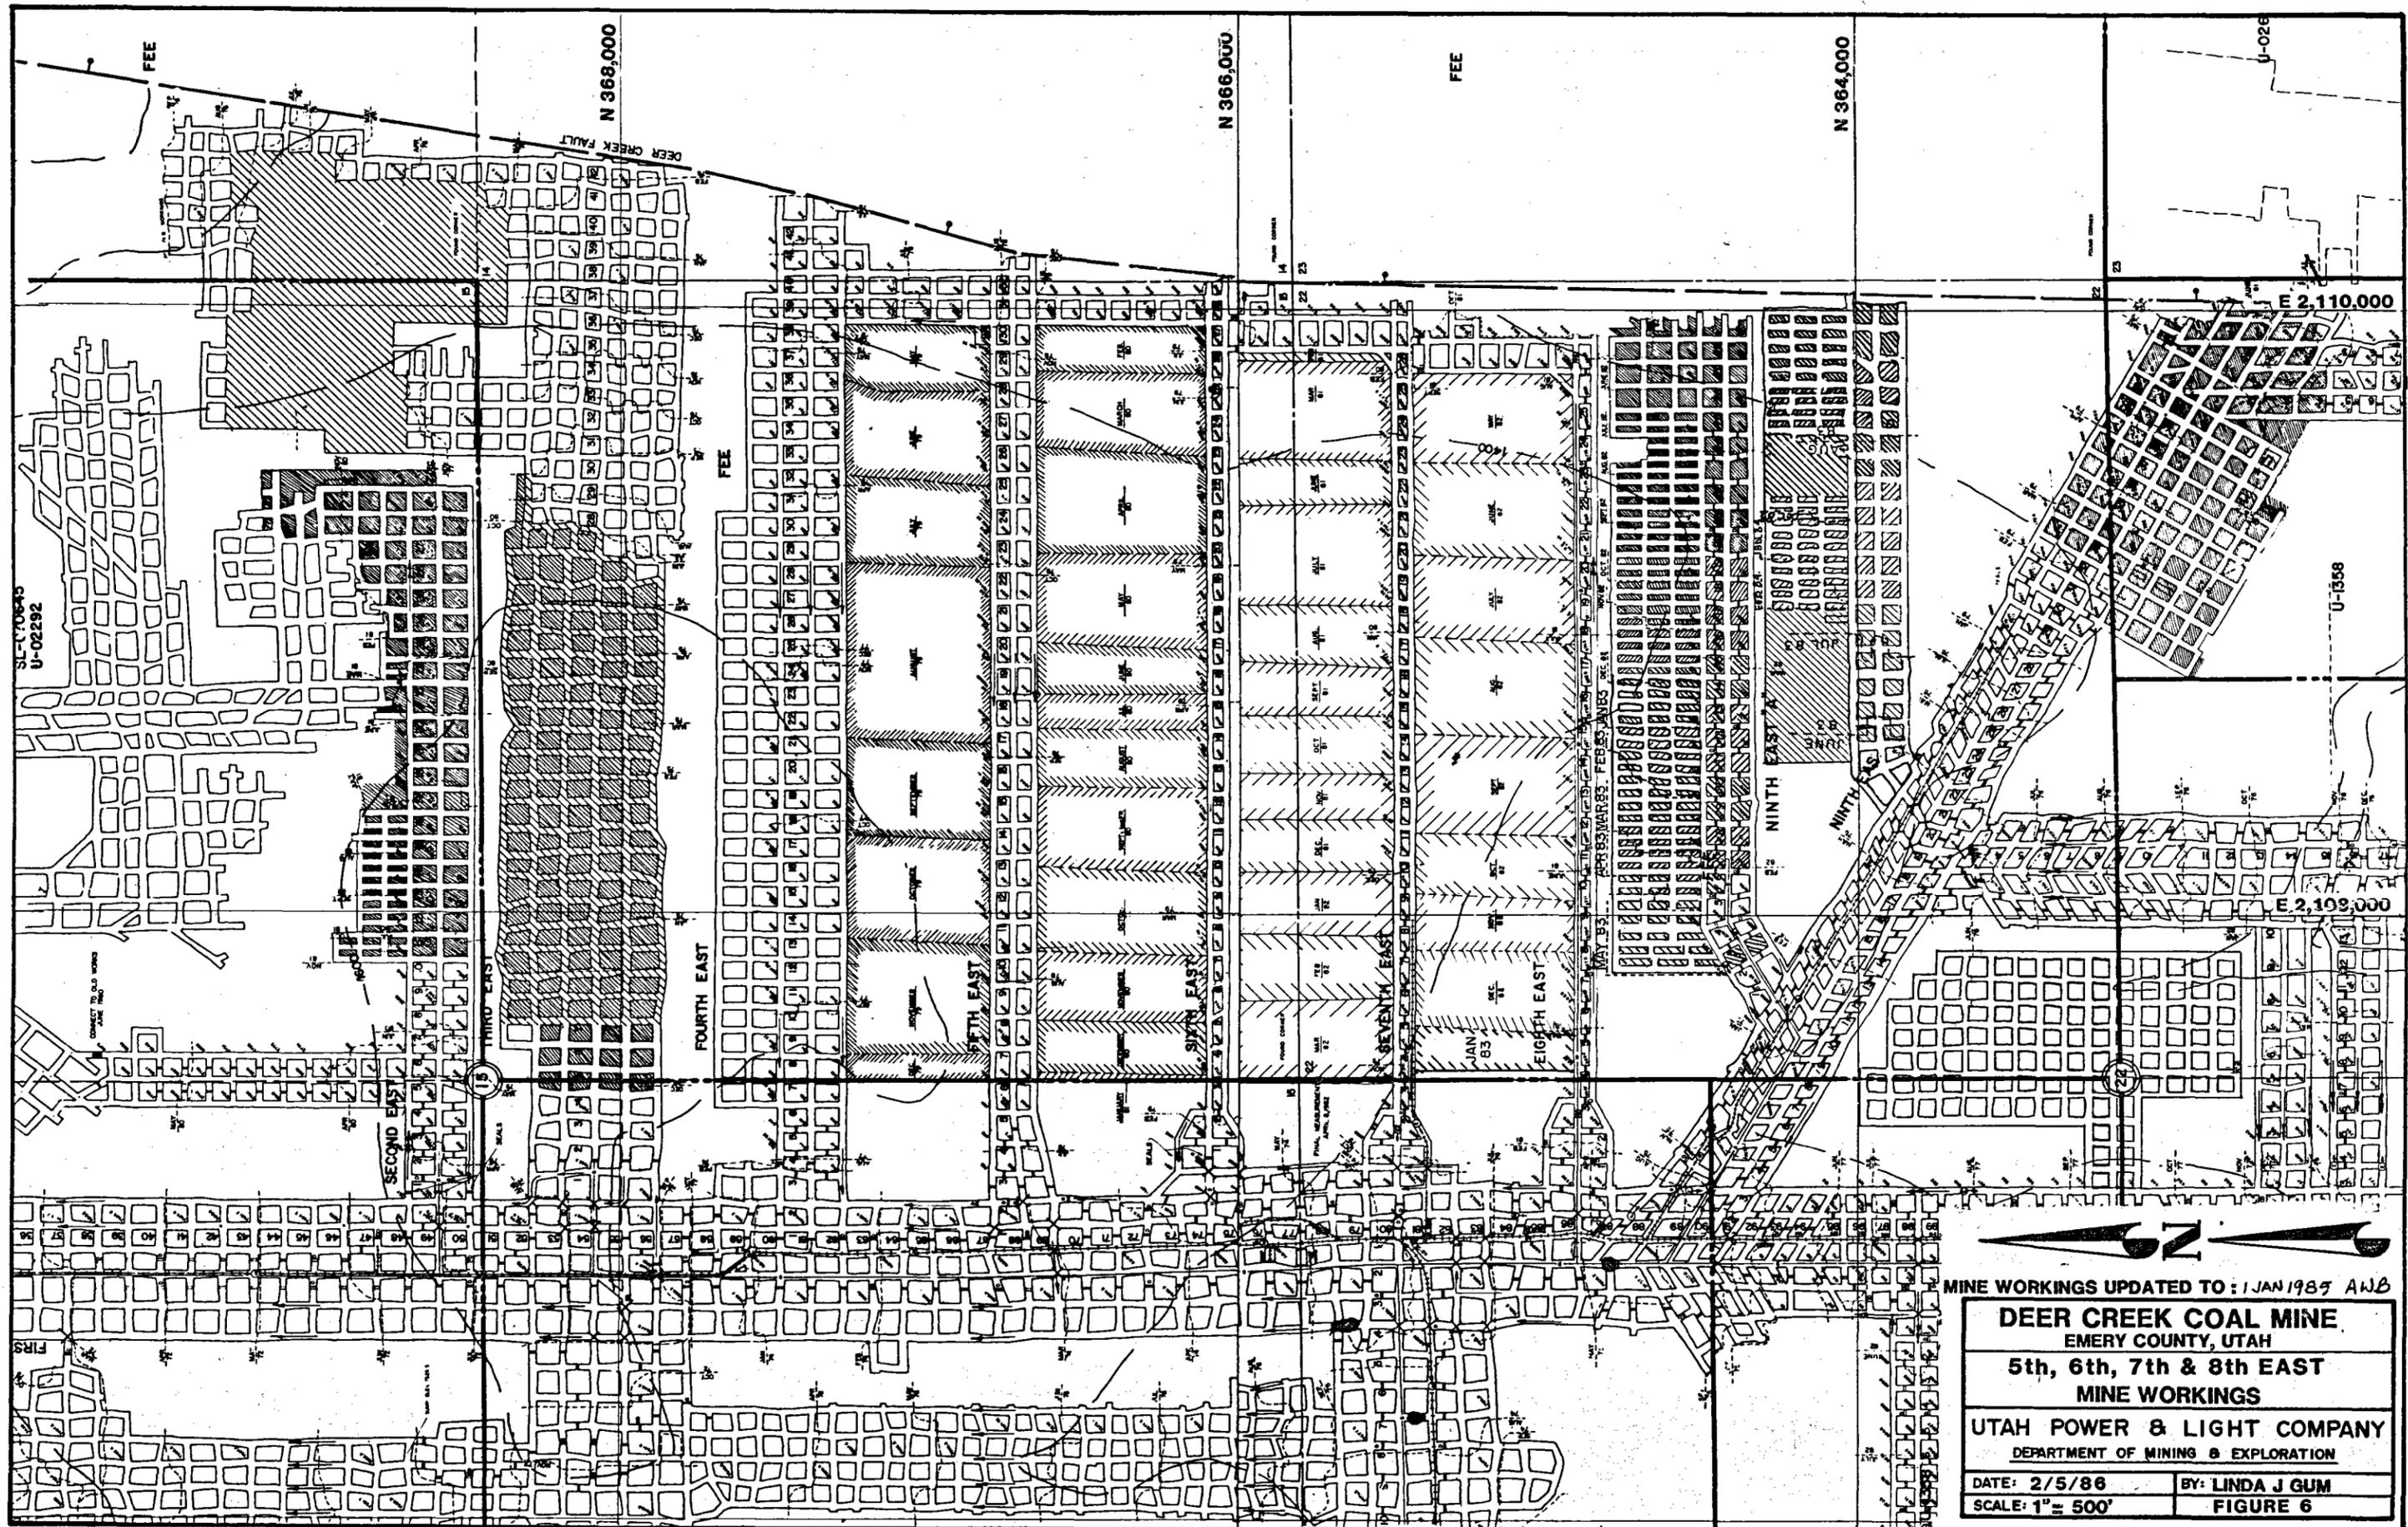
DATE: 2/5/86	BY: LINDA J GUM
SCALE: 1" = 500'	FIGURE 6

Mining in the Deer Creek Mine in this area had been completed by January 1983. Underlying this seam in the Wilberg Mine, coal extraction continued from September 1, 1984 until December 19, 1984 when mining was terminated due to a fire. During this time the 6th Right panel, 620 feet of the 5th Right panel, and 1,000 feet of the 13th Right longwall panel were completed (Figures 6 and 7).

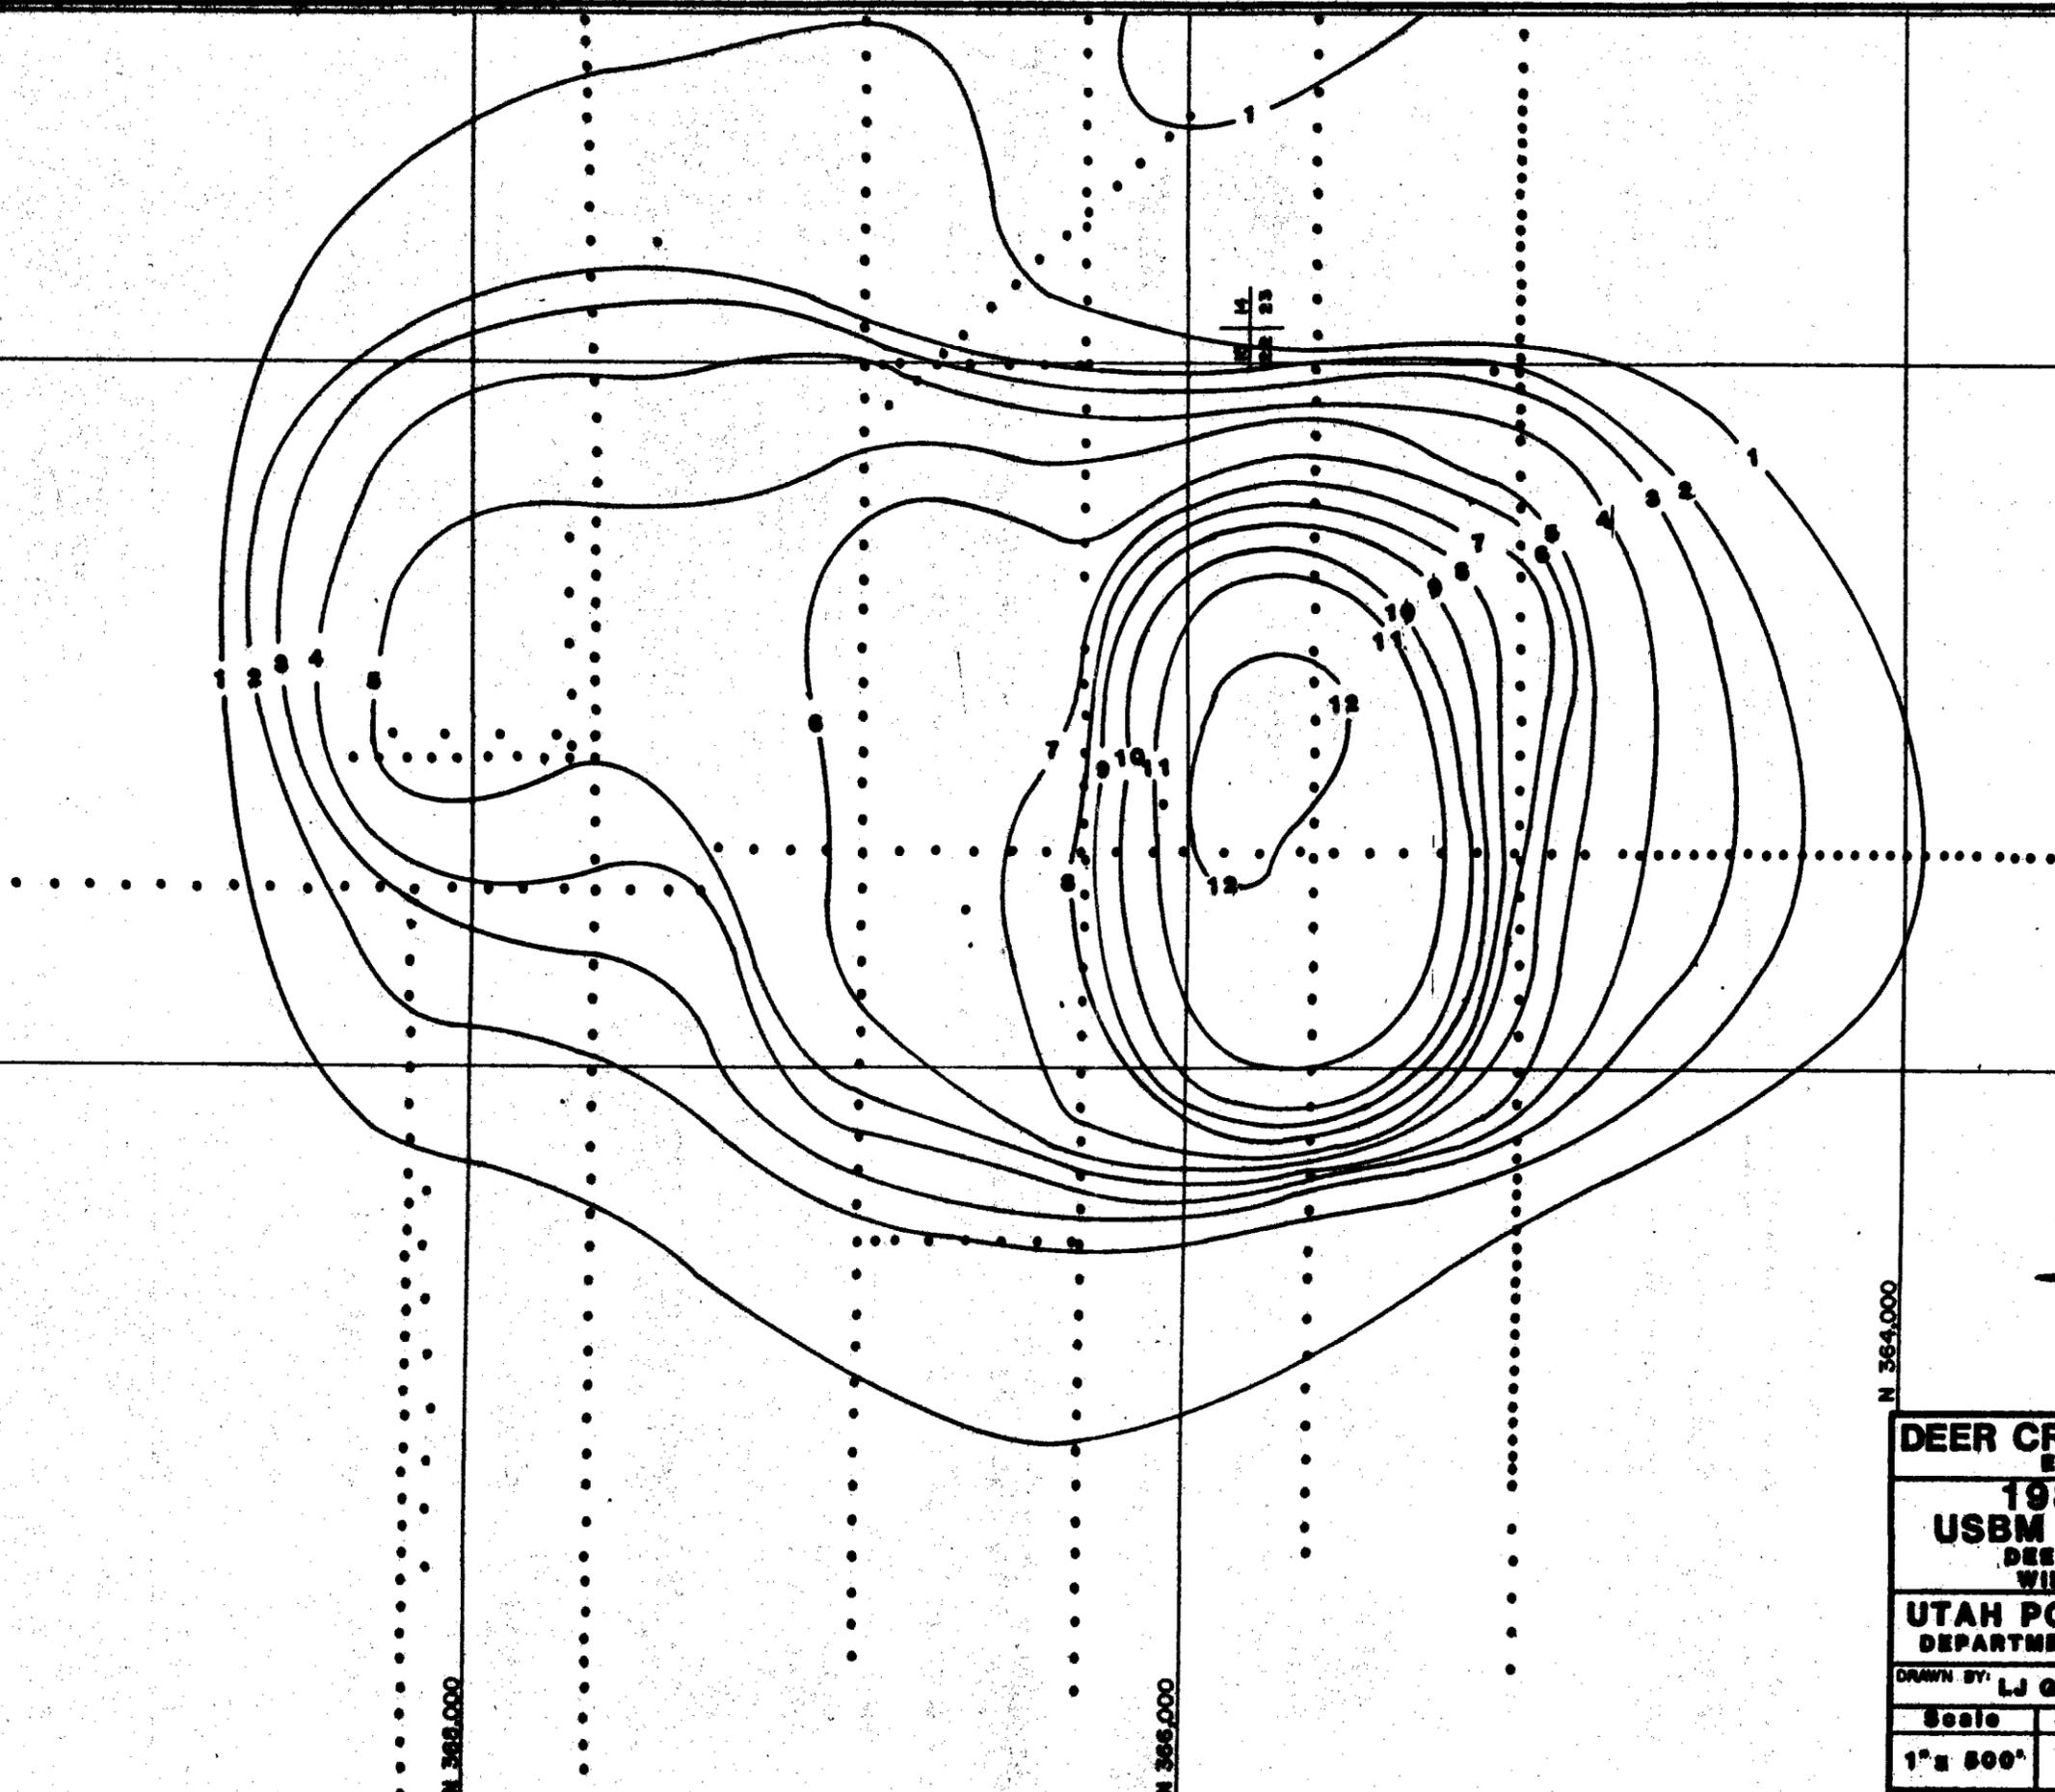
In 1985 this area was surveyed by both photogrammetric methods and U. S. Bureau of Mines on-the-ground monumentation (Figures 8a and 8b). Once again, the two surveys were in fairly close agreement. The photogrammetric survey showed a maximum of 13 feet of subsidence while on-the-ground methods indicated that 12 feet had occurred. In both surveys maximum subsidence occurred over the Deer Creek 6th East and Wilberg 6th and 7th Right longwall panels. The area of subsidence continued to elongate to the north and south in 1985 but neither UP&L nor USBM personnel have detected any surface fissures or other visible disturbance.

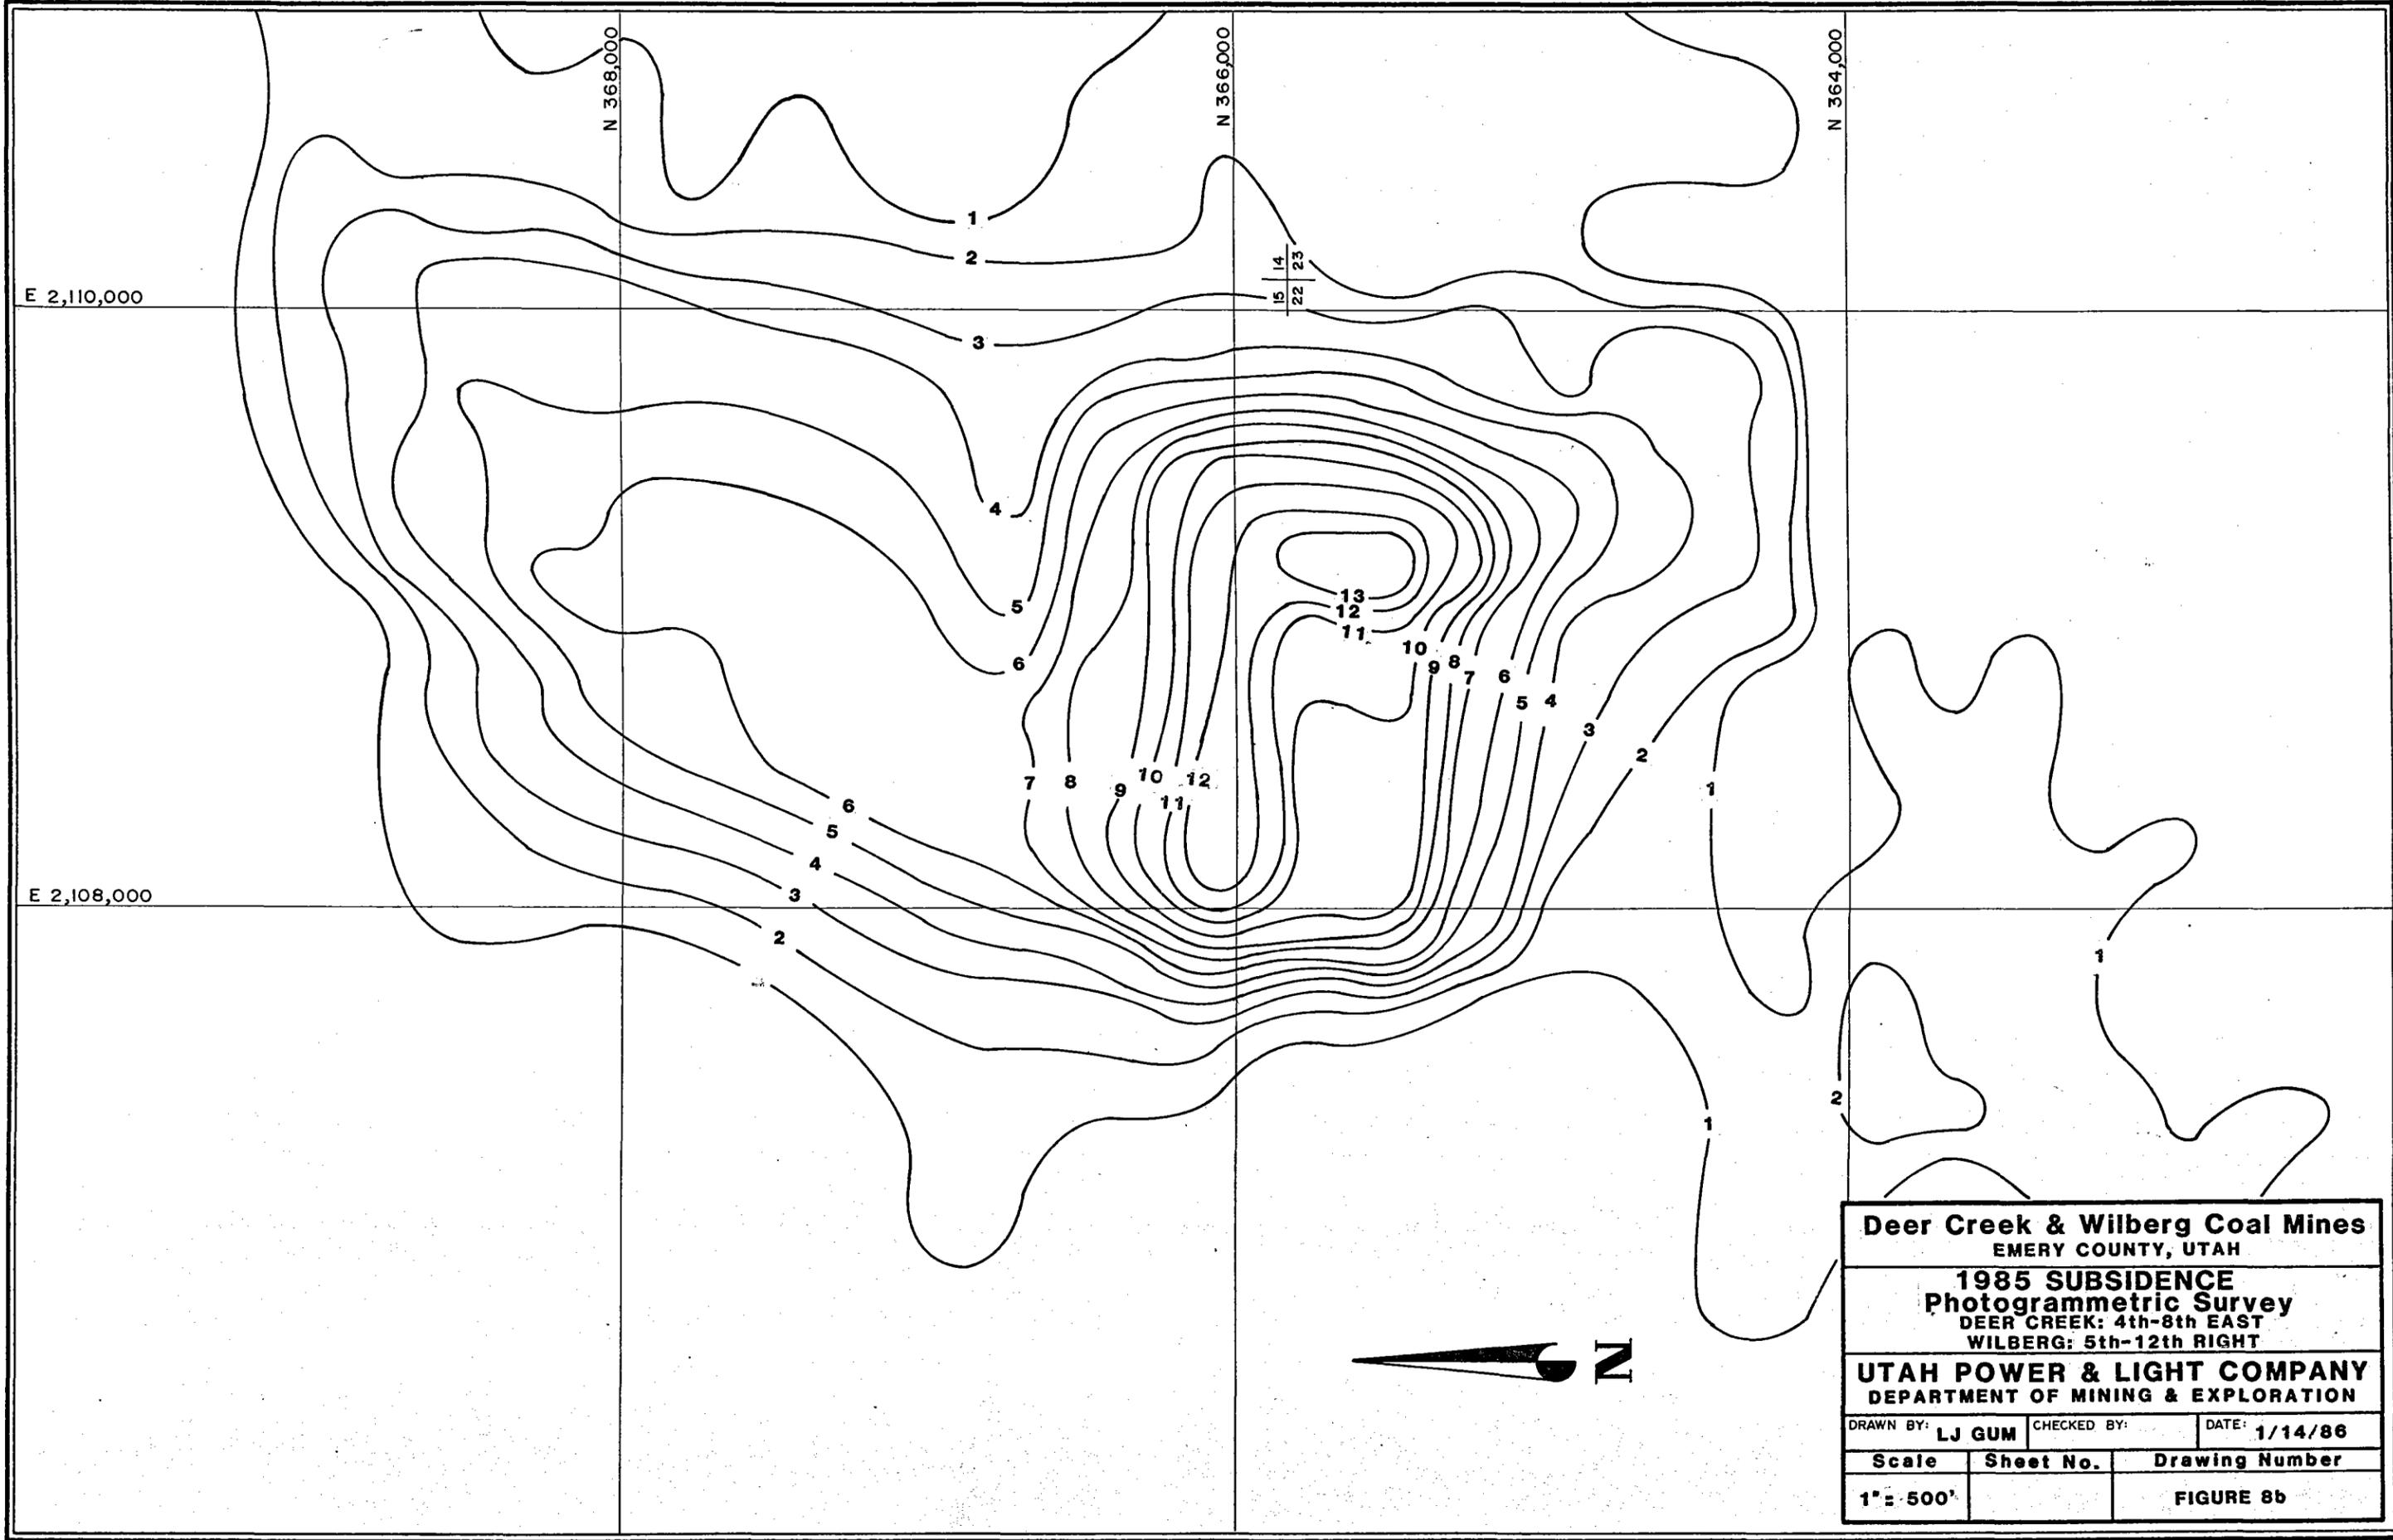
An angle-of-draw has been calculated where possible on the western side of this area. On the eastern side the angle is influenced by the Deer Creek fault and adjacent

Little Dove Mine workings across the fault; thus, we are unable to calculate a meaningful angle-of-draw there. Other mine workings to the north and south in the Deer Creek Mine cause similar problems with any calculation on those sides. On the western side the angle-of-draw ranges from near vertical to 20 degrees.
