**UTAH POWER & LIGHT COMPANY
SUBSIDENCE MONITORING PROGRAM
ANNUAL REPORT FOR 1985**

February 1986

Submitted to: United States Department of the Interior
Office of Surface Mining
Minerals Management Service
Utah Division of Oil, Gas and Mining

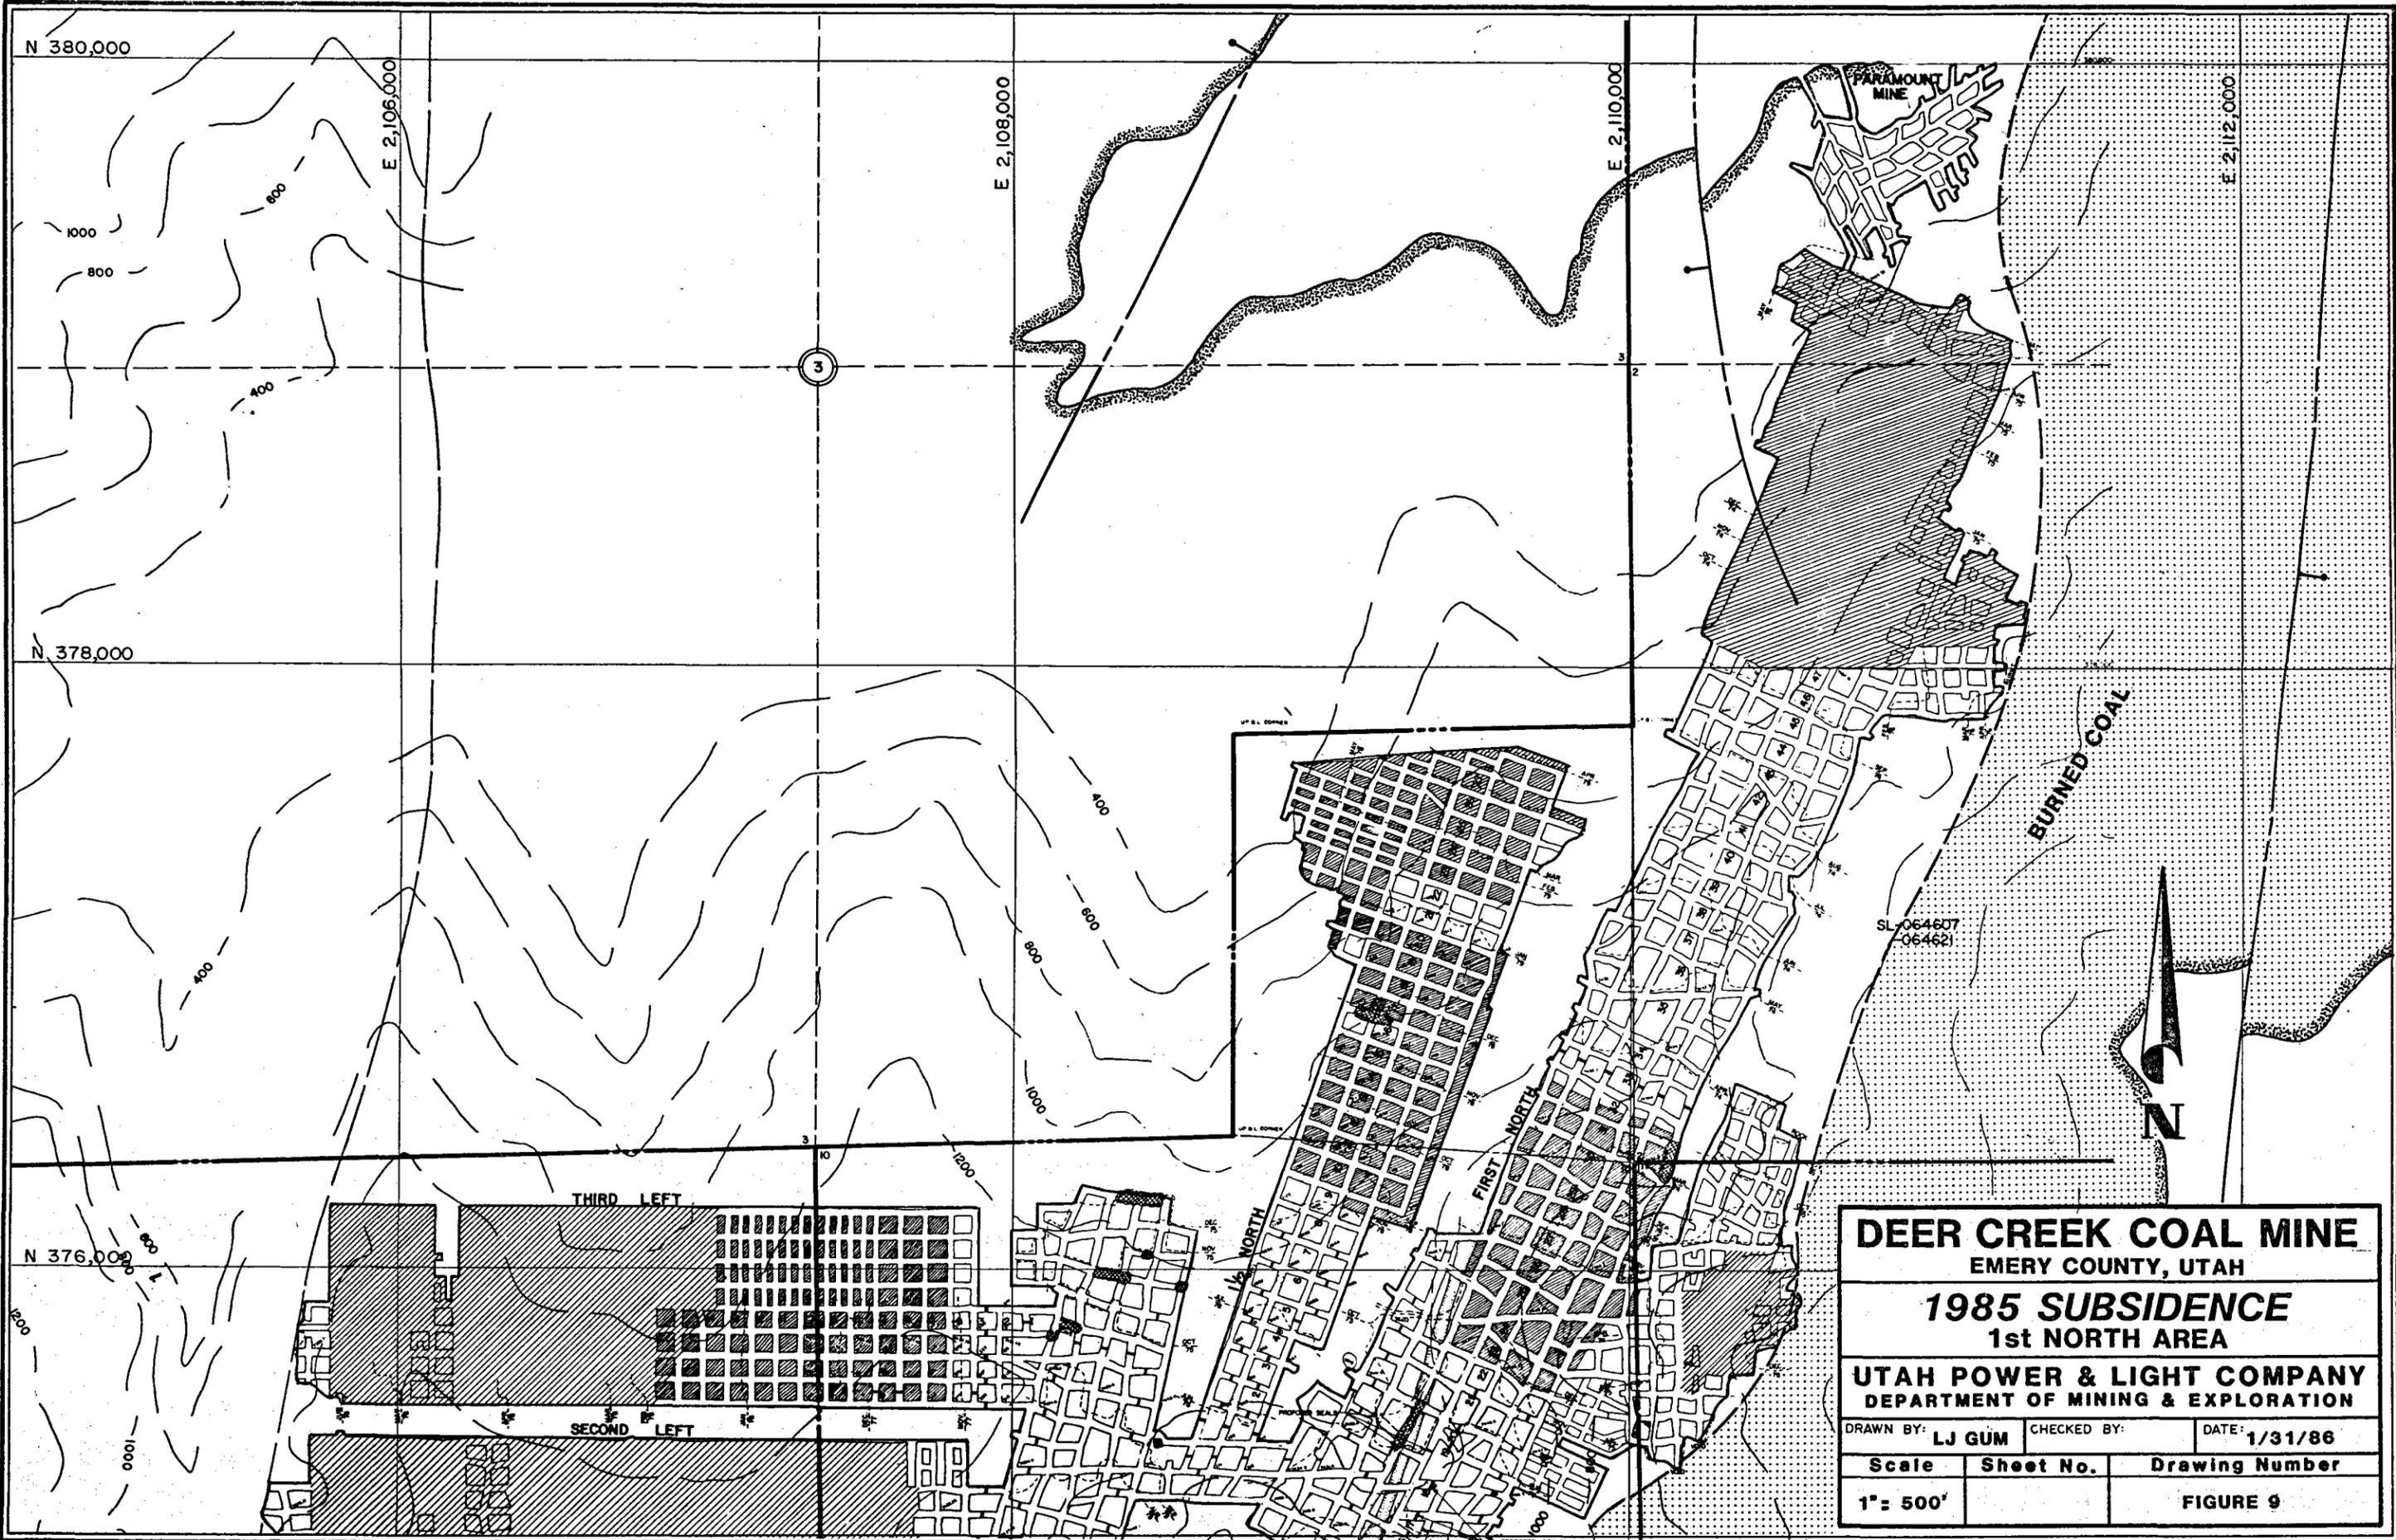
DEER CREEK COAL MINE		
EMERY COUNTY, UTAH		
1985 SUBSIDENCE		
1st NORTH AREA		
UTAH POWER & LIGHT COMPANY		
DEPARTMENT OF MINING & EXPLORATION		
DRAWN BY: LJ GUM	CHECKED BY:	DATE: 1/31/86
Scale	Sheet No.	Drawing Number
1" = 500'		FIGURE 9

Most of the 1st North section of the Deer Creek Mine was abandoned and sealed in 1978 after being mined out. The southern portion is still open and will be used for access to a block of coal which lies to the west. Pillar extraction in the 3rd Left and 1½ North sections was completed in early 1980. Subsidence has since been detected over each of the sections and over burned coal to the east of the 1st North workings (Figures 9 and 10). The greatest subsidence observed in the area occurs over a zone of complete pillar extraction in 1½ North where subsidence reached 15 feet even though only 7.5 feet of coal was removed. Because of the location of this anomaly, it must be attributed to mass wasting. Over the rest of the area maximum subsidence was 5 feet. Several zones of fracturing have been observed above the 1st and 1½ North sections mainly on the north side of the ridge that extends over the workings.

The calculated angle-of-draw for this area ranges from vertical to 40 degrees but these are not considered reliable angles since burned coal, steep slopes and fracturing have complicated the subsidence process.

In areas 3 and 7, where only minor fracturing has occurred on remote ridges and the present land use has not been affected, more damage would be done by gaining access to and repairing fractures than can be justified, therefore, mitigation is counter-productive in these areas.

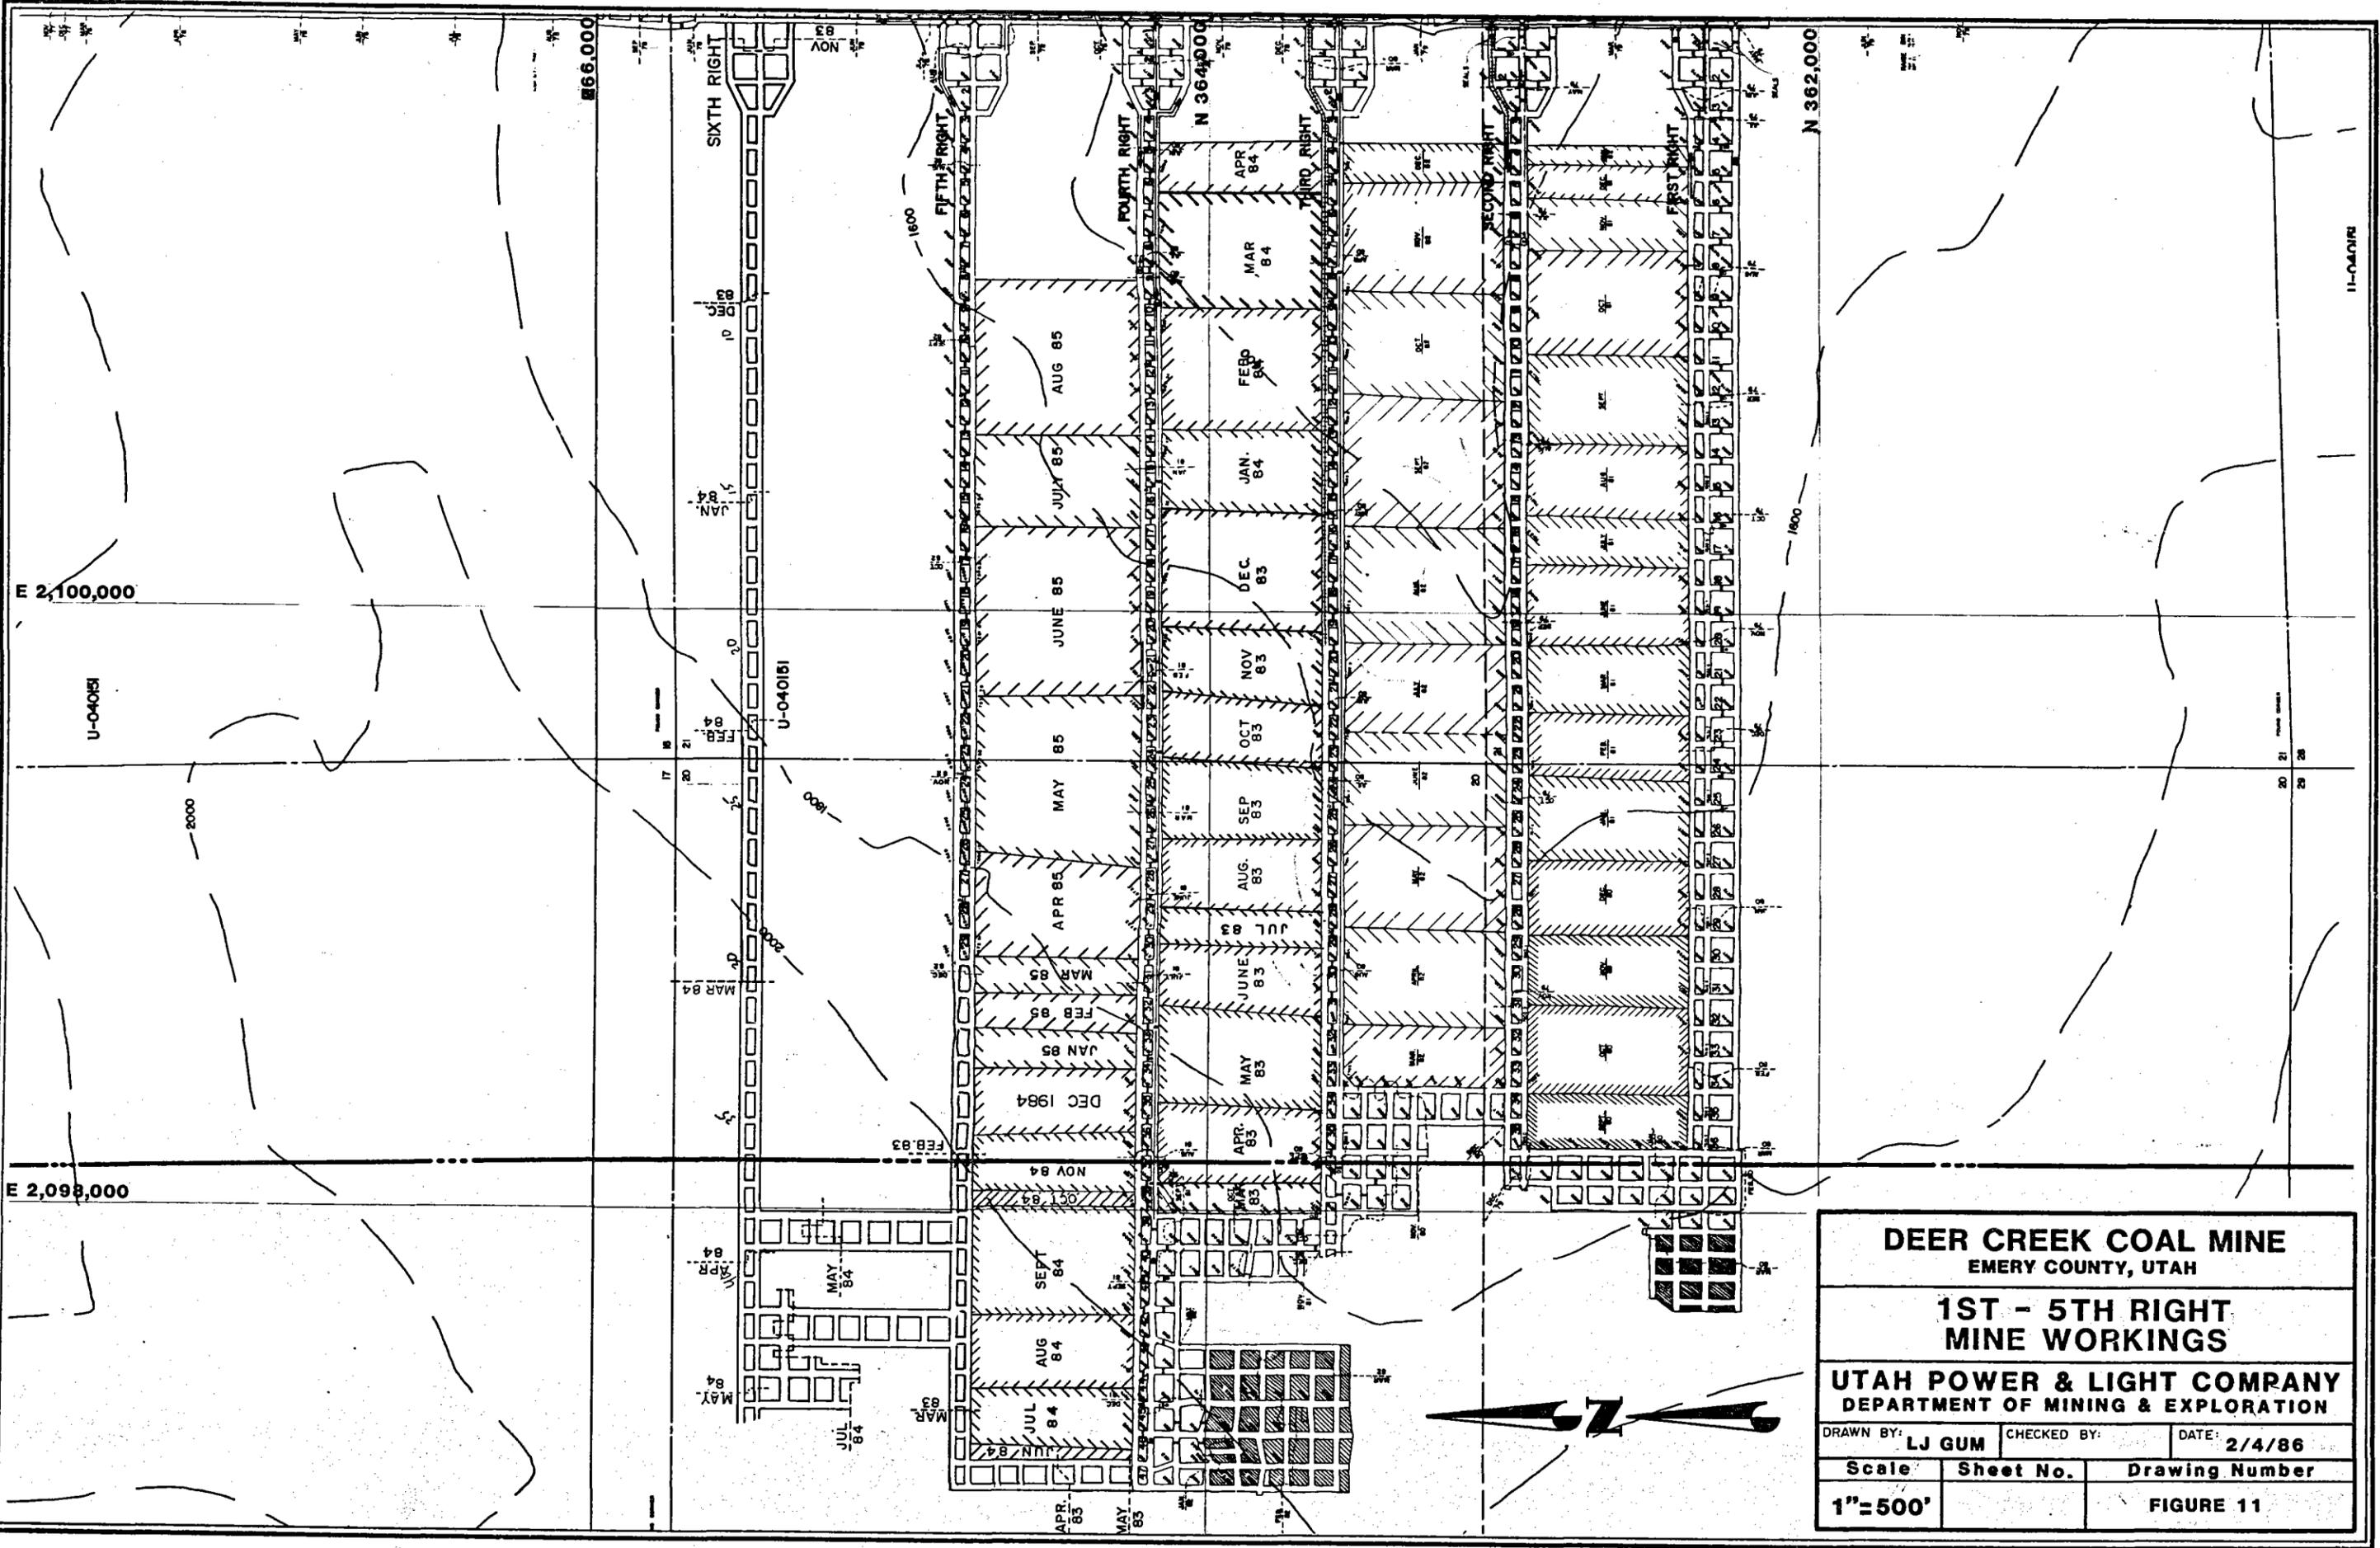
DEER CREEK COAL MINE EMERY COUNTY, UTAH		
1ST - 5TH RIGHT MINE WORKINGS		
UTAH POWER & LIGHT COMPANY DEPARTMENT OF MINING & EXPLORATION		
DRAWN BY: LJ GUM	CHECKED BY:	DATE: 2/4/86
Scale 1"=500'	Sheet No.	Drawing Number FIGURE 11

Subsidence in this area was detected for the first time in 1984 by photogrammetric methods. Longwall mining commenced in the 2nd Right longwall panel in 1980 and by the end of August 1985 the 2nd, 3rd, and 4th Right panels, and 3940 feet of the 5th Right longwall panel had been completed (figure 11).

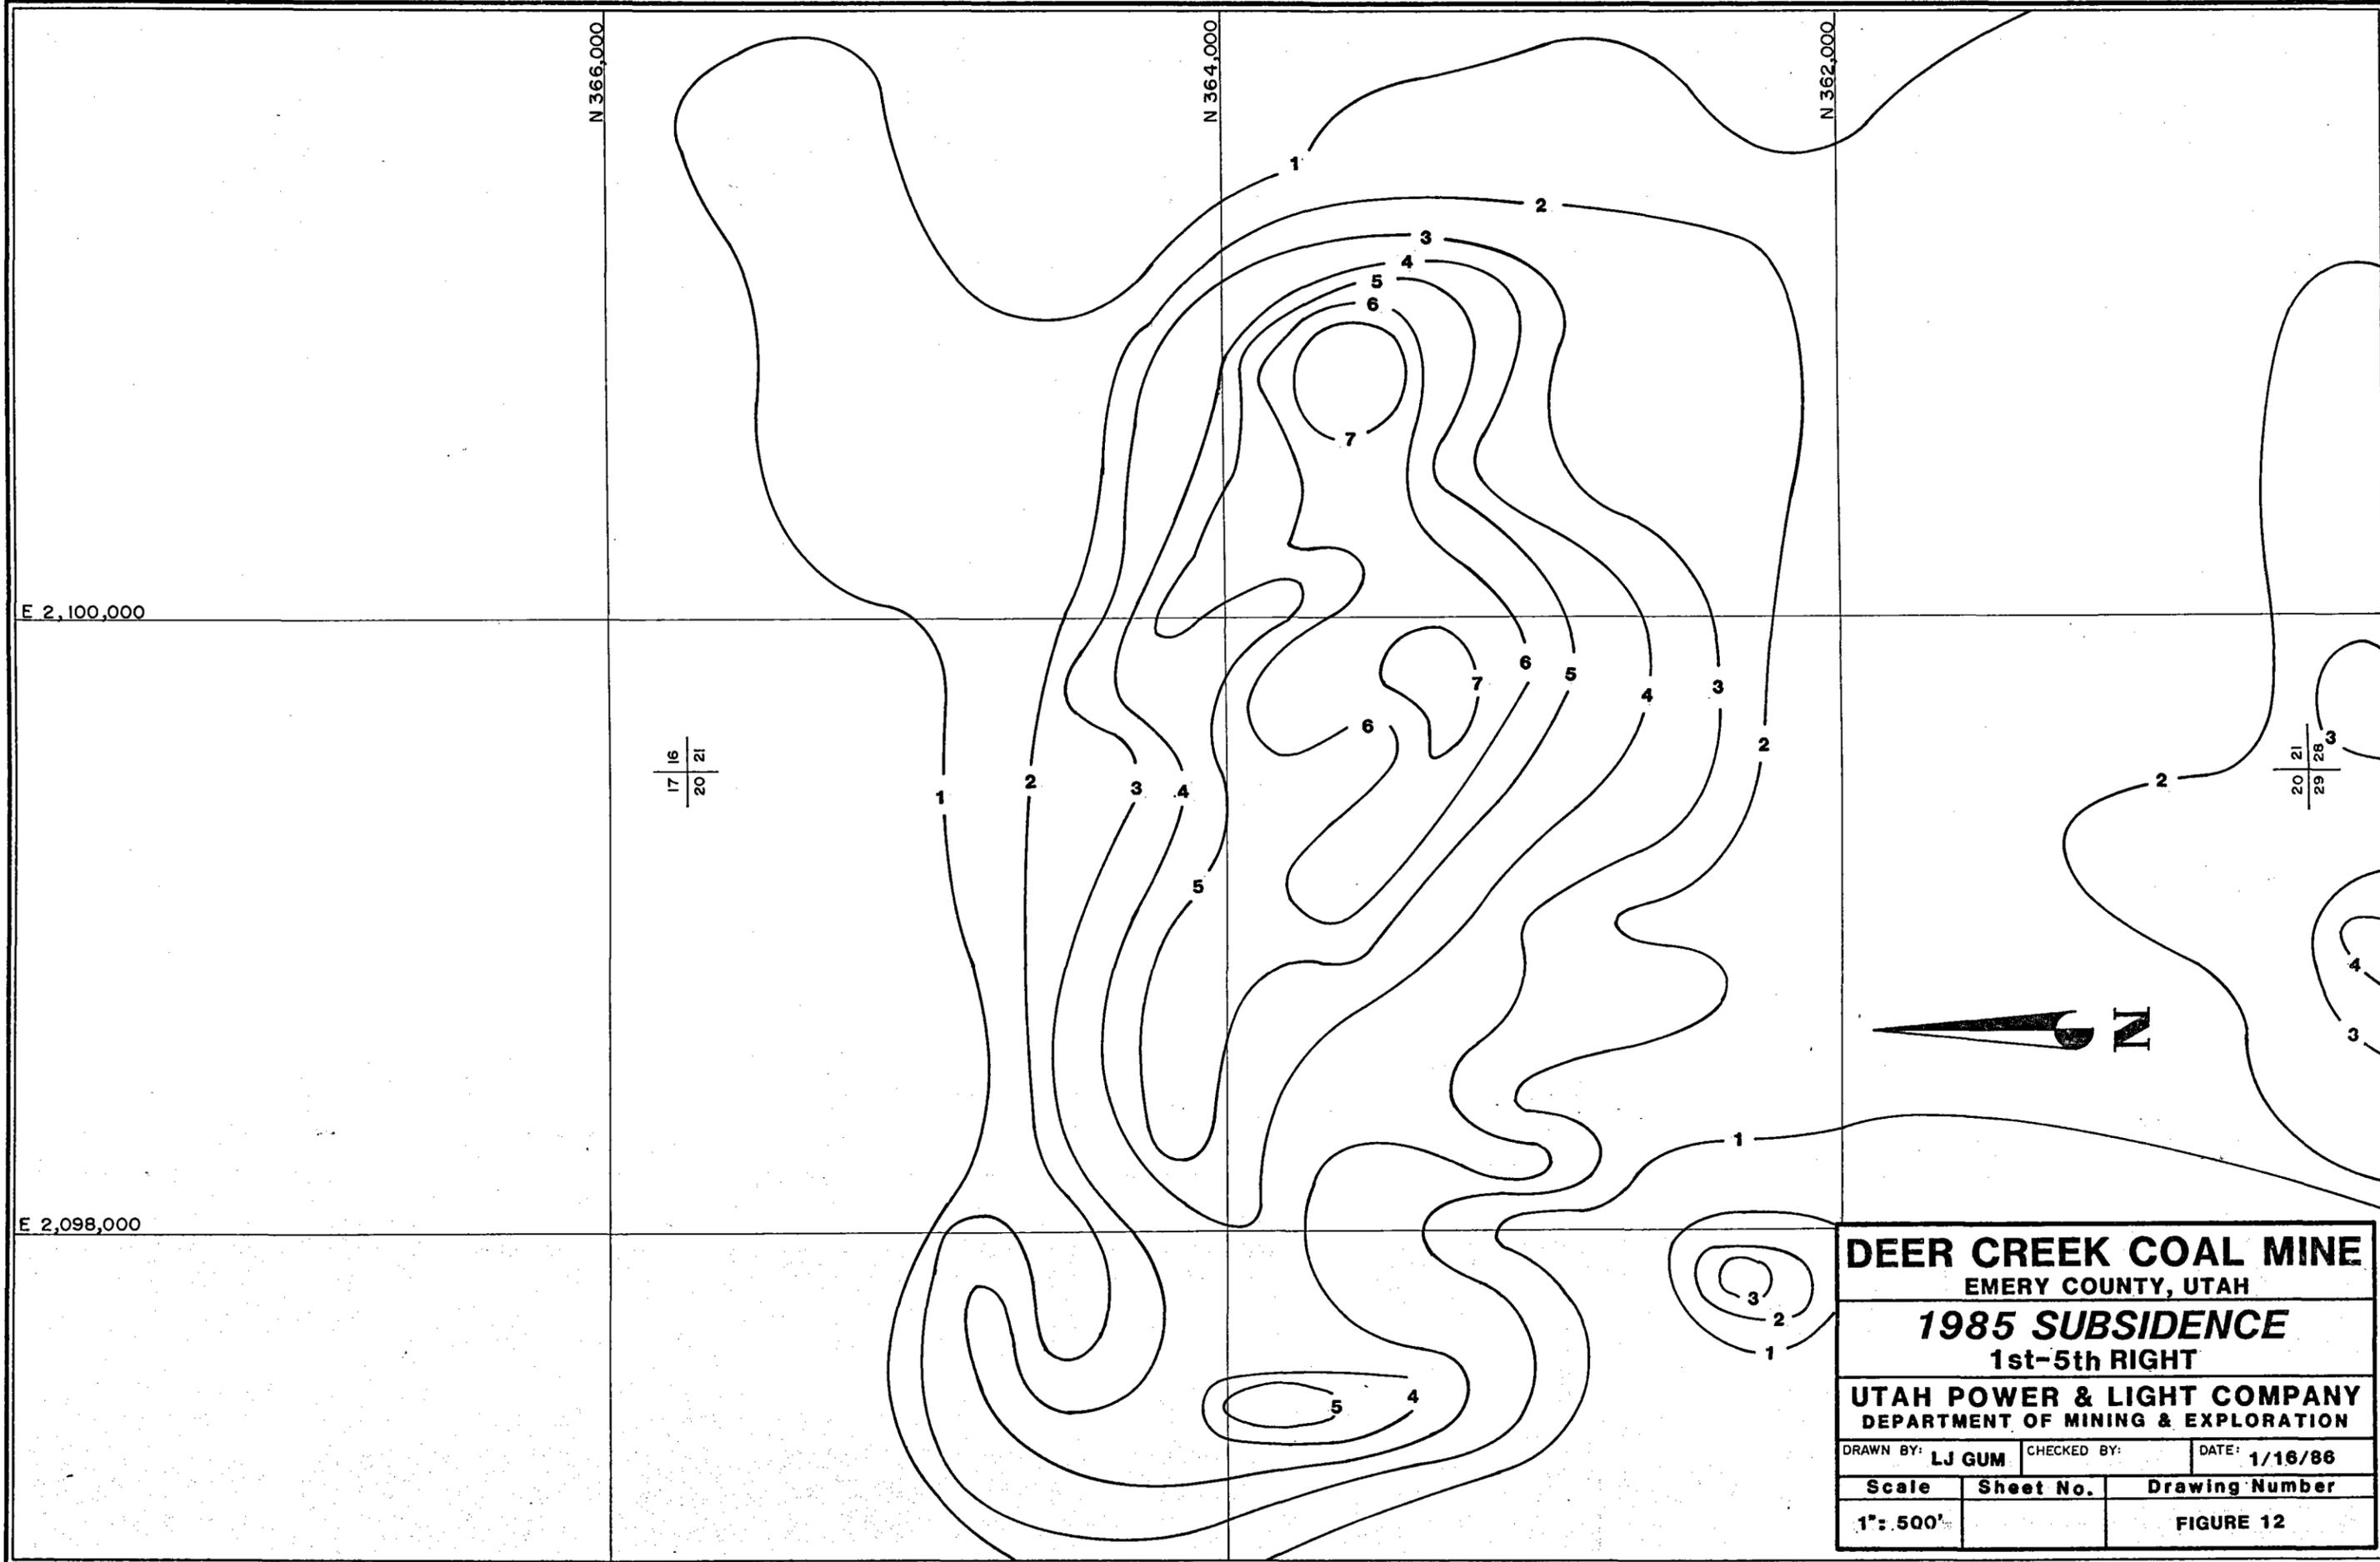
DEER CREEK COAL MINE		
EMERY COUNTY, UTAH		
1985 SUBSIDENCE		
1st-5th RIGHT		
UTAH POWER & LIGHT COMPANY		
DEPARTMENT OF MINING & EXPLORATION		
DRAWN BY: LJ GUM	CHECKED BY:	DATE: 1/16/86
Scale	Sheet No.	Drawing Number
1" = 500'		FIGURE 12

The maximum subsidence yet noted is 7.7 feet, centered over the 3rd Right longwall panel. Up to 5 feet of subsidence also occurred over two room-and-pillar sections to the west which had been completely mined out and abandoned by mid-1982 (Figure 12). No fractures or other visible surface disturbance have been detected in this area. The area is overlain by 1600 to 2000 feet of overburden. The calculated angle for the subsidence ranges from near vertical to about 22° but more meaningful estimates may be possible when subsidence has stabilized.

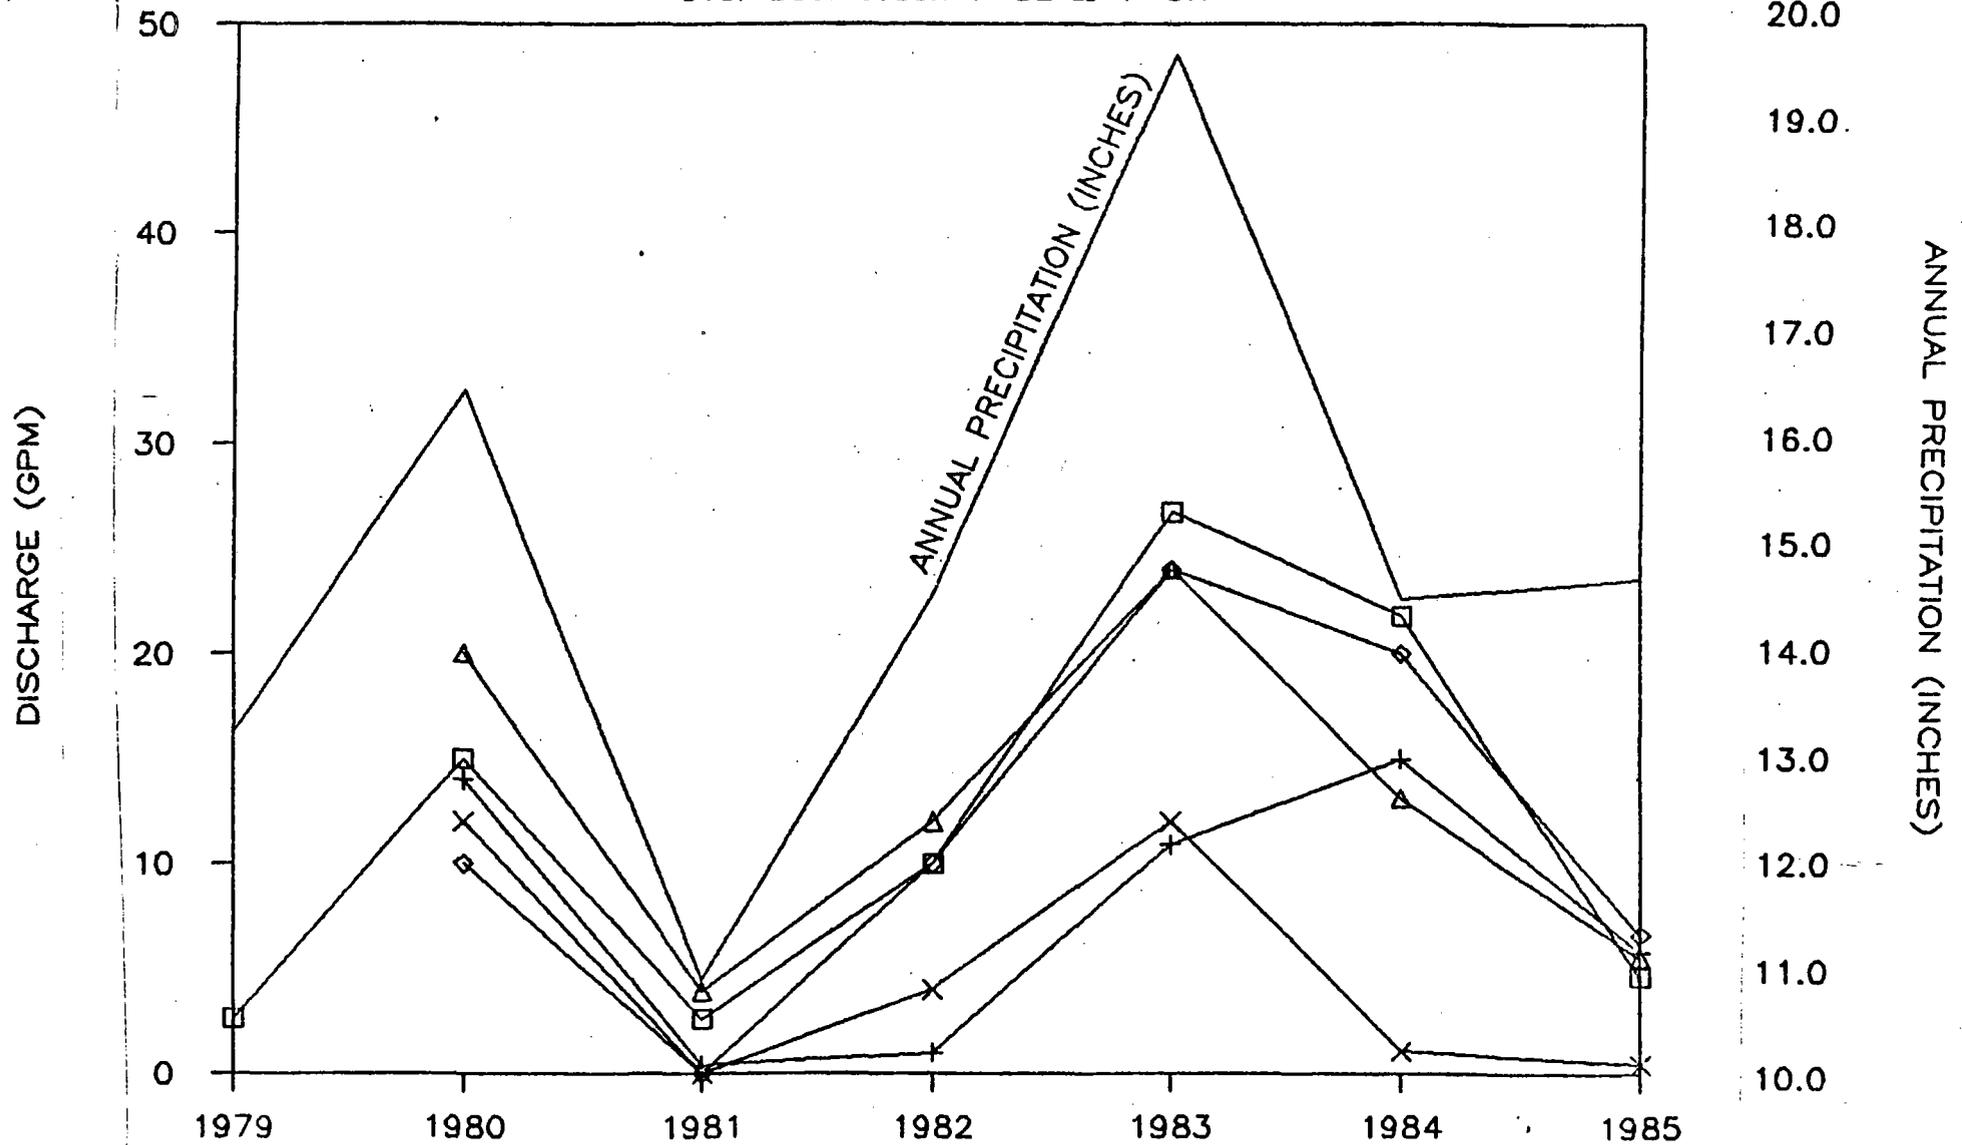
Figure 13 EAST MOUNTAIN SPRINGS

Several springs are located on East Mountain above the Deer Creek 1st through 5th Right and 1st through 5th Left (see Area 5) mine workings. Figure 13 is a graph comparing the discharge from these springs with the annual precipitation on East Mountain. Fluctuations in spring flow appear to be related to variations in precipitation. This relationship appears to hold well for all years except 1985. ?

In examining temperature data obtained from a weather station on East Mountain we found that during the months April and May of 1985 temperatures averaged 7 degrees above normal. These unusually high temperatures caused most of the snow-melt to occur before the springs could be sampled in July, when peak runoff usually occurs. This accounts for the lower than expected spring discharges measured in 1985.

As mentioned in the previous section, it is believed that none of the springs located above these workings show any adverse effects due to mining (see Figure 13 in the preceding section).

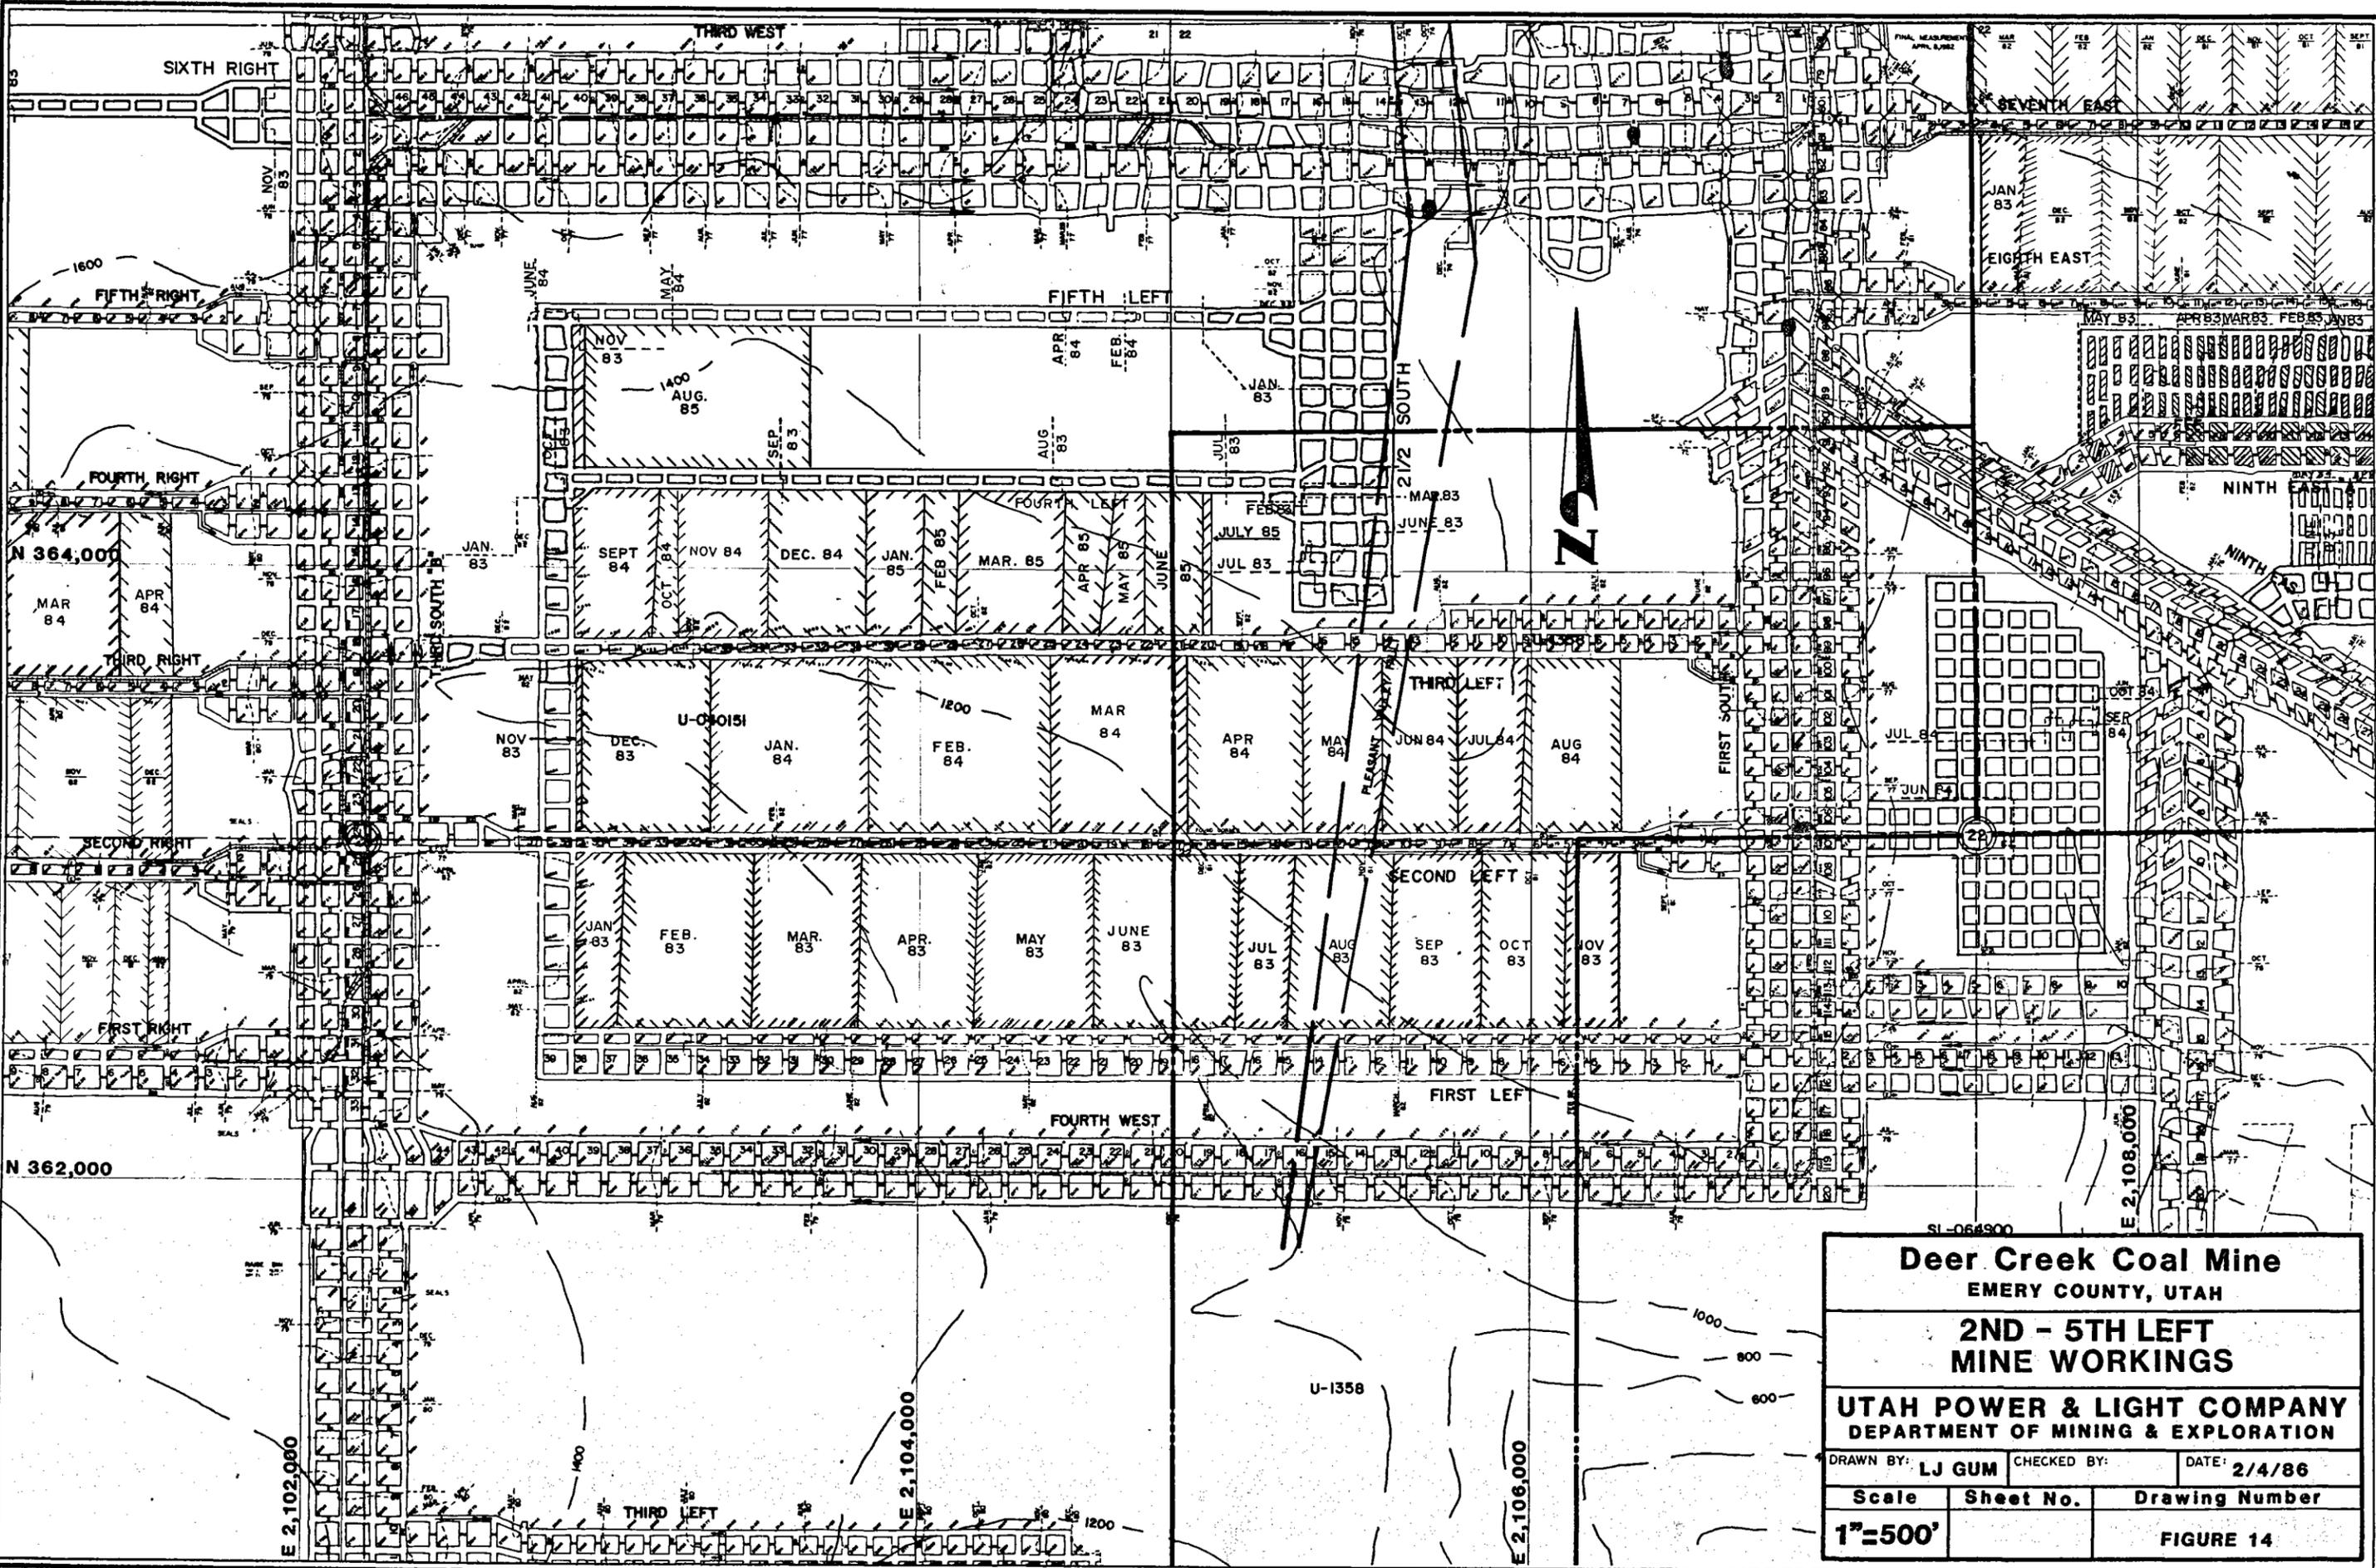
Deer Creek Coal Mine		
EMERY COUNTY, UTAH		
2ND - 5TH LEFT		
MINE WORKINGS		
UTAH POWER & LIGHT COMPANY		
DEPARTMENT OF MINING & EXPLORATION		
DRAWN BY: LJ GUM	CHECKED BY:	DATE: 2/4/86
Scale	Sheet No.	Drawing Number
1"=500'		FIGURE 14

Photogrammetric monitoring revealed subsidence in this area for the first time in 1984. Mining of the 2nd Left panel began in January 1983. By September of 1985 the 2nd, 3rd and 4th Left panels, and 770 feet of the 5th Left panel had been completed (Figure 14).

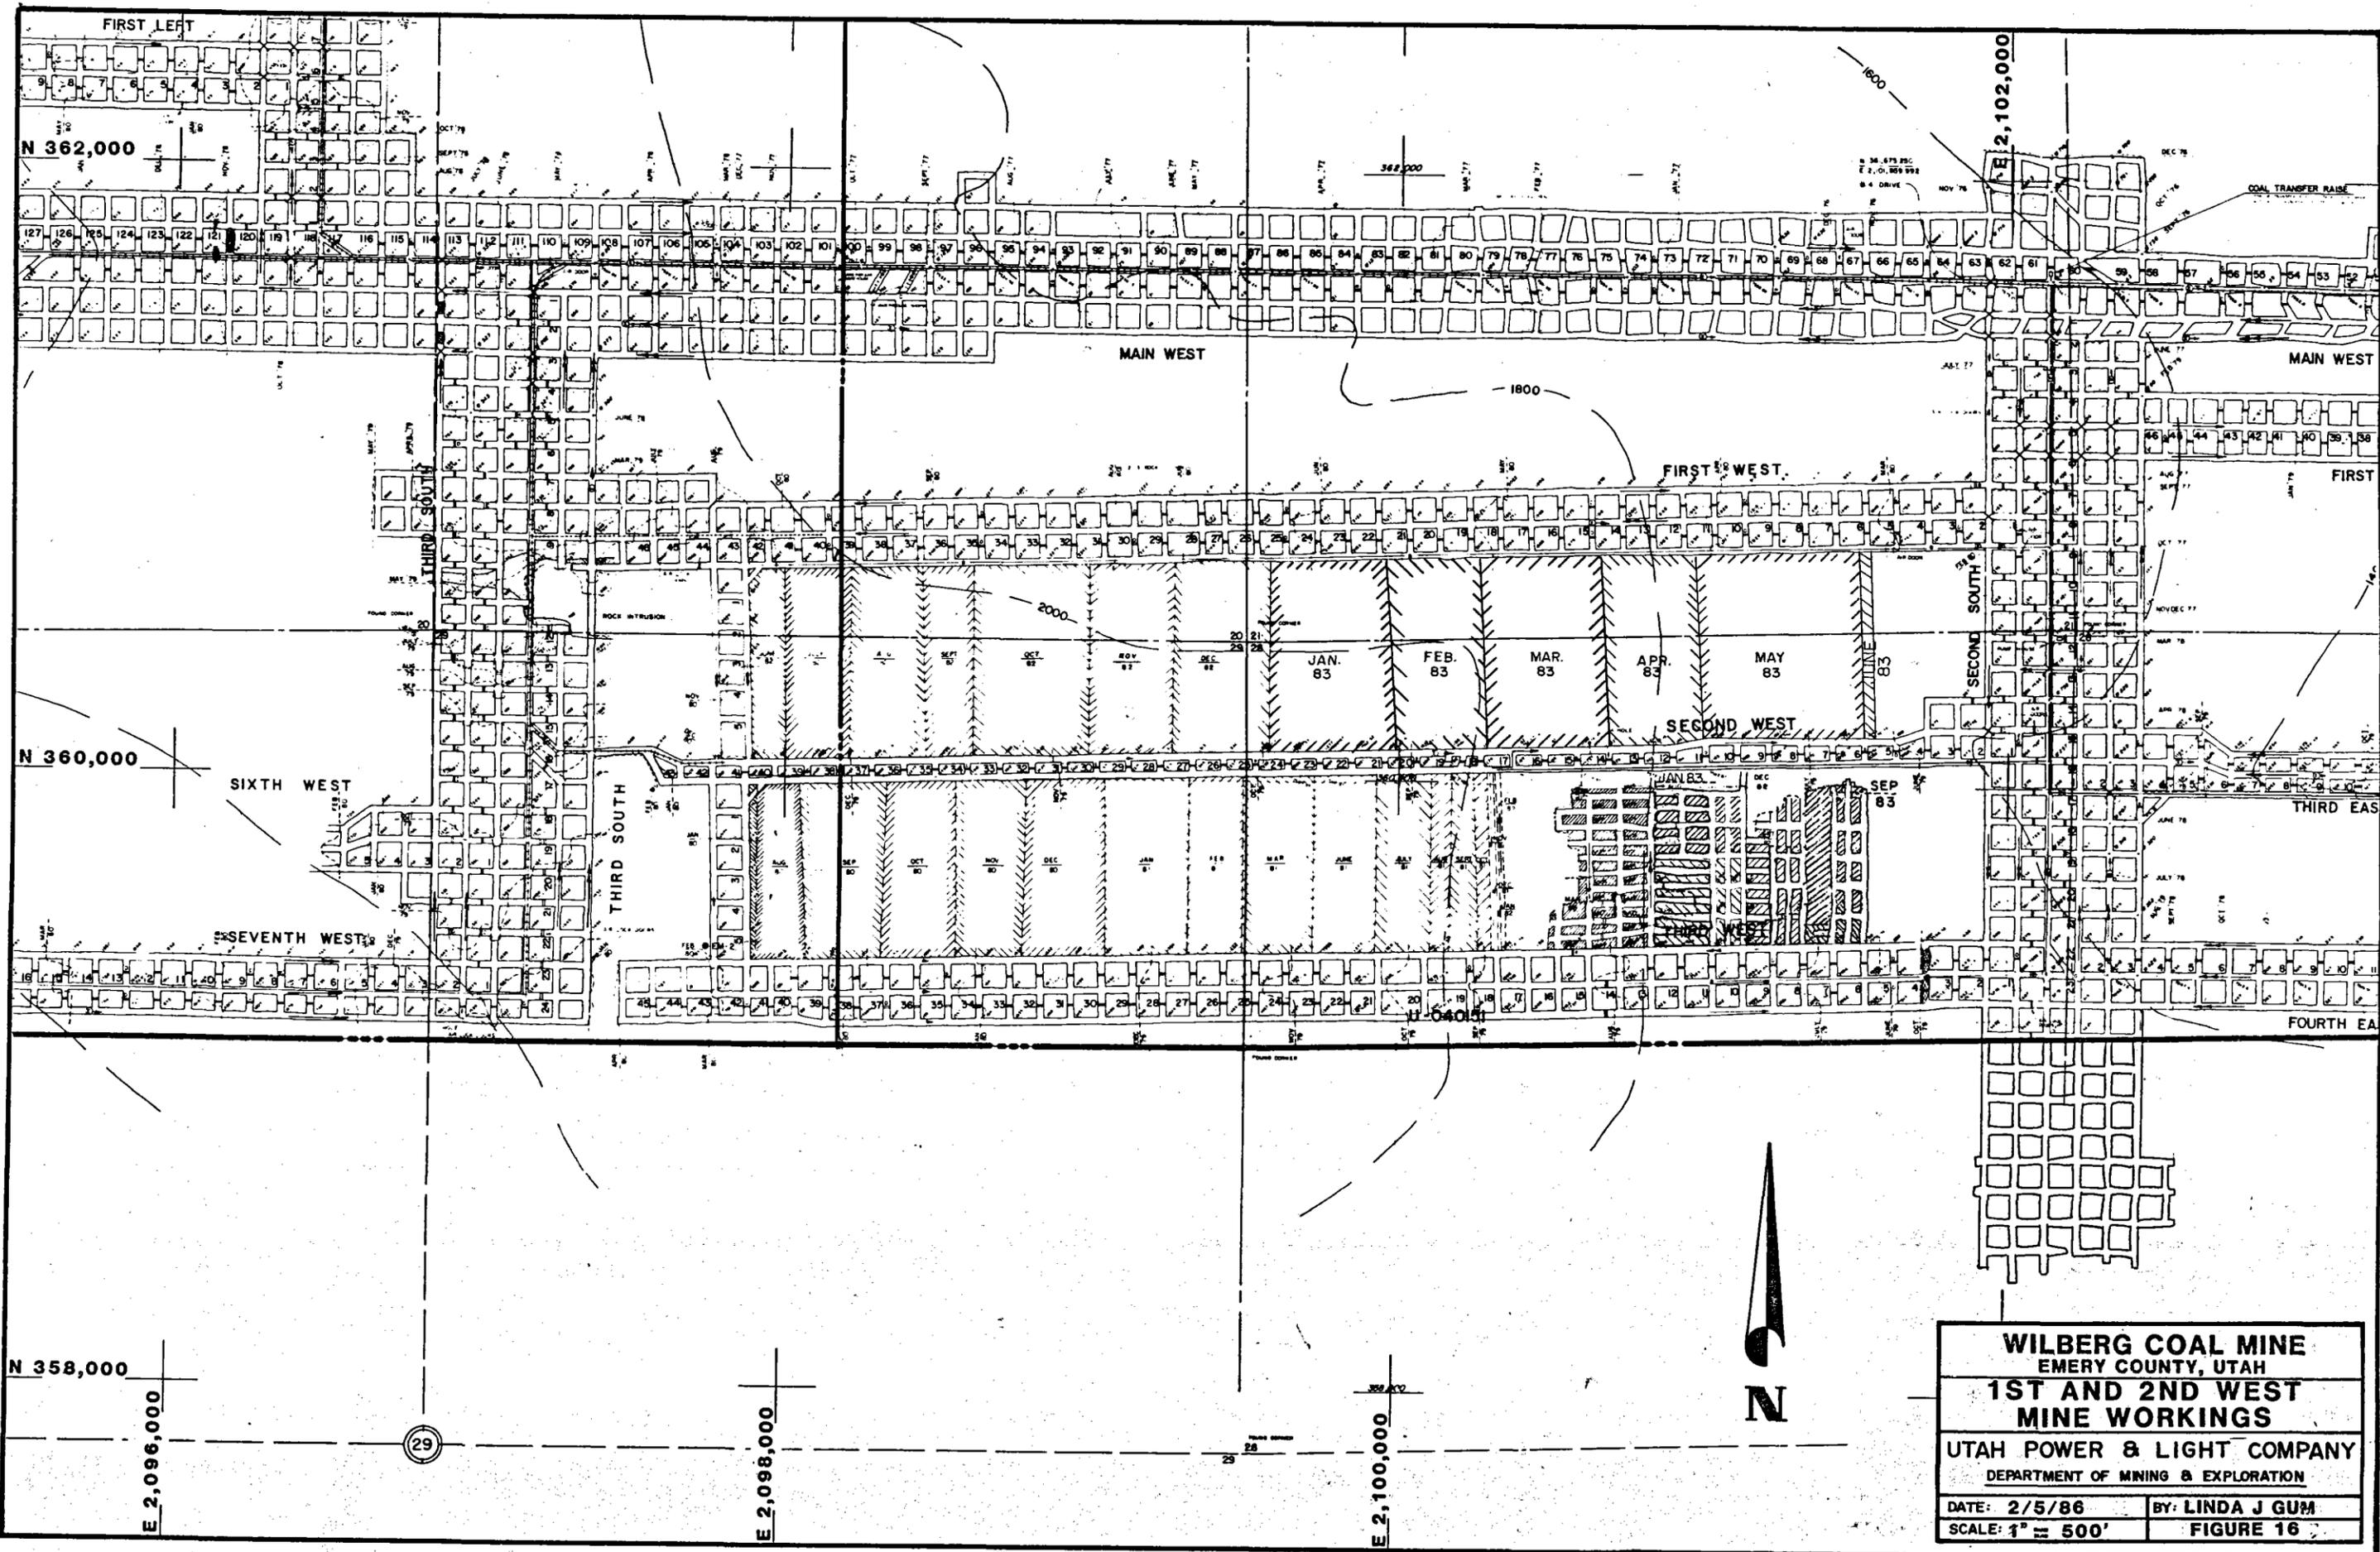
WILBERG COAL MINE	
EMERY COUNTY, UTAH	
1ST AND 2ND WEST	
MINE WORKINGS	
UTAH POWER & LIGHT COMPANY	
DEPARTMENT OF MINING & EXPLORATION	
DATE: 2/5/86	BY: LINDA J GUM
SCALE: 1" = 500'	FIGURE 16

The Bureau of Mines monitoring of a system of surface monuments revealed subsidence over the Wilberg 1st and 2nd West longwall panels during 1983 (Figure 16). Mining in these two panels was completed by early June 1983 but subsidence continued in the 1984 monitoring period.
