**UTAH POWER & LIGHT COMPANY
SUBSIDENCE MONITORING PROGRAM
ANNUAL REPORT FOR 1985**

February 1986

Submitted to: United States Department of the Interior
Office of Surface Mining
Minerals Management Service
Utah Division of Oil, Gas and Mining

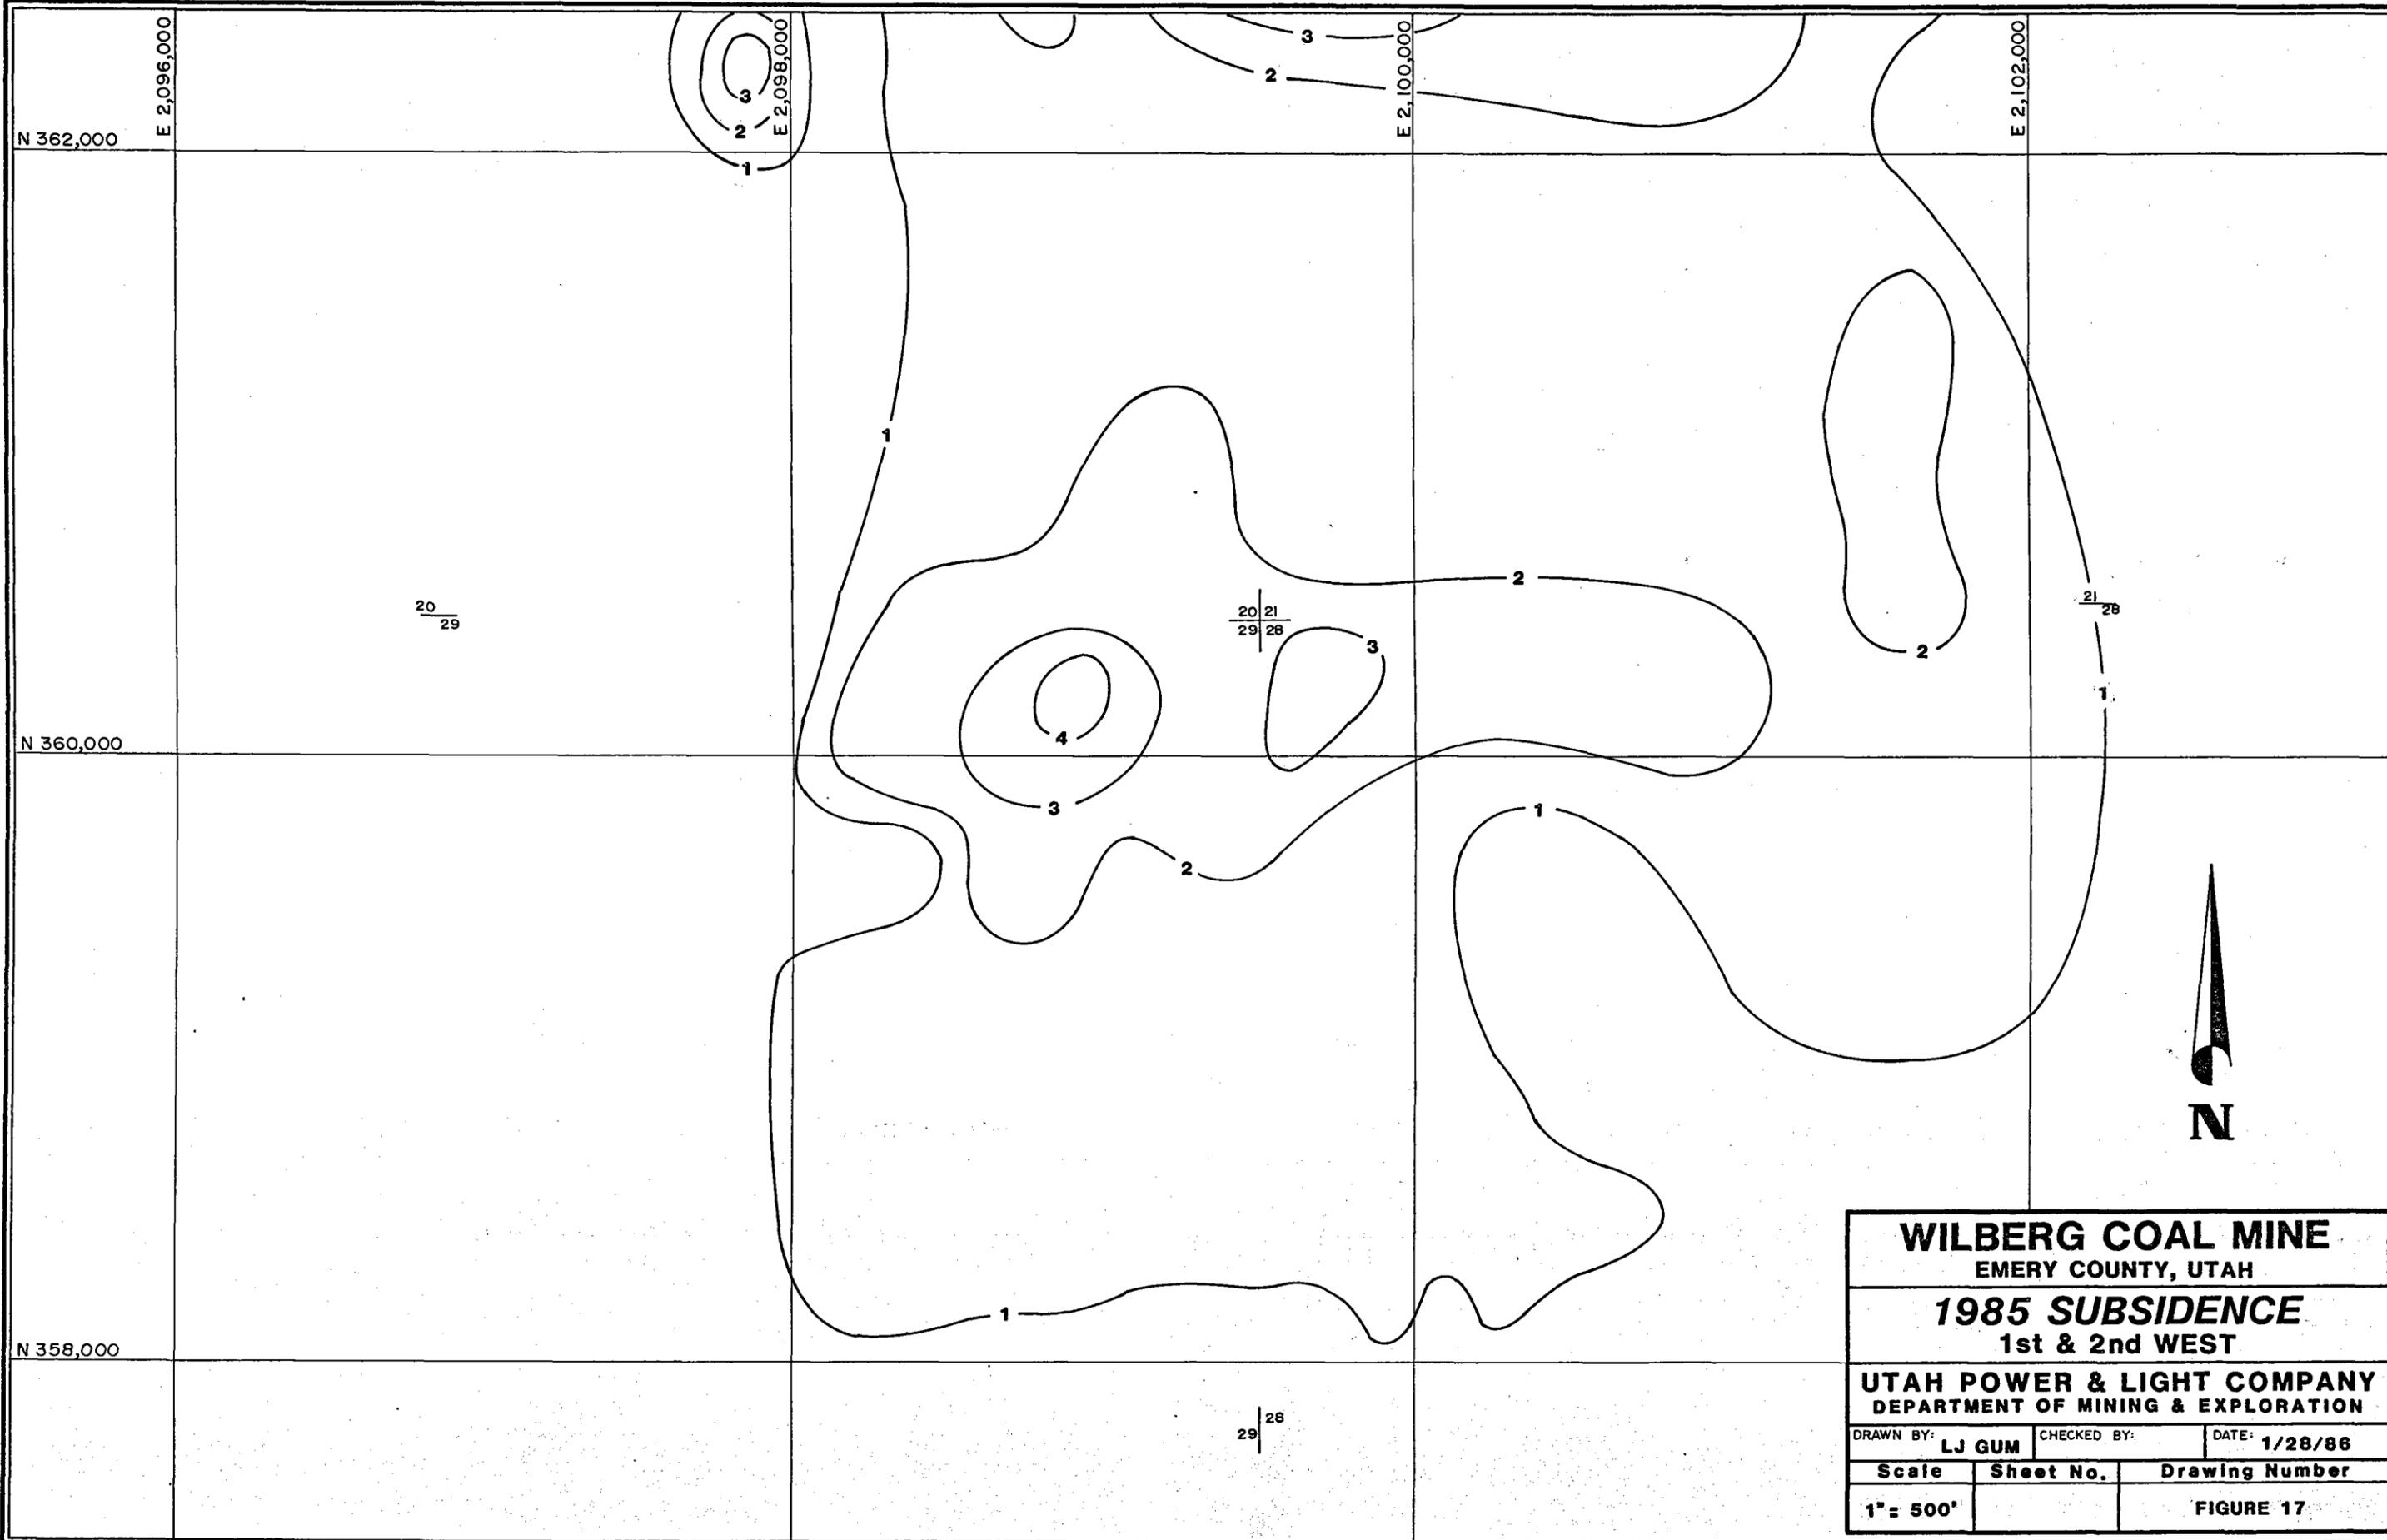
WILBERG COAL MINE		
EMERY COUNTY, UTAH		
1985 SUBSIDENCE		
1st & 2nd WEST		
UTAH POWER & LIGHT COMPANY		
DEPARTMENT OF MINING & EXPLORATION		
DRAWN BY: LJ GUM	CHECKED BY:	DATE: 1/28/86
Scale	Sheet No.	Drawing Number
1" = 500'		FIGURE 17

Maximum subsidence measured is now 4.2 feet using photogrammetry (Figure 17). No surface fractures or other visible disturbance have been found. On the south side of the area the subsidence diminishes to less than 0.5 feet within 1200 feet south of the longwall panels. With 2000 feet of overburden, this equates to an angle of draw of 21°.

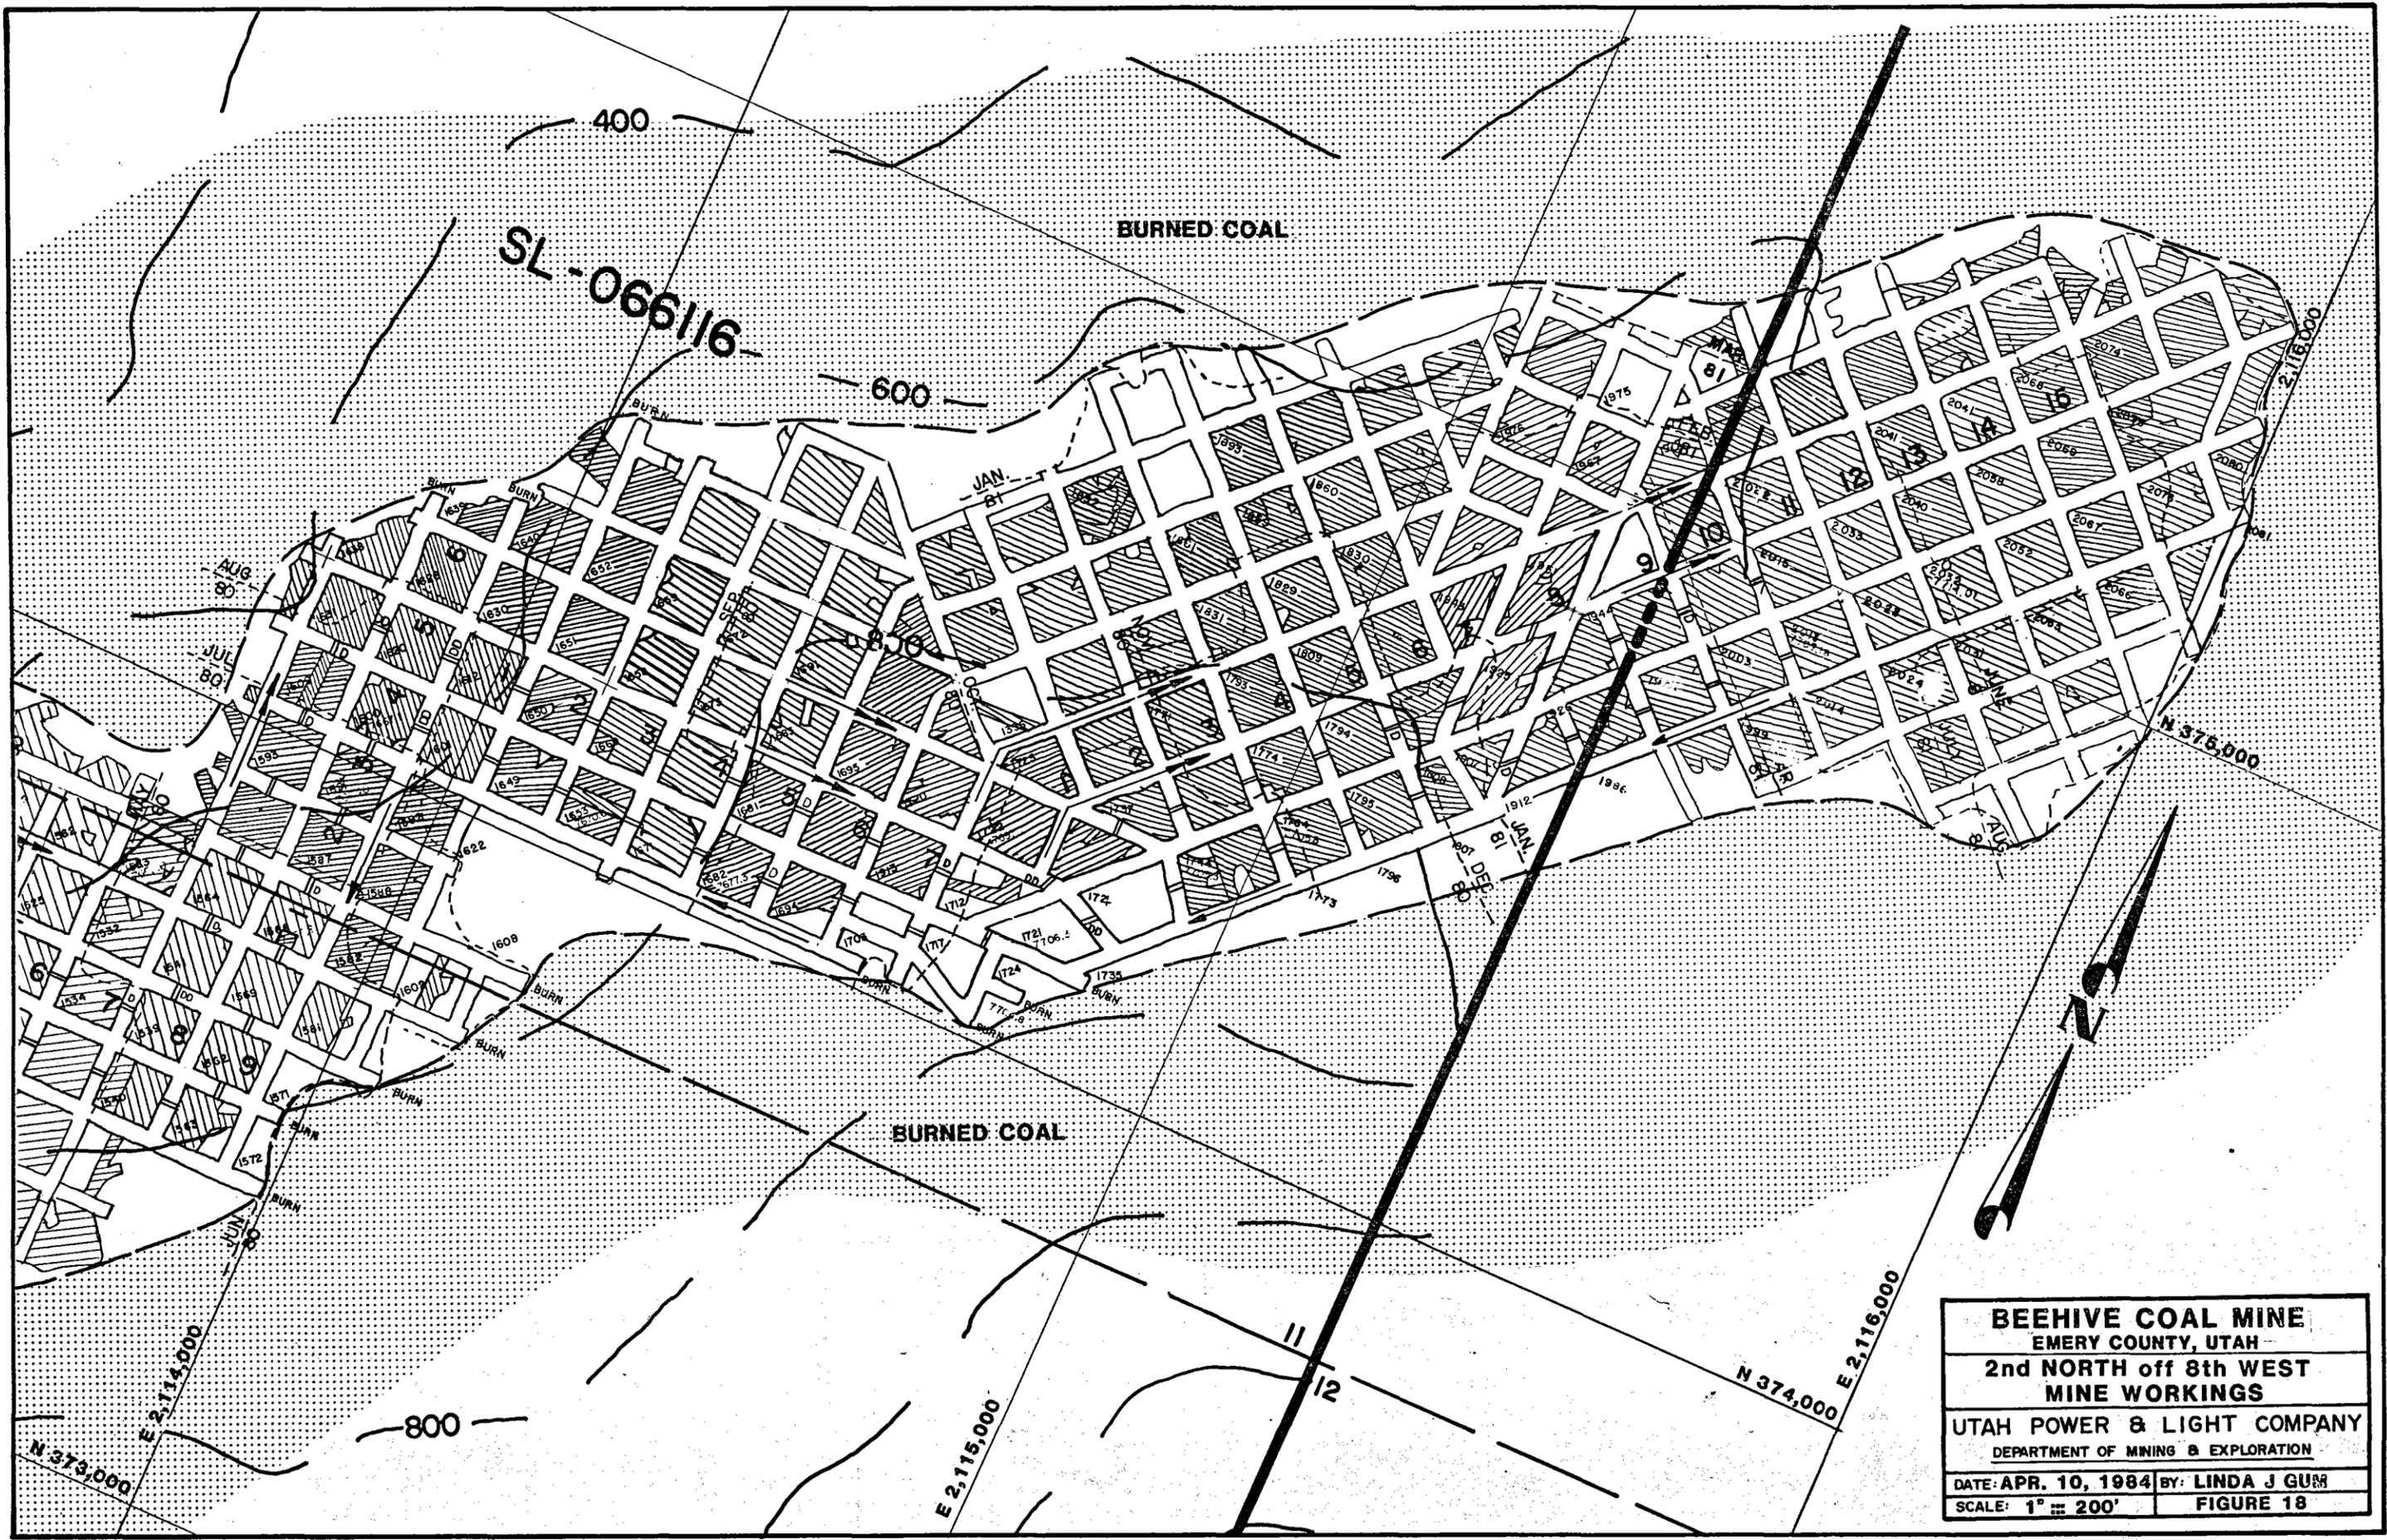
BEEHIVE COAL MINE	
EMERY COUNTY, UTAH	
2nd NORTH off 8th WEST	
MINE WORKINGS	
UTAH POWER & LIGHT COMPANY	
DEPARTMENT OF MINING & EXPLORATION	
DATE: APR. 10, 1984	BY: LINDA J GUM
SCALE: 1" = 200'	FIGURE 18

Pillar extraction mining was terminated in December 1983 in this section of the Beehive Mine. The area is surrounded by burned coal (Figure 18).

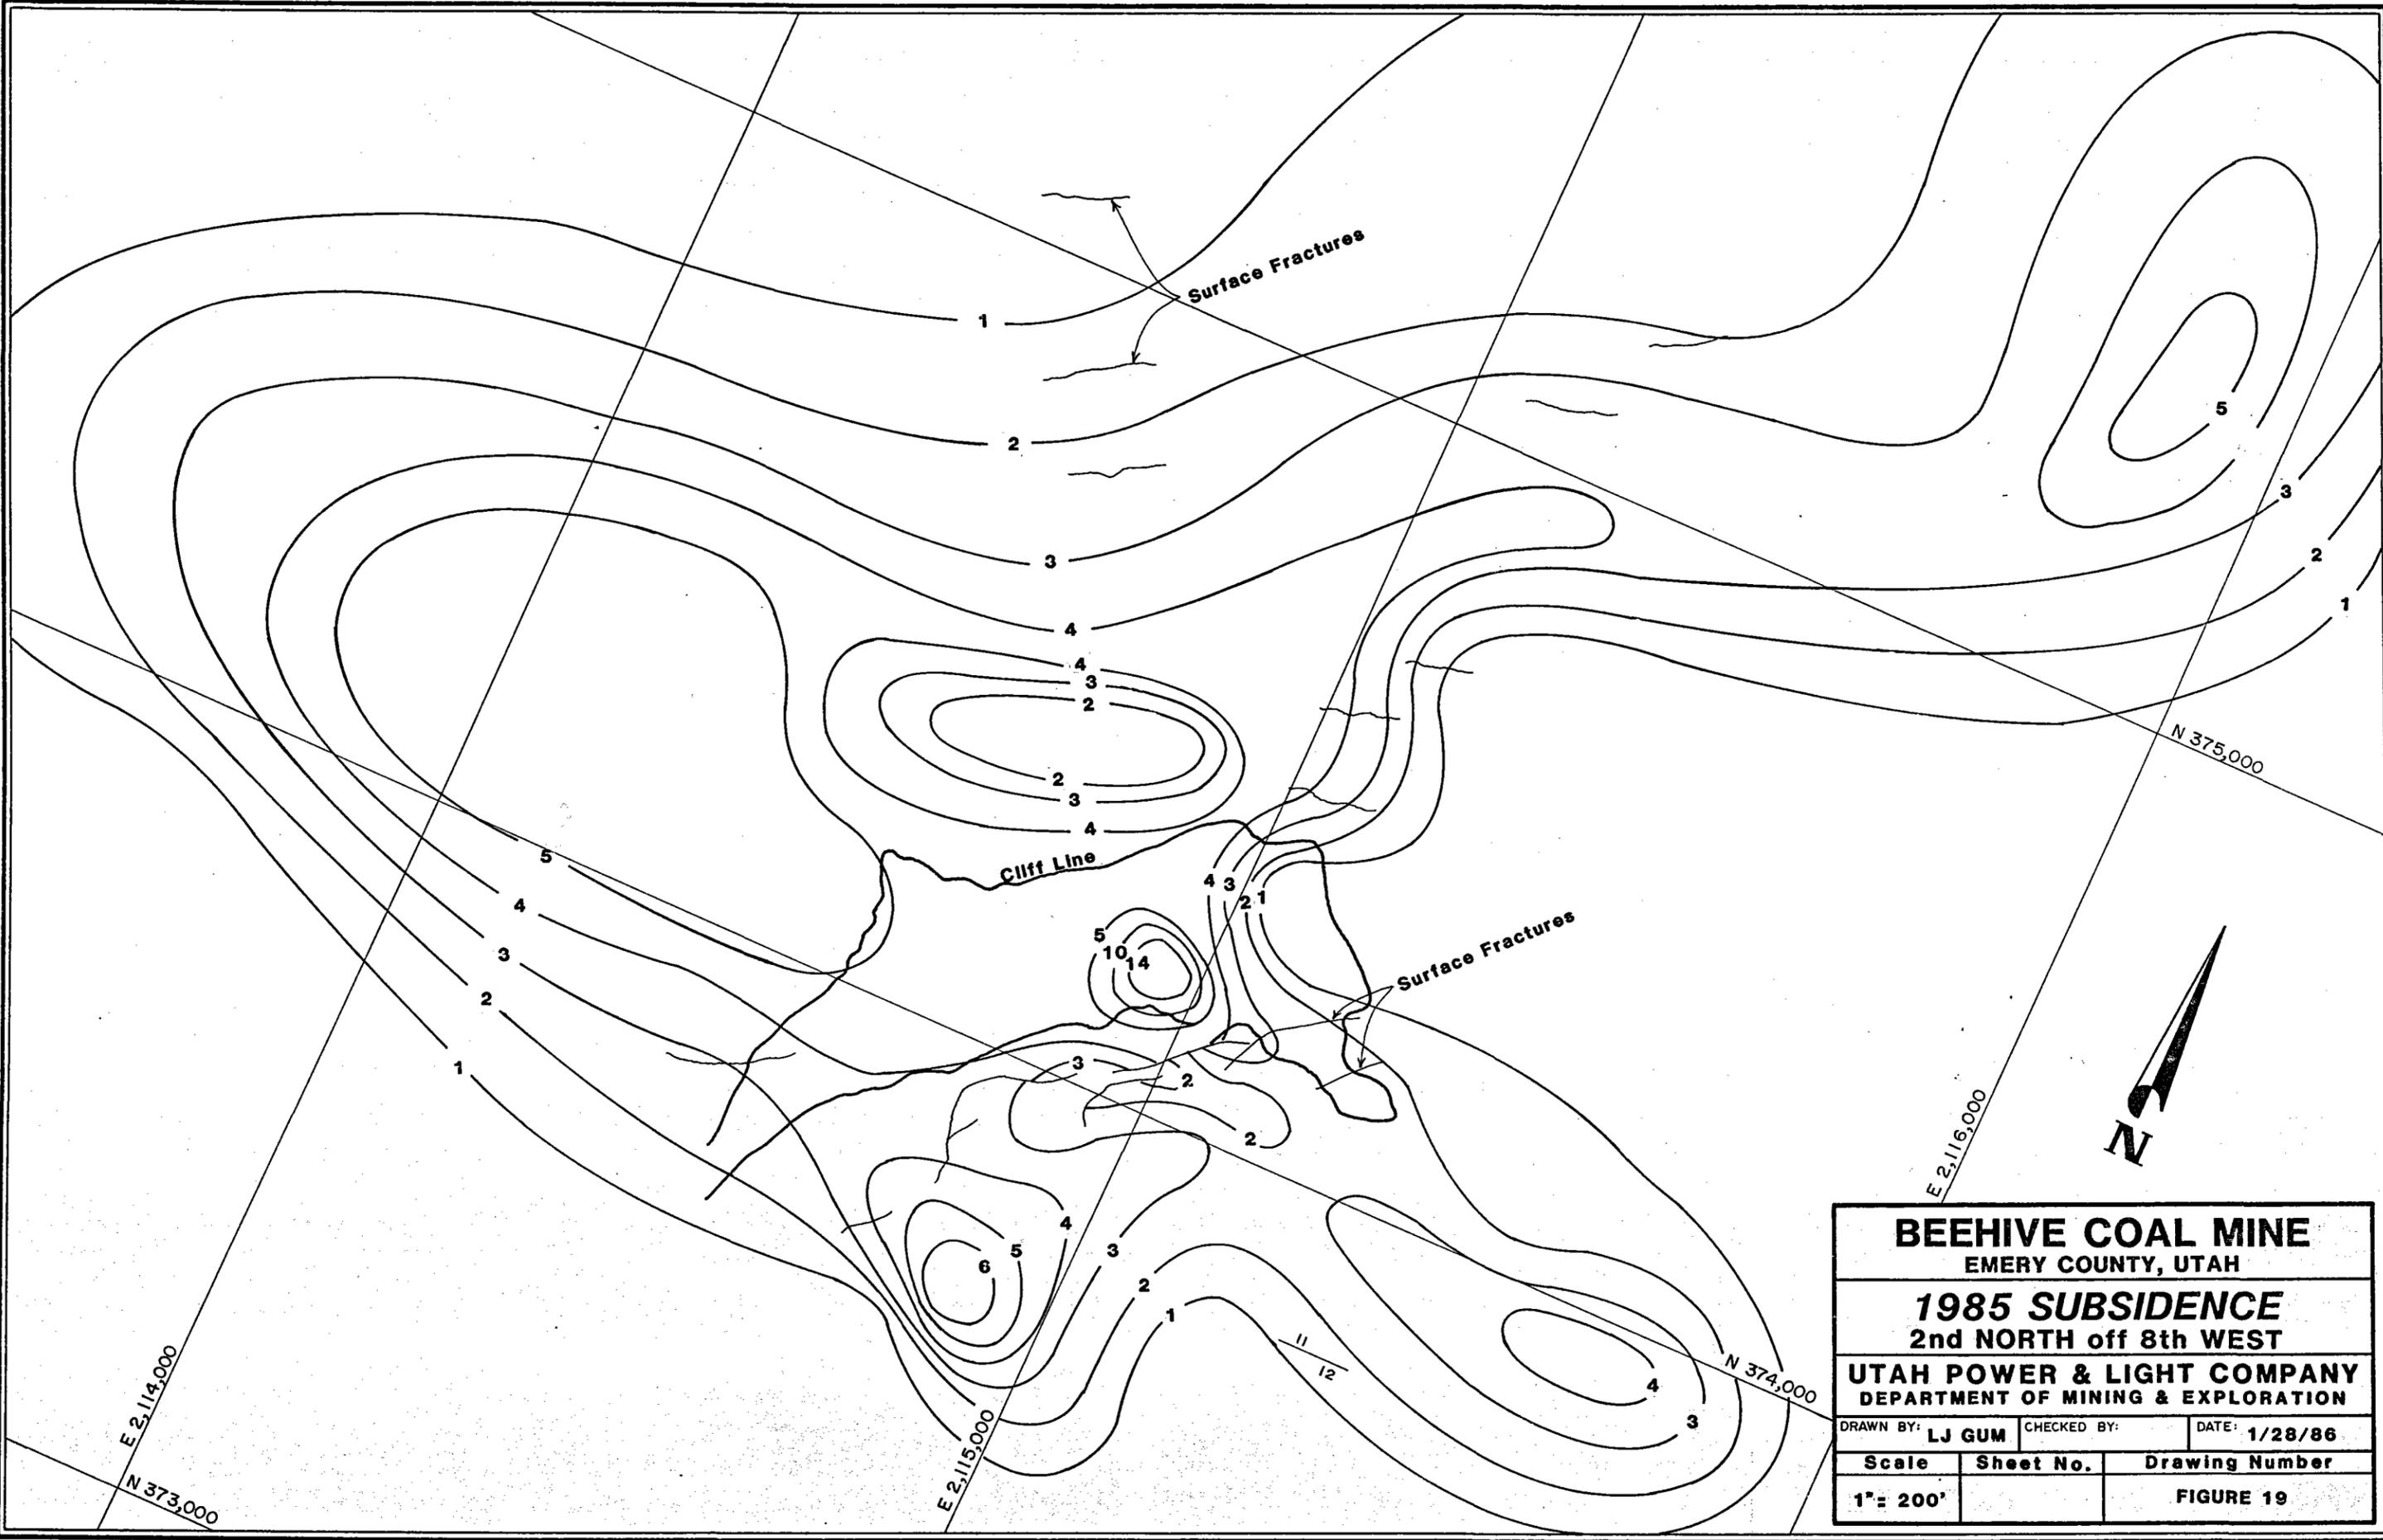
BEEHIVE COAL MINE		
EMERY COUNTY, UTAH		
1985 SUBSIDENCE		
2nd NORTH off 8th WEST		
UTAH POWER & LIGHT COMPANY		
DEPARTMENT OF MINING & EXPLORATION		
DRAWN BY: LJ GUM	CHECKED BY:	DATE: 1/28/86
Scale	Sheet No.	Drawing Number
1" = 200'		FIGURE 19

During the period from August 31, 1983 to August 31, 1984 subsidence continued to occur, reaching a maximum of 5.7 feet over the extracted mine workings. To the south of the workings over the burned coal a maximum of 14.6 feet of subsidence was observed (Figure 19). In examining aerial photography of the area taken in 1985, it appears that this subsidence is also due to mass wasting on the cliff edge. The rocks on the ridge were highly fractured prior to mining and it is probable that other instances of movement may occur given the fractured nature of the strata on the surface and the fact that this area overlies burned coal.

Because the area is surrounded by clinker beds it is not possible to calculate an accurate angle of draw.

In areas 3 and 7, where only minor fracturing has occurred on remote ridges and the present land use has not been affected, more damage would be done by gaining access to and repairing fractures than can be justified, therefore, mitigation is counter-productive in these areas.

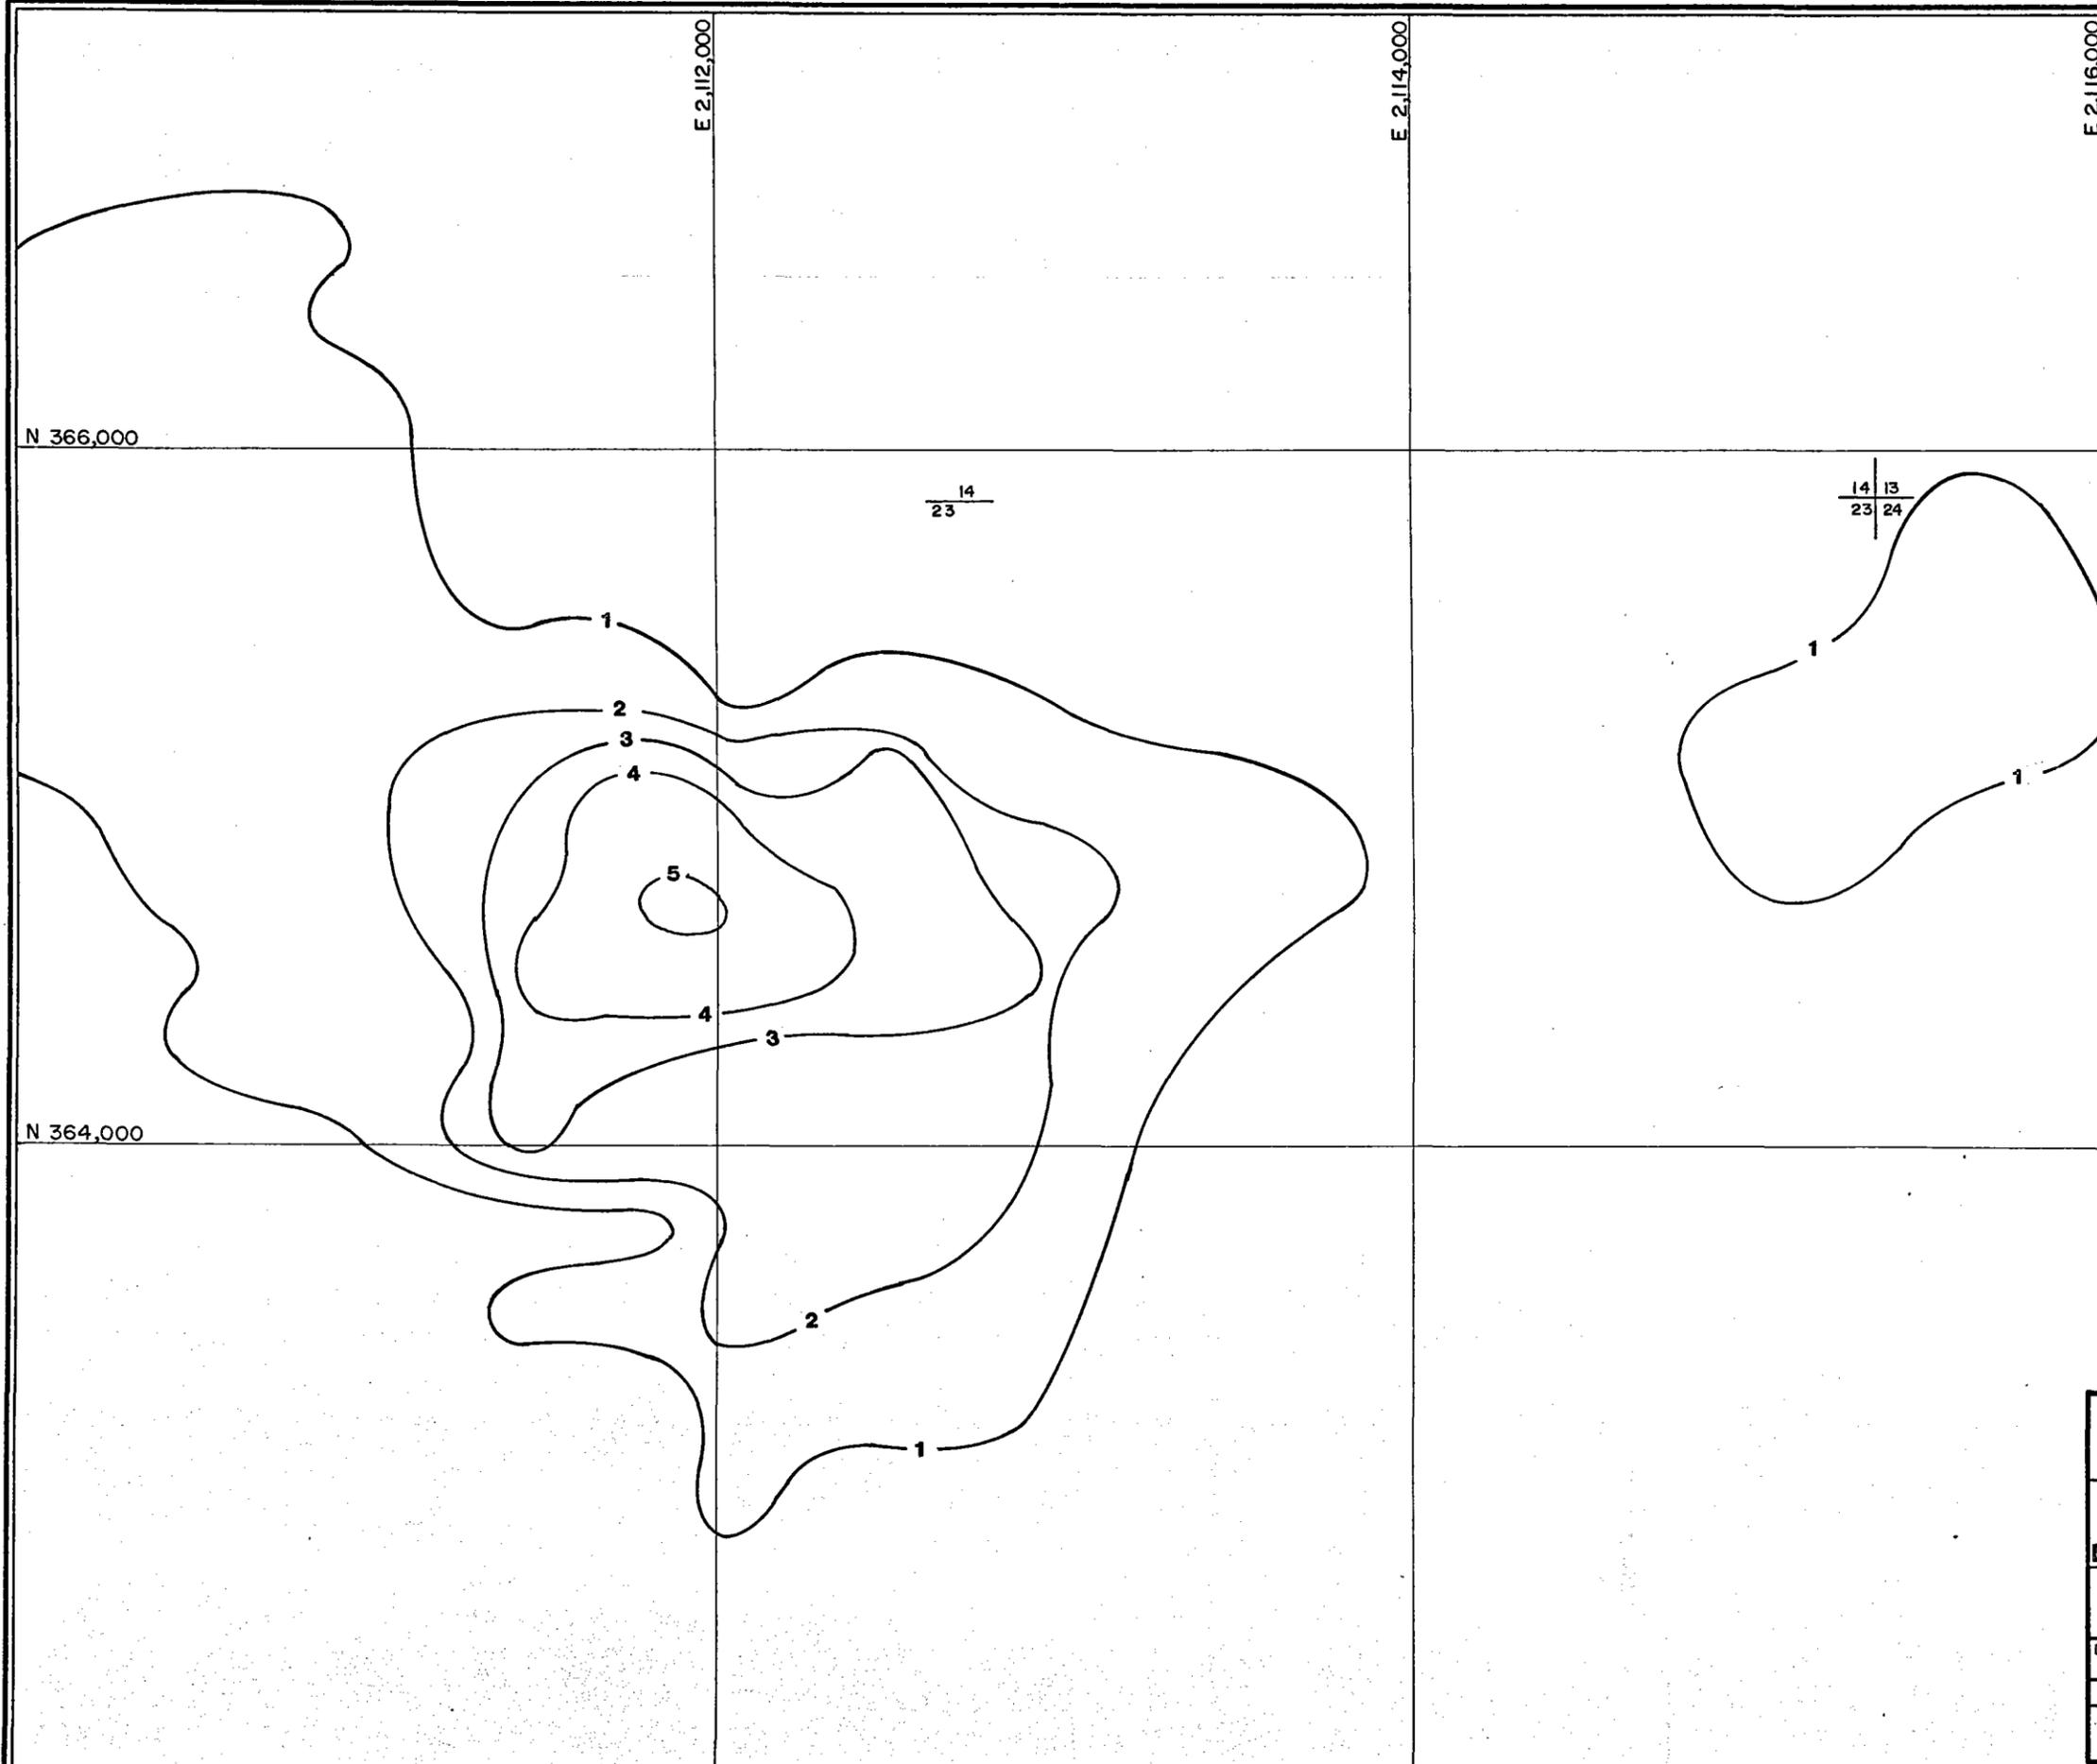
DES-BEE-DOVE COAL MINE		
EMERY COUNTY, UTAH		
1985 SUBSIDENCE		
BEEHIVE 4th-9th WEST & 3rd-6th EAST		
DESERET 5th-8th WEST & 3rd-10th EAST		
UTAH POWER & LIGHT COMPANY		
DEPARTMENT OF MINING & EXPLORATION		
DRAWN BY: LJ GUM	CHECKED BY:	DATE: 1/8/86
Scale	Sheet No.	Drawing Number
1" = 500'		FIGURE 22

Subsidence in the southern part of this area is somewhat less than expected, probably due to the above reasons. Further north, where mining in both seams has been more recent, observed subsidence has reached 5.0 feet (very close to the predicted maximum of 6.3 feet, see Figure 22).

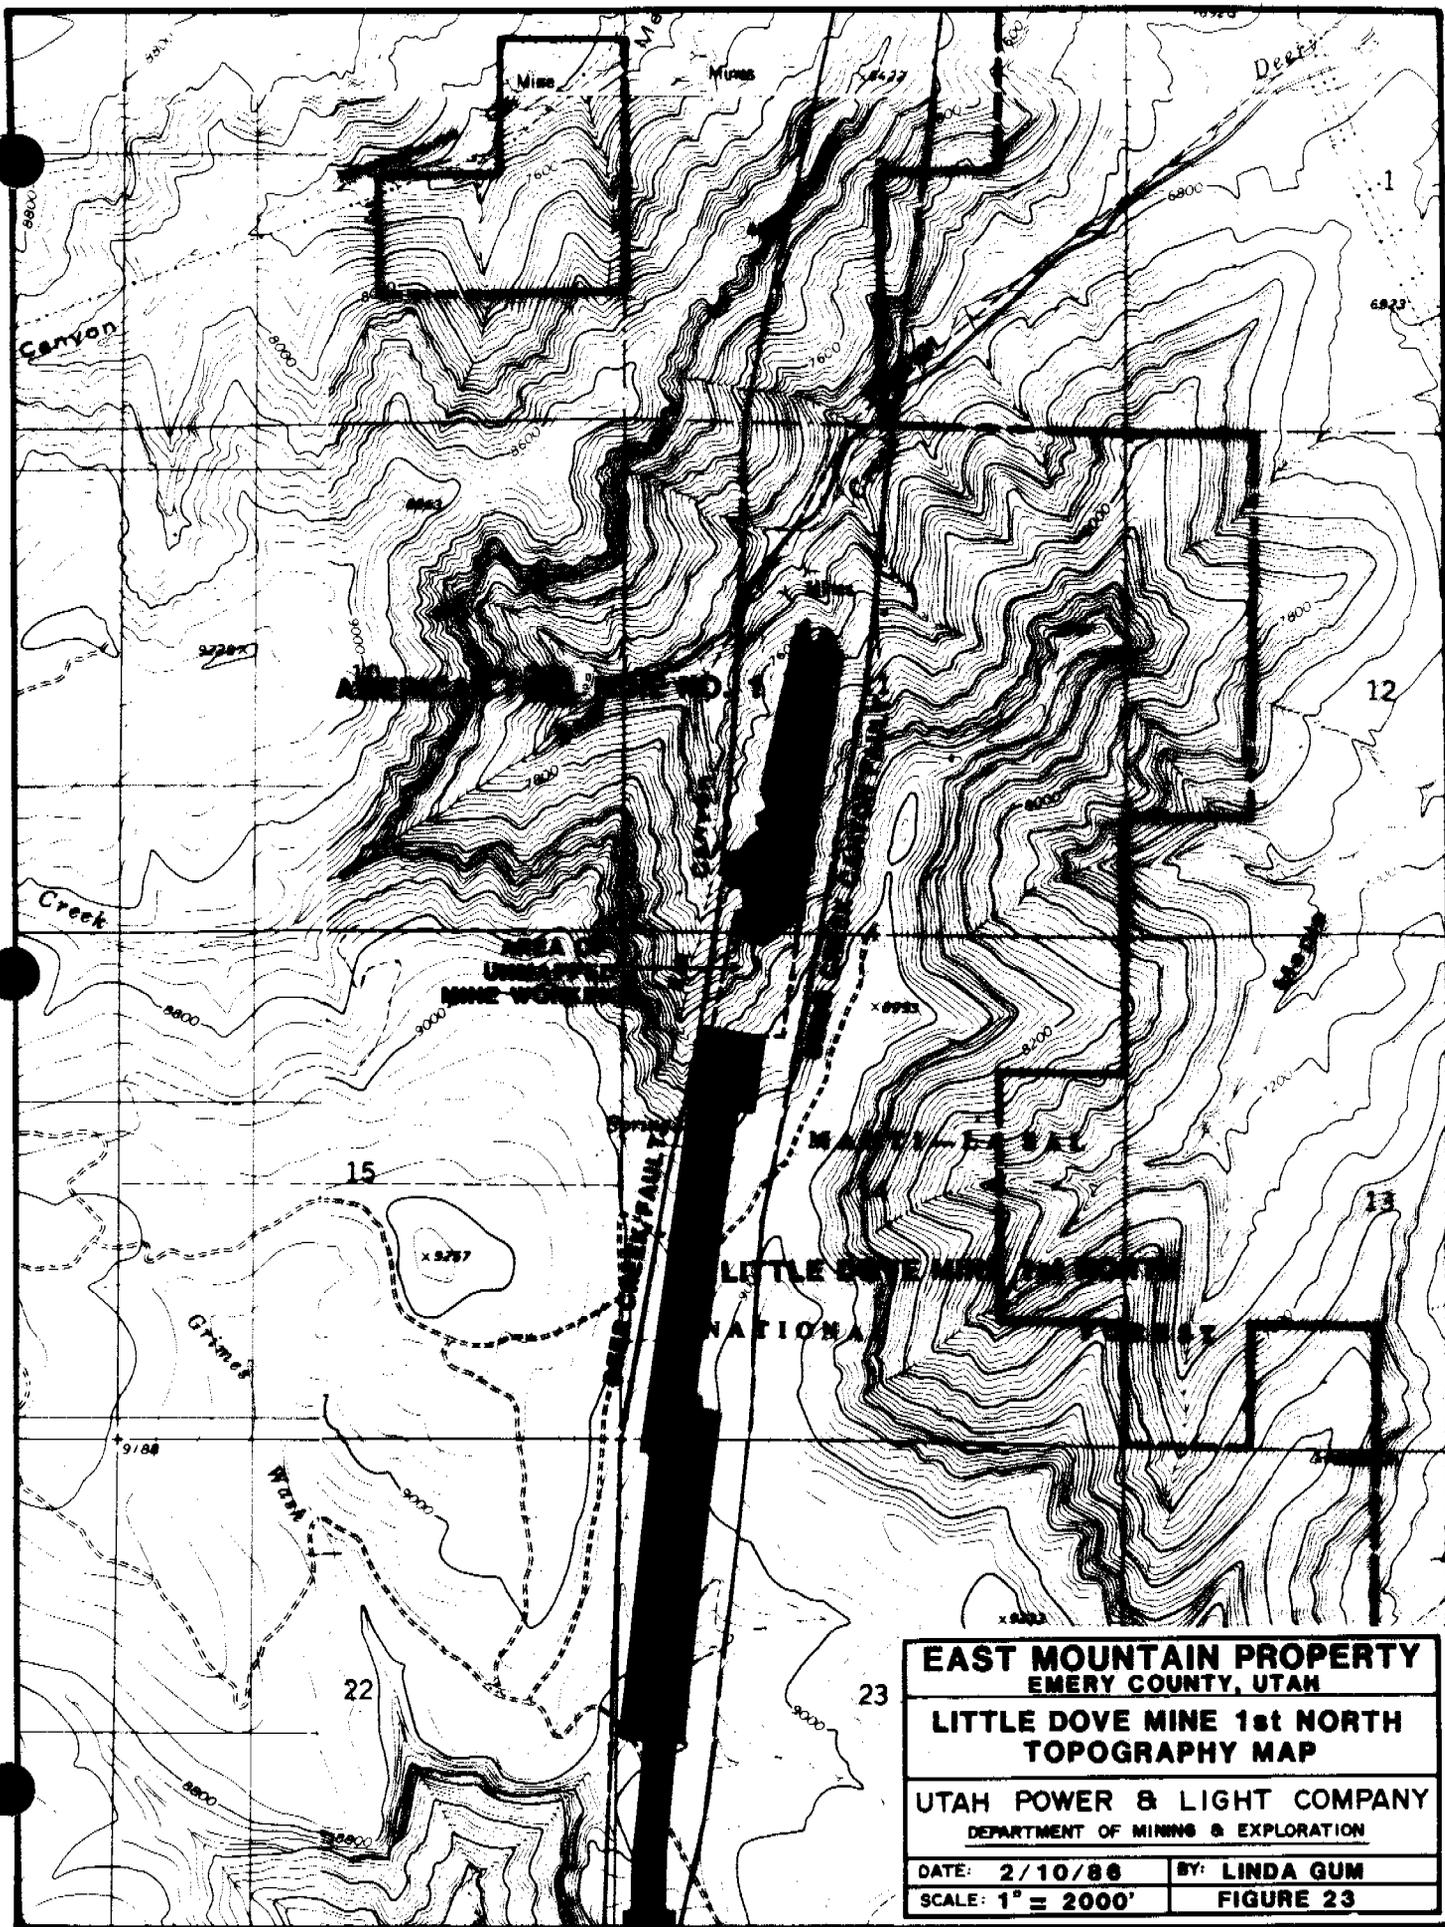
EAST MOUNTAIN PROPERTY	
EMERY COUNTY, UTAH	
LITTLE DOVE MINE 1st NORTH	
TOPOGRAPHY MAP	
UTAH POWER & LIGHT COMPANY	
DEPARTMENT OF MINING & EXPLORATION	
DATE: 2/10/86	BY: LINDA GUM
SCALE: 1" = 2000'	FIGURE 23

The Little Dove Mine and old American Fuel Mine are both located in a graben formed by the Deer Creek and Bear Creek Canyon Faults (see Figure 23). In August of 1982 the 1st North section of the Little Dove Mine intersected the old American Fuels Mine workings about 1,000 feet south of where available maps had indicated that they extend. Mining conditions in that area of Little Dove revealed that strata were highly stressed. In some cases pillars were crushed before they could be extracted.

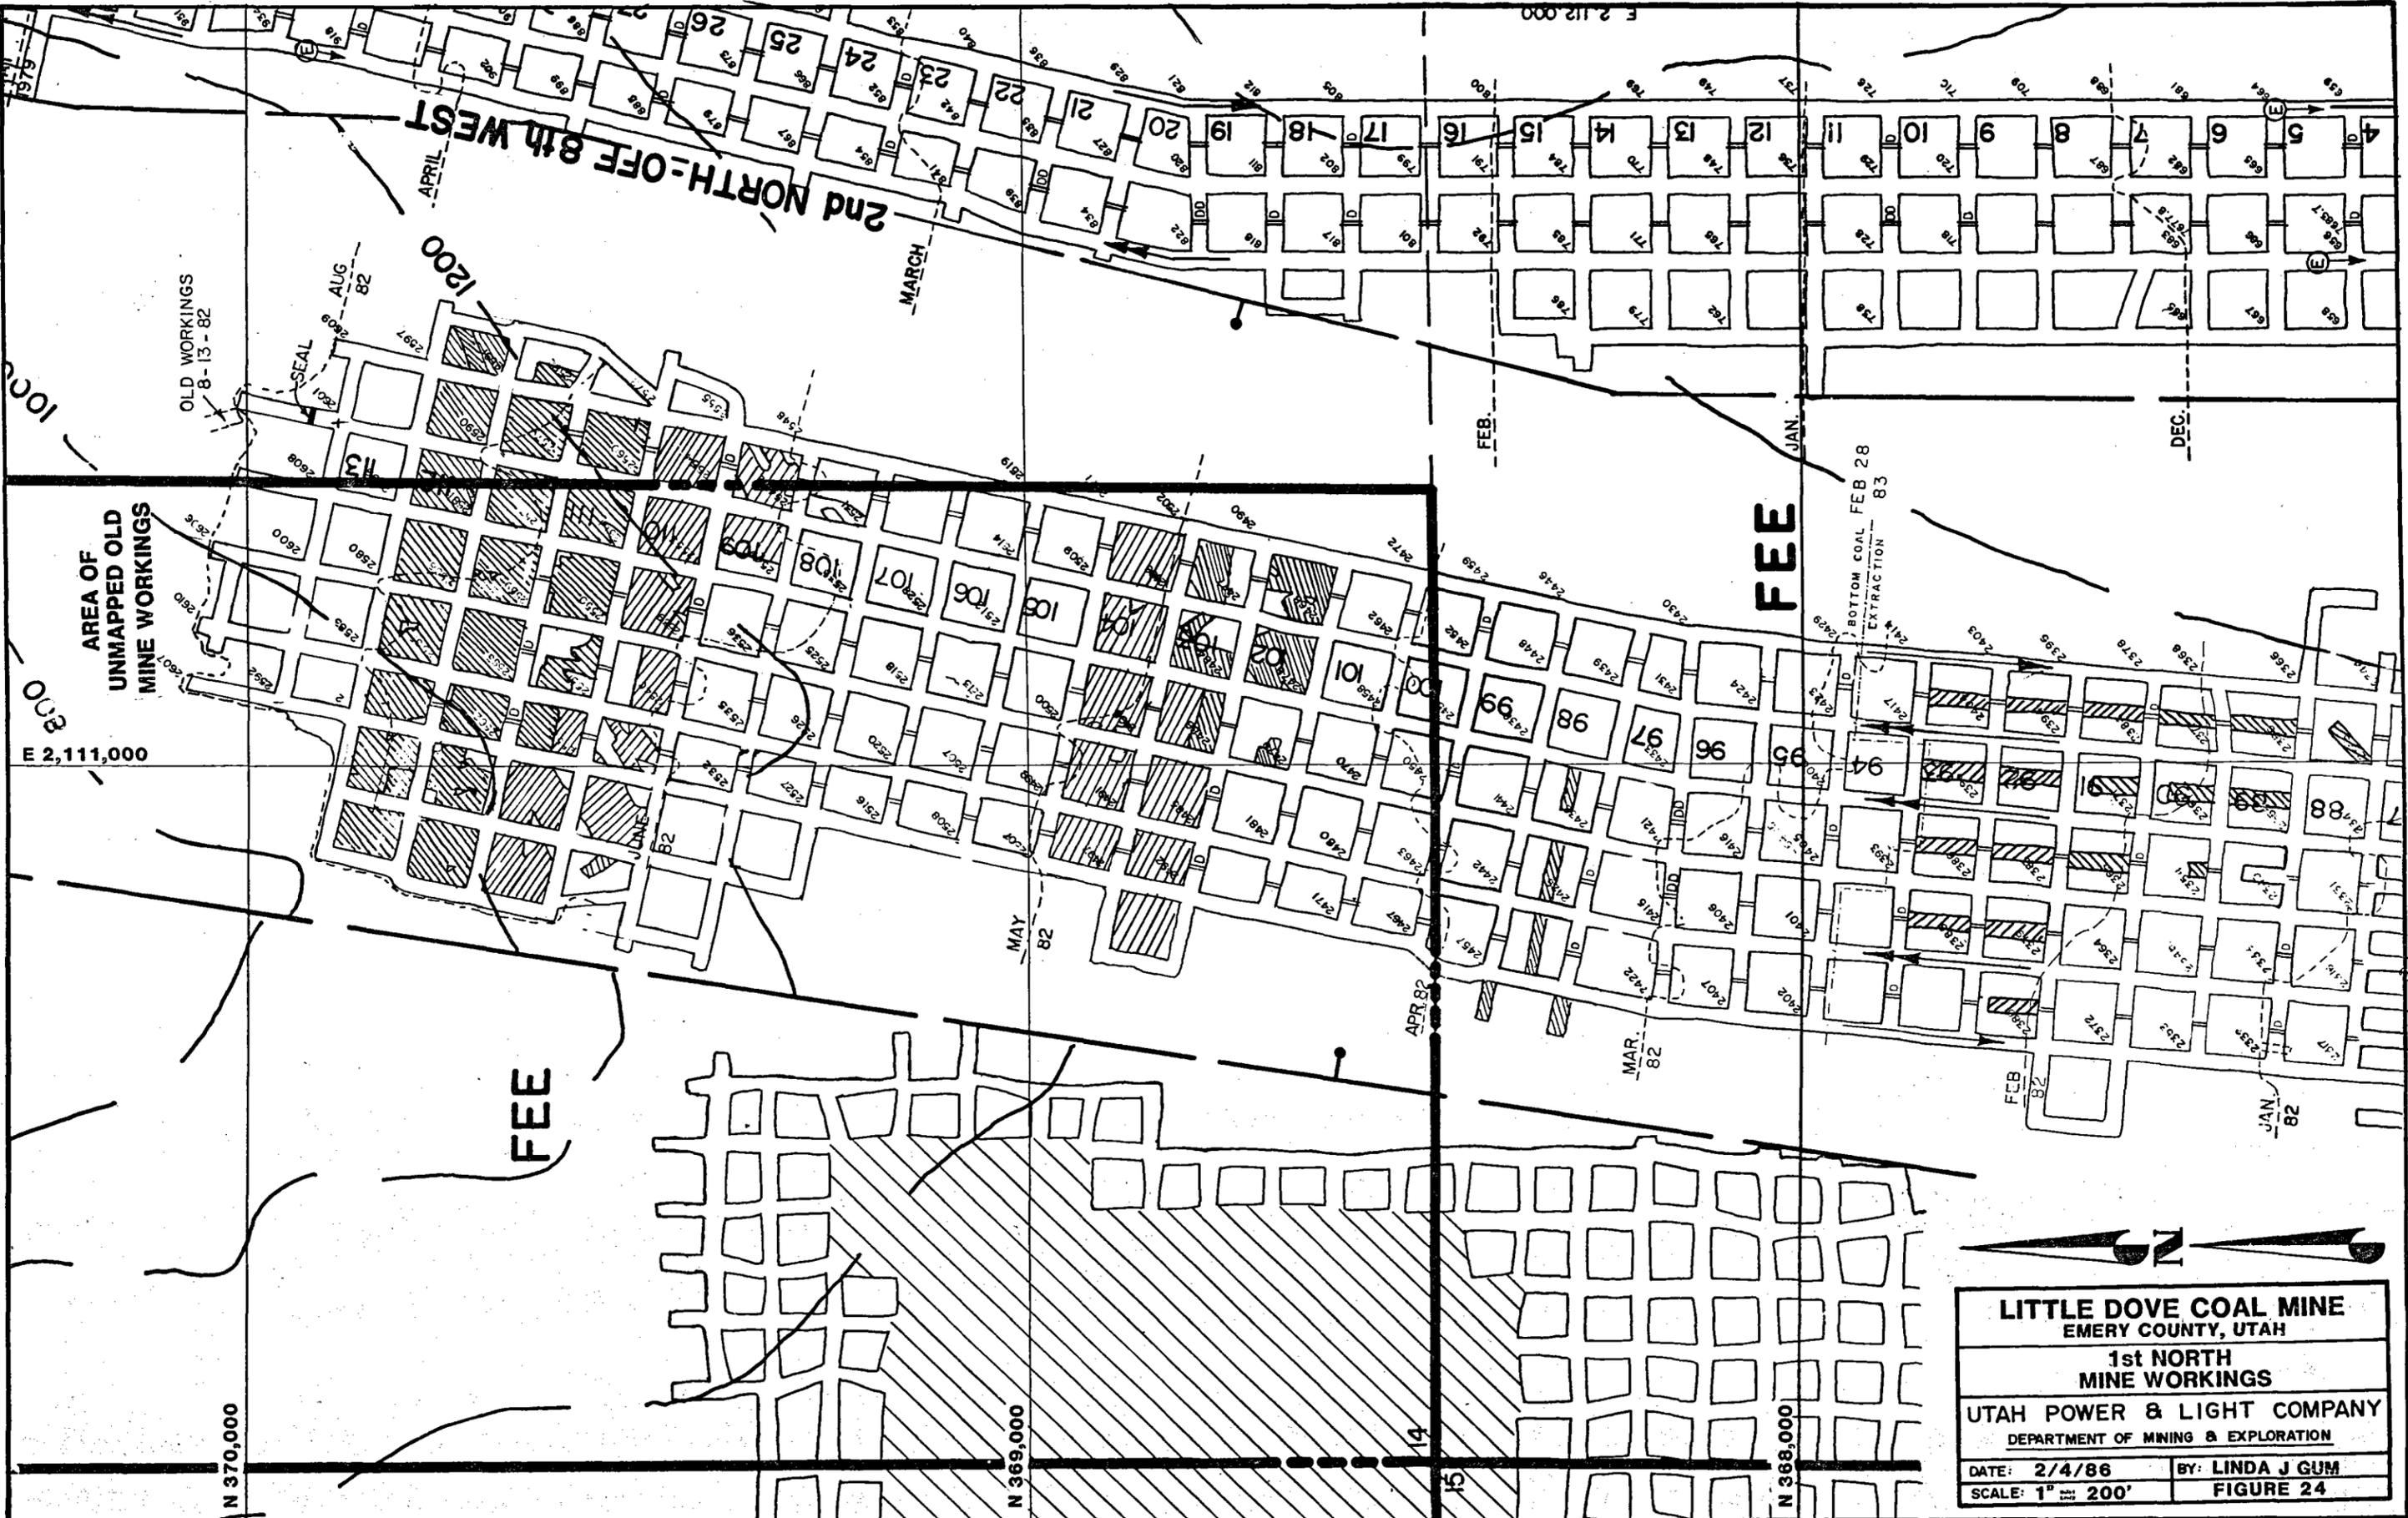
DATE: 2/4/86	BY: LINDA J GUM
SCALE: 1" = 200'	FIGURE 24

Maximum subsidence over the 1st North Little Dove workings remained at less than 2 feet in 1985 over an area of partial pillar extraction (compare Figures 24 and 25). The 4 feet of subsidence seen on Figure 25 actually occurs over the adjacent mined out workings of the Deer Creek and Wilberg Mines (Area 1).
